**Flood Control Project Maintenance
Levee Inspections**

Maintenance Issue Types Only, Levee Inspection Report By Mile - Spring 2020

Reclamation District No. 2096 Wetherbee Lake

Waterway	Bank	Unit Miles	Inspection Start/End	Inspector
Unit No. 01 San Joaquin River	Right	0.16	03/24/2020 03/24/2020	Alberto De Leon

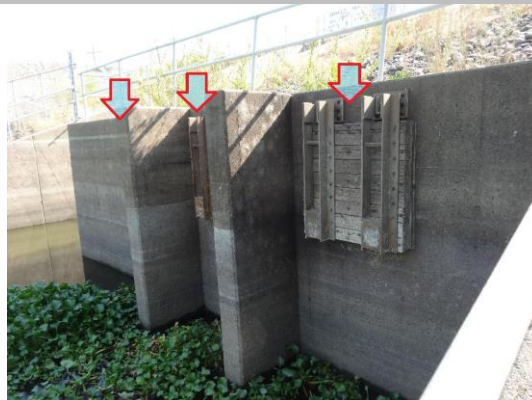
Photo 1 of 3 : UCIP_SP_2020_21505_36449.jpg

LM Start	0.02	Rating **	A/W	Issue No.	15	
LM End	0.02	Issue Type +	Ma	Location *		
Category	Supplemental			GPS Latitude/Longitude		
				Start	End	
Item	DWR UCIP LMA Responsibility			37.773852 °	37.773852 °	
				-121.298413 °	-121.298413 °	
DWR ID	22737

WS view: three wooden flap gates for drainage pipes. Concrete headwall at levee slope end.

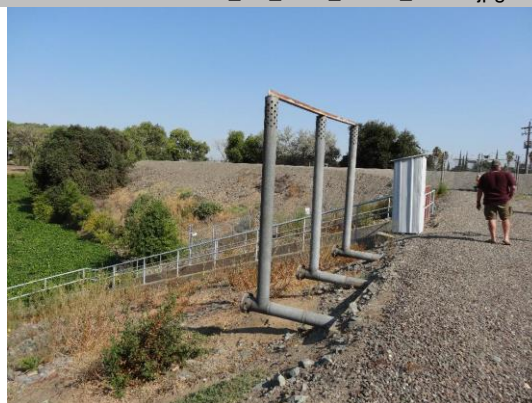
Photo 2 of 3 : UCIP_SP_2020_21505_36448.jpg

WS view: three air vents for three drainage pipes on levee shoulder.

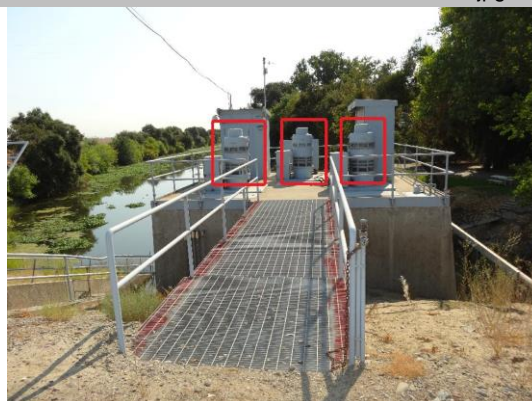
Photo 3 of 3 : UCIP_SP_2020_21505_36447.jpg

LS view: automatic pumping plant with three pumps. Steel walkway to pump platform.

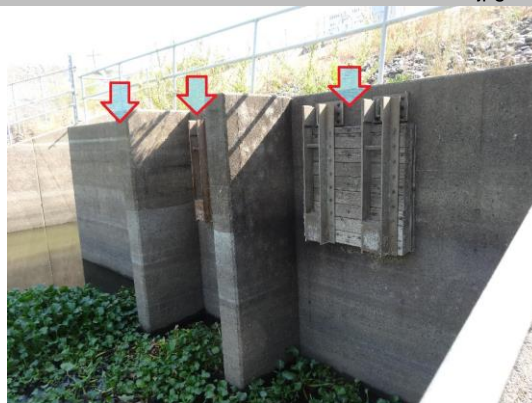
Photo 1 of 3 : UCIP_SP_2020_21507_36456.jpg

LM Start	0.02	Rating **	A/W	Issue No.	16
LM End	0.02	Issue Type +	Ma	Location *	
Category	Supplemental		GPS Latitude/Longitude		
			Start	End	
Item	DWR UCIP LMA Responsibility		37.773835 °	37.773835 °	
			-121.298419 °	-121.298419 °	
DWR ID	22740

WS view: three wooden flap gates for drainage pipes. Concrete headwall at levee slope end.

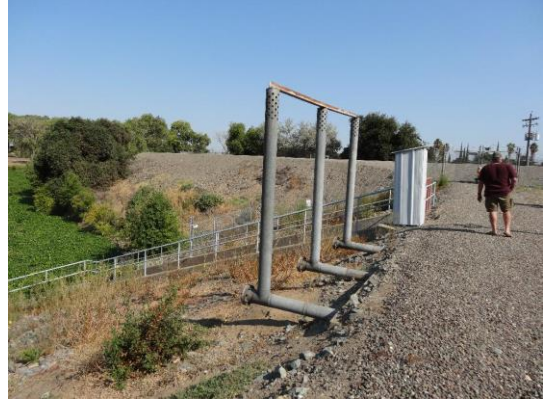
Photo 2 of 3 : UCIP_SP_2020_21507_36455.jpg

WS view: three air vents for three drainage pipes on levee shoulder.

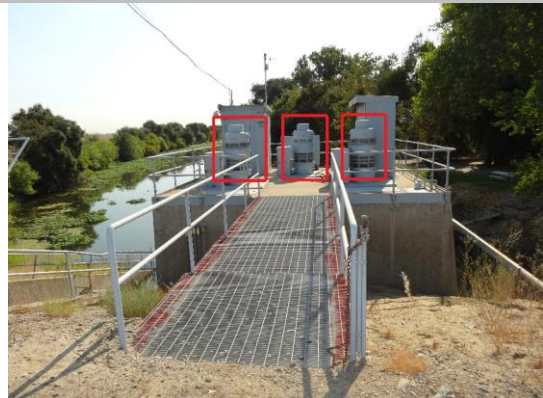
Photo 3 of 3 : UCIP_SP_2020_21507_36454.jpg

LS view: automatic pumping plant with three pumps. Steel walkway to pump platform.

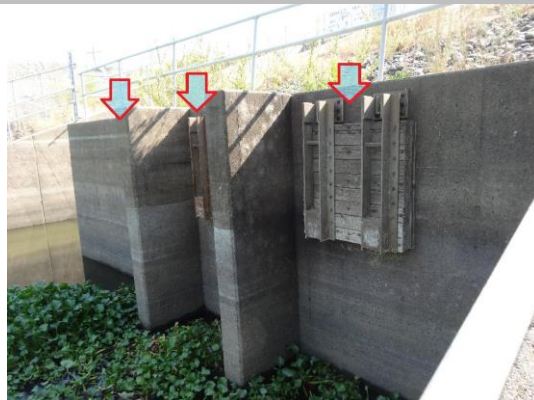
Photo 1 of 3 : UCIP_SP_2020_21508_36463.jpg

LM Start	0.03	Rating **	A/W	Issue No.	17	
LM End	0.03	Issue Type +	Ma	Location *		
Category	Supplemental			GPS Latitude/Longitude		
				Start	End	
Item	DWR UCIP LMA Responsibility			37.773818 °	37.773818 °	
				-121.298423 °	-121.298423 °	
DWR ID	22739

WS view: three wooden flap gates for drainage pipes. Concrete headwall at levee slope end.

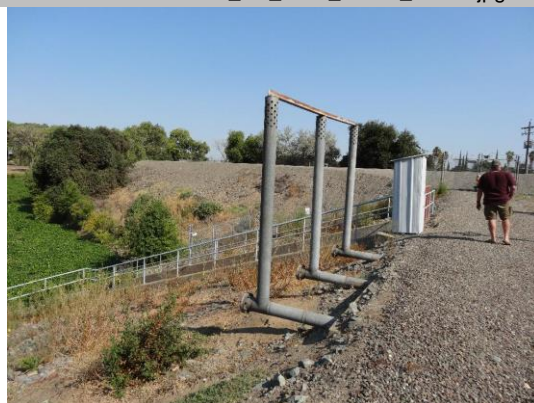
Photo 2 of 3 : UCIP_SP_2020_21508_36460.jpg

WS view: three air vents for three drainage pipes on levee shoulder.

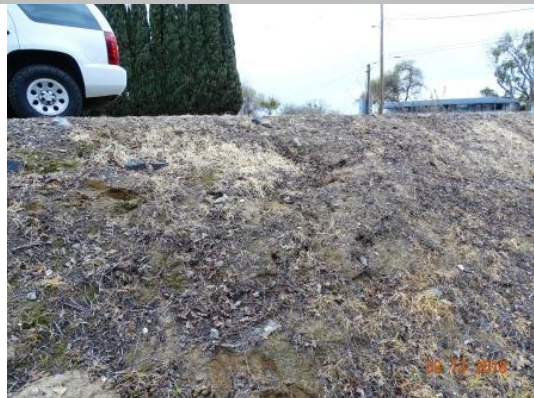
Photo 1 of 1 : SP_2020_RD2096_117_6_20200228_00001.jpg

LM Start	0.09	Rating **	A/W	Issue No.	6
LM End	0.09	Issue Type +	Ma	Location *	LS
Category	Earthen Levee			GPS Latitude/Longitude	
				Start	End
Item	Animal Control			37.772891 °	37.772891 °
				-121.298454 °	-121.298454 °
DWR ID	DWR_RD2096_01_s_2016_6				
Comment Code					
A3 : No rodents visible, but rodent burrows visible; need to backfill and compact or grout burrows.					
Inspector Comment					
The LMA has an effective rodent control program. Monitor this location for possible future activity.

View of the previously rodent infested area on the landside levee slope.

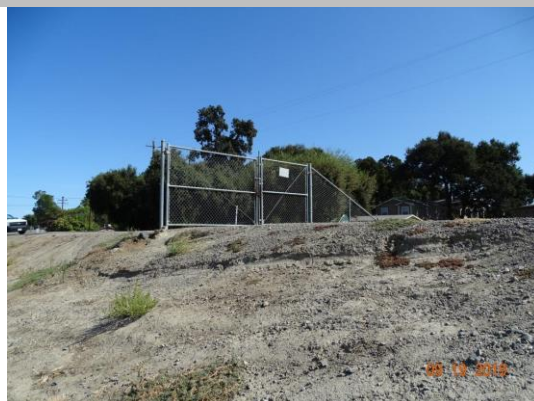
Photo 1 of 2 : SP_2020_RD2096_117_11_20200228_00004.jpg

LM Start	0.12	Rating **	M	Issue No.	11
LM End	0.12	Issue Type +	Ma	Location *	WS
Category	Earthen Levee			GPS Latitude/Longitude	
				Start	End
Item	Slope Stability			37.772434 °	37.772434 °
				-121.298433 °	-121.298433 °
DWR ID	DWR_RD2096_01_s_2015_11				
Comment Code					
S3 : Repair the levee slope damaged by vehicle traffic and prevent access where possible.					
Inspector Comment					
Waterside slope has rills/ruts caused by pedestrian and motorcycle traffic. The LMA is working with land owner to restrict access. Recommend slope be graded and restored to design standards.

View of waterside slope depressions caused by motorcycle and/or pedestrian traffic. Fall 2019

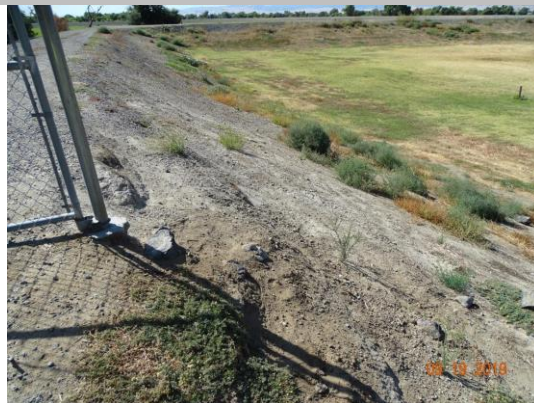
Photo 2 of 2 : SP_2020_RD2096_117_11_20200228_00005.jpg

View of waterside slope depressions caused by motorcycle and/or pedestrian traffic. Fall 2019

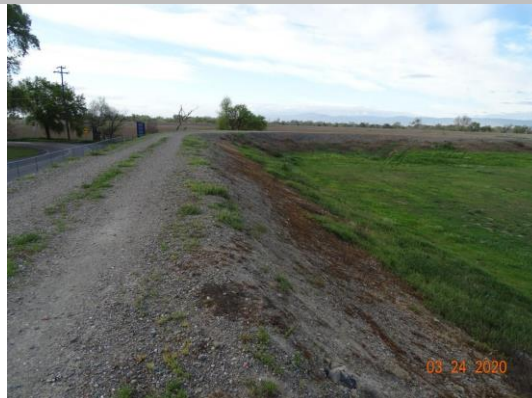
Photo 1 of 1 : SP_2020_RD2096_117_14_20200324_00018.jpg

LM Start	0.12	Rating **	A	Issue No.	14
LM End	0.12	Issue Type +	Ma	Location *	WS
Category	Earthen Levee			GPS Latitude/Longitude	
				Start	End
Item	Vegetation			37.772387 °	37.772387 °
				-121.298437 °	-121.298437 °
DWR ID	DWR_RD2096_01_s_2020_14				
Comment Code					
V1 : Control annual grass and weeds on the levee slopes and easements.					
Inspector Comment

Typical view of well maintained vegetation on waterside slope. Spring 2020

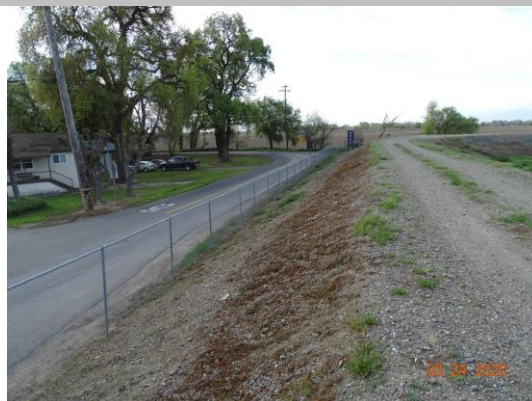
Photo 1 of 1 : SP_2020_RD2096_117_12_20200324_00019.jpg

LM Start	0.12	Rating **	A	Issue No.	12
LM End	0.12	Issue Type +	Ma	Location *	LS
Category	Earthen Levee			GPS Latitude/Longitude	
				Start	End
Item	Vegetation			37.772386 °	37.772386 °
				-121.298432 °	-121.298432 °
DWR ID	DWR_RD2096_01_s_2020_12				
Comment Code					
V1 : Control annual grass and weeds on the levee slopes and easements.					
Inspector Comment

Typical view of well maintained vegetation on landside slope. Spring 2020
