**Flood Control Project Maintenance  
Levee Inspections**

## Maintenance Issue Types Only, Levee Inspection Report By Mile - Spring 2021

### Reclamation District No. 2096 Wetherbee Lake

Waterway	Bank	Unit Miles	Inspection Start/End	Inspector
Unit No. 01 San Joaquin River	Right	0.16	05/05/2021 05/05/2021	Alberto De Leon

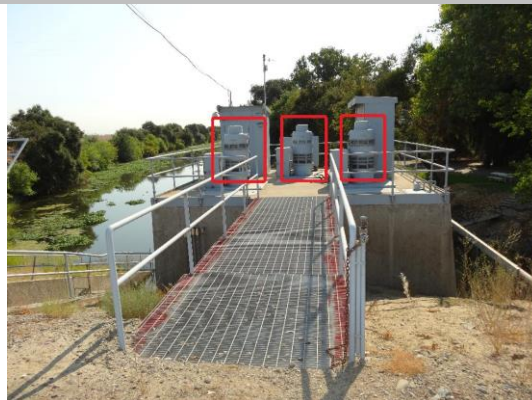
Photo 3 of 3 : UCIP\_SP\_2021\_21505\_36447.jpg

LS view: automatic pumping plant with three pumps. Steel walkway to pump platform.

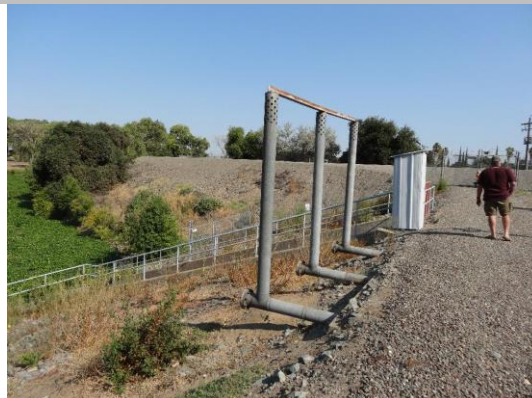
Photo 2 of 3 : UCIP\_SP\_2021\_21507\_36455.jpg

WS view: three air vents for three drainage pipes on levee shoulder.

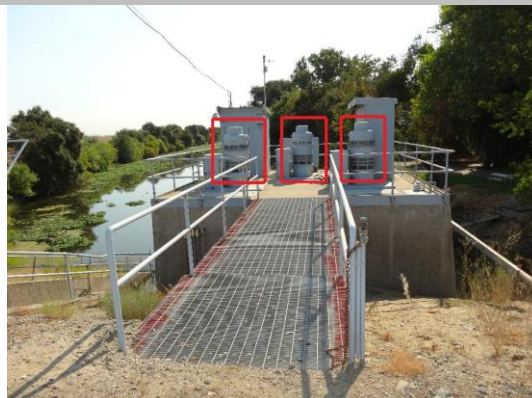
Photo 3 of 3 : UCIP\_SP\_2021\_21507\_36454.jpg

LS view: automatic pumping plant with three pumps. Steel walkway to pump platform.
