**Flood Control Project Maintenance
Levee Inspections**

Maintenance Issue Types Only, Levee Inspection Report By Mile - Spring 2022

Reclamation District No. 2096 Wetherbee Lake

Waterway	Bank	Unit Miles	Inspection Start/End	Inspector
Unit No. 01 San Joaquin River	Right	0.16	05/05/2022 05/05/2022	Alberto De Leon

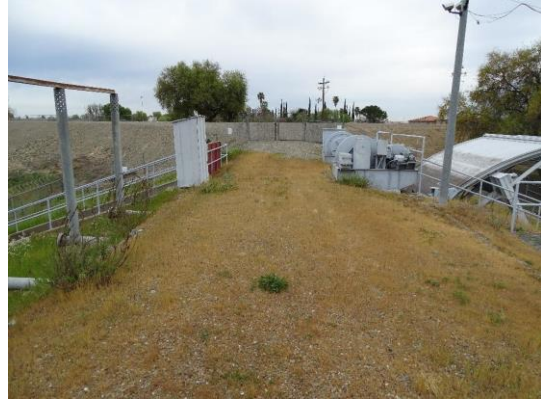
Photo 1 of 3 : UCIP_SP_2022_72694_108919.jpg

Comment Code					
Inspector Comment					
FS_ID:72694 DS_ID:22737 EP_NO: N/A Repair Type: Non-Urgent Crossing Status: Found UCIP Comments: 03/17/2022 Record updated from No Action Needed to Non-Urgent. No permit has been identified authorizing pipe. (D.Sanoski - DWR UCIP) 10/17/2019 This structure is inspected annually under the Structure and Channel Summer Inspection (part of the Levee Inspection Program) conducted by the DWR Flood Project Integrity and Inspection Branch (FPIIB). (DWR UCIP - O. Magana) 09/10/2013 - steel walkway to pump platform.- pumping plant and navigation structure area is fenced with gates at north and south end. (P. Amatya - DWR UCIP) FIELD_STRUCT_DESC: 1 of 3: 36-inch drainage discharge pipe of an unknown material through the levee, 3.5 feet below the crown. One concrete cutoff wall. Automatic pumping plant and concrete sump on the landside (LS). Vent pipes on the waterside (WS) shoulder. Concrete headwall and spill box on the WS. Flap gate on the WS end. [Additional Reference(s): DWR Levee Log, 2005. USACE San Joaquin O&M Manual 3, December 1968, (HLM 0.03)]. FS Date: 3/17/2022 12:54:00 PM

Top of Levee: view of crown.

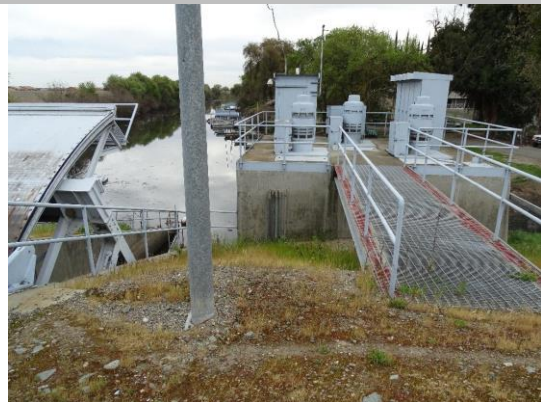
Photo 2 of 3 : UCIP_SP_2022_72694_108920.jpg

Land-Side: view of slope and walkway to pump.

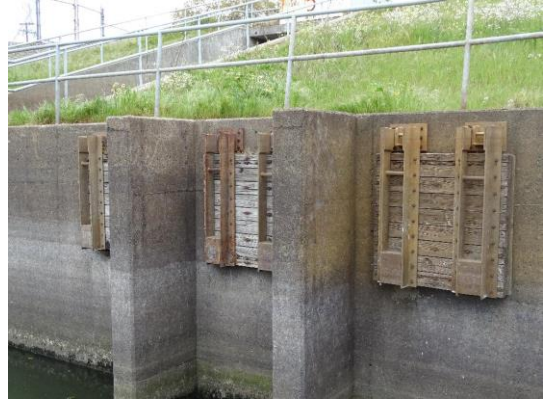
Photo 3 of 3 : UCIP_SP_2022_72694_108921.jpg

Water-Side: view of wooden flap gates and concrete headwall.

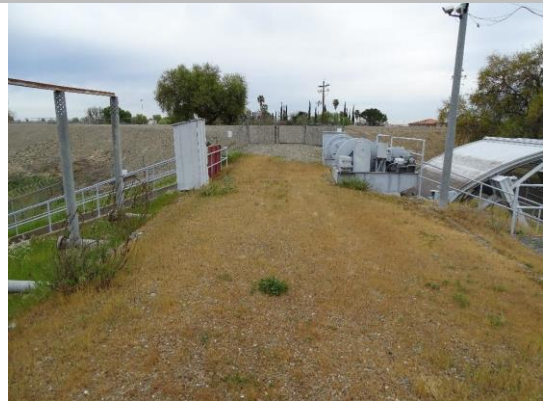
Photo 1 of 3 : UCIP_SP_2022_72695_108924.jpg

FS_ID:72695
DS_ID:22740
EP_NO: N/A
Repair Type: Non-Urgent
Crossing Status: Found
UCIP Comments: 03/17/2022 Record updated from No Action Needed to Non-Urgent. No permit has been identified authorizing pipe.
(D.Sanoski - DWR UCIP)
10/17/2019 This structure is inspected annually under the Structure and Channel Summer Inspection (part of the Levee Inspection Program) conducted by the DWR Flood Project Integrity and Inspection Branch (FPIIB). (DWR UCIP - O. Magana)
09/10/2013 - steel walkway to pump platform.- pumping plant and navigation structure area is fenced with gates at north and south end.

(P. Amatya - DWR UCIP)
FIELD_STRUCT_DESC: 2 of 3: 36-inch drainage discharge pipe of an unknown material through the levee, 3.5 feet below the crown. One concrete cutoff wall. Automatic pumping plant and concrete sump on the landside (LS). Vent pipes on the waterside (WS) shoulder. Concrete headwall and spill box on the WS. Flap gate on the WS end. [Additional Reference(s): DWR Levee Log, 2005. USACE San Joaquin O&M Manual 3, December 1968, (HLM 0.03)].
FS Date: 3/17/2022 1:08:44 PM

Top of Levee: view of crown.

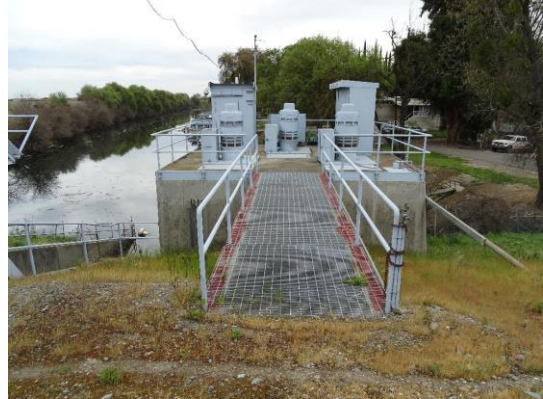
Photo 2 of 3 : UCIP_SP_2022_72695_108925.jpg

Land-Side: view of slope and walkway to pump

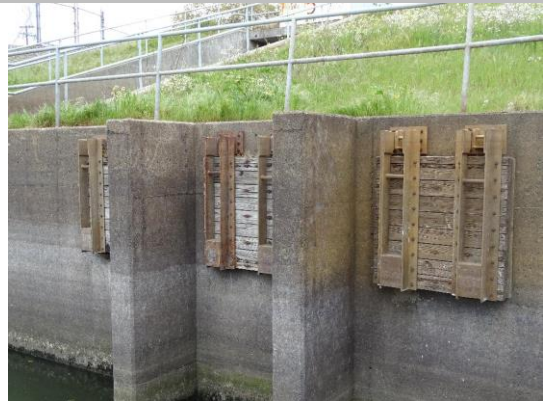
Photo 3 of 3 : UCIP_SP_2022_72695_108926.jpg

Water-Side: view of headwall with wooden flap gates.

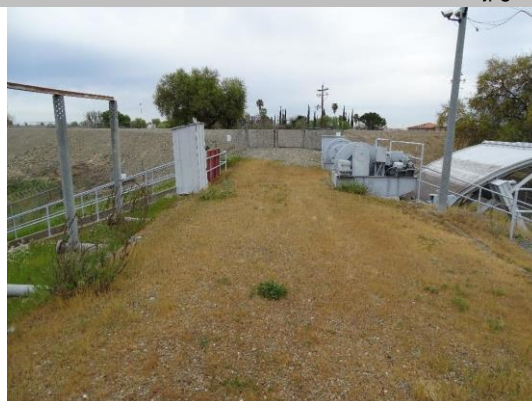
Photo 1 of 3 : UCIP_SP_2022_72696_108929.jpg

Comment Code						
Inspector Comment						
FS_ID:72696						
DS_ID:22739						
EP_NO: N/A						
Repair Type: Non-Urgent						
Crossing Status: Found						
UCIP Comments: 03/17/2022 Record updated from No Action Needed to Non-Urgent. No permit has been identified authorizing pipe.						
(D.Sanoski - DWR UCIP)						
10/17/2019 This structure is inspected annually under the Structure and Channel Summer Inspection (part of the Levee Inspection Program) conducted by the DWR Flood Project Integrity and Inspection Branch (FPIIB). (DWR UCIP - O. Magana)						
09/10/2013 - steel walkway to pump platform.- pumping plant and navigation structure area is fenced with gates at north and south end.

(P. Amatya - DWR UCIP)						
FIELD_STRUCT_DESC: 3 of 3: 36-inch drainage discharge pipe of an unknown material through the levee, 3.5 feet below the crown. One concrete cutoff wall. Automatic pumping plant and concrete sump on the landside (LS). Vent pipes on the waterside (WS) shoulder. Concrete headwall and spill box on the WS. Flap gate on the WS end. [Additional Reference(s): DWR Levee Log, 2005. USACE San Joaquin O&M Manual 3, December 1968, (HLM 0.03)].						
FS Date: 3/17/2022 1:20:53 PM

Top of Levee: view of crown.

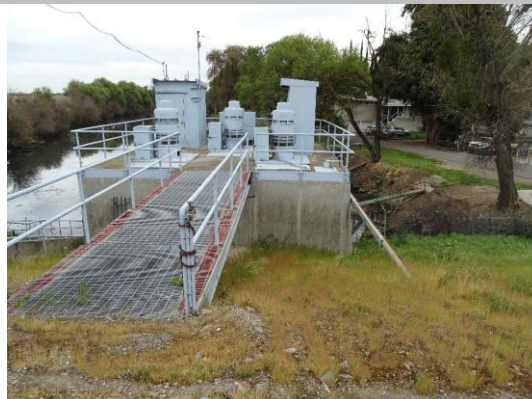
Photo 2 of 3 : UCIP_SP_2022_72696_108930.jpg

Land-Side: view of slope and walkway to pump.

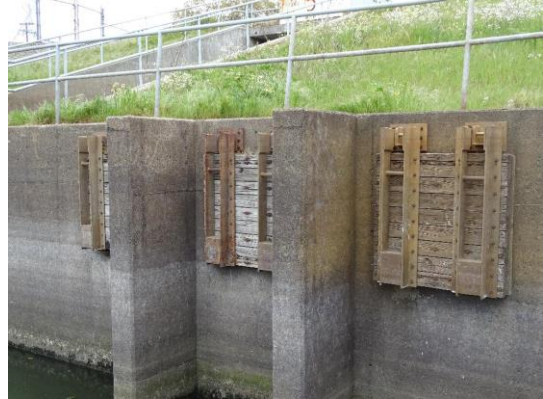
Photo 3 of 3 : UCIP_SP_2022_72696_108931.jpg

Water-Side: view of headwall with wooden flap gates.

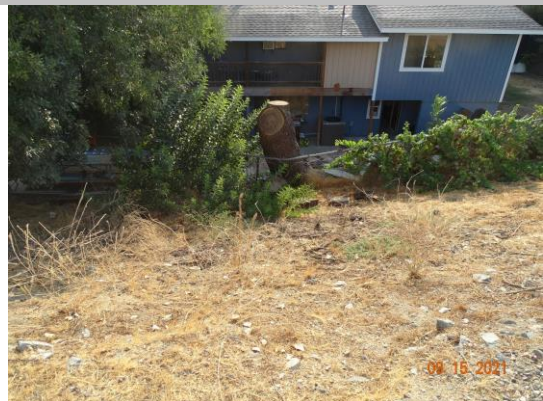
Photo 1 of 1 : SP_2022_RD2096_117_9_20220406_00001.jpg

LM Start	0.06	Rating **	N	Issue No.	9
LM End	0.06	Issue Type +	Ma	Location *	LS
Category	Earthen Levee			GPS Latitude/Longitude	
				Start	End
Item	Trim / Thin Trees			37.773348 °	37.773348 °
				-121.298475 °	-121.298475 °
DWR ID	DWR_RD2096_01_s_2014_9				
Comment Code					
T5 : Tree stumps.					
Inspector Comment

View of tree stump on the landside levee toe. Fall 2021
