**Flood Control Project Maintenance
Levee Inspections**

Maintenance Issue Types Only, Levee Inspection Report By Mile - Spring 2023

Reclamation District No. 2096 Wetherbee Lake

| Waterway | Bank | Unit Miles | Inspection Start/End | Inspector |
|---|---|---|---|---|
| Unit No. 01 San Joaquin River | Right | 0.16 | 05/01/2023 05/01/2023 | Alberto De Leon |

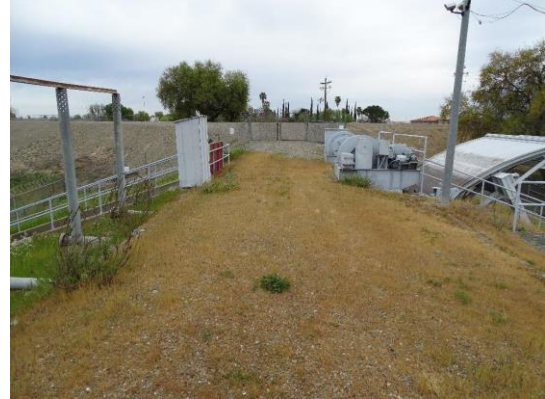
Photo 1 of 3 : UCIP_SP_2023_75022_108919.jpg

| DS_ID:22737 FS_ID:75022 EP_NO: N/A Repair Type: No Action Needed EVAL Issue: Crossing Status: Found UCIP Comments: 03/17/2022 Record remains No Action Needed. (D.Sanoski - DWR UCIP) 10/17/2019 This structure is inspected annually under the Structure and Channel Summer Inspection (part of the Levee Inspection Program) conducted by the DWR Flood Project Integrity and Inspection Branch (FPIIB). (DWR UCIP - O. Magana)09/10/2013 - steel walkway to pump platform.- pumping plant and navigation structure area is fenced with gates at north and south end. (P. Amatya - DWR UCIP) FIELD_STRUCT_DESC: 1 of 3: 36-inch drainage discharge pipe of an unknown material through the levee, 3.5 feet below the crown. One concrete cutoff wall. Automatic pumping plant and concrete sump on the landside (LS). Vent pipes on the waterside (WS) shoulder. Concrete headwall and spill box on the WS. Flap gate on the WS end. [Additional Reference(s): DWR Levee Log, 2005. USACE San Joaquin O&M Manual 3, December 1968, (HLM 0.03)]. FS Date: 3/17/2022 12:54:00 PM | | | | | |

Top of Levee: view of crown.

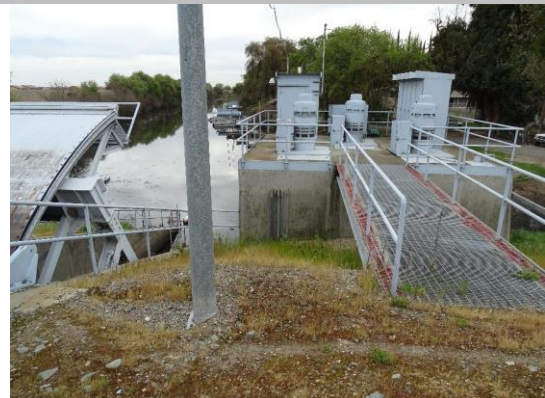
Photo 2 of 3 : UCIP_SP_2023_75022_108920.jpg

Land-Side: view of slope and walkway to pump.

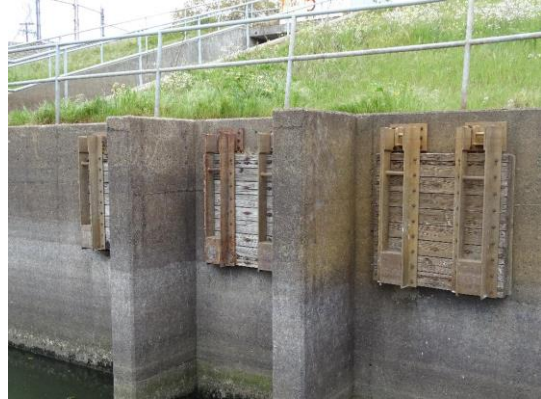
Photo 3 of 3 : UCIP_SP_2023_75022_108921.jpg

Water-Side: view of wooden flap gates and concrete headwall.

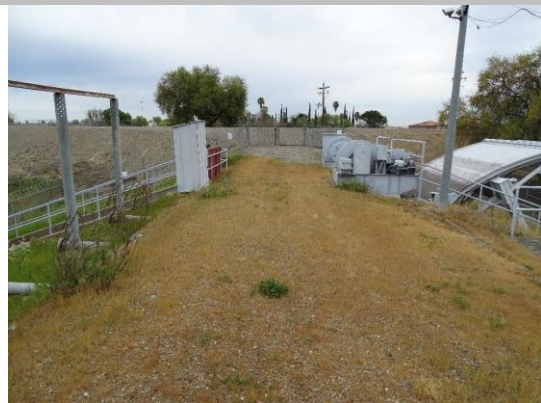
Photo 1 of 3 : UCIP_SP_2023_75066_108924.jpg

DS_ID:22740
 FS_ID:75066
 EP_NO: N/A
 Repair Type: No Action Needed
 EVAL Issue:
 Crossing Status: Found
 UCIP Comments: 03/17/2022 Record updated to No Action Needed.
 System Feature. (D.Sanoski - DWR UCIP) 10/17/2019 This structure is inspected annually under the Structure and Channel Summer Inspection (part of the Levee Inspection Program) conducted by the DWR Flood Project Integrity and Inspection Branch (FPIIB). (DWR UCIP - O. Magana)09/10/2013 - steel walkway to pump platform.- pumping plant and navigation structure area is fenced with gates at north and south end. (P. Amatya - DWR UCIP)
 FIELD_STRUCT_DESC: 2 of 3: 36-inch drainage discharge pipe of an unknown material through the levee, 3.5 feet below the crown. One concrete cutoff wall. Automatic pumping plant and concrete sump on the landside (LS). Vent pipes on the waterside (WS) shoulder. Concrete headwall and spill box on the WS. Flap gate on the WS end. [Additional Reference(s): DWR Levee Log, 2005. USACE San Joaquin O&M Manual 3, December 1968, (HLM 0.03)].

Top of Levee: view of crown.

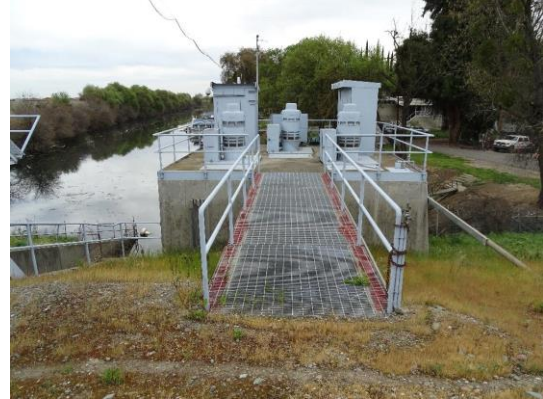
Photo 2 of 3 : UCIP_SP_2023_75066_108925.jpg

Land-Side: view of slope and walkway to pump

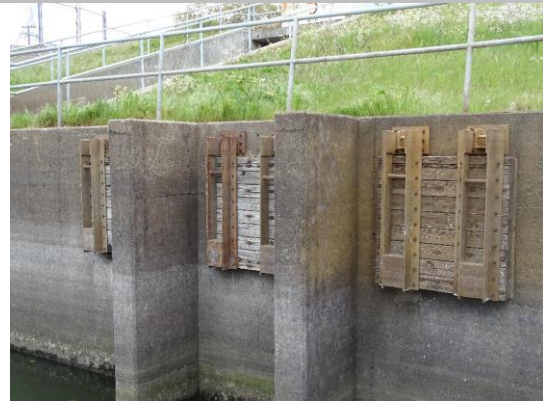
Photo 3 of 3 : UCIP_SP_2023_75066_108926.jpg

Water-Side: view of headwall with wooden flap gates.

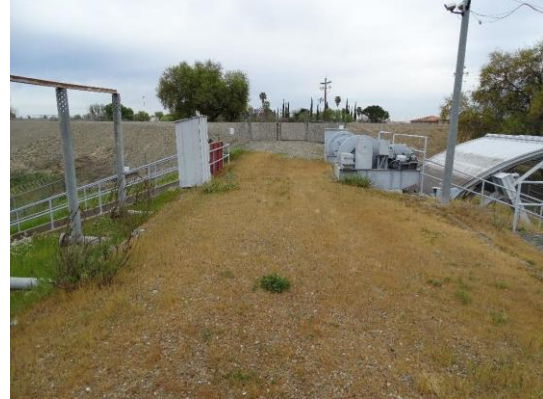
Photo 1 of 3 : UCIP_SP_2023_75067_108929.jpg

| DS_ID:22739 FS_ID:75067 EP_NO: N/A Repair Type: No Action Needed EVAL Issue: Crossing Status: Found UCIP Comments: 03/17/2022 Record updated to No Action Needed. System Features. (D.Sanoski - DWR UCIP) 10/17/2019 This structure is inspected annually under the Structure and Channel Summer Inspection (part of the Levee Inspection Program) conducted by the DWR Flood Project Integrity and Inspection Branch (FPIIB). (DWR UCIP - O. Magana)09/10/2013 - steel walkway to pump platform.- pumping plant and navigation structure area is fenced with gates at north and south end. (P. Amatya - DWR UCIP) FIELD_STRUCT_DESC: 3 of 3: 36-inch drainage discharge pipe of an unknown material through the levee, 3.5 feet below the crown. One concrete cutoff wall. Automatic pumping plant and concrete sump on the landside (LS). Vent pipes on the waterside (WS) shoulder. Concrete headwall and spill box on the WS. Flap gate on the WS end. [Additional Reference(s): DWR Levee Log, 2005. USACE San Joaquin O&M Manual 3, December 1968, (HLM 0.03)]. FS Date: 3/17/2022 1:20:53 PM | | | | | | |

Top of Levee: view of crown.

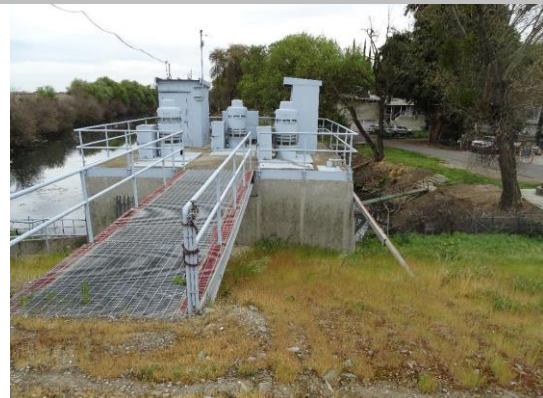
Photo 2 of 3 : UCIP_SP_2023_75067_108930.jpg

Land-Side: view of slope and walkway to pump.

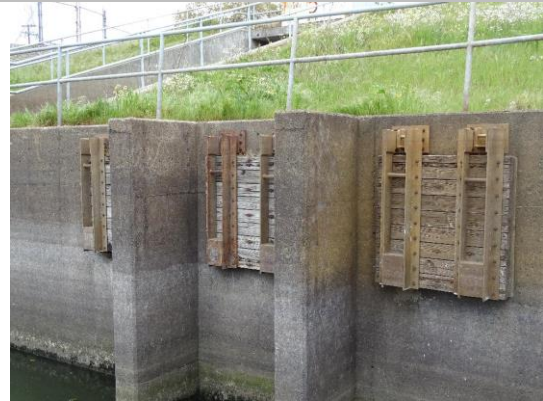
Photo 3 of 3 : UCIP_SP_2023_75067_108931.jpg

Water-Side: view of headwall with wooden flap gates.

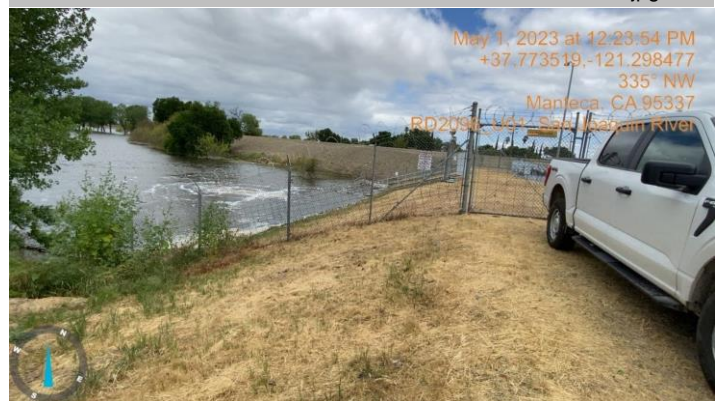
Photo 1 of 1 : SP_2023_RD2096_117_8_20230515_00012.jpg

| The annual vegetation is well maintained. | | | | | |

Typical view of well maintained vegetation along the waterside slope.
Spring 2023

| V1 : Control annual grass and weeds on the levee slopes and easements. | | | | | |

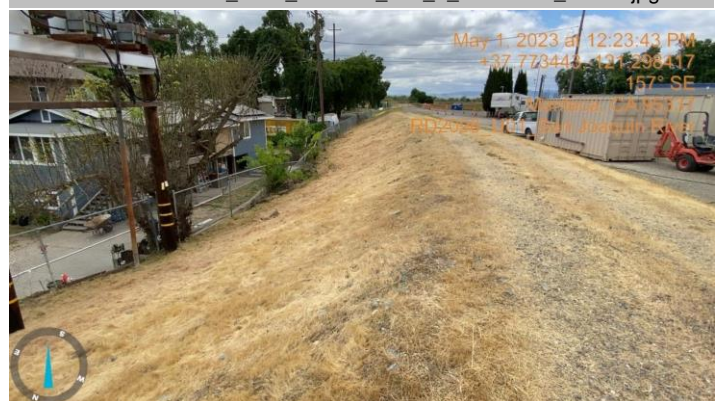
Photo 1 of 1 : SP_2023_RD2096_117_7_20230515_00011.jpg

| The annual vegetation is well maintained. | | | | | |

Typical view of well maintained vegetation along the landside slope.
Spring 2023

| V1 : Control annual grass and weeds on the levee slopes and easements. | | | | | |
