**Flood Control Project Maintenance
Levee Inspections**

Maintenance Issue Types Only, Levee Inspection Report By Mile - Spring 2024

Reclamation District No. 2096 Wetherbee Lake

Waterway	Bank	Unit Miles	Inspection Start/End	Inspector
Unit No. 01 San Joaquin River	Right	0.16	03/27/2024 03/27/2024	Alberto De Leon

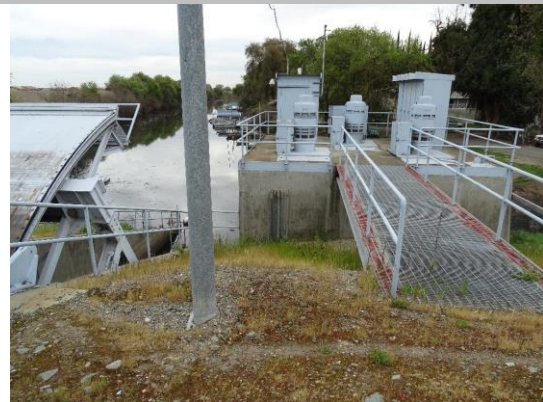
Photo 2 of 3 : UCIP_SP_2024_82698_108920.jpg

Land-Side: view of slope and walkway to pump.

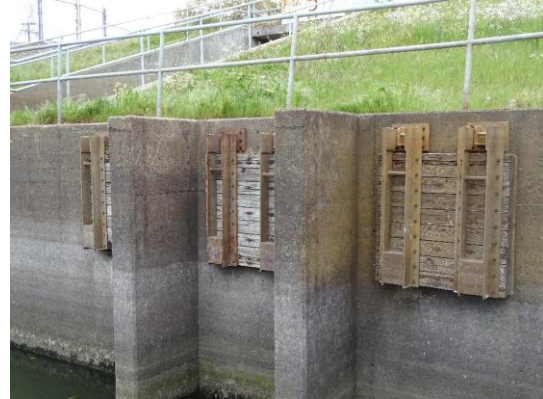
Photo 3 of 3 : UCIP_SP_2024_82698_108921.jpg

Water-Side: view of wooden flap gates and concrete headwall.

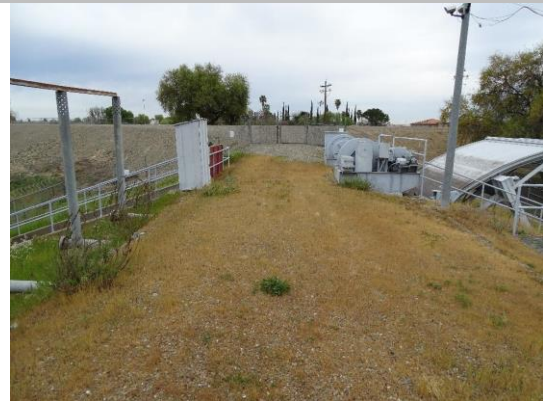
Photo 1 of 3 : UCIP_SP_2024_82699_108924.jpg

Top of Levee: view of crown.

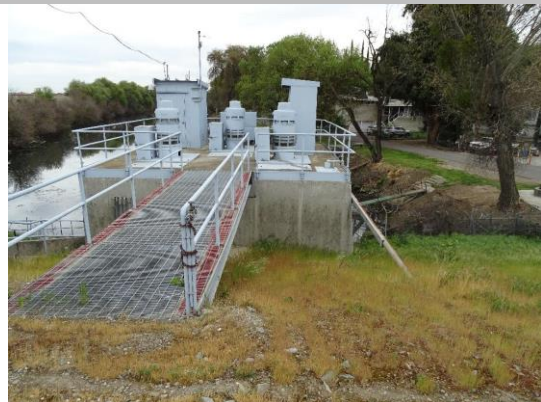
Photo 2 of 3 : UCIP_SP_2024_82700_108930.jpg

Land-Side: view of slope and walkway to pump.

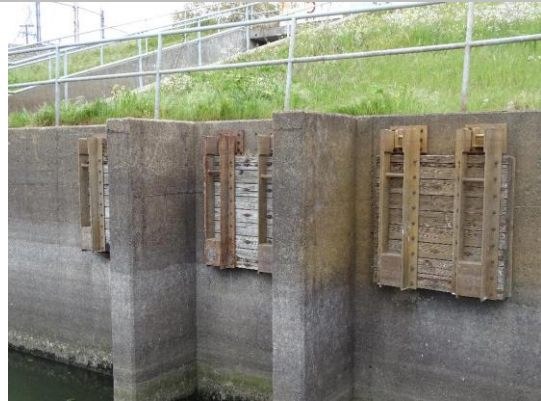
Photo 3 of 3 : UCIP_SP_2024_82700_108931.jpg

Water-Side: view of headwall with wooden flap gates.
