**Flood Control Project Maintenance
Levee Inspections
LMA District Cover Sheet
Spring 2010 Levee Inspection Results**

Reclamation District No. 2096 Wetherbee Lake

Levee Inspection Report By Mile - Spring 2010

Waterway	Bank	Unit Miles	Inspection Start/End	Inspector
Unit No. 01 San Joaquin River	Right	0.17	04/01/2010 04/01/2010	John Paasch

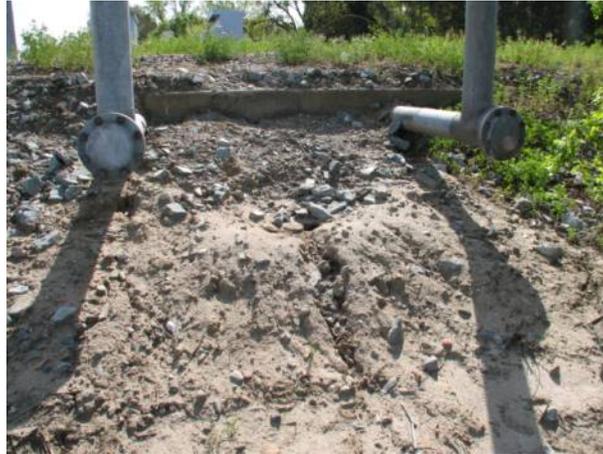
Levee Mile Report Line	1
Start Levee Mile	0.03
End Levee Mile	0.03
Location	Water Side
Category	Earthen Levee
Item	Animal Control
Previous burrow hole has been filled.	
jpaasch_s_20100405_250.jpg

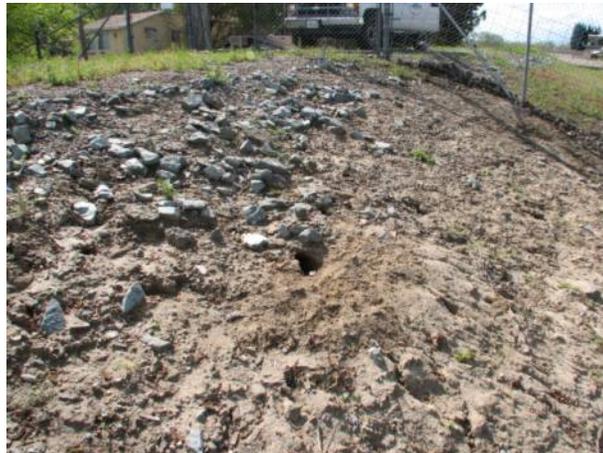
Levee Mile Report Line	1
Start Levee Mile	0.03
End Levee Mile	0.03
Location	Water Side
Category	Earthen Levee
Item	Animal Control
Several burrow holes remain despite use of bait stations.	
jpaasch_s_20100405_251.jpg

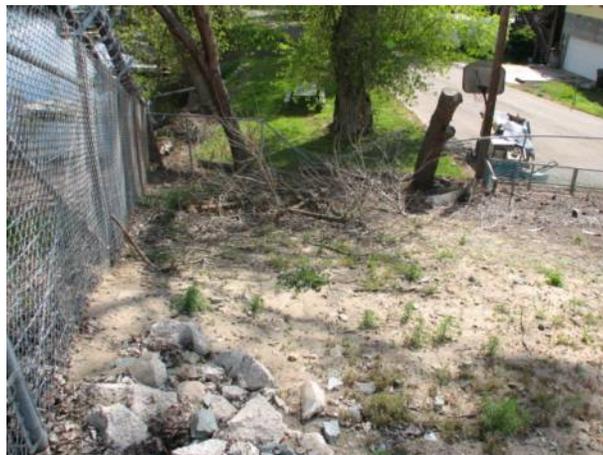
Levee Mile Report Line	2
Start Levee Mile	0.04
End Levee Mile	0.04
Location	Land Side
Category	Earthen Levee
Item	Encroachments
Tree prunings on landside slope should be removed.	
jpaasch_s_20100405_252.jpg

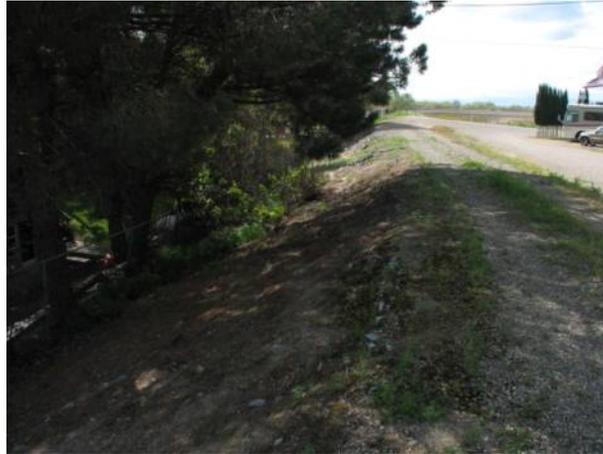
Levee Mile Report Line	5
Start Levee Mile	0.05
End Levee Mile	0.06
Location	Land Side
Category	Earthen Levee
Item	Vegetation
Condition unchanged. Vegetation and tree limbs on landside slope obstruct access.	
jpaasch_s_20100405_253.jpg

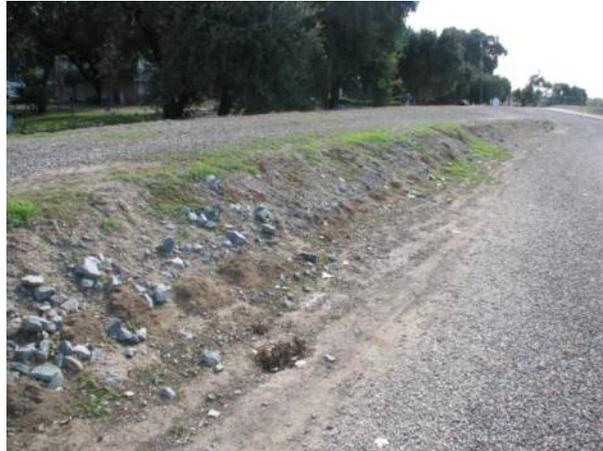
Levee Mile Report Line	7
Start Levee Mile	0.07
End Levee Mile	0.08
Location	Water Side
Category	Earthen Levee
Item	Animal Control
FALL 2009 photo of several animal burrows on the waterside slope.	
jpaasch_s_20100323_024.jpg

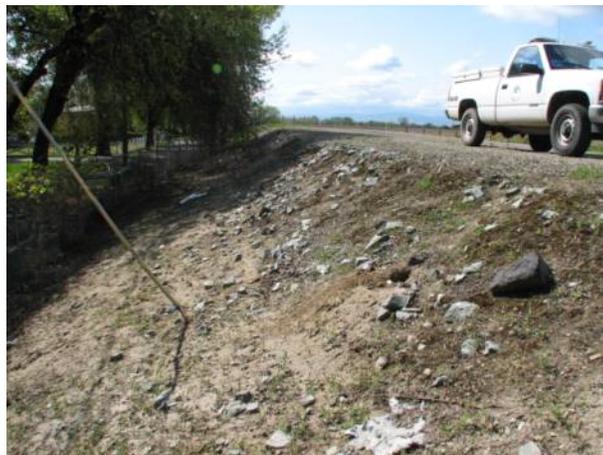
Levee Mile Report Line	8
Start Levee Mile	0.07
End Levee Mile	0.08
Location	Land Side
Category	Earthen Levee
Item	Animal Control
Several active animal burrows exist on landside slope.	
jpaasch_s_20100405_254.jpg

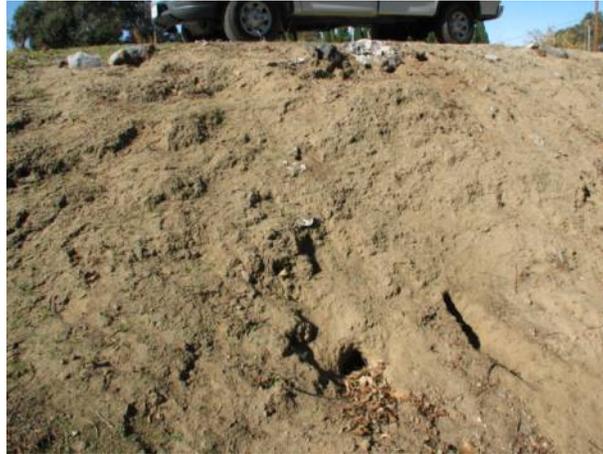
Levee Mile Report Line	9
Start Levee Mile	0.10
End Levee Mile	0.10
Location	Land Side
Category	Earthen Levee
Item	Animal Control
Fall 2009 photo of damaged waterward slope due to rodent burrows.	
jpaasch_s_20100323_026.jpg

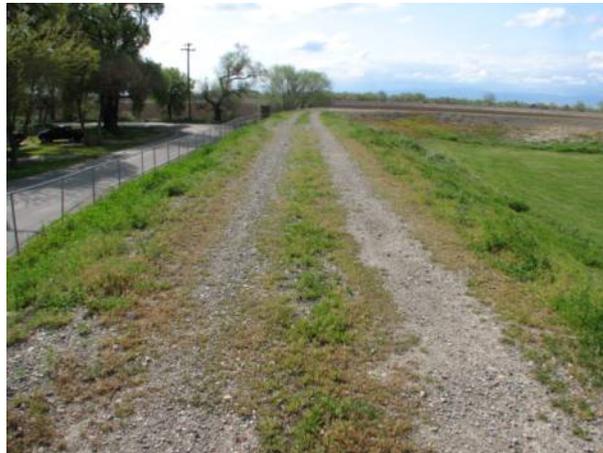
Levee Mile Report Line	10
Start Levee Mile	0.11
End Levee Mile	0.16
Location	Water Side
Category	Earthen Levee
Item	Vegetation
Annual grasses and weed are present on levee slopes.	
jpaasch_s_20100405_255.jpg

10	0.11	0.16	Earthen Levee	Vegetation	WS	M	Control annual grass and weeds on the levee slopes and easements.	37.772645 ° -121.298419 °	37.771945 ° -121.298392 °	10 Y
