**Flood Control Project Maintenance
Levee Inspections
LMA District Cover Sheet
Spring 2013 Levee Inspection Results**

Reclamation District No. 2096 Wetherbee Lake

Levee Inspection Report By Mile - Spring 2013

Waterway				Bank	Unit Miles	Inspection Start/End	Inspector
Unit No. 01 San Joaquin River				Right	0.17	03/15/2013 03/15/2013	Maksim Khashchuk

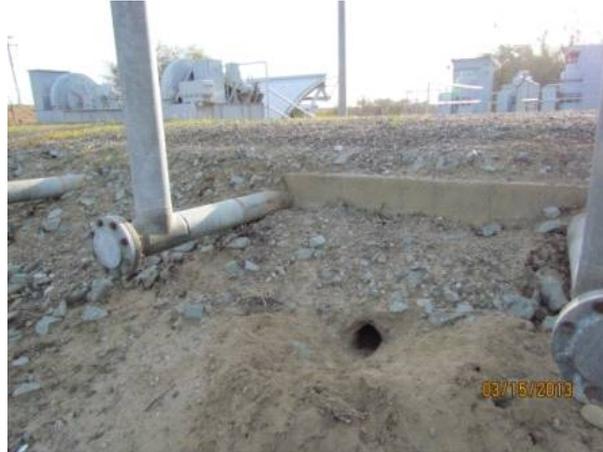
Levee Mile Report Line	4
Start Levee Mile	0.02
End Levee Mile	0.02
Location	Water Side
Category	
Item	Animal Control
View of the rodent burrow on the waterside levee slope.	
mkhashch_s_20130315_647.JPG

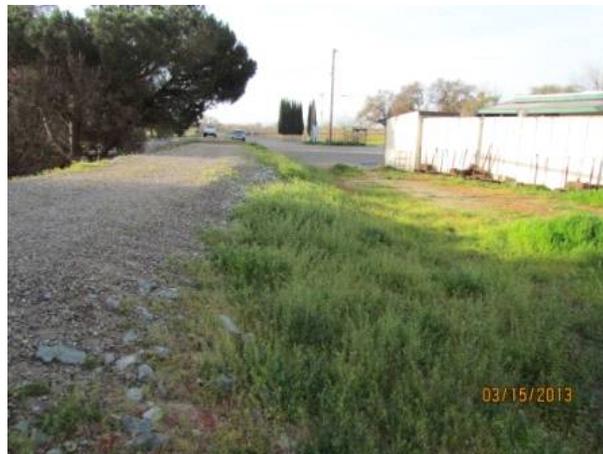
Levee Mile Report Line	5
Start Levee Mile	0.04
End Levee Mile	0.04
Location	Water Side
Category	
Item	Vegetation
View of the annual grass to be controlled.	
mkhashch_s_20130315_648.JPG

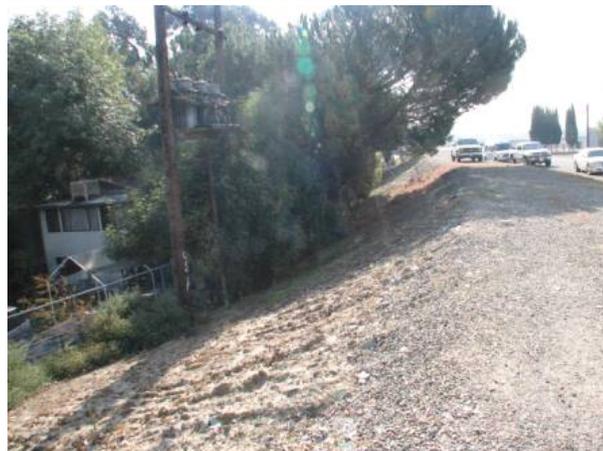
Levee Mile Report Line	6
Start Levee Mile	0.04
End Levee Mile	0.17
Location	Land Side
Category	
Item	Encroachments
11/09/2011 Fence at the toe of the levee.	
mkhashch_s_20130225_590.jpg

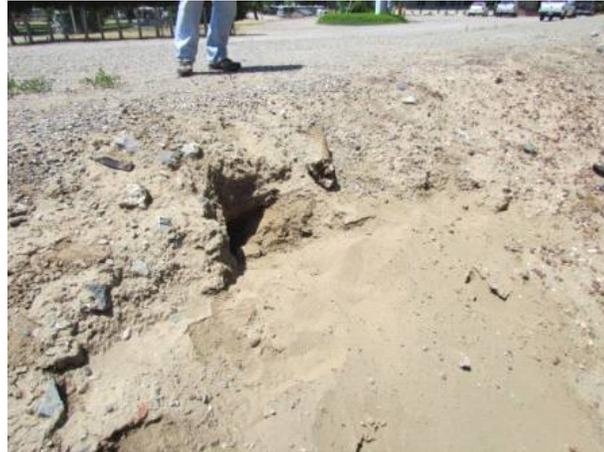
Levee Mile Report Line	7
Start Levee Mile	0.08
End Levee Mile	0.08
Location	Land Side
Category	
Item	Animal Control
View of a large burrow hole on the landside levee slope. The grout plug did not work as it was removed by squirrels. It is visible next to the hole on the right. 05/24/2012	
mkhashch_s_20130225_593.jpg

DWR ID: DWR_RD2096_01_s_2012_3		
7	0.08	0.08		Animal Control	LS	M Ma	A1 : Exterminate rodents and backfill and compact or grout burrows.	37.773048 ° -121.298390 °	37.773048 ° -121.298390 °	6 Y
								DWR ID: DWR_RD2096_01_s_2012_6		
8	0.11	0.11		Animal Control	WS	M Ma	A1 : Exterminate rodents and backfill and compact or grout burrows.	37.772688 ° -121.298452 °	37.772688 ° -121.298452 °	9 Y
								DWR ID: DWR_RD2096_01_s_2013_9		
9	0.12	0.12		Animal Control	WS	U Ma	A1 : Exterminate rodents and backfill and compact or grout burrows. Inspector Comments: LMA is actively managing rodent infestation. Recently completed grouting.	37.772485 ° -121.298463 °	37.772485 ° -121.298463 °	5 Y
								DWR ID: DWR_RD2096_01_s_2012_5		
10	0.12	0.12		Encroachments	WS	U Ma	PI : Pipe Inspector Comments: Open 2" steel pipe on waterside slope.	37.772477 ° -121.298383 °	37.772477 ° -121.298383 °	7 Y
								DWR ID: DWR_RD2096_01_f_2012_7

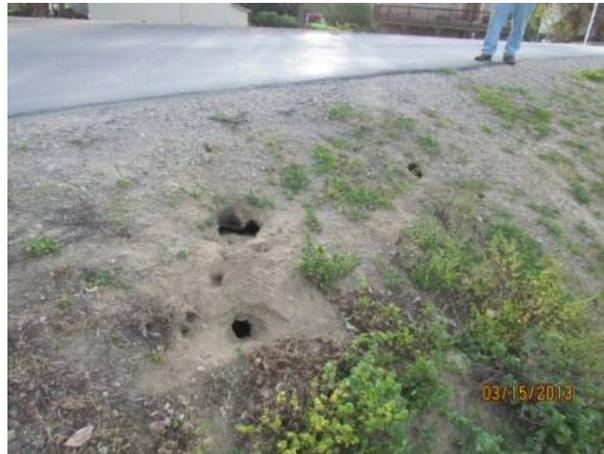
Levee Mile Report Line	8
Start Levee Mile	0.11
End Levee Mile	0.11
Location	Water Side
Category	
Item	Animal Control
View of multiple rodent burrows at the waterside levee hinge.	
mkhashch_s_20130315_651.JPG

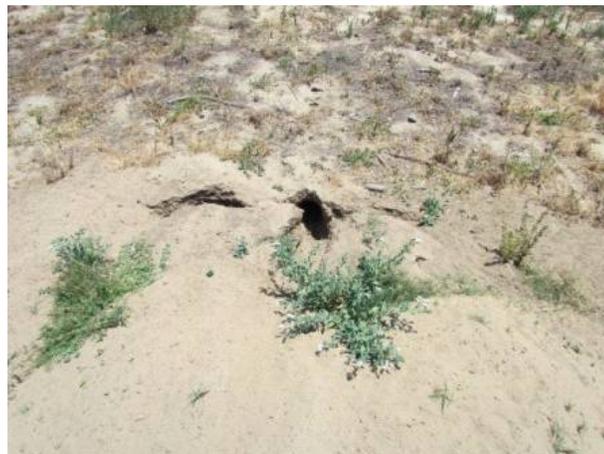
Levee Mile Report Line	9
Start Levee Mile	0.12
End Levee Mile	0.12
Location	Water Side
Category	
Item	Animal Control
View of large burrow holes at the waterside toe. 05/24/2012	
mkhashch_s_20130225_591.jpg

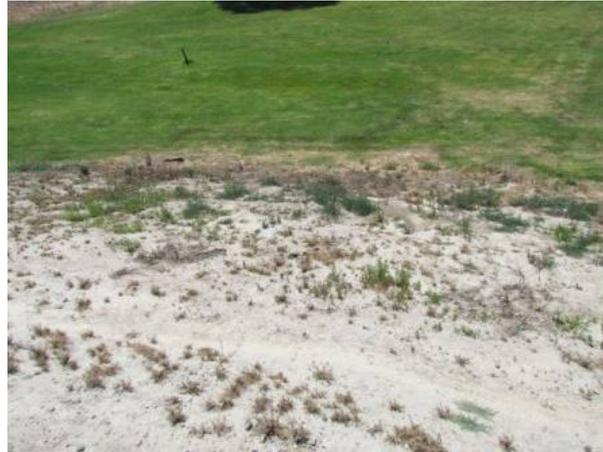
Levee Mile Report Line	9
Start Levee Mile	0.12
End Levee Mile	0.12
Location	Water Side
Category	
Item	Animal Control
View of active burrow holes at the waterside toe. 05/24/2012	
mkhashch_s_20130225_592.jpg

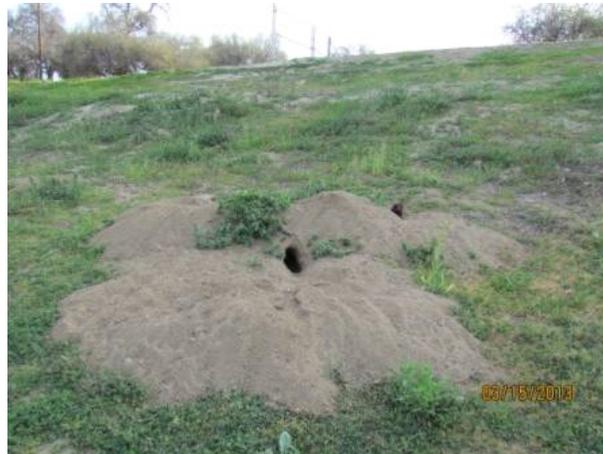
Levee Mile Report Line	9
Start Levee Mile	0.12
End Levee Mile	0.12
Location	Water Side
Category	
Item	Animal Control
View of rodent burrows at the waterside levee toe.	
mkhashch_s_20130315_649.JPG

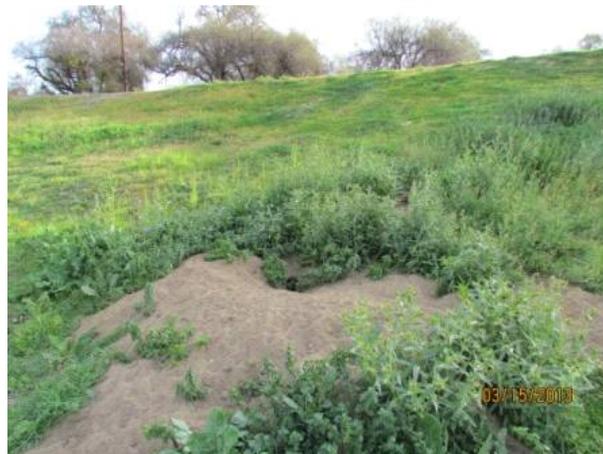
Levee Mile Report Line	9
Start Levee Mile	0.12
End Levee Mile	0.12
Location	Water Side
Category	
Item	Animal Control
View of another rodent burrow at the waterside levee toe.	
mkhashch_s_20130315_650.JPG

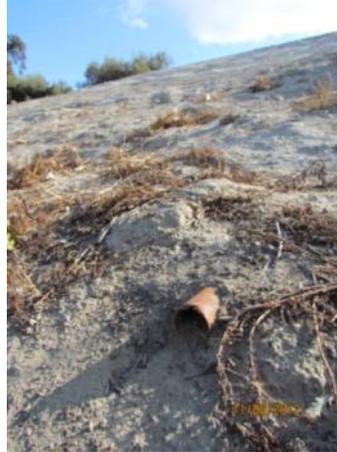
Levee Mile Report Line	10
Start Levee Mile	0.12
End Levee Mile	0.12
Location	Water Side
Category	
Item	Encroachments
View of the open two inch steel pipe on the waterside levee slope near the toe.	
mkhashch_s_20130225_594.JPG
