Flood Control Project Maintenance
2010 Structure Summary Report
Overall Unit and Item Ratings

Reclamation District No. 2096 Wetherbee Lake

Wetherbee Lake Pumping Plant & Navigation Gate

Flood Control Project Maintenance**Unit Cover Sheet****2010 Pumping Plant Inspection Results****Reclamation District No. 2096 Wetherbee Lake**

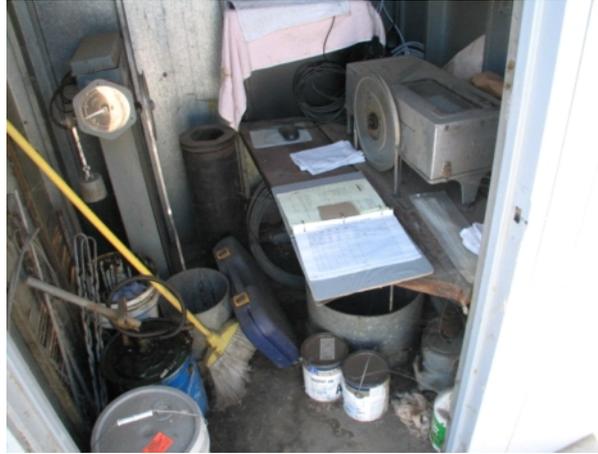
| jpaasch_t_20100730_045.jpg | |

| LMR No. | Levee Mile | | Category | Item | Location * | Rating ** | Action/Comment | GPS Latitude/Longitude | | Photo | Issue No. |
|---|---|---|---|---|---|---|---|---|---|---|---|
| 1 | 0.00 | 0.00 | Pump Stations | Operating Log | | A | Inspector Comments: Operation log located onsite in a metal shed. This item was identified with an Unacceptable rating in the USACE PI report for the San Joaquin River East Levee System (WTHR_2009_a_0013). | 37.773593 ° -121.298442 ° | 37.773593 ° -121.298442 ° | Y | 1 |

| Operation log in metal shed with surveillance and instrumentation equipment. | |

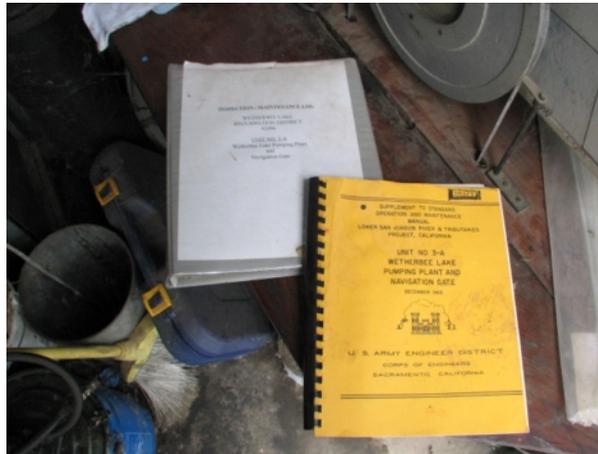
| jpaasch_t_20101206_053.jpg | |

| LMR No. | Levee Mile | | Category | Item | Location * | Rating ** | Action/Comment | GPS Latitude/Longitude | | Photo | Issue No. |
|---|---|---|---|---|---|---|---|---|---|---|---|
| 2 | 0.00 | 0.00 | Pump Stations | Operation & Maintenance Manual | | A | Inspector Comments: This item was identified with an Unacceptable rating in the USACE PI report for the San Joaquin River East Levee System (WTHR_2009_a_0014). O&M manual containing equipment numbers and procedures was present onsite during 12/2/10 reinspection. | 37.773593 ° -121.298442 ° | 37.773593 ° -121.298442 ° | Y | 2 |

| Supplemental Operation and Maintenance manual stored onsite. | |

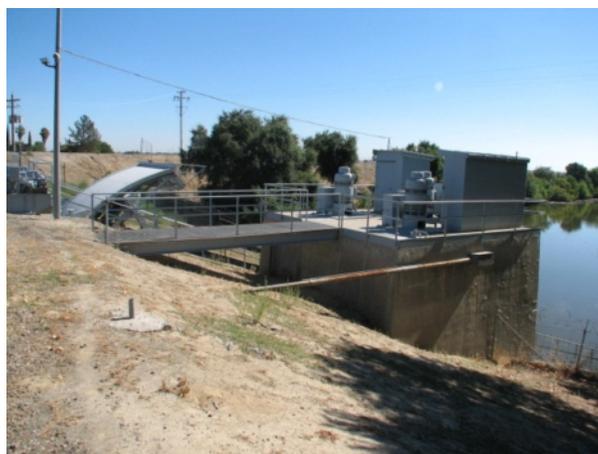
| jpaasch_t_20100730_046.jpg | |

| LMR No. | Levee Mile | | Category | Item | Location * | Rating ** | Action/Comment | GPS Latitude/Longitude | | Photo | Issue No. |
|---|---|---|---|---|---|---|---|---|---|---|---|
| 3 | 0.00 | 0.00 | Pump Stations | Plant Building | | A | Inspector Comments: Electronics and controls are housed in cabinets. Facilities were repainted late last summer. | 37.773593 ° -121.298442 ° | 37.773593 ° -121.298442 ° | Y | 3 |

| 2010 Wetherbee Lake Pumping Plant & Navigation Gate | |

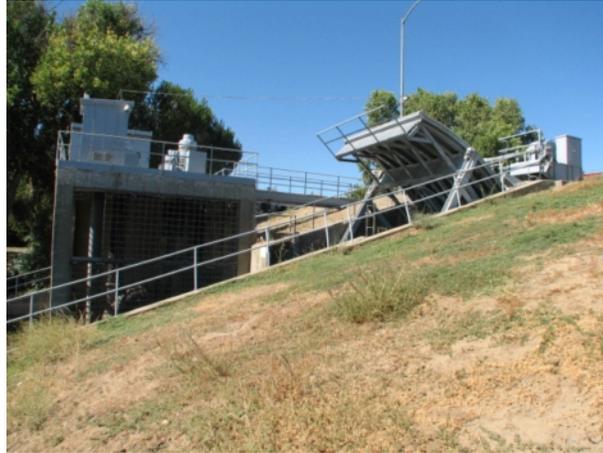
| jpaasch_t_20100730_052.jpg | |

| Pump plant and navigation gate facility from north. | |

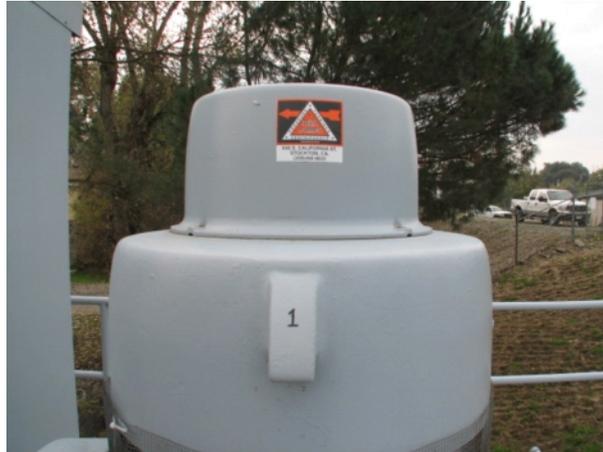
| jpaasch_t_20101207_059.jpg | |

| LMR No. | Levee Mile | | Category | Item | Location * | Rating ** | Action/Comment | GPS Latitude/Longitude | | Photo | Issue No. |
|---|---|---|---|---|---|---|---|---|---|---|---|
| 9 | 0.00 | 0.00 | Pump Stations | Motors, Engines, Fans & Gear Reducers | | A | Item inspected visually only. Item was not operated during the inspection. Inspector Comments: Annual maintenance of motors done in June. Lack of Megger Testing resulted in an Unacceptable rating in the USACE PI (WTHR_2009_a-0025). Megger Testing was completed on 9/29/10 by Delta Pump Co. | 37.773593 ° -121.298442 ° | 37.773593 ° -121.298442 ° | Y | 9 |

| Delta Pump Co. completed Megger Testing of all pump motor terminals and load wires. Letter from KSN contains results. | |

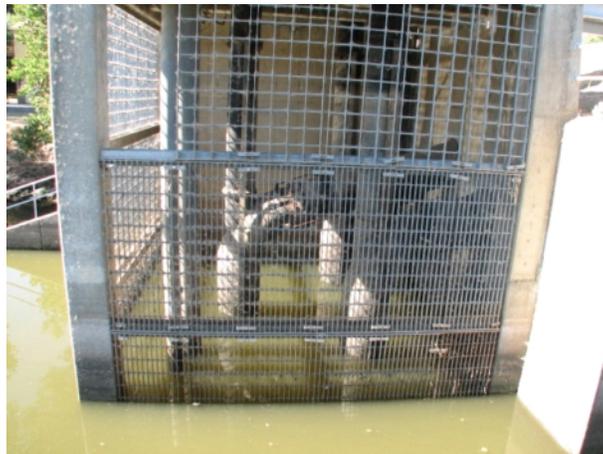
| jpaasch_t_20100730_047.jpg | |

| LMR No. | Levee Mile | | Category | Item | Location * | Rating ** | Action/Comment | GPS Latitude/Longitude | | Photo | Issue No. |
|---|---|---|---|---|---|---|---|---|---|---|---|
| 11 | 0.00 | 0.00 | Pump Stations | Sumps/Wet Well | | A | Inspector Comments: Sedimentation in Weatherbee Lake could migrate to pump intake. | 37.773593 ° | 37.773593 ° | Y | 11 |

| Sump for the three pumps. | |

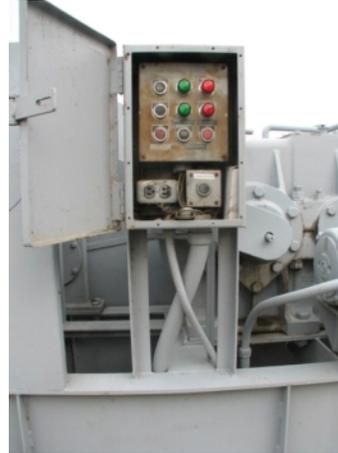
| <p>jpaasch_t_20101206_054.jpg</p> | |

| <p>This panel was identified in the USACE PI report as not functional (WTHR_2009_a_0031). Electronic gate controls were repaired and function properly as demonstrated during 12/2/10 reinspection.</p> | |

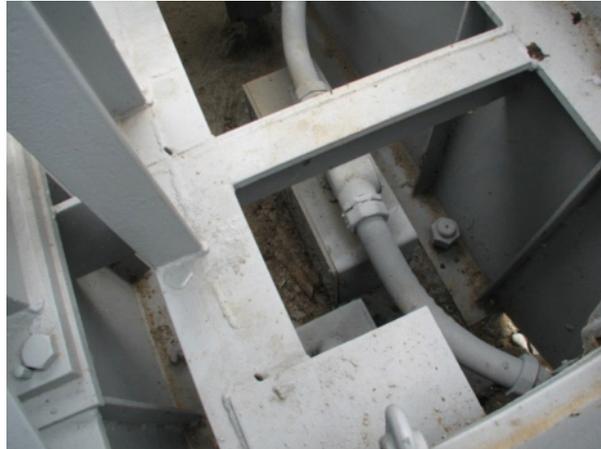
| <p>jpaasch_t_20101207_058.jpg</p> | |

| <p>Junction box and wiring for gate controls was identified in the USACE PI report as needing repair (WTHR_2009_a_0032). Reinspection on 12/2/10 verifies repairs have been made.</p> | |

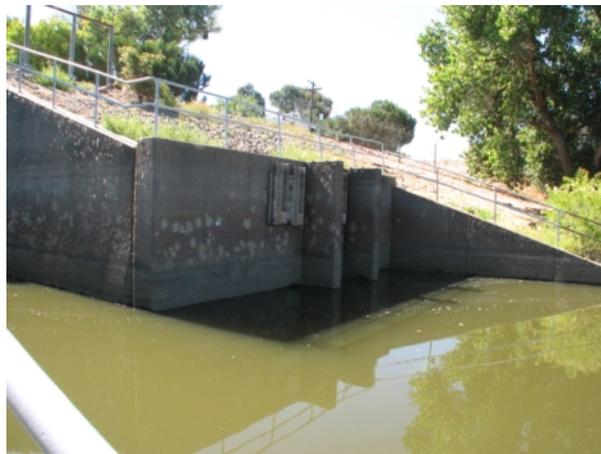
| <p>jpaasch_t_20100730_048.jpg</p> | |

| <p>Outfall structure of pumping plant. Three flap gates on San Joaquin River.</p> | |

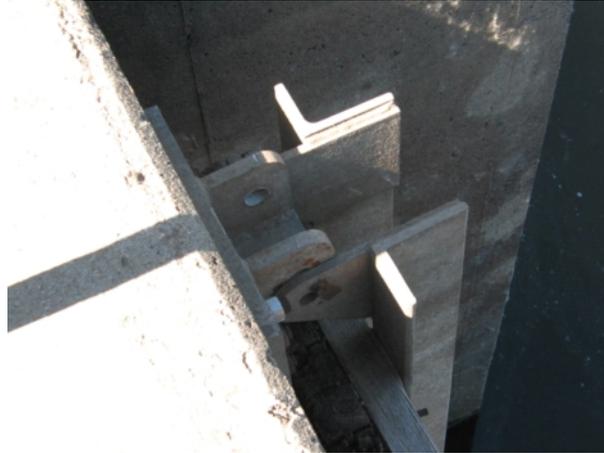
| jpaasch_t_20100730_049.jpg | |

| Missing stainless steel hinge bolt for Pump 3 flap gate. | |

| LMR No. | Levee Mile | | Category | Item | Location * | Rating ** | Action/Comment | GPS Latitude/Longitude | | Photo | Issue No. |
|---|---|---|---|---|---|---|---|---|---|---|---|
| 18 | 0.00 | 0.00 | Pump Stations | Flap Gates | | A | Inspector Comments: Reinsptection on 12/3/10. North flap gate hinge bolt was replaced. | 37.773593 ° | 37.773593 ° | Y | 18 |

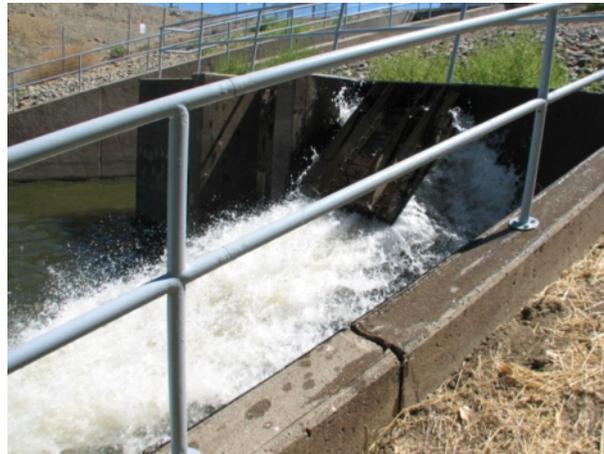
| jpaasch_t_20100730_051.jpg | |

| Pump 1 outfall during operation. | |

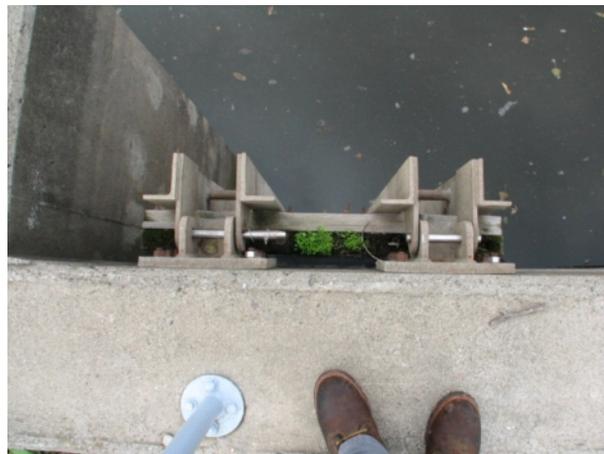
| jpaasch_t_20101206_057.jpg | |

| Photo of replaced hinge bolt for flap gate taken 12/2/10. | |

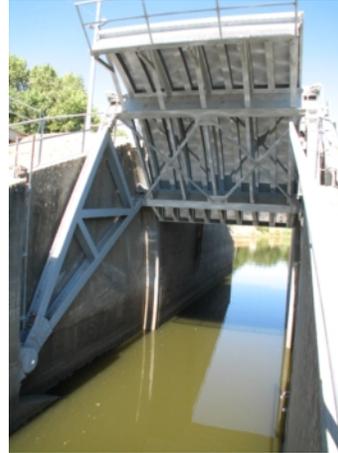
| <p>jpaasch_t_20100730_050.jpg</p> | |

| LMR No. | Levee Mile | | Category | Item | Location * | Rating ** | Action/Comment | GPS Latitude/Longitude | | Photo | Issue No. |
|---|---|---|---|---|---|---|---|---|---|---|---|
| 19 | 0.00 | 0.00 | Pump Stations | Closure Structures | | A | Item inspected visually only. Item was not operated during the inspection. Inspector Comments: Radial arm gate acts as closure structure. It functions and appears to be in good working condition. | 37.773593 ° | 37.773593 ° | Y | 19 |

| <p>Navigation channel closed by radial arm gate. The gate has electronic controls and manual turn wheels. Both appear functional.</p> | |

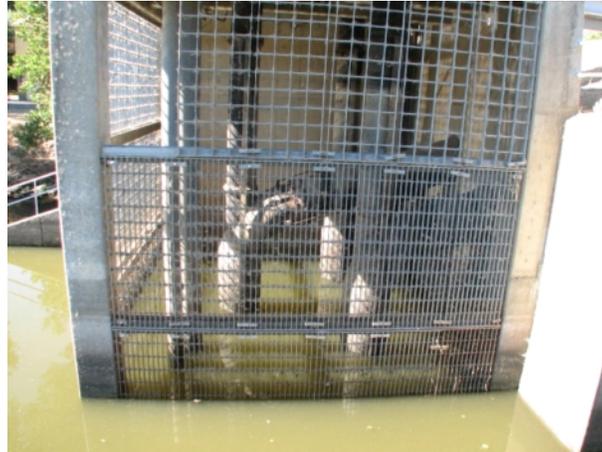
| <p>jpaasch_t_20101206_055.jpg</p> | |

| LMR No. | Levee Mile | | Category | Item | Location * | Rating ** | Action/Comment | GPS Latitude/Longitude | | Photo | Issue No. |
|---|---|---|---|---|---|---|---|---|---|---|---|
| 21 | 0.00 | 0.00 | Pump Stations | Intake and Discharge Pipes | | A | Item inspected visually only. Item was not operated during the inspection. Inspector Comments: This item was identified as Acceptable under Pump Stations (WTHR_2009_a_0027) and Unacceptable under Levee Embankment (no ID, Rated Item 11) in the USACE PI report . 12/2/10 visual reinspection verifies absence of leaks and major corrosion. | 37.773593 ° | 37.773593 ° | Y | 21 |

| <p>Discharge pipes appear to be in good condition. No visual evidence of leaks or corrosion were observed. Rated Unacceptable in USACE PI report for Levee Embankment perhaps for lack of video inspection.</p> | |

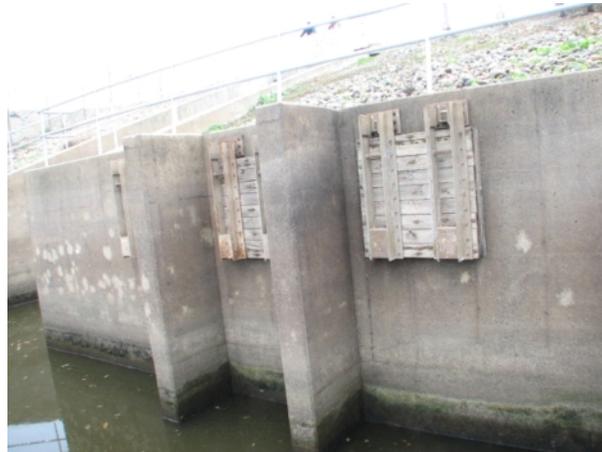
| <p>jpaasch_t_20101206_056.jpg</p> | |

| <p>Photo taken during 12/2/10 reinspection of discharge pipe outfall.</p> | |
