Flood Control Project Maintenance
2013 Structure Summary Report
Overall Unit and Item Ratings

Wetherbee Lake Pumping Plant & Navigation Gate

2013 Pumping Plant Inspection Results

Levee Inspection Report By Mile - Structure 2013

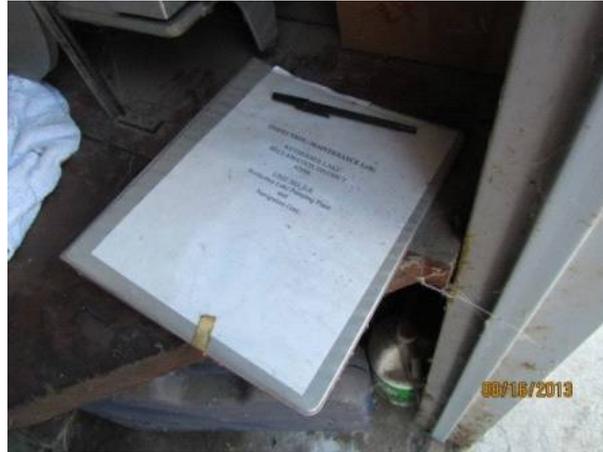
Levee Mile Report Line	1
Start Levee Mile	0.00
End Levee Mile	0.00
Location	
Category	Pump Stations
Item	Operating Log
Operating Log	
mkhashch_t_20130820_132.JPG

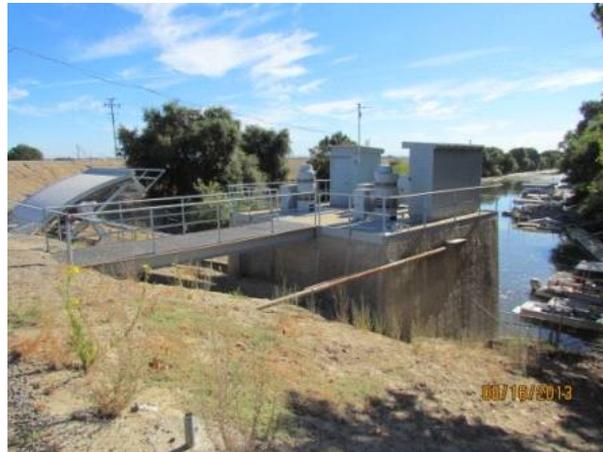
Levee Mile Report Line	3
Start Levee Mile	0.00
End Levee Mile	0.00
Location	
Category	Pump Stations
Item	Plant Building
View of the pumping facility and navigation gate.	
mkhashch_t_20130820_133.JPG

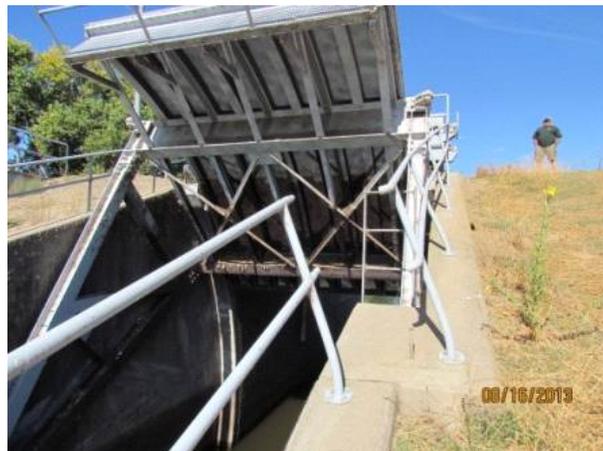
4	0.00	0.00	Pump Stations	Communications		A	Item inspected visually only. Item was not operated during the inspection. Inspector Comments: Trustee has cellular phone.	37.773593 ° -121.298442 °	37.773593 ° -121.298442 °	4
5	0.00	0.00	Pump Stations	Safety		M	Item inspected visually only. Item was not operated during the inspection. Inspector Comments: Missing guard rail on navigation canal.	37.773593 ° -121.298442 °	37.773593 ° -121.298442 °	5 Y
6	0.00	0.00	Pump Stations	Cranes		N	Inspector Comments: Item does not apply, cranes are not present on site.	37.773593 ° -121.298442 °	37.773593 ° -121.298442 °	6
7	0.00	0.00	Pump Stations	Pumps		A	Item inspected visually only. Item was not operated during the inspection. Inspector Comments: Pumps appear to be in working order.	37.773593 ° -121.298442 °	37.773593 ° -121.298442 °	7
8	0.00	0.00	Pump Stations	Power		A	Item inspected visually only. Item was not operated during the inspection. Inspector Comments: No electrical deficiencies observed. Backup generators can be brought in on an emergency basis.	37.773593 ° -121.298442 °	37.773593 ° -121.298442 °	8

Levee Mile Report Line	5
Start Levee Mile	0.00
End Levee Mile	0.00
Location	
Category	Pump Stations
Item	Safety
View of the missing guard rail.	
mkhashch_t_20130816_127.JPG

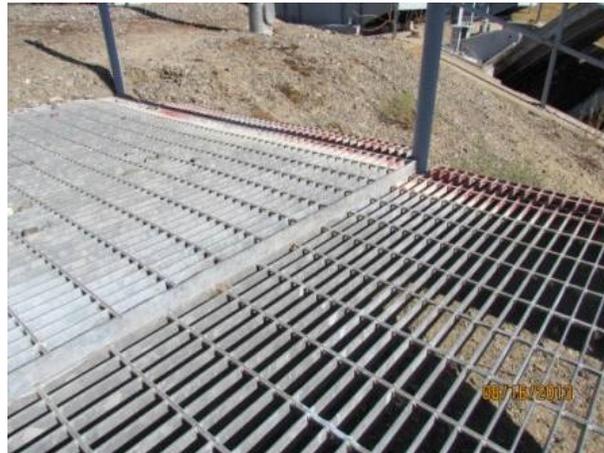
Levee Mile Report Line	5
Start Levee Mile	0.00
End Levee Mile	0.00
Location	
Category	Pump Stations
Item	Safety
View of the displaced footbridge panel. May act as a tripping hazard. Please address this issue to ensure a level walking surface.	
mkhashch_t_20130816_131.JPG

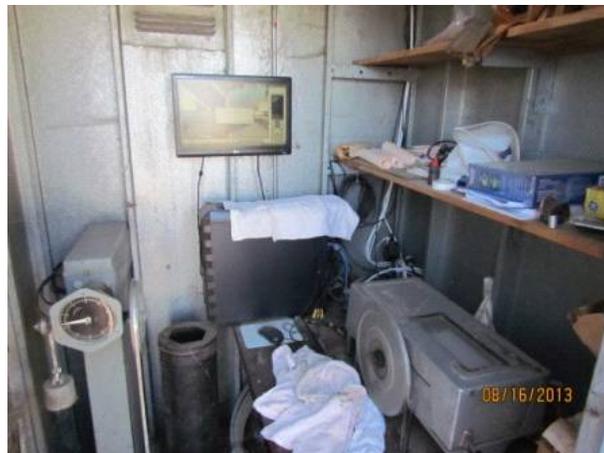
Levee Mile Report Line	10
Start Levee Mile	0.00
End Levee Mile	0.00
Location	
Category	Pump Stations
Item	Pump Control Systems
View of the control room.	
mkhashch_t_20130816_128.JPG

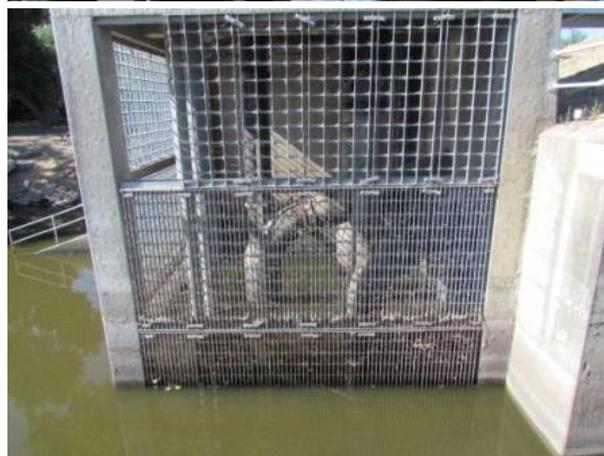
LMR No.	Levee Mile		Category	Item	Location	Rating	Action/Comment	GPS Latitude/Longitude		Issue No.
	Start	End						Start	End	Photo
12	0.00	0.00	Pump Stations	Trash Racks		M	Item inspected visually only. Item was not operated during the inspection. Inspector Comments: Trash rack is present, however one panel is missing from rack.	37.773593 ° -121.298442 °	37.773593 ° -121.298442 °	13 Y
13	0.00	0.00	Pump Stations	Trash Rakes		N	Inspector Comments: No trash rake present.	37.773593 ° -121.298442 °	37.773593 ° -121.298442 °	14
14	0.00	0.00	Pump Stations	Sluice / Slide Gates		N	Inspector Comments: No slide gates present	37.773593 ° -121.298442 °	37.773593 ° -121.298442 °	15
15	0.00	0.00	Pump Stations	Electric Gate Operators		A	Item inspected visually only. Item was not operated during the inspection. Inspector Comments: Item appears to be in good working condition. Radial arm gate was open at time of inspection.	37.773593 ° -121.298442 °	37.773593 ° -121.298442 °	16 Y

Levee Mile Report Line	12
Start Levee Mile	0.00
End Levee Mile	0.00
Location	
Category	Pump Stations
Item	Trash Racks
Section of trash rack is missing, missing section would be in upper left of photo.	
mkhashch_t_20130730_086.JPG

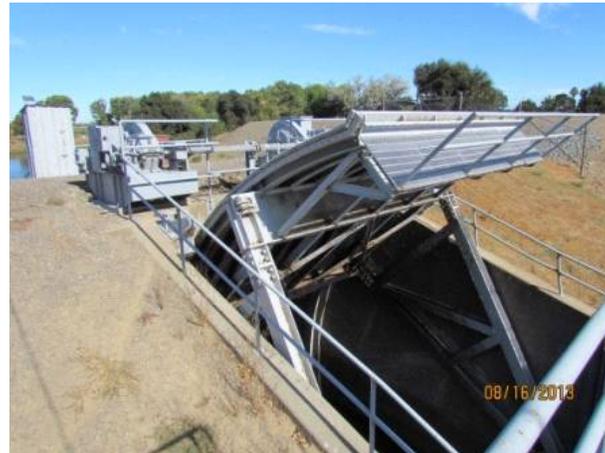
Levee Mile Report Line	15
Start Levee Mile	0.00
End Levee Mile	0.00
Location	
Category	Pump Stations
Item	Electric Gate Operators
View of the radial arm gate in the open position.	
mkhashch_t_20130816_129.JPG

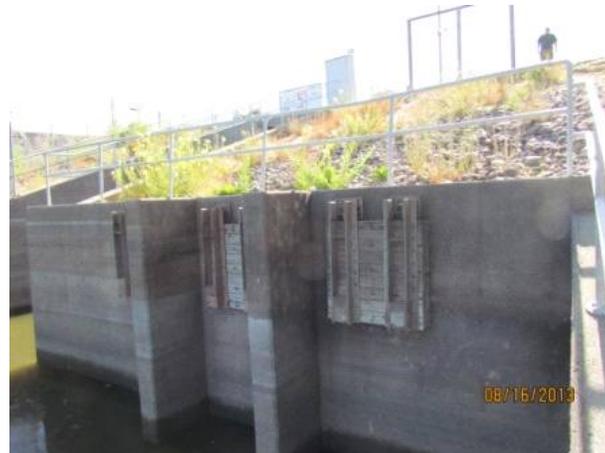
Levee Mile Report Line	18
Start Levee Mile	0.00
End Levee Mile	0.00
Location	
Category	Pump Stations
Item	Flap Gates
View of the flapgates.	
mkhashch_t_20130816_130.JPG

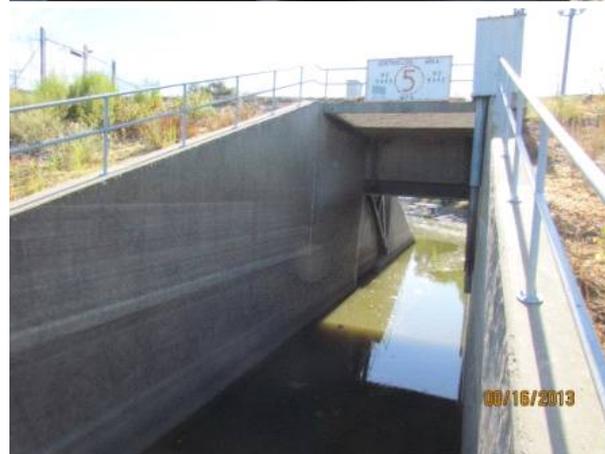
Levee Mile Report Line	19
Start Levee Mile	0.00
End Levee Mile	0.00
Location	
Category	Pump Stations
Item	Closure Structures
Radial arm gate, shown in open position.	
mkhashch_t_20130820_134.JPG
