Flood Control Project Maintenance
2014 Structure Summary Report
Overall Unit and Item Ratings

Reclamation District No. 2096 Wetherbee Lake

Wetherbee Lake Pumping Plant & Navigation Gate

Flood Control Project Maintenance**Unit Cover Sheet****2014 Pumping Plant Inspection Results****Reclamation District No. 2096 Wetherbee Lake**

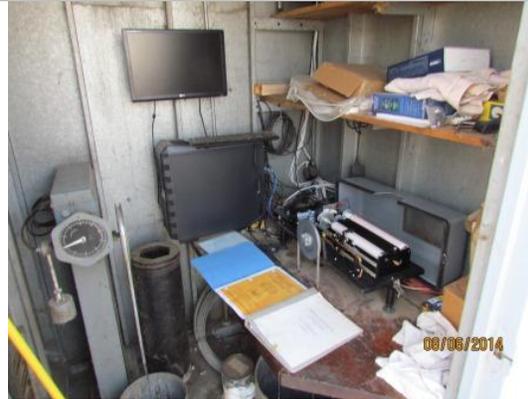
Photo 1 of 1 : ST_2014_RD2096_56_1_20140807_00010.jpg

LM Start	0.00	Rating **	A	Issue No.	1
LM End	0.00	Issue Type +	Ma	Location *	
Category	Pump Stations		GPS Latitude/Longitude		
			Start	End	
Item	Operating Log		37.773864 °	37.773864 °	
			-121.298427 °	-121.298427 °	
DWR ID	DWR_RD2096_56_t_2012_1				
Action/Comments					
Inspector Comments: O&M log presented at time of inspection

View of the Operating Log and O&M Manual.

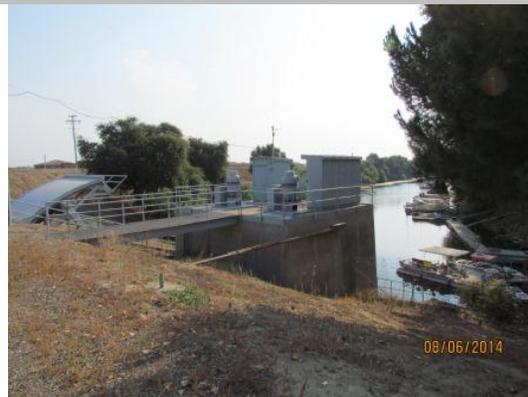
Photo 1 of 1 : ST_2014_RD2096_56_3_20140807_00011.jpg

LM Start	0.00	Rating **	A	Issue No.	3
LM End	0.00	Issue Type +	Ma	Location *	
Category	Pump Stations		GPS Latitude/Longitude		
			Start	End	
Item	Plant Building		37.773864 °	37.773864 °	
			-121.298430 °	-121.298430 °	
DWR ID	DWR_RD2096_56_t_2012_3				
Action/Comments					
Inspector Comments: Building protects the controls only.

View of the pumping facility and navigation gate.

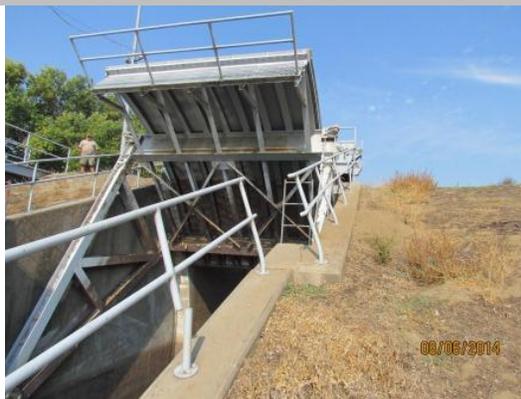
Photo 1 of 1 : ST_2014_RD2096_56_5_20140807_00012.jpg

LM Start	0.00	Rating **	M	Issue No.	5
LM End	0.00	Issue Type +	Ma	Location *	
Category	Pump Stations		GPS Latitude/Longitude		
			Start	End	
Item	Safety		37.773864 °	37.773864 °	
			-121.298430 °	-121.298430 °	
DWR ID	DWR_RD2096_56_t_2012_5				
Action/Comments					
Inspector Comments: Missing guard rail on navigation canal.

View of the missing guard rail.

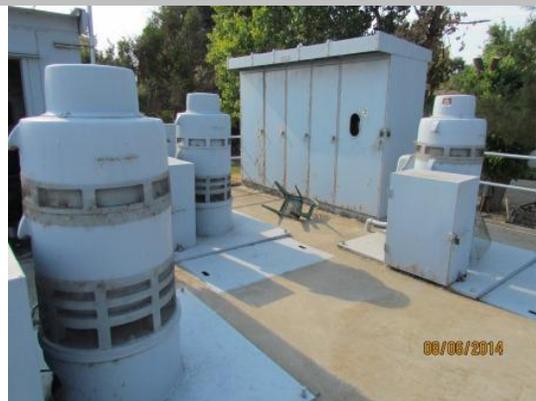
Photo 1 of 1 : ST_2014_RD2096_56_10_20140807_00013.jpg

LM Start	0.00	Rating **	A	Issue No.	10
LM End	0.00	Issue Type +	Ma	Location *	
Category	Pump Stations		GPS Latitude/Longitude		
			Start	End	
Item	Motors, Engines, Fans & Gear Reducers		37.773864 °	37.773864 °	
			-121.298430 °	-121.298430 °	
DWR ID	DWR_RD2096_56_t_2012_10				
Action/Comments					
Inspector Comments: All items appear operational.

View of the pump motors and electrical panel.

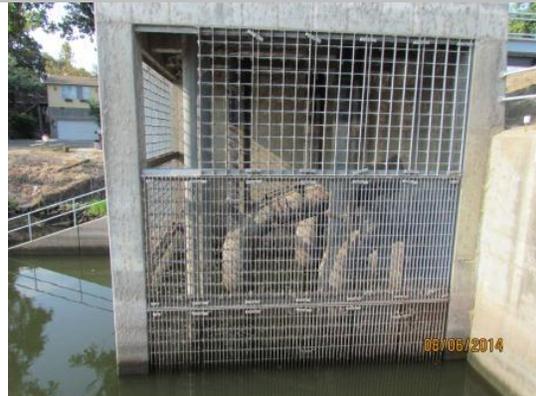
Photo 1 of 1 : ST_2014_RD2096_56_12_20140807_00014.jpg

LM Start	0.00	Rating **	A	Issue No.	12
LM End	0.00	Issue Type +	Ma	Location *	
Category	Pump Stations		GPS Latitude/Longitude		
			Start	End	
Item	Sumps/Wet Well		37.773864 °	37.773864 °	
			-121.298430 °	-121.298430 °	
DWR ID	DWR_RD2096_56_t_2012_12				
Action/Comments					
Inspector Comments: Sump is clear of debris.

View of the pump intake system. Note the missing grate at top left corner.

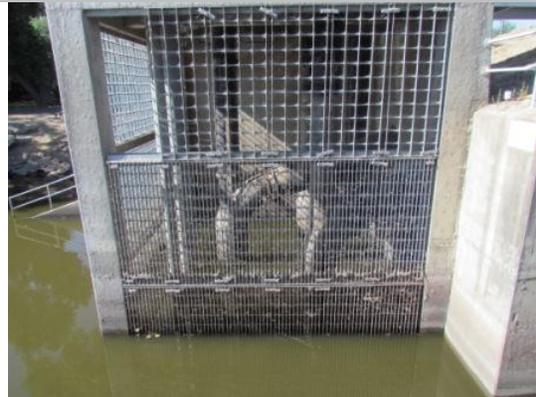
Photo 1 of 1 : ST_2014_RD2096_56_13_20140630_00006.jpg

LM Start	0.00	Rating **	M	Issue No.	13
LM End	0.00	Issue Type +	Ma	Location *	
Category	Pump Stations		GPS Latitude/Longitude		
			Start	End	
Item	Trash Racks		37.773864 °	37.773864 °	
			-121.298430 °	-121.298430 °	
DWR ID	DWR_RD2096_56_t_2012_13				
Action/Comments					
Inspector Comments: Trash rack is present, however one panel is missing from rack.

Section of trash rack is missing, missing section would be in upper left of photo.

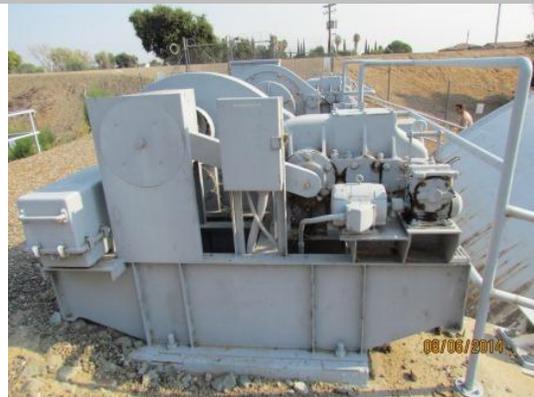
Photo 1 of 2 : ST_2014_RD2096_56_16_20140807_00015.jpg

LM Start	0.00	Rating **	A	Issue No.	16
LM End	0.00	Issue Type +	Ma	Location *	
Category	Pump Stations		GPS Latitude/Longitude		
			Start	End	
Item	Electric Gate Operators		37.773864 °	37.773864 °	
			-121.298430 °	-121.298430 °	
DWR ID	DWR_RD2096_56_t_2012_16				
Action/Comments					
Inspector Comments: Item appears to be in good working condition. Radial arm gate was open at time of inspection.

View of the gate controls.

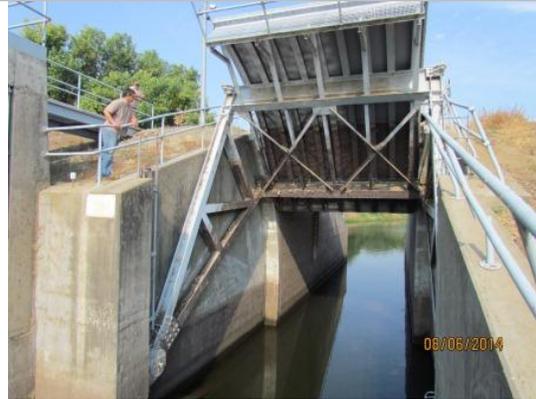
Photo 2 of 2 : ST_2014_RD2096_56_16_20140807_00016.jpg

LM Start	0.00	Rating **	A	Issue No.	16 (cont)
LM End	0.00	Issue Type +	Ma	Location *	
Category	Pump Stations			GPS Latitude/Longitude	
				Start	End
Item	Electric Gate Operators			37.773864 °	37.773864 °
				-121.298430 °	-121.298430 °
DWR ID	DWR_RD2096_56_t_2012_16				
Action/Comments					
Inspector Comments: Item appears to be in good working condition. Radial arm gate was open at time of inspection.

View of the radial arm gate in the open position.

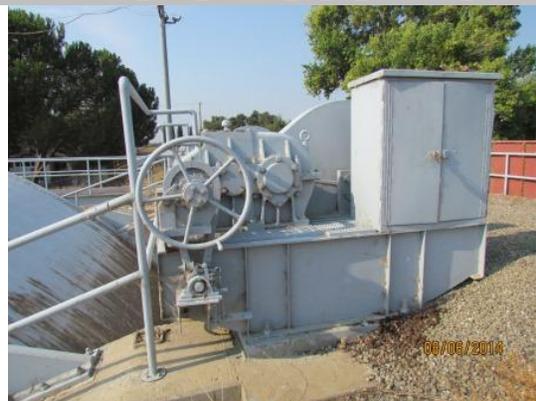
Photo 1 of 1 : ST_2014_RD2096_56_17_20140807_00017.jpg

LM Start	0.00	Rating **	A	Issue No.	17
LM End	0.00	Issue Type +	Ma	Location *	
Category	Pump Stations			GPS Latitude/Longitude	
				Start	End
Item	Manual Gate Operators			37.773864 °	37.773864 °
				-121.298430 °	-121.298430 °
DWR ID	DWR_RD2096_56_t_2012_17				
Action/Comments					
Inspector Comments: Manual gate operators appear to be maintained and in good working order.

View of the manual gate operation control.

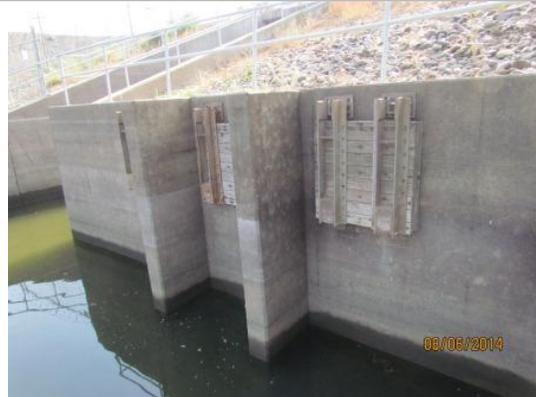
Photo 1 of 1 : ST_2014_RD2096_56_19_20140807_00018.jpg

LM Start	0.00	Rating **	A	Issue No.	19
LM End	0.00	Issue Type +	Ma	Location *	
Category	Pump Stations		GPS Latitude/Longitude		
			Start	End	
Item	Flap Gates		37.773864 °	37.773864 °	
			-121.298430 °	-121.298430 °	
DWR ID	DWR_RD2096_56_t_2012_19				
Action/Comments					
Inspector Comments: Flap gates appear to be fully operational.

View of the flapgates.

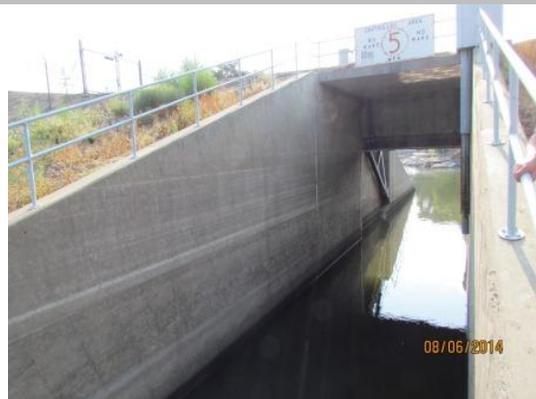
Photo 1 of 1 : ST_2014_RD2096_56_20_20140807_00019.jpg

LM Start	0.00	Rating **	A	Issue No.	20
LM End	0.00	Issue Type +	Ma	Location *	
Category	Pump Stations		GPS Latitude/Longitude		
			Start	End	
Item	Closure Structures		37.773864 °	37.773864 °	
			-121.298430 °	-121.298430 °	
DWR ID	DWR_RD2096_56_t_2012_20				
Action/Comments					
Inspector Comments: Radial arm gate acts as closure structure, gate was open at time of inspection.

Radial arm gate, shown in open position.

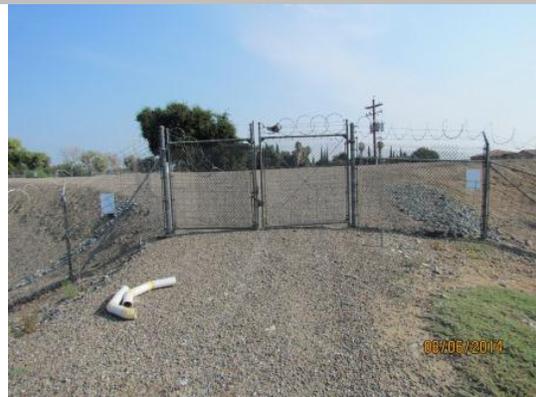
Photo 1 of 1 : ST_2014_RD2096_56_21_20140807_00020.jpg

LM Start	0.00	Rating **	A	Issue No.	21
LM End	0.00	Issue Type +	Ma	Location *	
Category	Pump Stations		GPS Latitude/Longitude		
			Start	End	
Item	Security Fencing		37.773864 °	37.773864 °	
			-121.298430 °	-121.298430 °	
DWR ID	DWR_RD2096_56_t_2012_21				
Action/Comments					
Inspector Comments: Security fencing is in place. Closed circuit cameras are also in place.

View of the security fencing around the facility.
