**Flood Control Project Maintenance  
Levee Inspections**

**Fall 2011 Levee Maintenance Deficiency Summary Report**

**Reclamation District No. 2098 Cache and Haas Slough**

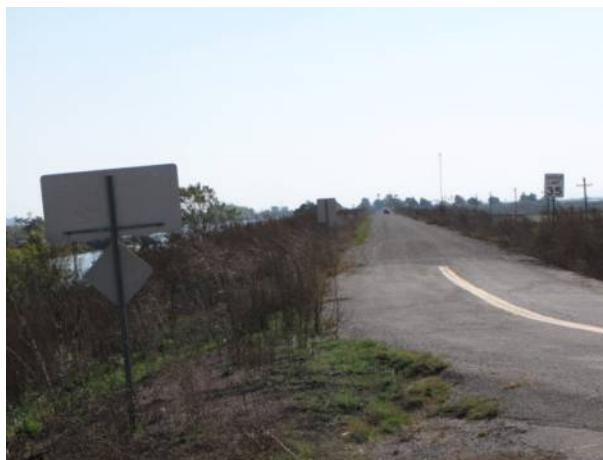
LMR No.	Levee Mile		Category	Item	Location *	Rating **	Action/Comment	GPS Latitude/Longitude		Issue No.
	Start	End						Start	End	Photo
1	0.00	0.00	Earthen Levee	Vegetation	WS	M	Remove the wild growth other than native grasses from the levee slopes.	38.329118 ° -121.694060 °	38.329118 ° -121.694060 °	3 Y
2	0.00	0.00	Earthen Levee	Vegetation	LS	M	Remove the wild growth other than native grasses from the levee slopes.	38.329118 ° -121.694060 °	38.329118 ° -121.694060 °	7 Y
3	0.17	1.95	Earthen Levee	Vegetation	LS	M	Remove the wild growth other than native grasses from the levee slopes.	38.326610 ° -121.694064 °	38.300761 ° -121.693626 °	1
4	0.22	1.71	Earthen Levee	Vegetation	WS	M	Remove the wild growth other than native grasses from the levee slopes.	38.325896 ° -121.694065 °	38.304308 ° -121.693669 °	2

Levee Mile Report Line	1
Start Levee Mile	0.00
End Levee Mile	0.00
Location	Water Side
Category	Earthen Levee
Item	Vegetation
Looking down unit 1 from levee mile 0.00 waterside. Photo taken 10-20-2011.	
phillips_f_20111212_151.jpg

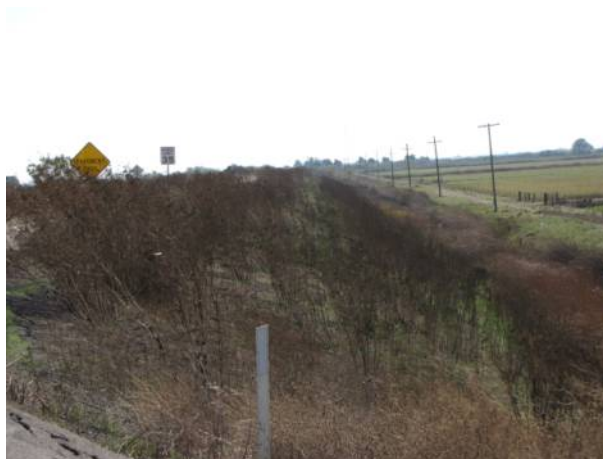
Levee Mile Report Line	2
Start Levee Mile	0.00
End Levee Mile	0.00
Location	Land Side
Category	Earthen Levee
Item	Vegetation
Unit 1 looking downstream landward from levee mile 0.00. Photo taken 10-20-2011.	
phillips_f_20111212_152.jpg

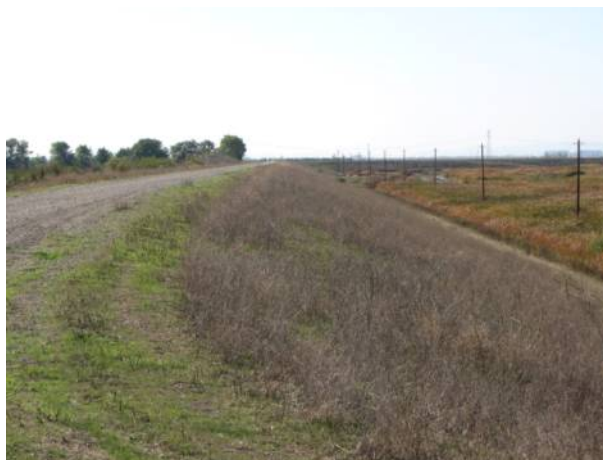
Levee Mile Report Line	1
Start Levee Mile	0.00
End Levee Mile	0.00
Location	Water Side
Category	Earthen Levee
Item	Vegetation

LMR No.	Levee Mile		Category	Item	* Location	** Rating	Action/Comment	GPS Latitude/Longitude		Issue No.
	Start	End						Start	End	Photo
1	0.00	0.00	Earthen Levee	Vegetation	WS	A	Remove the wild growth other than native grasses from the levee slopes.	38.277411 ° -121.696281 °	38.277411 ° -121.696281 °	2 Y
2	0.00	0.00	Earthen Levee	Vegetation	WS	A	Remove the wild growth other than native grasses from the levee slopes.	38.277411 ° -121.696281 °	38.277411 ° -121.696281 °	4 Y

Landward levee slope levee mile 0.00 Unit 1A.  
Photo taken 10-19-2011.

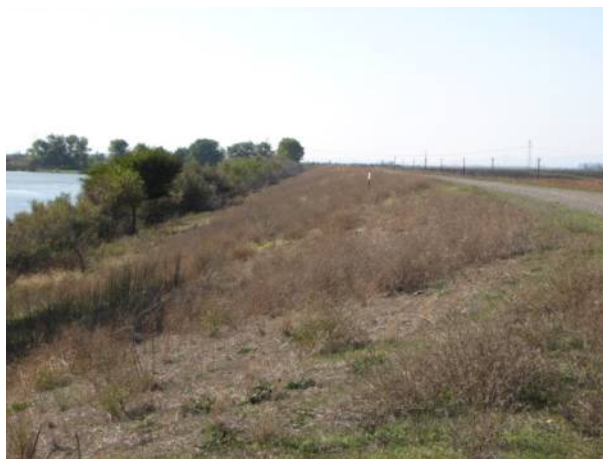
Levee Mile Report Line	2
Start Levee Mile	0.00
End Levee Mile	0.00
Location	Water Side
Category	Earthen Levee
Item	Vegetation

Waterward levee slope Unit 1A looking  
downstream from levee mile 0.00. Photo taken  
10-19-2011.

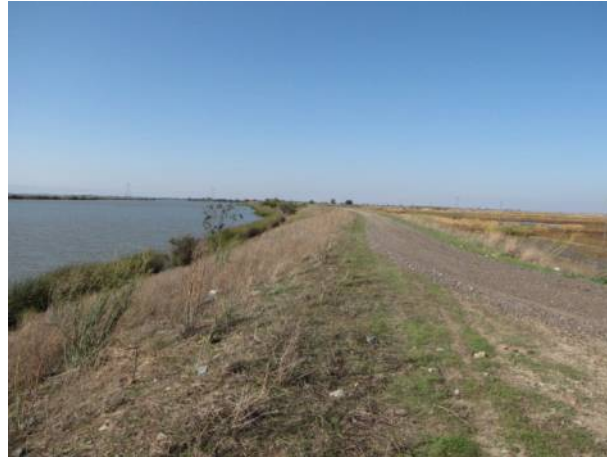
Levee Mile Report Line	1
Start Levee Mile	5.29
End Levee Mile	5.29
Location	Water Side
Category	Earthen Levee
Item	Vegetation

LMR No.	Levee Mile		Category	Item	Location *	Rating **	Action/Comment	GPS Latitude/Longitude		Issue No. Photo
	Start	End						Start	End	
1	5.29	5.29	Earthen Levee	Vegetation	WS	A	Remove the wild growth other than native grasses from the levee slopes.	38.275706 ° -121.705698 °	38.275706 ° -121.705698 °	3 Y
2	5.29	5.29	Earthen Levee	Vegetation	LS	A	Remove the wild growth other than native grasses from the levee slopes.	38.275706 ° -121.705698 °	38.275706 ° -121.705698 °	4 Y

Looking downstream from levee mile 5.29 Unit 2 waterward levee slope. Photo taken 10-19-2011.

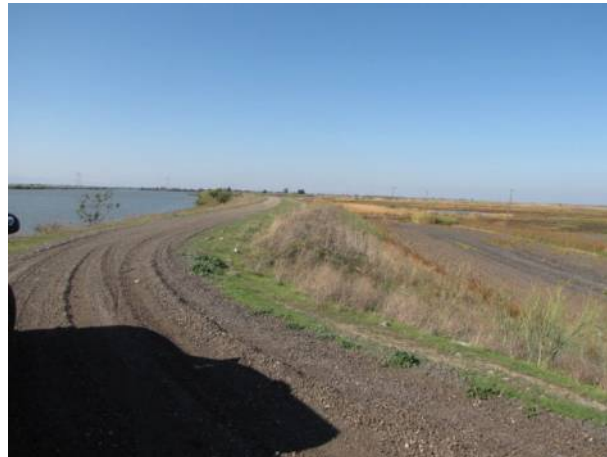
Levee Mile Report Line	2
Start Levee Mile	5.29
End Levee Mile	5.29
Location	Land Side
Category	Earthen Levee
Item	Vegetation

Looking downstream from levee mile 5.29 landside. Photo taken 10-19-2011.

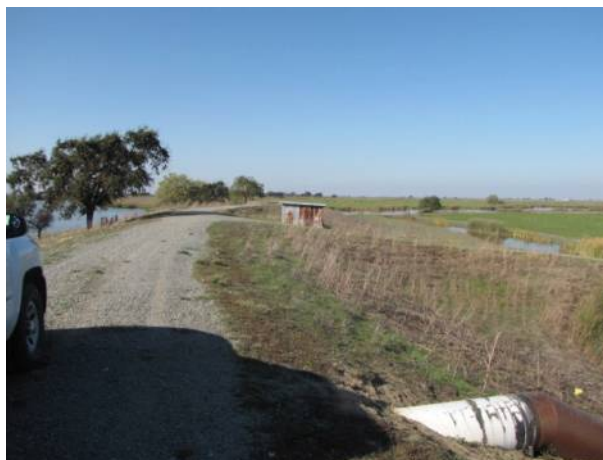
Levee Mile Report Line	2
Start Levee Mile	7.30
End Levee Mile	7.30
Location	Land Side
Category	Earthen Levee
Item	Vegetation

Looking downstream from levee mile 7.30 Unit 3.  
Phot taken 10-19-2011.

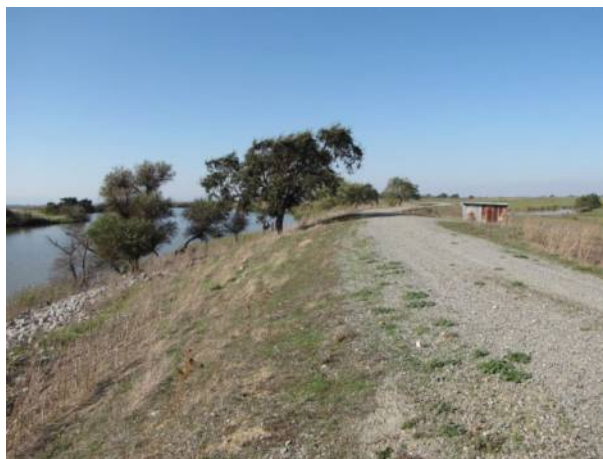
Levee Mile Report Line	3
Start Levee Mile	7.30
End Levee Mile	7.30
Location	Water Side
Category	Earthen Levee
Item	Vegetation

Looking downstream from levee mile 7.30 Unit 3.  
Photo taken 10-19-2011.

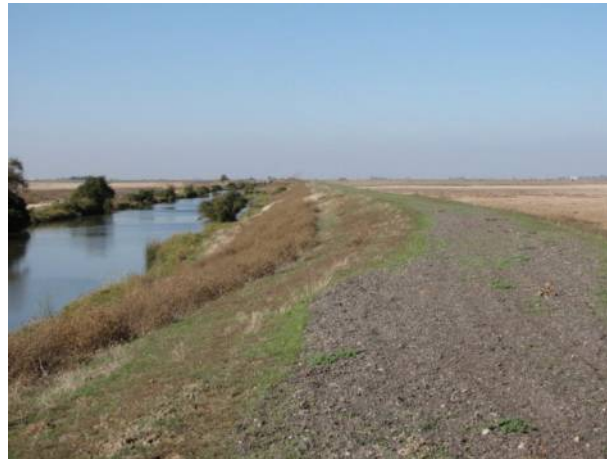
Levee Mile Report Line	1
Start Levee Mile	9.19
End Levee Mile	9.19
Location	Land Side
Category	Earthen Levee
Item	Vegetation

LMR No.	Levee Mile		Category	Item	Location *	Rating **	Action/Comment	GPS Latitude/Longitude		Issue No.
	Start	End						Start	End	Photo
1	9.19	9.19	Earthen Levee	Vegetation	LS	A	Remove the wild growth other than native grasses from the levee slopes.	38.316669 ° -121.740071 °	38.316669 ° -121.740071 °	2 Y
2	9.19	9.19	Earthen Levee	Vegetation	LS	A	Remove the wild growth other than native grasses from the levee slopes.	38.316669 ° -121.740071 °	38.316669 ° -121.740071 °	3 Y
3	9.46	9.46	Supplemental	USACE Erosion Survey	WS	M	Inspector Comments: 2011: Several scallops of erosion. Erosion primarily due to the weight of cattle on the slope. [2011 Site ID: HAS_9-7_L]	38.320240 ° -121.740183 °	38.324587 ° -121.740254 °	4 Y
4	9.81	9.81	Earthen Levee	Vegetation	WS	C	Remove the wild growth other than native grasses from the levee slopes.	38.324993 ° -121.740082 °	38.324993 ° -121.740082 °	1
5	10.93	10.94	Earthen Levee	Trim / Thin Trees	WS	M	Trim trees to at least five feet above ground level.	38.340930 ° -121.740783 °	38.341077 ° -121.740735 °	10

Looking downstream from levee mile 9.19 Unit 4.  
Photo taken 10-19-2011.

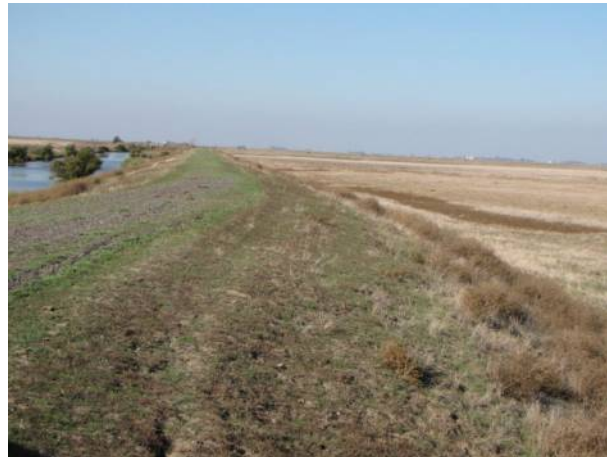
Levee Mile Report Line	2
Start Levee Mile	9.19
End Levee Mile	9.19
Location	Land Side
Category	Earthen Levee
Item	Vegetation

Looking downstream from levee mile 9.19  
landward slope. Photo taken 10-19-2011.

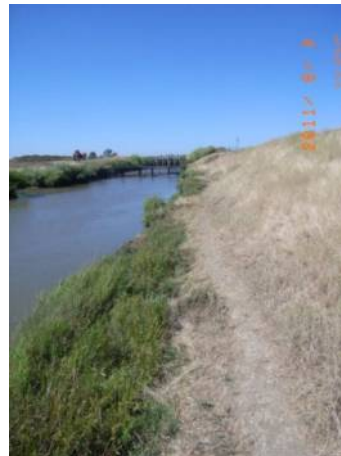
USACE 2011 Photo #1

Levee Mile Report Line	3
Start Levee Mile	9.46
End Levee Mile	9.46
Location	Water Side
Category	Supplemental
Item	USACE Erosion Survey

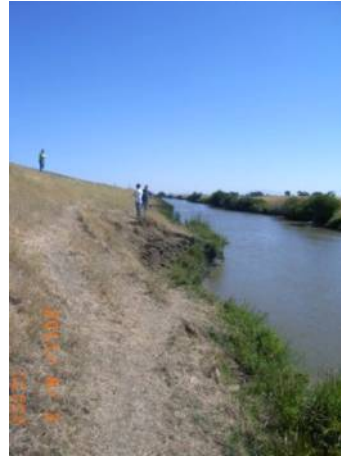
Levee Mile Report Line	3
Start Levee Mile	9.46
End Levee Mile	9.46
Location	Water Side
Category	Supplemental
Item	USACE Erosion Survey
USACE 2011 Photo #2	
USACE2011_HAS_9-7_L_2.jpg

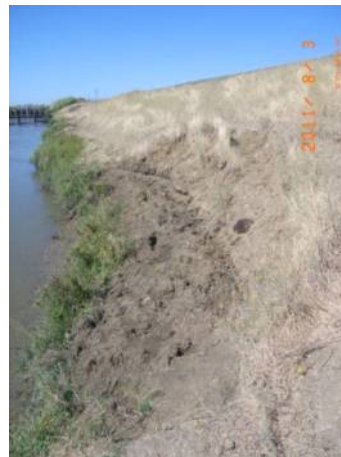
Levee Mile Report Line	3
Start Levee Mile	9.46
End Levee Mile	9.46
Location	Water Side
Category	Supplemental
Item	USACE Erosion Survey
USACE 2011 Photo #3	
USACE2011_HAS_9-7_L_3.jpg

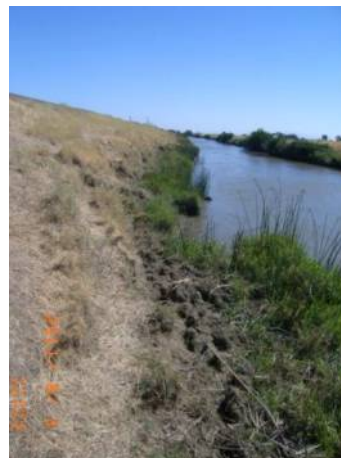
Levee Mile Report Line	3
Start Levee Mile	9.46
End Levee Mile	9.46
Location	Water Side
Category	Supplemental
Item	USACE Erosion Survey
USACE 2011 Photo #4	
USACE2011_HAS_9-7_L_4.jpg
