**Flood Control Project Maintenance
Levee Inspections**

Fall 2012 Levee Maintenance Deficiency Summary Report

Reclamation District No. 2098 Cache and Haas Slough

Levee Inspection Report By Mile - Fall 2012

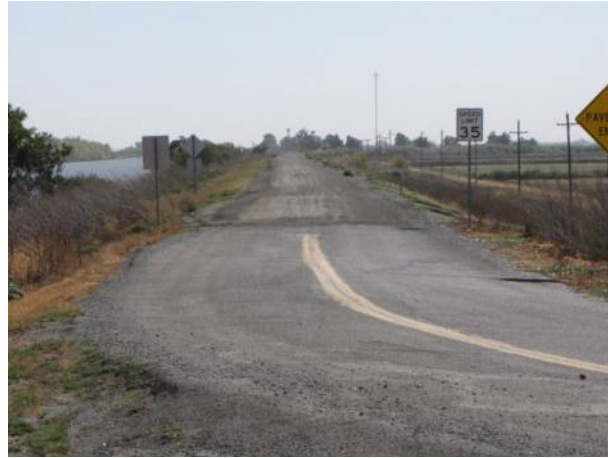
Levee Mile Report Line	4
Start Levee Mile	0.00
End Levee Mile	0.00
Location	Land Side
Category	Earthen Levee
Item	Vegetation

RD 2098 Unit 1. Looking downstream levee mile 0.00. Photo taken 10-17-2012.

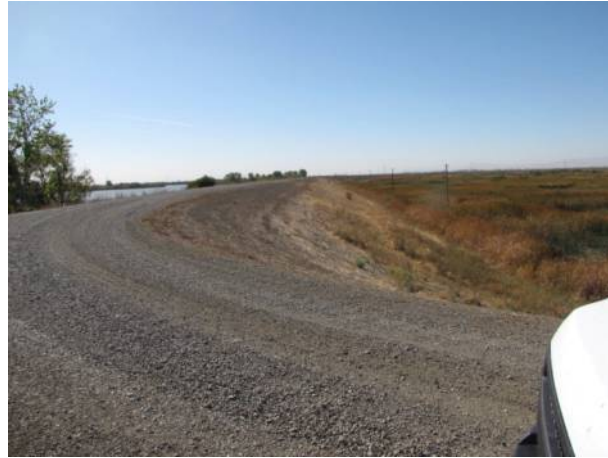
Levee Mile Report Line	1
Start Levee Mile	0.00
End Levee Mile	0.00
Location	Land Side
Category	Earthen Levee
Item	Vegetation
RD 2098 Unit 1A looking downstream. Photo taken 10-17-2012.	
phillips_f_20121206_479.jpg

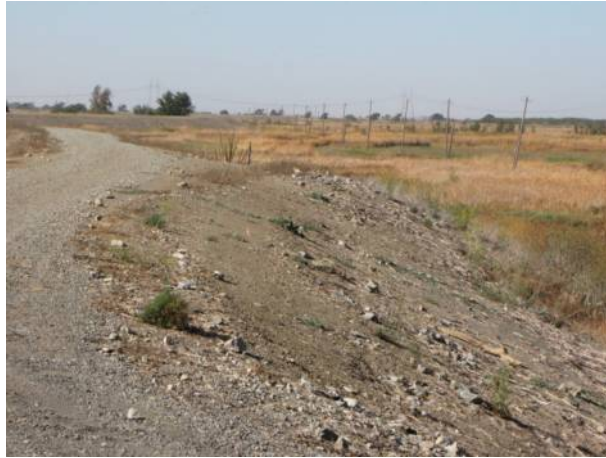
Levee Mile Report Line	1
Start Levee Mile	5.29
End Levee Mile	5.29
Location	Water Side
Category	Earthen Levee
Item	Vegetation
RD 2098 Unit 2 looking downstream. Photo taken 10-17-2012.	
phillips_f_20121206_482.jpg
