**Flood Control Project Maintenance
Levee Inspections**

Fall 2013 Levee Maintenance Deficiency Summary Report

Reclamation District No. 2098 Cache and Haas Slough

Levee Inspection Report By Mile - Fall 2013

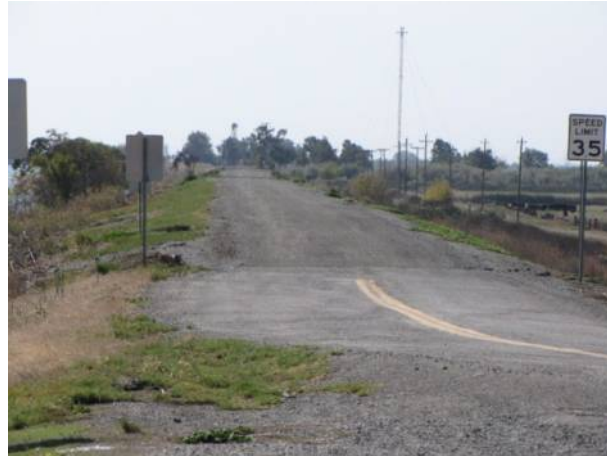
Levee Mile Report Line	4
Start Levee Mile	0.00
End Levee Mile	0.00
Location	Land Side
Category	Earthen Levee
Item	Vegetation
RD 2098 Unit 1 levee mile 0.00 looking downstream from downstream limits of RD 2068 Unit 1. Photo taken 10-09-2013.	
phillips_f_20131015_632.JPG

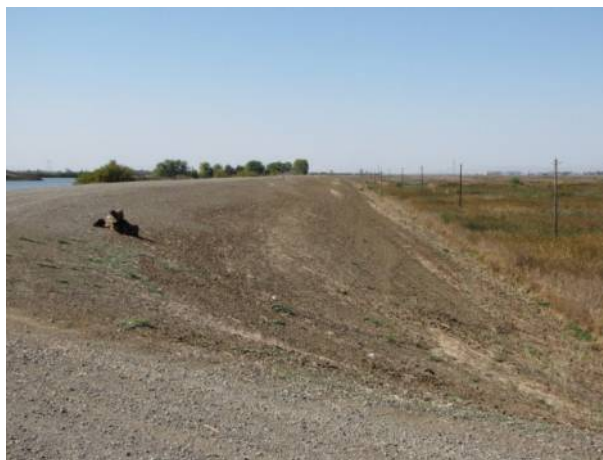
Levee Mile Report Line	1
Start Levee Mile	0.00
End Levee Mile	0.53
Location	Land Side
Category	Earthen Levee
Item	Vegetation

LMR No.	Levee Mile		Category	Item	Location	Rating	Action/Comment	GPS Latitude/Longitude		Issue No. Photo
	Start	End						Start	End	
1	0.00	0.53	Earthen Levee	Vegetation	LS	A	V1 : Control annual grass and weeds on the levee slopes and easements. Inspector Comments: All vegetation has been removed from the landside slope. Photo taken 10-09-2013.	38.277534 ° -121.696248 °	38.275720 ° -121.706730 °	16 Y
DWR ID: DWR_RD2098_01A_f_2013_16										
2	0.00	0.53	Earthen Levee	Vegetation	WS	A	V1 : Control annual grass and weeds on the levee slopes and easements. Inspector Comments: Vegetation completely removed from waterside slope. Photo taken 10-09-2013.	38.277534 ° -121.696248 °	38.275720 ° -121.706730 °	17 Y
DWR ID: DWR_RD2098_01A_f_2013_17

RD 2098 Unit 1A Looking downstream from landside slope. Photo taken 10-09-2013.

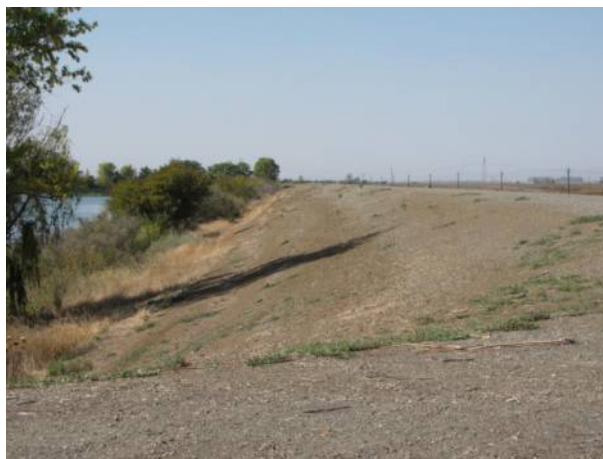
Levee Mile Report Line	2
Start Levee Mile	0.00
End Levee Mile	0.53
Location	Water Side
Category	Earthen Levee
Item	Vegetation

RD 2068 Unit 1A looking downstream from waterside slope. Photo taken 10-09-2013.

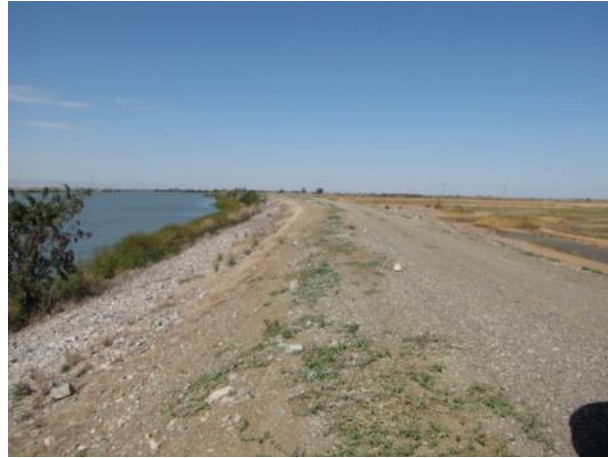
Levee Mile Report Line	1
Start Levee Mile	5.29
End Levee Mile	5.29
Location	Land Side
Category	Earthen Levee
Item	Vegetation

RD 2098 Unit 2 looking downstream from levee 5.29 waterside. Photo taken 10-09-2013.

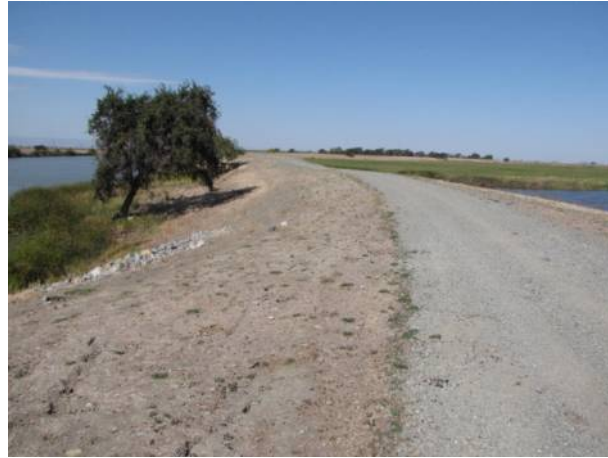
Levee Mile Report Line	1
Start Levee Mile	7.30
End Levee Mile	9.19
Location	Water Side
Category	Earthen Levee
Item	Vegetation

RD 2098 Unit 3 looking downstream from levee mile 7.30 waterside. Photo taken 10-09-2013.

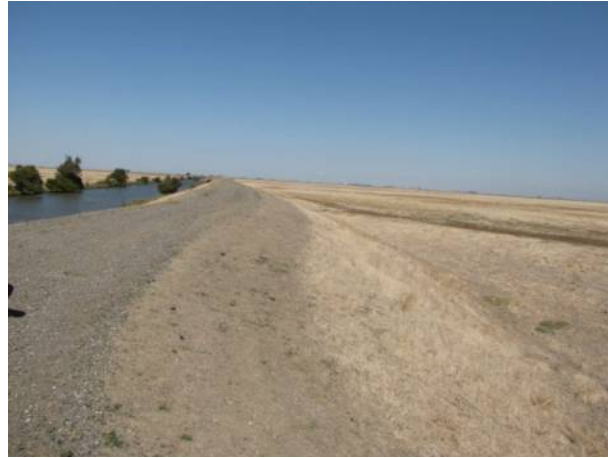
Levee Mile Report Line	1
Start Levee Mile	9.15
End Levee Mile	10.89
Location	Water Side
Category	Earthen Levee
Item	Vegetation

RD 2098 Unit 4 looking downstream at landside slope from levee mile 9.15. Photo taken 10-9-2013.
