**Flood Control Project Maintenance  
Levee Inspections**

**Fall 2014 Levee Maintenance Deficiency Summary Report**

**Reclamation District No. 2098 Cache and Haas Slough**

**Levee Inspection Report By Mile - Fall 2014**

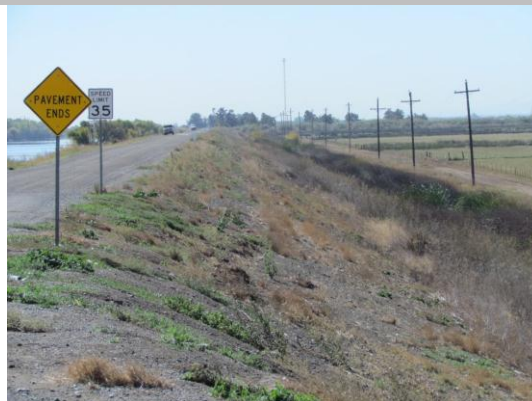
Photo 1 of 1 : FA\_2014\_RD2098\_244\_2\_20141126\_00001.jpg

LM Start	0.02	Rating **	A	Issue No.	2
LM End	3.58	Issue Type +	Ma	Location *	LS
Category	Earthen Levee			GPS Latitude/Longitude	
				Start	End
Item	Vegetation			38.328788 °	38.329117 °
				-121.694072 °	-121.694060 °
DWR ID	DWR_RD2098_01_f_2014_2				
Action/Comments					
Control annual grass and weeds on the levee slopes and easements.

RD 2098 Unit 1 looking downstream from landside slope. Goats were used to remove vegetation.

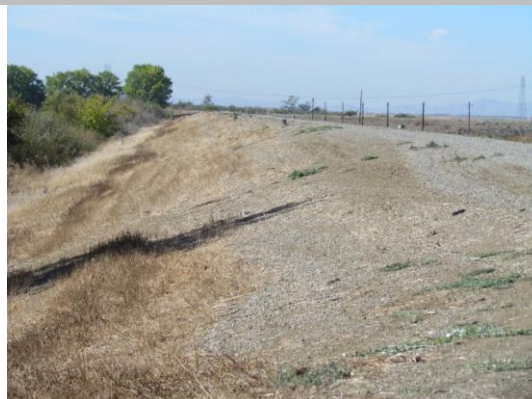
Photo 1 of 1 : FA\_2014\_RD2098\_245\_3\_20141126\_00002.jpg

LM Start	0.02	Rating **	A	Issue No.	3
LM End	0.55	Issue Type +	Ma	Location *	WS
Category	Earthen Levee			GPS Latitude/Longitude	
				Start	End
Item	Vegetation			38.277411 °	38.275735 °
				-121.690280 °	-121.705765 °
DWR ID	DWR_RD2098_01A_f_2014_3				
Action/Comments					
Control annual grass and weeds on the levee slopes and easements. Inspector Comments: Waterside levee slope has been mowed.

Looking downstream from waterside levee mile 0.02 to 0.55.

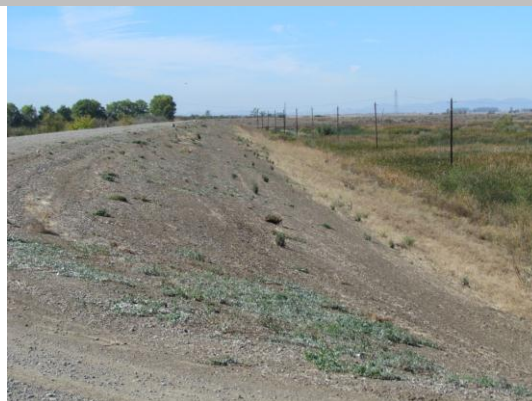
Photo 1 of 1 : FA\_2014\_RD2098\_245\_2\_20141126\_00001.jpg

LM Start	0.02	Rating **	A	Issue No.	2
LM End	0.55	Issue Type +	Ma	Location *	LS
Category	Earthen Levee			GPS Latitude/Longitude	
				Start	End
Item	Vegetation			38.277325 °	38.275735 °
				-121.696650 °	-121.705765 °
DWR ID	DWR_RD2098_01A_f_2014_2				
Action/Comments					
Control annual grass and weeds on the levee slopes and easements. Inspector Comments: Goats has cleared all vegetation from landward levee slope.

Looking downstream from Unit 1A RD 2098 Landside slope.

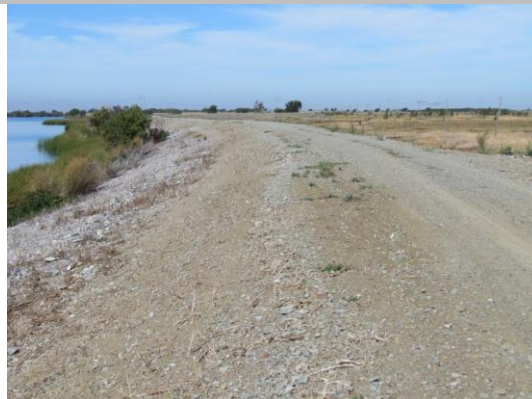
Photo 1 of 1 : FA\_2014\_RD2098\_246\_15\_20141126\_00003.jpg

LM Start	5.29	Rating **	A	Issue No.	15
LM End	7.30	Issue Type +	Ma	Location *	LS
Category	Earthen Levee			GPS Latitude/Longitude	
				Start	End
Item	Vegetation			38.275706 °	38.294171 °
				-121.705698 °	-121.725037 °
DWR ID	DWR_RD2098_02_f_2014_15				
Action/Comments					
Control annual grass and weeds on the levee slopes and easements. Inspector Comments: Goats has done a great job of removing the vegetation.

RD 2098 Unit 2 looking downstream from waterside slope. Goats have removed vegetation from the slope.

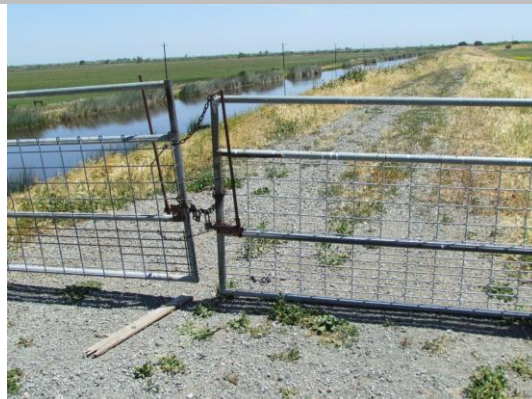
Photo 1 of 1 : FA\_2014\_RD2098\_246\_4\_20141008\_00001.jpg

LM Start	6.71	Rating **	U	Issue No.	4
LM End	6.71	Issue Type +	Ma	Location *	CR
Category	Earthen Levee			GPS Latitude/Longitude	
				Start	End
Item	Repair Gates			38.289452 °	38.289452 °
				-121.716814 °	-121.716814 °
DWR ID	DWR_RD2098_02_f_2013_4				
Action/Comments					
Inspector Comments: This gate is damaged and requires replacement.

This gate has no hinges. No new photo; no repairs done.

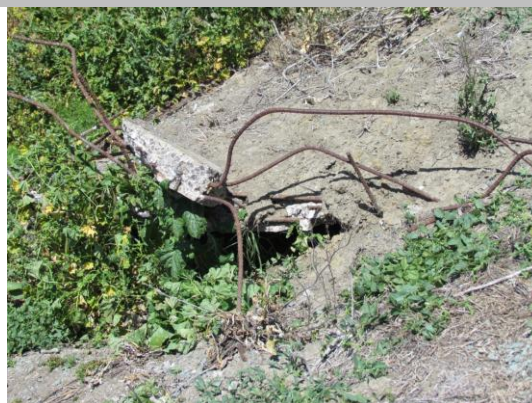
Photo 1 of 1 : FA\_2014\_RD2098\_246\_10\_20141008\_00002.jpg

LM Start	6.72	Rating **	U	Issue No.	10
LM End	6.72	Issue Type +	Ma	Location *	WS
Category	Earthen Levee			GPS Latitude/Longitude	
				Start	End
Item	Slope Stability			38.292076 °	38.292076 °
				-121.715792 °	-121.715792 °
DWR ID	DWR_RD2098_02_s_2014_10				
Action/Comments					
Repair slope instability. Inspector Comments: RD 2098 will send out crew to inspect site and make repairs as needed.

There is some slope damage at this location under this concrete. No new photo; RD will send crew out to check area out.

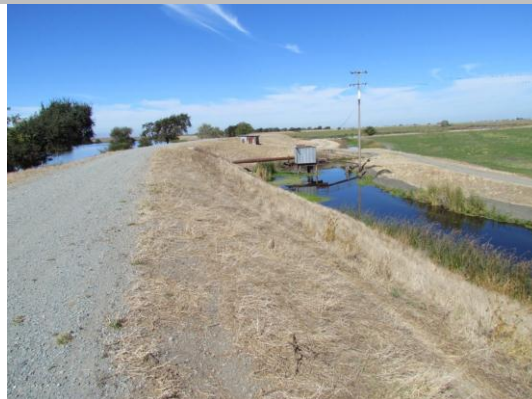
Photo 1 of 1 : FA\_2014\_RD2098\_247\_17\_20141126\_00008.jpg

LM Start	7.30	Rating **	M	Issue No.	17
LM End	9.19	Issue Type +	Ma	Location *	LS
Category	Earthen Levee			GPS Latitude/Longitude	
				Start	End
Item	Vegetation			38.294171 °	38.316093 °
				-121.725037 °	-121.704014 °
DWR ID	DWR_RD2098_03_f_2014_17				
Action/Comments					
Control annual grass and weeds on the levee slopes and easements.

Looking downstream from levee mile 7.30 Unit 3 landside slope.

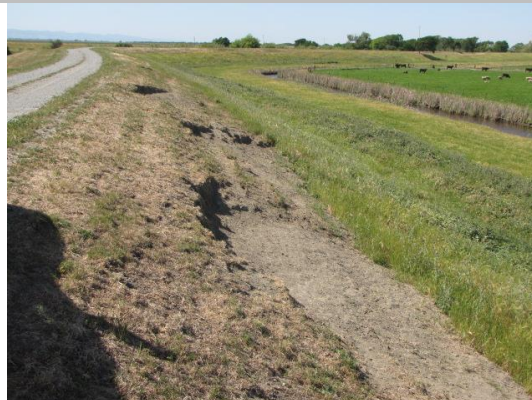
Photo 1 of 1 : FA\_2014\_RD2098\_247\_4\_20141008\_00001.jpg

LM Start	7.50	Rating **	M	Issue No.	4
LM End	7.61	Issue Type +	Ma	Location *	WS
Category	Earthen Levee			GPS Latitude/Longitude	
				Start	End
Item	Slope Stability			38.295930 °	38.298142 °
				-121.727043 °	-121.739715 °
DWR ID	DWR_RD2098_03_s_2013_4				
Action/Comments					
Repair slope instability. Inspector Comments: There is erosion on waterside covered by tullies. This is not a new site. Monitor but it appears to be stable at this time, 4-23-2013. During inspection 5-14-2014 no movement at site.

RD 2098 Unit 3 landside slope erosion levee mile 7.50-7.61. Photo taken 4-23-2013.

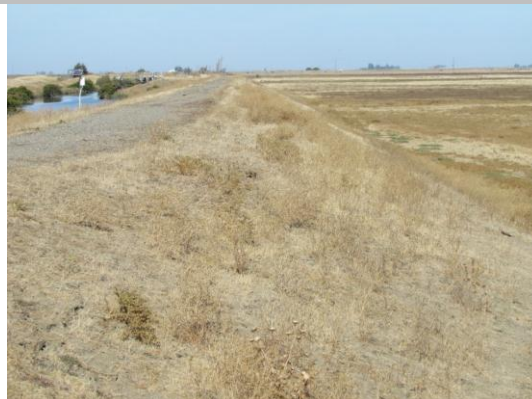
Photo 1 of 1 : FA\_2014\_RD2098\_248\_4\_20141126\_00005.jpg

LM Start	9.20	Rating **	M	Issue No.	4
LM End	9.20	Issue Type +	Ma	Location *	LS
Category	Earthen Levee			GPS Latitude/Longitude	
				Start	End
Item	Vegetation			38.316167 °	38.316167 °
				-121.740115 °	-121.740120 °
DWR ID	DWR_RD2098_04_s_2014_4				
Action/Comments					
Remove the wild growth other than native grasses from the levee slopes.

RD 2098 Unit 4 looking downstream along the landside at levee mile 9.20.
