**Flood Control Project Maintenance
Levee Inspections**

Fall 2015 Levee Maintenance Deficiency Summary Report

**Flood Control Project Maintenance
Levee Inspections**
LMA District Cover Sheet
Fall 2015 Levee Inspection Results

Reclamation District No. 2098 Cache and Haas Slough

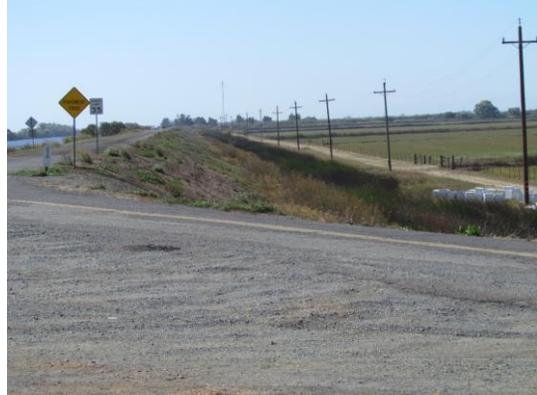
Photo 1 of 1 : FA_2015_RD2098_244_10_20151006_00001.jpg

LM Start	0.02	Rating **	A	Issue No.	10
LM End	3.59	Issue Type +	Ma	Location *	LS
Category	Earthen Levee		GPS Latitude/Longitude		
			Start	End	
Item	Vegetation		38.328835 °	38.277543 °	
			-121.694085 °	-121.696202 °	
DWR ID	DWR_RD2098_01_f_2015_10				
Action/Comments					
Control annual grass and weeds on the levee slopes and easements. Inspector Comments: Burned levee slope landward.

RD 2098 Unit 1 looking downstream from levee mile 0.00 landside slope.

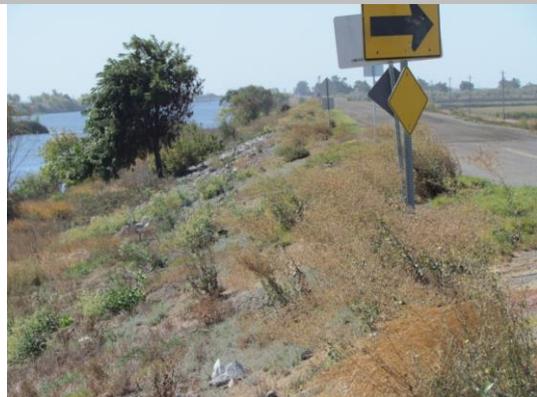
Photo 1 of 1 : FA_2015_RD2098_244_11_20151006_00002.jpg

LM Start	0.10	Rating **	M	Issue No.	11
LM End	0.53	Issue Type +	Ma	Location *	WS
Category	Earthen Levee		GPS Latitude/Longitude		
			Start	End	
Item	Vegetation		38.327652 °	38.321435 °	
			-121.694050 °	-121.694047 °	
DWR ID	DWR_RD2098_01_f_2015_11				
Action/Comments					
Control annual grass and weeds on the levee slopes and easements. Inspector Comments: Slope appears to been sprayed some tall weed growth present on slope.

RD 2098 Unit 1 waterside slope looking downstream levee mile 0.10.

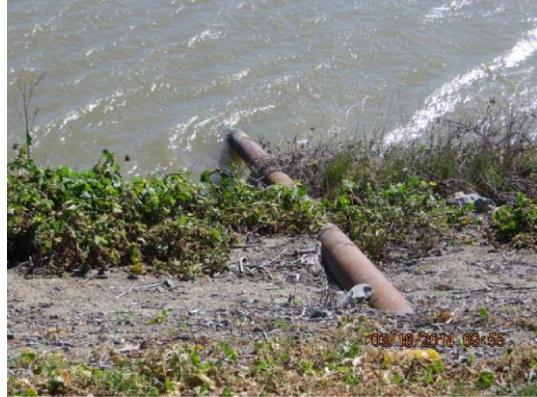
Photo 3 of 3 : UCIP_FA_2015_4104.jpg

LM Start	1.82	Rating **	M	Issue No.	13 (cont)
LM End	1.82	Issue Type +	En	Location *	WS
Category	Supplemental			GPS Latitude/Longitude	
				Start	End
Item	DWR UCIP Field Study			38.302770 °	38.302770 °
				-121.693640 °	-121.693640 °
DWR ID					
Action/Comments					
Inspector Comments: FS_ID:32197 DS_ID:20965 EP_NO: 10168 FS_HLM: 1.81 Repair Type: Non-Urgent Crossing Status: Found

Pipe on WS slope.

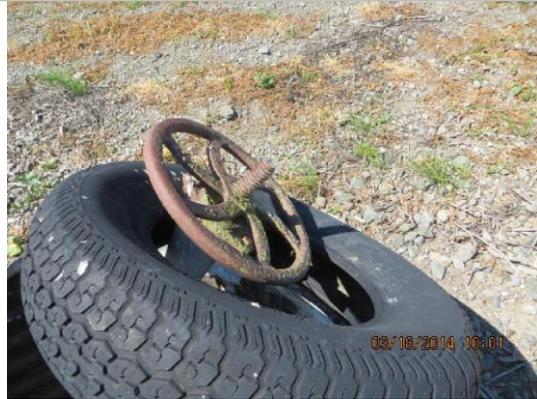
Photo 1 of 3 : UCIP_FA_2015_4105.jpg

LM Start	1.83	Rating **	M	Issue No.	14
LM End	1.83	Issue Type +	En	Location *	WS
Category	Supplemental			GPS Latitude/Longitude	
				Start	End
Item	DWR UCIP Field Study			38.302552 °	38.302552 °
				-121.693653 °	-121.693653 °
DWR ID					
Action/Comments					
Inspector Comments: FS_ID:32207 DS_ID:20966 EP_NO: 10168 FS_HLM: 1.8251 Repair Type: Non-Urgent Crossing Status: Found UCIP Comments: Slide gate actuator bent but appears to be in closed position. No lid on standpipe. Appears abandoned and if so should be done so properly. FIELD_STRUCT_DESC: 24-inch pipe through the levee, 24.5 feet below the crown. Two CM cutoff wall around pipe at center of levee. Slide gate in 36-inch CMP riser on the waterward slope. Concrete saddle and apron on waterward end. Flap gate and "U" headwall on landward end. This pipe was retained under ABO No. 10168 (1974). FS Date: 03/18/2014

bent actuator on WS slope.

Inspector Comments: FS_ID:32207
 DS_ID:20966
 EP_NO: 10168
 FS_HLM: 1.8251
 Repair Type: Non-Urgent
 Crossing Status: Found
 UCIP Comments: Slide gate actuator bent but appears to be in closed position. No lid on standpipe. Appears abandoned and if so should be done so properly.
 FIELD_STRUCT_DESC: 24-inch pipe through the levee, 24.5 feet below the crown. Two CM cutoff wall around pipe at center of levee. Slide gate in 36-inch CMP riser on the waterward slope. Concrete saddle and apron on waterward end. Flap gate and "U" headwall on landward end. This pipe was retained under ABO No. 10168 (1974).
 FS Date: 03/18/2014

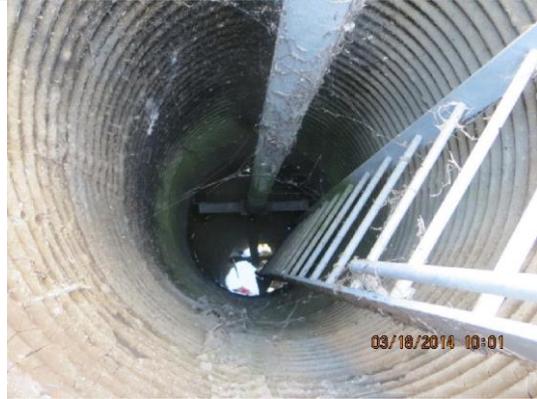
Photo 2 of 3 : UCIP_FA_2015_4106.jpg

No lid on CMP riser that is 24-feet deep.

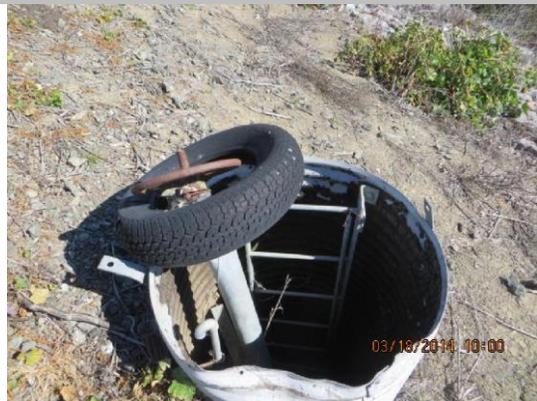
Photo 3 of 3 : UCIP_FA_2015_4107.jpg

36-inch CMP riser with bent slide gate actuator on WS slope.

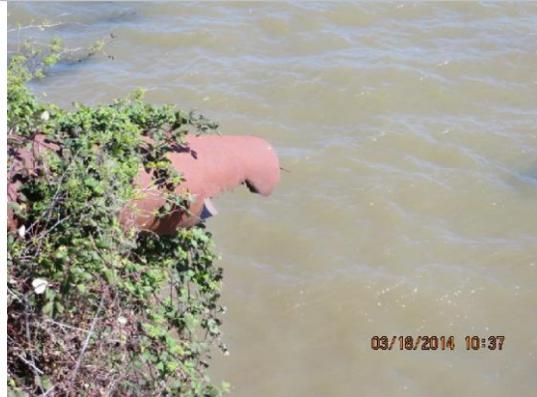
Photo 1 of 3 : UCIP_FA_2015_4111.jpg

LM Start	3.01	Rating **	M	Issue No.	16
LM End	3.01	Issue Type +	En	Location *	WS
Category	Supplemental			GPS Latitude/Longitude	
				Start	End
Item	DWR UCIP Field Study			38.285525 °	38.285525 °
				-121.693640 °	-121.693640 °
DWR ID					
Action/Comments					
Inspector Comments: FS_ID:32227 DS_ID:20969 EP_NO: 13222 FS_HLM: 2.993 Repair Type: Non-Urgent Crossing Status: Found UCIP Comments: Pipe rusted through at outlet on WS slope, may indicate further degradation of pipe within levee. Good candidate for video inspection. FIELD_STRUCT_DESC: 20-inch steel drainpipe through the levee, 7.5 feet below the crown. Siphon breaker at waterward shoulder. Pump on pile structure in drain ditch on landward side. (USACE-1962). This entry matches the Drainage or Irrigation Structure referenced in O&M manual (HLM 2.98). This pipe was retained under ABO No. 10168 (1974). Pipe removed and replaced with 19-inch steel pipe under crown and along landward slope under Permit No. 13222 (1982). FS Date: 03/18/2014

Pipe rusted through at outlet on WS slope.

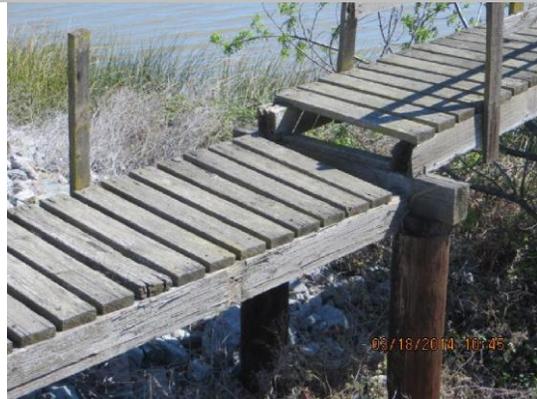
Photo 2 of 3 : UCIP_FA_2015_4115.jpg

Walkway may not be structurally sound.

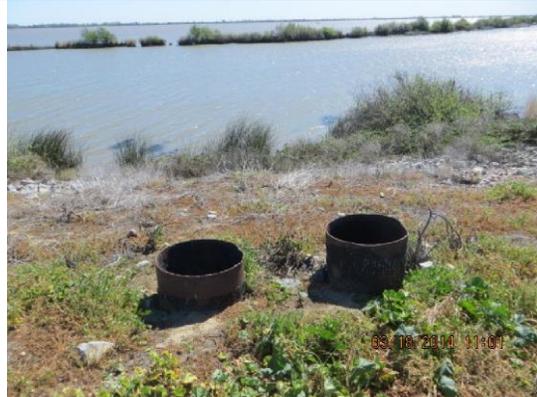
Photo 1 of 3 : UCIP_FA_2015_3594.jpg

Siphon breaker in steel riser on WS shoulder.

Inspector Comments: FS_ID:32245
 DS_ID:20959
 EP_NO: 15169
 FS_HLM: 3.487
 Repair Type: Non-Urgent
 Crossing Status: Found
 UCIP Comments: Soil and debris buildup in steel riser on WS shoulder may prevent proper function of siphon breaker.
 FIELD_STRUCT_DESC: 2 of 2: 24-inch steel pipe through the levee, 5.6 feet below the crown. Cutoff wall around pipe at center of levee. Siphon breaker at waterward shoulder. Flap gate on waterward end. Pump in pump house on piling structure on landward side. (Permit No. 15169-1989)
 FS Date: 03/18/2014

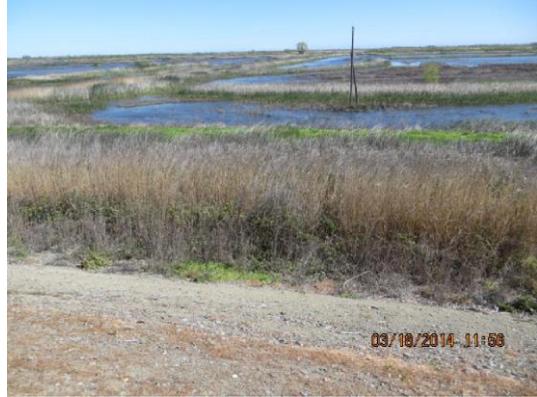
Photo 3 of 3 : UCIP_FA_2015_3157.jpg

LS - no pipe visible.

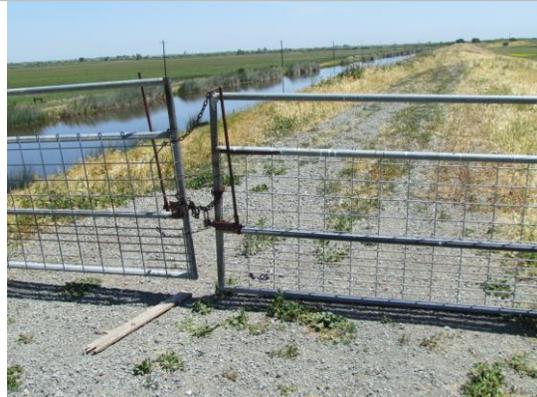
Photo 1 of 1 : FA_2015_RD2098_246_4_20150915_00001.jpg

LM Start	6.51	Rating **	U	Issue No.	4
LM End	6.51	Issue Type +	Ma	Location *	CR
Category	Earthen Levee			GPS Latitude/Longitude	
				Start	End
Item	Repair Gates			38.289452 °	38.289452 °
				-121.716814 °	-121.716814 °
DWR ID	DWR_RD2098_02_f_2013_4				
Action/Comments					
Inspector Comments: This gate is damaged and requires replacement.

This gate has no hinges. No new photo; no repairs done.

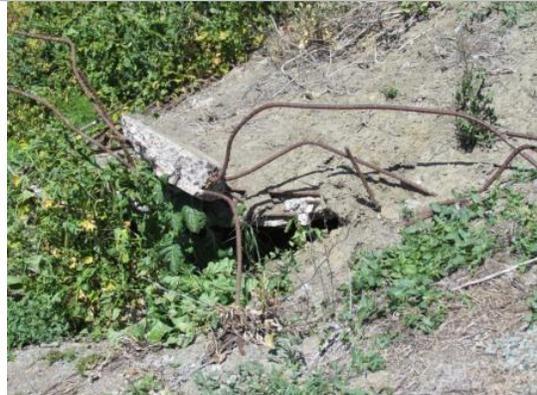
Photo 1 of 1 : FA_2015_RD2098_246_10_20150915_00002.jpg

There is some slope damage at this location under this concrete. No new photo; RD will send crew out to check area out.

LM Start	6.70	Rating **	M	Issue No.	10
LM End	6.70	Issue Type +	Ma	Location *	WS
Category	Earthen Levee			GPS Latitude/Longitude	
				Start	End
Item	Slope Stability			38.292076 °	38.292076 °
				-121.715792 °	-121.715792 °
DWR ID	DWR_RD2098_02_s_2014_10				
Action/Comments					
Repair slope instability. Inspector Comments: RD 2098 will send out crew to inspect site and make repairs as needed.

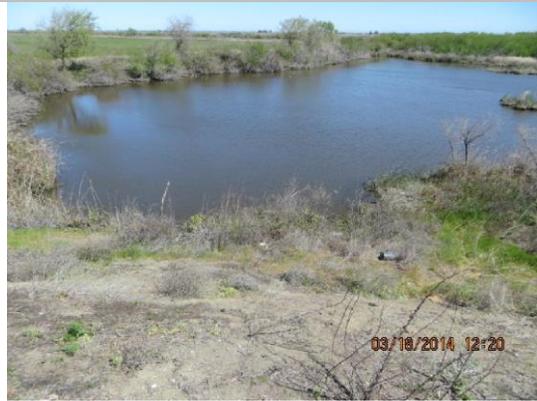
Photo 2 of 3 : UCIP_FA_2015_4184.jpg

Inlet not visible on LS toe.

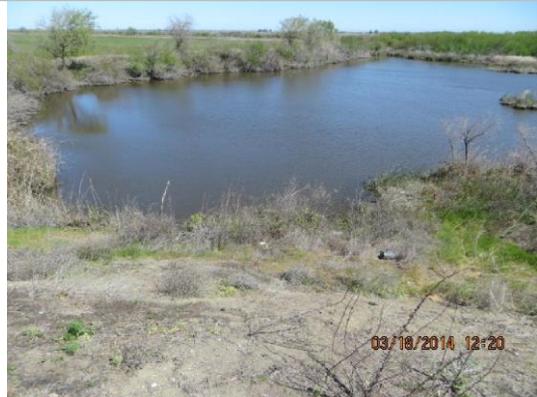
Photo 1 of 3 : UCIP_FA_2015_3154.jpg

Inlet not visible on LS toe.

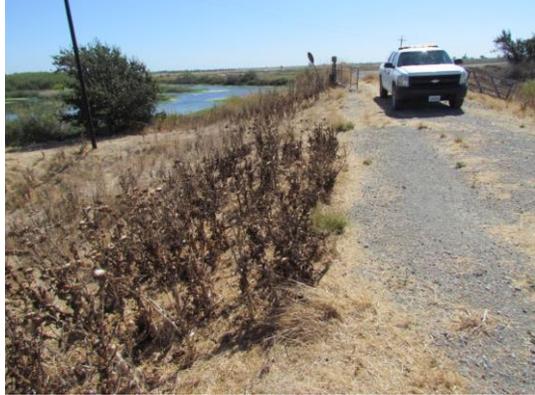
Photo 1 of 1 : FA_2015_RD2098_246_13_20151006_00004.jpg

Unsatisfactory tall weeds on the landside shoulder and slope.

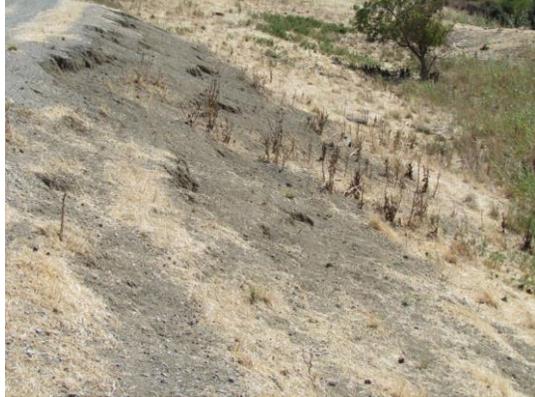
Photo 1 of 1 : FA_2015_RD2098_246_15_20151006_00005.jpg

Slope damage caused by goats.

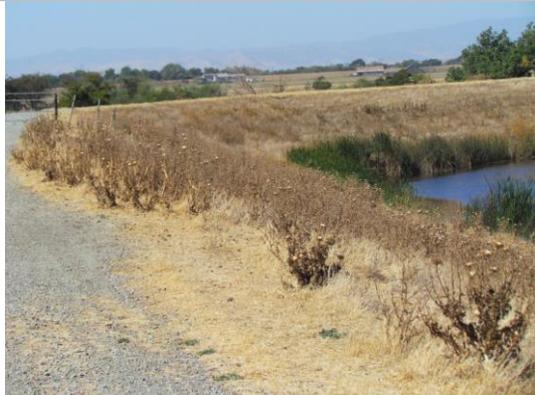
Photo 1 of 1 : FA_2015_RD2098_246_16_20151006_00006.jpg

Landside slope covered with star thistle from 7.08- 7.14.

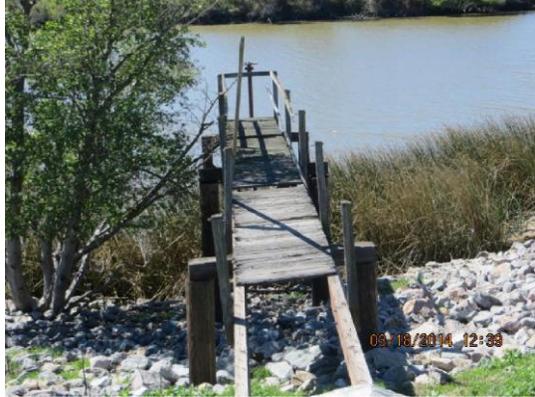
Photo 2 of 3 : UCIP_FA_2015_3159.jpg

Delapidated wooden pier on WS shoulder.

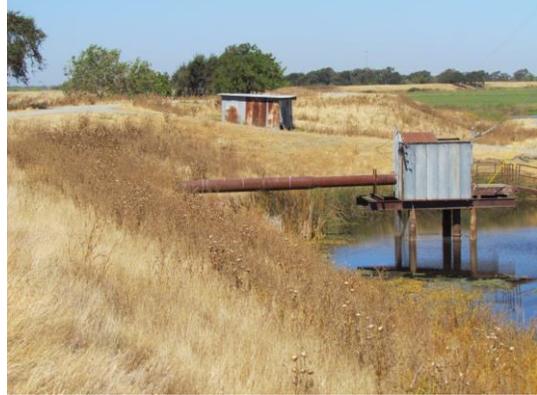
Photo 1 of 1 : FA_2015_RD2098_247_8_20151006_00006.jpg

Looking upstream from levee mile 7.19 tall thistle present on the landside slope.

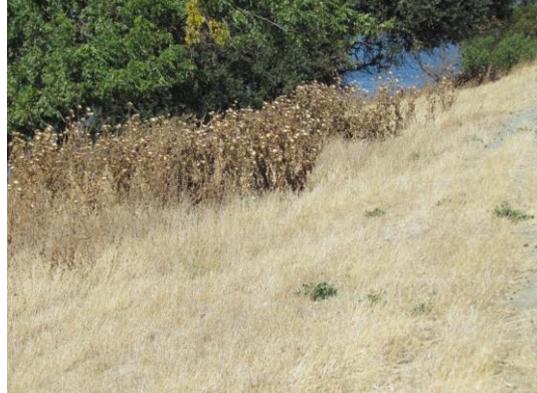
Photo 1 of 1 : FA_2015_RD2098_247_10_20151006_00005.jpg

Looking upstream from levee mile 7.19 tall weeds present on the waterside slope.

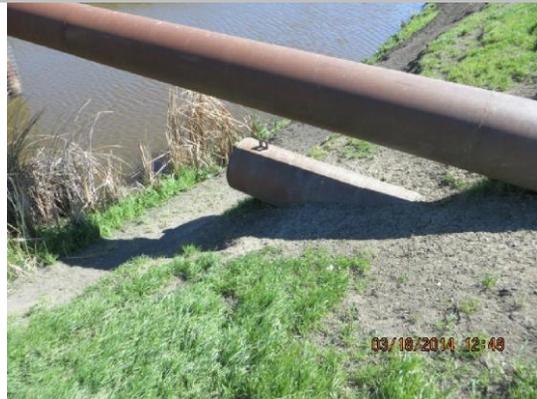
Photo 2 of 2 : UCIP_FA_2015_3712.jpg

Abandoned pipe visible under new replacement pipe.

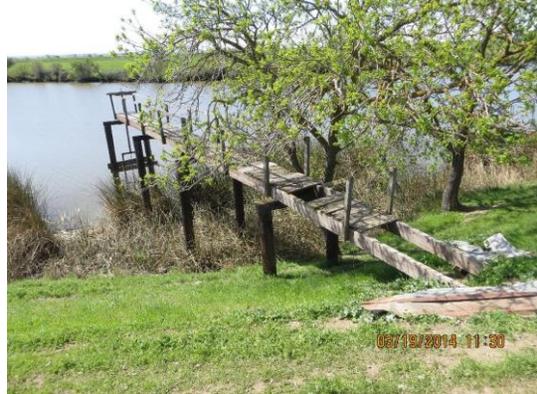
Photo 2 of 3 : UCIP_FA_2015_3830.jpg

Walkway over pipe on WS toe in poor structural condition.

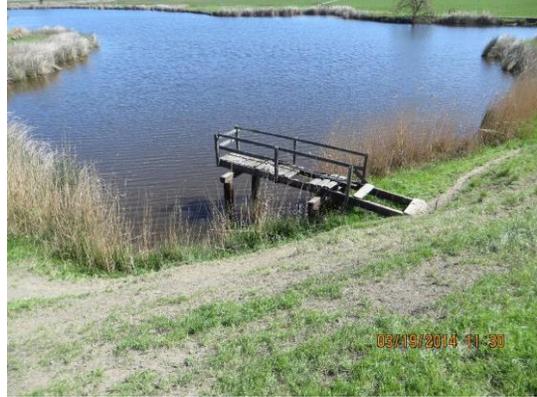
Photo 3 of 3 : UCIP_FA_2015_3831.jpg

Walkway over pipe on LS toe in poor structural condition and Slidegate not visible

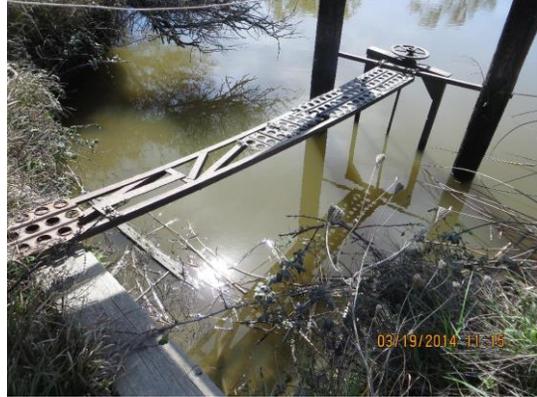
Photo 1 of 3 : UCIP_FA_2015_4186.jpg

Inadequate access walkway to slidegate at WS toe.

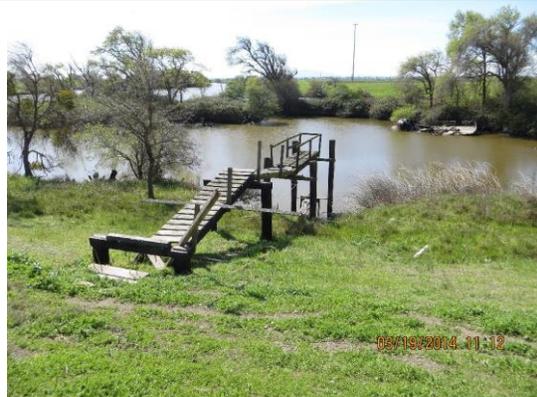
Photo 3 of 3 : UCIP_FA_2015_4188.jpg

Wooden walkway at WS toe is in disrepair.

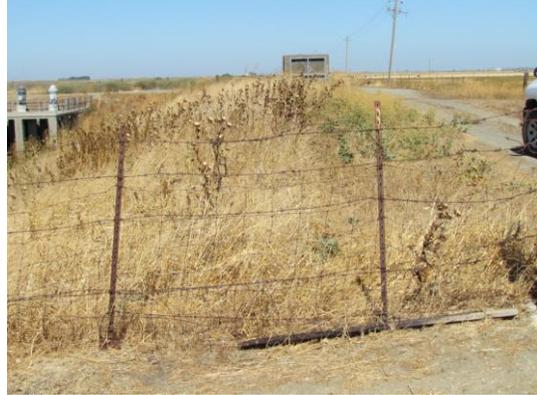
Photo 1 of 1 : FA_2015_RD2098_248_10_20151006_00003.jpg

From levee mile 9.77-9.79 tall weed growth on the waterside levee shoulder and slope.

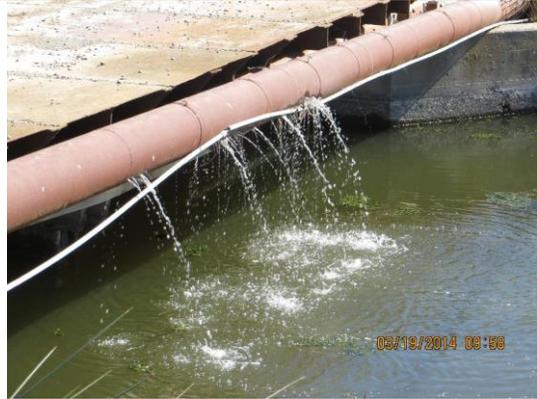
Photo 1 of 3 : UCIP_FA_2015_3923.jpg

Holes in pipe next to bridge. PVC electrical conduit shown.

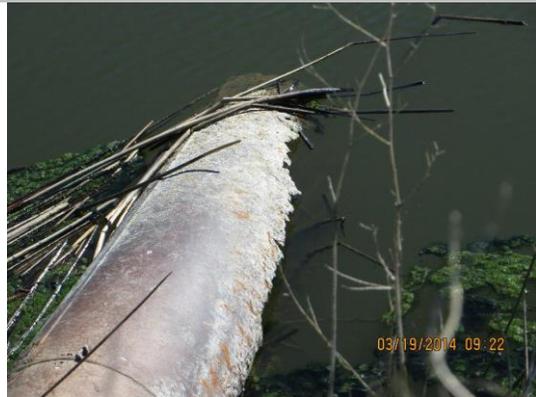
Photo 1 of 3 : UCIP_FA_2015_3625.jpg

Pipe rusted through at canal on LS toe.

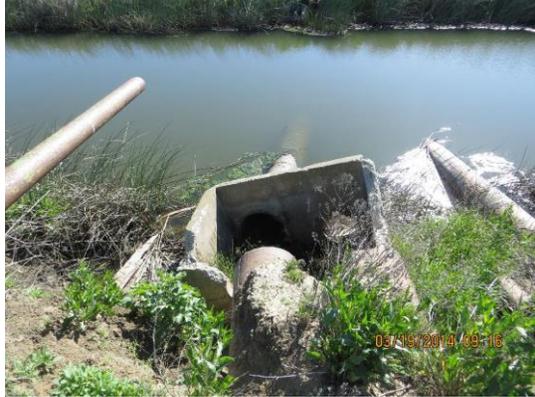
Photo 3 of 3 : UCIP_FA_2015_3624.jpg

Concrete distribution box on LS slope has slipped into canal.

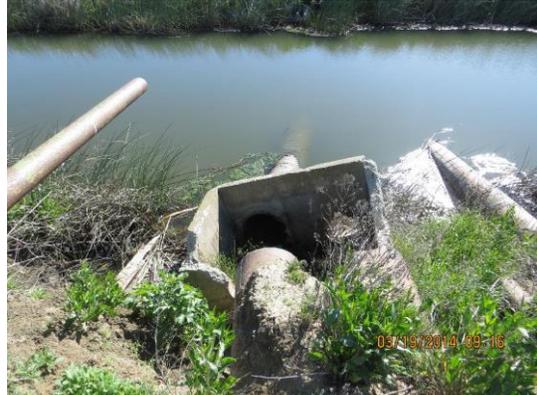
Photo 3 of 3 : UCIP_FA_2015_3621.jpg

Concrete distribution box on LS slope has lost its foundation stability and slid into canal on LS slope.
