**Flood Control Project Maintenance
Levee Inspections**

Fall 2016 Levee Maintenance Deficiency Summary Report

**Flood Control Project Maintenance
Levee Inspections**
LMA District Cover Sheet
Fall 2016 Levee Inspection Results

Reclamation District No. 2098 Cache and Haas Slough

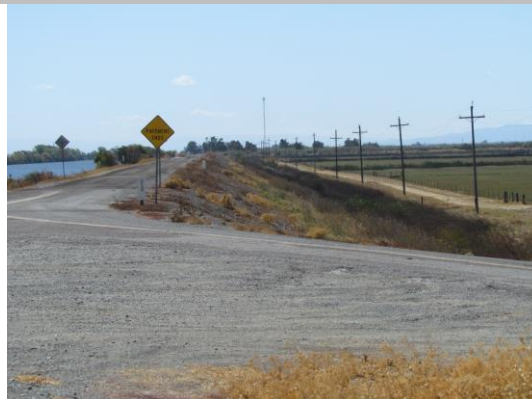
Photo 1 of 1 : FA_2016_RD2098_244_11_20160926_00022.jpg

RD2098 landside levee slope, looking downstream.

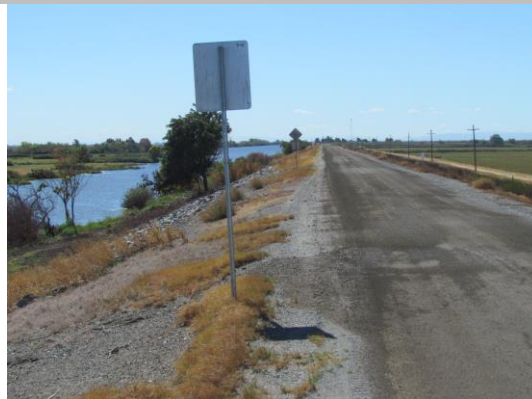
Photo 1 of 1 : FA_2016_RD2098_244_12_20160926_00023.jpg

RD 2068 Waterside levee slope Unit 1 looking downstream from levee mile 0.03-0.45.

LM Start	0.45	Rating **	M	Issue No.	13
LM End	0.56	Issue Type +	Ma	Location *	WS
Category	Earthen Levee			GPS Latitude/Longitude	
				Start	End
Item	Vegetation			38.322577 °	38.320957 °
				-121.694028 °	-121.694037 °
DWR ID	DWR_RD2098_01_f_2016_13				
Comment Code					
V1 : Control annual grass and weeds on the levee slopes and easements.					
Inspector Comment					
Weeds sprayed in this section of levee were not removed from the slope.

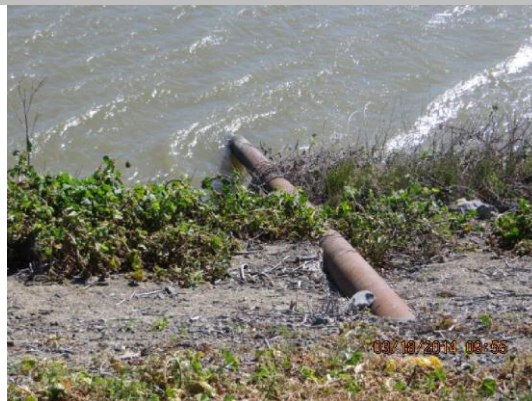
Photo 1 of 2 : UCIP_FA_2016_32197_58662.jpg

LM Start	1.82	Rating **	M	Issue No.	14
LM End	1.82	Issue Type +	En	Location *	WS
Category	Supplemental			GPS Latitude/Longitude	
				Start	End
Item	DWR UCIP Field Study			38.302770°	38.302770°
				-121.693640°	-121.693640°
DWR ID					
Comment Code					
Inspector Comment					
FS_ID:32197					
DS_ID:20965					
EP_NO: 10168					
Repair Type: Non-Urgent					
Crossing Status: Found					
UCIP Comments: Erosion under pipe at WS toe.					
FIELD_STRUCT_DESC: 10-inch steel drainpipe through the levee, 2.8-feet below the crown. Pump in pump house off the landward side. (USACE-1962). This entry matches the Drainage or Irrigation Structure referenced in O&M manual (HLM 1.80). This pipe was retained under ABO No. 10168 (1974).					
FS Date: 3/18/2014

Pipe on WS slope.

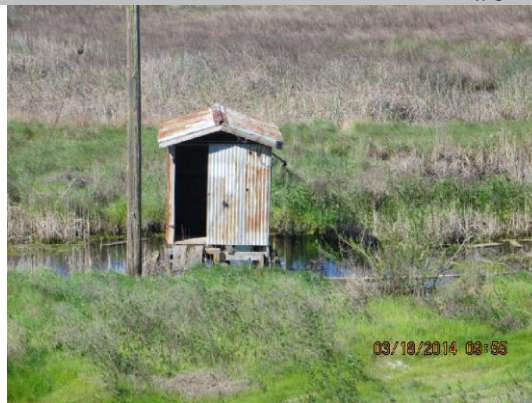
Photo 2 of 2 : UCIP_FA_2016_32197_58661.jpg

Pumphouse at lowpoint off LS toe.

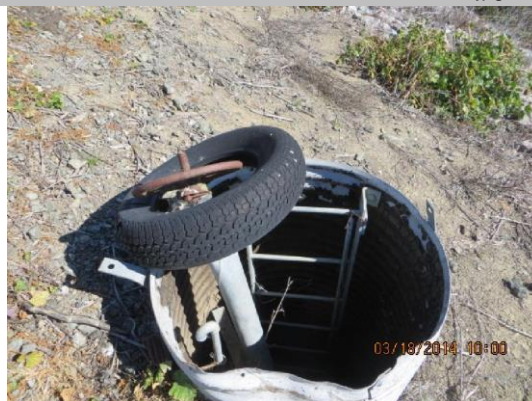
Photo 1 of 2 : UCIP_FA_2016_32207_58665.jpg

LM Start	1.83	Rating **	M	Issue No.	15
LM End	1.83	Issue Type +	En	Location *	WS
Category	Supplemental			GPS Latitude/Longitude	
				Start	End
Item	DWR UCIP Field Study			38.302552 °	38.302552 °
				-121.693653 °	-121.693653 °
DWR ID					
Comment Code					
Inspector Comment					
FS_ID:32207 DS_ID:20966 EP_NO: 10168 Repair Type: Non-Urgent Crossing Status: Found UCIP Comments: Slide gate actuator bent but appears to be in closed position. No lid on standpipe. Appears abandoned and if so should be done so properly. FIELD_STRUCT_DESC: 24-inch pipe through the levee, 24.5 feet below the crown. Two CM cutoff wall around pipe at center of levee. Slide gate in 36-inch CMP riser on the waterward slope. Concrete saddle and apron on waterward end. Flap gate and "U" headwall on landward end. This pipe was retained under ABO No. 10168 (1974). FS Date: 3/18/2014

36-inch CMP riser with bent slide gate actuator on WS slope.

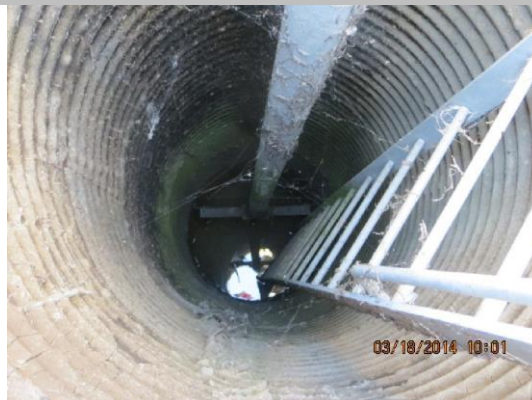
Photo 2 of 2 : UCIP_FA_2016_32207_58664.jpg

No lid on CMP riser that is 24-feet deep.

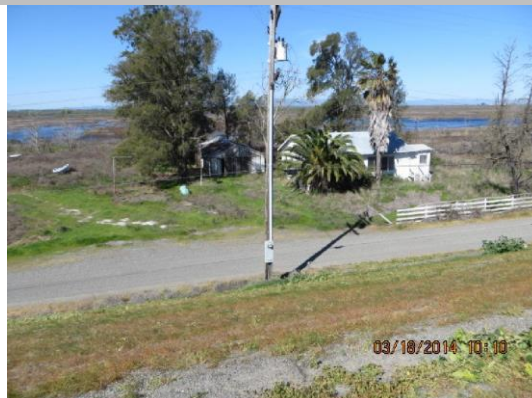
Photo 2 of 2 : UCIP_FA_2016_32225_58686.jpg

Power pole and meter next to spigot on LS toe.

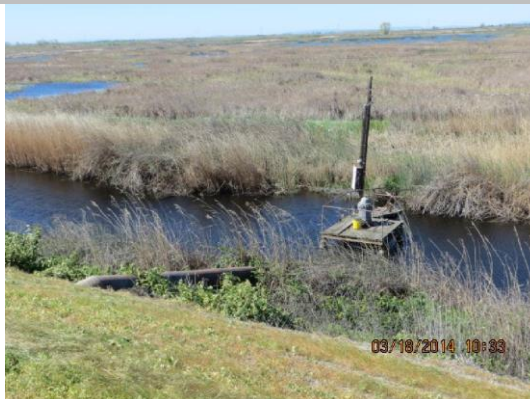
Photo 1 of 2 : UCIP_FA_2016_32227_58692.jpg

Comment Code					
Inspector Comment					
FS_ID:32227					
DS_ID:20969					
EP_NO: 13222					
Repair Type: Non-Urgent					
Crossing Status: Found					
UCIP Comments: Pipe rusted through at outlet on WS slope, may indicate further degradation of pipe within levee. Good candidate for video inspection.					
FIELD_STRUCT_DESC: 20-inch steel drainpipe through the levee, 7.5 feet below the crown. Siphon breaker at waterward shoulder. Pump on pile structure in drain ditch on landward side. (USACE-1962). This entry matches the Drainage or Irrigation Structure referenced in O&M manual (HLM 2.98). This pipe was retained under ABO No. 10168 (1974). Pipe removed and replaced with 19-inch steel pipe under crown and along landward slope under Permit No. 13222 (1982).					
FS Date: 3/18/2014

Pump on pile structure in drainage channel on LS toe.

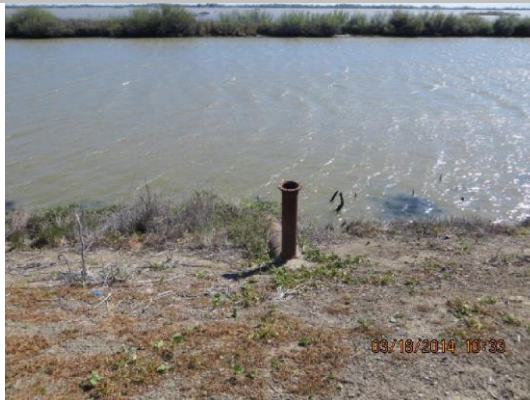
Photo 2 of 2 : UCIP_FA_2016_32227_58691.jpg

Siphon breaker in steel riser on WS slope.

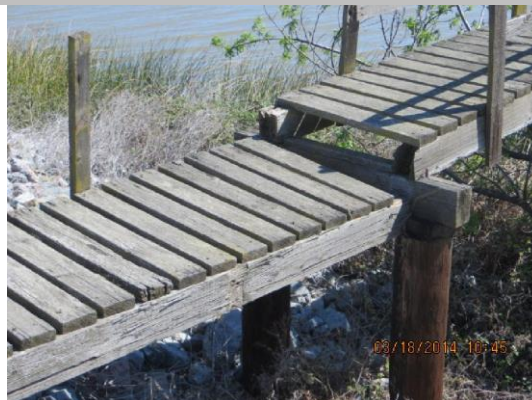
Photo 2 of 2 : UCIP_FA_2016_32243_58701.jpg

Walkway may not be structurally sound.

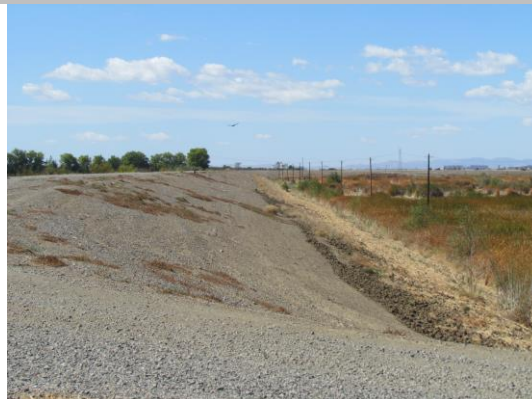
Photo 1 of 1 : FA_2016_RD2098_245_2_20160926_00002.jpg

RD 2098 Unit 1A looking downstream from the landside 0.00.

LM Start	0.00	Rating **	A	Issue No.	3
LM End	0.53	Issue Type +	Ma	Location *	WS
Category	Earthen Levee			GPS Latitude/Longitude	
				Start	End
Item	Vegetation			38.277440 °	38.275710 °
				-121.696245 °	-121.705713 °
DWR ID	DWR_RD2098_01A_f_2016_3				
Comment Code					
V1 : Control annual grass and weeds on the levee slopes and easements.					
Inspector Comment					
This levee section has no unwanted vegetation.

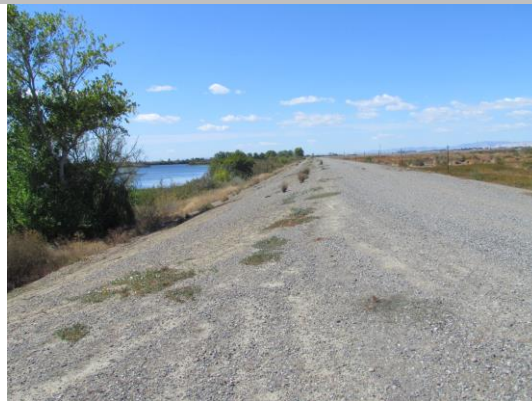
Photo 1 of 1 : FA_2016_RD2098_245_3_20160926_00001.jpg

RD 2098 Unit 1A looking downstream from the waterside slope.

LM Start	0.01	Rating **	A	Issue No.	4
LM End	0.54	Issue Type +	Ma	Location *	CR
Category	Earthen Levee			GPS Latitude/Longitude	
				Start	End
Item	Vegetation			38.277388 °	38.275847 °
				-121.696465 °	-121.705833 °
DWR ID	DWR_RD2098_01A_s_2014_4				
Comment Code					
V9 : Keep the crown roadway free of vegetation.					
Inspector Comment

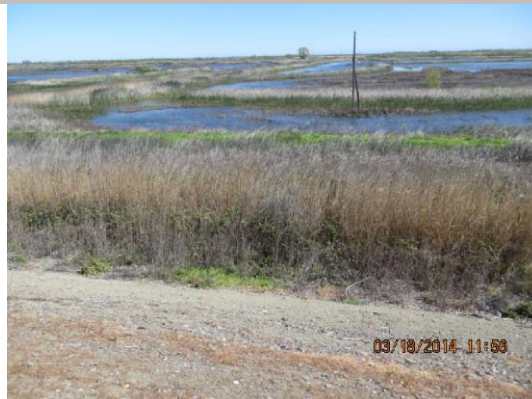
Photo 1 of 2 : UCIP_FA_2016_32287_58755.jpg

LM Start	5.71	Rating **	M	Issue No.	23
LM End	5.71	Issue Type +	En	Location *	WS
Category	Supplemental			GPS Latitude/Longitude	
				Start	End
Item	DWR UCIP Field Study			38.280788 °	38.280788 °
				-121.709617 °	-121.709617 °
DWR ID					
Comment Code					
Inspector Comment					
FS_ID:32287 DS_ID:20973 EP_NO: 10172 Repair Type: Non-Urgent Crossing Status: Found UCIP Comments: Pipe appears abandoned and if so should be done so properly. Slide gate appears to be open and should be closed for the season. FIELD_STRUCT_DESC: 24-inch CM pipe through the levee, 22.8 feet below the crown. Two cutoff walls around pipe at levee shoulders. Slide gate in 36-inch CMP riser on waterward slope. Flap gate and concrete "U" headwall on landward end. This pipe was retained under ABO No. 10172 (1974). FS Date: 3/18/2014

LS - no pipe visible.

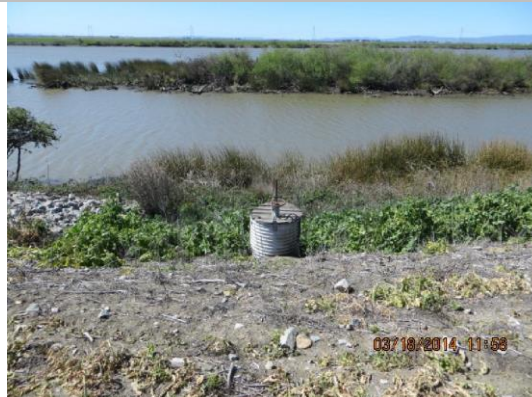
Photo 2 of 2 : UCIP_FA_2016_32287_58754.jpg

Slide gate in 36-inch standpipe on WS slope.

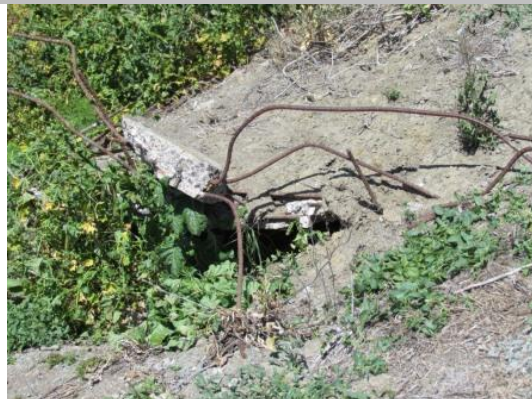
Photo 1 of 1 : FA_2016_RD2098_246_10_20160919_00002.jpg

There is some slope damage at this location under this concrete. No new photo; RD will send crew out to check area out.

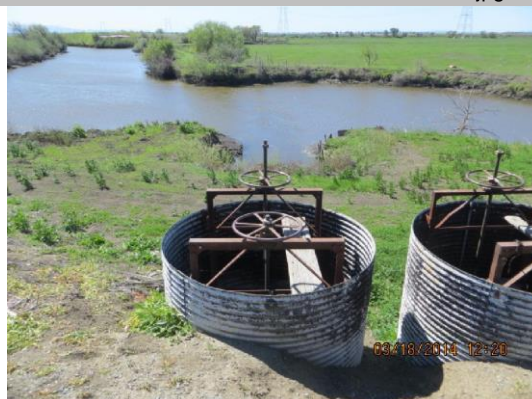
Photo 1 of 2 : UCIP_FA_2016_33784_61162.jpg

LM Start	6.71	Rating **	M	Issue No.	21
LM End	6.71	Issue Type +	En	Location *	WS
Category	Supplemental			GPS Latitude/Longitude	
				Start	End
Item	DWR UCIP Field Study			38.292194 °	38.292194 °
				-121.715853 °	-121.715853 °
DWR ID					
Comment Code					
Inspector Comment					
FS_ID:33784 DS_ID:20976 EP_NO: 10172 Repair Type: Non-Urgent Crossing Status: Found UCIP Comments: Headwalls on WS toe failing at outlet. It is unclear if these were permanent installations or something that was installed as a temporary fix. FIELD_STRUCT_DESC: 1 of 2: 48-inch CM drainpipe through the levee, 29.0 feet below the crown. Two slide gates in 7-foot diameter CMP riser on waterward slope. (USACE-1962). This entry matches the Drainage or Irrigation Structure referenced in O&M manual (HLM 6.75). This pipe was retained under ABO No. 10172 (1974). FS Date: 3/18/2014

Two slide gates in 7-foot diameter CMP riser on waterward slope.

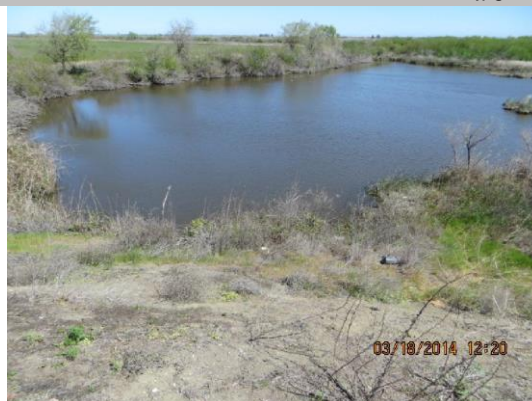
Photo 2 of 2 : UCIP_FA_2016_33784_61161.jpg

LM Start	6.71	Rating **	M	Issue No.	21 (cont)	
LM End	6.71	Issue Type +	En	Location *	WS	
Category	Supplemental			GPS Latitude/Longitude		
				Start		End
Item	DWR UCIP Field Study			38.292194 °		38.292194 °
				-121.715853 °		-121.715853 °
DWR ID						
Comment Code						
Inspector Comment						
FS_ID:33784 DS_ID:20976 EP_NO: 10172 Repair Type: Non-Urgent Crossing Status: Found UCIP Comments: Headwalls on WS toe failing at outlet. It is unclear if these were permanent installations or something that was installed as a temporary fix. FIELD_STRUCT_DESC: 1 of 2: 48-inch CM drainpipe through the levee, 29.0 feet below the crown. Two slide gates in 7-foot diameter CMP riser on waterward slope. (USACE-1962). This entry matches the Drainage or Irrigation Structure referenced in O&M manual (HLM 6.75). This pipe was retained under ABO No. 10172 (1974). FS Date: 3/18/2014

Inlet not visible on LS toe.

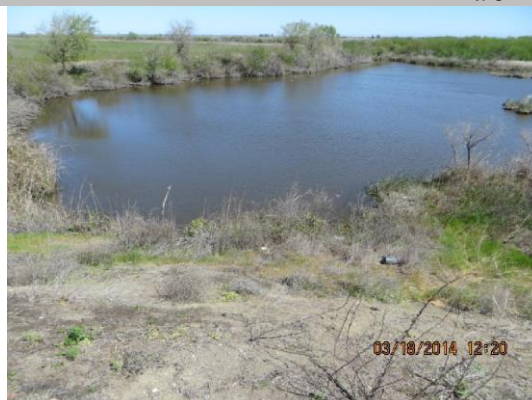
Photo 1 of 2 : UCIP_FA_2016_32285_58749.jpg

LM Start	6.72	Rating **	M	Issue No.	22
LM End	6.72	Issue Type +	En	Location *	WS
Category	Supplemental			GPS Latitude/Longitude	
				Start	End
Item	DWR UCIP Field Study			38.292234 °	38.292234 °
				-121.715875 °	-121.715875 °
DWR ID					
Comment Code					
Inspector Comment					
FS_ID:32285 DS_ID:20961 EP_NO: 10172 Repair Type: Non-Urgent Crossing Status: Found UCIP Comments: Headwalls at WS toe failing. It is uncertain if these retaining walls were a permanent fixture or a temporary fix that failed. FIELD_STRUCT_DESC: 2 of 2: 48-inch CM drainpipe through the levee, 29.0 feet below the crown. Two slidegates in a 7-foot diameter CMP riser on WS shoulder (USACE-1962). This entry matches the Drainage or Irrigation Structure referenced in O&M manual (HLM 6.75). This pipe was retained under ABO No. 10172 (1974). FS Date: 3/18/2014

Inlet not visible on LS toe.

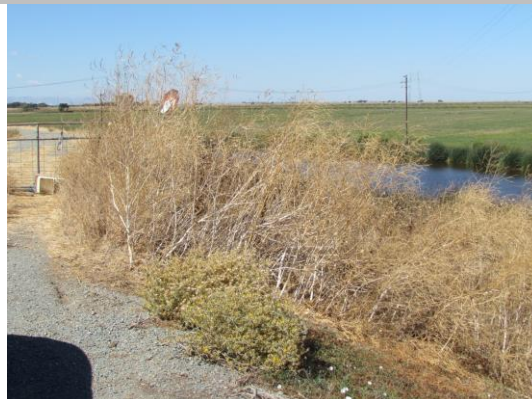
Photo 1 of 1 : FA_2016_RD2098_246_13_20161102_00020.jpg

RD 2098 Unit 2 landside levee slope looking downstream levee mile 6.72-6.75.

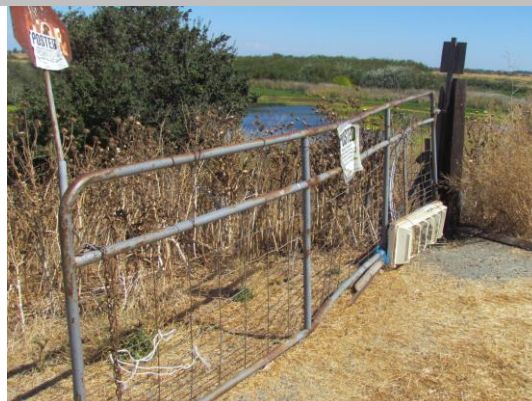
Photo 1 of 1 : FA_2016_RD2098_246_16_20161102_00021.jpg

LM Start	6.74	Rating **	U	Issue No.	16
LM End	6.74	Issue Type +	Ma	Location *	CR
Category	Earthen Levee			GPS Latitude/Longitude	
				Start	End
Item	Repair Gates			38.292467 °	38.292467 °
				-121.716138 °	-121.716138 °
DWR ID	DWR_RD2098_02_f_2016_16				
Comment Code					
Inspector Comment					
Repair this gate that has been damaged.

Levee mile 6.74 crown roadway gate crossing.

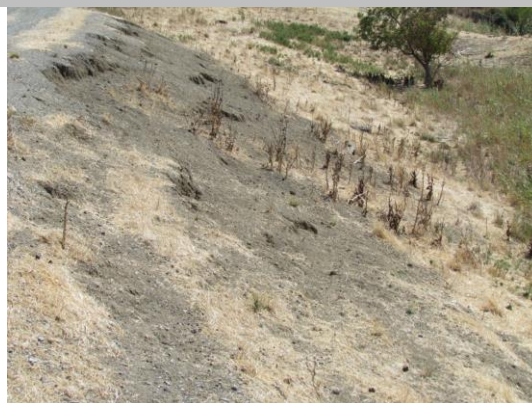
Photo 1 of 2 : FA_2016_RD2098_246_15_20160919_00003.jpg

LM Start	6.78	Rating **	M	Issue No.	15
LM End	6.80	Issue Type +	Ma	Location *	WS
Category	Earthen Levee			GPS Latitude/Longitude	
				Start	End
Item	Erosion / Bank Caving			38.292838 °	38.292917 °
				-121.716733 °	-121.717160 °
DWR ID	DWR_RD2098_02_f_2015_15				
Comment Code					
E1 : Note and monitor erosion site.					
Inspector Comment					
Need to add material to the damaged slope caused by goats.

Slope damage caused by goats. Spring 2016

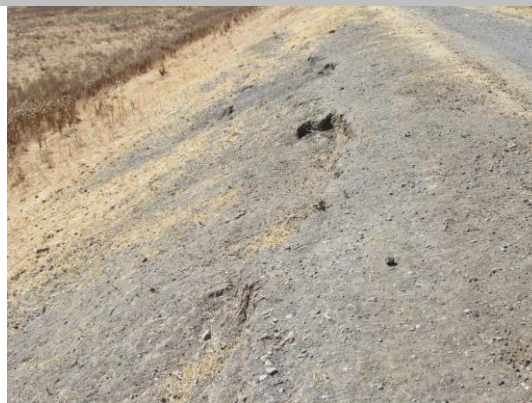
Photo 2 of 2 : FA_2016_RD2098_246_15_20161102_00022.jpg

Looking downstream levee mile 6.78-6.80 slope damaged by resident goats. (Fall 2016).

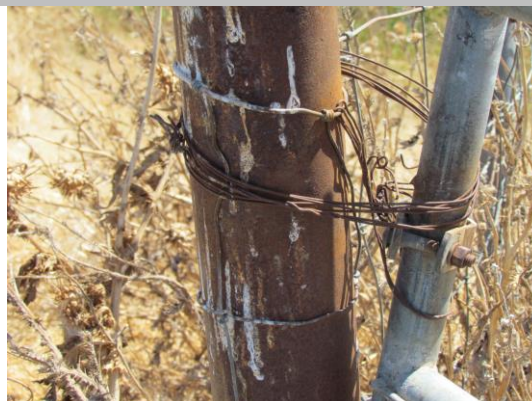
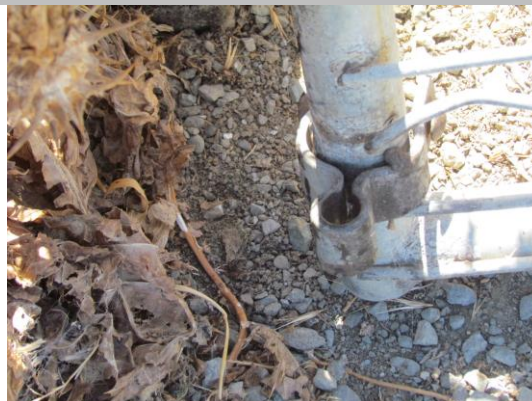
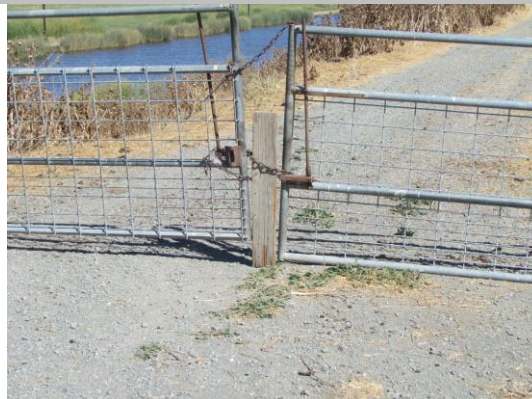
LM Start	7.14	Rating **	U	Issue No.	5
LM End	7.14	Issue Type +	Ma	Location *	CR
Category	Earthen Levee			GPS Latitude/Longitude	
				Start	End
Item	Repair Gates			38.292962 °	38.292962 °
				-121.723312 °	-121.723312 °
DWR ID	DWR_RD2098_02_f_2013_5				
Comment Code					
Inspector Comment					
Gate damage, make repairs to this gate. This gate could cause injury to someone.

RD 2098 Unit 2 levee mile 7.14 crown crossing.

RD 2098 Unit 2 levee mile 7.14.

LM Start	7.14	Rating **	U	Issue No.	5 (cont)	
LM End	7.14	Issue Type +	Ma	Location *	CR	
Category	Earthen Levee			GPS Latitude/Longitude		
				Start		End
Item	Repair Gates			38.292962 °		38.292962 °
				-121.723312 °		-121.723312 °
DWR ID	DWR_RD2098_02_f_2013_5					
Comment Code						
Inspector Comment						
Gate damage, make repairs to this gate. This gate could cause injury to someone.

RD 2098 Unut 2 levee mile 7.14

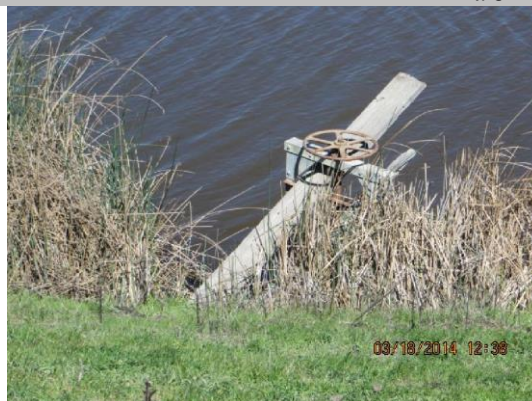
Photo 1 of 2 : UCIP_FA_2016_32290_58764.jpg

LM Start	7.19	Rating **	M	Issue No.	24
LM End	7.19	Issue Type +	En	Location *	CR
Category	Supplemental			GPS Latitude/Longitude	
				Start	End
Item	DWR UCIP Field Study			38.293139 °	38.293139 °
				-121.724174 °	-121.724174 °
DWR ID					
Comment Code					
Inspector Comment					
FS_ID:32290 DS_ID:20977 EP_NO: 10171 Repair Type: Non-Urgent Crossing Status: Found UCIP Comments: Pipe appears to be abandoned and if so it should be done so properly. Walkway to gate valve actuator on WS slope is in disrepair and does not appear to be safe for use. FIELD_STRUCT_DESC: 36-inch CM drain/irrigation pipe through the levee, 23.0 feet below the crown. Walkway to slide gate on waterward end. Slide gate at LS toe (USACE-1962). This entry matches the Drainage or Irrigation Structure referenced in O&M manual (HLM 7.23). This pipe was retained under ABO No. 10171 (1974). FS Date: 3/18/2014

Slide gate at LS toe.

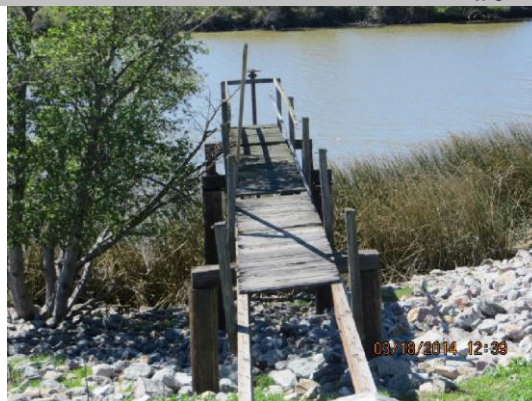
Photo 2 of 2 : UCIP_FA_2016_32290_58763.jpg

Comment Code						
Inspector Comment						
FS_ID:32290 DS_ID:20977 EP_NO: 10171 Repair Type: Non-Urgent Crossing Status: Found UCIP Comments: Pipe appears to be abandoned and if so it should be done so properly. Walkway to gate valve actuator on WS slope is in disrepair and does not appear to be safe for use. FIELD_STRUCT_DESC: 36-inch CM drain/irrigation pipe through the levee, 23.0 feet below the crown. Walkway to slide gate on waterward end. Slide gate at LS toe (USACE-1962). This entry matches the Drainage or Irrigation Structure referenced in O&M manual (HLM 7.23). This pipe was retained under ABO No. 10171 (1974). FS Date: 3/18/2014

Delapidated wooden pier on WS shoulder.

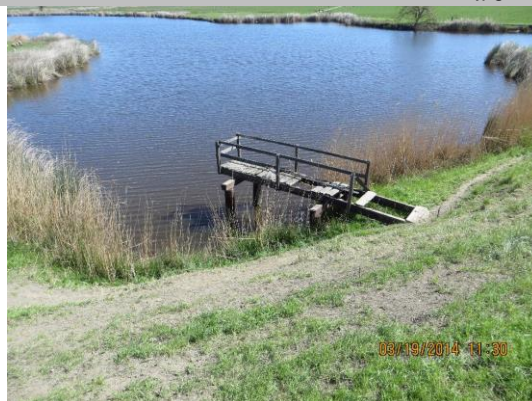
Photo 1 of 2 : UCIP_FA_2016_32389_58893.jpg

LM Start	7.39	Rating **	U	Issue No.	14
LM End	7.39	Issue Type +	En	Location *	LS
Category	Supplemental			GPS Latitude/Longitude	
				Start	End
Item	DWR UCIP Field Study			38.295669 °	38.295669 °
				-121.725980 °	-121.725980 °
DWR ID					
Comment Code					
Inspector Comment					
FS_ID:32389					
DS_ID:20979					
EP_NO: 2591					
Repair Type: Urgent					
Crossing Status: Found					
UCIP Comments: Both walkways to slidegates in poor structural condition. Can not safely access slide gate on WS slope.					
FIELD_STRUCT_DESC: 30-inch CM irrigation/drain pipe through the levee, 25.0 feet below the crown. Two CM cutoff walls around pipe at both shoulders. Walkways to slide gates at both ends of pipe. (Permit No. 2591-1959)					
FS Date: 3/19/2014

Walkway over pipe on LS toe in poor structural condition and Slidegate not visible

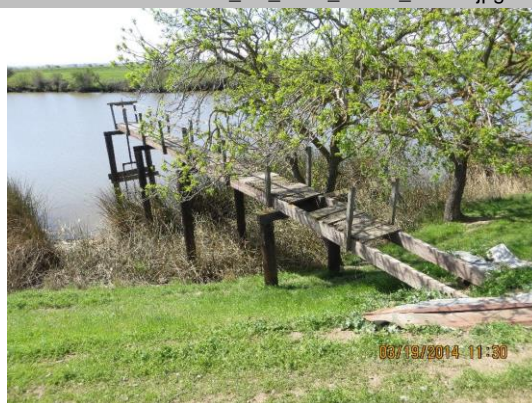
Photo 2 of 2 : UCIP_FA_2016_32389_58892.jpg

Walkway over pipe on WS toe in poor structural condition.

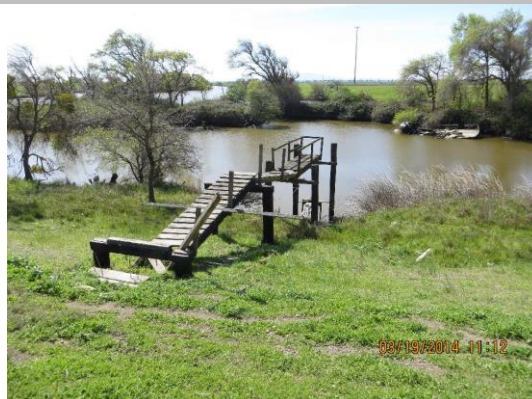
Photo 1 of 2 : UCIP_FA_2016_33785_61166.jpg

Wooden walkway at WS toe is in disrepair.

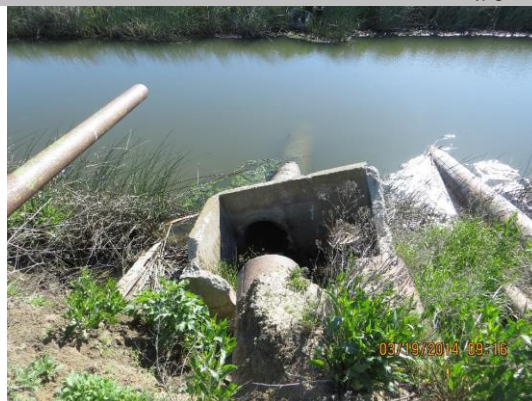
Photo 1 of 2 : UCIP_FA_2016_32326_58817.jpg

Concrete distribution box on LS slope has slipped into canal.

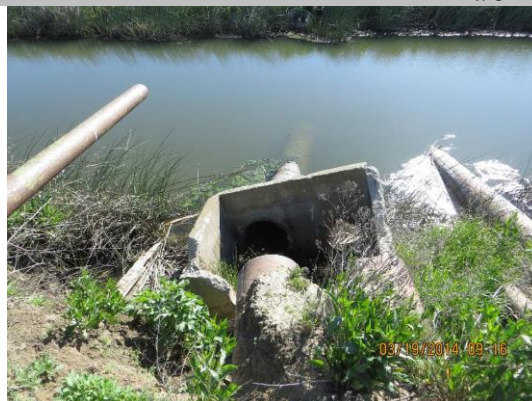
Photo 1 of 2 : UCIP_FA_2016_32325_58812.jpg

Concrete distribution box on LS slope has lost its foundation stability and slid into canal on LS slope.
