**Flood Control Project Maintenance
Levee Inspections**

Fall 2017 Levee Maintenance Deficiency Summary Report

Sacramento River Basin

RD2098	Overall LMA Rating	Total LMA Miles						
Reclamation District No. 2098 Cache and Haas Slough	U	10.91						
Rated Item	Maintenance Deficiency				Enforcement		Design & System Obsolescence	
	M Miles	U Miles	M + 4U Miles	Threshold %	M Miles	U Miles	M Miles	U Miles
<i>Earthen Levee</i>								
Vegetation	4.41		4.41	40.44%				
Trim / Thin Trees	0.01		0.01	0.09%				
Encroachments	0.02		0.02	0.18%	0.01			
Slope Stability	0.02		0.02	0.18%				
Erosion / Bank Caving	0.50		0.50	4.59%				
Cracking		0.01	0.04	0.37%				
Crown Surface / Depressions / Rutting	0.86		0.86	7.89%				
Repair Gates	0.02		0.02	0.18%				
<i>Supplemental</i>								
2015 USACE Erosion Survey, DRAFT	0.39		0.39	3.58%				
DWR UCIP Field Study					0.13	0.04		
DWR UCIP LMA Responsibility								
2017 Storm Damage	0.21		0.21	1.93%				
<i>LMA Totals:</i>	6.44	0.01	6.48	59.42%	0.14	0.04	0.00	0.00

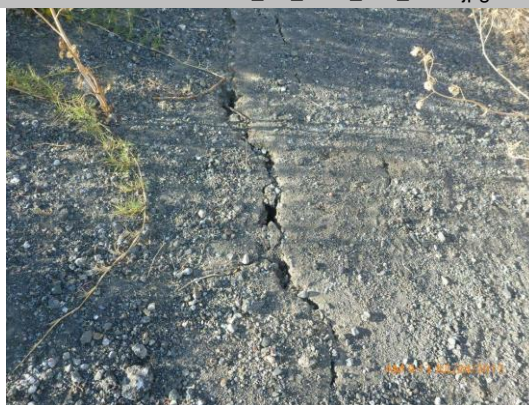
Photo 1 of 3 : LEVAL_FA_2017_414_3594.jpg

LM Start	0.96	Rating **	M	Issue No.	22
LM End	0.96	Issue Type +	Ma	Location *	
Category	Supplemental			GPS Latitude/Longitude	
				Start	End
Item	2017 Storm Damage			38.315200 °	38.315100 °
				-121.694100 °	-121.694100 °
DWR ID	DWR_RD2098_01_f_2017_22				
Comment Code					
Inspector Comment					
Levee Evaluation Comments					
Description:The damage consists of cracking and sloughing of the lower landside levee slope.					
Site ID No:414					
Site Designation:LMA-241					
Repair Type: Erosion					
Rating:Area of Concern					
Field Date:7/24/2017					
Notes: Landside sloughing about 2' deep and extends to toe ditch.

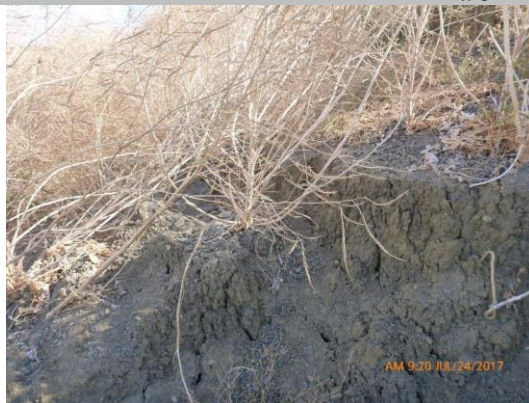
Photo 2 of 3 : LEVAL_FA_2017_414_3596.jpg

LM Start	0.96	Rating **	M	Issue No.	22 (cont)
LM End	0.96	Issue Type +	Ma	Location *	
Category	Supplemental			GPS Latitude/Longitude	
				Start	End
Item	2017 Storm Damage			38.315200 °	38.315100 °
				-121.694100 °	-121.694100 °
DWR ID	DWR_RD2098_01_f_2017_22				
Comment Code					
Inspector Comment					
Levee Evaluation Comments					
Description:The damage consists of cracking and sloughing of the lower landside levee slope.					
Site ID No:414					
Site Designation:LMA-241					
Repair Type: Erosion					
Rating:Area of Concern					
Field Date:7/24/2017					
Notes: Landside sloughing about 2' deep and extends to toe ditch.

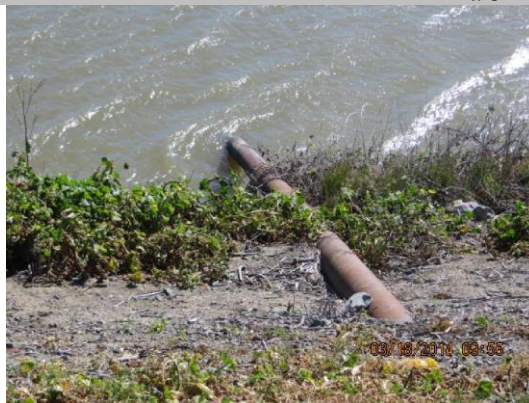
Photo 1 of 3 : UCIP_FA_2017_32197_58662.jpg

LM Start	1.82	Rating **	M	Issue No.	41
LM End	1.82	Issue Type +	En	Location *	
Category	Supplemental			GPS Latitude/Longitude	
				Start	End
Item	DWR UCIP Field Study			38.302770 °	38.302770 °
				-121.693640 °	-121.693640 °
DWR ID					
Comment Code					
Inspector Comment					
FS_ID:32197 DS_ID:20965 EP_NO: 10168 Repair Type: Non-Urgent Crossing Status: Found UCIP Comments: Erosion under pipe at WS toe. FIELD_STRUCT_DESC: 10-inch steel drainage pipe through the levee, 2.8 feet below the crown. Pump in pump house off the landside (LS). (This pipe was retained under Automatic Board Order (ABO) issued as Permit No. 10168, 1974 - Moresco Brothers). [Additional Reference(s): DWR Levee Log, 2003. USACE Sacramento O&M Manual 109, April 1962, (HLM 1.80)]. FS Date: 3/18/2014

Pipe on WS slope.

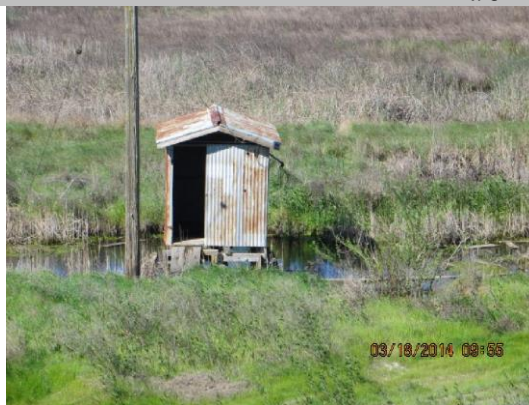
Photo 2 of 3 : UCIP_FA_2017_32197_58661.jpg

Pumphouse at lowpoint off LS toe.

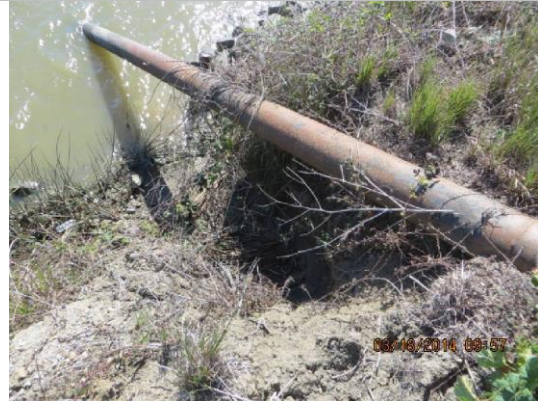
Photo 3 of 3 : UCIP_FA_2017_32197_58660.jpg

LM Start	1.82	Rating **	M	Issue No.	41 (cont)	
LM End	1.82	Issue Type +	En	Location *		
Category	Supplemental			GPS Latitude/Longitude		
				Start	End	
Item	DWR UCIP Field Study			38.302770 °	38.302770 °	
				-121.693640 °	-121.693640 °	
DWR ID						
Comment Code						
Inspector Comment						
FS_ID:32197 DS_ID:20965 EP_NO: 10168 Repair Type: Non-Urgent Crossing Status: Found UCIP Comments: Erosion under pipe at WS toe. FIELD_STRUCT_DESC: 10-inch steel drainage pipe through the levee, 2.8 feet below the crown. Pump in pump house off the landside (LS). (This pipe was retained under Automatic Board Order (ABO) issued as Permit No. 10168, 1974 - Moresco Brothers). [Additional Reference(s): DWR Levee Log, 2003. USACE Sacramento O&M Manual 109, April 1962, (HLM 1.80)]. FS Date: 3/18/2014

Erosion under pipe at WS toe.

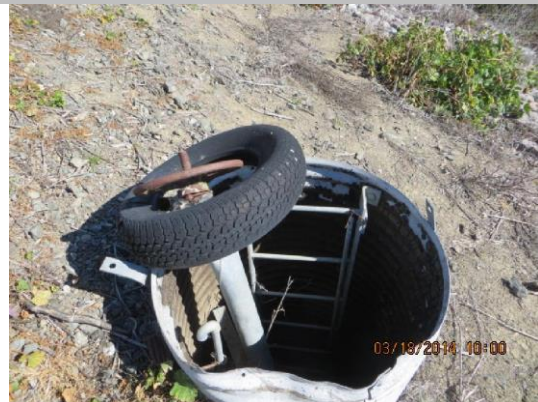
Photo 1 of 3 : UCIP_FA_2017_32207_58665.jpg

Comment Code					
Inspector Comment					
FS_ID:32207 DS_ID:20966 EP_NO: 10168 Repair Type: Non-Urgent Crossing Status: Found UCIP Comments: Slide gate actuator bent but appears to be in closed position. No lid on standpipe. Appears abandoned and if so should be done so properly. FIELD_STRUCT_DESC: 24-inch irrigation pipe of an unknown material through the levee, 24.5 feet below the crown. Two corrugated metal cutoff walls around the pipe at the center of the levee. Slide gate in a 36-inch corrugated metal pipe (CMP) riser on the waterside (WS) slope. Concrete saddle and apron on the WS end. Flap gate and U-shaped headwall on the landside (LS) end. (This pipe was retained under Automatic Board Order (ABO) issued as Permit No. 10168, 1974 - Moresco Brothers). [Additional Reference(s): DWR Levee Log, 2003]. FS Date: 3/18/2014

36-inch CMP riser with bent slide gate actuator on WS slope.

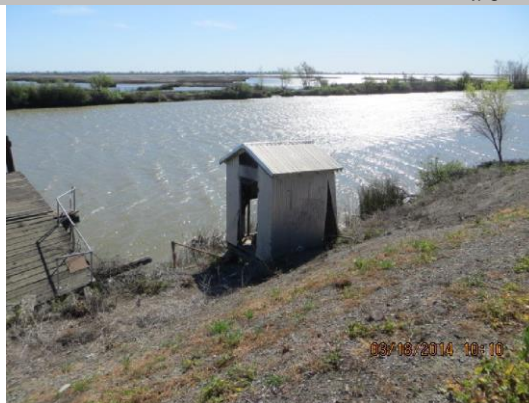
Photo 1 of 3 : UCIP_FA_2017_32225_58687.jpg

Comment Code					
Inspector Comment					
FS_ID:32225 DS_ID:20967 EP_NO: 10168 Repair Type: Non-Urgent Crossing Status: Found UCIP Comments: Pipe appears abandoned and if so should be done so properly. Pipe open on WS at pumphouse as there is no connection to pump. FIELD_STRUCT_DESC: 2-inch galvanized iron irrigation pipe through the levee, 10 feet below the crown. Pump in pump house on the waterside (WS) slope next to fishing dock. Power pole and meter at the landside (LS) toe, next to hose bib. 1-inch steel electrical conduit at the same location. (This pipe was retained under Automatic Board Order (ABO) issued as Permit No. 10168, 1974 - Moresco Brothers). [Additional Reference(s): DWR Levee Log, 2003]. FS Date: 3/18/2014

Pumphouse next to fishing dock on WS slope.

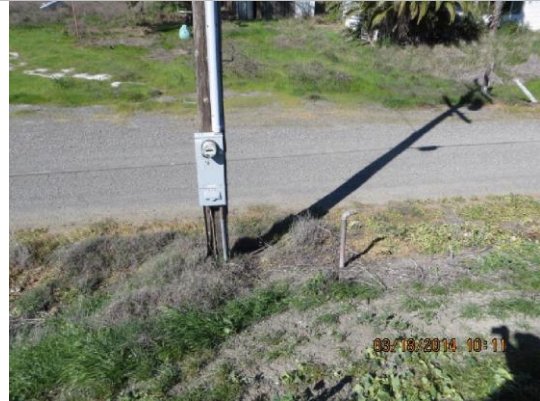
Photo 3 of 3 : UCIP_FA_2017_32225_58685.jpg

Comment Code						
Inspector Comment						
FS_ID:32225 DS_ID:20967 EP_NO: 10168 Repair Type: Non-Urgent Crossing Status: Found UCIP Comments: Pipe appears abandoned and if so should be done so properly. Pipe open on WS at pumphouse as there is no connection to pump. FIELD_STRUCT_DESC: 2-inch galvanized iron irrigation pipe through the levee, 10 feet below the crown. Pump in pump house on the waterside (WS) slope next to fishing dock. Power pole and meter at the landside (LS) toe, next to hose bib. 1-inch steel electrical conduit at the same location. (This pipe was retained under Automatic Board Order (ABO) issued as Permit No. 10168, 1974 - Moresco Brothers). [Additional Reference(s): DWR Levee Log, 2003]. FS Date: 3/18/2014

Power pole and meter next to spigot on LS toe.

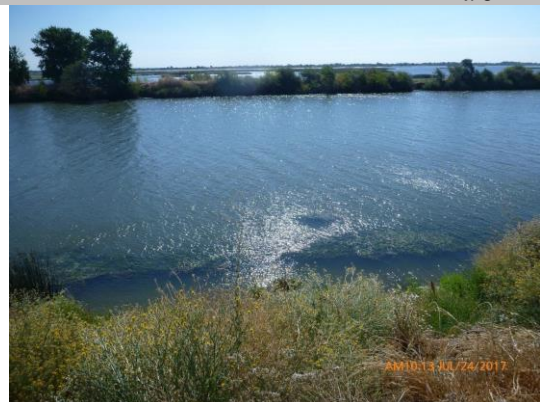
Photo 1 of 3 : LEVAL_FA_2017_416_2726.jpg

LM Start	2.21	Rating **	A/W	Issue No.	23
LM End	2.22	Issue Type +	Ma	Location *	
Category	Supplemental			GPS Latitude/Longitude	
				Start	End
Item	2017 Storm Damage			38.297100 °	38.297000 °
				-121.693300 °	-121.693300 °
DWR ID	DWR_RD2098_01_f_2017_23				
Comment Code					
Inspector Comment					
Levee Evaluation Comments					
Description:The damage consists of erosion, cracking, and sloughing of the waterside levee slope.					
Site ID No:416					
Site Designation:LMA-243					
Repair Type: Erosion					
Rating:Serious					
Field Date:7/24/2017					
Notes: Erosion with sloughing. About 2' vertical cut at top of erosion.					
10/26/17: Dutra repairs in progress.

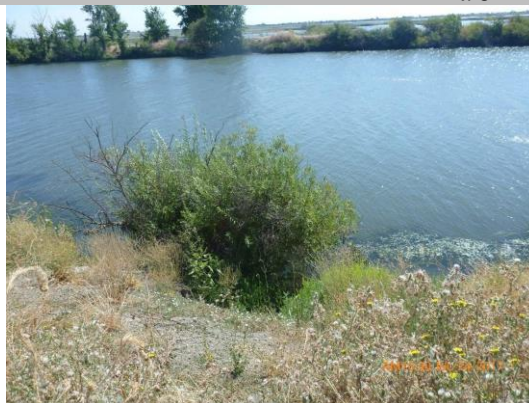
Photo 1 of 3 : LEVAL_FA_2017_417_2731.jpg

LM Start	2.22	Rating **	A/W	Issue No.	24
LM End	2.23	Issue Type +	Ma	Location *	
Category	Supplemental			GPS Latitude/Longitude	
				Start	End
Item	2017 Storm Damage			38.296900 °	38.296800 °
				-121.693400 °	-121.693400 °
DWR ID	DWR_RD2098_01_f_2017_24				
Comment Code					
Inspector Comment					
Levee Evaluation Comments					
Description:The damage consists of scour and sloughing of the lower waterside levee slope.					
Site ID No:417					
Site Designation:LMA-244					
Repair Type: Erosion					
Rating:Area of Concern					
Field Date:7/24/2017					
Notes: Minor toe erosion around base of tree

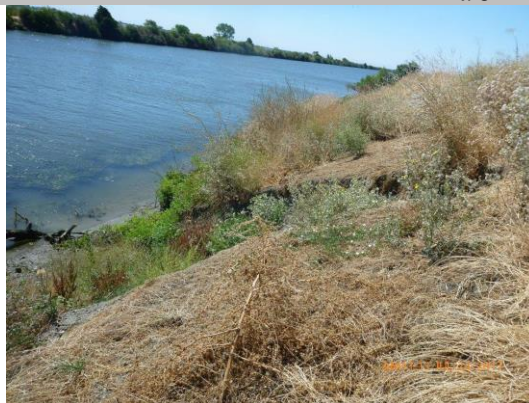
Photo 2 of 3 : LEVAL_FA_2017_418_3052.jpg

LM Start	2.25	Rating **	A/W	Issue No.	25 (cont)
LM End	2.25	Issue Type +	Ma	Location *	
Category	Supplemental			GPS Latitude/Longitude	
				Start	End
Item	2017 Storm Damage			38.296500 °	38.296500 °
				-121.693400 °	-121.693500 °
DWR ID	DWR_RD2098_01_f_2017_25				
Comment Code					
Inspector Comment					
Levee Evaluation Comments					
Description:The damage consists of scour and sloughing of the lower waterside levee slope.					
Site ID No:418					
Site Designation:LMA-245					
Repair Type: Erosion					
Rating:Critical					
Field Date:7/24/2017					
Notes: LMA 245 and LMA 246 have merged together. Erosion with sloughing on the upper slope. 10/26/17: Dutra repairs in progress.

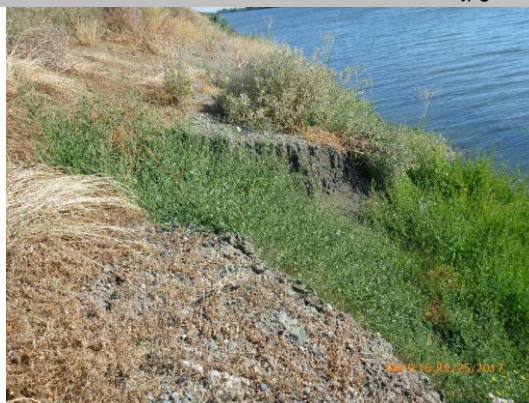
Photo 1 of 3 : LEVAL_FA_2017_429_3445.jpg

LM Start	2.75	Rating **	A/W	Issue No.	34
LM End	2.78	Issue Type +	Ma	Location *	
Category	Supplemental			GPS Latitude/Longitude	
				Start	End
Item	2017 Storm Damage			38.289200 °	38.288800 °
				-121.693500 °	-121.693500 °
DWR ID	DWR_RD2098_01_f_2017_34				
Comment Code					
Inspector Comment					
Levee Evaluation Comments					
Description:The damage consists of scour and sloughing of the waterside levee slope.					
Site ID No:429					
Site Designation:LMA-256					
Repair Type: Erosion					
Rating:Serious					
Field Date:7/25/2017					
Notes: Erosion at WS toe, causing sloughing half-way down WS slope.					
10/26/17: Dutra repairs in progress.

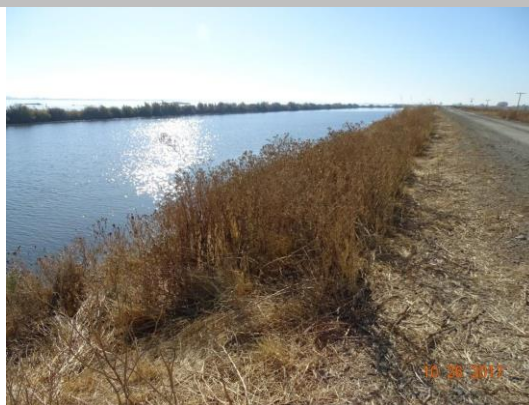
Photo 1 of 1 : FA_2017_RD2098_244_11_20171117_00081.jpg

LM Start	2.80	Rating **	M	Issue No.	11
LM End	2.97	Issue Type +	Ma	Location *	WS
Category	Earthen Levee			GPS Latitude/Longitude	
				Start	End
Item	Vegetation			38.288590 °	38.286013 °
				-121.693645 °	-121.693632 °
DWR ID	DWR_RD2098_01_f_2017_11				
Comment Code					
V2 : Remove the wild growth other than native grasses from the levee slopes.					
Inspector Comment					
Nearby construction operations forced termination of goat grazing. Vegetation should be cleared.

Nearby construction operations forced termination of goat grazing.
Vegetation should be cleared.

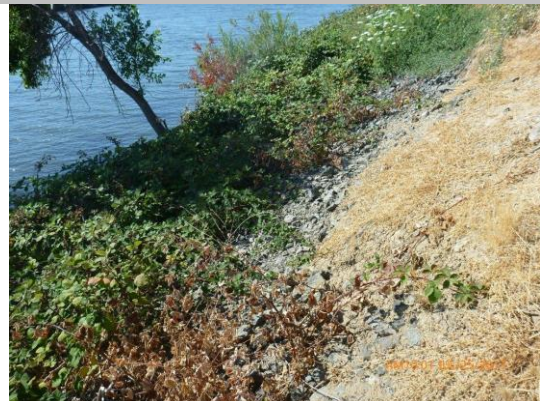
Photo 1 of 3 : LEVAL_FA_2017_431_3790.jpg

LM Start	2.91	Rating **	A/W	Issue No.	36					
LM End	2.93	Issue Type +	Ma	Location *						
Category	Supplemental			GPS Latitude/Longitude						
				Start	End					
Item	2017 Storm Damage			38.286900 °	38.286700 °					
				-121.693500 °	-121.693500 °					
DWR ID	DWR_RD2098_01_f_ 2017_36									
Comment Code										
Inspector Comment										
Levee Evaluation Comments Description:The damage consists of scour and sloughing of the waterside levee slope. Site ID No:431 Site Designation:LMA-258 Repair Type: Erosion Rating:Serious Field Date:7/25/2017 Notes: Erosion of WS toe, resulting in 8' verticle wall. 10/26/17: Dutra repairs in progress.

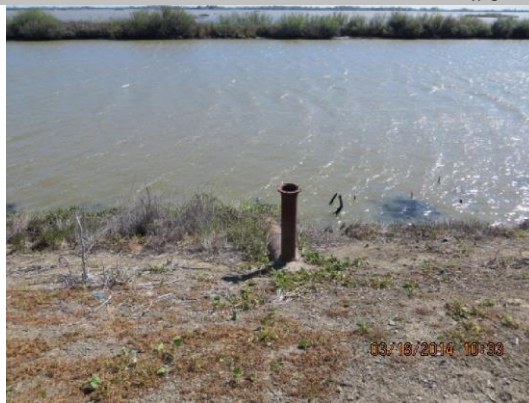
Photo 2 of 3 : UCIP_FA_2017_32227_58691.jpg

Siphon breaker in steel riser on WS slope.

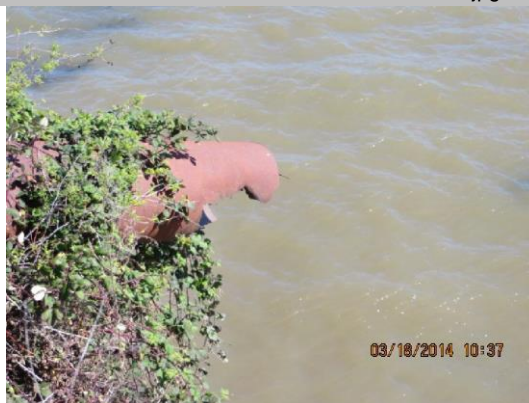
Photo 3 of 3 : UCIP_FA_2017_32227_58690.jpg

Pipe rusted through at outlet on WS slope.

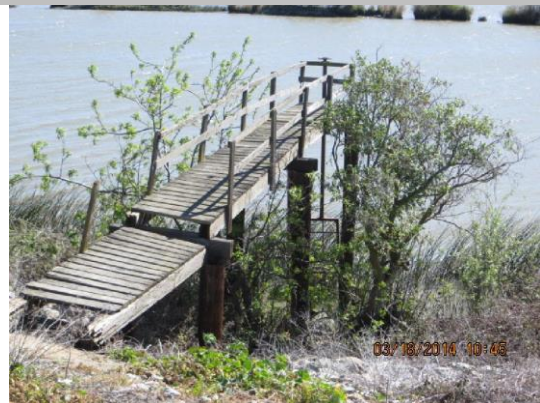
Photo 1 of 3 : UCIP_FA_2017_32243_58702.jpg

Walkway to slide gate actuator on WS toe.

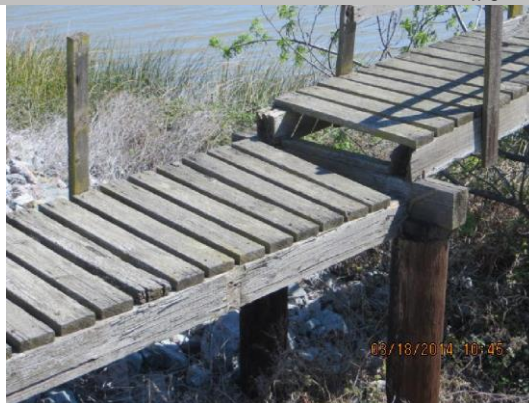
Photo 2 of 3 : UCIP_FA_2017_32243_58701.jpg

Walkway may not be structurally sound.

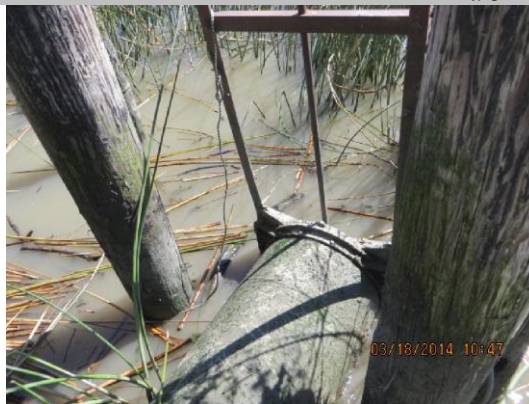
Photo 3 of 3 : UCIP_FA_2017_32243_58700.jpg

Slidegate on WS toe at pipe.

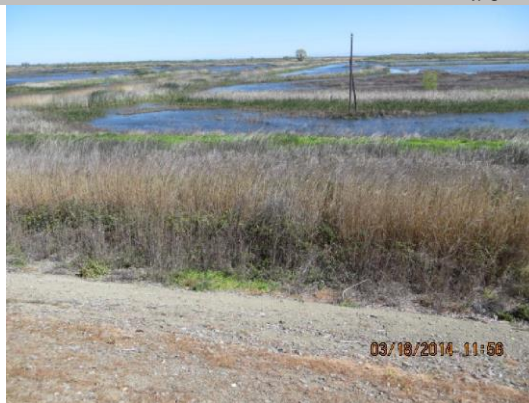
Photo 1 of 3 : UCIP_FA_2017_32287_58755.jpg

LS - no pipe visible.

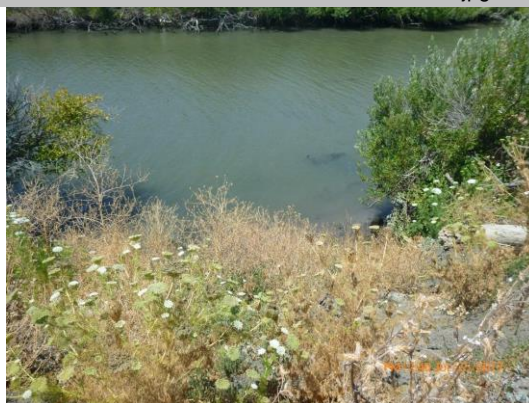
Photo 1 of 3 : LEVAL_FA_2017_440_3887.jpg

LM Start	6.46	Rating **	A/W	Issue No.	15
LM End	6.46	Issue Type +	Ma	Location *	
Category	Supplemental			GPS Latitude/Longitude	
				Start	End
Item	2017 Storm Damage			38.288700 °	38.288800 °
				-121.717000 °	-121.717000 °
DWR ID	DWR_RD2098_02_f_2017_15				
Comment Code					
Inspector Comment					
Levee Evaluation Comments					
Description:The damage consists of scour of the lower and mid waterside levee slope.					
Site ID No:440					
Site Designation:LMA-267					
Repair Type: Erosion					
Rating:Area of Concern					
Field Date:7/25/2017					
Notes: Sloughing on waterside slope due to toe erosion.

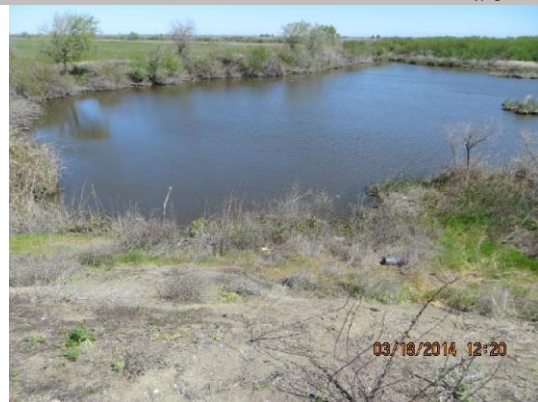
Photo 1 of 3 : UCIP_FA_2017_32285_58749.jpg

Inlet not visible on LS toe.

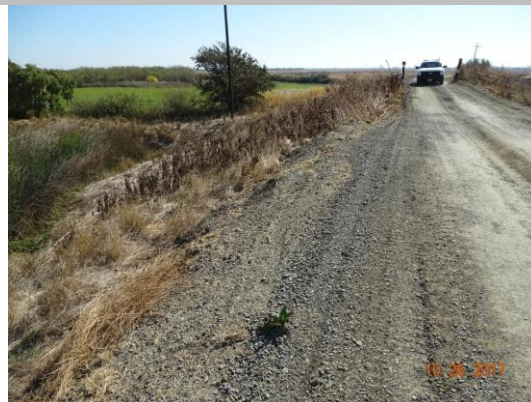
Photo 4 of 4 : FA_2017_RD2098_246_20_20171117_00058.jpg

10/26/17: Notice depression in crown road and slumping toward the left/landside (bulge at toe of levee).

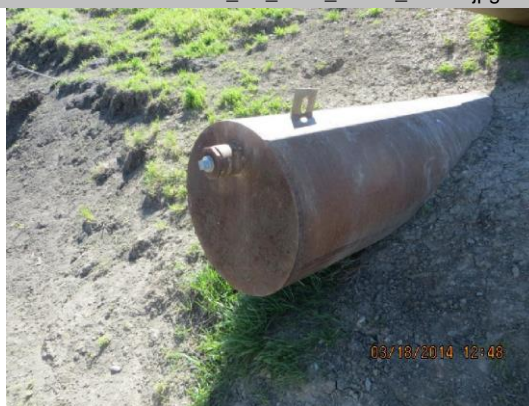
Photo 3 of 3 : UCIP_FA_2017_32303_58780.jpg

Welded steel cap over LS end of pipe.

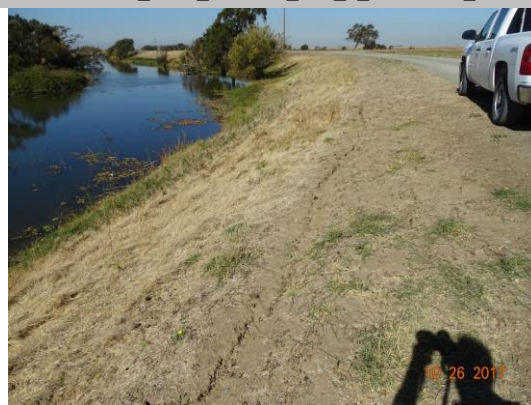
Photo 1 of 1 : FA_2017_RD2098_247_5_20171117_00026.jpg

View upstream of cracks in waterside shoulder.
