**Flood Control Project Maintenance
Levee Inspections**

Fall 2018 Levee Maintenance Deficiency Summary Report

**Flood Control Project Maintenance
Levee Inspections****LMA District Cover Sheet****Fall 2018 Levee Inspection Results****Reclamation District No. 2098 Cache and Haas Slough**

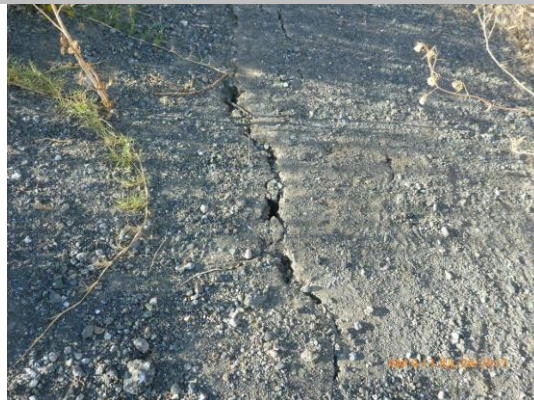
Photo 1 of 3 : LEVAL_FA_2018_414_3594.jpg

LM Start	0.96	Rating **	A/W	Issue No.	19
LM End	0.96	Issue Type +	Ma	Location *	
Category	Supplemental			GPS Latitude/Longitude	
				Start	End
Item	2017 Storm Damage			38.315200°	38.315100°
				-121.694100°	-121.694100°
DWR ID	DWR_RD2098_01_s_2018_19				
Comment Code					
Inspector Comment					
Levee Evaluation Comments					
Description:The damage consists of cracking and sloughing of the lower landside levee slope.					
Site ID No:414					
Site Designation:LMA-241					
Repair Type: Erosion					
Rating:Area of Concern					
Field Date:7/24/2017					
Notes: Landside sloughing about 2' deep and extends to toe ditch.

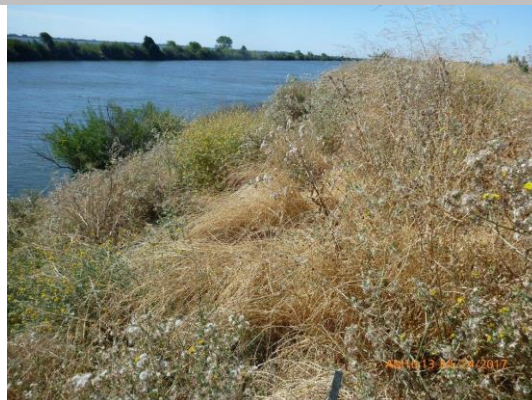
Photo 2 of 3 : LEVAL_FA_2018_416_2727.jpg

LM Start	2.21	Rating **	A/W	Issue No.	21
LM End	2.22	Issue Type +	Ma	Location *	
Category	Supplemental			GPS Latitude/Longitude	
				Start	End
Item	2017 Storm Damage			38.297100°	38.297000°
				-121.693300°	-121.693300°
DWR ID	DWR_RD2098_01_s_2018_21				
Comment Code					
Inspector Comment					
Levee Evaluation Comments					
Description:The damage consists of erosion, cracking, and sloughing of the waterside levee slope.					
Site ID No:416					
Site Designation:LMA-243					
Repair Type: Erosion					
Rating:Serious					
Field Date:7/24/2017					
Notes: Erosion with sloughing. About 2' vertical cut at top of erosion.

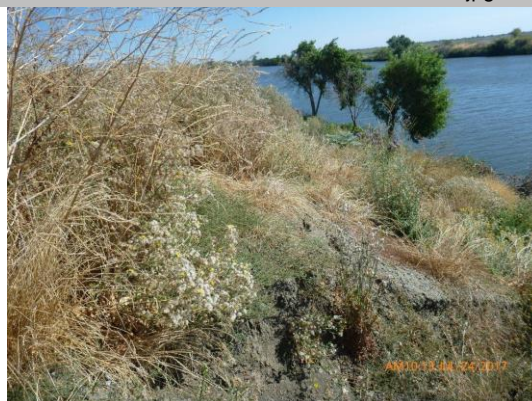
Photo 3 of 3 : LEVAL_FA_2018_416_2728.jpg

LM Start	2.21	Rating **	A/W	Issue No.	21 (cont)	
LM End	2.22	Issue Type +	Ma	Location *		
Category	Supplemental			GPS Latitude/Longitude		
				Start		End
Item	2017 Storm Damage			38.297100 °		38.297000 °
				-121.693300 °		-121.693300 °
DWR ID	DWR_RD2098_01_s_2018_21					
Comment Code						
Inspector Comment						
Levee Evaluation Comments						
Description:The damage consists of erosion, cracking, and sloughing of the waterside levee slope.						
Site ID No:416						
Site Designation:LMA-243						
Repair Type: Erosion						
Rating:Serious						
Field Date:7/24/2017						
Notes: Erosion with sloughing. About 2' vertical cut at top of erosion.

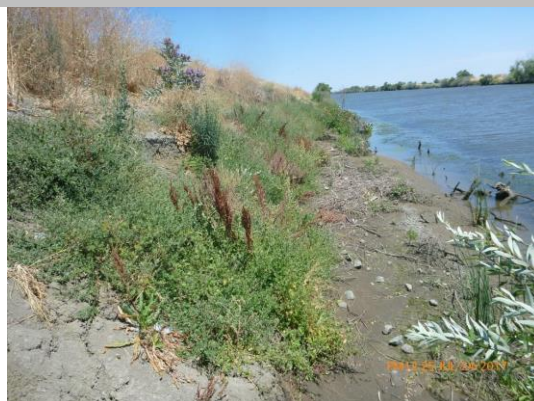
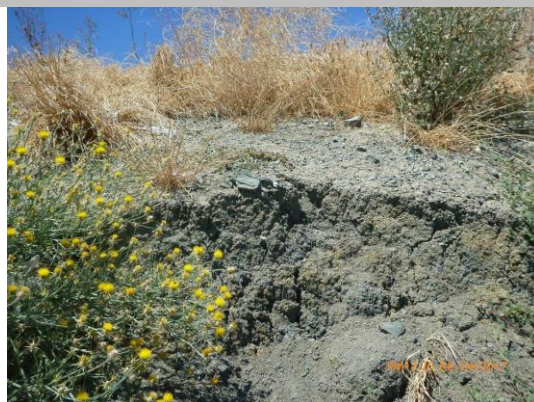
LM Start	2.29	Rating **	A/W	Issue No.	27 (cont)	
LM End	2.31	Issue Type +	Ma	Location *		
Category	Supplemental			GPS Latitude/Longitude		
				Start	End	
Item	2017 Storm Damage			38.295900 °	38.295700 °	
				-121.693500 °	-121.693500 °	
DWR ID	DWR_RD2098_01_f _ 2017_27					
Comment Code						
Inspector Comment						
Levee Evaluation Comments						
Description:The damage consists of scour and sloughing of the waterside levee slope.						
Site ID No:421						
Site Designation:LMA-248						
Repair Type: Erosion						
Rating:Serious						
Field Date:7/24/2017						
Notes: Toe of slope has eroded and minor sloughing has started.

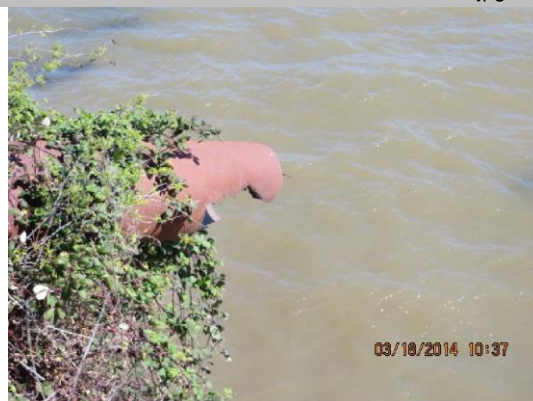
Photo 3 of 3 : UCIP_FA_2018_32227_58690.jpg

Pipe rusted through at outlet on WS slope.

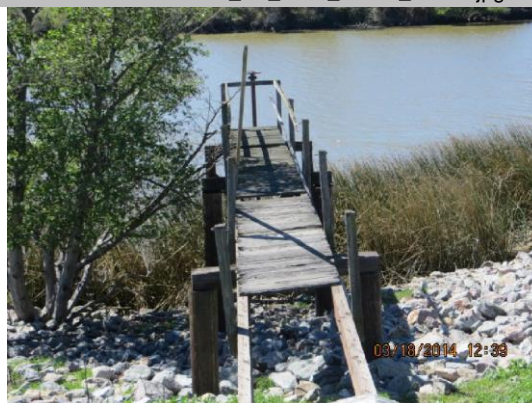
Photo 2 of 3 : UCIP_FA_2018_32290_58763.jpg

Delapidated wooden pier on WS shoulder.

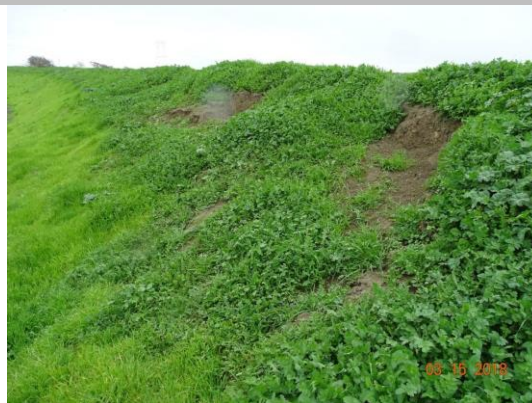
Photo 2 of 3 : FA_2018_RD2098_247_1_20180925_00002.jpg

Erosion site on 03/15/18.

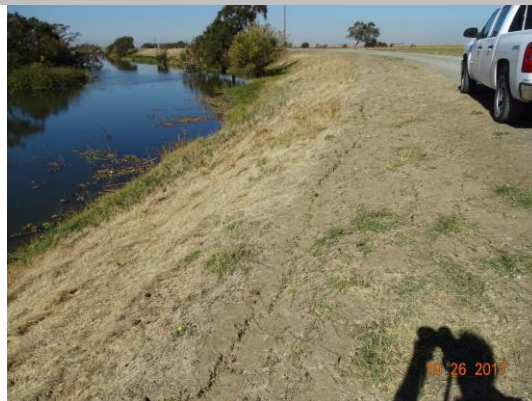
View upstream of cracks in waterside shoulder.

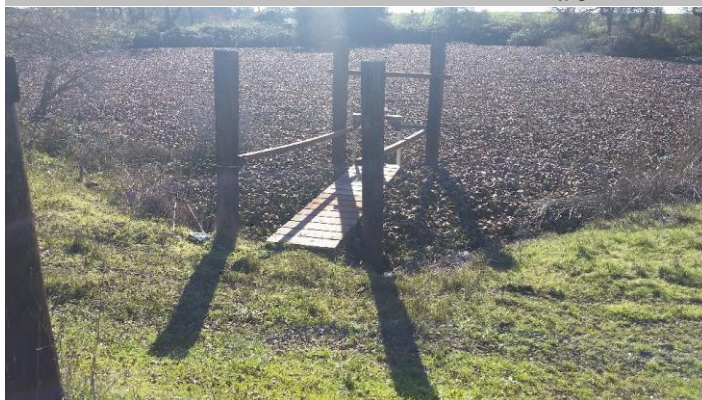
Walkway has been re-built, photo 2 of 2.

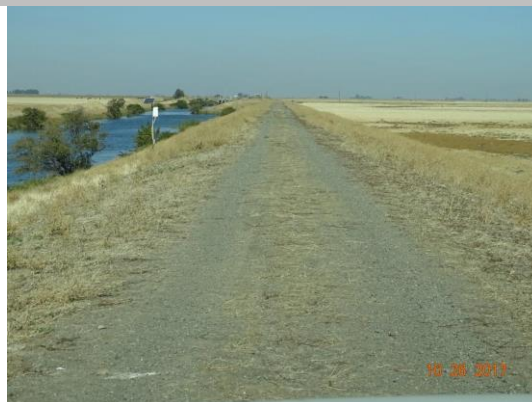
Several areas of scalloped erosion at waterside toe. Largest area is visible in distance in this photo.

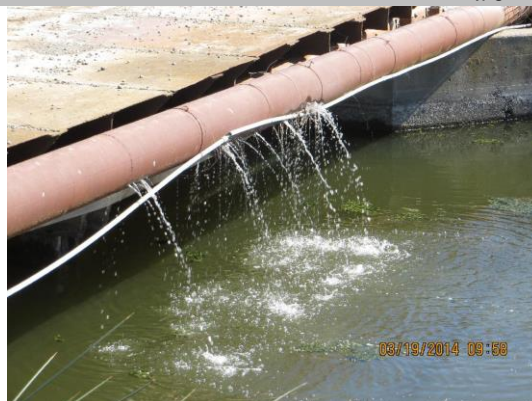
Holes in pipe next to bridge. PVC electrical conduit shown.

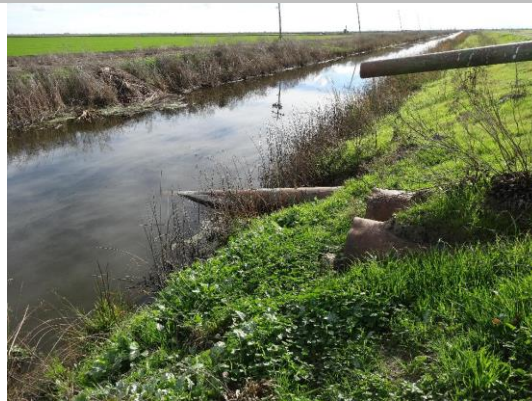
View of LS--damaged concrete distribution box has been removed.

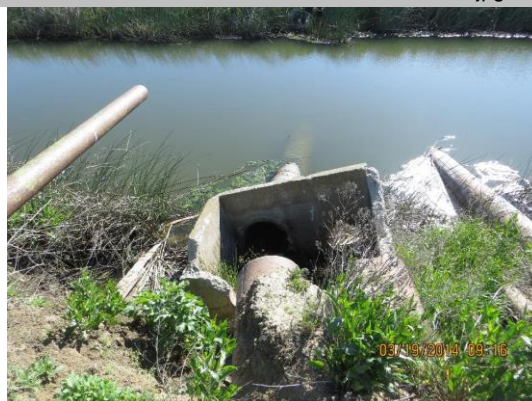
Concrete distribution box on LS slope has slipped into canal.

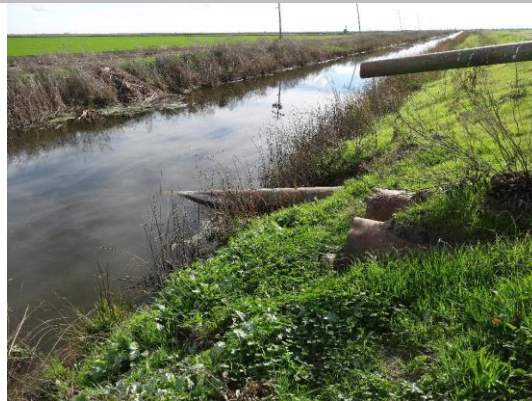
View of LS--damage distribution box noted in last inspection has been removed.
