**Flood Control Project Maintenance
Levee Inspections**

Fall 2019 Levee Maintenance Deficiency Summary Report

**Flood Control Project Maintenance
Levee Inspections**
LMA District Cover Sheet
Fall 2019 Levee Inspection Results

Reclamation District No. 2098 Cache and Haas Slough

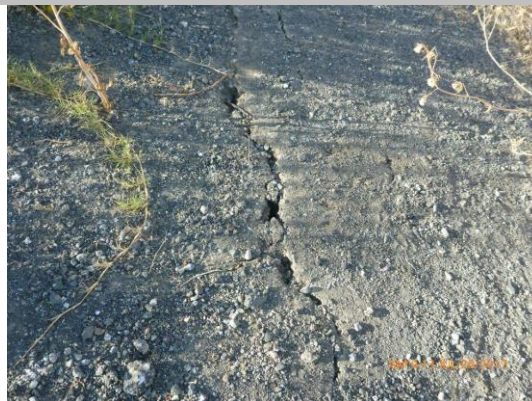
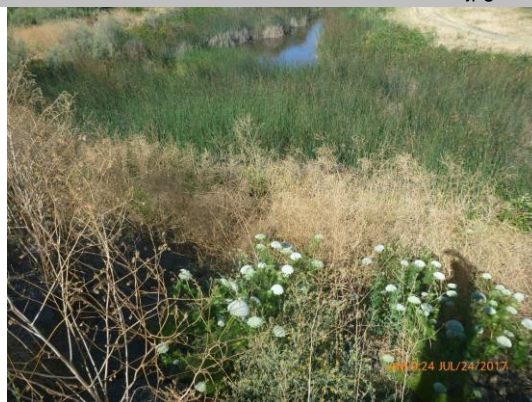
LM Start	0.96	Rating **	A/W	Issue No.	19
LM End	0.96	Issue Type +	Ma	Location *	LS
Category	Supplemental			GPS Latitude/Longitude	
				Start	End
Item	2017 Storm Damage			38.315200 °	38.315100 °
				-121.694100 °	-121.694100 °
DWR ID	LMA-241				
Comment Code					
Inspector Comment					
Levee Evaluation Comments					
Description:The damage consists of cracking and sloughing of the lower landside levee slope.					
Site ID No:414					
Site Designation:LMA-241					
Repair Type: Erosion					
Rating:Area of Concern					
Field Date:7/24/2017					
Notes: Landside sloughing about 2' deep and extends to toe ditch.

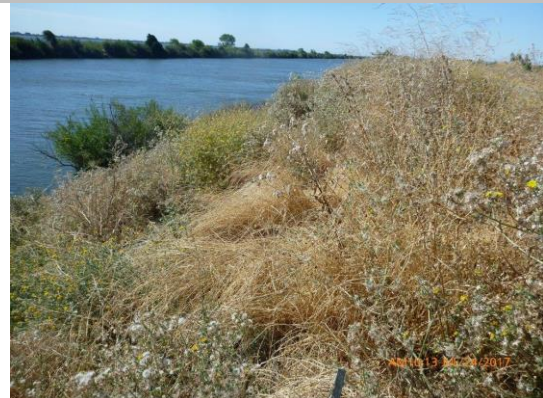
Photo 2 of 3 : LEVAL_FA_2019_416_2727.jpg

LM Start	2.21	Rating **	A/W	Issue No.	21
LM End	2.22	Issue Type +	Ma	Location *	WS
Category	Supplemental			GPS Latitude/Longitude	
				Start	End
Item	2017 Storm Damage			38.297100 °	38.297000 °
				-121.693300 °	-121.693300 °
DWR ID	LMA-243				
Comment Code					
Inspector Comment					
Levee Evaluation Comments					
Description:The damage consists of erosion, cracking, and sloughing of the waterside levee slope.					
Site ID No:416					
Site Designation:LMA-243					
Repair Type: Erosion					
Rating:Serious					
Field Date:7/24/2017					
Notes: Erosion with sloughing. About 2' vertical cut at top of erosion.

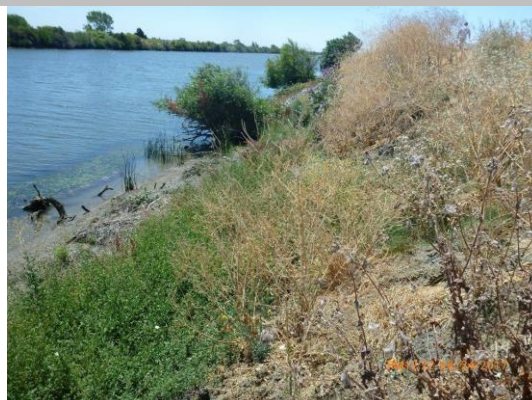
LM Start	2.29	Rating **	A/W	Issue No.	27
LM End	2.31	Issue Type +	Ma	Location *	WS
Category	Supplemental			GPS Latitude/Longitude	
				Start	End
Item	2017 Storm Damage			38.295900 °	38.295700 °
				-121.693500 °	-121.693500 °
DWR ID	LMA-248				
Comment Code					
Inspector Comment					
Levee Evaluation Comments					
Description:The damage consists of scour and sloughing of the waterside levee slope.					
Site ID No:421					
Site Designation:LMA-248					
Repair Type: Erosion					
Rating:Serious					
Field Date:7/24/2017					
Notes: Toe of slope has eroded and minor sloughing has started.

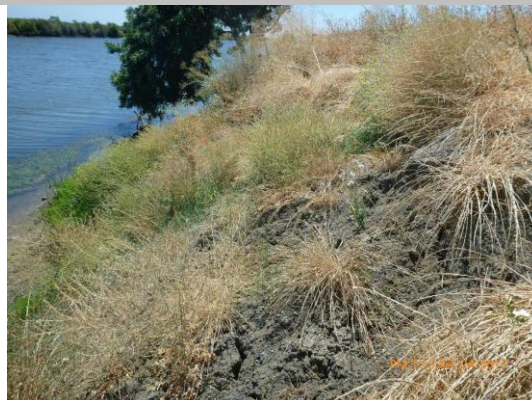
LM Start	2.35	Rating **	A/W	Issue No.	28
LM End	2.39	Issue Type +	Ma	Location *	WS
Category	Supplemental			GPS Latitude/Longitude	
				Start	End
Item	2017 Storm Damage			38.295100 °	38.294500 °
				-121.693400 °	-121.693400 °
DWR ID	LMA-250				
Comment Code					
Inspector Comment					
Levee Evaluation Comments					
Description:The damage consists of scour, sloughing, and cracking of the lower and mid waterside levee slope.					
Site ID No:423					
Site Designation:LMA-250					
Repair Type: Erosion					
Rating:Area of Concern					
Field Date:7/24/2017					
Notes: 2' of sloughing about half way up the slope.

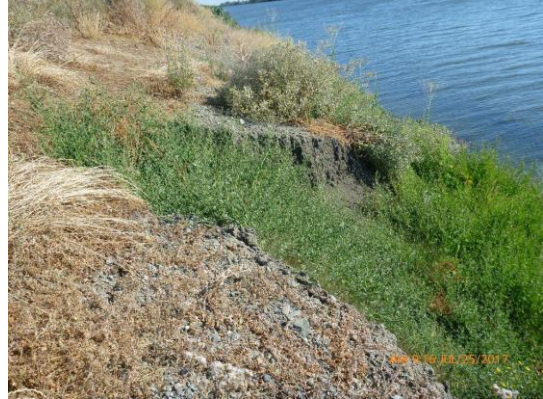
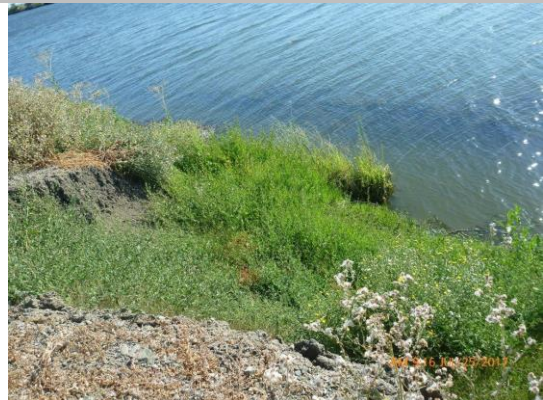
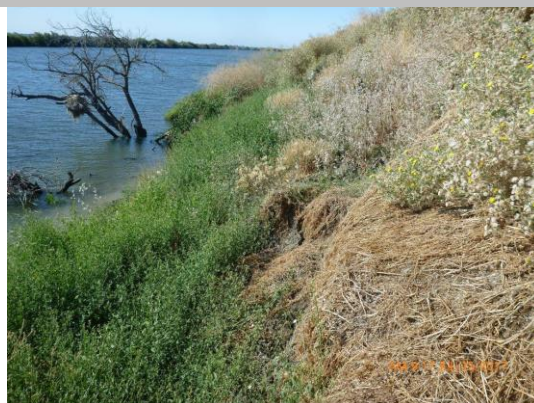
LM Start	2.75	Rating **	A/W	Issue No.	34
LM End	2.78	Issue Type +	Ma	Location *	WS
Category	Supplemental			GPS Latitude/Longitude	
				Start	End
Item	2017 Storm Damage			38.289200°	38.288800°
				-121.693500°	-121.693500°
DWR ID	LMA-256				
Comment Code					
Inspector Comment					
Levee Evaluation Comments					
Description:The damage consists of scour and sloughing of the waterside levee slope.					
Site ID No:429					
Site Designation:LMA-256					
Repair Type: Erosion					
Rating:Serious					
Field Date:7/25/2017					
Notes: Erosion at WS toe, causing sloughing half-way down WS slope.

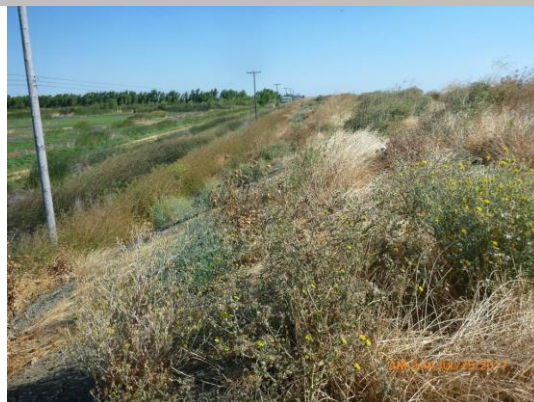
Photo 1 of 3 : FA_2019_RD2098_244_35_20190826_00021.jpg

LM Start	2.78	Rating **	A/W	Issue No.	35
LM End	2.81	Issue Type +	Ma	Location *	WS
Category	Supplemental			GPS Latitude/Longitude	
				Start	End
Item	2017 Storm Damage			38.288800 °	38.288400 °
				-121.693500 °	-121.693500 °
DWR ID	LMA-257				
Comment Code					
Inspector Comment					
Levee Evaluation Comments					
Description:The damage consists of scour and sloughing of the waterside levee slope.					
Site ID No:430					
Site Designation:LMA-257					
Repair Type: Erosion					
Rating:Serious					
Field Date:7/25/2017					
Notes: Erosion at waterside toe, causing sloughing 2/3 down waterside slope.

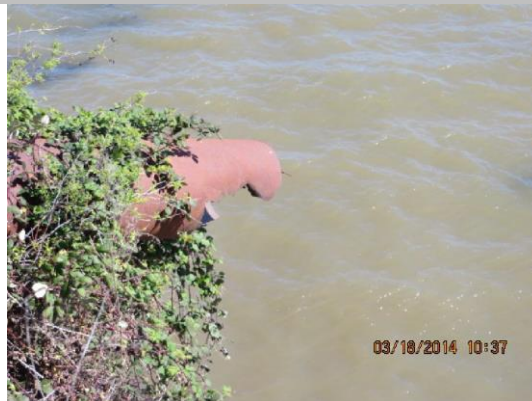
Photo 3 of 3 : UCIP_FA_2019_32227_58690.jpg

Pipe rusted through at outlet on WS slope.

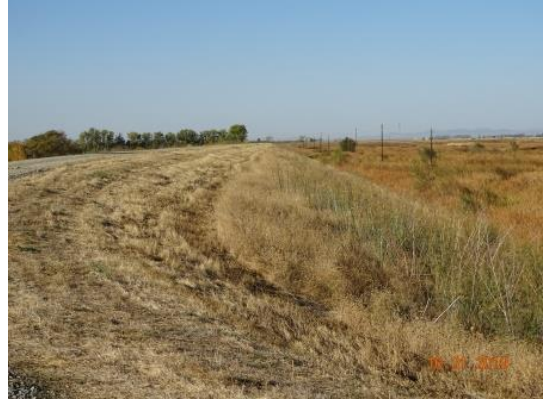
Photo 1 of 1 : FA_2019_RD2098_245_1_20191031_00001.jpg

View looking upstream at annual vegetation on the landside slope (Fall 2019).

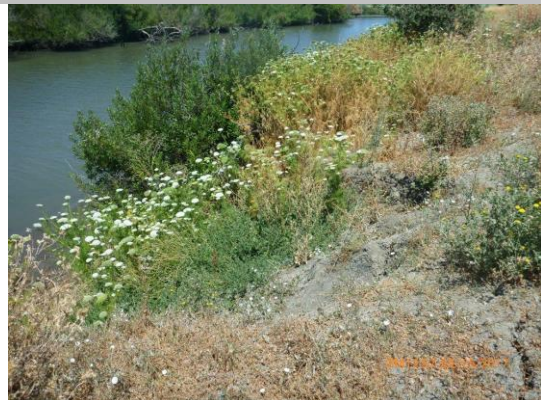
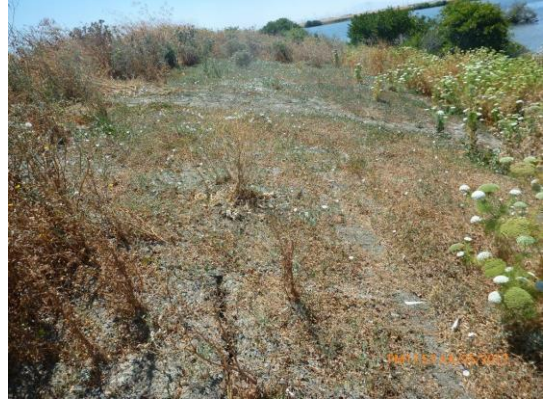
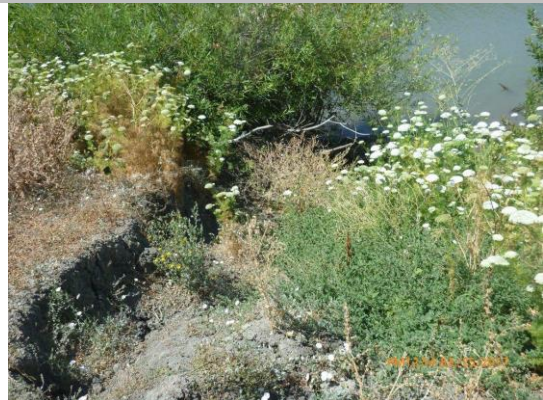
LM Start	6.47	Rating **	A/W	Issue No.	17
LM End	6.48	Issue Type +	Ma	Location *	WS
Category	Supplemental			GPS Latitude/Longitude	
				Start	End
Item	2017 Storm Damage			38.288900 °	38.289000 °
				-121.717000 °	-121.717000 °
DWR ID	LMA-268				
Comment Code					
Inspector Comment					
Levee Evaluation Comments					
Description:The damage consists of scour and sloughing of the lower and mid waterside levee slope.					
Site ID No:441					
Site Designation:LMA-268					
Repair Type: Erosion					
Rating:Area of Concern					
Field Date:7/25/2017					
Notes: Sloughing on waterside slope due to toe erosion.

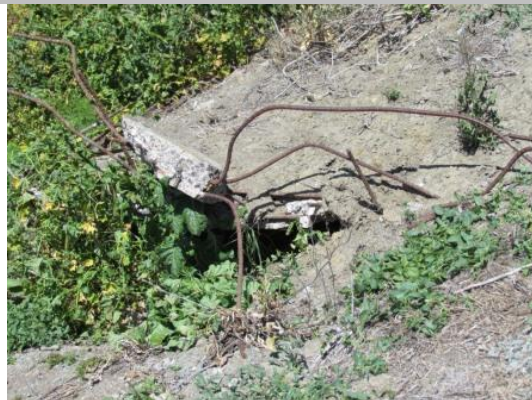
Photo 1 of 1 : FA_2019_RD2098_246_10_20190826_00001.jpg

There is some slope damage at this location under this concrete. No new photo; RD will send crew out to check area out.

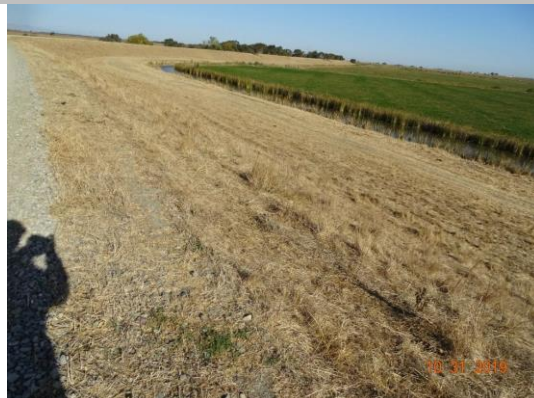
Photo 1 of 4 : FA_2019_RD2098_247_1_20191031_00021.jpg

View looking upstream at slope depressions caused by cows (Fall 2019).

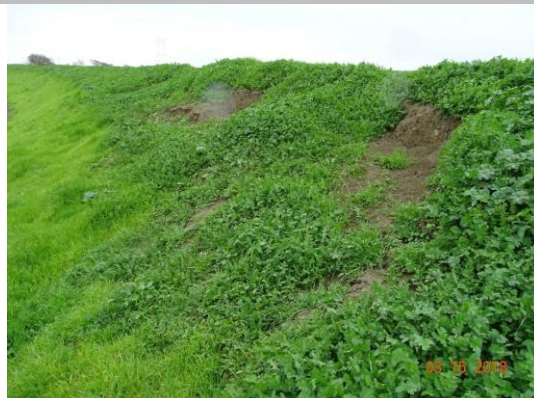
Photo 3 of 4 : FA_2019_RD2098_247_1_20190311_00002.jpg

Erosion site on 03/15/18.

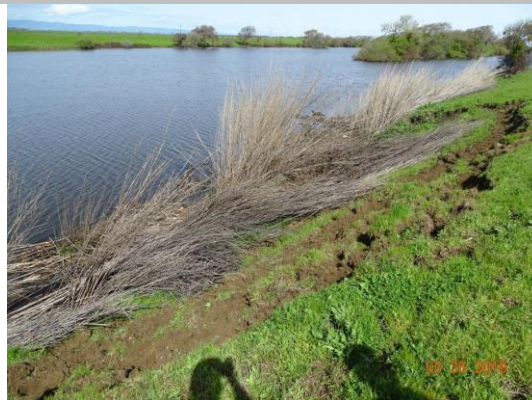
Photo 2 of 5 : FA_2019_RD2098_247_15_20190826_00012.jpg

View looking upstream at erosion at the storm damage site that has worsened over January and February of 2019 (Spring 2019).

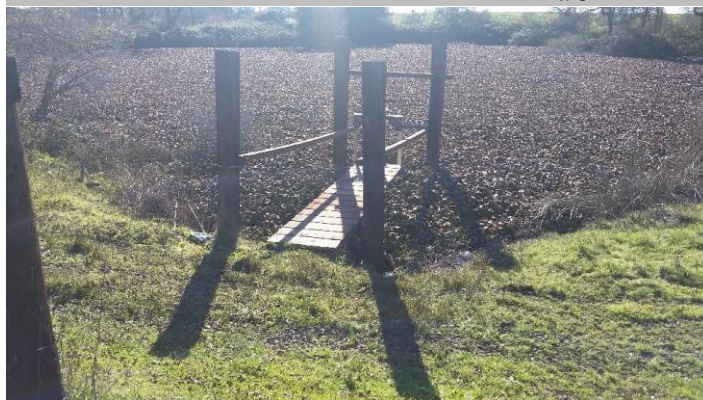
Photo 2 of 3 : UCIP_FA_2019_51453_76861.jpg

Walkway has been re-built, photo 2 of 2.

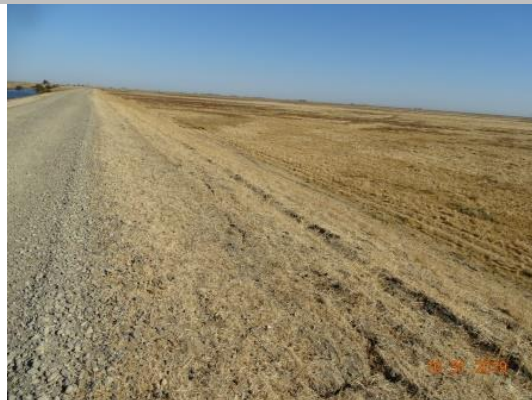
Photo 1 of 1 : FA_2019_RD2098_248_10_20191031_00023.jpg

View looking upstream at depressions in the landside slope due to cows (Fall 2019).

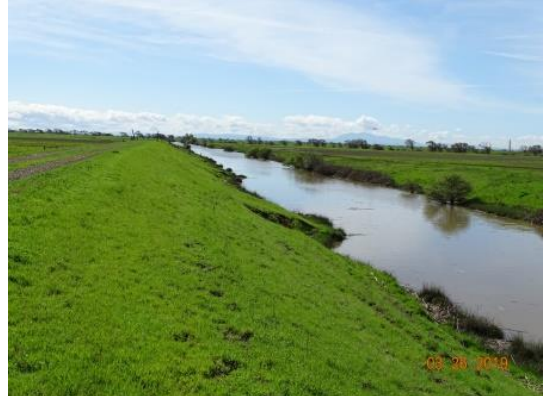
Photo 3 of 3 : FA_2019_RD2098_248_9_20190826_00003.jpg

View looking downstream at worst section of the erosion on the waterside slope (Spring 2019).

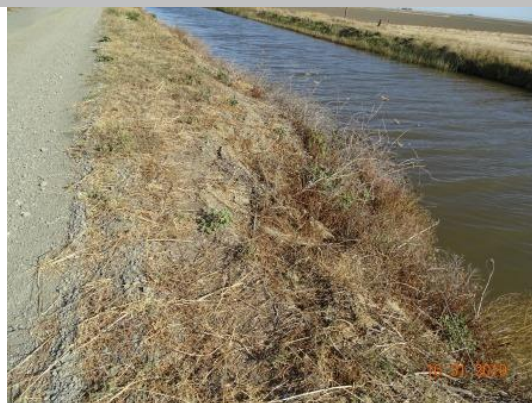
Photo 1 of 1 : FA_2019_RD2098_248_17_20191031_00024.jpg

View looking upstream at slope stability site on the landside slope next to the canal (Fall 2019).

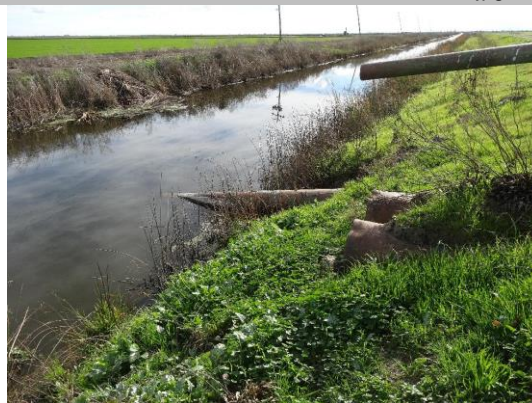
View of LS--damage distribution box noted in last inspection has been removed.
