Flood Control Project Maintenance Levee Inspections

Fall 2020 Levee Maintenance Deficiency Summary Report

Sacramento River Basin

Reclamation District No. 2098 Cache and Haas Slough

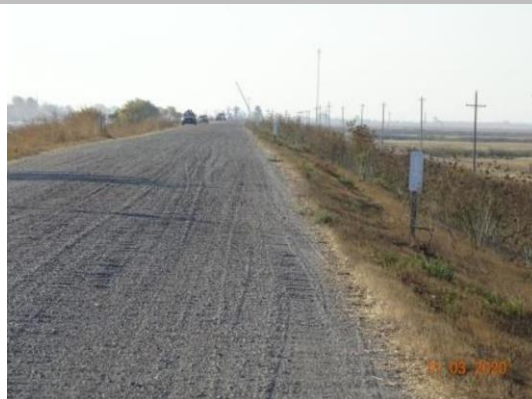
Photo 1 of 1 : FA_2020_RD2098_244_12_20201103_00034.jpg

View looking downstream at vegetation on the landside slope (Fall 2020).

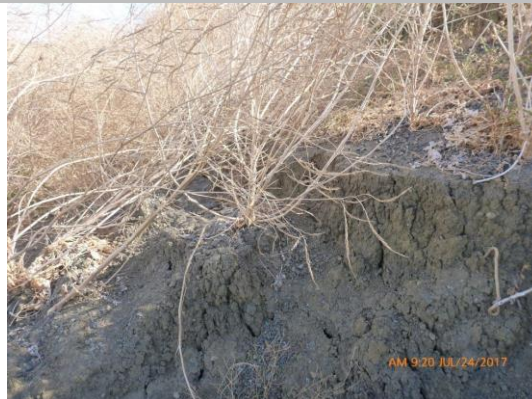
Photo 1 of 1 : LEVAL_FA_2020_414_3596.jpg

LM Start	0.96	Rating **	A/W	Issue No.	19
LM End	0.96	Issue Type +	Ma	Location *	LS
Category	Earthen Levee			GPS Latitude/Longitude	
				Start	End
Item	Erosion / Bank Caving			38.315200 °	38.315100 °
				-121.694100 °	-121.694100 °
DWR ID	LMA-241				
Comment Code					
E1 : Note and monitor erosion site.					
Inspector Comment					
This was a 2017 Storm Damage site. The damage consists of cracking and sloughing of the lower landside levee slope. Site ID No:414 Site Designation:LMA-241 4/24/2020 Field Notes: Vegetation is to thick to see. Verify in fall when vegetation less.

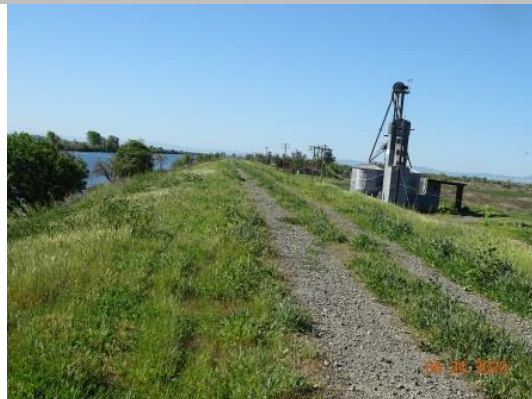
Photo 1 of 1 : FA_2020_RD2098_244_17_20201009_00002.jpg

View looking downstream at vegetation on the crown (Spring 2020).

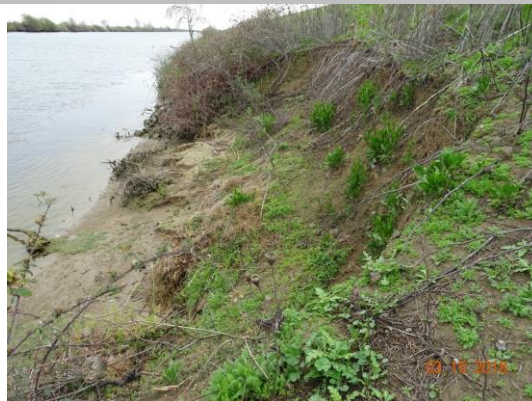
Photo 1 of 1 : FA_2020_RD2098_244_18_20201009_00003.jpg

LM Start	1.76	Rating **	M	Issue No.	18
LM End	1.76	Issue Type +	Ma	Location *	WS
Category	Earthen Levee			GPS Latitude/Longitude	
				Start	End
Item	Erosion / Bank Caving			38.303611 °	38.303611 °
				-121.693607 °	-121.693607 °
DWR ID	DWR_RD2098_01_s_2018_18				
Comment Code					
E2 : Schedule repair of erosion site prior to the next inspection.					
Inspector Comment					
Erosion at the waterside toe.

View of erosion.

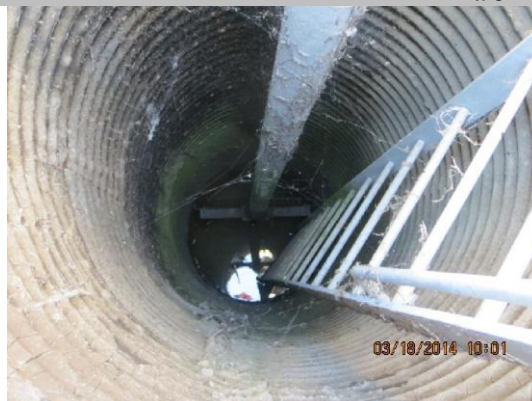
Photo 2 of 3 : UCIP_FA_2020_32207_58664.jpg

No lid on CMP riser that is 24-feet deep.

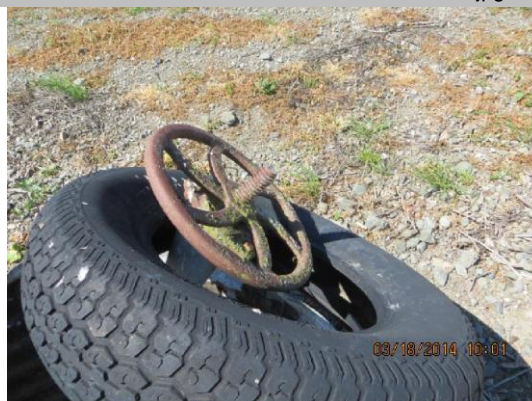
Photo 3 of 3 : UCIP_FA_2020_32207_58663.jpg

bent actuator on WS slope.

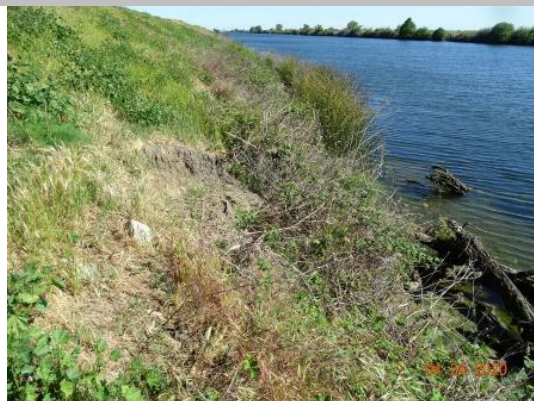
Photo 1 of 1 : FA_2020_RD2098_244_36_20201009_00009.jpg

LM Start	2.91	Rating **	U	Issue No.	36
LM End	2.93	Issue Type +	Ma	Location *	WS
Category	Earthen Levee			GPS Latitude/Longitude	
				Start	End
Item	Erosion / Bank Caving			38.286900 °	38.286700 °
				-121.693500 °	-121.693500 °
DWR ID	LMA-258				
Comment Code					
E2 : Schedule repair of erosion site prior to the next inspection.					
Inspector Comment					
This was a 2017 Storm Damage site. The damage consists of scour and sloughing of the waterside levee slope. Site ID No:431 Site Designation:LMA-258

View looking upstream at erosion into the waterside slope (Spring 2020).

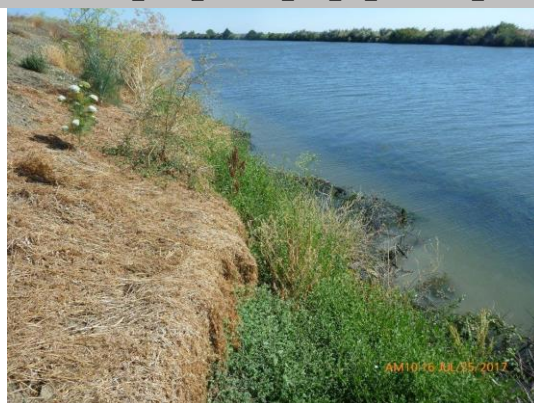
Photo 1 of 1 : FA_2020_RD2098_244_37_20201009_00011.jpg

LM Start	2.99	Rating **	M	Issue No.	37
LM End	3.29	Issue Type +	Ma	Location *	WS
Category	Earthen Levee			GPS Latitude/Longitude	
				Start	End
Item	Erosion / Bank Caving			38.285700 °	38.281500 °
				-121.693500 °	-121.694300 °
DWR ID	LMA-259				
Comment Code					
E2 : Schedule repair of erosion site prior to the next inspection.					
Inspector Comment					
This was a 2017 Storm Damage site. The damage consists of scour and sloughing of the waterside levee slope. Site ID No:432 Site Designation:LMA-259

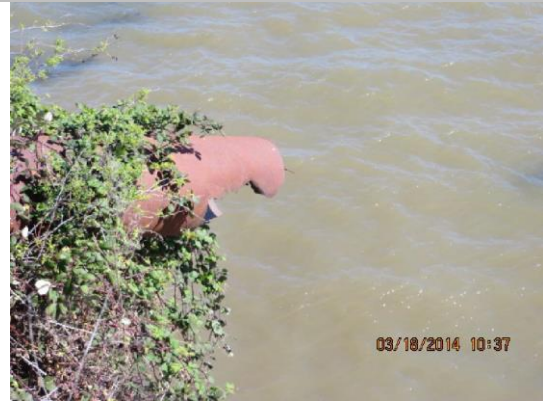
Photo 3 of 3 : UCIP_FA_2020_32227_58690.jpg

DS_ID:20969
FS_ID:32227
EP_NO: 13222
Repair Type: Non-Urgent
EVAL Issue:
Crossing Status: Found
UCIP Comments: 03/18/2014 Pipe rusted through at outlet on WS slope, may indicate further degradation of pipe within levee. Good candidate for video inspection. (W. Wylie - DWR UCIP)
FIELD_STRUCT_DESC: 20-inch steel drainage pipe through the levee, 7.5 feet below the crown. Siphon breaker on the waterside (WS) shoulder. Pump on pile structure in drainage ditch on the landside (LS). (This pipe was retained under Automatic Board Order (ABO) issued as Permit No. 10168, 1974 - Moresco Brothers. Pipe removed and replaced with a 19-inch steel pipe under the crown and along the LS slope under Permit No. 13222, 1981 - Prudential Insurance Company of America). [Additional Reference(s): DWR Levee Log, 2003. USACE Sacramento O&M Manual 109, April 1962, (HLM 2.98)].
FS Date: 3/18/2014

Pipe rusted through at outlet on WS slope.

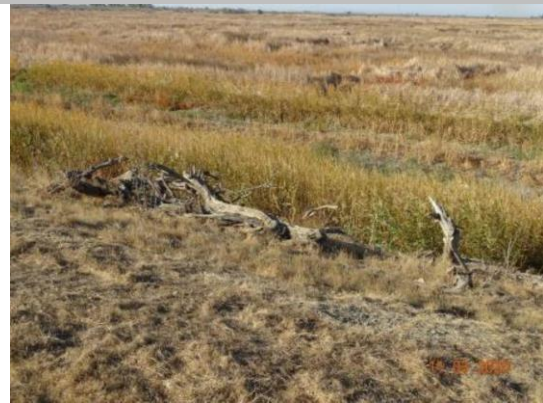
Photo 1 of 1 : FA_2020_RD2098_244_20_20201103_00035.jpg

View of tree limb on the landside slope (Fall 2020).

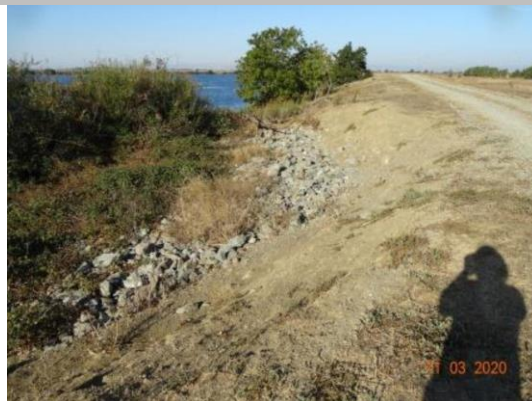
Photo 1 of 1 : FA_2020_RD2098_246_11_20201103_00027.jpg

View looking upstream at erosion into waterside slope (Fall 2020).

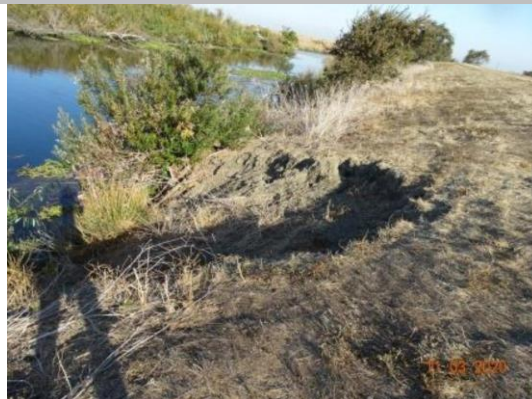
Photo 1 of 1 : FA_2020_RD2098_246_15_20201103_00028.jpg

View looking upstream at erosion into the waterside slope (Fall 2020).

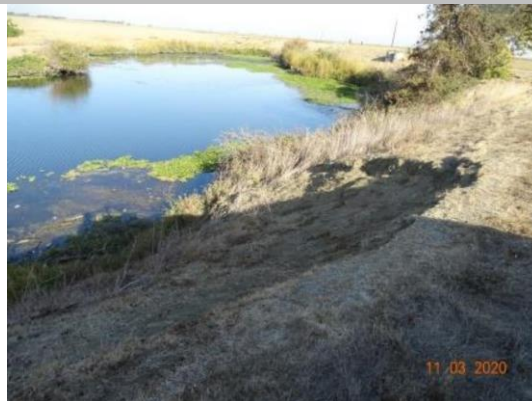
Photo 1 of 1 : FA_2020_RD2098_246_18_20201103_00026.jpg

View looking upstream at erosion into the waterside slope (Fall 2020).

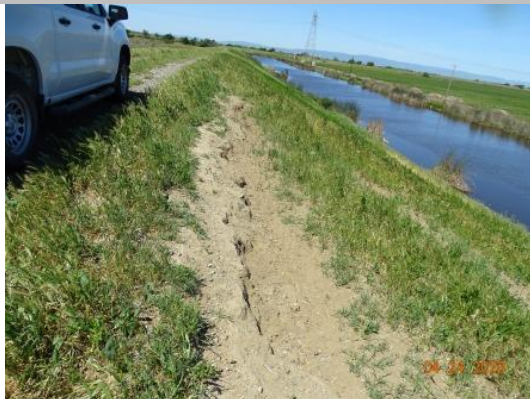
Photo 1 of 1 : FA_2020_RD2098_246_12_20201009_00004.jpg

View looking upstream at erosion at the top of the landside slope (Spring 2020).

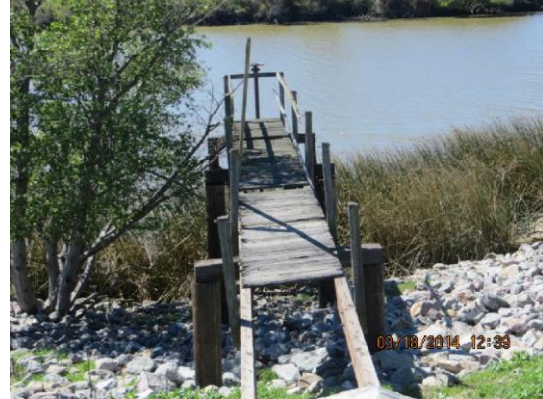
Photo 2 of 3 : UCIP_FA_2020_32290_58763.jpg

Delapidated wooden pier on WS shoulder.

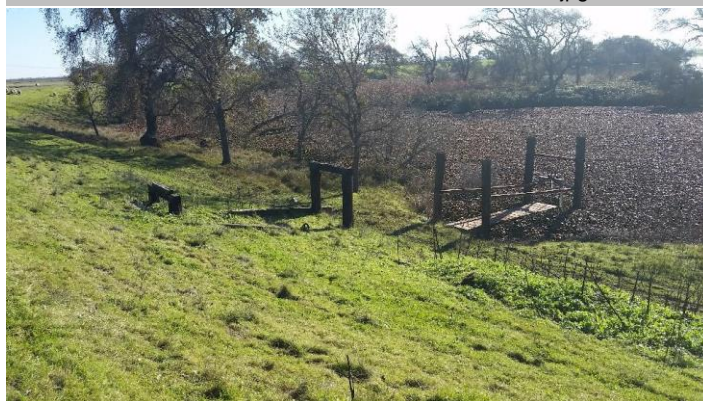
Photo 1 of 3 : UCIP_FA_2020_51453_76858.jpg

Walkway has been re-built, photo 1 of 2.

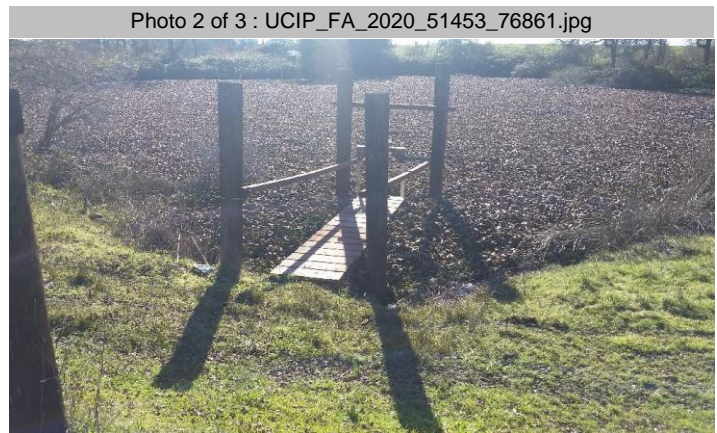
Walkway has been re-built, photo 2 of 2.

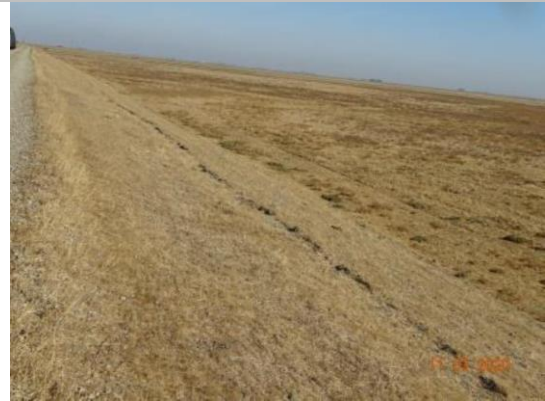
Photo 1 of 1 : FA_2020_RD2098_248_10_20201103_00023.jpg

View looking upstream at depressions in the landside slope due to cows (Fall 2020).

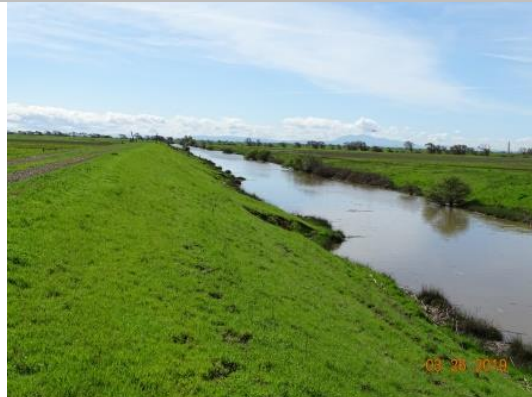
Photo 1 of 1 : FA_2020_RD2098_248_9_20201009_00003.jpg

View looking downstream at worst section of the erosion on the waterside slope (Spring 2019).

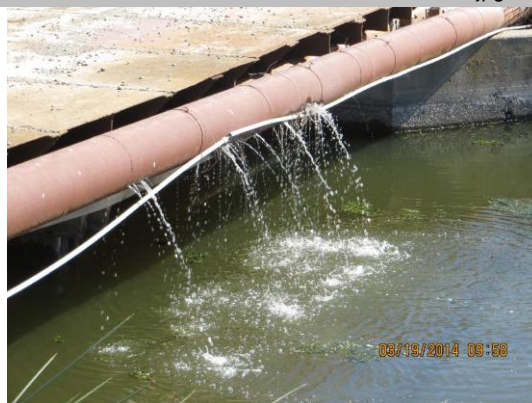
Photo 3 of 3 : UCIP_FA_2020_32403_58903.jpg

Holes in pipe next to bridge. PVC electrical conduit shown.

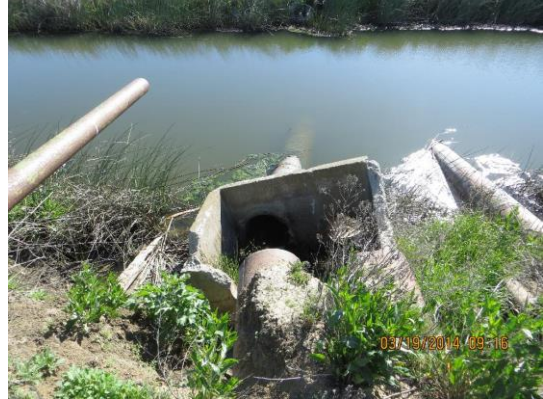
Photo 3 of 3 : UCIP_FA_2020_53382_58817.jpg

Concrete distribution box on LS slope has slipped into canal.
