Flood Control Project Maintenance Levee Inspections

Fall 2021 Levee Maintenance Deficiency Summary Report

Sacramento River Basin

Reclamation District No. 2098 Cache and Haas Slough

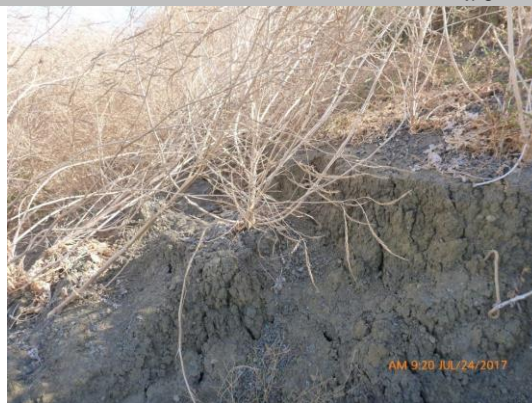
Photo 1 of 1 : LEVAL_FA_2021_414_3596.jpg

LM Start	0.96	Rating **	A/W	Issue No.	19
LM End	0.96	Issue Type +	Ma	Location *	LS
Category	Earthen Levee			GPS Latitude/Longitude	
				Start	End
Item	Erosion / Bank Caving			38.315200 °	38.315100 °
				-121.694100 °	-121.694100 °
DWR ID	DWR_RD2098_01_s_2021_19				
Comment Code					
E1 : Note and monitor erosion site.					
Inspector Comment					
This was a 2017 Storm Damage site. The damage consists of cracking and sloughing of the lower landside levee slope. Site ID No:414 Site Designation:LMA-241 4/24/2020 Field Notes: Vegetation is to thick to see. Verify in fall when vegetation less.

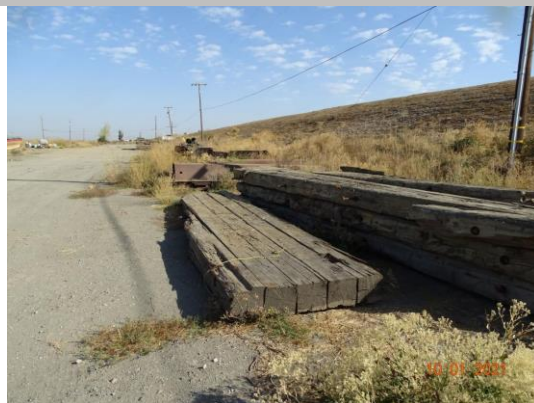
Photo 1 of 1 : FA_2021_RD2098_244_12_20211014_00034.jpg

View of demolition debris on the landside toe (Fall 2021).

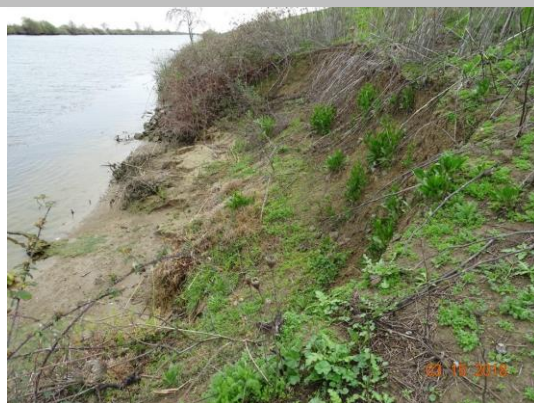
Photo 1 of 1 : FA_2021_RD2098_244_18_20210830_00003.jpg

LM Start	1.76	Rating **	M	Issue No.	18
LM End	1.76	Issue Type +	Ma	Location *	WS
Category	Earthen Levee			GPS Latitude/Longitude	
				Start	End
Item	Erosion / Bank Caving			38.303611 °	38.303611 °
				-121.693607 °	-121.693607 °
DWR ID	DWR_RD2098_01_s_2018_18				
Comment Code					
E2 : Schedule repair of erosion site prior to the next inspection.					
Inspector Comment					
There is erosion at the waterside toe.

View of erosion.

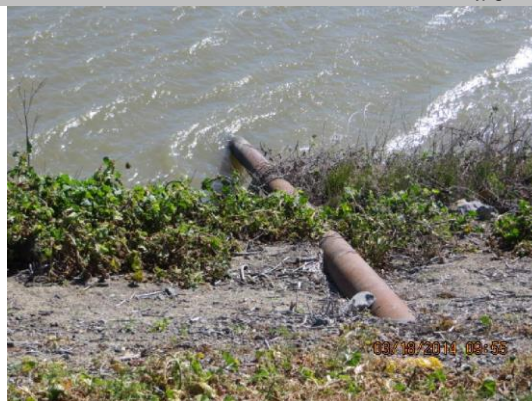
Photo 1 of 3 : UCIP_FA_2021_32197_58662.jpg

Comment Code						
Inspector Comment						
DS_ID:20965 FS_ID:32197 EP_NO: 10168 Repair Type: Non-Urgent EVAL Issue: Crossing Status: Found UCIP Comments: 12/22/2016 Met with Mike Hadesty, LMA Superintendent, and Brian Bush, LMA General Manager, to go over the list of pipes in RD2098. Per LMA records, this pipe has a different owner. (O. Magana - DWR UCIP) 03/18/2014 Erosion under pipe at WS toe. (W. Wylie - DWR UCIP) FIELD_STRUCT_DESC: 10-inch steel drainage pipe through the levee, 2.8 feet below the crown. Pump in pump house off the landside (LS). (This pipe was retained under Automatic Board Order (ABO) issued as Permit No. 10168, 1974 - Moresco Brothers). [Additional Reference(s): DWR Levee Log, 2003. USACE Sacramento O&M Manual 109, April 1962, (HLM 1.80)]. FS Date: 3/18/2014

Pipe on WS slope.

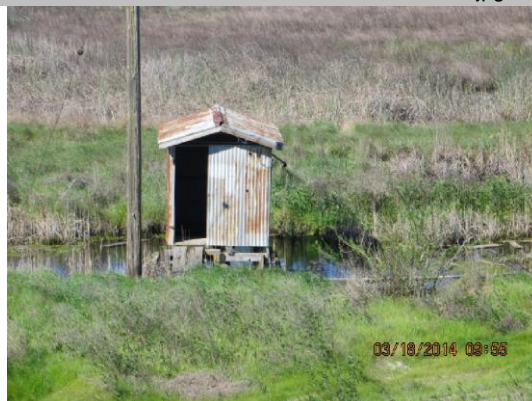
Photo 2 of 3 : UCIP_FA_2021_32197_58661.jpg

Pumphouse at lowpoint off LS toe.

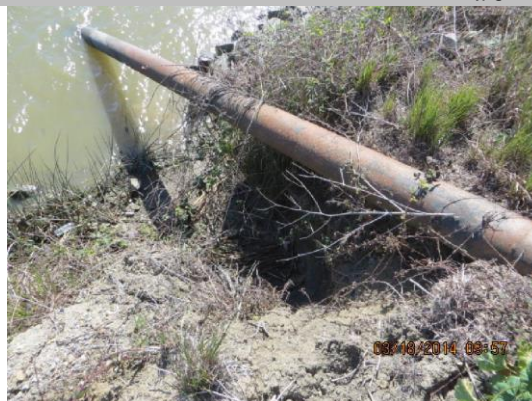
Photo 3 of 3 : UCIP_FA_2021_32197_58660.jpg

Erosion under pipe at WS toe.

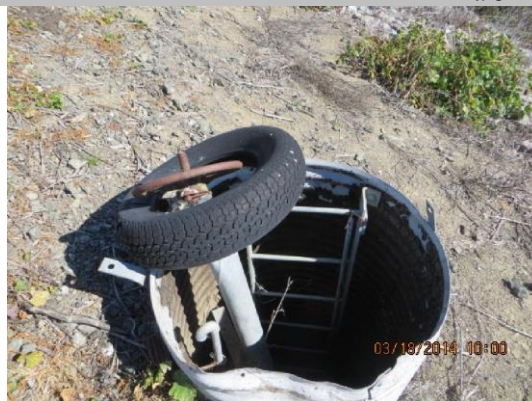
Photo 1 of 3 : UCIP_FA_2021_32207_58665.jpg

DS_ID:20966
 FS_ID:32207
 EP_NO: 10168
 Repair Type: Non-Urgent
 EVAL Issue:
 Crossing Status: Found
 UCIP Comments: 12/22/2016 Met with Mike Hadesty, LMA Superintendent, and Brian Bush, LMA General Manager, to go over the list of pipes in RD2098. Per LMA records, this pipe is a drainage pipe. Need to coordinate with owner to obtain records to confirm line integrity. (O. Magana - DWR UCIP)
 03/18/2014 Slide gate actuator bent but appears to be in closed position. No lid on standpipe. Appears abandoned and if so should be done so properly. (W. Wylie - DWR UCIP)
 FIELD_STRUCT_DESC: 24-inch drainage pipe of an unknown material through the levee, 24.5 feet below the crown. Two corrugated metal cutoff walls around the pipe at the center of the levee. Slide gate in a 36-inch corrugated metal pipe (CMP) riser on the waterside (WS) slope. Concrete saddle and apron on the WS end. Flap gate and U-shaped headwall on the landside (LS) end. (This pipe was retained under Automatic Board Order (ABO) issued as Permit No. 10168, 1974 - Moresco Brothers). [Additional Reference(s): DWR Levee Log, 2003].

36-inch CMP riser with bent slide gate actuator on WS slope.

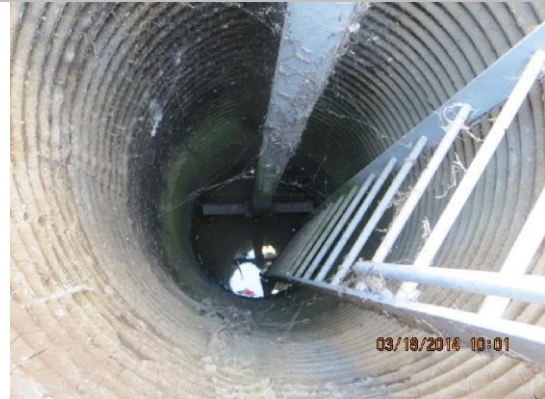
Photo 2 of 3 : UCIP_FA_2021_32207_58664.jpg

No lid on CMP riser that is 24-feet deep.

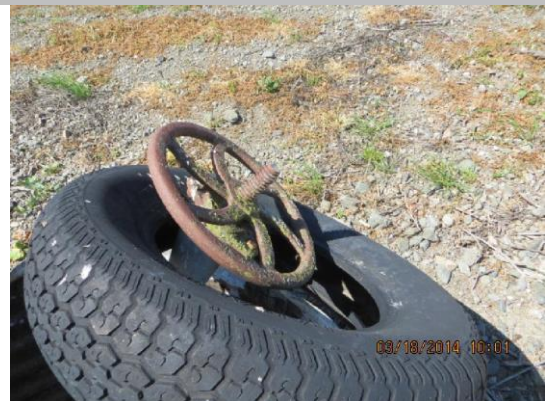
Photo 3 of 3 : UCIP_FA_2021_32207_58663.jpg

bent actuator on WS slope.

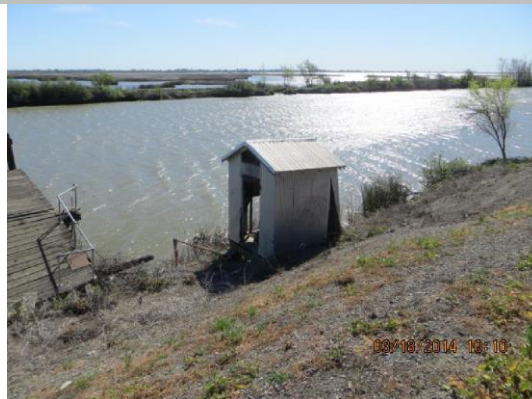
Photo 1 of 3 : UCIP_FA_2021_32225_58687.jpg

Comment Code					
Inspector Comment					
DS_ID:20967 FS_ID:32225 EP_NO: 10168 Repair Type: Non-Urgent EVAL Issue: Crossing Status: Found UCIP Comments: 12/22/2016 Met with Mike Hadesty, LMA Superintendent, and Brian Bush, LMA General Manager, to go over the list of pipes in RD2098. Per LMA, line has been abandoned. New property owner is Anderson. (O. Magana - DWR UCIP) 03/18/2014 Pipe appears abandoned and if so should be done so properly. Pipe open on WS at pumphouse as there is no connection to pump. (W. Wylie - DWR UCIP) FIELD_STRUCT_DESC: *ABANDONED* 2-inch galvanized iron irrigation pipe through the levee, 10 feet below the crown. Pump in pump house on the waterside (WS) slope next to fishing dock. Power pole and meter at the landside (LS) toe, next to hose bib. 1-inch steel electrical conduit at the same location. (This pipe was retained under Automatic Board Order (ABO) issued as Permit No. 10168, 1974 - Moresco Brothers). [Additional Reference(s): DWR Levee Log, 2003]. FS Date: 3/18/2014

Pumphouse next to fishing dock on WS slope.

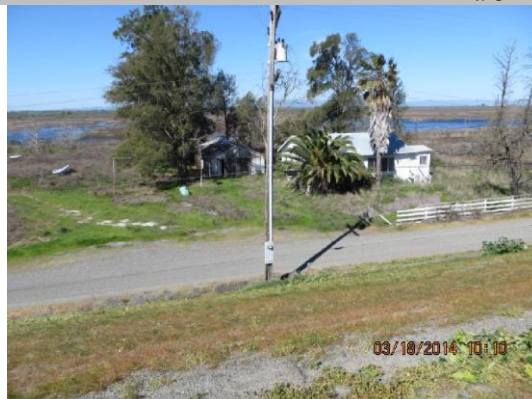
Photo 2 of 3 : UCIP_FA_2021_32225_58686.jpg

Power pole and meter next to spigot on LS toe.

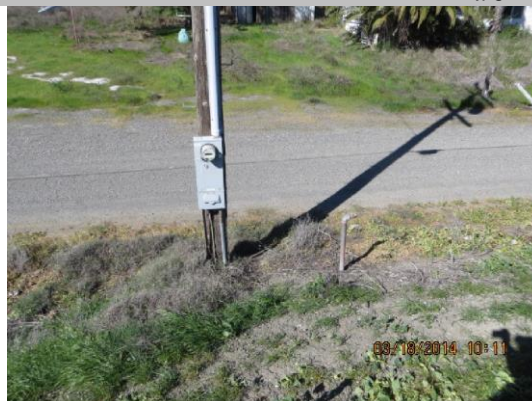
Photo 3 of 3 : UCIP_FA_2021_32225_58685.jpg

Power pole and meter next to spigot on LS toe.

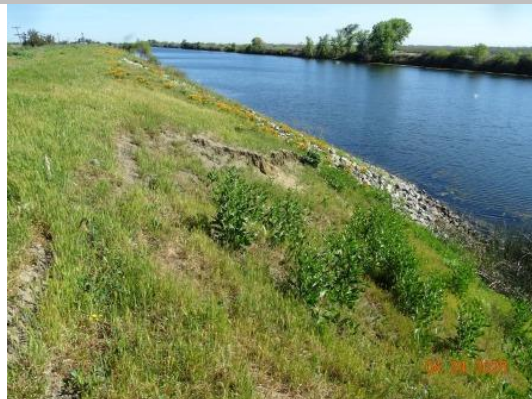
Photo 1 of 1 : FA_2021_RD2098_244_27_20210830_00006.jpg

LM Start	2.29	Rating **	U	Issue No.	27
LM End	2.32	Issue Type +	Ma	Location *	WS
Category	Earthen Levee			GPS Latitude/Longitude	
				Start	End
Item	Erosion / Bank Caving			38.295900 °	38.295468 °
				-121.693500 °	-121.693619 °
DWR ID	LMA-248				
Comment Code					
E2 : Schedule repair of erosion site prior to the next inspection.					
Inspector Comment					
This was a 2017 Storm Damage site. The damage consists of scour and sloughing of the waterside levee slope. Site ID No:421 Site Designation:LMA-248

View looking upstream at erosion in the waterside slope (Spring 2020).

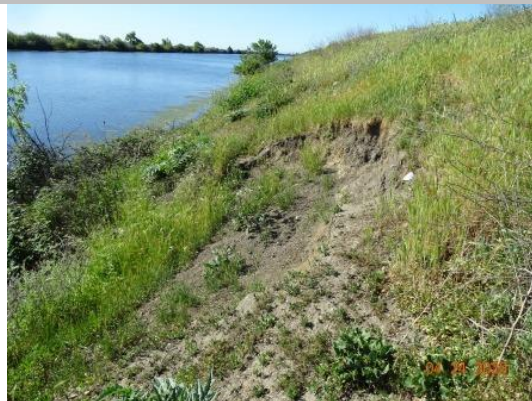
Photo 1 of 1 : FA_2021_RD2098_244_28_20210830_00007.jpg

LM Start	2.35	Rating **	U	Issue No.	28
LM End	2.39	Issue Type +	Ma	Location *	WS
Category	Earthen Levee			GPS Latitude/Longitude	
				Start	End
Item	Erosion / Bank Caving			38.295100 °	38.294500 °
				-121.693400 °	-121.693400 °
DWR ID	LMA-250				
Comment Code					
E2 : Schedule repair of erosion site prior to the next inspection.					
Inspector Comment					
This was a 2017 Storm Damage site. The damage consists of scour, sloughing, and cracking of the lower and mid waterside levee slope. Site ID No:423 Site Designation:LMA-250

View looking upstream at erosion into the waterside slope (Spring 2020).

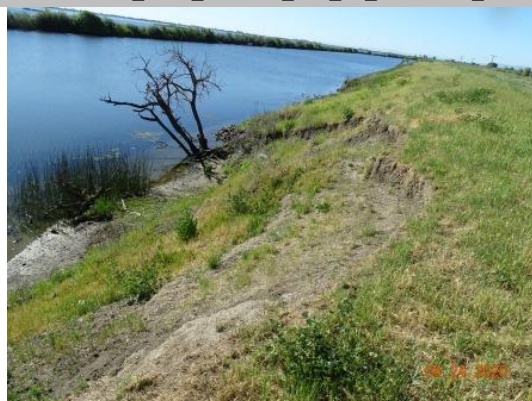
Photo 1 of 1 : FA_2021_RD2098_244_34_20210830_00008.jpg

LM Start	2.75	Rating **	U	Issue No.	34
LM End	2.81	Issue Type +	Ma	Location *	WS
Category	Earthen Levee			GPS Latitude/Longitude	
				Start	End
Item	Erosion / Bank Caving			38.289200 °	38.288405 °
				-121.693500 °	-121.693617 °
DWR ID	LMA-256				
Comment Code					
E2 : Schedule repair of erosion site prior to the next inspection.					
Inspector Comment					
This was a 2017 Storm Damage site. The damage consists of scour and sloughing of the waterside levee slope. Site ID No:429 & 430 Site Designation:LMA-256, LMA-257

View looking downstream at erosion into the waterside slope (Spring 2020).

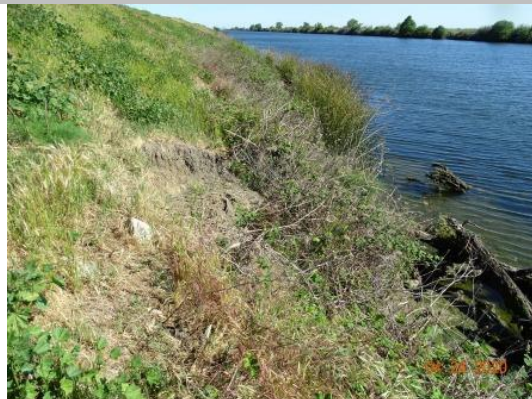
Photo 1 of 1 : FA_2021_RD2098_244_36_20210830_00009.jpg

LM Start	2.91	Rating **	U	Issue No.	36
LM End	2.93	Issue Type +	Ma	Location *	WS
Category	Earthen Levee			GPS Latitude/Longitude	
				Start	End
Item	Erosion / Bank Caving			38.286900 °	38.286700 °
				-121.693500 °	-121.693500 °
DWR ID	LMA-258				
Comment Code					
E2 : Schedule repair of erosion site prior to the next inspection.					
Inspector Comment					
This was a 2017 Storm Damage site. The damage consists of scour and sloughing of the waterside levee slope. Site ID No:431 Site Designation:LMA-258

View looking upstream at erosion into the waterside slope (Spring 2020).

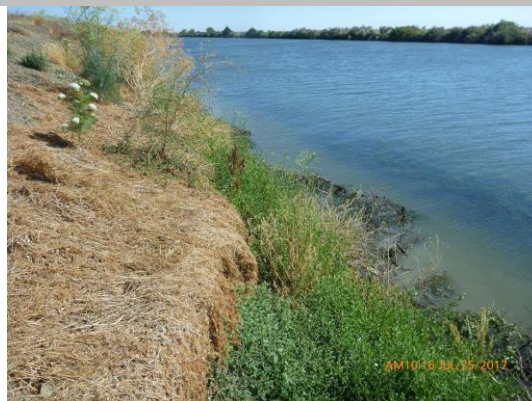
Photo 1 of 1 : FA_2021_RD2098_244_37_20210830_00010.jpg

LM Start	2.99	Rating **	M	Issue No.	37
LM End	3.29	Issue Type +	Ma	Location *	WS
Category	Earthen Levee			GPS Latitude/Longitude	
				Start	End
Item	Erosion / Bank Caving			38.285700 °	38.281500 °
				-121.693500 °	-121.694300 °
DWR ID	LMA-259				
Comment Code					
E2 : Schedule repair of erosion site prior to the next inspection.					
Inspector Comment					
This was a 2017 Storm Damage site. The damage consists of scour and sloughing of the waterside levee slope. Site ID No:432 Site Designation:LMA-259

View of erosion on the waterside slope. Photo was taken in 2017.

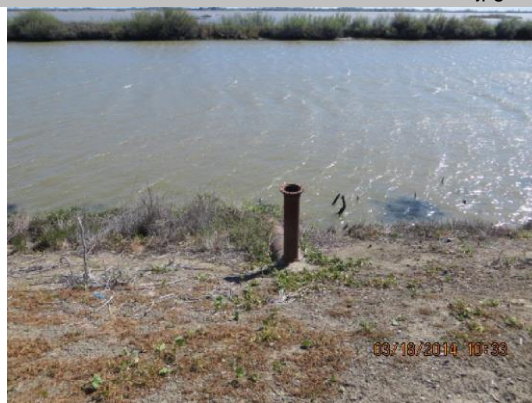
Photo 2 of 3 : UCIP_FA_2021_32227_58691.jpg

Siphon breaker in steel riser on WS slope.

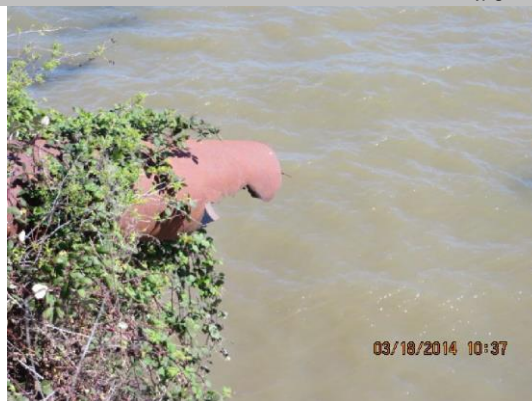
Photo 3 of 3 : UCIP_FA_2021_32227_58690.jpg

Comment Code						
Inspector Comment						
DS_ID:20969 FS_ID:32227 EP_NO: 13222 Repair Type: Non-Urgent EVAL Issue: Crossing Status: Found UCIP Comments: 03/18/2014 Pipe rusted through at outlet on WS slope, may indicate further degradation of pipe within levee. Good candidate for video inspection. (W. Wylie - DWR UCIP) FIELD_STRUCT_DESC: 20-inch steel drainage pipe through the levee, 7.5 feet below the crown. Siphon breaker on the waterside (WS) shoulder. Pump on pile structure in drainage ditch on the landside (LS). (This pipe was retained under Automatic Board Order (ABO) issued as Permit No. 10168, 1974 - Moresco Brothers. Pipe removed and replaced with a 19-inch steel pipe under the crown and along the LS slope under Permit No. 13222, 1981 - Prudential Insurance Company of America). [Additional Reference(s): DWR Levee Log, 2003. USACE Sacramento O&M Manual 109, April 1962, (HLM 2.98)]. FS Date: 3/18/2014

Pipe rusted through at outlet on WS slope.

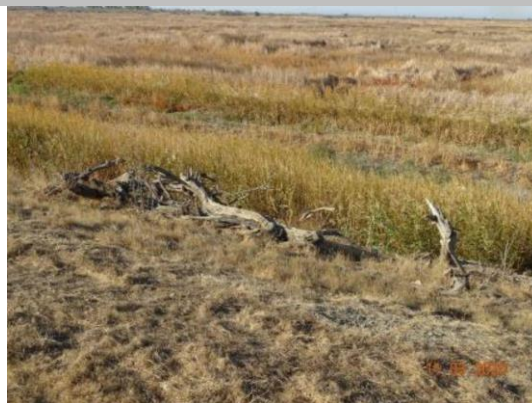
Photo 1 of 1 : FA_2021_RD2098_244_20_20210830_00005.jpg

View of tree limb on the landside slope (Fall 2020).

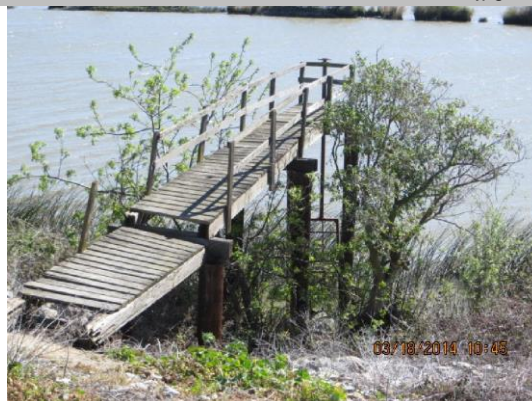
Photo 1 of 3 : UCIP_FA_2021_32243_58702.jpg

Comment Code					
Inspector Comment					
DS_ID:20970 FS_ID:32243 EP_NO: 10168 Repair Type: Non-Urgent EVAL Issue: Crossing Status: Found UCIP Comments: 03/18/2014 Walkway to slidegate on WS toe is in poor structural condition and may not be safe for accessing the slide gate actuator. Pipe appears abandoned and if so should be done so properly. Outlet on LS toe may be buried. (W. Wylie - DWR UCIP) FIELD_STRUCT_DESC: 24-inch steel irrigation pipe through the levee, 22.3 feet below the crown. Slide gate on the waterside (WS) end. Walkway from the WS shoulder to the slide gate control. Flap gate on the landside (LS) end. (This pipe was retained under Automatic Board Order (ABO) issued as Permit No. 10168, 1974 - Moresco Brothers). [Additional Reference(s): DWR Levee Log, 2003]. FS Date: 3/18/2014

Walkway to slide gate actuator on WS toe.

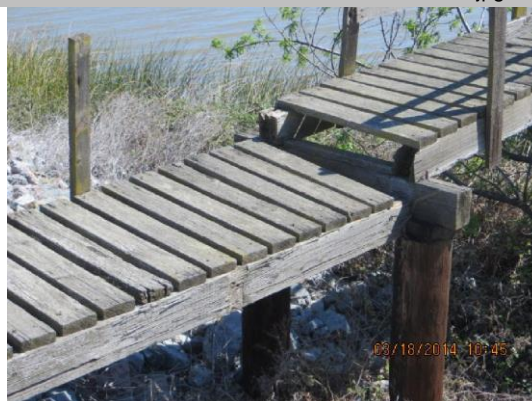
Photo 2 of 3 : UCIP_FA_2021_32243_58701.jpg

Walkway may not be structurally sound.

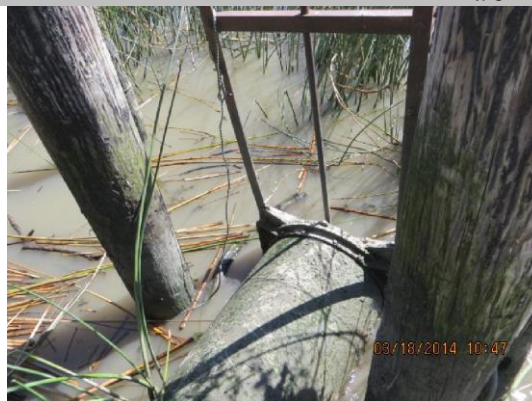
Photo 3 of 3 : UCIP_FA_2021_32243_58700.jpg

Slidegate on WS toe at pipe.

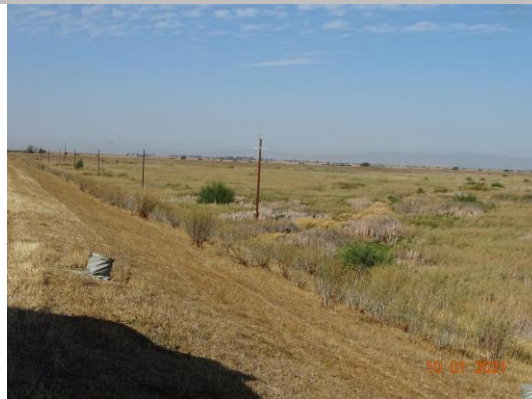
Photo 1 of 1 : FA_2021_RD2098_245_1_20211014_00001.jpg

View looking upstream at vegetation on the landside slope (Fall 2021).

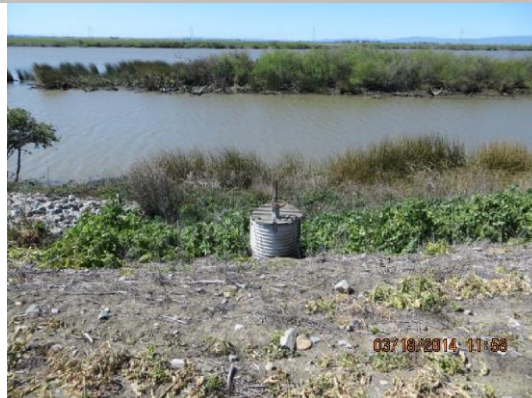
Photo 2 of 3 : UCIP_FA_2021_32287_58754.jpg

Slide gate in 36-inch standpipe on WS slope.

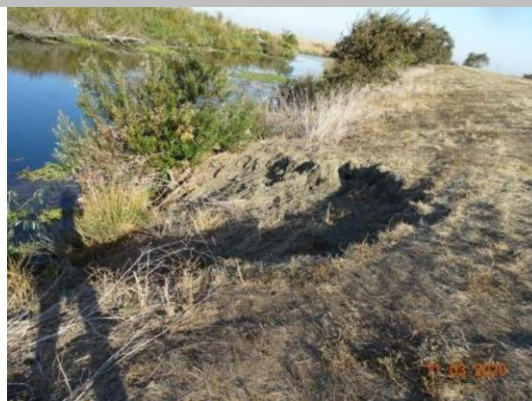
Photo 1 of 1 : FA_2021_RD2098_246_15_20210830_00004.jpg

This was a 2017 Storm Damage site.
The damage consists of scour of the lower and mid waterside levee slope.

View looking upstream at erosion into the waterside slope (Fall 2020).

E2 : Schedule repair of erosion site prior to the next inspection.

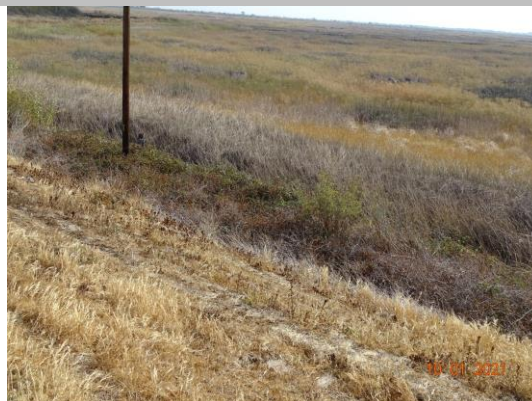
Photo 1 of 1 : FA_2021_RD2098_246_6_20211014_00023.jpg

View of vegetation on the landside toe (Fall 2021).

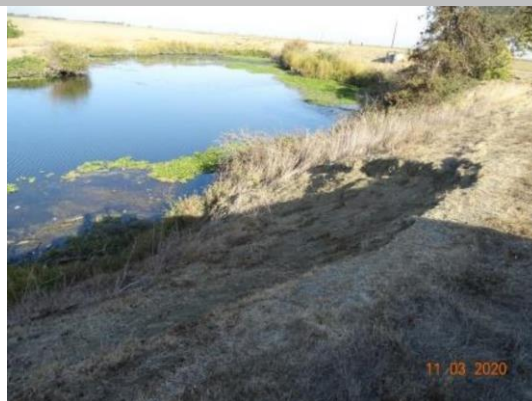
Photo 1 of 1 : FA_2021_RD2098_246_18_20210830_00005.jpg

View looking upstream at erosion into the waterside slope (Fall 2020).

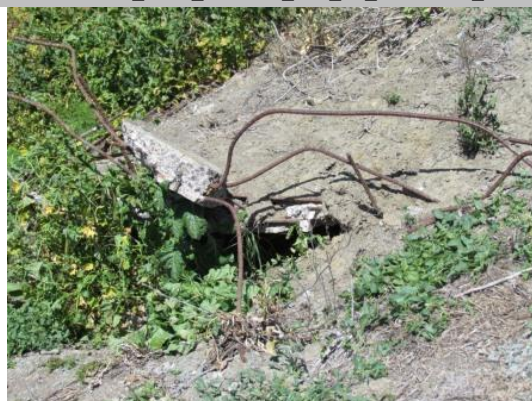
Photo 1 of 1 : FA_2021_RD2098_246_10_20210830_00001.jpg

There is some slope damage at this location under this concrete.

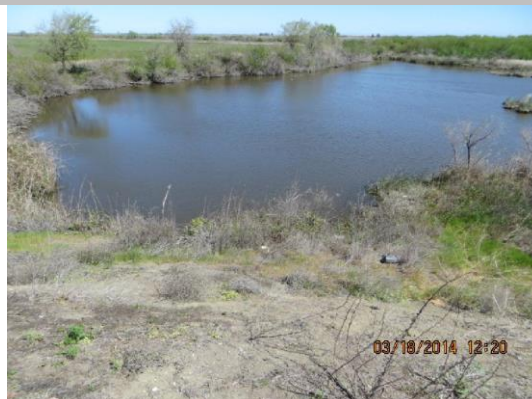
Photo 2 of 3 : UCIP_FA_2021_33784_61161.jpg

Inlet not visible on LS toe.

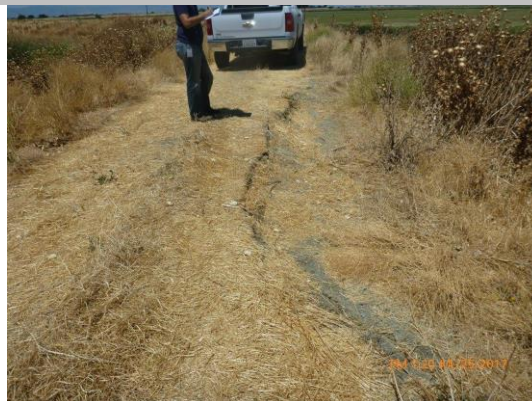
Photo 1 of 1 : FA_2021_RD2098_246_19_20210830_00006.jpg

View of landside sloughing. Photo taken in 2017.

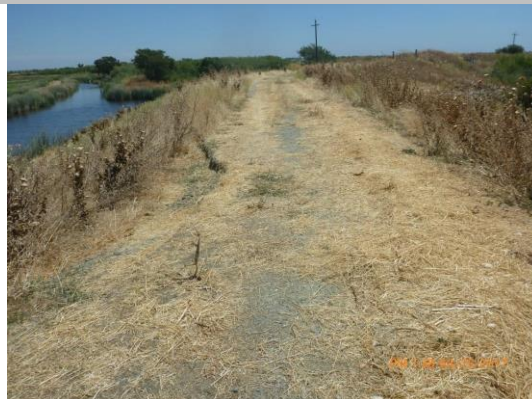
Photo 1 of 1 : FA_2021_RD2098_246_20_20210830_00007.jpg

View of erosion on the landside levee crest. Photo taken in 2017.

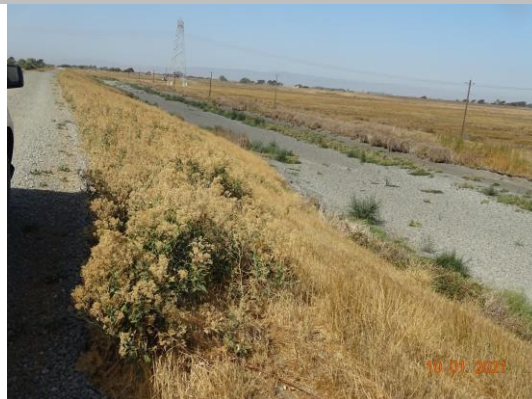
Photo 1 of 1 : FA_2021_RD2098_246_7_20211014_00024.jpg

View looking upstream at vegetation on the landside slope (Fall 2021).

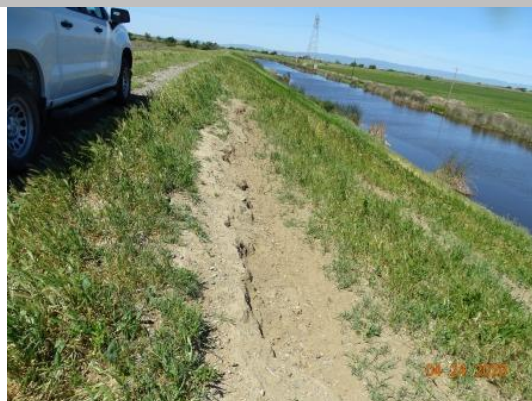
Photo 1 of 1 : FA_2021_RD2098_246_12_20210830_00003.jpg

View looking upstream at erosion at the top of the landside slope (Spring 2020).

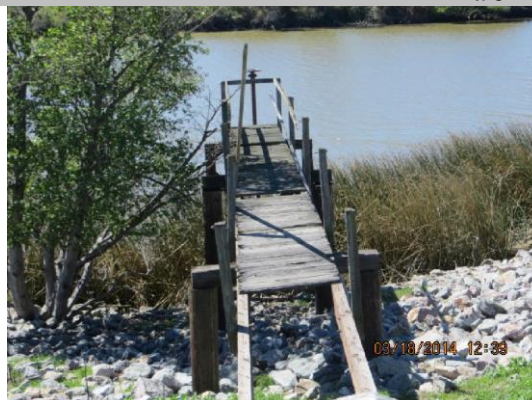
Photo 2 of 3 : UCIP_FA_2021_32290_58763.jpg

Delapidated wooden pier on WS shoulder.

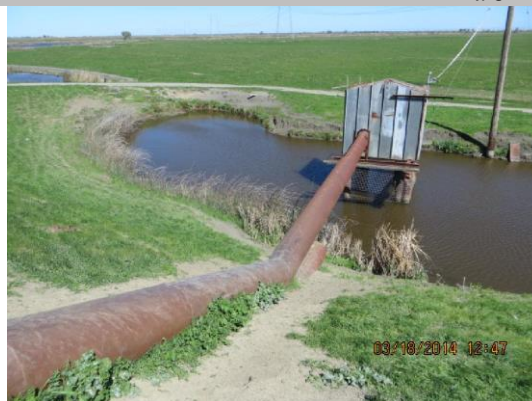
Photo 1 of 3 : UCIP_FA_2021_32303_58782.jpg

Pipe visible under new pipe on LS slope.

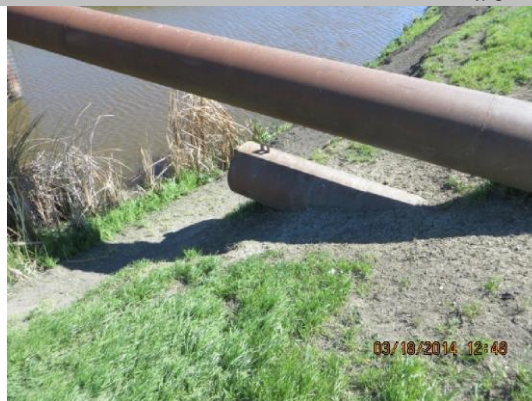
Photo 2 of 3 : UCIP_FA_2021_32303_58781.jpg

Pipe visible under new pipe on LS slope.

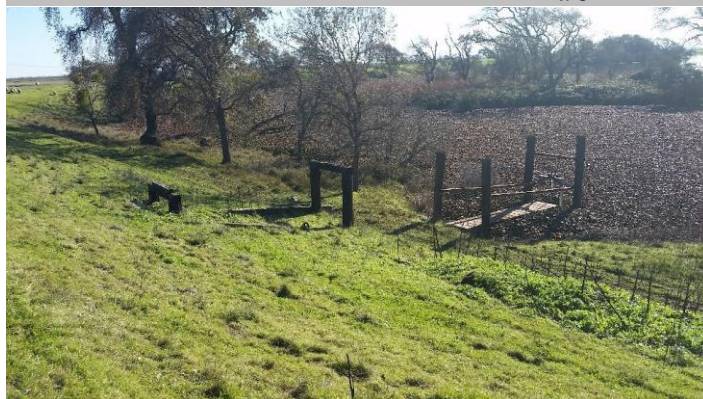
Photo 1 of 3 : UCIP_FA_2021_51453_76858.jpg

Walkway has been re-built, photo 1 of 2.

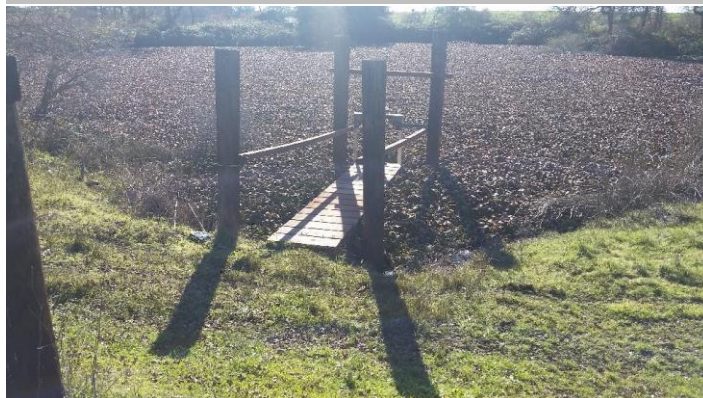
Photo 2 of 3 : UCIP_FA_2021_51453_76861.jpg

Walkway has been re-built, photo 2 of 2.

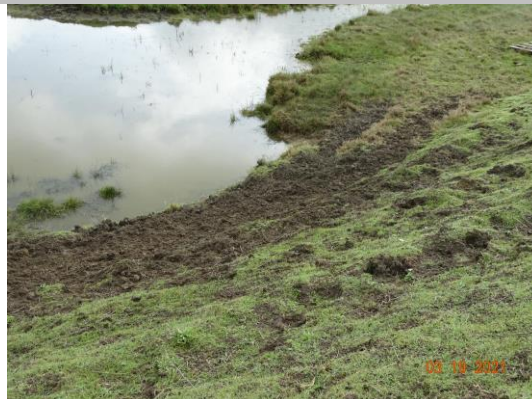
Photo 1 of 1 : FA_2021_RD2098_247_4_20210830_00001.jpg

View of slope terracing caused by cattle on the landside slope (Spring 2021).

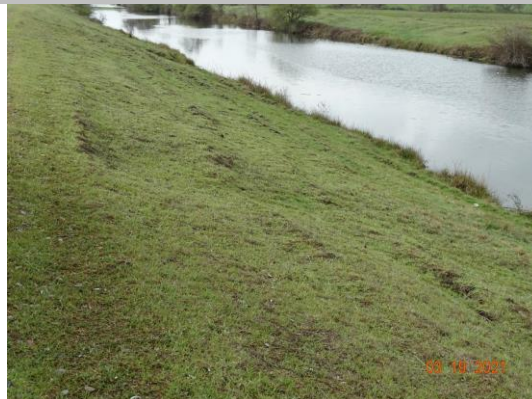
Photo 1 of 1 : FA_2021_RD2098_248_11_20210830_00003.jpg

View of terracing due to cows on the landside slope (Spring 2021).

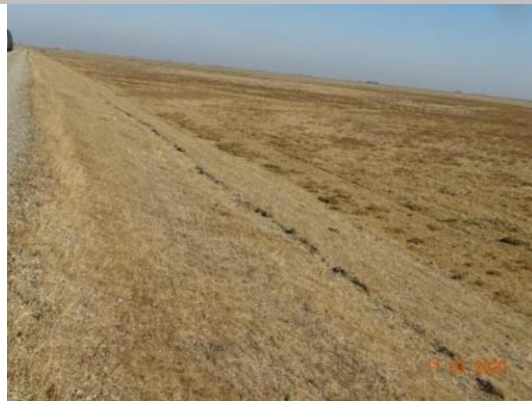
Photo 1 of 1 : FA_2021_RD2098_248_10_20210830_00002.jpg

View looking upstream at depressions in the landside slope due to cows (Fall 2020).

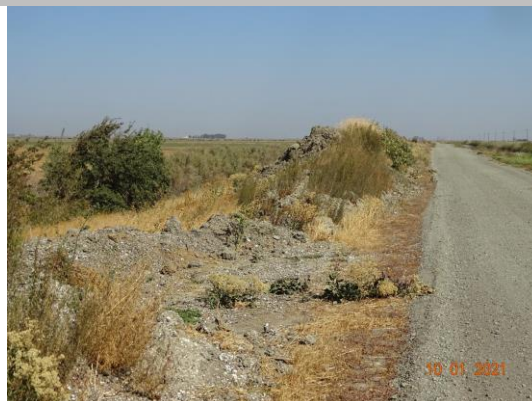
Photo 1 of 1 : FA_2021_RD2098_248_8_20211014_00022.jpg

View looking upstream at dredge materials on the waterside hinge (Fall 2021).

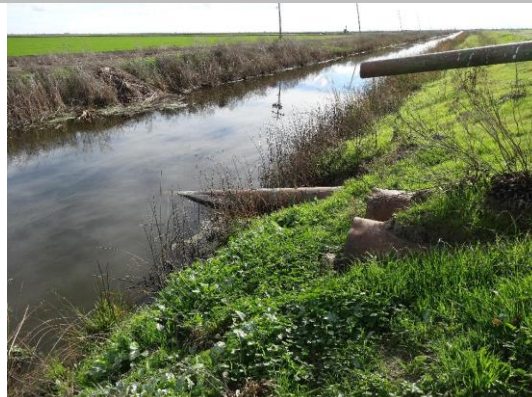
Photo 2 of 3 : UCIP_FA_2021_53382_76876.jpg

View of LS--damaged concrete distribution box has been removed.

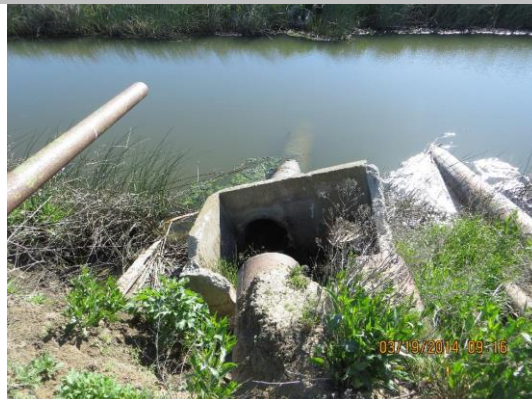
Photo 3 of 3 : UCIP_FA_2021_53382_58817.jpg

Concrete distribution box on LS slope has slipped into canal.

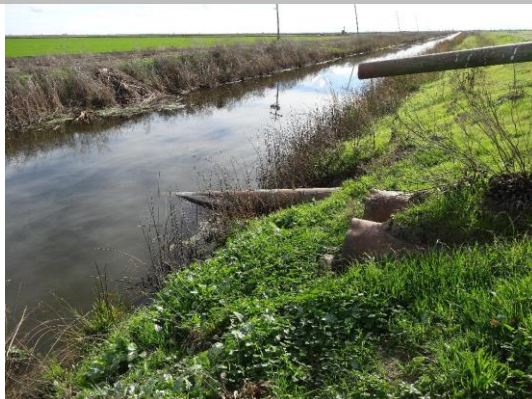
Photo 2 of 3 : UCIP_FA_2021_53383_76884.jpg

View of LS--damage distribution box noted in last inspection has been removed.

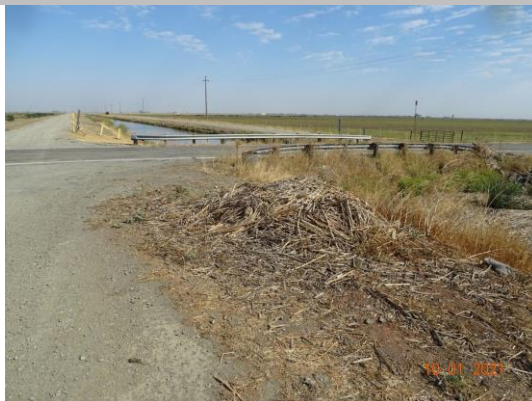
Photo 1 of 1 : FA_2021_RD2098_248_13_20211014_00023.jpg

View of cattails on the landside hinge (Fall 2021).
