Flood Control Project Maintenance Levee Inspections

Fall 2022 Levee Maintenance Deficiency Summary Report

Sacramento River Basin

Reclamation District No. 2098 Cache and Haas Slough

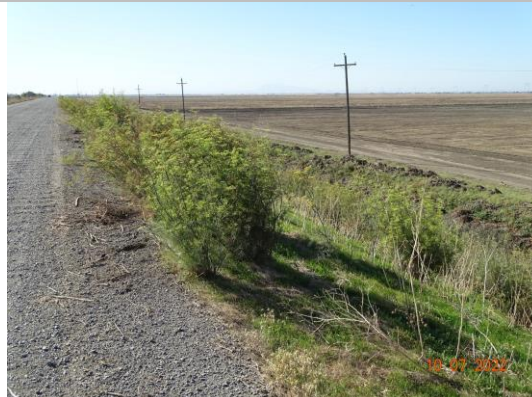
Photo 1 of 1 : FA_2022_RD2098_244_24_20221101_00013.jpg

View of the annual vegetation on the LS slope (Fall 2022).

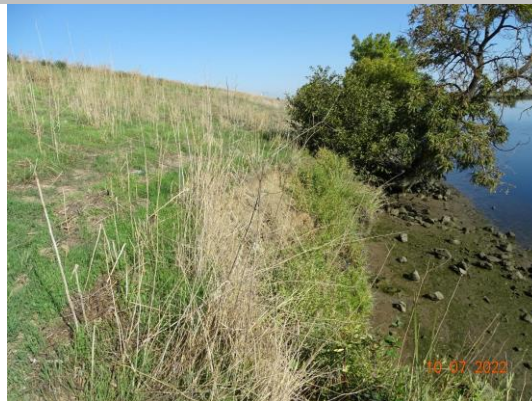
Photo 1 of 1 : FA_2022_RD2098_244_13_20221101_00014.jpg

LM Start	0.57	Rating **	M	Issue No.	13
LM End	1.06	Issue Type +	Ma	Location *	WS
Category	Earthen Levee			GPS Latitude/Longitude	
				Start	End
Item	Erosion / Bank Caving			38.320755 °	38.313700 °
				-121.693982 °	-121.693639 °
DWR ID	DWR_RD2098_01_s_2017_13				
Comment Code					
E2 : Schedule repair of erosion site prior to the next inspection.					
Inspector Comment					
There is erosion on the waterside slope. Several areas of pocket erosion on the bank are encroaching into the extended levee prism. There is some riprap protection on the lower slope in some areas.

View of the erosion on the WS bank (Fall 2022).

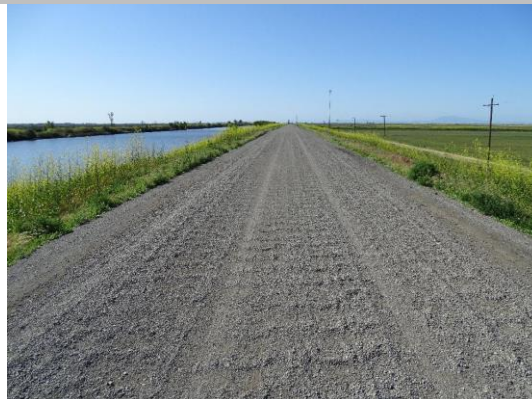
Photo 1 of 3 : UCIP_FA_2022_74264_111252.jpg

Comment Code						
Inspector Comment						
DS_ID:20997 FS_ID:74264 EP_NO: N/A Repair Type: Non-Urgent EVAL Issue: Crossing Status: Not Found UCIP Comments: 04/12/2022 Record remains Non-Urgent. Geophysical results did not confirm presence of pipe through levee. Record will remain in UCIP's inspection records until future Levee Improvement Project can confirm no crossing was found through the levee. System Feature. (D.Sanoski - DWR UCIP) FIELD_STRUCT_DESC: 42-inch drainage pipe of an unknown material through the levee, 21 feet below the crown. [Additional Reference(s): USACE Sacramento O&M Manual 109, April 1962, (HLM 0.69)]. FS Date: 4/12/2022 10:30:41 AM

View of levee crown.

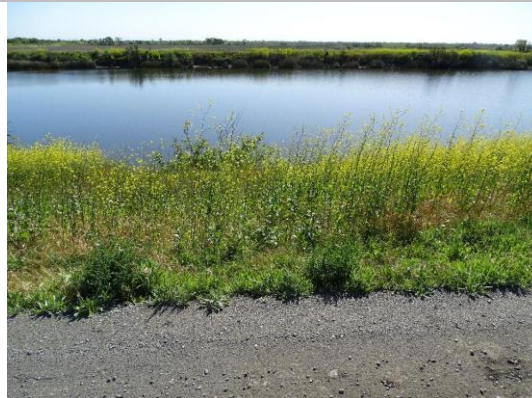
Photo 2 of 3 : UCIP_FA_2022_74264_111251.jpg

View of WS slope.

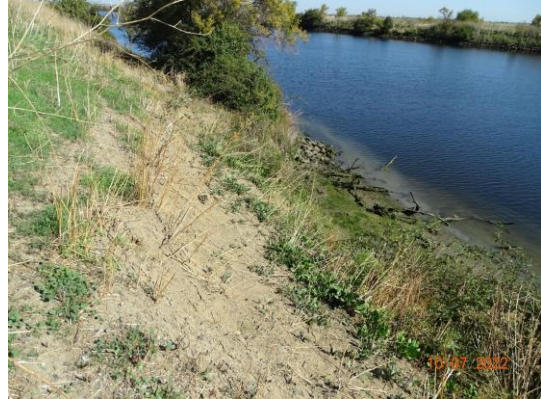
Photo 1 of 1 : FA_2022_RD2098_244_18_20221101_00017.jpg

LM Start	1.76	Rating **	M	Issue No.	18
LM End	1.76	Issue Type +	Ma	Location *	WS
Category	Earthen Levee			GPS Latitude/Longitude	
				Start	End
Item	Erosion / Bank Caving			38.303611 °	38.303611 °
				-121.693607 °	-121.693607 °
DWR ID	DWR_RD2098_01_s_2018_18				
Comment Code					
E2 : Schedule repair of erosion site prior to the next inspection.					
Inspector Comment					
There is erosion at the waterside toe.

View of the erosion on the WS toe (Fall 2022).

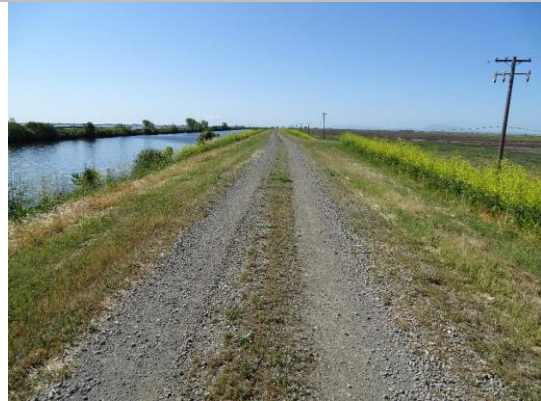
Photo 1 of 3 : UCIP_FA_2022_74544_111287.jpg

Comment Code						
Inspector Comment						
DS_ID:20965 FS_ID:74544 EP_NO: 10168 Repair Type: Non-Urgent EVAL Issue: 6, Levee Damage or Threat for Levee Damage Crossing Status: Found UCIP Comments: 04/12/2022 Record remains Non-Urgent. Threat for levee damage with same erosion under pipe at WS toe. System Feature. (D.Sanoski - DWR UCIP) 12/22/2016 Met with Mike Hadesty, LMA Superintendent, and Brian Bush, LMA General Manager, to go over the list of pipes in RD2098. Per LMA records, this pipe has a different owner. (O. Magana - DWR UCIP) 03/18/2014 Erosion under pipe at WS toe. (W. Wylie - DWR UCIP) FIELD_STRUCT_DESC: 10-inch steel drainage pipe through the levee, 2.8 feet below the crown. Pump in pump house off the landside (LS). (This pipe was retained under Automatic Board Order (ABO) issued as Permit No. 10168, 1974 - Moresco Brothers). [Additional Reference(s): DWR Levee Log, 2003. USACE Sacramento O&M Manual 109, April 1962, (HLM 1.80)]. FS Date: 4/12/2022 12:51:06 PM

View of levee crown.

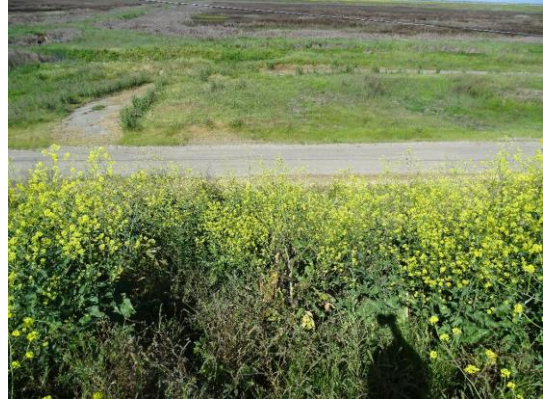
Photo 2 of 3 : UCIP_FA_2022_74544_111286.jpg

View of LS slope and no sign of pumphouse off toe.

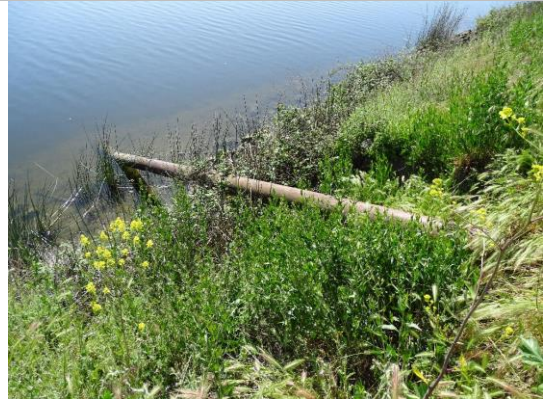
Photo 3 of 3 : UCIP_FA_2022_74544_111285.jpg

View of pipe out of WS slope with same erosion under pipe.

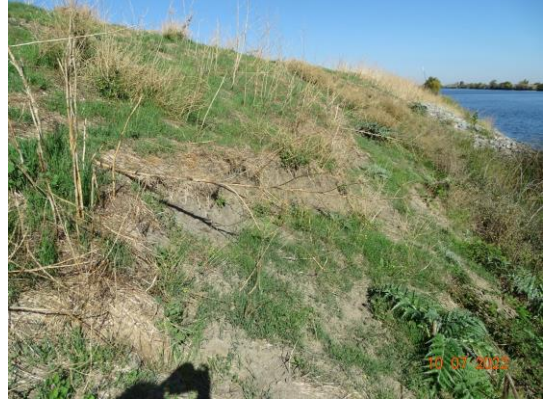
Photo 1 of 1 : FA_2022_RD2098_244_27_20221101_00018.jpg

LM Start	2.29	Rating **	U	Issue No.	27
LM End	2.32	Issue Type +	Ma	Location *	WS
Category	Earthen Levee			GPS Latitude/Longitude	
				Start	End
Item	Erosion / Bank Caving			38.295900 °	38.295468 °
				-121.693500 °	-121.693619 °
DWR ID	LMA-248				
Comment Code					
E2 : Schedule repair of erosion site prior to the next inspection.					
Inspector Comment					
This was a 2017 Storm Damage site. The damage consists of scour and sloughing of the waterside levee slope. Site ID No:421 Site Designation:LMA-248

View of the erosion on the WS slope (Fall 2022).

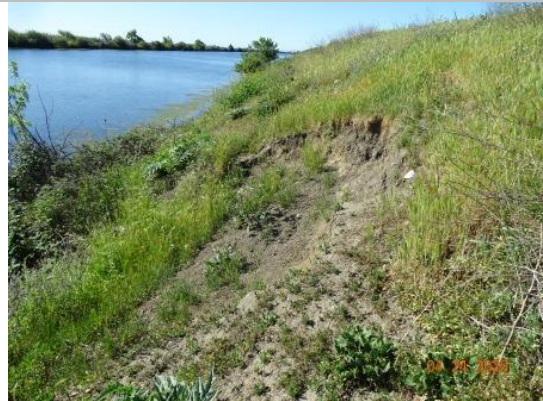
Photo 1 of 1 : FA_2022_RD2098_244_28_20220831_00006.jpg

LM Start	2.35	Rating **	U	Issue No.	28
LM End	2.39	Issue Type +	Ma	Location *	WS
Category	Earthen Levee			GPS Latitude/Longitude	
				Start	End
Item	Erosion / Bank Caving			38.295100 °	38.294500 °
				-121.693400 °	-121.693400 °
DWR ID	LMA-250				
Comment Code					
E2 : Schedule repair of erosion site prior to the next inspection.					
Inspector Comment					
This was a 2017 Storm Damage site. The damage consists of scour, sloughing, and cracking of the lower and mid waterside levee slope. Site ID No:423 Site Designation:LMA-250

View looking upstream at erosion into the waterside slope (Spring 2020).

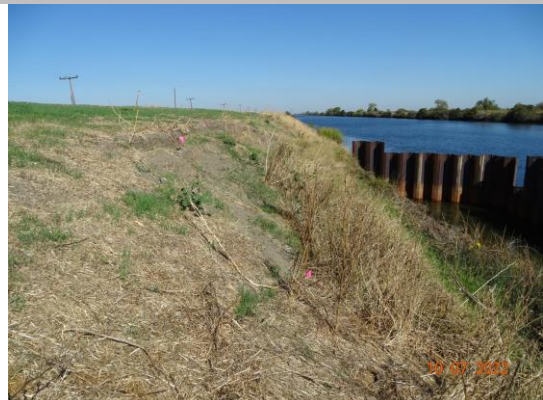
Photo 1 of 1 : FA_2022_RD2098_244_34_20221101_00019.jpg

LM Start	2.75	Rating **	U	Issue No.	34
LM End	2.81	Issue Type +	Ma	Location *	WS
Category	Earthen Levee			GPS Latitude/Longitude	
				Start	End
Item	Erosion / Bank Caving			38.289200 °	38.288405 °
				-121.693500 °	-121.693617 °
DWR ID	LMA-256				
Comment Code					
E2 : Schedule repair of erosion site prior to the next inspection.					
Inspector Comment					
Fall 2022: Site is pending repair. This was a 2017 Storm Damage site. The damage consists of scour and sloughing of the waterside levee slope.					
Site ID No:429 & 430					
Site Designation:LMA-256, LMA-257

View of the erosion on the WS slope (Fall 2022).

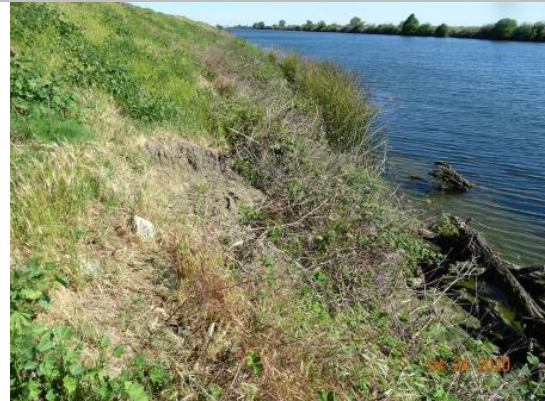
Photo 1 of 1 : FA_2022_RD2098_244_36_20220831_00008.jpg

LM Start	2.91	Rating **	U	Issue No.	36
LM End	2.93	Issue Type +	Ma	Location *	WS
Category	Earthen Levee		GPS Latitude/Longitude		
			Start	End	
Item	Erosion / Bank Caving		38.286900 °	38.286700 °	
			-121.693500 °	-121.693500 °	
DWR ID	LMA-258

This was a 2017 Storm Damage site.
The damage consists of scour and sloughing of the waterside levee slope.
Site ID No:431
Site Designation:LMA-258

View looking upstream at erosion into the waterside slope (Spring 2020).

E2 : Schedule repair of erosion site prior to the next inspection.

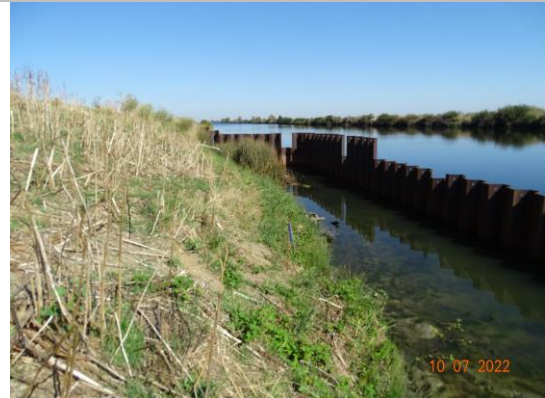
Photo 1 of 1 : FA_2022_RD2098_244_37_20221101_00020.jpg

LM Start	2.99	Rating **	M	Issue No.	37
LM End	3.29	Issue Type +	Ma	Location *	WS
Category	Earthen Levee		GPS Latitude/Longitude		
			Start	End	
Item	Erosion / Bank Caving		38.285700 °	38.281500 °	
			-121.693500 °	-121.694300 °	
DWR ID	LMA-259

Fall 2022: Site is pending repair. This was a 2017 Storm Damage site.
The damage consists of scour and sloughing of the waterside levee slope.
Site ID No:432
Site Designation:LMA-259

View of the erosion on the WS slope (Fall 2022).

E2 : Schedule repair of erosion site prior to the next inspection.

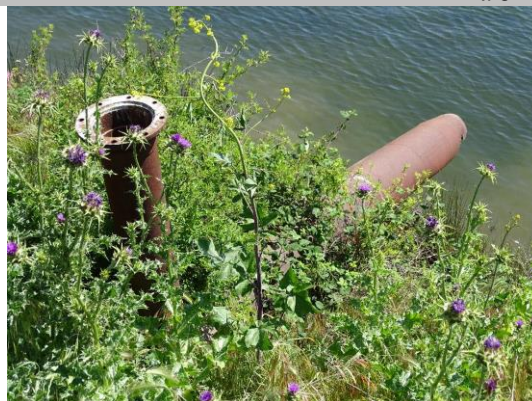
Photo 3 of 3 : UCIP_FA_2022_74562_111329.jpg

Comment Code					
Inspector Comment					
DS_ID:20969 FS_ID:74562 EP_NO: 13222 Repair Type: Non-Urgent EVAL Issue: 5, Pipe Damage Crossing Status: Found UCIP Comments: 04/12/2022 Record remains Non-Urgent. Pipe rusted out on WS slope at toe. (D.Sanoski - DWR UCIP) 03/18/2014 Pipe rusted through at outlet on WS slope, may indicate further degradation of pipe within levee. Good candidate for video inspection. (W. Wylie - DWR UCIP) FIELD_STRUCT_DESC: 20-inch steel drainage pipe through the levee, 7.5 feet below the crown. Siphon breaker on the waterside (WS) shoulder. Pump on pile structure in drainage ditch on the landside (LS). (This pipe was retained under Automatic Board Order (ABO) issued as Permit No. 10168, 1974 - Moresco Brothers. Pipe removed and replaced with a 19-inch steel pipe under the crown and along the LS slope under Permit No. 13222, 1981 - Prudential Insurance Company of America). [Additional Reference(s): DWR Levee Log, 2003. USACE Sacramento O&M Manual 109, April 1962, (HLM 2.98)]. FS Date: 4/12/2022 12:53:15 PM

View of pipe out of WS slope near toe.

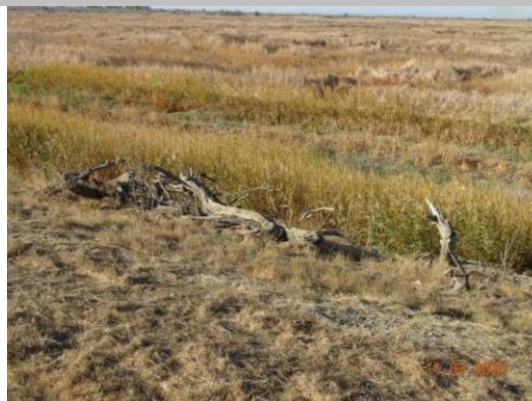
Photo 1 of 1 : FA_2022_RD2098_244_20_20220831_00004.jpg

LM Start	3.13	Rating **	M	Issue No.	20
LM End	3.13	Issue Type +	Ma	Location *	LS
Category	Earthen Levee			GPS Latitude/Longitude	
				Start	End
Item	Trim / Thin Trees			38.283800 °	38.283800 °
				-121.693618 °	-121.693618 °
DWR ID	DWR_RD2098_01_s_2020_20				
Comment Code					
T2 : Tree or limb.					
Inspector Comment

View of tree limb on the landside slope (Fall 2020).

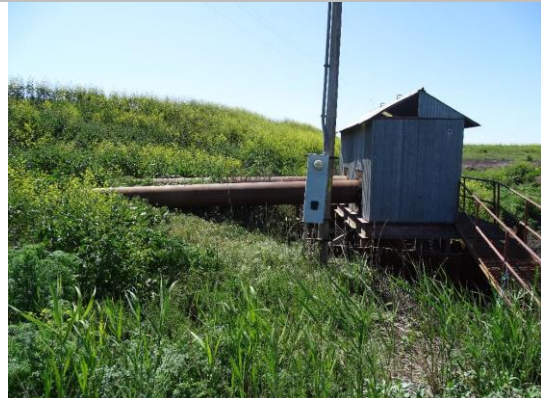
Photo 2 of 3 : UCIP_FA_2022_74573_111372.jpg

Comment Code					
Inspector Comment					
DS_ID:20959 FS_ID:74573 EP_NO: 15169 Repair Type: Non-Urgent EVAL Issue: 11, Maintenance Compliance Issue Crossing Status: Found UCIP Comments: 04/12/2022 Record remains Non-Urgent. Maintenance compliant issue with siphon breaker riser broken on WS shoulder. Otherwise, all good besides the overgrown vegetation, but looks like same conditions as last inspection. (D.Sanoski - DWR UCIP) 12/22/2016 Met with Mike Hadesty, LMA Superintendent, and Brian Bush, LMA General Manager, to go over the list of pipes in RD2098. Per LMA, pipe is a drainage pipe. New property owner is John Anderson. (O. Magana - DWR UCIP) 03/18/2014 Soil and debris buildup in steel riser on WS shoulder may prevent proper function of siphon breaker. (W. Wylie - DWR UCIP) FIELD_STRUCT_DESC: 2 of 2: 24-inch coated steel drainage pipe through the levee, 5.6 feet below the crown. Cutoff wall around the pipe at the center of the levee. Siphon breaker on the waterside (WS) shoulder. Flap gate on the WS end. Pump in pump house on piling structure on the landside (LS). (Permit No. 15169, 1989 - Maxim Development). [Additional Reference(s): DWR Levee Log, 2003]. FS Date: 4/12/2022 12:54:15 PM

View of pipe into pumphouse on LS toe.

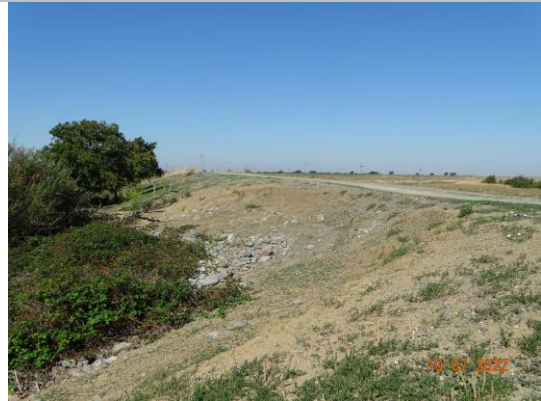
Photo 1 of 1 : FA_2022_RD2098_246_11_20221102_00009.jpg

LM Start	5.88	Rating **	U	Issue No.	11
LM End	5.88	Issue Type +	Ma	Location *	WS
Category	Earthen Levee			GPS Latitude/Longitude	
				Start	End
Item	Erosion / Bank Caving			38.282946 °	38.282946 °
				-121.710902 °	-121.710902 °
DWR ID	DWR_RD2098_02_f_2020_11				
Comment Code					
E2 : Schedule repair of erosion site prior to the next inspection.					
Inspector Comment					
This waterside slump site is not new, and is somewhat protected by riprap and thick brushy vegetation, but it has the potential to erode into crown during high water with a strong south wind. It currently has a two-foot vertical scarp at the levee shoulder.

View of the erosion on the WS slope (Fall 2022).

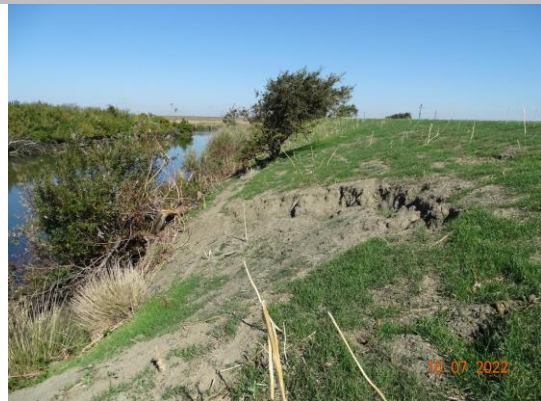
Photo 1 of 1 : FA_2022_RD2098_246_15_20221102_00010.jpg

LM Start	6.46	Rating **	U	Issue No.	15
LM End	6.48	Issue Type +	Ma	Location *	WS
Category	Earthen Levee			GPS Latitude/Longitude	
				Start	End
Item	Erosion / Bank Caving			38.288700 °	38.289061 °
				-121.717000 °	-121.716885 °
DWR ID	LMA-267				
Comment Code					
E2 : Schedule repair of erosion site prior to the next inspection.					
Inspector Comment					
This was a 2017 Storm Damage site. The damage consists of scour of the lower and mid waterside levee slope. Site ID No:440 & 441 Site Designation:LMA-267 & LMA-268

View of the erosion on the WS slope (Fall 2022).

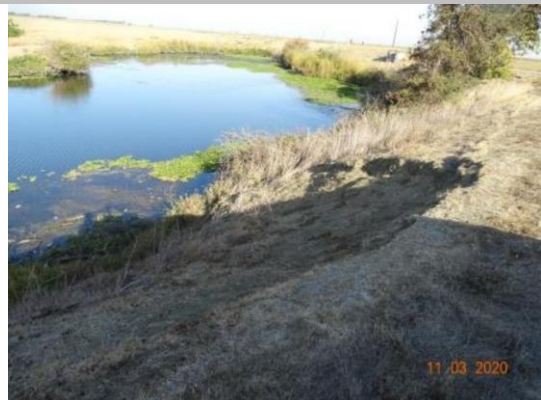
Photo 1 of 1 : FA_2022_RD2098_246_18_20220831_00006.jpg

LM Start	6.64	Rating **	U	Issue No.	18
LM End	6.65	Issue Type +	Ma	Location *	WS
Category	Earthen Levee			GPS Latitude/Longitude	
				Start	End
Item	Erosion / Bank Caving			38.291300 °	38.291400 °
				-121.716100 °	-121.716000 °
DWR ID	LMA-269				
Comment Code					
E2 : Schedule repair of erosion site prior to the next inspection.					
Inspector Comment					
This was a 2017 Storm Damage site. The damage consists of scour, cracking, instability, and sloughing of the waterside levee slope. Site ID No:442 Site Designation:LMA-269

View looking upstream at erosion into the waterside slope (Fall 2020).

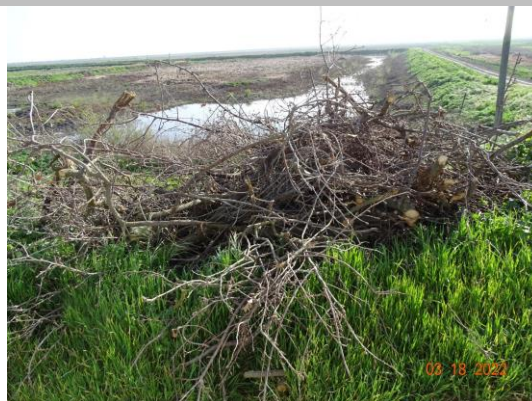
Photo 1 of 1 : FA_2022_RD2098_246_9_20220831_00001.jpg

View of cut up tree limbs on the landside shoulder (Spring 2022).

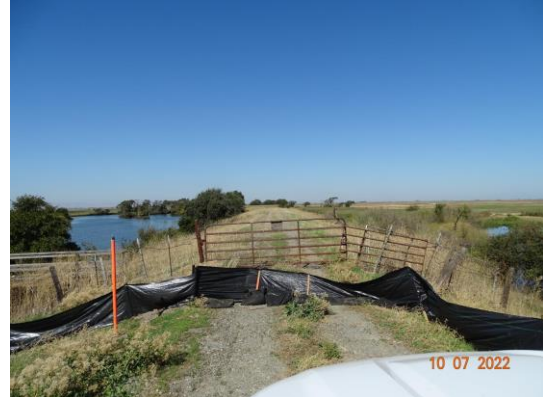
Photo 1 of 1 : FA_2022_RD2098_247_18_20221102_00006.jpg

View of levee section at LM 8.34 being blocked off due to ongoing construction activities in the entire area (Fall 2022).

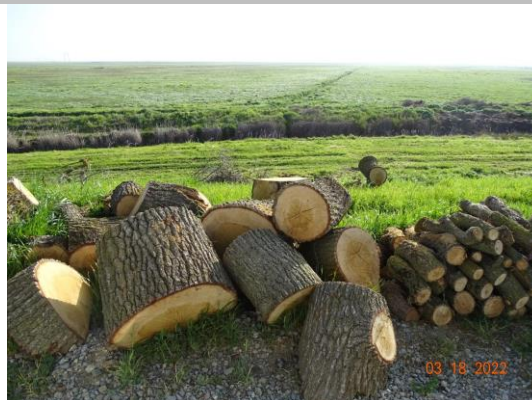
Photo 1 of 1 : FA_2022_RD2098_247_13_20220831_00005.jpg

View of cut up tree trunk and limbs on the landside shoulder (Spring 2022).

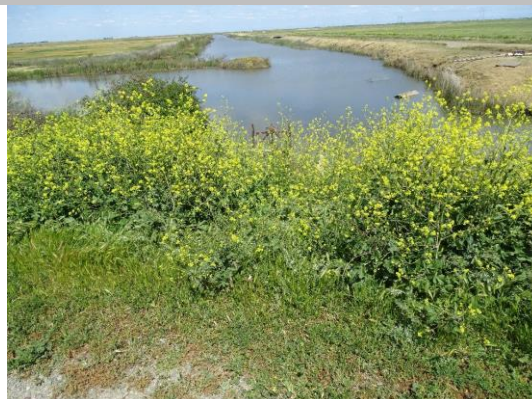
Photo 2 of 3 : UCIP_FA_2022_74612_111495.jpg

View of LS shoulder and overgrown slope.

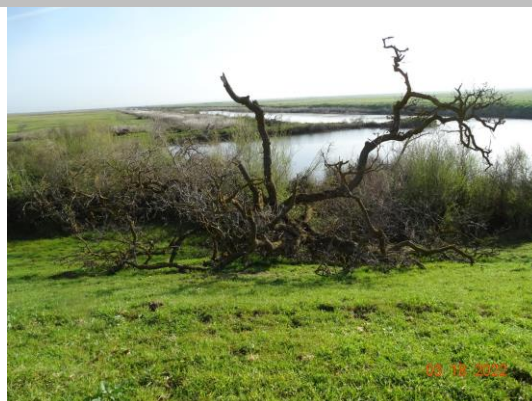
Photo 1 of 1 : FA_2022_RD2098_247_12_20220831_00004.jpg

View of down tree on the landside slope (Spring 2022).

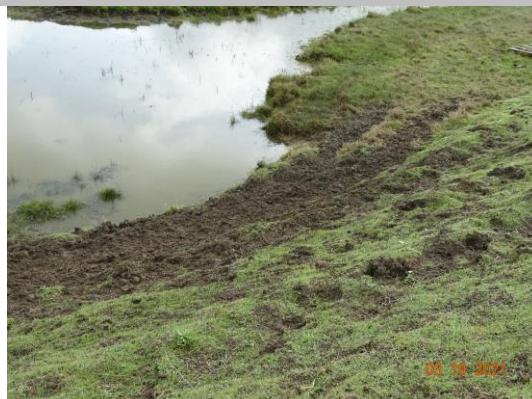
Photo 1 of 1 : FA_2022_RD2098_247_4_20220831_00001.jpg

View of slope terracing caused by cattle on the landside slope (Spring 2021).

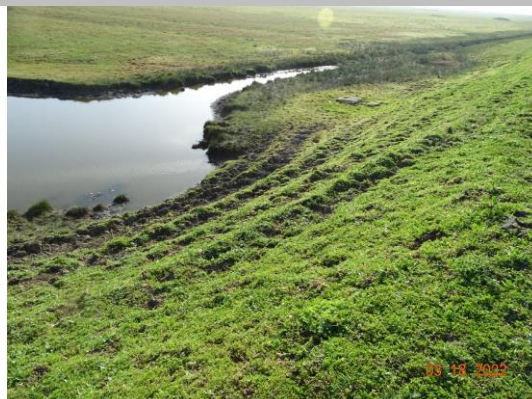
Photo 1 of 1 : FA_2022_RD2098_247_10_20220831_00003.jpg

View looking downstream erosion due to livestock into the landside slope (Spring 2022).

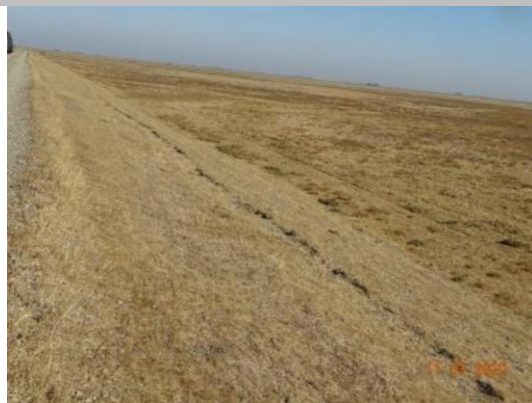
Photo 1 of 1 : FA_2022_RD2098_248_10_20220831_00002.jpg

View looking upstream at depressions in the landside slope due to cows (Fall 2020).

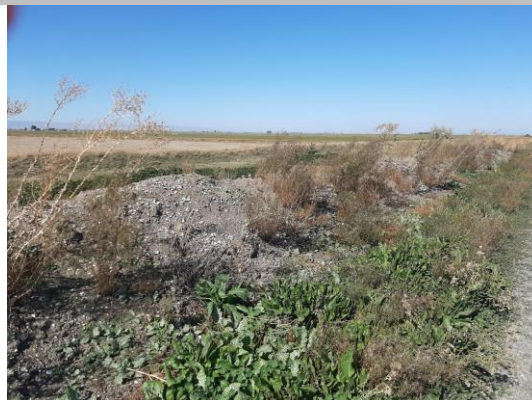
Photo 1 of 1 : FA_2022_RD2098_248_8_20221102_00007.jpg

View of the dredge material on the WS shoulder (Fall 2022).

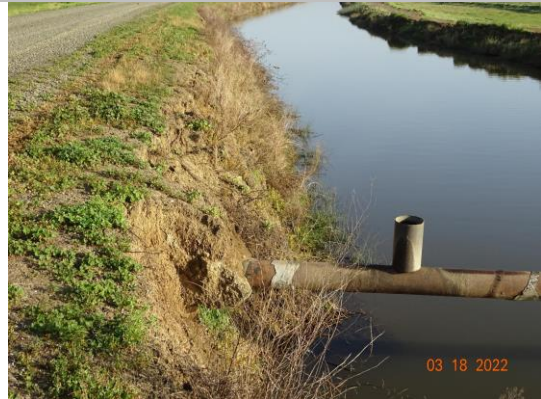
Photo 1 of 1 : FA_2022_RD2098_248_15_20220831_00006.jpg

View looking upstream at erosion into the landside slope (Spring 2022).

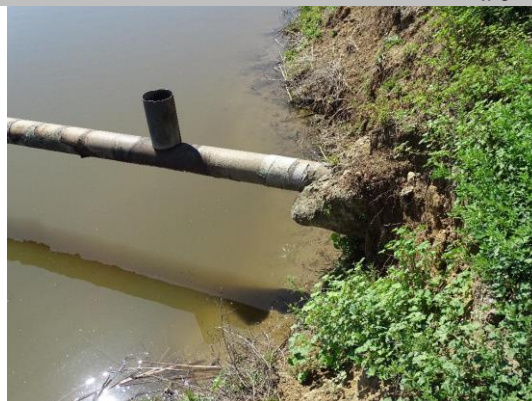
Photo 2 of 3 : UCIP_FA_2022_74679_111678.jpg

View of serious scour around pipe on LS slope.

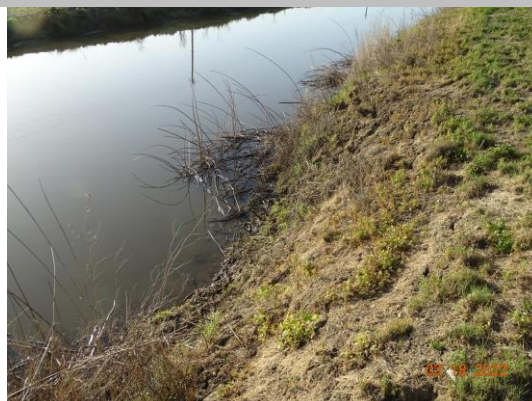
Photo 1 of 1 : FA_2022_RD2098_248_14_20220831_00005.jpg

View looking downstream at erosion into the landside slope (Spring 2022).
