Flood Control Project Maintenance Levee Inspections

Fall 2023 Levee Maintenance Deficiency Summary Report

Sacramento River Basin

Reclamation District No. 2098 Cache and Haas Slough

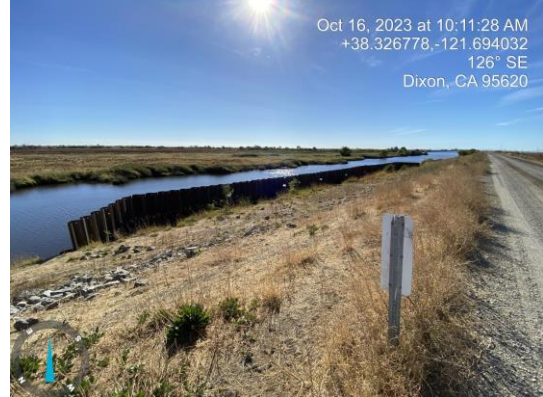
Photo 1 of 2 : FA_2023_RD2098_244_10_20231020_00029.jpg

LM Start	0.00	Rating **	A/W	Issue No.	10
LM End	3.60	Issue Type +	En	Location *	CR
Category	Earthen Levee			GPS Latitude/Longitude	
				Start	End
Item	Encroachments			38.329084°	38.277407°
				-121.694047°	-121.696281°
DWR ID	DWR_RD2098_01_s_ 2023_10				
Comment Code					
LC : Authorized Levee Construction					
Inspector Comment					
Unit 1 is part of the Lookout Slough Tidal Habitat Restoration and Flood Improvement Project (in progress). The levee will be breached in several locations and degraded. Existing maintenance issues in Unit 1 are rated A/W.

View of location that will be breached as part of the project (Fall 2023).

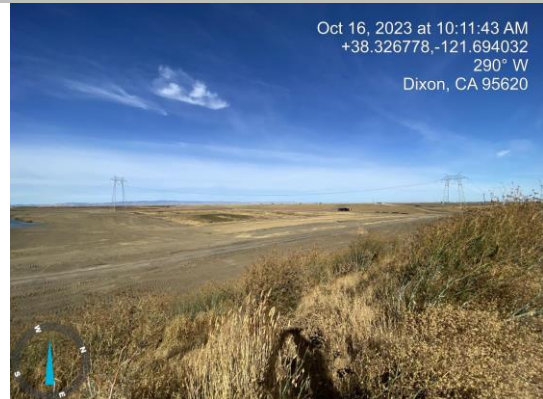
Photo 2 of 2 : FA_2023_RD2098_244_10_20231020_00030.jpg

View of construction of the new levees (Fall 2023).

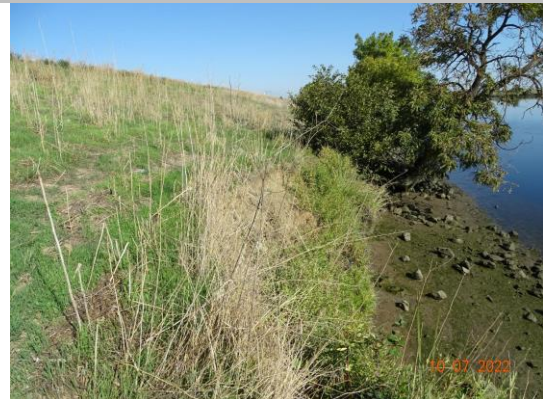
Photo 1 of 1 : FA_2023_RD2098_244_13_20231003_00002.jpg

LM Start	0.57	Rating **	A/W	Issue No.	13
LM End	1.06	Issue Type +	Ma	Location *	WS
Category	Earthen Levee			GPS Latitude/Longitude	
				Start	End
Item	Erosion / Bank Caving			38.320755°	38.313700°
				-121.693982°	-121.693639°
DWR ID	DWR_RD2098_01_s_ 2017_13				
Comment Code					
E2 : Schedule repair of erosion site prior to the next inspection.					
Inspector Comment					
There is erosion on the waterside slope. Several areas of pocket erosion on the bank are encroaching into the extended levee prism. There is some riprap protection on the lower slope in some areas. Spring 2023: Rated A/W due to ongoing habitat restoration and flood improvement project.

View of the erosion on the WS bank (Fall 2022).

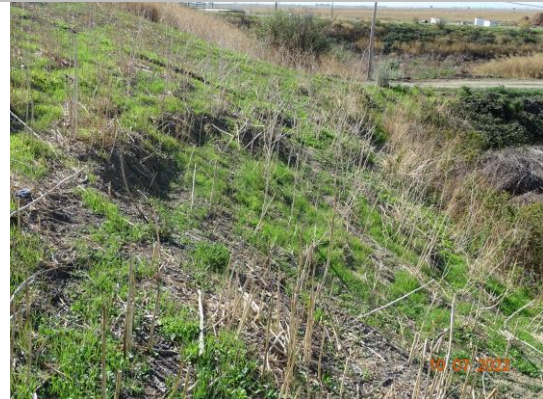
Photo 1 of 1 : FA_2023_RD2098_244_19_20231003_00004.jpg

LM Start	0.96	Rating **	A/W	Issue No.	19
LM End	0.96	Issue Type +	Ma	Location *	LS
Category	Earthen Levee			GPS Latitude/Longitude	
				Start	End
Item	Erosion / Bank Caving			38.315200°	38.315100°
				-121.694100°	-121.694100°
DWR ID	DWR_RD2098_01_s_2021_19				
Comment Code					
E1 : Note and monitor erosion site.					
Inspector Comment					
This was a 2017 Storm Damage site. The damage consists of cracking and sloughing of the lower landside levee slope.					
Site ID No:414					
Site Designation:LMA-241 Spring 2023: Rated A/W due to ongoing habitat restoration and flood improvement project.

View of the sloughing/caving on the LS slope (Fall 2022).

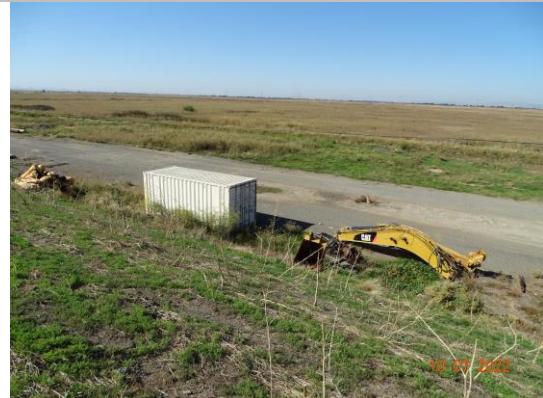
Photo 1 of 1 : FA_2023_RD2098_244_12_20231003_00001.jpg

LM Start	1.66	Rating **	A/W	Issue No.	12
LM End	1.72	Issue Type +	En	Location *	LS
Category	Earthen Levee			GPS Latitude/Longitude	
				Start	End
Item	Encroachments			38.305059 °	38.304209 °
				-121.693631 °	-121.693997 °
DWR ID	DWR_RD2098_01_f_2021_12				
Comment Code					
MA : Material					
Inspector Comment					
There is additional material and equipment on the LS toe. Spring 2023: Rated A/W due to ongoing habitat restoration and flood improvement project.

View of material and equipment on the LS toe (Fall 2022).

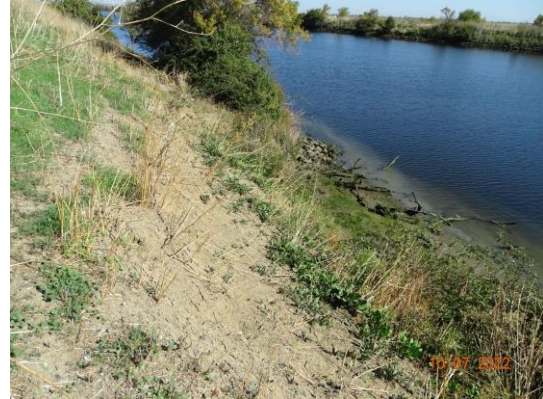
Photo 1 of 1 : FA_2023_RD2098_244_18_20231003_00003.jpg

LM Start	1.76	Rating **	A/W	Issue No.	18
LM End	1.76	Issue Type +	Ma	Location *	WS
Category	Earthen Levee			GPS Latitude/Longitude	
				Start	End
Item	Erosion / Bank Caving			38.303611°	38.303611°
				-121.693607°	-121.693607°
DWR ID	DWR_RD2098_01_s_2018_18				
Comment Code					
E2 : Schedule repair of erosion site prior to the next inspection.					
Inspector Comment					
There is erosion at the waterside toe. Spring 2023: Rated A/W due to ongoing habitat restoration and flood improvement project.

View of the erosion on the WS toe (Fall 2022).

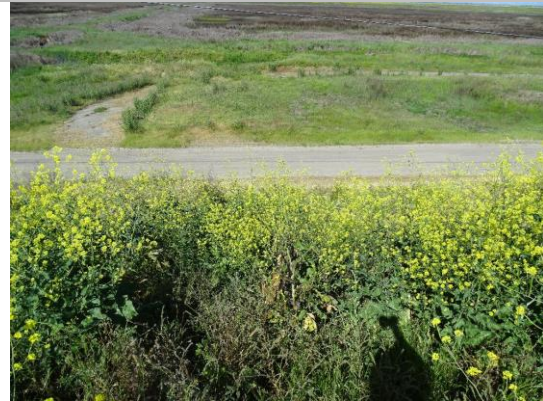
Photo 2 of 3 : UCIP_FA_2023_74544_111286.jpg

View of LS slope and no sign of pumphouse off toe.

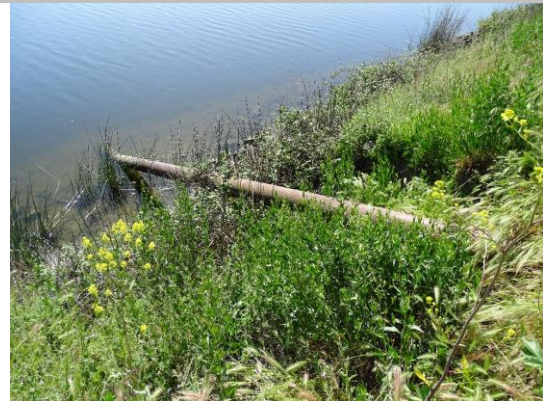
Photo 3 of 3 : UCIP_FA_2023_74544_111285.jpg

Comment Code						
Inspector Comment						
DS_ID:20965 FS_ID:74544 EP_NO: 10168 Repair Type: Non-Urgent EVAL Issue: 6, Levee Damage or Threat for Levee Damage Crossing Status: Found UCIP Comments: 04/12/2022 Record remains Non-Urgent. Threat for levee damage with same erosion under pipe at WS toe. System Feature. (D.Sanoski - DWR UCIP) 12/22/2016 Met with Mike Hadesty, LMA Superintendent, and Brian Bush, LMA General Manager, to go over the list of pipes in RD2098. Per LMA records, this pipe has a different owner. (O. Magana - DWR UCIP) 03/18/2014 Erosion under pipe at WS toe. (W. Wylie - DWR UCIP) FIELD_STRUCT_DESC: 10-inch steel drainage pipe through the levee, 2.8 feet below the crown. Pump in pump house off the landside (LS). (This pipe was retained under Automatic Board Order (ABO) issued as Permit No. 10168, 1974 - Moresco Brothers). [Additional Reference(s): DWR Levee Log, 2003. USACE Sacramento O&M Manual 109, April 1962, (HLM 1.80)]. FS Date: 4/12/2022 12:51:06 PM

View of pipe out of WS slope with same erosion under pipe.

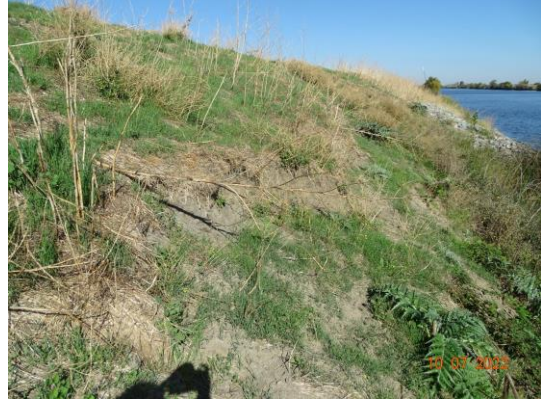
Photo 1 of 1 : FA_2023_RD2098_244_27_20231003_00006.jpg

LM Start	2.29	Rating **	A/W	Issue No.	27
LM End	2.32	Issue Type +	Ma	Location *	WS
Category	Earthen Levee			GPS Latitude/Longitude	
				Start	End
Item	Erosion / Bank Caving			38.295900°	38.295468°
				-121.693500°	-121.693619°
DWR ID	LMA-248				
Comment Code					
E2 : Schedule repair of erosion site prior to the next inspection.					
Inspector Comment					
This was a 2017 Storm Damage site. The damage consists of scour and sloughing of the waterside levee slope. Site ID No:421 Site Designation:LMA-248 Spring 2023: Rated A/W due to ongoing habitat restoration and flood improvement project.

View of the erosion on the WS slope (Fall 2022).

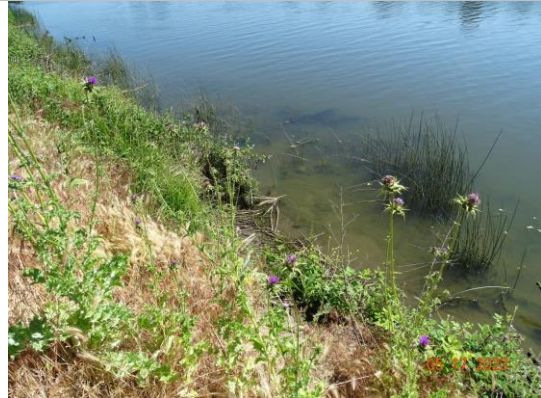
Photo 1 of 1 : FA_2023_RD2098_244_28_20231003_00007.jpg

LM Start	2.35	Rating **	A/W	Issue No.	28
LM End	2.39	Issue Type +	Ma	Location *	WS
Category	Earthen Levee			GPS Latitude/Longitude	
				Start	End
Item	Erosion / Bank Caving			38.295100 °	38.294500 °
				-121.693400 °	-121.693400 °
DWR ID	LMA-250				
Comment Code					
E2 : Schedule repair of erosion site prior to the next inspection.					
Inspector Comment					
This was a 2017 Storm Damage site. The damage consists of scour, sloughing, and cracking of the lower and mid waterside levee slope. Site ID No:423 Site Designation:LMA-250 Spring 2023: Rated A/W due to ongoing habitat restoration and flood improvement project.

View of the erosion on the WS slope (Spring 2023).

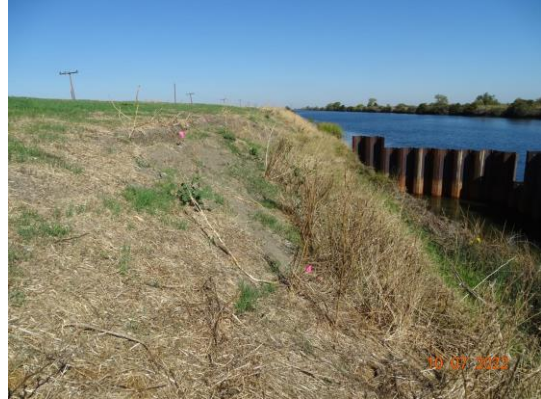
Photo 1 of 1 : FA_2023_RD2098_244_34_20231003_00008.jpg

LM Start	2.75	Rating **	A/W	Issue No.	34
LM End	2.81	Issue Type +	Ma	Location *	WS
Category	Earthen Levee			GPS Latitude/Longitude	
				Start	End
Item	Erosion / Bank Caving			38.289200°	38.288405°
				-121.693500°	-121.693617°
DWR ID	LMA-256				
Comment Code					
E2 : Schedule repair of erosion site prior to the next inspection.					
Inspector Comment					
Fall 2022: Site is pending repair. This was a 2017 Storm Damage site. The damage consists of scour and sloughing of the waterside levee slope.					
Site ID No:429 & 430					
Site Designation:LMA-256, LMA-257 Spring 2023: Rated A/W due to ongoing habitat restoration and flood improvement project.

View of the erosion on the WS slope (Fall 2022).

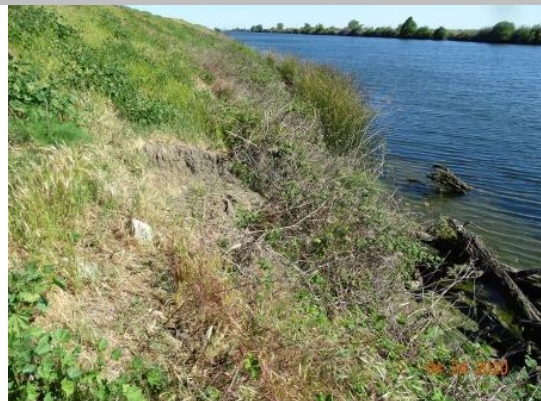
Photo 1 of 1 : FA_2023_RD2098_244_36_20231003_00009.jpg

View looking upstream at erosion into the waterside slope (Spring 2020).

Comment Code					
E2 : Schedule repair of erosion site prior to the next inspection.					
Inspector Comment					
This was a 2017 Storm Damage site. The damage consists of scour and sloughing of the waterside levee slope. Site ID No:431 Site Designation:LMA-258 Spring 2023: Rated A/W due to ongoing habitat restoration and flood improvement project.

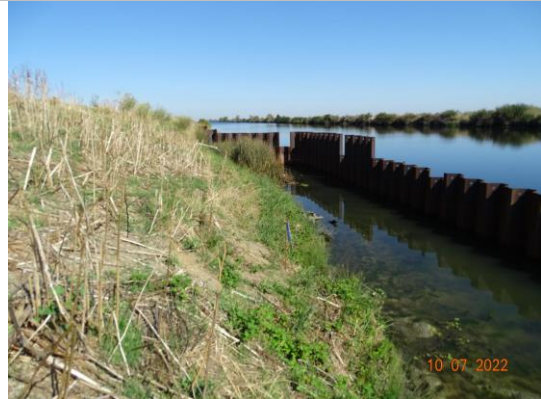
Photo 1 of 1 : FA_2023_RD2098_244_37_20231003_00010.jpg

LM Start	2.99	Rating **	A/W	Issue No.	37
LM End	3.29	Issue Type +	Ma	Location *	WS
Category	Earthen Levee			GPS Latitude/Longitude	
				Start	End
Item	Erosion / Bank Caving			38.285700°	38.281500°
				-121.693500°	-121.694300°
DWR ID	LMA-259				
Comment Code					
E2 : Schedule repair of erosion site prior to the next inspection.					
Inspector Comment					
Fall 2022: Site is pending repair. This was a 2017 Storm Damage site. The damage consists of scour and sloughing of the waterside levee slope.					
Site ID No:432					
Site Designation:LMA-259 Spring 2023: Rated A/W due to ongoing habitat restoration and flood improvement project.

View of the erosion on the WS slope (Fall 2022).

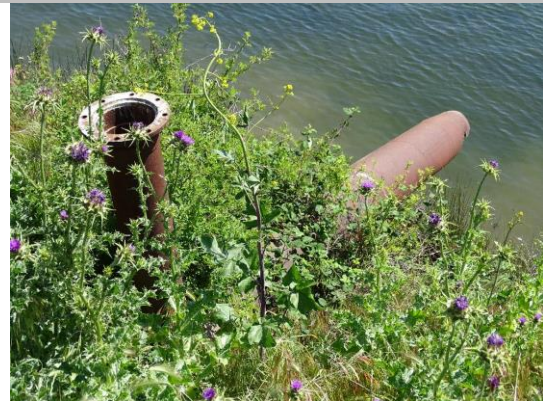
Photo 3 of 3 : UCIP_FA_2023_74562_111329.jpg

Comment Code					
Inspector Comment					
DS_ID:20969 FS_ID:74562 EP_NO: 13222 Repair Type: Non-Urgent EVAL Issue: 5, Pipe Damage Crossing Status: Found UCIP Comments: 04/12/2022 Record remains Non-Urgent. Pipe rusted out on WS slope at toe. (D.Sanoski - DWR UCIP) 03/18/2014 Pipe rusted through at outlet on WS slope, may indicate further degradation of pipe within levee. Good candidate for video inspection. (W. Wylie - DWR UCIP) FIELD_STRUCT_DESC: 20-inch steel drainage pipe through the levee, 7.5 feet below the crown. Siphon breaker on the waterside (WS) shoulder. Pump on pile structure in drainage ditch on the landside (LS). (This pipe was retained under Automatic Board Order (ABO) issued as Permit No. 10168, 1974 - Moresco Brothers. Pipe removed and replaced with a 19-inch steel pipe under the crown and along the LS slope under Permit No. 13222, 1981 - Prudential Insurance Company of America). [Additional Reference(s): DWR Levee Log, 2003. USACE Sacramento O&M Manual 109, April 1962, (HLM 2.98)]. FS Date: 4/12/2022 12:53:15 PM

View of pipe out of WS slope near toe.

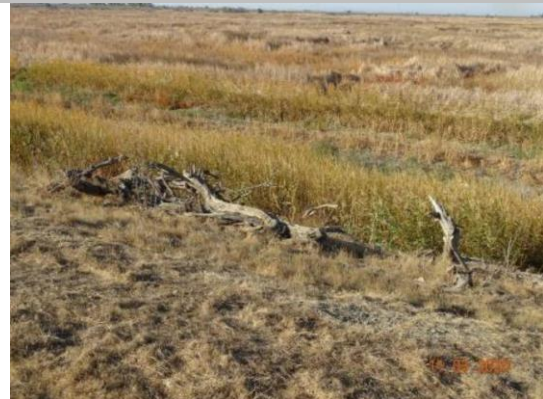
Photo 1 of 1 : FA_2023_RD2098_244_20_20231003_00005.jpg

View of tree limb on the landside slope (Fall 2020).

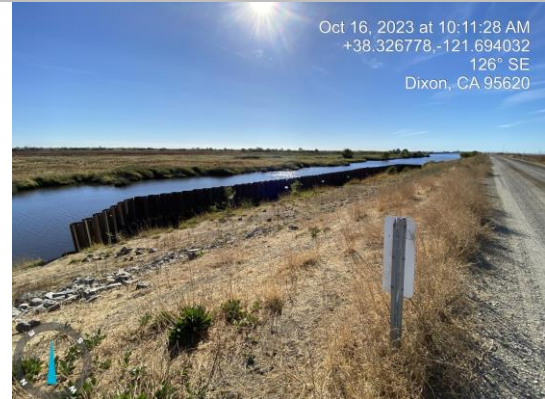
Photo 1 of 1 : FA_2023_RD2098_245_2_20231102_00001.jpg

LM Start	0.00	Rating **	A/W	Issue No.	2
LM End	0.53	Issue Type +	En	Location *	CR
Category	Earthen Levee			GPS Latitude/Longitude	
				Start	End
Item	Encroachments			38.277410°	38.275707°
				-121.696280°	-121.705705°
DWR ID	DWR_RD2098_01A_s _ 2023_2				
Comment Code					
LC : Authorized Levee Construction					
Inspector Comment					
Unit 1A is part of the Lookout Slough Tidal Habitat Restoration and Flood Improvement Project (in progress) and will be degraded.

View of construction area on Unit 1 that extends through Unit 1A (Fall 2023).

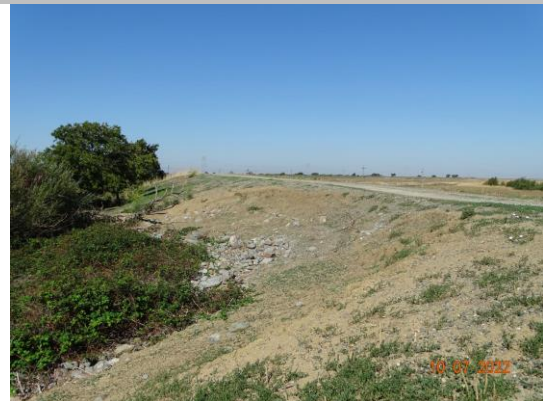
Photo 1 of 1 : FA_2023_RD2098_246_11_20231003_00002.jpg

LM Start	5.88	Rating **	A/W	Issue No.	11
LM End	5.88	Issue Type +	Ma	Location *	WS
Category	Earthen Levee			GPS Latitude/Longitude	
				Start	End
Item	Erosion / Bank Caving			38.282946°	38.282946°
				-121.710902°	-121.710902°
DWR ID	DWR_RD2098_02_f_2020_11				
Comment Code					
E2 : Schedule repair of erosion site prior to the next inspection.					
Inspector Comment					
This waterside slump site is not new, and is somewhat protected by riprap and thick brushy vegetation, but it has the potential to erode into crown during high water with a strong south wind. It currently has a two-foot vertical scarp at the levee shoulder. Spring 2023: Rated A/W due to ongoing habitat restoration and flood improvement project.

View of the erosion on the WS slope (Fall 2022).

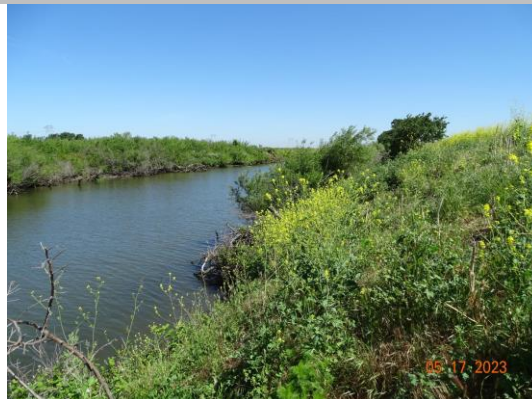
Photo 1 of 1 : FA_2023_RD2098_246_15_20231003_00003.jpg

View of the erosion on the WS (Spring 2023).

E2 : Schedule repair of erosion site prior to the next inspection.

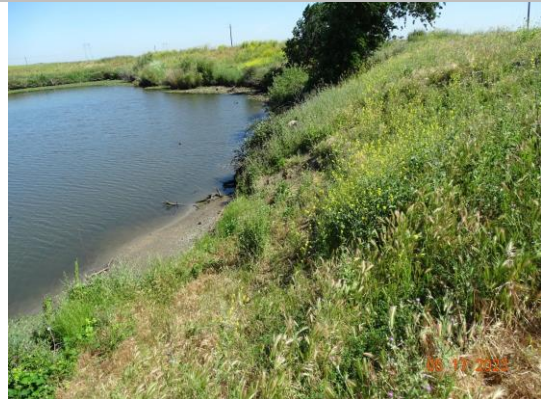
Photo 1 of 1 : FA_2023_RD2098_246_18_20231003_00004.jpg

View of the erosion on the WS (Spring 2023).

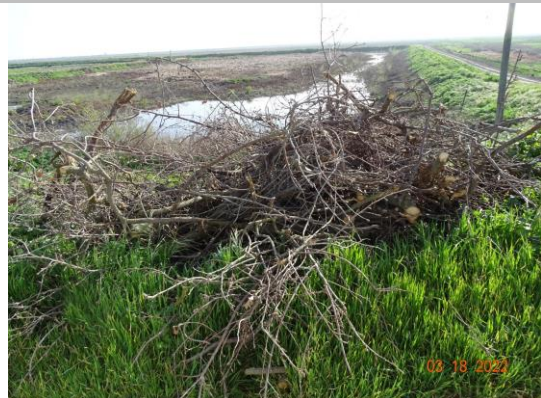
Photo 1 of 1 : FA_2023_RD2098_246_9_20231003_00001.jpg

View of cut up tree limbs on the landside shoulder (Spring 2022).

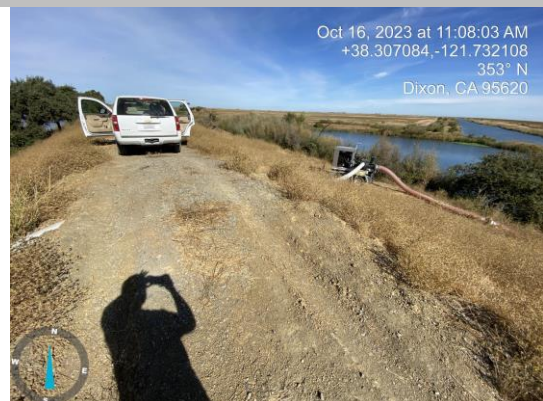
Photo 1 of 1 : FA_2023_RD2098_247_5_20231020_00010.jpg

View of pipe crossing the levee crown (Fall 2023).

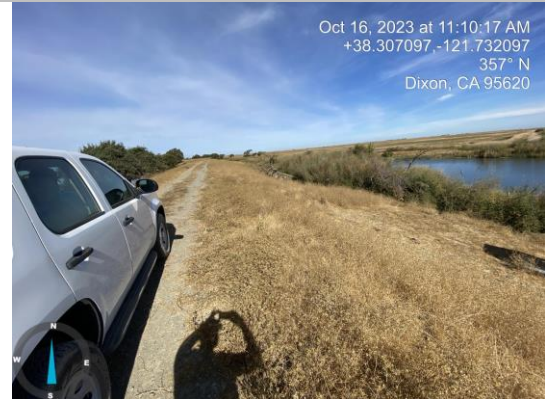
Photo 1 of 1 : FA_2023_RD2098_247_10_20231020_00011.jpg

View of vegetation on landside slope (Fall 2023).

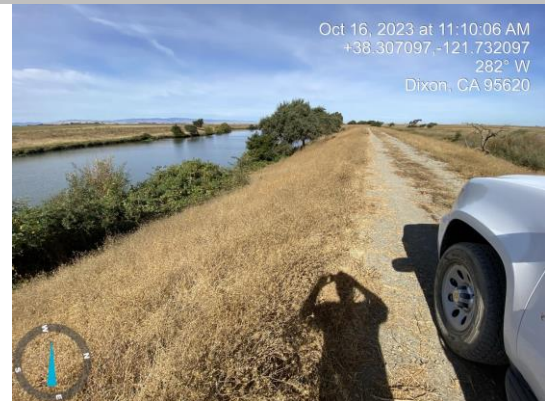
Photo 1 of 1 : FA_2023_RD2098_247_8_20231020_00012.jpg

View of vegetation on waterside slope (Fall 2023).

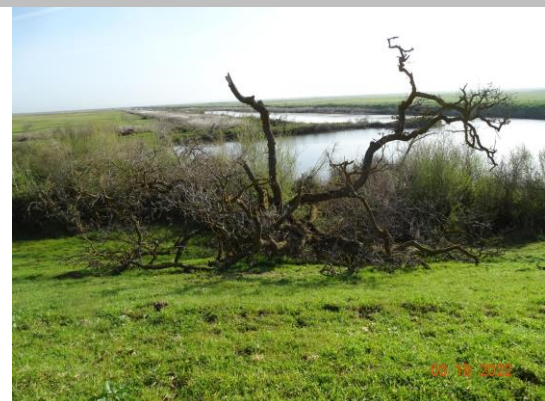
Photo 1 of 1 : FA_2023_RD2098_247_12_20231003_00003.jpg

View of down tree on the landside slope (Spring 2022).

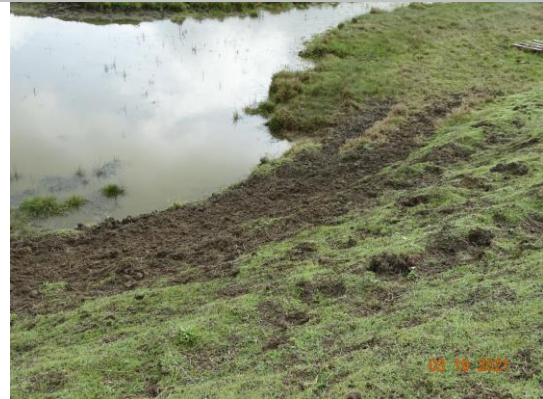
Photo 1 of 1 : FA_2023_RD2098_247_4_20231003_00001.jpg

View of slope terracing caused by cattle on the landside slope (Spring 2021).

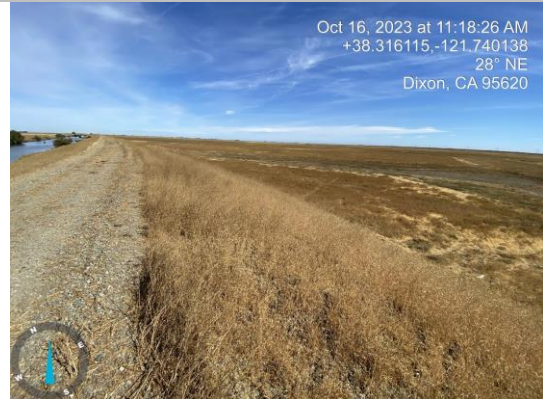
Photo 1 of 1 : FA_2023_RD2098_248_6_20231020_00019.jpg

View of vegetation on landside slope (Fall 2023).

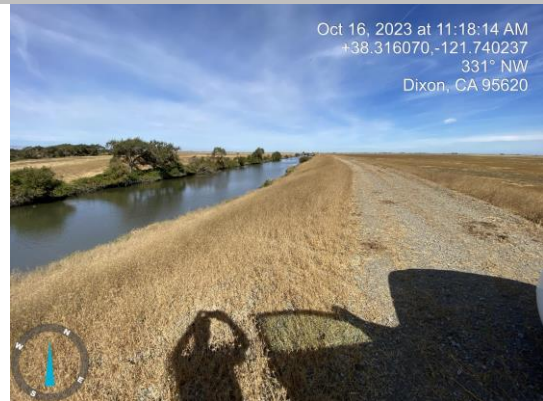
Photo 1 of 1 : FA_2023_RD2098_248_5_20231020_00018.jpg

View of vegetation on waterside slope (Fall 2023).

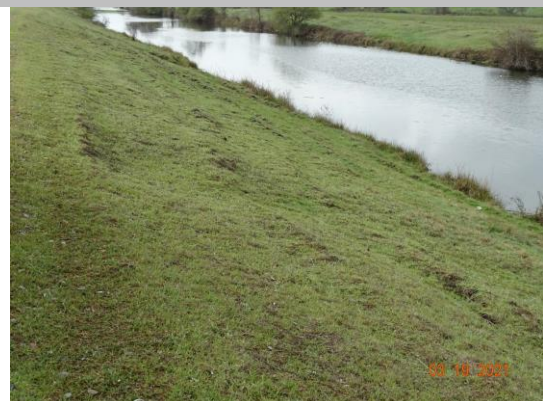
Photo 1 of 1 : FA_2023_RD2098_248_11_20231003_00003.jpg

View of terracing due to cows on the landside slope (Spring 2021).

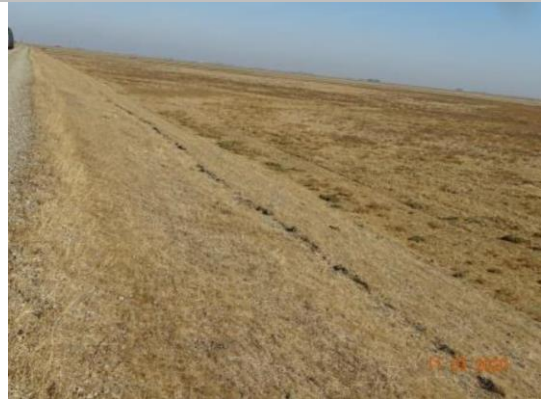
Photo 1 of 1 : FA_2023_RD2098_248_10_20231003_00002.jpg

View looking upstream at depressions in the landside slope due to cows (Fall 2020).

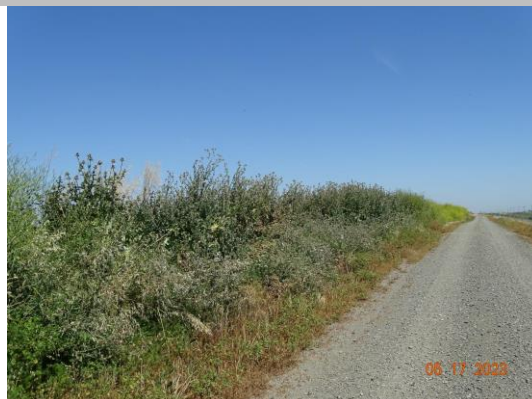
Photo 1 of 1 : FA_2023_RD2098_248_8_20231003_00001.jpg

View of the overgrown dredge material on the WS shoulder (Spring 2023).

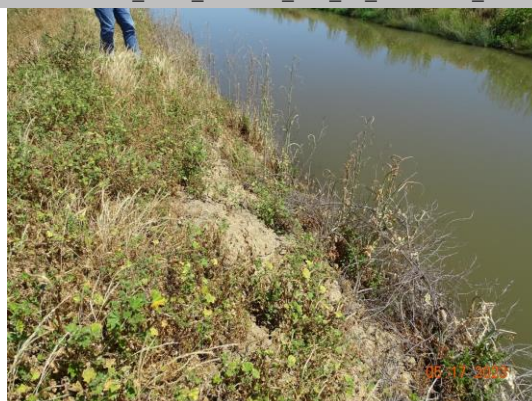
Photo 1 of 1 : FA_2023_RD2098_248_15_20231003_00005.jpg

View of the erosion on the LS (Spring 2023).

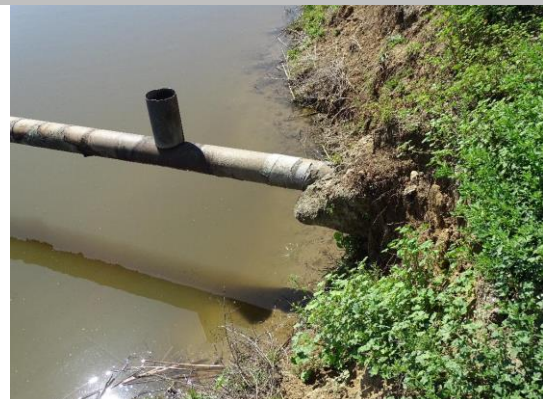
Photo 2 of 3 : UCIP_FA_2023_74679_111678.jpg

View of serious scour around pipe on LS slope.

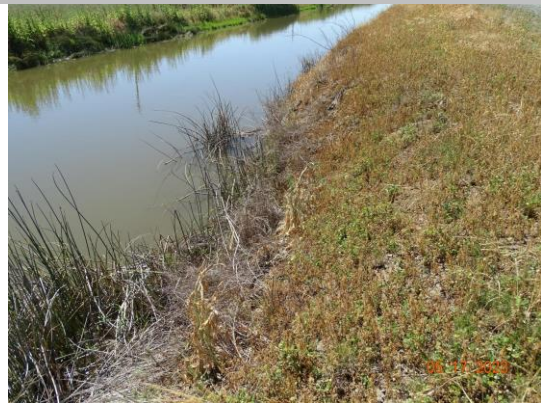
Photo 1 of 1 : FA_2023_RD2098_248_14_20231003_00004.jpg

View of the erosion on the LS (Spring 2023).

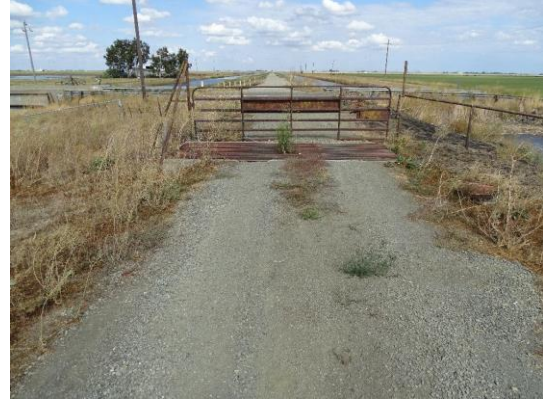
Photo 1 of 3 : UCIP_FA_2023_74696_78546.jpg

Crown view - looks in good condition.

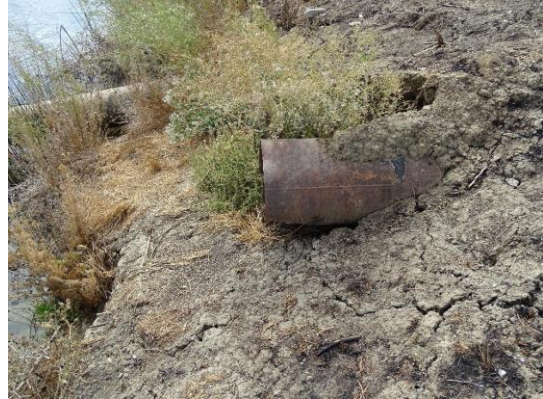
Photo 2 of 3 : UCIP_FA_2023_74696_78547.jpg

LS view - erosion around bottom of pipe.

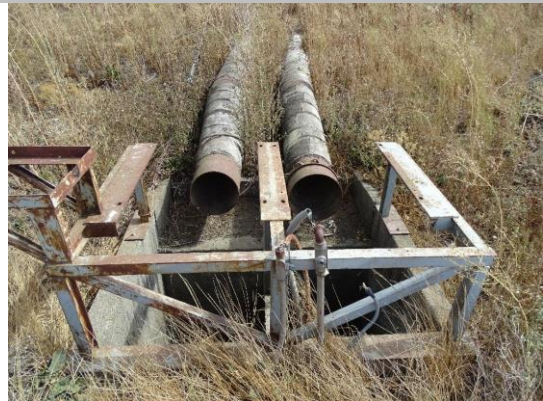
Photo 3 of 3 : UCIP_FA_2023_74696_78548.jpg

WS view - looks in good condition.
