Flood Control Project Maintenance Levee Inspections

Fall 2024 Levee Maintenance Deficiency Summary Report

Reclamation District No. 2098 Cache and Haas Slough

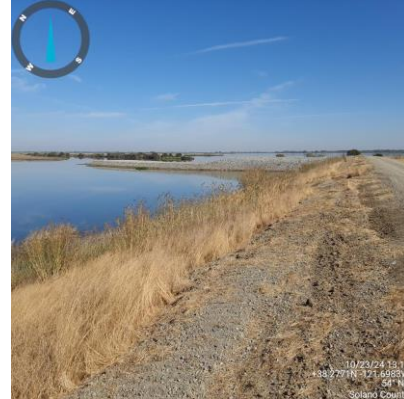
Photo 1 of 2 : FA_2024_RD2098_244_10_20241106_00031.jpg

LM Start	0.00	Rating **	A/W	Issue No.	10
LM End	3.60	Issue Type +	En	Location *	CR
Category	Earthen Levee			GPS Latitude/Longitude	
				Start	End
Item	Encroachments			38.329084 °	38.277407 °
				-121.694047 °	-121.696281 °
DWR ID	DWR_RD2098_01_s _ 2023_10				
Comment Code					
LC : Authorized Levee Construction					
Inspector Comment					
Unit 1 is part of the Lookout Slough Tidal Habitat Restoration and Flood Improvement Project (in progress). The levee has been breached in several locations, degraded, and it is not possible to drive the full length of the levee. Existing maintenance issues in Unit 1 will continue to be rated A/W until the O&M manual is updated.

View of the southern end of Unit 1 and one of the breached locations of the levee. (Fall 2024)

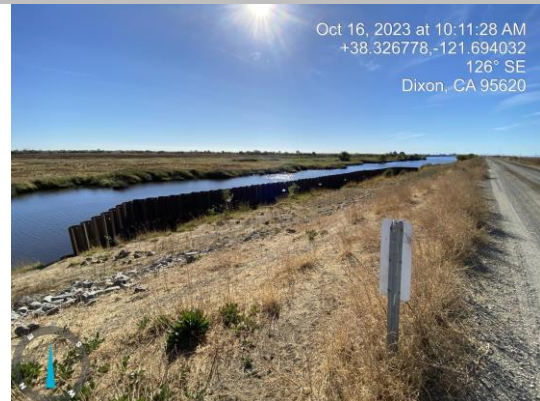
Photo 2 of 2 : FA_2024_RD2098_244_10_20241001_00001.jpg

View of location that will be breached as part of the project (Fall 2023).

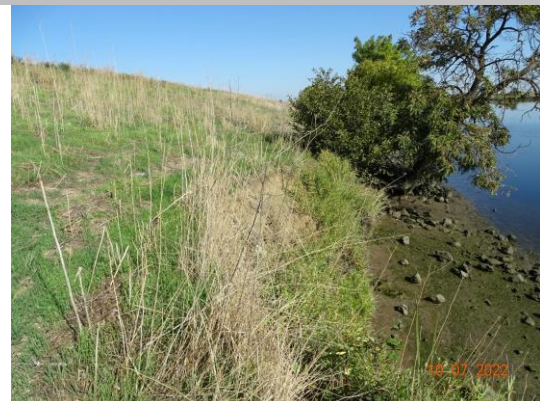
Photo 1 of 1 : FA_2024_RD2098_244_13_20241001_00004.jpg

LM Start	0.57	Rating **	A/W	Issue No.	13
LM End	1.06	Issue Type +	Ma	Location *	WS
Category	Earthen Levee			GPS Latitude/Longitude	
				Start	End
Item	Erosion / Bank Caving			38.320755 °	38.313700 °
				-121.693982 °	-121.693639 °
DWR ID	DWR_RD2098_01_s _ 2017_13				
Comment Code					
E2 : Schedule repair of erosion site prior to the next inspection.					
Inspector Comment					
There is erosion on the waterside slope. Several areas of pocket erosion on the bank are encroaching into the extended levee prism. There is some riprap protection on the lower slope in some areas. Spring 2023: Rated A/W due to ongoing habitat restoration and flood improvement project.

View of the erosion on the WS bank (Fall 2022).

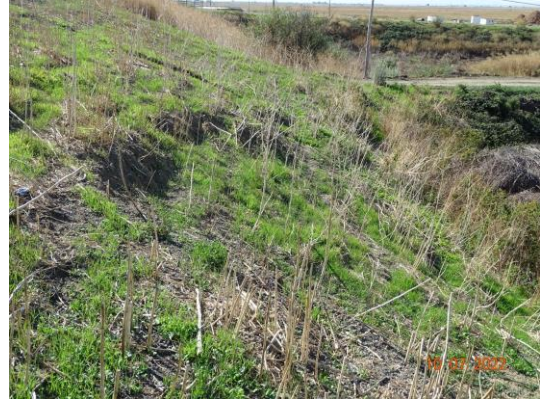
Photo 1 of 1 : FA_2024_RD2098_244_19_20241001_00006.jpg

LM Start	0.96	Rating **	A/W	Issue No.	19
LM End	0.96	Issue Type +	Ma	Location *	LS
Category	Earthen Levee			GPS Latitude/Longitude	
				Start	End
Item	Erosion / Bank Caving			38.315200 °	38.315100 °
				-121.694100 °	-121.694100 °
DWR ID	DWR_RD2098_01_s _ 2021_19				
Comment Code					
E1 : Note and monitor erosion site.					
Inspector Comment					
This was a 2017 Storm Damage site. The damage consists of cracking and sloughing of the lower landside levee slope.					
Site ID No:414					
Site Designation:LMA-241 Spring 2023: Rated A/W due to ongoing habitat restoration and flood improvement project.

View of the sloughing/caving on the LS slope (Fall 2022).

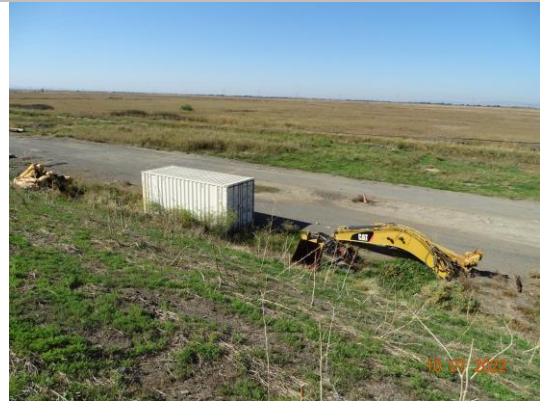
Photo 1 of 1 : FA_2024_RD2098_244_12_20241001_00003.jpg

LM Start	1.66	Rating **	A/W	Issue No.	12
LM End	1.72	Issue Type +	En	Location *	LS
Category	Earthen Levee			GPS Latitude/Longitude	
				Start	End
Item	Encroachments			38.305059 °	38.304209 °
				-121.693631 °	-121.693997 °
DWR ID	DWR_RD2098_01_f _ 2021_12				
Comment Code					
MA : Material					
Inspector Comment					
There is additional material and equipment on the LS toe. Spring 2023: Rated A/W due to ongoing habitat restoration and flood improvement project.

View of material and equipment on the LS toe (Fall 2022).

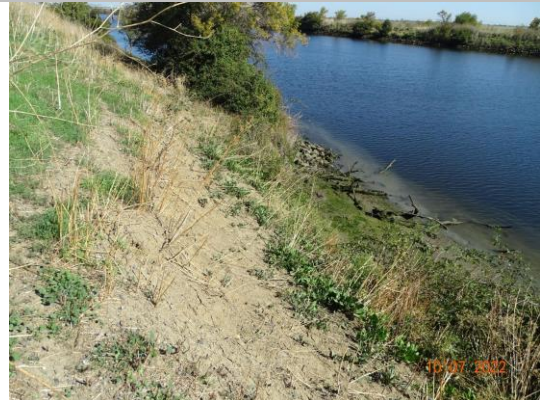
Photo 1 of 1 : FA_2024_RD2098_244_18_20241001_00005.jpg

LM Start	1.76	Rating **	A/W	Issue No.	18
LM End	1.76	Issue Type +	Ma	Location *	WS
Category	Earthen Levee			GPS Latitude/Longitude	
				Start	End
Item	Erosion / Bank Caving			38.303611 °	38.303611 °
				-121.693607 °	-121.693607 °
DWR ID	DWR_RD2098_01_s _ 2018_18				
Comment Code					
E2 : Schedule repair of erosion site prior to the next inspection.					
Inspector Comment					
There is erosion at the waterside toe. Spring 2023: Rated A/W due to ongoing habitat restoration and flood improvement project.

View of the erosion on the WS toe (Fall 2022).

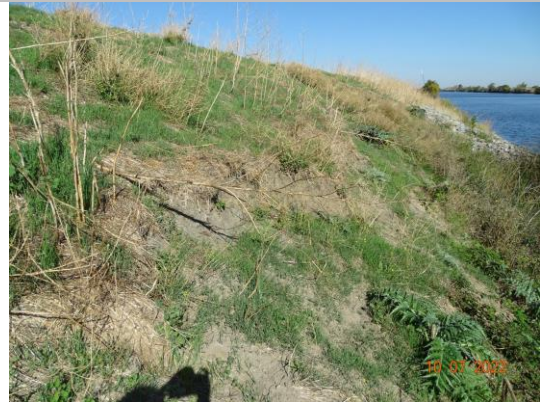
Photo 1 of 1 : FA_2024_RD2098_244_27_20241001_00008.jpg

LM Start	2.29	Rating **	A/W	Issue No.	27
LM End	2.32	Issue Type +	Ma	Location *	WS
Category	Earthen Levee			GPS Latitude/Longitude	
				Start	End
Item	Erosion / Bank Caving			38.295900°	38.295468°
				-121.693500°	-121.693619°
DWR ID	LMA-248				
Comment Code					
E2 : Schedule repair of erosion site prior to the next inspection.					
Inspector Comment					
This was a 2017 Storm Damage site. The damage consists of scour and sloughing of the waterside levee slope. Site ID No:421 Site Designation:LMA-248 Spring 2023: Rated A/W due to ongoing habitat restoration and flood improvement project.

View of the erosion on the WS slope (Fall 2022).

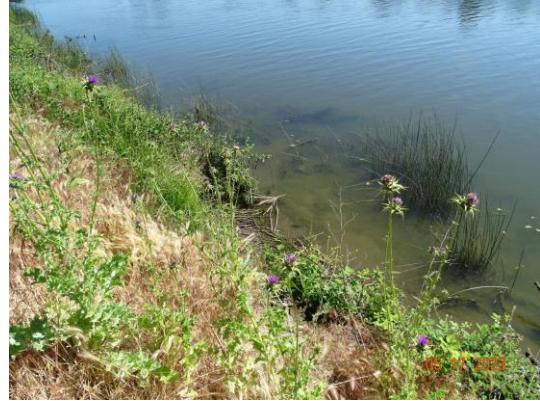
Photo 1 of 1 : FA_2024_RD2098_244_28_20241001_00009.jpg

LM Start	2.35	Rating **	A/W	Issue No.	28
LM End	2.39	Issue Type +	Ma	Location *	WS
Category	Earthen Levee			GPS Latitude/Longitude	
				Start	End
Item	Erosion / Bank Caving			38.295100 °	38.294500 °
				-121.693400 °	-121.693400 °
DWR ID	LMA-250				
Comment Code					
E2 : Schedule repair of erosion site prior to the next inspection.					
Inspector Comment					
This was a 2017 Storm Damage site. The damage consists of scour, sloughing, and cracking of the lower and mid waterside levee slope. Site ID No:423 Site Designation:LMA-250 Spring 2023: Rated A/W due to ongoing habitat restoration and flood improvement project.

View of the erosion on the WS slope (Spring 2023).

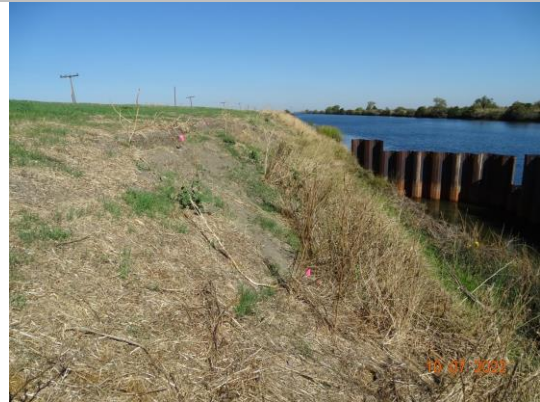
Photo 1 of 1 : FA_2024_RD2098_244_34_20241001_00010.jpg

LM Start	2.75	Rating **	A/W	Issue No.	34
LM End	2.81	Issue Type +	Ma	Location *	WS
Category	Earthen Levee			GPS Latitude/Longitude	
				Start	End
Item	Erosion / Bank Caving			38.289200 °	38.288405 °
				-121.693500 °	-121.693617 °
DWR ID	LMA-256				
Comment Code					
E2 : Schedule repair of erosion site prior to the next inspection.					
Inspector Comment					
Fall 2022: Site is pending repair. This was a 2017 Storm Damage site. The damage consists of scour and sloughing of the waterside levee slope.					
Site ID No:429 & 430					
Site Designation:LMA-256, LMA-257 Spring 2023: Rated A/W due to ongoing habitat restoration and flood improvement project.

View of the erosion on the WS slope (Fall 2022).

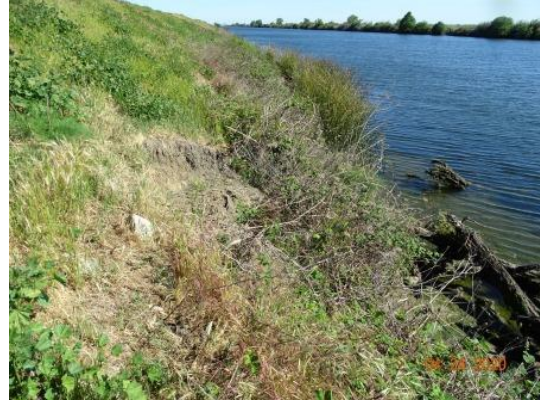
Photo 1 of 1 : FA_2024_RD2098_244_36_20241001_00011.jpg

LM Start	2.91	Rating **	A/W	Issue No.	36
LM End	2.93	Issue Type +	Ma	Location *	WS
Category	Earthen Levee			GPS Latitude/Longitude	
				Start	End
Item	Erosion / Bank Caving			38.286900 °	38.286700 °
				-121.693500 °	-121.693500 °
DWR ID	LMA-258				
Comment Code					
E2 : Schedule repair of erosion site prior to the next inspection.					
Inspector Comment					
This was a 2017 Storm Damage site. The damage consists of scour and sloughing of the waterside levee slope. Site ID No:431 Site Designation:LMA-258 Spring 2023: Rated A/W due to ongoing habitat restoration and flood improvement project.

View looking upstream at erosion into the waterside slope (Spring 2020).

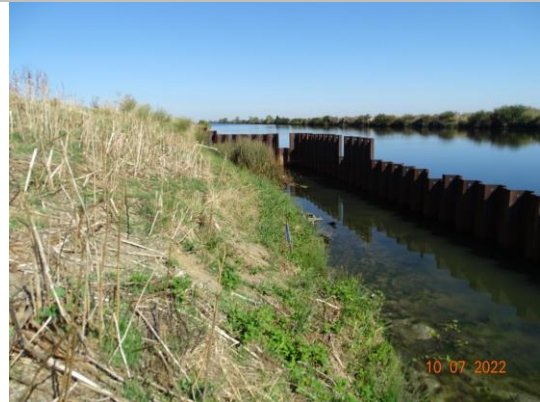
Photo 1 of 1 : FA_2024_RD2098_244_37_20241001_00012.jpg

LM Start	2.99	Rating **	A/W	Issue No.	37
LM End	3.29	Issue Type +	Ma	Location *	WS
Category	Earthen Levee			GPS Latitude/Longitude	
				Start	End
Item	Erosion / Bank Caving			38.285700 °	38.281500 °
				-121.693500 °	-121.694300 °
DWR ID	LMA-259				
Comment Code					
E2 : Schedule repair of erosion site prior to the next inspection.					
Inspector Comment					
Fall 2022: Site is pending repair. This was a 2017 Storm Damage site. The damage consists of scour and sloughing of the waterside levee slope.					
Site ID No:432					
Site Designation:LMA-259 Spring 2023: Rated A/W due to ongoing habitat restoration and flood improvement project.

View of the erosion on the WS slope (Fall 2022).

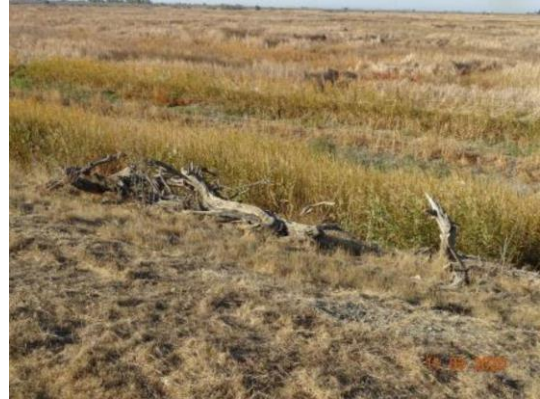
Photo 1 of 1 : FA_2024_RD2098_244_20_20241001_00007.jpg

View of tree limb on the landside slope (Fall 2020).

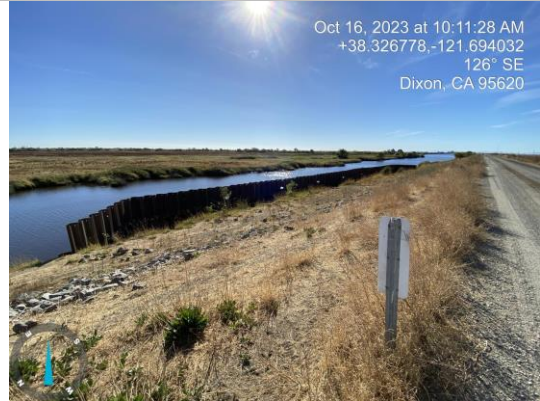
Photo 1 of 1 : FA_2024_RD2098_245_2_20241001_00001.jpg

View of construction area on Unit 1 that extends through Unit 1A (Fall 2023).

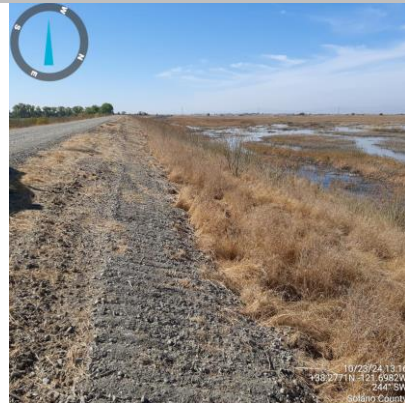
Photo 1 of 1 : FA_2024_RD2098_245_1_20241106_00002.jpg

LM Start	0.09	Rating **	A/W	Issue No.	1
LM End	0.52	Issue Type +	Ma	Location *	LS
Category	Earthen Levee			GPS Latitude/Longitude	
				Start	End
Item	Vegetation			38.277124 °	38.275701 °
				-121.697906 °	-121.705579 °
DWR ID	DWR_RD2098_01A_f_2024_1				
Comment Code					
V1 : Control annual grass and weeds on the levee slopes and easements.					
Inspector Comment

View of vegetation on the landside slope. (Fall 2024)

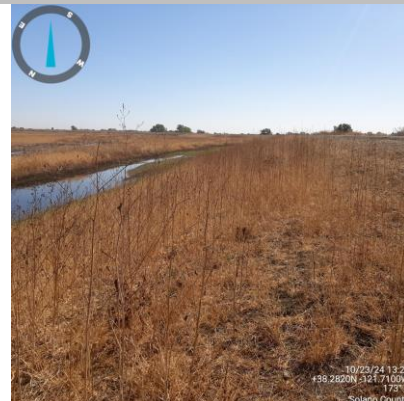
Photo 1 of 1 : FA_2024_RD2098_246_5_20241106_00017.jpg

View of vegetation on the landside slope. (Fall 2024)

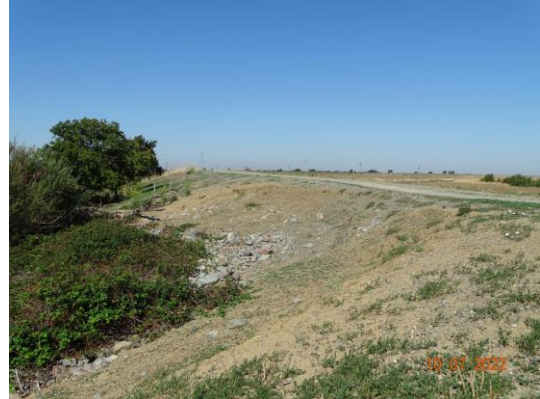
Photo 1 of 1 : FA_2024_RD2098_246_11_20241001_00002.jpg

LM Start	5.88	Rating **	A/W	Issue No.	11
LM End	5.88	Issue Type +	Ma	Location *	WS
Category	Earthen Levee			GPS Latitude/Longitude	
				Start	End
Item	Erosion / Bank Caving			38.282946°	38.282946°
				-121.710902°	-121.710902°
DWR ID	DWR_RD2098_02_f_2020_11				
Comment Code					
E2 : Schedule repair of erosion site prior to the next inspection.					
Inspector Comment					
This waterside slump site is not new, and is somewhat protected by riprap and thick brushy vegetation, but it has the potential to erode into crown during high water with a strong south wind. It currently has a two-foot vertical scarp at the levee shoulder. Spring 2023: Rated A/W due to ongoing habitat restoration and flood improvement project.

View of the erosion on the WS slope (Fall 2022).

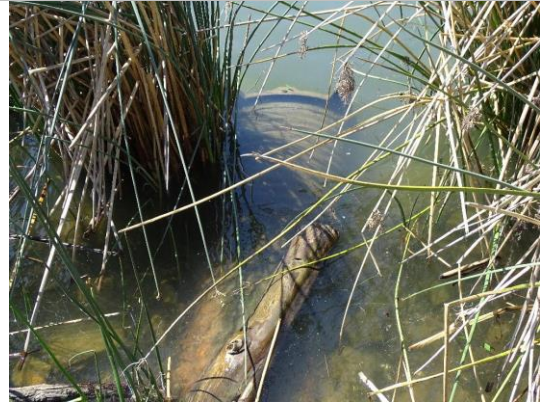
Photo 2 of 3 : UCIP_FA_2024_74580_111389.jpg

View of pipe with flap gate out of WS toe.

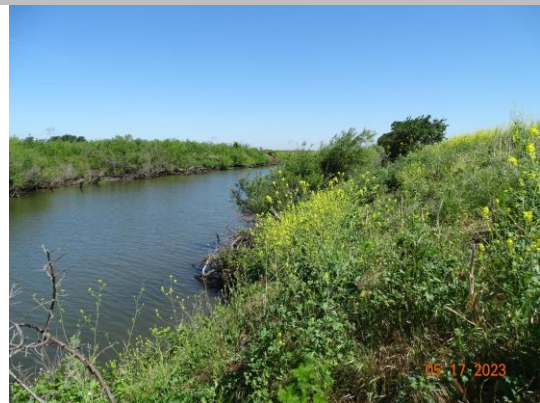
Photo 1 of 1 : FA_2024_RD2098_246_15_20241001_00003.jpg

This was a 2017 Storm Damage site.
The damage consists of scour of the lower and mid waterside levee slope.
Site ID No:440 & 441
Site Designation:LMA-267 & LMA-268 Spring 2023: Rated A/W due to ongoing habitat restoration and flood improvement project.

View of the erosion on the WS (Spring 2023).

E2 : Schedule repair of erosion site prior to the next inspection.

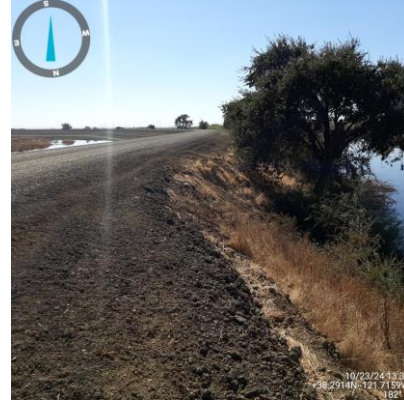
Photo 1 of 1 : FA_2024_RD2098_246_18_20241106_00018.jpg

LM Start	6.64	Rating **	A/W	Issue No.	18
LM End	6.65	Issue Type +	Ma	Location *	WS
Category	Earthen Levee			GPS Latitude/Longitude	
				Start	End
Item	Erosion / Bank Caving			38.291300 °	38.291400 °
				-121.716100 °	-121.716000 °
DWR ID	LMA-269				
Comment Code					
E2 : Schedule repair of erosion site prior to the next inspection.					
Inspector Comment					
This was a 2017 Storm Damage site. The damage consists of scour, cracking, instability, and sloughing of the waterside levee slope. Site ID No:442 Site Designation:LMA-269 Spring 2023: Rated A/W due to ongoing habitat restoration and flood improvement project.

View of the erosion on the waterside (Fall 2024).

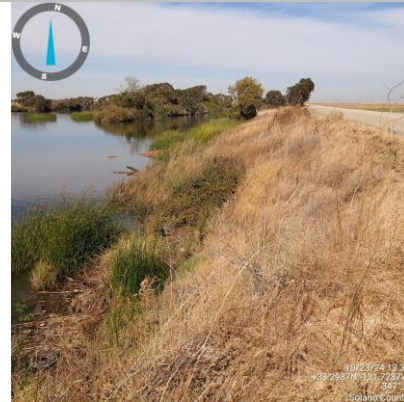
Photo 1 of 1 : FA_2024_RD2098_247_15_20241106_00013.jpg

LM Start	7.67	Rating **	A/W	Issue No.	15
LM End	7.67	Issue Type +	Ma	Location *	WS
Category	Earthen Levee			GPS Latitude/Longitude	
				Start	End
Item	Erosion / Bank Caving			38.298779 °	38.298779 °
				-121.728582 °	-121.728582 °
DWR ID	DWR_RD2098_03_s _ 2024_15				
Comment Code					
E1 : Note and monitor erosion site.					
Inspector Comment					
Bank caving observed at location that appears to be an old erosion site.

View of erosion on the waterside slope. (Fall 2024)

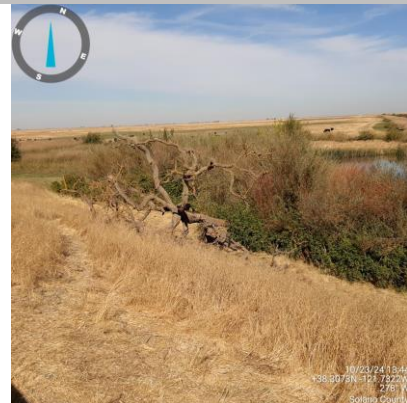
Photo 1 of 1 : FA_2024_RD2098_247_12_20241106_00016.jpg

View of fallen tree on the landside slope. (Fall 2024)

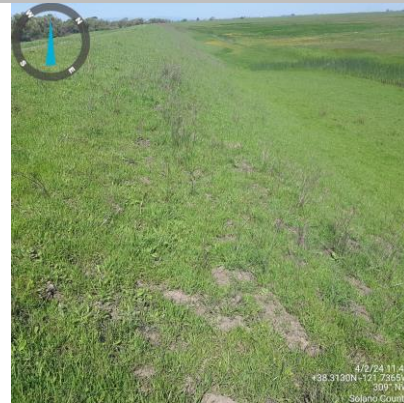
Photo 1 of 1 : FA_2024_RD2098_247_4_20241001_00001.jpg

View of slope terracing caused by cattle on the landside slope (Spring 2024).

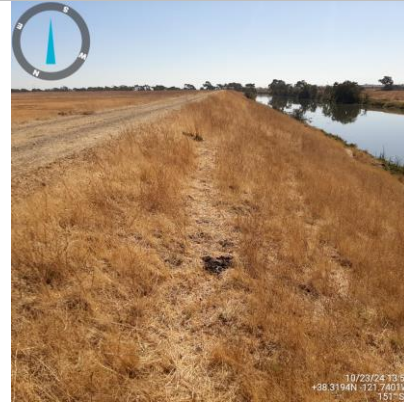
Photo 1 of 1 : FA_2024_RD2098_248_11_20241106_00021.jpg

View of terracing due to cows on the waterside slope (Fall 2024).

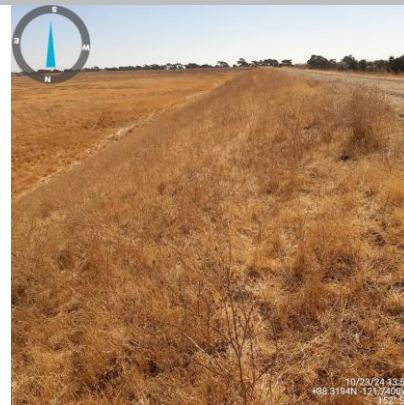
Photo 1 of 1 : FA_2024_RD2098_248_10_20241106_00022.jpg

View of terracing due to cows on the landside slope (Fall 2024).

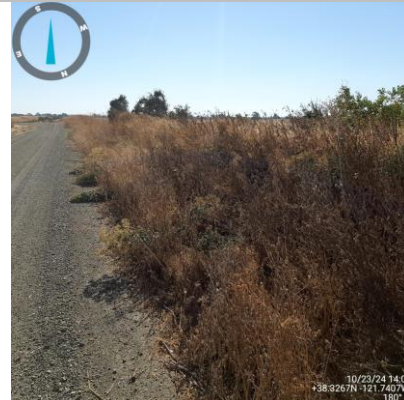
Photo 1 of 1 : FA_2024_RD2098_248_8_20241106_00023.jpg

View of the overgrown dredge material on the waterside shoulder (Fall 2024).

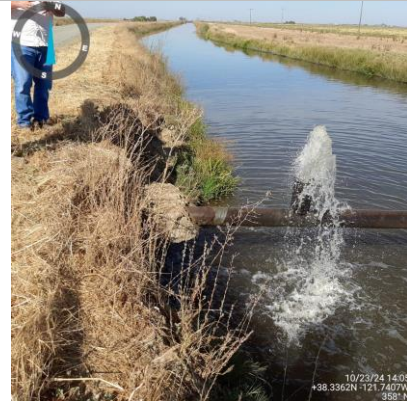
Photo 1 of 1 : FA_2024_RD2098_248_15_20241106_00024.jpg

View of the erosion on the landside. (Fall 2024)

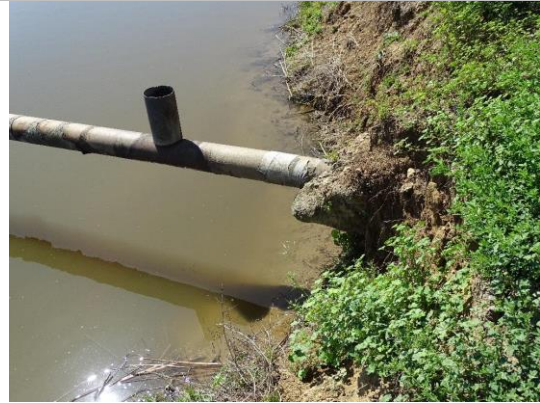
Photo 2 of 3 : UCIP_FA_2024_74679_111678.jpg

View of serious scour around pipe on LS slope.

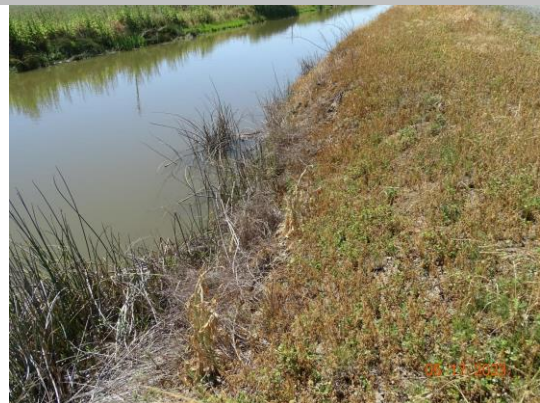
Photo 1 of 1 : FA_2024_RD2098_248_14_20241001_00004.jpg

View of the erosion on the LS (Spring 2023).

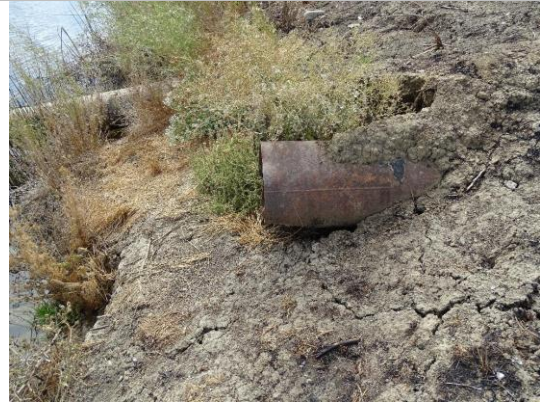
Photo 2 of 3 : UCIP_FA_2024_74696_78547.jpg

LS view - erosion around bottom of pipe.
