**Flood Control Project Maintenance
Levee Inspections
LMA District Cover Sheet
Spring 2010 Levee Inspection Results**

Reclamation District No. 2098 Cache and Haas Slough

Levee Inspection Report By Mile - Spring 2010

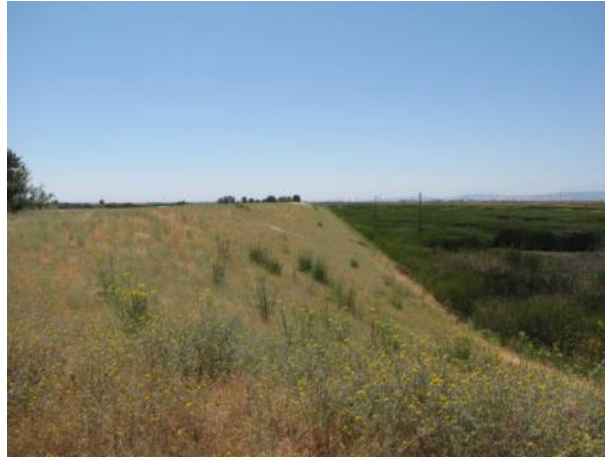
jhirabay_s_20100709_001.jpg

LMR No	Levee Mile		Category	Item	Location *	Rating **	Action/Comment	GPS Latitude/Longitude		Issue No.
	Start	End						Start	End	Photo
1	0.00	0.00	Earthen Levee	Vegetation	LS	A	Control annual grass and weeds on the levee slopes and easements.	38.277411 ° -121.696281 °	38.277411 ° -121.696281 °	4 Y

Levee Mile Report Line	1
Start Levee Mile	0.00
End Levee Mile	0.00
Location	Land Side
Category	Earthen Levee
Item	Vegetation

Looking downstream from levee mile 0.00 at land side of Unit 1A RD 2098. Good levee coverage.

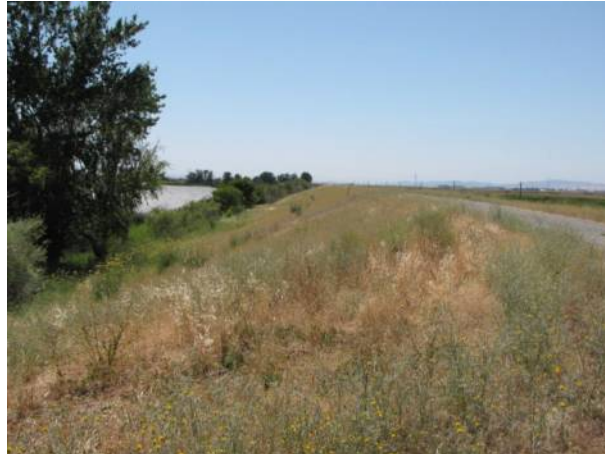
jhirabay_s_20100709_002.jpg

Levee Mile Report Line	1
Start Levee Mile	0.00
End Levee Mile	0.00
Location	Land Side
Category	Earthen Levee
Item	Vegetation

Looking downstream of Unit 1A levee mile 0.00 waterside view.

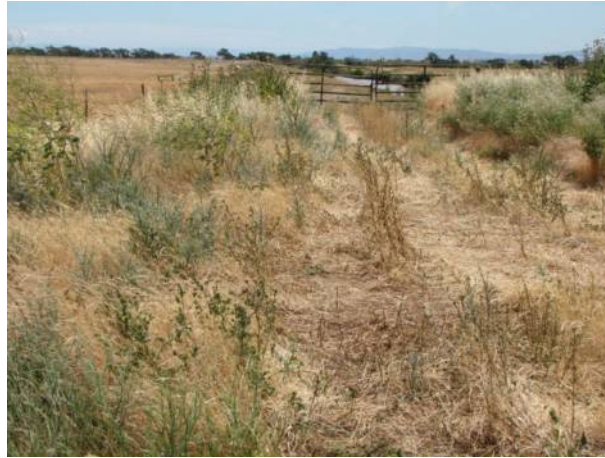
phillips_s_20100608_069.jpg

Levee Mile Report Line	1
Start Levee Mile	9.80
End Levee Mile	13.11
Location	Water Side
Category	Earthen Levee
Item	Vegetation

Standing downstream from L/M 9.83 looking back upstream from landside. As you can see beyond the fence back up stream the live in area keeps the veg. low on levee section.

LMR No	Levee Mile		Category	Item	Location *	Rating **	Action/Comment	GPS Latitude/Longitude		Issue No. Photo
	Start	End						Start	End	
1	9.80	13.11	Earthen Levee	Vegetation	WS	M	Control annual grass and weeds on the levee slopes and easements. Inspector Comments: There are two photos added to the inspection to show how the veg is over grown from the gate downstream to 9.82. The growth continues down stream to levee mile 13.11 just not as tall.	38.325060 ° -121.740077 °	38.372562 ° -121.739037 °	8 Y
2	9.81	9.81	Earthen Levee	Vegetation	WS	M	Remove the wild growth other than native grasses from the levee slopes.	38.324993 ° -121.740082 °	38.324993 ° -121.740082 °	1
3	9.81	13.11	Earthen Levee	Vegetation	LS	M	Control annual grass and weeds on the levee slopes and easements.	38.325035 ° -121.740080 °	38.372565 ° -121.739022 °	7
4	9.81	9.83	Earthen Levee	Vegetation	CR	M	Control annual grass and weeds on the levee slopes and easements.	38.325038 ° -121.740103 °	38.325372 ° -121.740030 °	9

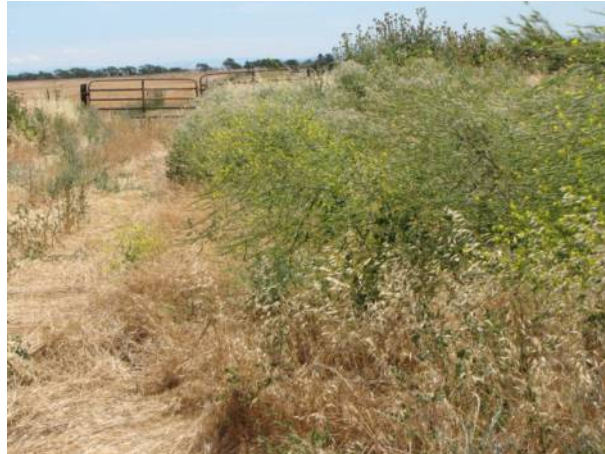
phillips_s_20100608_070.jpg

Levee Mile Report Line	1
Start Levee Mile	9.80
End Levee Mile	13.11
Location	Water Side
Category	Earthen Levee
Item	Vegetation

This shot shows veg on water side from the gate at levee mile 9.79 down stream to 9.84.
