**Flood Control Project Maintenance  
Levee Inspections**  
**LMA District Cover Sheet**  
**Spring 2011 Levee Inspection Results**

**Reclamation District No. 2098 Cache and Haas Slough**

**Levee Inspection Report By Mile - Spring 2011**

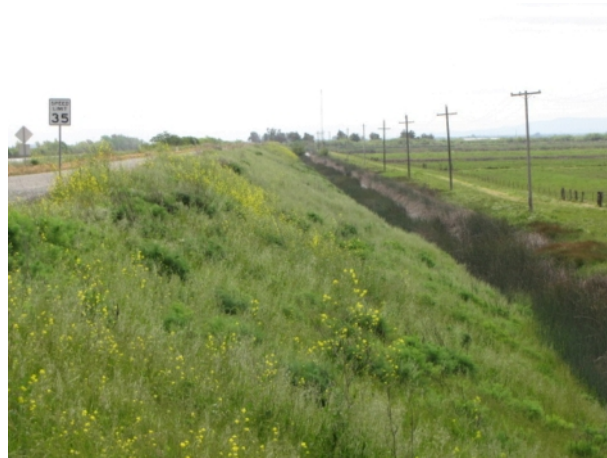
Levee Mile Report Line	1
Start Levee Mile	0.00
End Levee Mile	0.00
Location	Land Side
Category	Earthen Levee
Item	Vegetation

Looking downstream from landside of Unit 1 of RD 2098. Photo taken 4-20-2011

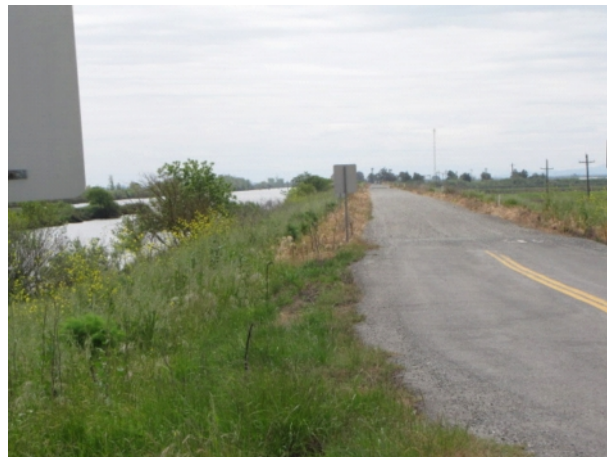
Levee Mile Report Line	2
Start Levee Mile	0.00
End Levee Mile	0.00
Location	Water Side
Category	Earthen Levee
Item	Vegetation

Standing on waterside levee slope looking downstream of RD 2098 Unit 1. This photo was taken 4-20-2011.

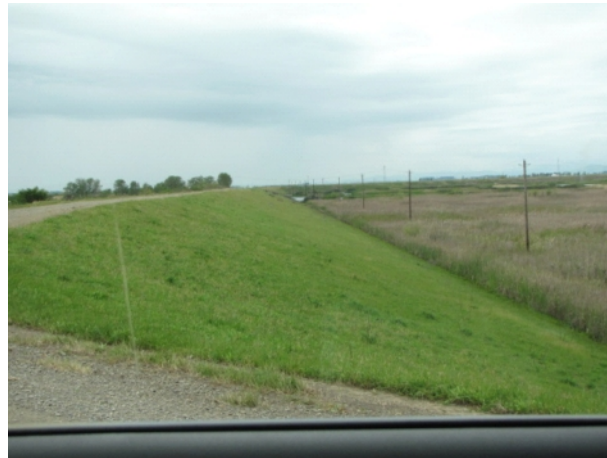
Levee Mile Report Line	1
Start Levee Mile	0.00
End Levee Mile	0.00
Location	Land Side
Category	Earthen Levee
Item	Vegetation

Looking downstream at the cross levee Unit 1A RD 2098 Unit 1A Levee mile 0.00. Photo taken 4-20-2011.

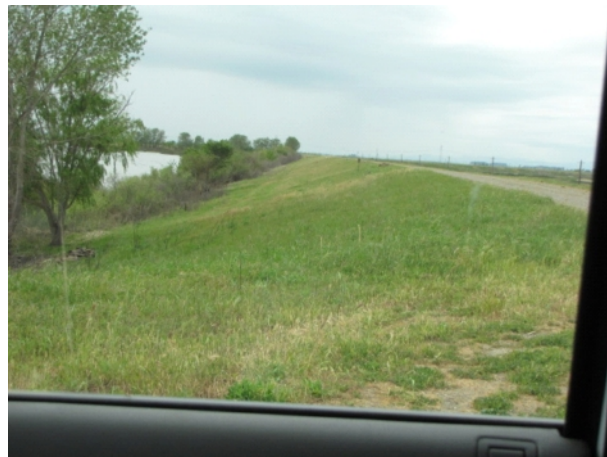
Levee Mile Report Line	2
Start Levee Mile	0.00
End Levee Mile	0.00
Location	Water Side
Category	Earthen Levee
Item	Vegetation

This photo shows the waterside of the cross levee Unit 1A of RD 2098 levee mile 0.00 looking downstream. Photo taken 4-20-2011.

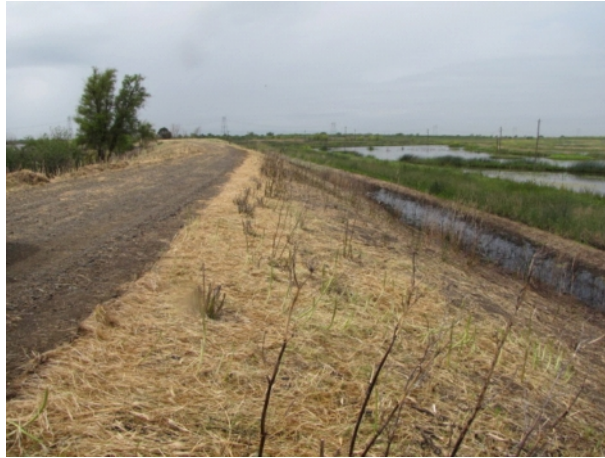
Levee Mile Report Line	1
Start Levee Mile	5.29
End Levee Mile	5.29
Location	Land Side
Category	Earthen Levee
Item	Vegetation

Standing on landside of Unit 2 levee mile 5.29 looking downstream of the landward slope, goats are in the area eating the vegetation off the slope. Photo taken 4-20-2011.

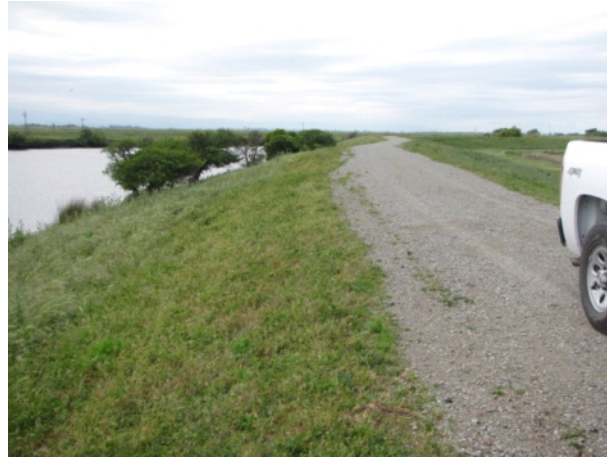
Levee Mile Report Line	2
Start Levee Mile	7.27
End Levee Mile	7.27
Location	Land Side
Category	Earthen Levee
Item	Vegetation
Waterside levee slope unit 3 starts here. 4-20-2011	
phillips_s_20110512_313.jpg

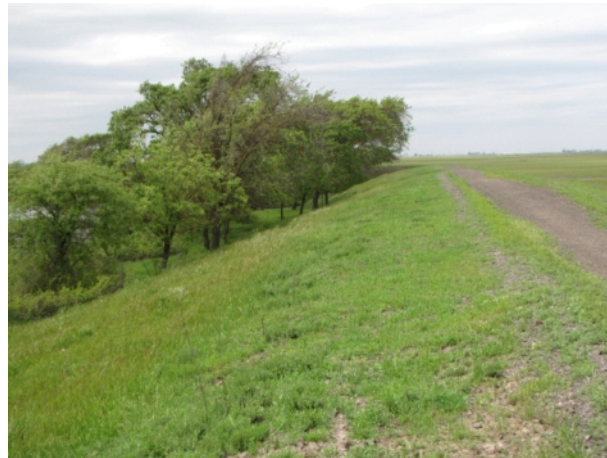
Levee Mile Report Line	1
Start Levee Mile	9.15
End Levee Mile	9.15
Location	Water Side
Category	Earthen Levee
Item	Vegetation

Standing on waterside start of unit 4 looking downstream. Photo taken 4-20-2011

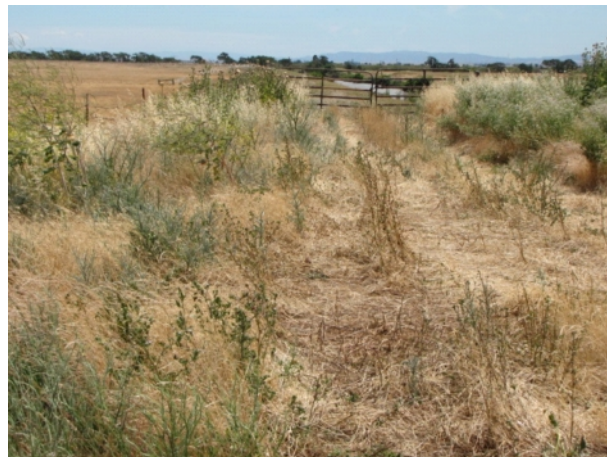
Levee Mile Report Line	2
Start Levee Mile	9.80
End Levee Mile	12.11
Location	Water Side
Category	Earthen Levee
Item	Vegetation

Standing downstream from L/M 9.83 looking back upstream from landside. As you can see beyond the fence back up stream the live in area leaps the veg. low on levee section.

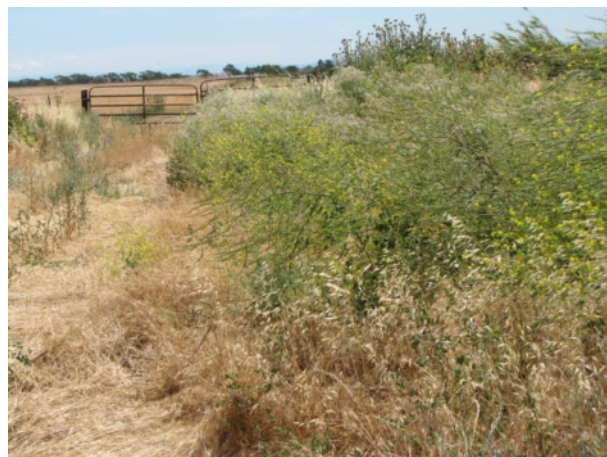
Levee Mile Report Line	2
Start Levee Mile	9.80
End Levee Mile	12.11
Location	Water Side
Category	Earthen Levee
Item	Vegetation

This shot shows veg on water side from the gate at levee mile 9.79 down stream to 9.84.
