**Flood Control Project Maintenance
Levee Inspections****LMA District Cover Sheet****Spring 2012 Levee Inspection Results****Reclamation District No. 2098 Cache and Haas Slough**

Levee Inspection Report By Mile - Spring 2012

Reclamation District No. 2098 Cache and Haas Slough

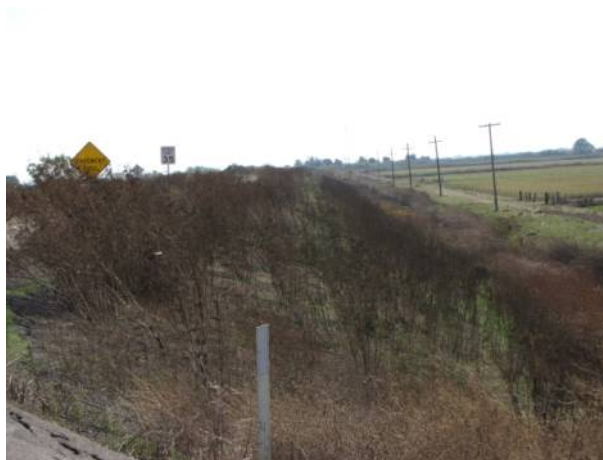
Levee Mile Report Line	4
Start Levee Mile	0.00
End Levee Mile	0.00
Location	Land Side
Category	Earthen Levee
Item	Vegetation

Unit 1 looking downstream landward from levee mile 0.00. Photo taken 10-20-2011.

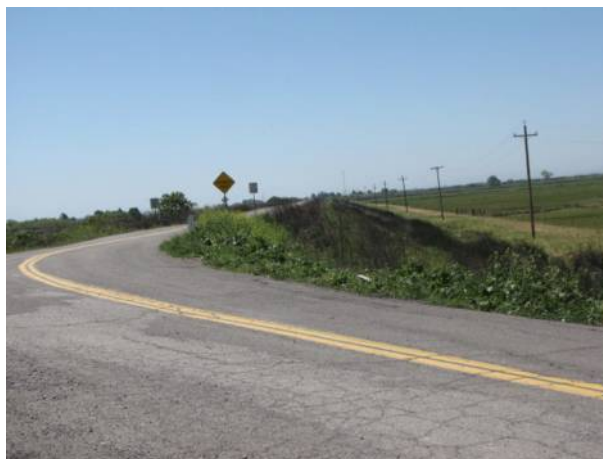
Levee Mile Report Line	4
Start Levee Mile	0.00
End Levee Mile	0.00
Location	Land Side
Category	Earthen Levee
Item	Vegetation

RD 2098 Looking downstream from levee mile 0.00 landside slope Photo taken 5-9-2012.

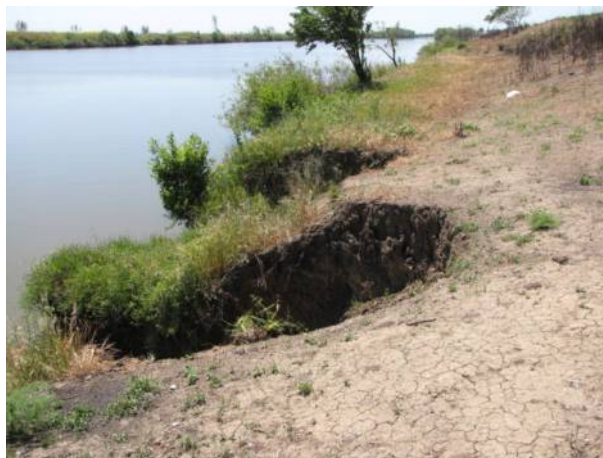
Levee Mile Report Line	12
Start Levee Mile	0.64
End Levee Mile	0.66
Location	Water Side
Category	Earthen Levee
Item	Erosion / Bank Caving

Levee mile 0.64-0.66 Erosion in levee berm. Photo taken 5-9-2012.

DWR ID: DWR_RD2098_01_s_2012_16										
11	0.61	0.63	Earthen Levee	Erosion / Bank Caving	WS M Ma	E1 : Note and monitor erosion site.	38.320979 ° -121.694029 °	38.319984 ° -121.694001 °	17	
DWR ID: DWR_RD2098_01_s_2012_17										
12	0.64	0.66	Earthen Levee	Erosion / Bank Caving	WS U Ma	E2 : Schedule repair of erosion site prior to the next inspection.	38.319839 ° -121.694008 °	38.319549 ° -121.694000 °	18 Y	
DWR ID: DWR_RD2098_01_s_2012_18										
13	0.84	0.84	Earthen Levee	Erosion / Bank Caving	WS M Ma	E2 : Schedule repair of erosion site prior to the next inspection.	38.318517 ° -121.693957 °	38.318517 ° -121.693957 °	19 Y	
DWR ID: DWR_RD2098_01_s_2012_19										
14	1.57	1.64	Earthen Levee	Vegetation	WS C Ma	V1 : Control annual grass and weeds on the levee slopes and easements.	38.306244 ° -121.693624 °	38.305236 ° -121.693645 °	9	
DWR ID: DWR_RD2098_01_s_2012_9

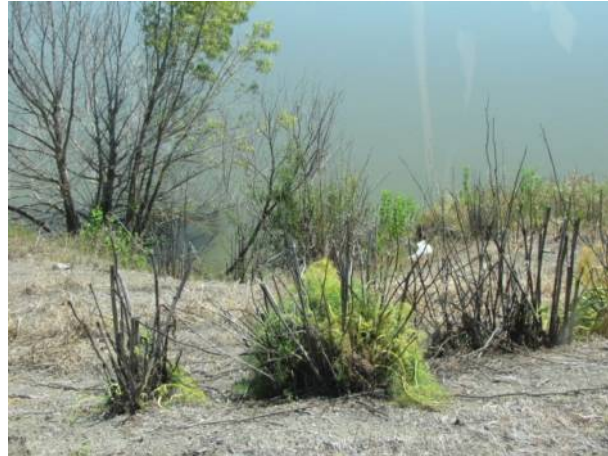
Levee Mile Report Line	13
Start Levee Mile	0.84
End Levee Mile	0.84
Location	Water Side
Category	Earthen Levee
Item	Erosion / Bank Caving
Erosion levee mile 0.84. Photo taken 5-9-2012.	
phillips_s_20120516_425.jpg

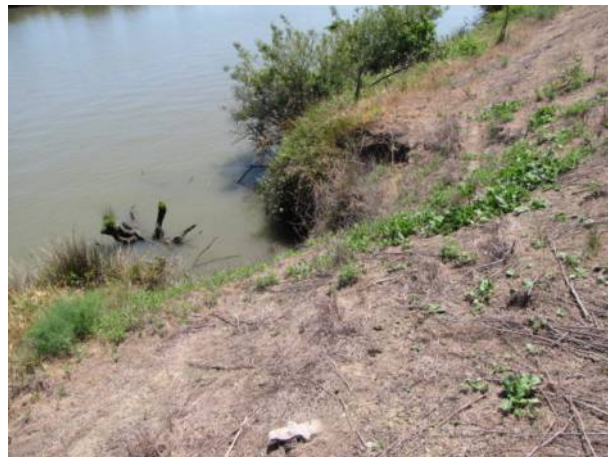
Levee Mile Report Line	17
Start Levee Mile	3.09
End Levee Mile	3.09
Location	Water Side
Category	Earthen Levee
Item	Erosion / Bank Caving
Erosion at levee mile 3.09 waterward. Photo taken 5-9-2012.	
phillips_s_20120516_426.jpg

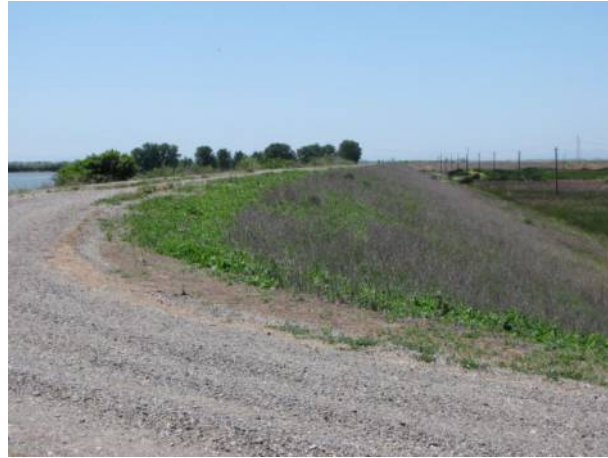
Levee Mile Report Line	1
Start Levee Mile	0.00
End Levee Mile	0.00
Location	Land Side
Category	Earthen Levee
Item	Vegetation

RD 2098 Unit 1A looking downstream from levee mile 0.00 landward slope. Photo taken 5-09-2012.

LMR No.	Levee Mile		Category	Item	Location *	Rating ** +	Action/Comment	GPS Latitude/Longitude		Issue No. Photo
	Start	End						Start	End	
1	0.00	0.00	Earthen Levee	Vegetation	LS	A	V1 : Control annual grass and weeds on the levee slopes and easements.	38.277418 ° -121.696242 °	38.277418 ° -121.696242 °	2 Y
DWR ID: DWR_RD2098_01A_s_2012_2

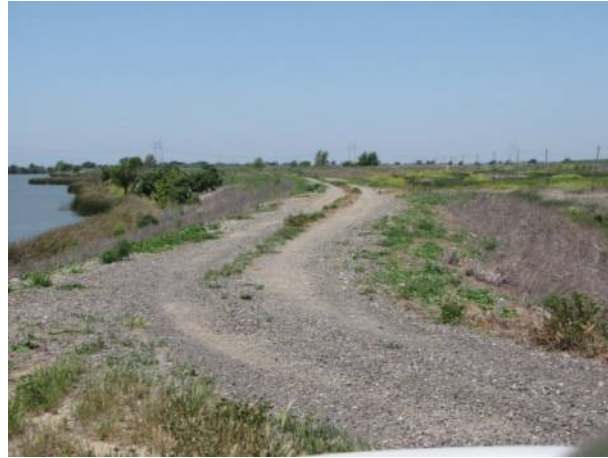
Levee Mile Report Line	1
Start Levee Mile	5.29
End Levee Mile	5.56
Location	Crown
Category	Earthen Levee
Item	Crown Surface / Depressions / Rutting

RD 2098 Unit 2 looking downstream from levee mile 5.29, both landside and waterside is in view. Photo taken 5-09-2012.

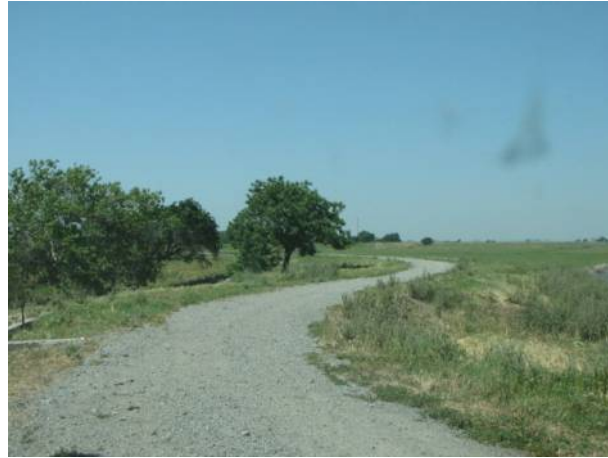
Levee Mile Report Line	1
Start Levee Mile	7.30
End Levee Mile	7.30
Location	Land Side
Category	Earthen Levee
Item	Vegetation

RD 2098 Unit 3 Haas Slough looking downstream from levee mile 7.30. Photo taken 5-09-2012.

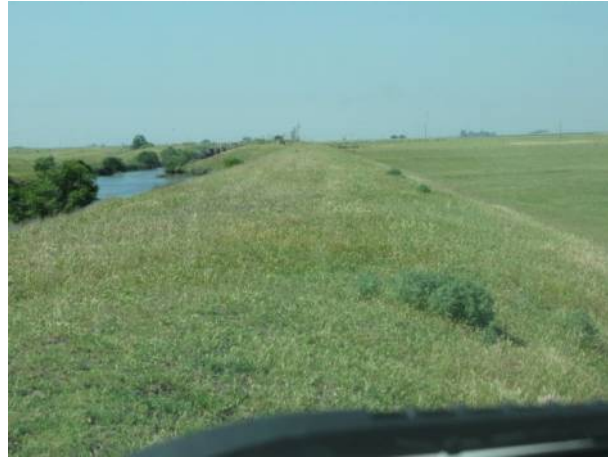
Levee Mile Report Line	1
Start Levee Mile	9.19
End Levee Mile	10.03
Location	Crown
Category	Earthen Levee
Item	Crown Surface / Depressions / Rutting
RD 2098 Unit 4 levee mile 9.19 looking downstream crown roadway. Photo taken 5-09-2012.	
phillips_s_20120522_442.jpg

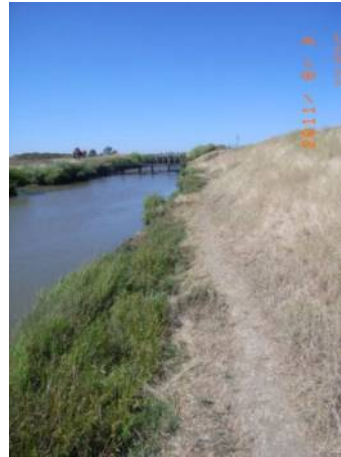
Levee Mile Report Line	2
Start Levee Mile	9.46
End Levee Mile	9.46
Location	Water Side
Category	Supplemental
Item	USACE Erosion Survey
USACE 2011 Photo #1	
phillips_s_20120306_325.jpg

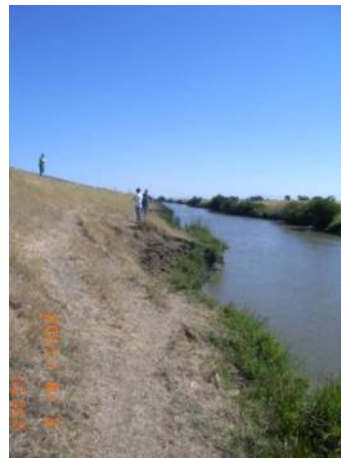
Levee Mile Report Line	2
Start Levee Mile	9.46
End Levee Mile	9.46
Location	Water Side
Category	Supplemental
Item	USACE Erosion Survey
USACE 2011 Photo #2	
phillips_s_20120306_326.jpg

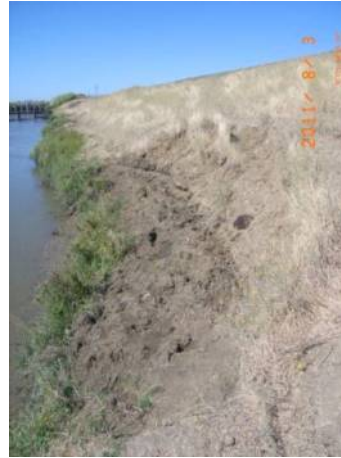
Levee Mile Report Line	2
Start Levee Mile	9.46
End Levee Mile	9.46
Location	Water Side
Category	Supplemental
Item	USACE Erosion Survey
USACE 2011 Photo #3	
phillips_s_20120306_327.jpg

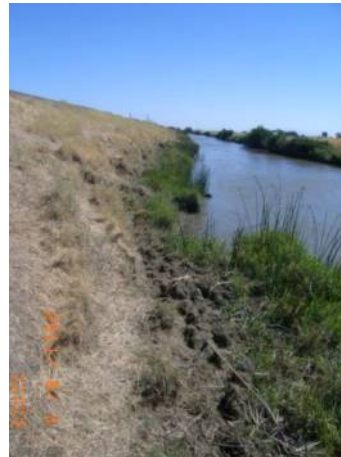
Levee Mile Report Line	2
Start Levee Mile	9.46
End Levee Mile	9.46
Location	Water Side
Category	Supplemental
Item	USACE Erosion Survey
USACE 2011 Photo #4	
phillips_s_20120306_328.jpg

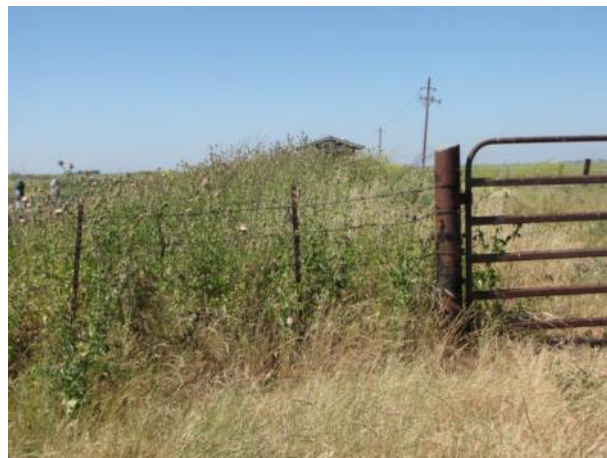
Levee Mile Report Line	3
Start Levee Mile	9.80
End Levee Mile	9.84
Location	Water Side
Category	Earthen Levee
Item	Vegetation
RD 2098 Unit 4 levee mile 9.80 to 9.84 waterside. Photo taken 5-09-2012.	
phillips_s_20120522_441.jpg
