**Flood Control Project Maintenance
Levee Inspections**
LMA District Cover Sheet
Spring 2013 Levee Inspection Results

Reclamation District No. 2098 Cache and Haas Slough

Levee Inspection Report By Mile - Spring 2013

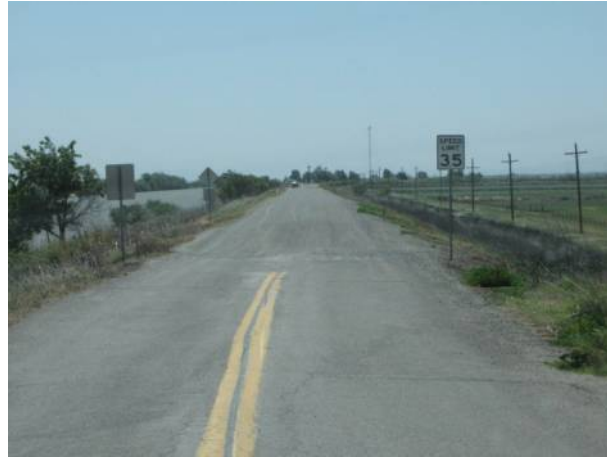
Levee Mile Report Line	4
Start Levee Mile	0.00
End Levee Mile	0.00
Location	Land Side
Category	
Item	Vegetation
RD 2098 Looking downstream from levee mile 0.00 both slopes and crown roadway in view. Photo taken 4-23-2013.	
phillips_s_20130514_427.JPG

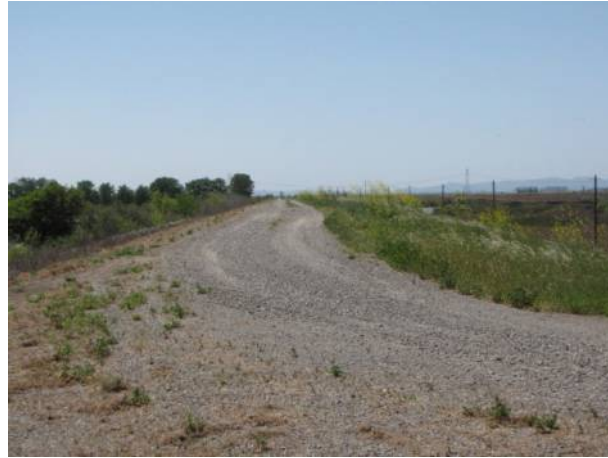
Levee Mile Report Line	1
Start Levee Mile	0.00
End Levee Mile	0.32
Location	Land Side
Category	
Item	Vegetation

LMR No.	Levee Mile		Category	Item	Location *	Rating ** +	Action/Comment	GPS Latitude/Longitude		Issue No. Photo
	Start	End						Start	End	
1	0.00	0.32		Vegetation	LS	M	V1 : Control annual grass and weeds on the levee slopes and easements.	38.277487 ° -121.696207 °	38.276445 ° -121.701725 °	1 Y
DWR ID: DWR_RD2098_01A_s_2013_1

RD 2098 Unit 1a looking downstream from levee mile 0.00 landside slope. Photo taken 4-23-2013.

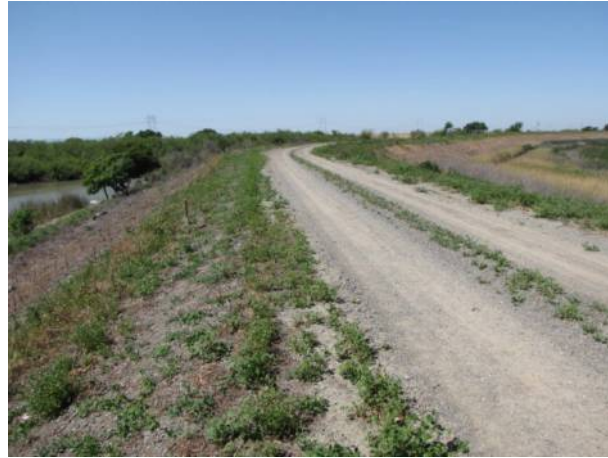
LMR No.	Levee Mile		Category	Item	Location *	Rating **	Action/Comment	GPS Latitude/Longitude		Issue No.
	Start	End						Start	End	
1	5.29	5.29		Vegetation	LS	M	V2 : Remove the wild growth other than native grasses from the levee slopes.	38.275706 ° -121.705698 °	38.275706 ° -121.705698 °	1 Y
DWR ID: DWR_RD2098_02_s_2013_1										
2	5.29	7.17		Vegetation	CR	M	V1 : Control annual grass and weeds on the levee slopes and easements.	38.275706 ° -121.705698 °	38.292990 ° -121.723502 °	4
DWR ID: DWR_RD2098_02_s_2013_4										
3	5.31	5.49		Vegetation	LS	M	V2 : Remove the wild growth other than native grasses from the levee slopes.	38.275923 ° -121.705940 °	38.278053 ° -121.707833 °	2
DWR ID: DWR_RD2098_02_s_2013_2

Levee Mile Report Line	1
Start Levee Mile	5.29
End Levee Mile	5.29
Location	Land Side
Category	
Item	Vegetation
RD 2098 Looking downstream from levee mile 5.29 at waterward slope. Photo taken 4-23-2013.	
phillips_s_20130514_429.JPG

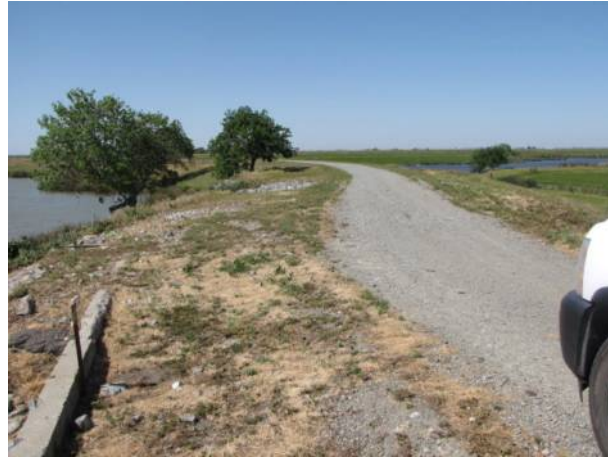
Levee Mile Report Line	1
Start Levee Mile	7.30
End Levee Mile	9.19
Location	Water Side
Category	
Item	Vegetation

LMR No.	Levee Mile		Category	Item	Location *	Rating ** +	Action/Comment	GPS Latitude/Longitude		Issue No. Photo
	Start	End						Start	End	
1	7.30	9.19		Vegetation	WS	A	V2 : Remove the wild growth other than native grasses from the levee slopes.	38.294198 ° -121.725085 °	38.315638 ° -121.739715 °	3 Y
DWR ID: DWR_RD2098_03_s_2012_3										
2	7.33	7.33	Supplemental	USACE Erosion Survey	WS	M	Inspector Comments: 2011 - Large vertical erosion pockets and bank slumping. 2012: Site is part of the extended inventory, last inspected 2011. [2012 Site ID: HAS_7-9_L]	38.299606 ° -121.728621 °	38.294858 ° -121.725433 °	7
DWR ID: DWR_RD2098_03_s_2013_7										
3	7.40	7.54		Slope Stability	LS	M	S2 : Repair the levee slope damaged by foot traffic and prevent access where possible.	38.295513 ° -121.725776 °	38.296799 ° -121.727510 °	6
DWR ID: DWR_RD2098_03_s_2013_6										
4	7.41	7.41		Slope Stability	LS	M	S1 : Repair slope instability.	38.295542 ° -121.725816 °	38.295636 ° -121.725909 °	5

RD 2098 Unit 3 standing on waterside slope looking downstream from levee mile 7.30. Photo taken 4-23-2013.

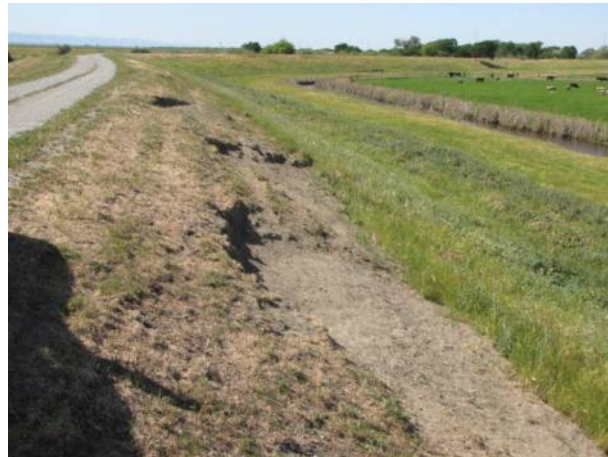
Levee Mile Report Line	5
Start Levee Mile	7.50
End Levee Mile	7.61
Location	Land Side
Category	
Item	Slope Stability

DWR ID: DWR_RD2098_03_s_2013_5										
5	7.50	7.61		Slope Stability	LS	M	S2 : Repair the levee slope damaged by foot traffic and prevent access where possible. Inspector Comments: There is erosion on waterside covered by arundo This is not a new site. Monitor but it appears to be stable at this time. 4-23-2013.	38.295930 ° -121.727043 °	38.298142 ° -121.739715 °	4 Y
DWR ID: DWR_RD2098_03_s_2013_4

RD 2098 Unit 3 landside slope erosion levee mile 7.50-7.61. Photo taken 4-23-2013.

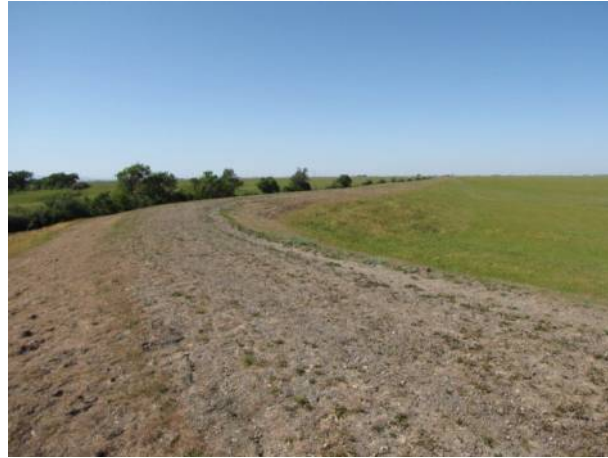
LMR No.	Levee Mile		Category	Item	Location *	Rating **	Action/Comment	GPS Latitude/Longitude		Issue No. Photo
	Start	End						Start	End	
1	9.15	10.89		Vegetation	WS	A	V2 : Remove the wild growth other than native grasses from the levee slopes.	38.316093 ° -121.740144 °	38.340449 ° -121.740796 °	1 Y
								DWR ID: DWR_RD2098_04_s_2013_1		
2	9.44	9.44	Supplemental	USACE Erosion Survey	WS	C	Inspector Comments: 2011 - Several scallops of erosion. Erosion primarily due to the weight of cattle on the slope. 2012: Site is part of the extended inventory, last inspected 2011. [2012 Site ID: HAS_9-7_L]	38.324587 ° -121.740254 °	38.320240 ° -121.740183 °	4
								DWR ID: DWR_RD2098_04_s_2013_4		
3	9.82	10.02		Vegetation	WS	C	V2 : Remove the wild growth other than native grasses from the levee slopes.	38.325251 ° -121.740104 °	38.324998 ° -121.740136 °	2
								DWR ID: DWR_RD2098_04_s_2013_2		
4	9.83	10.01		Vegetation	LS	C	V1 : Control annual grass and weeds on the levee slopes and easements.	38.325289 ° -121.740104 °	38.327656 ° -121.740646 °	12

Levee Mile Report Line	1
Start Levee Mile	9.15
End Levee Mile	10.89
Location	Water Side
Category	
Item	Vegetation
RD 2098 Unit 4 looking downstream waterside slope. Photo taken 4-23-2013.	
phillips_s_20130514_431.JPG
