**Flood Control Project Maintenance  
Levee Inspections****LMA District Cover Sheet  
Spring 2014 Levee Inspection Results****Reclamation District No. 2098 Cache and Haas Slough**

**Levee Inspection Report By Mile - Spring 2014**

**Reclamation District No. 2098 Cache and Haas Slough**

Waterway	Bank	Unit Miles	Inspection Start/End	Inspector
Unit No. 01 Yolo Bypass	Right	3.58	05/13/2014 05/13/2014	Herman Phillips

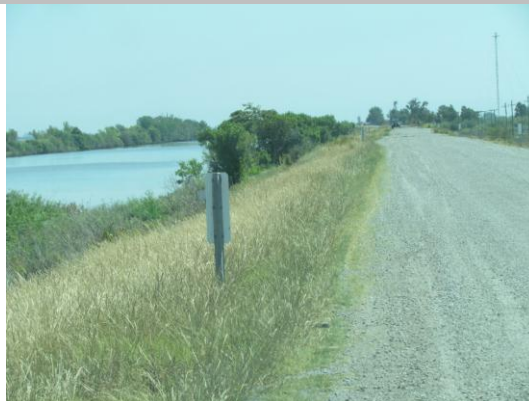
Photo 1 of 1 : phillips\_s\_20140603\_06018.jpg

LM Start	0.02	Rating **	M	Issue No.	2
LM End	0.59	Issue Type +	Ma	Location *	WS
Category	Earthen Levee			GPS Latitude/Longitude	
				Start	End
Item	Vegetation			38.328833 °	38.320446 °
				-121.694141 °	-121.693999 °
DWR ID	DWR_RD2098_01_s _ 2014_2				
Action/Comments					
Control annual grass and weeds on the levee slopes and easements.

RD 2098 Looking downstream waterside levee mile 0.02. Photo taken 13-05-2014.

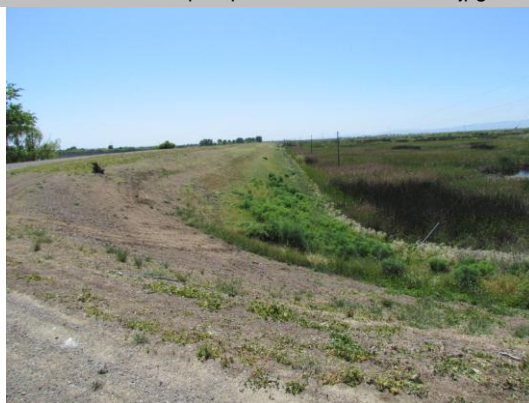
Photo 1 of 1 : phillips\_s\_20140603\_06019.jpg

LM Start	0.02	Rating **	M	Issue No.	1
LM End	3.56	Issue Type +	Ma	Location *	LS
Category	Earthen Levee			GPS Latitude/Longitude	
				Start	End
Item	Vegetation			38.328831 °	38.277636 °
				-121.694142 °	-121.696221 °
DWR ID	DWR_RD2098_01_s _ 2014_1				
Action/Comments					
Control annual grass and weeds on the levee slopes and easements.

Looking downstream from landside slope levee mile 0.02 RD 2098 Unit 1. Photo taken 05-13-2014.

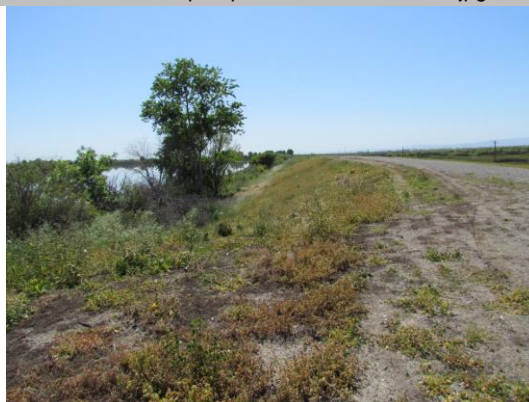
Photo 1 of 1 : phillips\_s\_20140603\_06020.jpg

LM Start	0.01	Rating **	M	Issue No.	2
LM End	0.53	Issue Type +	Ma	Location *	WS
Category	Earthen Levee			GPS Latitude/Longitude	
				Start	End
Item	Vegetation			38.277388 °	38.275763 °
				-121.696465 °	-121.705424 °
DWR ID	DWR_RD2098_01A_s _ 2014_2				
Action/Comments					
Control annual grass and weeds on the levee slopes and easements.

Unit 1A waterside looking downstream. 0.01. Photo taken 05-13-2014.

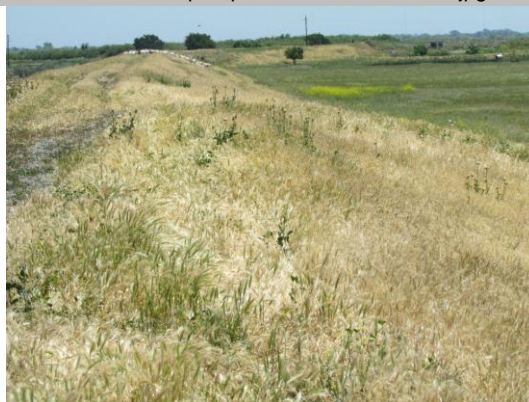
Photo 1 of 1 : phillips\_s\_20140603\_06021.jpg

LM Start	5.29	Rating **	U	Issue No.	2
LM End	7.17	Issue Type +	Ma	Location *	LS
Category	Earthen Levee			GPS Latitude/Longitude	
				Start	End
Item	Vegetation			38.275709 °	38.293009 °
				-121.705718 °	-121.723461 °
DWR ID	DWR_RD2098_02_s _ 2014_2				
Action/Comments					
Control annual grass and weeds on the levee slopes and easements.

Looking downstream from landside slope tall weeds on levee slope.

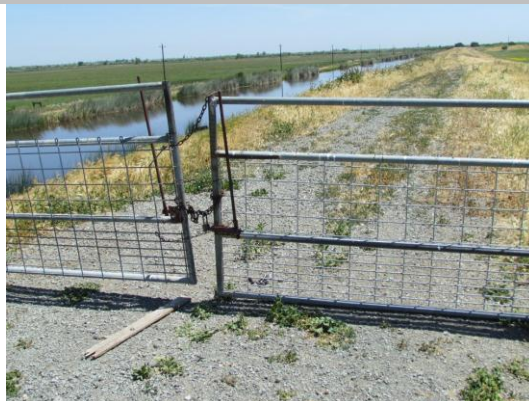
Photo 1 of 1 : phillips\_s\_20140603\_06022.jpg

LM Start	6.71	Rating **	U	Issue No.	4
LM End	6.71	Issue Type +	Ma	Location *	CR
Category	Earthen Levee			GPS Latitude/Longitude	
				Start	End
Item	Repair Gates			38.289452 °	38.289452 °
				-121.716814 °	-121.716814 °
DWR ID	DWR_RD2098_02_f_2013_4				
Action/Comments					
Inspector Comments: This gate is damaged and requires replacement.

This gate has no hinges.

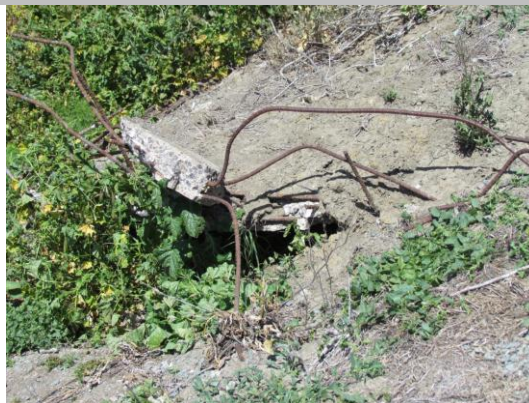
Photo 1 of 1 : phillips\_s\_20140603\_06023.jpg

LM Start	6.72	Rating **	U	Issue No.	10
LM End	6.72	Issue Type +	Ma	Location *	WS
Category	Earthen Levee			GPS Latitude/Longitude	
				Start	End
Item	Slope Stability			38.292076 °	38.292076 °
				-121.715792 °	-121.715792 °
DWR ID	DWR_RD2098_02_s_2014_10				
Action/Comments					
Repair slope instability.

There is some slope damage at this location under this concrete.

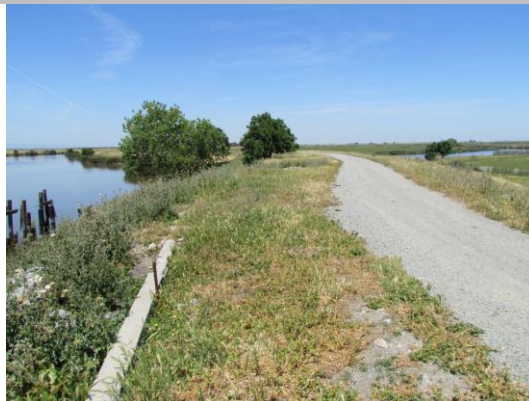
Photo 1 of 1 : phillips\_s\_20140603\_06024.jpg

LM Start	7.30	Rating **	M	Issue No.	3
LM End	9.09	Issue Type +	Ma	Location *	WS
Category	Earthen Levee			GPS Latitude/Longitude	
				Start	End
Item	Vegetation			38.294205 °	38.314957 °
				-121.725057 °	-121.738939 °
DWR ID	DWR_RD2098_03_s_2014_3				
Action/Comments					
Control annual grass and weeds on the levee slopes and easements.

Looking downstream from the waterside of Unit 3. Photo taken 05-14-2014.

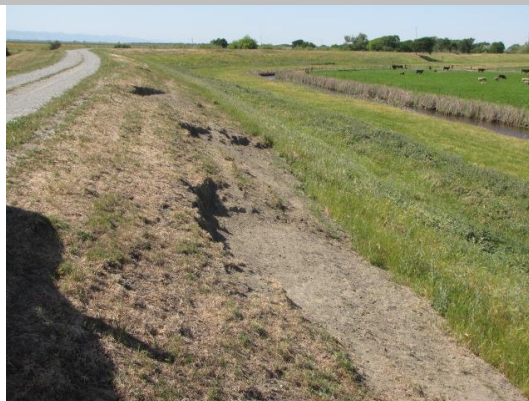
Photo 1 of 1 : phillips\_s\_20140513\_05867.jpg

LM Start	7.50	Rating **	M	Issue No.	4
LM End	7.61	Issue Type +	Ma	Location *	WS
Category	Earthen Levee			GPS Latitude/Longitude	
				Start	End
Item	Slope Stability			38.295930 °	38.298142 °
				-121.727043 °	-121.739715 °
DWR ID	DWR_RD2098_03_s _ 2013_4				
Action/Comments					
Repair slope instability. Inspector Comments: There is erosion on waterside covered by tullies. This is not a new site. Monitor but it appears to be stable at this time, 4-23-2013. During inspection 5-14-2014 no movement at site.

RD 2098 Unit 3 landside slope erosion levee mile 7.50-7.61. Photo taken 4-23-2013.

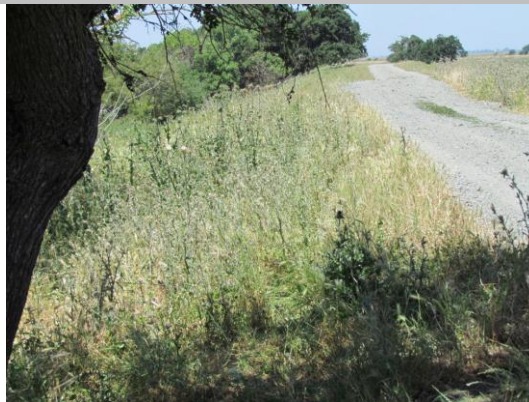
Photo 1 of 1 : phillips\_s\_20140603\_06026.jpg

LM Start	7.89	Rating **	U	Issue No.	10
LM End	7.91	Issue Type +	Ma	Location *	WS
Category	Earthen Levee			GPS Latitude/Longitude	
				Start	End
Item	Vegetation			38.301498 °	38.301846 °
				-121.728064 °	-121.728047 °
DWR ID	DWR_RD2098_03_s _ 2014_10				
Action/Comments					
Remove the wild growth other than native grasses from the levee slopes.

Looking downstream from the waterside slope tall weeds covering the levee section.

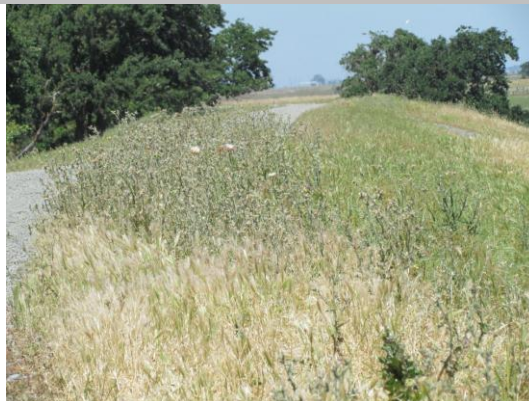
Photo 1 of 1 : phillips\_s\_20140603\_06025.jpg

LM Start	7.89	Rating **	U	Issue No.	11
LM End	7.92	Issue Type +	Ma	Location *	LS
Category	Earthen Levee			GPS Latitude/Longitude	
				Start	End
Item	Vegetation			38.301502 °	38.302011 °
				-121.728055 °	-121.728037 °
DWR ID	DWR_RD2098_03_s _ 2014_11				
Action/Comments					
Remove the wild growth other than native grasses from the levee slopes.

Looking downstream from the landside slope there are tall weeds covering the levee section.

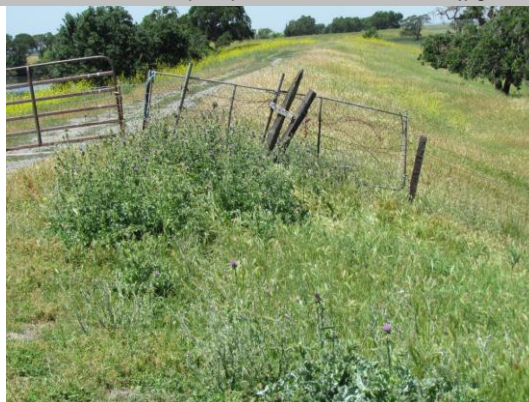
Photo 1 of 1 : phillips\_s\_20140603\_06027.jpg

LM Start	8.34	Rating **	U	Issue No.	13
LM End	9.09	Issue Type +	Ma	Location *	LS
Category	Earthen Levee			GPS Latitude/Longitude	
				Start	End
Item	Vegetation			38.306442 °	38.314957 °
				-121.731284 °	-121.738939 °
DWR ID	DWR_RD2098_03_s_2014_13				
Action/Comments					
Remove the wild growth other than native grasses from the levee slopes.

Tall weeds on the landside shoulder slope and toe of the levee section.

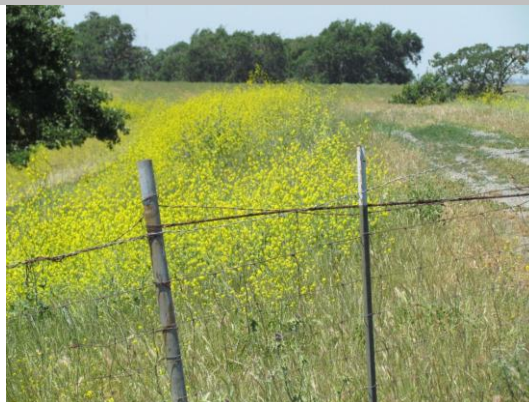
Photo 1 of 1 : phillips\_s\_20140603\_06028.jpg

LM Start	8.37	Rating **	U	Issue No.	14
LM End	9.07	Issue Type +	Ma	Location *	WS
Category	Earthen Levee			GPS Latitude/Longitude	
				Start	End
Item	Vegetation			38.306778 °	38.314746 °
				-121.731875 °	-121.738696 °
DWR ID	DWR_RD2098_03_s_2014_14				
Action/Comments					
Remove the wild growth other than native grasses from the levee slopes.

Unsatisfactory growth of tall mustard grass completely covering the waterward levee slope.

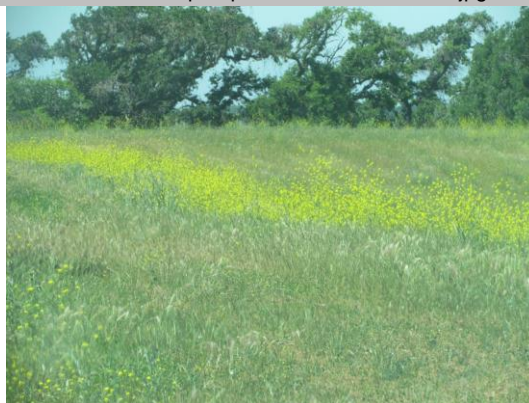
Photo 1 of 1 : phillips\_s\_20140603\_06029.jpg

LM Start	8.39	Rating **	U	Issue No.	15
LM End	8.97	Issue Type +	Ma	Location *	CR
Category	Earthen Levee			GPS Latitude/Longitude	
				Start	End
Item	Vegetation			38.307004 °	38.313686 °
				-121.732025 °	-121.737480 °
DWR ID	DWR_RD2098_03_s _ 2014_15				
Action/Comments					
Keep the crown roadway free of vegetation.

Unsatisfactory tall weeds are covering landside slope.

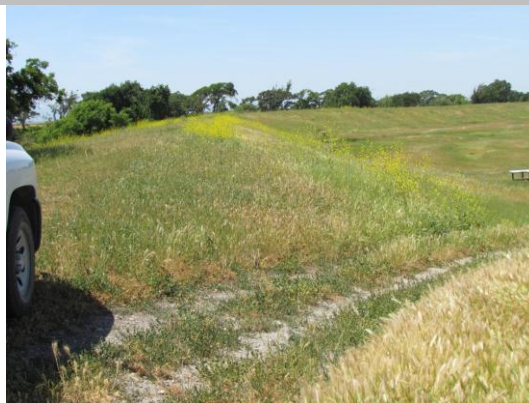
Photo 1 of 1 : phillips\_s\_20140603\_06030.jpg

LM Start	8.49	Rating **	U	Issue No.	16
LM End	9.07	Issue Type +	Ma	Location *	LS
Category	Earthen Levee			GPS Latitude/Longitude	
				Start	End
Item	Vegetation			38.308240 °	38.314906 °
				-121.732891 °	-121.738885 °
DWR ID	DWR_RD2098_03_s _ 2014_16				
Action/Comments					
Remove the wild growth other than native grasses from the levee slopes.

Tall weed grasses covering the landside levee slope.

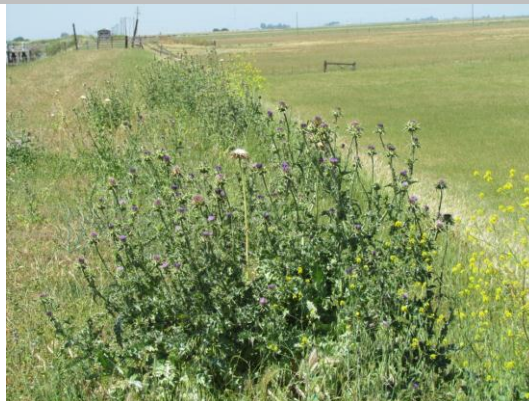
Photo 1 of 1 : phillips\_s\_20140603\_06031.jpg

LM Start	9.51	Rating **	U	Issue No.	5
LM End	9.54	Issue Type +	Ma	Location *	LS
Category	Earthen Levee			GPS Latitude/Longitude	
				Start	End
Item	Vegetation			38.320664 °	38.321113 °
				-121.740173 °	-121.740143 °
DWR ID	DWR_RD2098_04_s_2014_5				
Action/Comments					
Remove the wild growth other than native grasses from the levee slopes.

Unsatisfactory tall weeds on the landside shoulder and slope. Photo taken 05-14-2014.

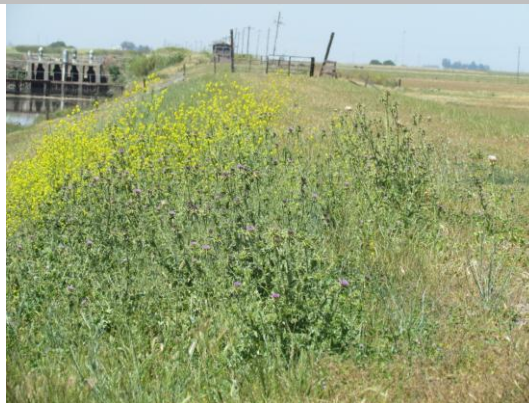
Photo 1 of 1 : phillips\_s\_20140603\_06032.jpg

LM Start	9.51	Rating **	U	Issue No.	3
LM End	9.54	Issue Type +	Ma	Location *	WS
Category	Earthen Levee			GPS Latitude/Longitude	
				Start	End
Item	Vegetation			38.320664 °	38.321116 °
				-121.740173 °	-121.740146 °
DWR ID	DWR_RD2098_04_s_2014_3				
Action/Comments					
Remove the wild growth other than native grasses from the levee slopes.

Unsatisfactory milk weeds covering the waterside levee section. Photo taken 05-14-2014.

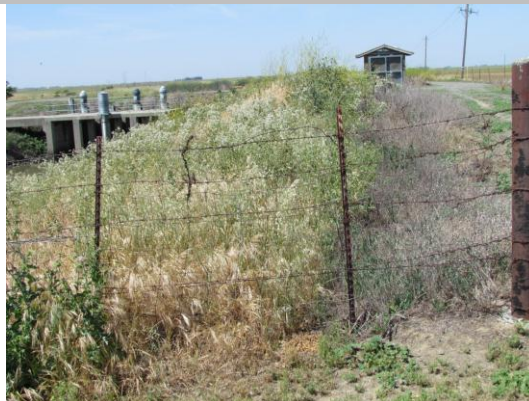
Photo 1 of 1 : phillips\_s\_20140603\_06033.jpg

LM Start	9.80	Rating **	U	Issue No.	9
LM End	9.83	Issue Type +	Ma	Location *	WS
Category	Earthen Levee			GPS Latitude/Longitude	
				Start	End
Item	Vegetation			38.324968 °	38.325364 °
				-121.740118 °	-121.740084 °
DWR ID	DWR_RD2098_04_s _ 2014_9				
Action/Comments					
Control annual grass and weeds on the levee slopes and easements.

Unsatisfactory tall weeds covering the waterward slope and shoulder.

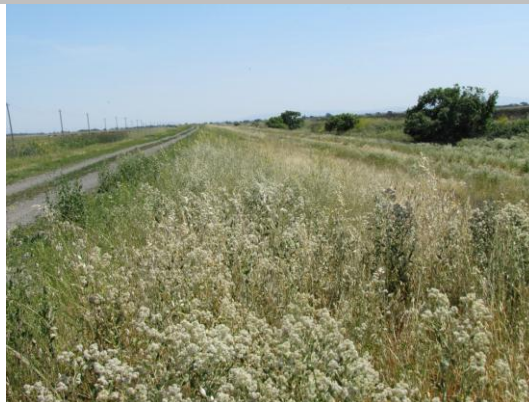
Photo 1 of 1 : phillips\_s\_20140603\_06035.jpg

LM Start	9.83	Rating **	U	Issue No.	13
LM End	11.13	Issue Type +	Ma	Location *	WS
Category	Earthen Levee			GPS Latitude/Longitude	
				Start	End
Item	Vegetation			-38.325355 °	38.343856 °
				121.740095 °	-21.740803 °
DWR ID	DWR_RD2098_04_s _ 2014_13				
Action/Comments					
Remove the wild growth other than native grasses from the levee slopes.

Waterside looking upstream at tall weeds covering the levee section.

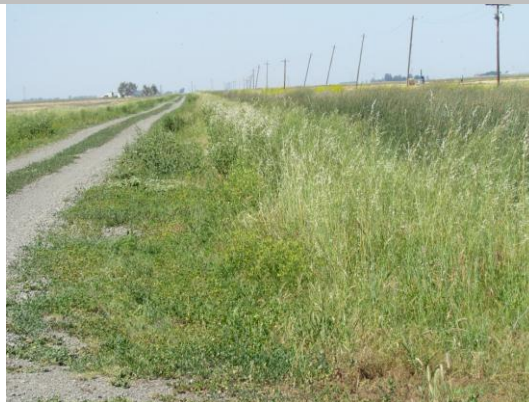
Photo 1 of 1 : phillips\_s\_20140603\_06034.jpg

LM Start	11.13	Rating **	U	Issue No.	11
LM End	12.12	Issue Type +	Ma	Location *	WS
Category	Earthen Levee			GPS Latitude/Longitude	
				Start	End
Item	Vegetation			38.343856 °	38.358206 °
				-121.740803 °	-121.740377 °
DWR ID	DWR_RD2098_04_s_2014_11				
Action/Comments					
Remove the wild growth other than native grasses from the levee slopes.

Tall weeds along the canal.
