**Flood Control Project Maintenance
Levee Inspections**
LMA District Cover Sheet
Spring 2015 Levee Inspection Results

Reclamation District No. 2098 Cache and Haas Slough

Spring 2015 Levee Inspection Results

Levee Inspection Report By Mile - Spring 2015

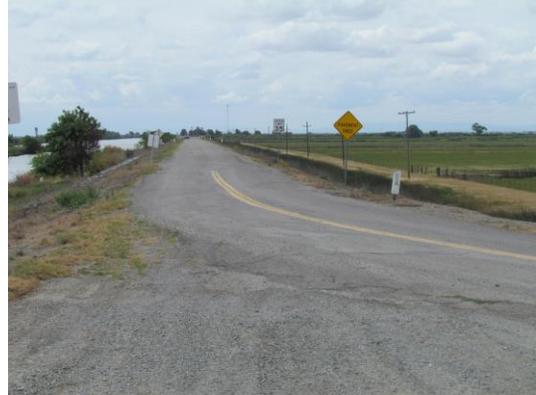
Photo 1 of 1 : SP_2015_RD2098_244_10_20150604_00002.jpg

LM Start	0.14	Rating **	A	Issue No.	10
LM End	3.58	Issue Type +	Ma	Location *	WS
Category	Earthen Levee		GPS Latitude/Longitude		
			Start	End	
Item	Vegetation		38.327017 °	38.277623 °	
			-121.694053 °	-121.696213 °	
DWR ID	DWR_RD2098_01_s_2015_10				
Action/Comments					
Control annual grass and weeds on the levee slopes and easements.

Looking downstream at the waterside levee slope.

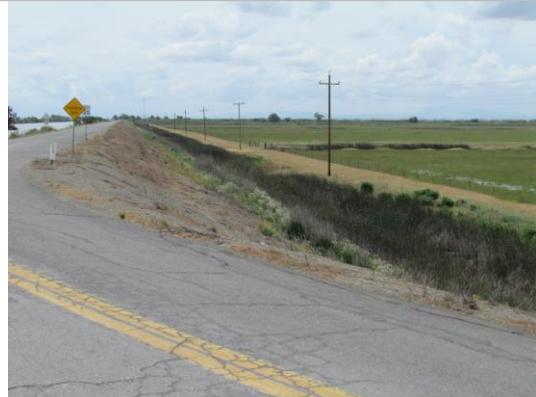
Photo 1 of 1 : SP_2015_RD2098_244_11_20150604_00001.jpg

LM Start	0.14	Rating **	A	Issue No.	11
LM End	3.58	Issue Type +	Ma	Location *	LS
Category	Earthen Levee		GPS Latitude/Longitude		
			Start	End	
Item	Vegetation		38.327010 °	38.277623 °	
			-121.694055 °	-121.696213 °	
DWR ID	DWR_RD2098_01_s_2015_11				
Action/Comments					
Control annual grass and weeds on the levee slopes and easements.

View looking downstream at the landside levee slope.

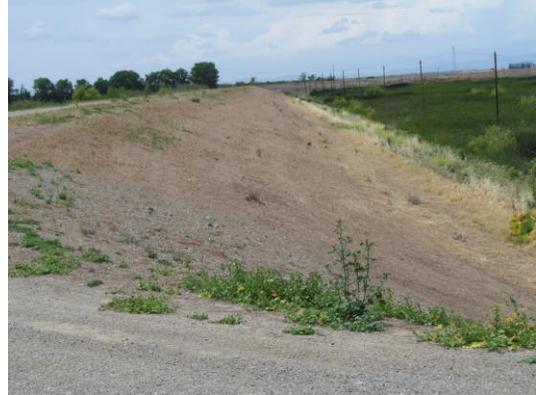
Photo 1 of 1 : SP_2015_RD2098_245_2_20150604_00001.jpg

LM Start	0.00	Rating **	A	Issue No.	2
LM End	0.53	Issue Type +	Ma	Location *	LS
Category	Earthen Levee			GPS Latitude/Longitude	
				Start	End
Item	Vegetation			38.277408 °	38.275722 °
				-121.696282 °	-121.705772 °
DWR ID	DWR_RD2098_01A_s_2015_2				
Action/Comments					
Control annual grass and weeds on the levee slopes and easements.

View looking at the landside slope.

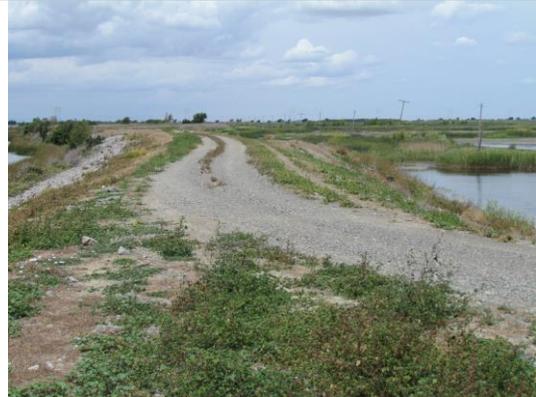
Photo 1 of 1 : SP_2015_RD2098_246_11_20150604_00003.jpg

LM Start	5.31	Rating **	A	Issue No.	11
LM End	6.74	Issue Type +	Ma	Location *	LS
Category	Earthen Levee		GPS Latitude/Longitude		
			Start	End	
Item	Vegetation		38.275935 °	38.292505 °	
			-121.705900 °	-121.716120 °	
DWR ID	DWR_RD2098_02_s_2015_11				
Action/Comments					
Control annual grass and weeds on the levee slopes and easements.

View looking downstream at levee section.

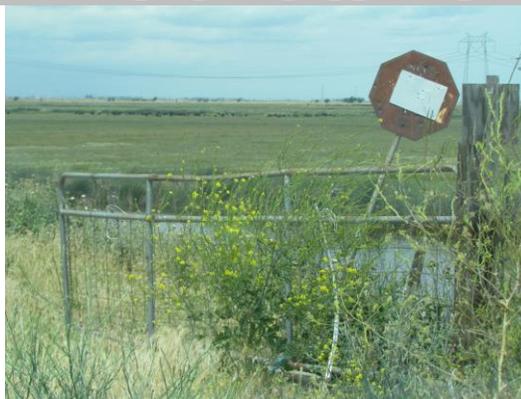
Photo 1 of 1 : SP_2015_RD2098_246_4_20150604_00004.jpg

LM Start	6.73	Rating **	U	Issue No.	4
LM End	6.73	Issue Type +	Ma	Location *	CR
Category	Earthen Levee			GPS Latitude/Longitude	
				Start	End
Item	Repair Gates			38.292428 °	38.292428 °
				-121.716062 °	-121.716062 °
DWR ID	DWR_RD2098_02_f_2013_4				
Action/Comments					
Inspector Comments: This gate is damaged and requires replacement.

View of the broken gate.

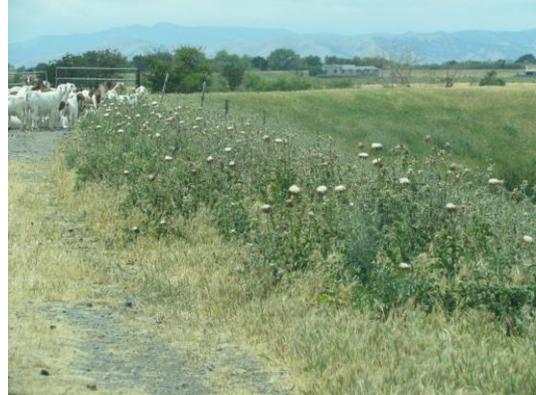
Photo 1 of 1 : SP_2015_RD2098_246_17_20150604_00008.jpg

LM Start	7.09	Rating **	U	Issue No.	17
LM End	7.15	Issue Type +	Ma	Location *	LS
Category	Earthen Levee			GPS Latitude/Longitude	
				Start	End
Item	Vegetation			38.292975 °	38.293008 °
				-121.722357 °	-121.723457 °
DWR ID	DWR_RD2098_02_s_2015_17				
Action/Comments					
Remove the wild growth other than native grasses from the levee slopes. Inspector Comments: Remove the unacceptable weeds from the landside slope.

View of unacceptable weeds on the landside levee slope.

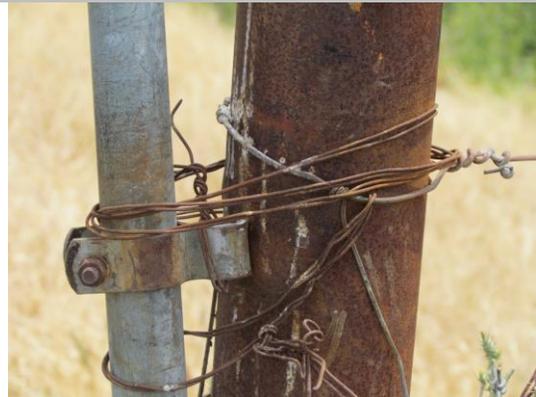
Photo 1 of 2 : SP_2015_RD2098_246_19_20150604_00006.jpg

LM Start	7.15	Rating **	U	Issue No.	19
LM End	7.15	Issue Type +	Ma	Location *	CR
Category	Earthen Levee			GPS Latitude/Longitude	
				Start	End
Item	Repair Gates			38.293008 °	38.293008 °
				-121.723457 °	-121.723457 °
DWR ID	DWR_RD2098_02_s_2015_19				
Action/Comments					
Inspector Comments: Repair the broken gate.

View of the broken gate hinge.

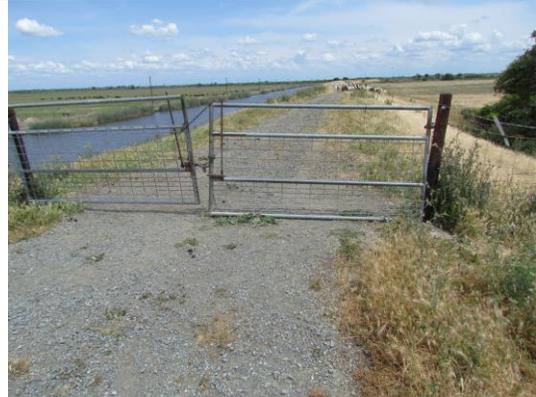
Photo 2 of 2 : SP_2015_RD2098_246_19_20150604_00007.jpg

LM Start	7.15	Rating **	U	Issue No.	19 (cont)
LM End	7.15	Issue Type +	Ma	Location *	CR
Category	Earthen Levee			GPS Latitude/Longitude	
				Start	End
Item	Repair Gates			38.293008 °	38.293008 °
				-121.723457 °	-121.723457 °
DWR ID	DWR_RD2098_02_s_2015_19				
Action/Comments					
Inspector Comments: Repair the broken gate.

View of the broken gate crossing levee crown.

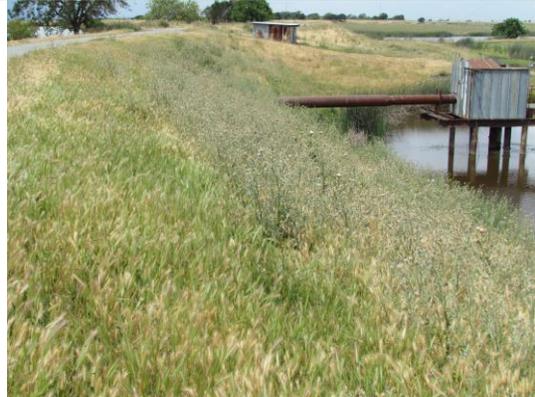
Photo 1 of 1 : SP_2015_RD2098_247_8_20150604_00007.jpg

LM Start	7.22	Rating **	U	Issue No.	8
LM End	7.77	Issue Type +	Ma	Location *	LS
Category	Earthen Levee			GPS Latitude/Longitude	
				Start	End
Item	Vegetation			38.293483 °	38.300218 °
				-121.724547 °	-121.728303 °
DWR ID	DWR_RD2098_03_s_2015_8				
Action/Comments					
Remove the wild growth other than native grasses from the levee slopes. Inspector Comments: Remove the tall weeds from the landside slope.

View of unacceptable tall weeds on the landside levee slope.

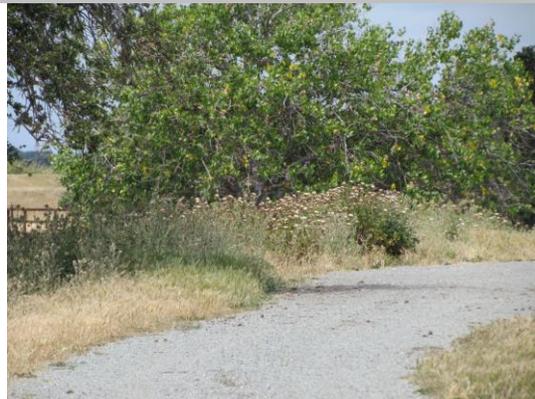
Photo 1 of 1 : SP_2015_RD2098_247_10_20150604_00008.jpg

LM Start	7.25	Rating **	U	Issue No.	10
LM End	7.60	Issue Type +	Ma	Location *	WS
Category	Earthen Levee			GPS Latitude/Longitude	
				Start	End
Item	Vegetation			38.293902 °	38.297882 °
				-121.724890 °	-121.728647 °
DWR ID	DWR_RD2098_03_s_2015_10				
Action/Comments					
Remove the wild growth other than native grasses from the levee slopes. Inspector Comments: Remove the unacceptable tall weeds from the waterside slope.

View of unacceptable tall weeds on the waterside levee shoulder and slope.

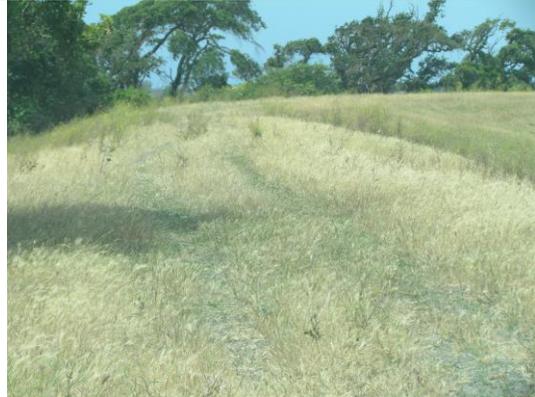
Photo 1 of 1 : SP_2015_RD2098_247_19_20150604_00009.jpg

LM Start	8.46	Rating **	U	Issue No.	19
LM End	8.69	Issue Type +	Ma	Location *	CR
Category	Earthen Levee		GPS Latitude/Longitude		
			Start	End	
Item	Vegetation		38.308293 °	38.311033 °	
			-121.732993 °	-121.734652 °	
DWR ID	DWR_RD2098_03_s_2015_19				
Action/Comments					
Keep the crown roadway free of vegetation. Inspector Comments: Control the weeds off the crown roadway.

View of unacceptable weeds on the crown roadway.

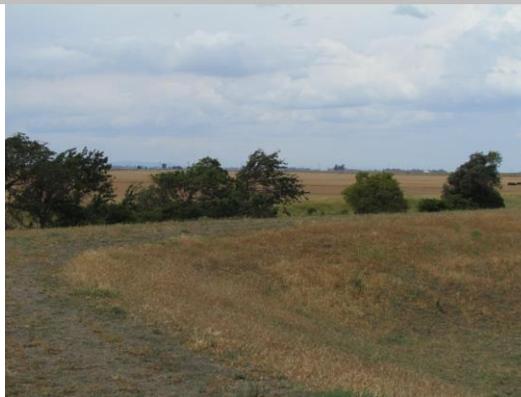
Photo 1 of 1 : SP_2015_RD2098_248_4_20150604_00002.jpg

LM Start	9.15	Rating **	M	Issue No.	4
LM End	9.15	Issue Type +	Ma	Location *	LS
Category	Earthen Levee		GPS Latitude/Longitude		
			Start	End	
Item	Vegetation		38.316167 °	38.316167 °	
			-121.740120 °	-121.740115 °	
DWR ID	DWR_RD2098_04_s_2014_4				
Action/Comments					
Remove the wild growth other than native grasses from the levee slopes.

View looking downstream along the landside slope.

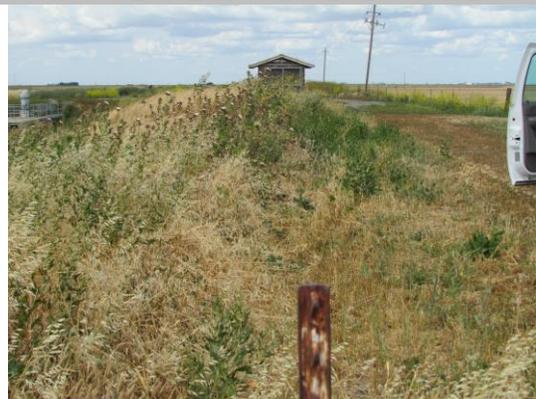
Photo 1 of 1 : SP_2015_RD2098_248_12_20150604_00003.jpg

LM Start	9.77	Rating **	U	Issue No.	12
LM End	9.78	Issue Type +	Ma	Location *	WS
Category	Earthen Levee		GPS Latitude/Longitude		
			Start	End	
Item	Vegetation		38.325062 °	38.325265 °	
			-121.740128 °	-121.740100 °	
DWR ID	DWR_RD2098_04_s_2015_12				
Action/Comments					
Control annual grass and weeds on the levee slopes and easements. Inspector Comments: Remove the unacceptable vegetation.

View of unacceptable tall weeds on the waterside levee slope.
