**Flood Control Project Maintenance
Levee Inspections****LMA District Cover Sheet
Spring 2016 Levee Inspection Results****Reclamation District No. 2098 Cache and Haas Slough**

Spring 2016 Levee Inspection Results

Reclamation District No. 2098 Cache and Haas Slough

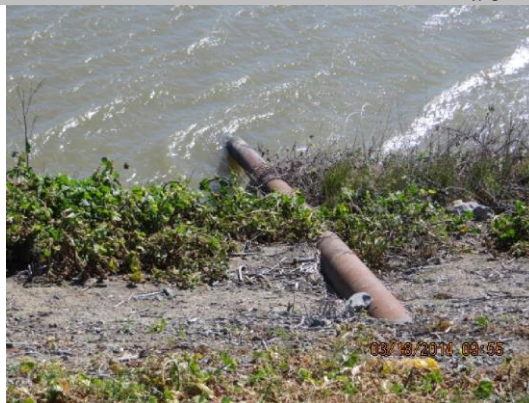
Photo 1 of 2 : UCIP_SP_2016_32197_58662.jpg

LM Start	1.82	Rating **	M	Issue No.	14
LM End	1.82	Issue Type +	En	Location *	WS
Category	Supplemental			GPS Latitude/Longitude	
				Start	End
Item	DWR UCIP Field Study			38.302770 °	38.302770 °
				-121.693640 °	-121.693640 °
DWR ID					
Comment Code					
Inspector Comment					
FS_ID:32197					
DS_ID:20965					
EP_NO: 10168					
Repair Type: Non-Urgent					
Crossing Status: Found					
UCIP Comments: Erosion under pipe at WS toe.					
FIELD_STRUCT_DESC: 10-inch steel drainpipe through the levee, 2.8-feet below the crown. Pump in pump house off the landward side. (USACE-1962). This entry matches the Drainage or Irrigation Structure referenced in O&M manual (HLM 1.80). This pipe was retained under ABO No. 10168 (1974).					
FS Date: 3/18/2014

Pipe on WS slope.

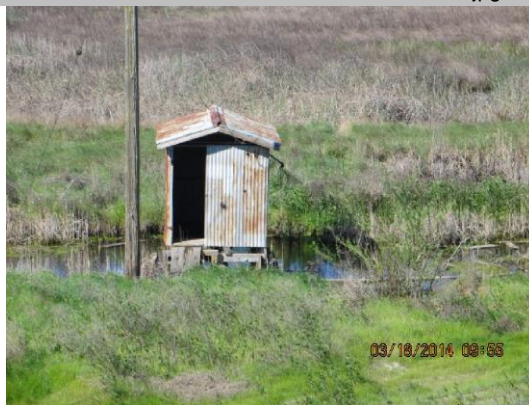
Photo 2 of 2 : UCIP_SP_2016_32197_58661.jpg

Pumphouse at lowpoint off LS toe.

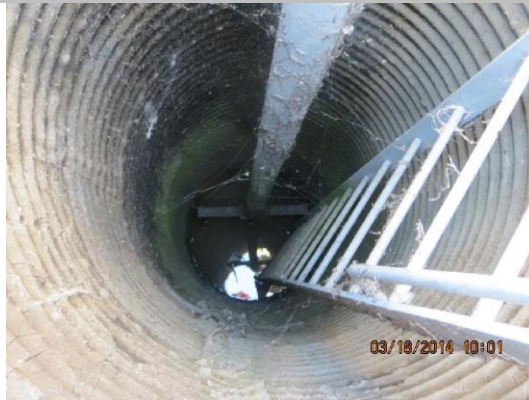
Photo 2 of 2 : UCIP_SP_2016_32207_58664.jpg

No lid on CMP riser that is 24-feet deep.

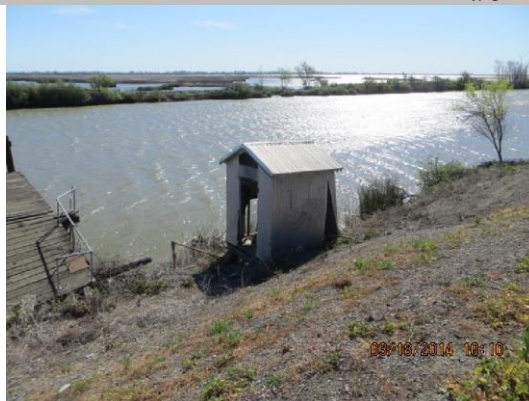
Photo 1 of 2 : UCIP_SP_2016_32225_58687.jpg

LM Start	2.00	Rating **	M	Issue No.	16
LM End	2.00	Issue Type +	En	Location *	WS
Category	Supplemental			GPS Latitude/Longitude	
				Start	End
Item	DWR UCIP Field Study			38.300152 °	38.300152 °
				-121.693626 °	-121.693626 °
DWR ID					
Comment Code					
Inspector Comment					
FS_ID:32225 DS_ID:20967 EP_NO: 10168 Repair Type: Non-Urgent Crossing Status: Found UCIP Comments: Pipe appears abandoned and if so should be done so properly. Pipe open on WS at pumphouse as there is no connection to pump. FIELD_STRUCT_DESC: 2-inch galvanized iron irrigation pipe through the levee, 10.0 feet below the crown. Pump in pump house on the waterward slope next to Fishing dock. Power pole and meter at LS toe, next to hose bib. 1-inch steel electrical conduit at same location. This pipe was retained under ABO No. 10168 (1974). FS Date: 3/18/2014

Pumphouse next to fishing dock on WS slope.

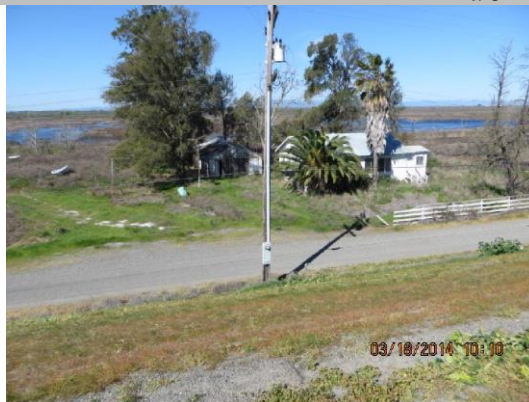
Photo 2 of 2 : UCIP_SP_2016_32225_58686.jpg

Power pole and meter next to spigot on LS toe.

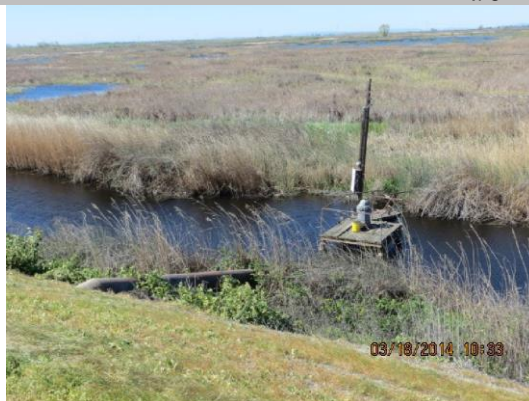
Photo 1 of 2 : UCIP_SP_2016_32227_58692.jpg

Comment Code					
Inspector Comment					
FS_ID:32227 DS_ID:20969 EP_NO: 13222 Repair Type: Non-Urgent Crossing Status: Found UCIP Comments: Pipe rusted through at outlet on WS slope, may indicate further degradation of pipe within levee. Good candidate for video inspection. FIELD_STRUCT_DESC: 20-inch steel drainpipe through the levee, 7.5 feet below the crown. Siphon breaker at waterward shoulder. Pump on pile structure in drain ditch on landward side. (USACE-1962). This entry matches the Drainage or Irrigation Structure referenced in O&M manual (HLM 2.98). This pipe was retained under ABO No. 10168 (1974). Pipe removed and replaced with 19-inch steel pipe under crown and along landward slope under Permit No. 13222 (1982). FS Date: 3/18/2014

Pump on pile structure in drainage channel on LS toe.

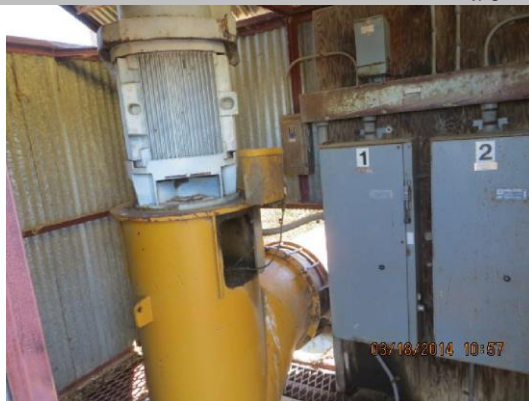
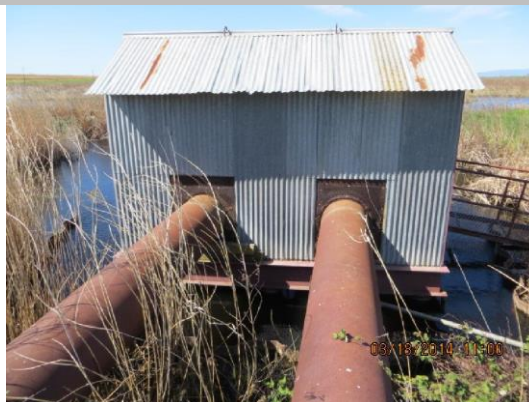
LM Start	3.50	Rating **	M	Issue No.	20
LM End	3.50	Issue Type +	En	Location *	WS
Category	Supplemental			GPS Latitude/Longitude	
				Start	End
Item	DWR UCIP Field Study			38.278770 °	38.278770 °
				-121.696050 °	-121.696050 °
DWR ID					
Comment Code					
Inspector Comment					
FS_ID:41717 DS_ID:20971 EP_NO: 15169 Repair Type: Non-Urgent Crossing Status: Found UCIP Comments: Debris and soil buildup in riser may prevent proper function of siphon breaker. FIELD_STRUCT_DESC: 1 of 2: 24-inch steel drainpipe through the levee, 5.6 feet below the crown. Cutoff wall around pipe at center of levee. Siphon breaker at waterward shoulder. Flap gate on waterward end. Pump in pump house on piling structure on landward side. (Permit No. 15169-1989) FS Date: 3/18/2014

Pump in pumphouse on LS toe.

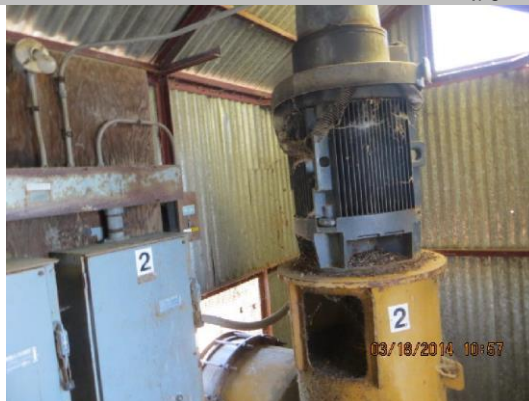
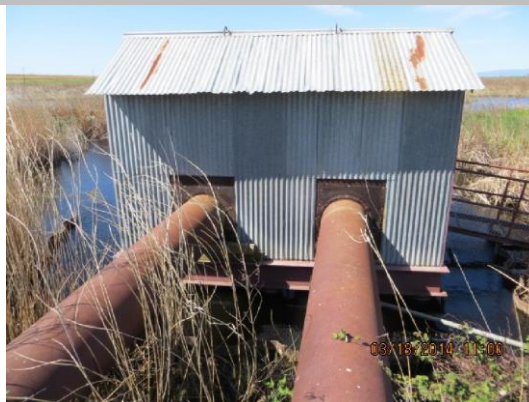
LM Start	3.50	Rating **	M	Issue No.	19
LM End	3.50	Issue Type +	En	Location *	WS
Category	Supplemental			GPS Latitude/Longitude	
				Start	End
Item	DWR UCIP Field Study			38.278759 °	38.278759 °
				-121.696059 °	-121.696059 °
DWR ID					
Comment Code					
Inspector Comment					
FS_ID:32245 DS_ID:20959 EP_NO: 15169 Repair Type: Non-Urgent Crossing Status: Found UCIP Comments: Soil and debris buildup in steel riser on WS shoulder may prevent proper function of siphon breaker. FIELD_STRUCT_DESC: 2 of 2: 24-inch steel pipe through the levee, 5.6 feet below the crown. Cutoff wall around pipe at center of levee. Siphon breaker at waterward shoulder. Flap gate on waterward end. Pump in pump house on piling structure on landward side. (Permit No. 15169-1989) FS Date: 3/18/2014

Pump in pumphouse on LS toe.

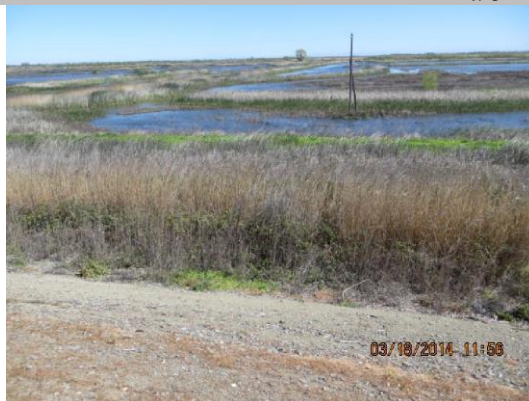
Photo 1 of 2 : UCIP_SP_2016_32287_58755.jpg

LM Start	5.71	Rating **	M	Issue No.	22
LM End	5.71	Issue Type +	En	Location *	LS
Category	Supplemental			GPS Latitude/Longitude	
				Start	End
Item	DWR UCIP Field Study			38.280788 °	38.280788 °
				-121.709617 °	-121.709617 °
DWR ID					
Comment Code					
Inspector Comment					
FS_ID:32287 DS_ID:20973 EP_NO: 10172 Repair Type: Non-Urgent Crossing Status: Found UCIP Comments: Pipe appears abandoned and if so should be done so properly. Slide gate appears to be open and should be closed for the season. FIELD_STRUCT_DESC: 24-inch CM pipe through the levee, 22.8 feet below the crown. Two cutoff walls around pipe at levee shoulders. Slide gate in 36-inch CMP riser on waterward slope. Flap gate and concrete "U" headwall on landward end. This pipe was retained under ABO No. 10172 (1974). FS Date: 3/18/2014

LS - no pipe visible.

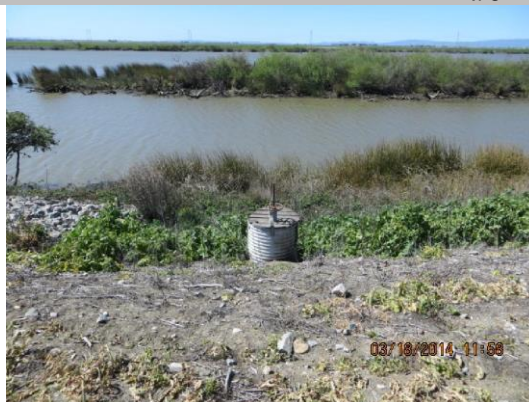
Photo 2 of 2 : UCIP_SP_2016_32287_58754.jpg

Slide gate in 36-inch standpipe on WS slope.

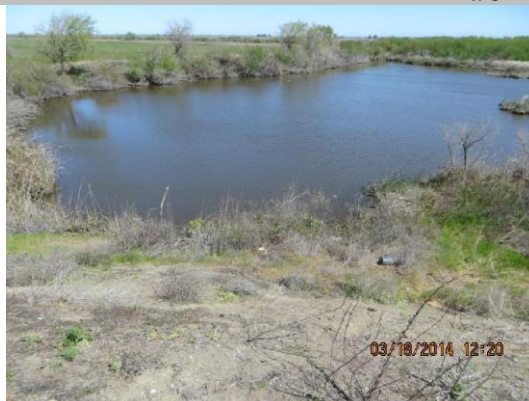
Photo 1 of 2 : UCIP_SP_2016_32285_58749.jpg

LM Start	6.72	Rating **	M	Issue No.	21
LM End	6.72	Issue Type +	En	Location *	WS
Category	Supplemental			GPS Latitude/Longitude	
				Start	End
Item	DWR UCIP Field Study			38.292234 °	38.292234 °
				-121.715875 °	-121.715875 °
DWR ID					
Comment Code					
Inspector Comment					
FS_ID:32285 DS_ID:20961 EP_NO: 10172 Repair Type: Non-Urgent Crossing Status: Found UCIP Comments: Headwalls at WS toe failing. It is uncertain if these retaining walls were a permanent fixture or a temporary fix that failed. FIELD_STRUCT_DESC: 2 of 2: 48-inch CM drainpipe through the levee, 29.0 feet below the crown. Two slidegates in a 7-foot diameter CMP riser on WS shoulder (USACE-1962). This entry matches the Drainage or Irrigation Structure referenced in O&M manual (HLM 6.75). This pipe was retained under ABO No. 10172 (1974). FS Date: 3/18/2014

Inlet not visible on LS toe.

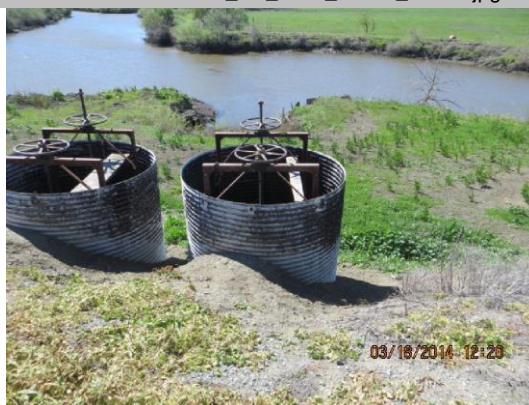
Photo 2 of 2 : UCIP_SP_2016_32285_58748.jpg

7-foot diameter CMP riser with two slide gates inside.

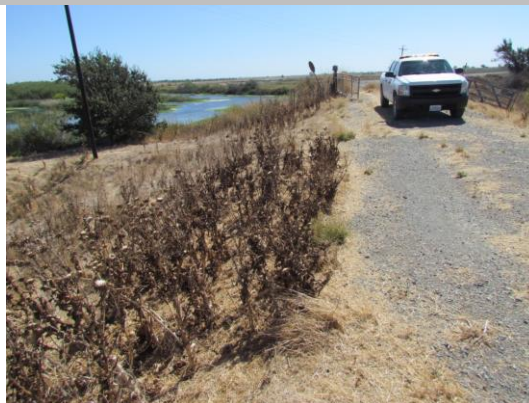
Photo 1 of 1 : SP_2016_RD2098_246_13_20160223_00003.jpg

Unsatisfactory tall weeds on the landside shoulder and slope.

LM Start	6.74	Rating **	M	Issue No.	14
LM End	7.10	Issue Type +	Ma	Location *	WS
Category	Earthen Levee			GPS Latitude/Longitude	
				Start	End
Item	Vegetation			38.292500 °	38.292967 °
				-121.716143 °	-121.722650 °
DWR ID	DWR_RD2098_02_s_2016_14				
Comment Code					
V1 : Control annual grass and weeds on the levee slopes and easements.					
Inspector Comment

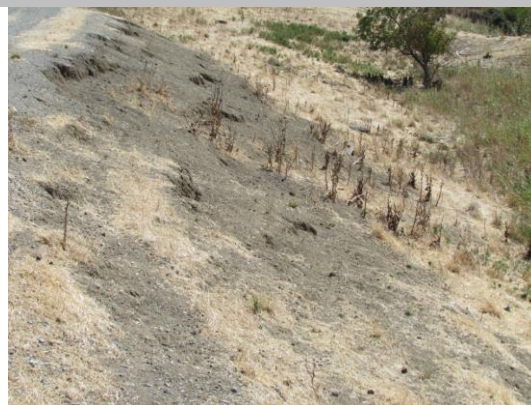
Photo 1 of 1 : SP_2016_RD2098_246_15_20160223_00004.jpg

LM Start	6.78	Rating **	M	Issue No.	15
LM End	6.80	Issue Type +	Ma	Location *	WS
Category	Earthen Levee			GPS Latitude/Longitude	
				Start	End
Item	Erosion / Bank Caving			38.292838 °	38.292917 °
				-121.716733 °	-121.717160 °
DWR ID	DWR_RD2098_02_f_2015_15				
Comment Code					
E1 : Note and monitor erosion site.					
Inspector Comment					
Need to add material to the damaged slope caused by goats.

Slope damage caused by goats.

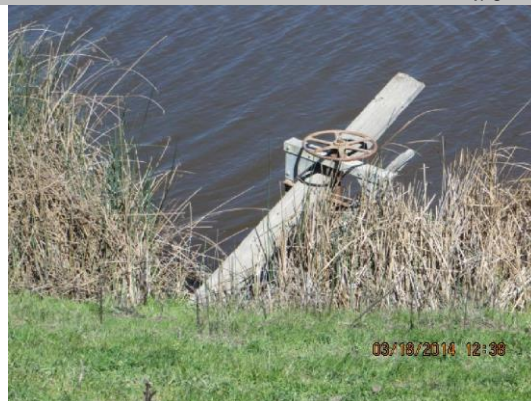
Photo 1 of 2 : UCIP_SP_2016_32290_58764.jpg

LM Start	7.19	Rating **	M	Issue No.	23
LM End	7.19	Issue Type +	En	Location *	LS
Category	Supplemental			GPS Latitude/Longitude	
				Start	End
Item	DWR UCIP Field Study			38.293139 °	38.293139 °
				-121.724174 °	-121.724174 °
DWR ID					
Comment Code					
Inspector Comment					
FS_ID:32290 DS_ID:20977 EP_NO: 10171 Repair Type: Non-Urgent Crossing Status: Found UCIP Comments: Pipe appears to be abandoned and if so it should be done so properly. Walkway to gate valve actuator on WS slope is in disrepair and does not appear to be safe for use. FIELD_STRUCT_DESC: 36-inch CM drain/irrigation pipe through the levee, 23.0 feet below the crown. Walkway to slide gate on waterward end. Slide gate at LS toe (USACE-1962). This entry matches the Drainage or Irrigation Structure referenced in O&M manual (HLM 7.23). This pipe was retained under ABO No. 10171 (1974). FS Date: 3/18/2014

Slide gate at LS toe.

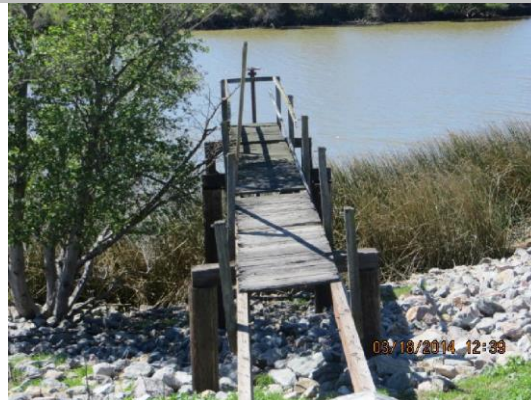
Photo 2 of 2 : UCIP_SP_2016_32290_58763.jpg

Delapidated wooden pier on WS shoulder.

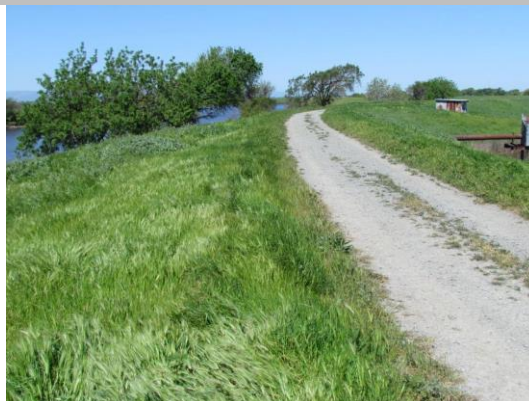
Photo 1 of 1 : SP_2016_RD2098_247_15_20160511_00009.jpg

RD 2098 Unit 3 levee mile 7.19-7.43 looking downstream tall weeds covering the waterside levee slope.

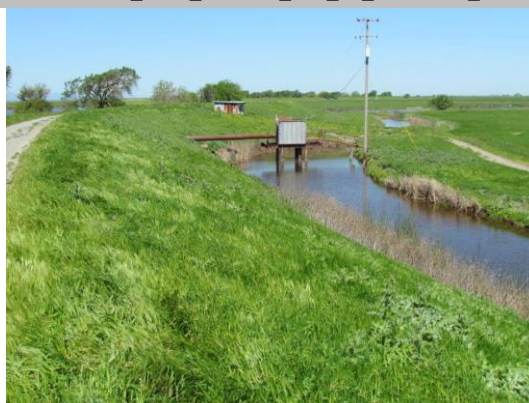
Photo 1 of 1 : SP_2016_RD2098_247_14_20160511_00010.jpg

LM Start	7.19	Rating **	U	Issue No.	14
LM End	7.44	Issue Type +	Ma	Location *	LS
Category	Earthen Levee			GPS Latitude/Longitude	
				Start	End
Item	Vegetation			38.293208 °	38.296122 °
				-121.724258 °	-121.726648 °
DWR ID	DWR_RD2098_03_s_2016_14				
Comment Code					
V1 : Control annual grass and weeds on the levee slopes and easements.					
Inspector Comment					
Spray or mow the landside levee slope.

Looking downstream from the landside levee mile 7.19-7.44 tall weeds covering the levee slope.

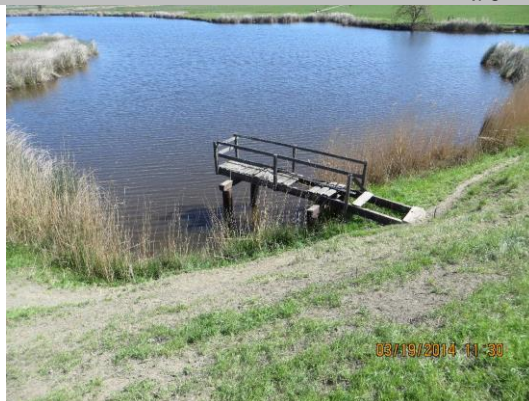
Photo 1 of 2 : UCIP_SP_2016_32389_58893.jpg

LM Start	7.39	Rating **	U	Issue No.	22
LM End	7.39	Issue Type +	En	Location *	WS
Category	Supplemental			GPS Latitude/Longitude	
				Start	End
Item	DWR UCIP Field Study			38.295669 °	38.295669 °
				-121.725980 °	-121.725980 °
DWR ID					
Comment Code					
Inspector Comment					
FS_ID:32389					
DS_ID:20979					
EP_NO: 2591					
Repair Type: Urgent					
Crossing Status: Found					
UCIP Comments: Both walkways to slidegates in poor structural condition. Can not safely access slide gate on WS slope.					
FIELD_STRUCT_DESC: 30-inch CM irrigation/drain pipe through the levee, 25.0 feet below the crown. Two CM cutoff walls around pipe at both shoulders. Walkways to slide gates at both ends of pipe. (Permit No. 2591-1959)					
FS Date: 3/19/2014

Walkway over pipe on LS toe in poor structural condition and Slidegate not visible

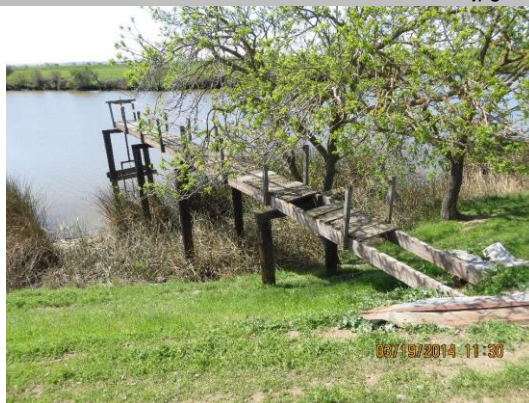
Photo 2 of 2 : UCIP_SP_2016_32389_58892.jpg

Walkway over pipe on WS toe in poor structural condition.

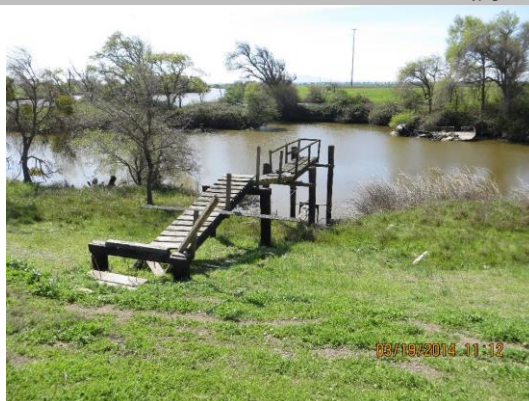
Photo 1 of 2 : UCIP_SP_2016_33785_61166.jpg

Wooden walkway at WS toe is in disrepair.

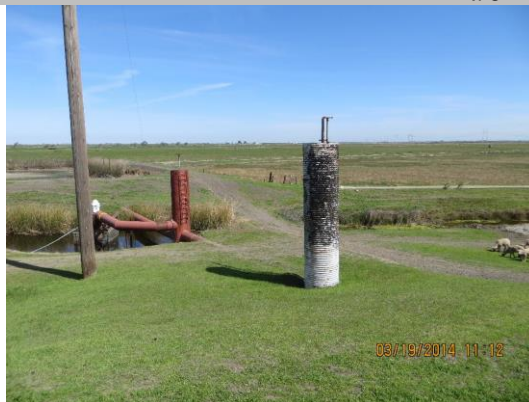
Photo 2 of 2 : UCIP_SP_2016_33785_61165.jpg

48-inch CMP riser with pump on metal pier visible at LS toe.

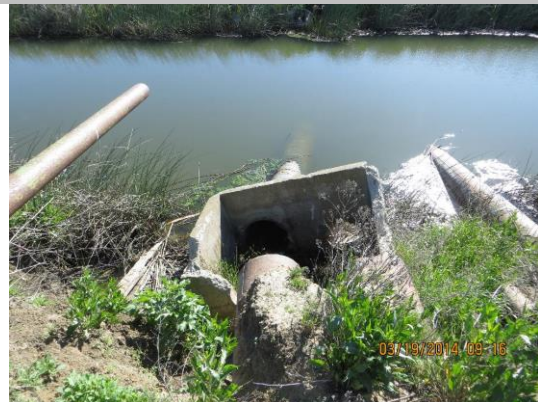
Photo 1 of 2 : UCIP_SP_2016_32326_58817.jpg

LM Start	12.05	Rating **	U	Issue No.	20
LM End	12.05	Issue Type +	En	Location *	WS
Category	Supplemental			GPS Latitude/Longitude	
				Start	End
Item	DWR UCIP Field Study			38.357863 °	38.357863 °
				-121.740394 °	-121.740394 °
DWR ID

Concrete distribution box on LS slope has slipped into canal.

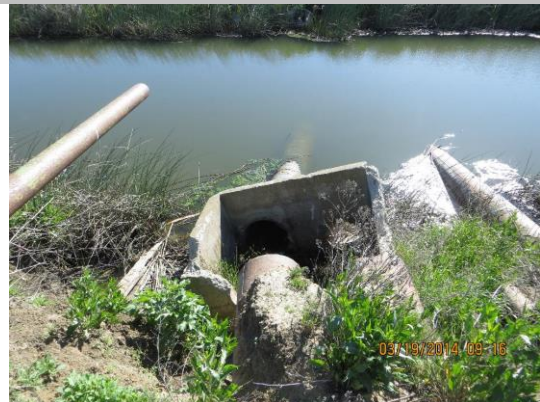
Photo 1 of 2 : UCIP_SP_2016_32325_58812.jpg

LM Start	12.05	Rating **	U	Issue No.	19
LM End	12.05	Issue Type +	En	Location *	WS
Category	Supplemental			GPS Latitude/Longitude	
				Start	End
Item	DWR UCIP Field Study			38.357870 °	38.357870 °
				-121.740396 °	-121.740396 °
DWR ID

Concrete distribution box on LS slope has lost its foundation stability and slid into canal on LS slope.
