**Flood Control Project Maintenance
Levee Inspections**
LMA District Cover Sheet
Spring 2017 Levee Inspection Results

Reclamation District No. 2098 Cache and Haas Slough

Spring 2017 Levee Inspection Results

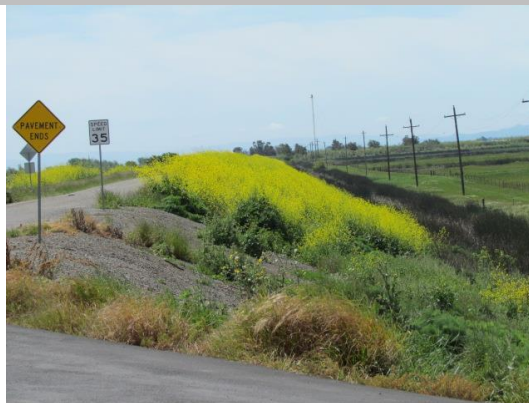
Photo 1 of 1 : SP_2017_RD2098_244_11_20170523_00022.jpg

RD 2098 Unit 1 landside looking upstream from the landside shoulder tall unwanted mustard grass and other vegetation present on the levee slope.

LM Start	0.03	Rating **	U	Issue No.	12
LM End	3.58	Issue Type +	Ma	Location *	WS
Category	Earthen Levee			GPS Latitude/Longitude	
				Start	End
Item	Vegetation			38.328715 °	38.277708 °
				-121.694037 °	-121.696232 °
DWR ID	DWR_RD2098_01_s_2017_12				
Comment Code					
V2 : Remove the wild growth other than native grasses from the levee slopes.					
Inspector Comment

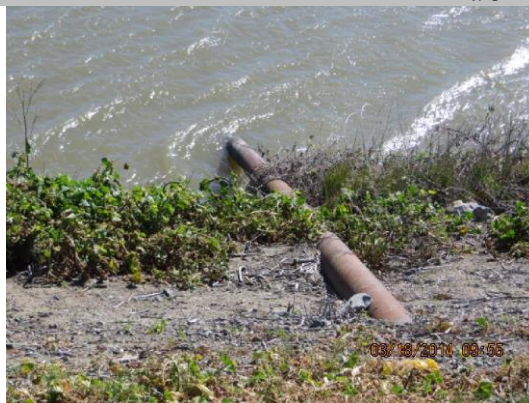
Photo 1 of 3 : UCIP_SP_2017_32197_58662.jpg

LM Start	1.82	Rating **	M	Issue No.	21
LM End	1.82	Issue Type +	En	Location *	CR
Category	Supplemental			GPS Latitude/Longitude	
				Start	End
Item	DWR UCIP Field Study			38.302770 °	38.302770 °
				-121.693640 °	-121.693640 °
DWR ID					
Comment Code					
Inspector Comment					
FS_ID:32197 DS_ID:20965 EP_NO: 10168 Repair Type: Non-Urgent Crossing Status: Found UCIP Comments: Erosion under pipe at WS toe. FIELD_STRUCT_DESC: 10-inch steel drainpipe through the levee, 2.8-feet below the crown. Pump in pump house off the landward side. (USACE-1962). This entry matches the Drainage or Irrigation Structure referenced in O&M manual (HLM 1.80). This pipe was retained under ABO No. 10168 (1974). FS Date: 3/18/2014

Pipe on WS slope.

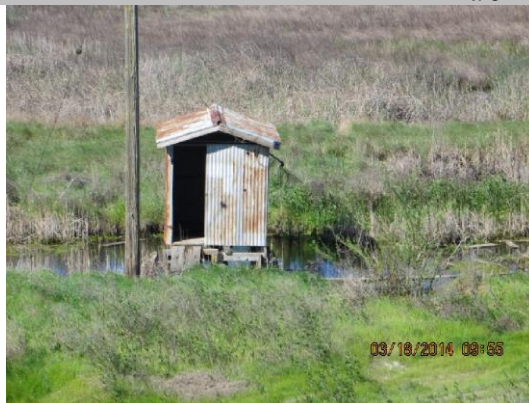
Photo 2 of 3 : UCIP_SP_2017_32197_58661.jpg

Pumphouse at lowpoint off LS toe.

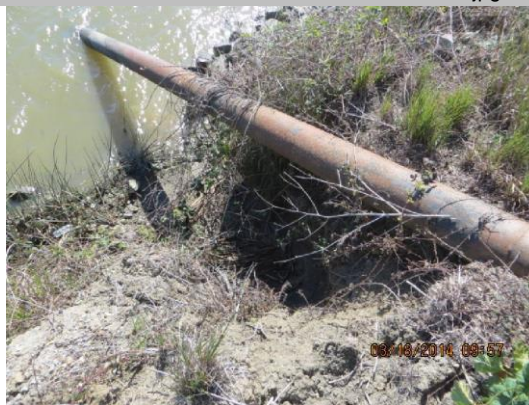
Photo 3 of 3 : UCIP_SP_2017_32197_58660.jpg

Erosion under pipe at WS toe.

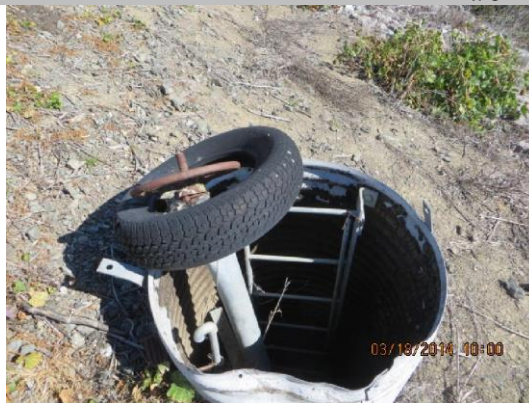
Photo 1 of 3 : UCIP_SP_2017_32207_58665.jpg

LM Start	1.83	Rating **	M	Issue No.	22
LM End	1.83	Issue Type +	En	Location *	CR
Category	Supplemental			GPS Latitude/Longitude	
				Start	End
Item	DWR UCIP Field Study			38.302552 °	38.302552 °
				-121.693653 °	-121.693653 °
DWR ID					
Comment Code					
Inspector Comment					
FS_ID:32207 DS_ID:20966 EP_NO: 10168 Repair Type: Non-Urgent Crossing Status: Found UCIP Comments: Slide gate actuator bent but appears to be in closed position. No lid on standpipe. Appears abandoned and if so should be done so properly. FIELD_STRUCT_DESC: 24-inch pipe through the levee, 24.5 feet below the crown. Two CM cutoff wall around pipe at center of levee. Slide gate in 36-inch CMP riser on the waterward slope. Concrete saddle and apron on waterward end. Flap gate and "U" headwall on landward end. This pipe was retained under ABO No. 10168 (1974). FS Date: 3/18/2014

36-inch CMP riser with bent slide gate actuator on WS slope.

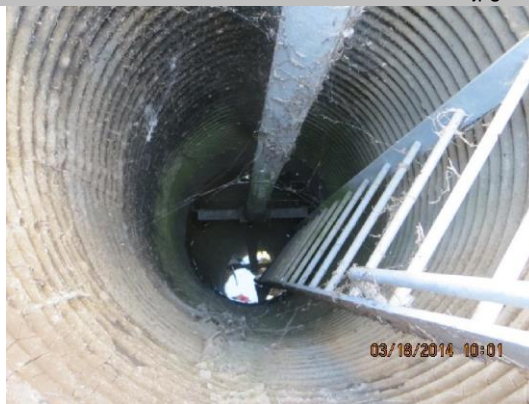
Photo 2 of 3 : UCIP_SP_2017_32207_58664.jpg

No lid on CMP riser that is 24-feet deep.

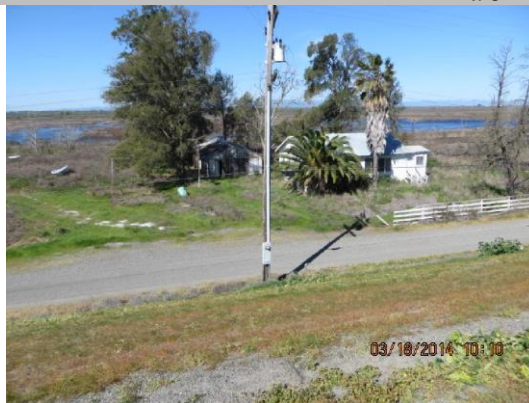
Photo 2 of 3 : UCIP_SP_2017_32225_58686.jpg

Power pole and meter next to spigot on LS toe.

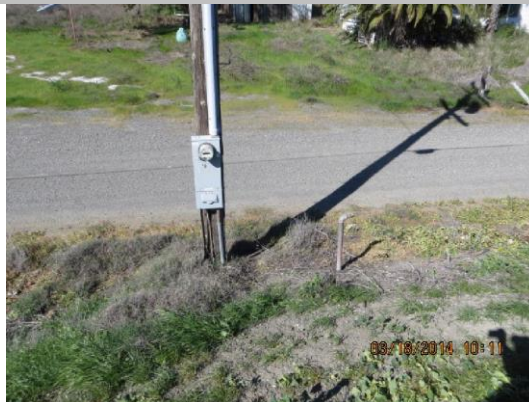
Photo 3 of 3 : UCIP_SP_2017_32225_58685.jpg

Power pole and meter next to spigot on LS toe.

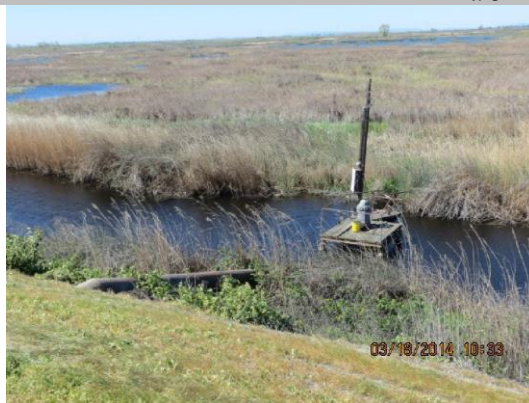
Photo 1 of 3 : UCIP_SP_2017_32227_58692.jpg

Comment Code					
Inspector Comment					
FS_ID:32227 DS_ID:20969 EP_NO: 13222 Repair Type: Non-Urgent Crossing Status: Found UCIP Comments: Pipe rusted through at outlet on WS slope, may indicate further degradation of pipe within levee. Good candidate for video inspection. FIELD_STRUCT_DESC: 20-inch steel drainpipe through the levee, 7.5 feet below the crown. Siphon breaker at waterward shoulder. Pump on pile structure in drain ditch on landward side. (USACE-1962). This entry matches the Drainage or Irrigation Structure referenced in O&M manual (HLM 2.98). This pipe was retained under ABO No. 10168 (1974). Pipe removed and replaced with 19-inch steel pipe under crown and along landward slope under Permit No. 13222 (1982). FS Date: 3/18/2014

Pump on pile structure in drainage channel on LS toe.

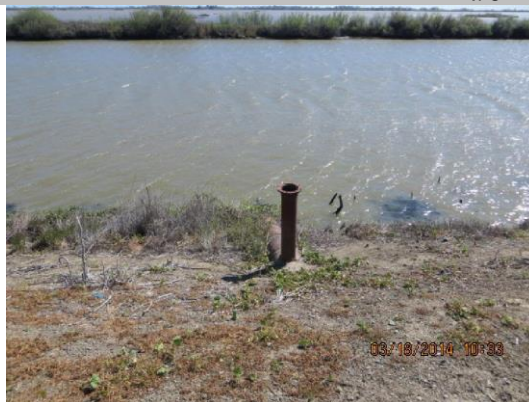
Photo 2 of 3 : UCIP_SP_2017_32227_58691.jpg

Siphon breaker in steel riser on WS slope.

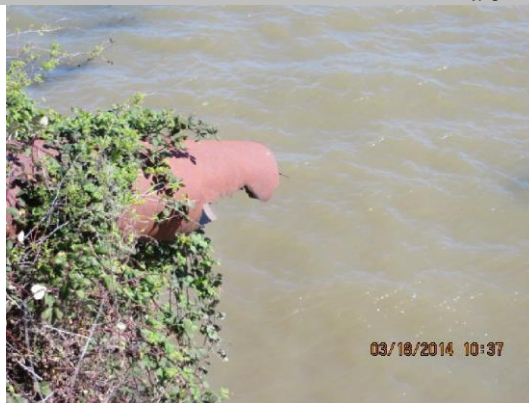
Photo 3 of 3 : UCIP_SP_2017_32227_58690.jpg

Comment Code						
Inspector Comment						
FS_ID:32227						
DS_ID:20969						
EP_NO: 13222						
Repair Type: Non-Urgent						
Crossing Status: Found						
UCIP Comments: Pipe rusted through at outlet on WS slope, may indicate further degradation of pipe within levee. Good candidate for video inspection.						
FIELD_STRUCT_DESC: 20-inch steel drainpipe through the levee, 7.5 feet below the crown. Siphon breaker at waterward shoulder. Pump on pile structure in drain ditch on landward side. (USACE-1962). This entry matches the Drainage or Irrigation Structure referenced in O&M manual (HLM 2.98). This pipe was retained under ABO No. 10168 (1974). Pipe removed and replaced with 19-inch steel pipe under crown and along landward slope under Permit No. 13222 (1982).						
FS Date: 3/18/2014

Pipe rusted through at outlet on WS slope.

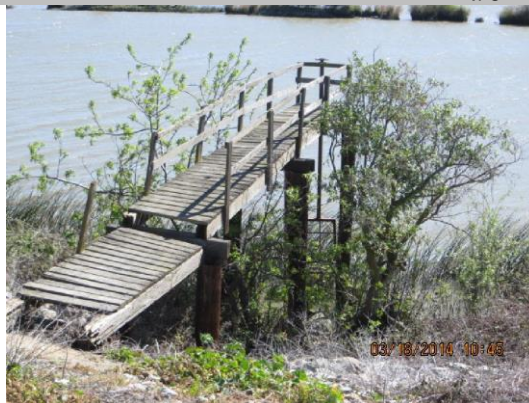
Photo 1 of 3 : UCIP_SP_2017_32243_58702.jpg

LM Start	3.49	Rating **	M	Issue No.	25
LM End	3.49	Issue Type +	En	Location *	WS
Category	Supplemental			GPS Latitude/Longitude	
				Start	End
Item	DWR UCIP Field Study			38.278879 °	38.278879 °
				-121.695957 °	-121.695957 °
DWR ID					
Comment Code					
Inspector Comment					
FS_ID:32243 DS_ID:20970 EP_NO: 10168 Repair Type: Non-Urgent Crossing Status: Found UCIP Comments: Walkway to slidegate on WS toe is in poor structural condition and may not be safe for accessing the slide gate actuator. Pipe appears abandoned and if so should be done so properly. Outlet on LS toe may be burried. FIELD_STRUCT_DESC: 24-inch steel irrigation pipe through the levee, 22.3 feet below the crown. Slide gate on the waterward end. Walkway from waterward shoulder to slide gate control. Flap gate on landward end. This pipe was retained under ABO No. 10168 (1974). FS Date: 3/18/2014

Walkway to slide gate actuator on WS toe.

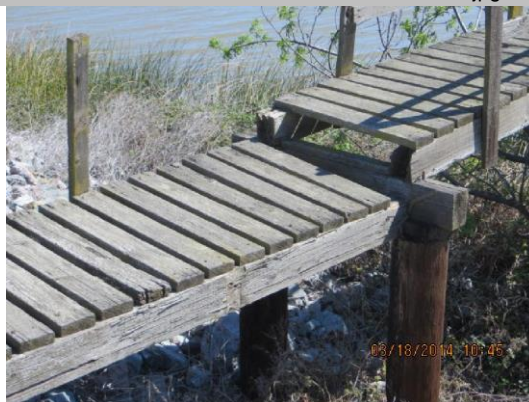
Photo 2 of 3 : UCIP_SP_2017_32243_58701.jpg

Walkway may not be structurally sound.

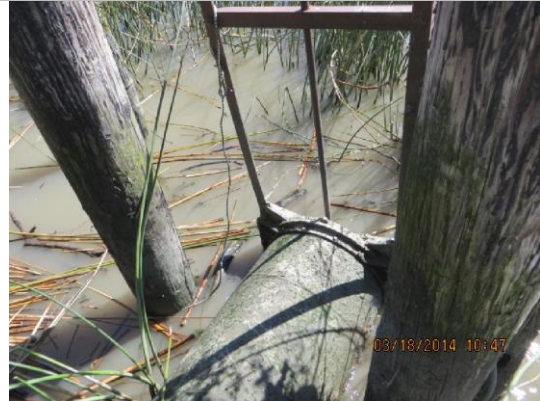
Photo 3 of 3 : UCIP_SP_2017_32243_58700.jpg

Slidegate on WS toe at pipe.

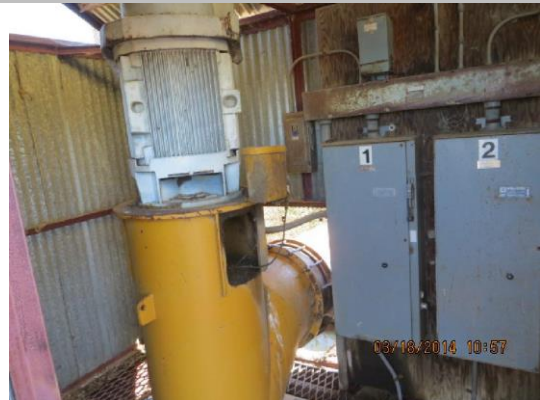
Photo 1 of 3 : UCIP_SP_2017_41717_58704.jpg

LM Start	3.50	Rating **	M	Issue No.	26
LM End	3.50	Issue Type +	En	Location *	WS
Category	Supplemental			GPS Latitude/Longitude	
				Start	End
Item	DWR UCIP Field Study			38.278770 °	38.278770 °
				-121.696050 °	-121.696050 °
DWR ID					
Comment Code					
Inspector Comment					
FS_ID:41717					
DS_ID:20971					
EP_NO: 15169					
Repair Type: Non-Urgent					
Crossing Status: Found					
UCIP Comments: Debris and soil buildup in riser may prevent proper function of siphon breaker.					
FIELD_STRUCT_DESC: 1 of 2: 24-inch steel drainpipe through the levee, 5.6 feet below the crown. Cutoff wall around pipe at center of levee. Siphon breaker at waterward shoulder. Flap gate on waterward end. Pump in pump house on piling structure on landward side. (Permit No. 15169-1989)					
FS Date: 3/18/2014

Pump in pumphouse on LS toe.

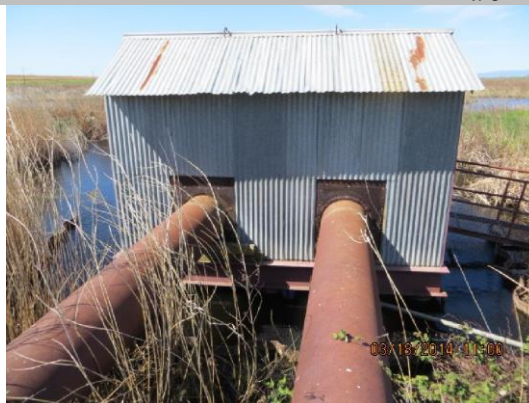
Photo 2 of 3 : UCIP_SP_2017_41717_58703.jpg

Pump in pumphouse on LS toe.

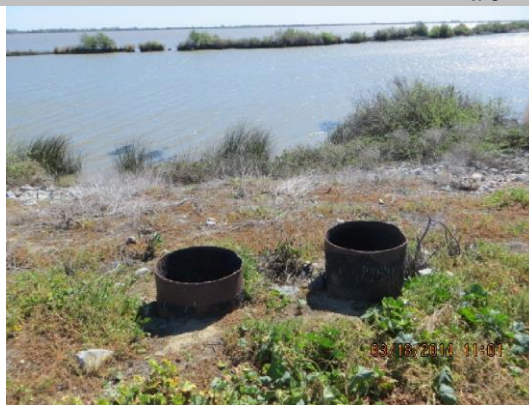
Photo 3 of 3 : UCIP_SP_2017_41717_58707.jpg

Siphon breaker in 24-inch steel riser on WS shoulder.

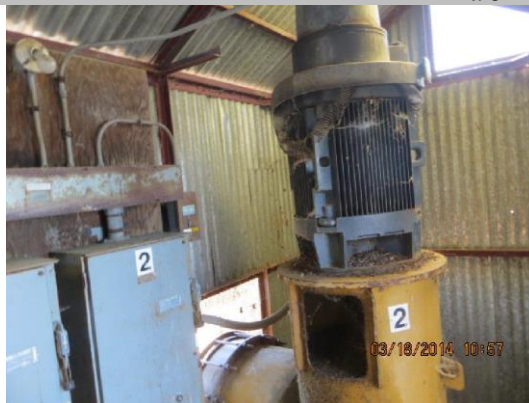
Photo 1 of 3 : UCIP_SP_2017_32245_58710.jpg

LM Start	3.50	Rating **	M	Issue No.	27
LM End	3.50	Issue Type +	En	Location *	WS
Category	Supplemental			GPS Latitude/Longitude	
				Start	End
Item	DWR UCIP Field Study			38.278759 °	38.278759 °
				-121.696059 °	-121.696059 °
DWR ID					
Comment Code					
Inspector Comment					
FS_ID:32245 DS_ID:20959 EP_NO: 15169 Repair Type: Non-Urgent Crossing Status: Found UCIP Comments: Soil and debris buildup in steel riser on WS shoulder may prevent proper function of siphon breaker. FIELD_STRUCT_DESC: 2 of 2: 24-inch steel pipe through the levee, 5.6 feet below the crown. Cutoff wall around pipe at center of levee. Siphon breaker at waterward shoulder. Flap gate on waterward end. Pump in pump house on piling structure on landward side. (Permit No. 15169-1989) FS Date: 3/18/2014

Pump in pumphouse on LS toe.

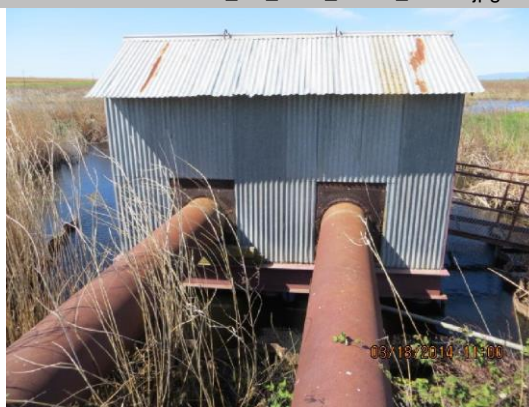
Photo 2 of 3 : UCIP_SP_2017_32245_58709.jpg

Pump in pumphouse on LS toe.

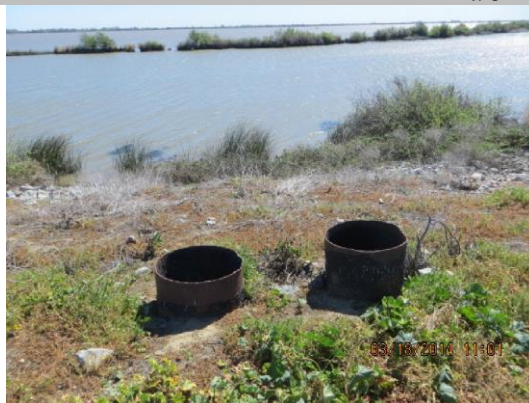
Photo 3 of 3 : UCIP_SP_2017_32245_58708.jpg

Siphon breaker in steel riser on WS shoulder.

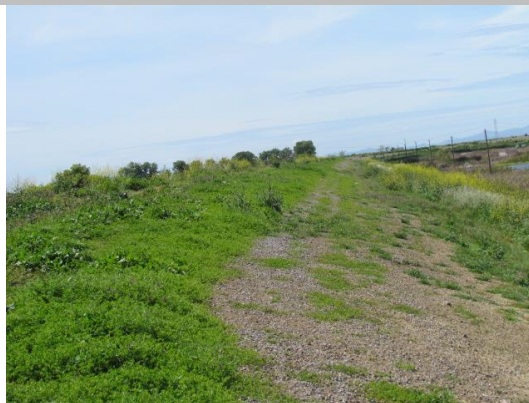
Photo 1 of 1 : SP_2017_RD2098_245_1_20170523_00002.jpg

RD 2098 1A Looking upstream from levee mile 0.00-0.52 landside slope.

LM Start	0.00	Rating **	U	Issue No.	2
LM End	0.52	Issue Type +	Ma	Location *	WS
Category	Earthen Levee			GPS Latitude/Longitude	
				Start	End
Item	Vegetation			38.277382 °	38.275722 °
				-121.696270 °	-121.705675 °
DWR ID	DWR_RD2098_01A_s _ 2017_2				
Comment Code					
V2 : Remove the wild growth other than native grasses from the levee slopes.					
Inspector Comment					
Remove the wild grasses other than native from the levee section.

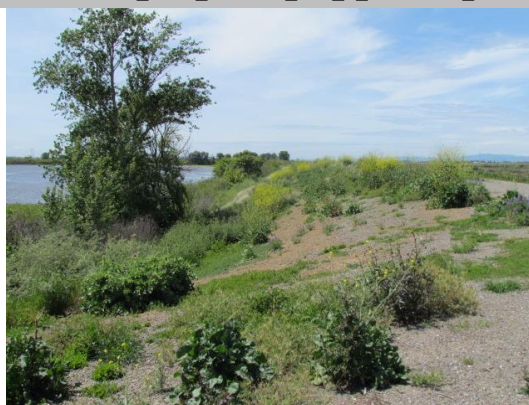
Photo 1 of 1 : SP_2017_RD2098_245_2_20170523_00001.jpg

RD 2098 Unit 1A looking upstream from the waterside slope.

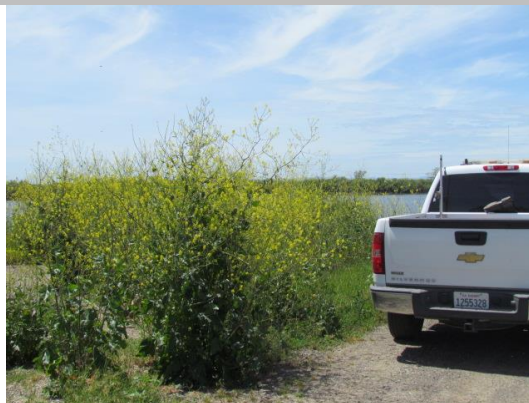
Photo 1 of 1 : SP_2017_RD2098_245_3_20170523_00003.jpg

RD 2098 1A Levee mile 0.52 crown roadway. Unwanted tall weeds present on the crown roadway.

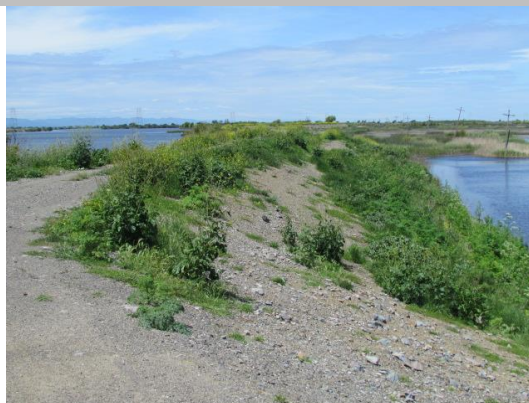
Photo 1 of 1 : SP_2017_RD2098_246_8_20170523_00028.jpg

RD 2098 Unit 2 Levee mile 5.30-7.14 wild growth on the landside slope.

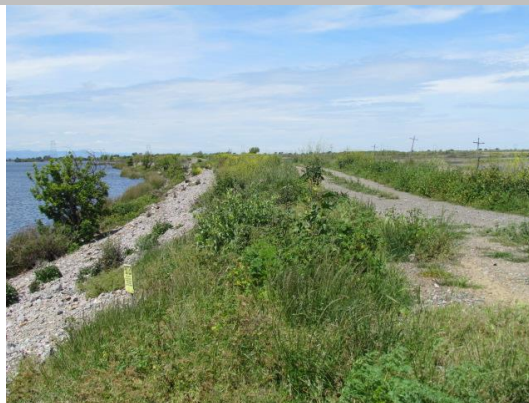
Photo 1 of 1 : SP_2017_RD2098_246_9_20170523_00029.jpg

RD 2098 Unit 2 levee mile 5.30- 7.14 waterside levee slope and shoulder.

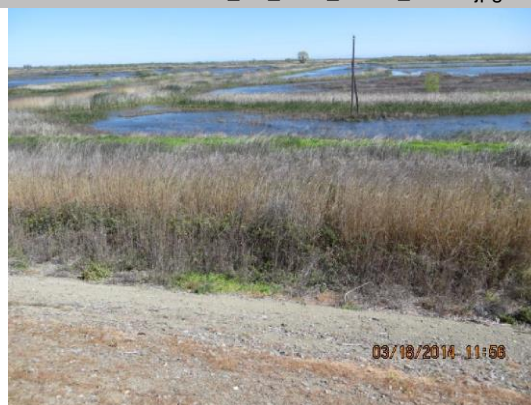
Photo 1 of 3 : UCIP_SP_2017_32287_58755.jpg

LM Start	5.71	Rating **	M	Issue No.	27
LM End	5.71	Issue Type +	En	Location *	CR
Category	Supplemental			GPS Latitude/Longitude	
				Start	End
Item	DWR UCIP Field Study			38.280788 °	38.280788 °
				-121.709617 °	-121.709617 °
DWR ID					
Comment Code					
Inspector Comment					
FS_ID:32287 DS_ID:20973 EP_NO: 10172 Repair Type: Non-Urgent Crossing Status: Found UCIP Comments: Pipe appears abandoned and if so should be done so properly. Slide gate appears to be open and should be closed for the season. FIELD_STRUCT_DESC: 24-inch CM pipe through the levee, 22.8 feet below the crown. Two cutoff walls around pipe at levee shoulders. Slide gate in 36-inch CMP riser on waterward slope. Flap gate and concrete "U" headwall on landward end. This pipe was retained under ABO No. 10172 (1974). FS Date: 3/18/2014

LS - no pipe visible.

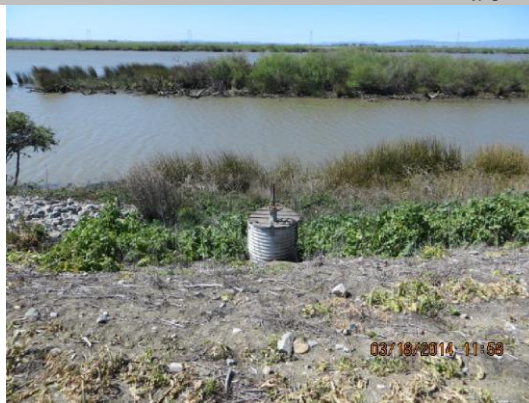
Photo 2 of 3 : UCIP_SP_2017_32287_58754.jpg

Slide gate in 36-inch standpipe on WS slope.

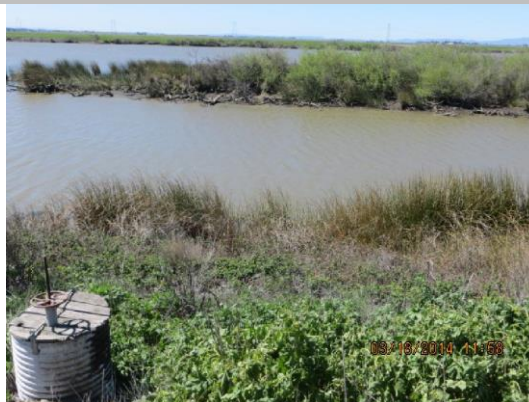
Photo 3 of 3 : UCIP_SP_2017_32287_58753.jpg

Slide gate in 36-inch standpipe on WS slope.

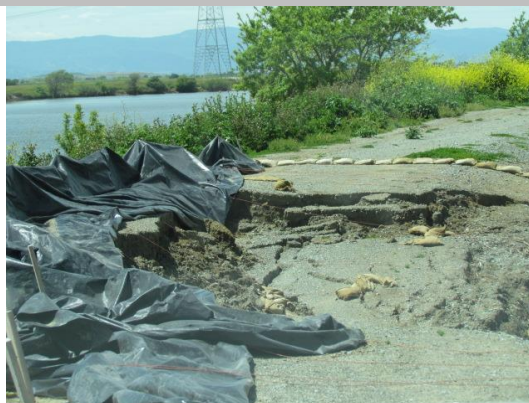
Photo 1 of 3 : SP_2017_RD2098_246_26_20170523_00031.jpg

RD 2098 LEVEE MILE 6.03 MAJOR CROWN/SLOPE DAMAGE.

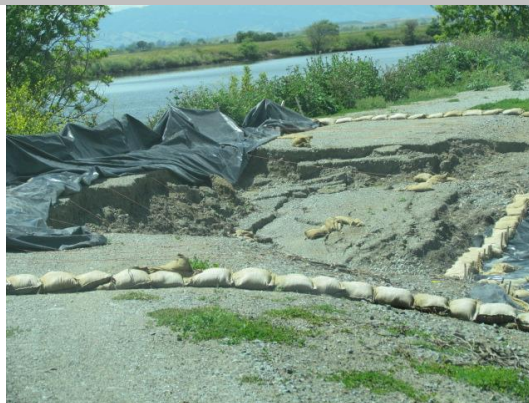
Photo 2 of 3 : SP_2017_RD2098_246_26_20170523_00032.jpg

RD 2098 Levee damage crown roadway and landside slope damage.

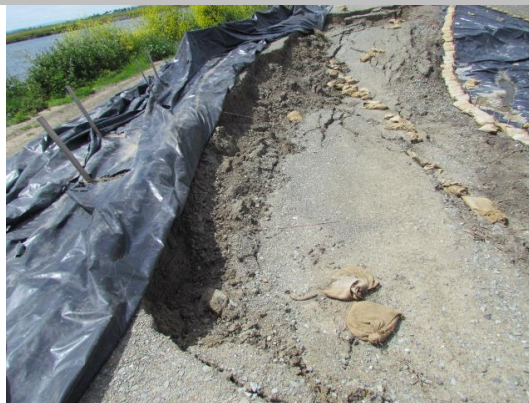
Photo 3 of 3 : SP_2017_RD2098_246_26_20170523_00033.jpg

Close up of damage.

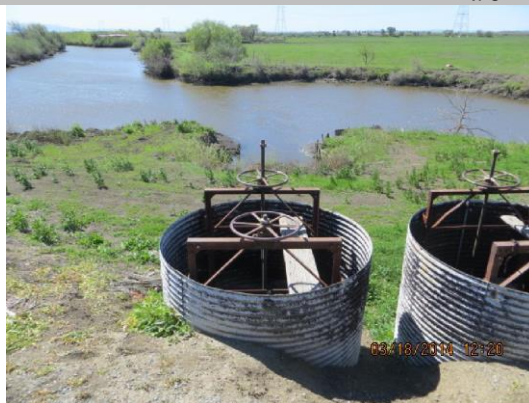
Photo 1 of 3 : UCIP_SP_2017_33784_61162.jpg

Two slide gates in 7-foot diameter CMP riser on waterward slope.

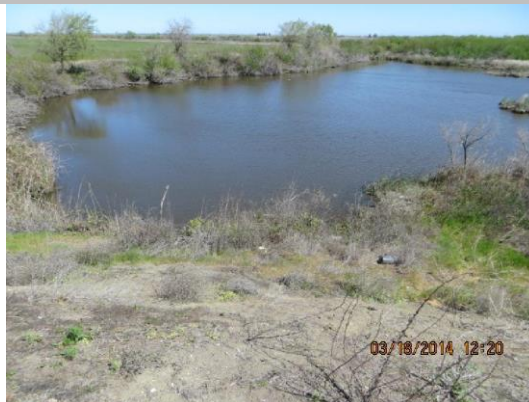
Photo 2 of 3 : UCIP_SP_2017_33784_61161.jpg

Inlet not visible on LS toe.

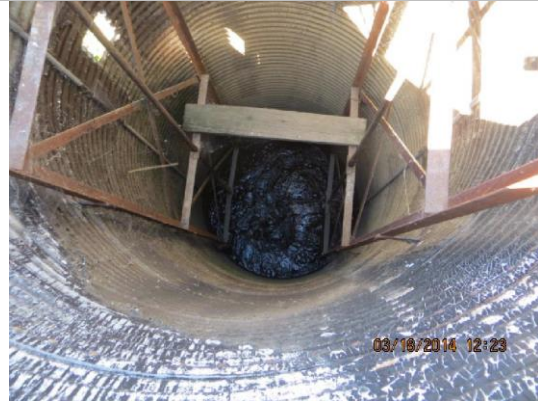
Photo 3 of 3 : UCIP_SP_2017_33784_61160.jpg

View inside CMP riser on WS shoulder.

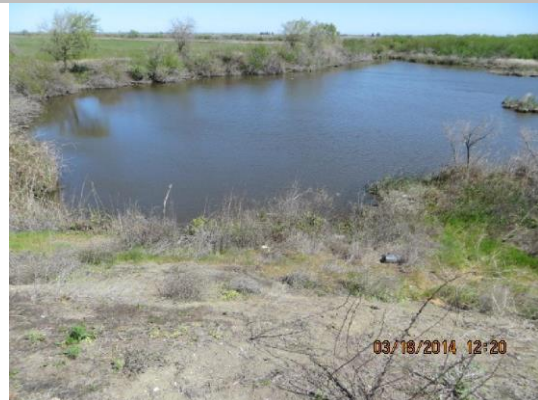
Photo 1 of 3 : UCIP_SP_2017_32285_58749.jpg

Inlet not visible on LS toe.

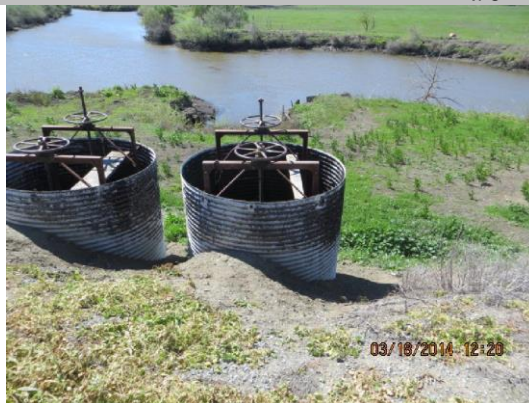
Photo 2 of 3 : UCIP_SP_2017_32285_58748.jpg

7-foot diameter CMP riser with two slide gates inside.

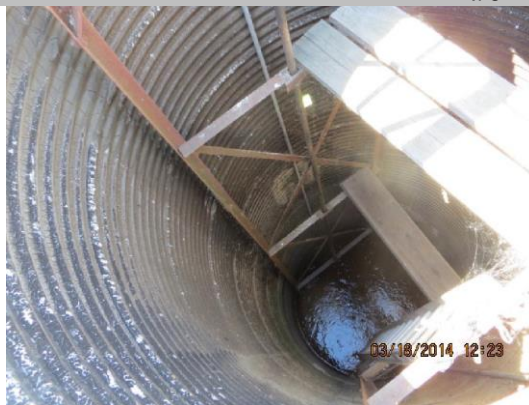
Photo 3 of 3 : UCIP_SP_2017_32285_58747.jpg

7-foot diameter CMP riser with two slide gates inside.

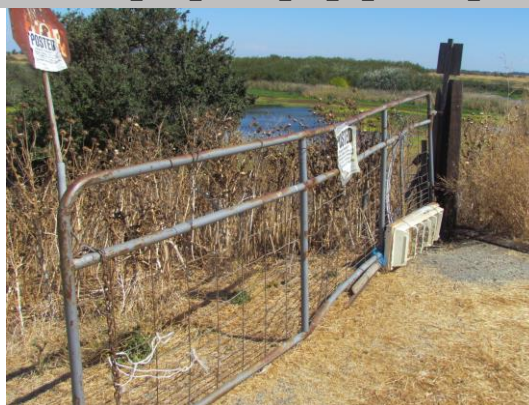
Photo 1 of 1 : SP_2017_RD2098_246_16_20170404_00010.jpg

Levee mile 6.74 crown roadway gate crossing.

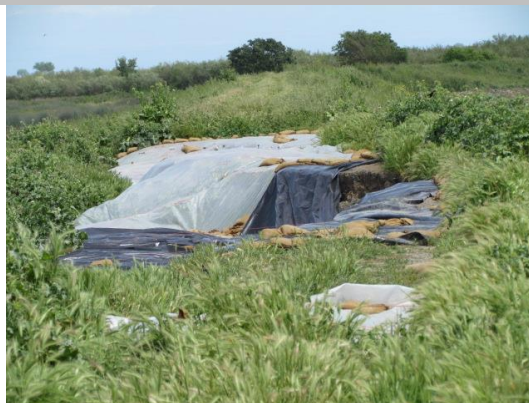
Photo 1 of 1 : SP_2017_RD2098_246_11_20170523_00030.jpg

RD 2098 Levee mile 7.12 major levee damage crown roadway and landside slope.

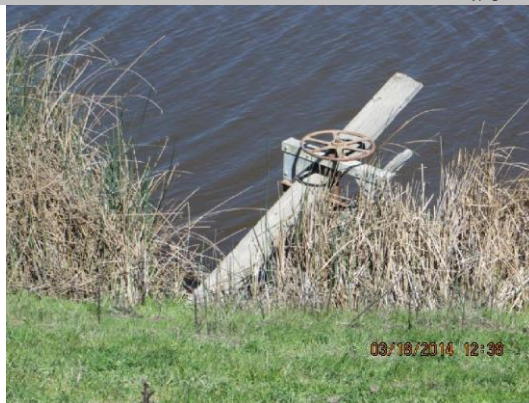
Photo 1 of 3 : UCIP_SP_2017_32290_58764.jpg

Slide gate at LS toe.

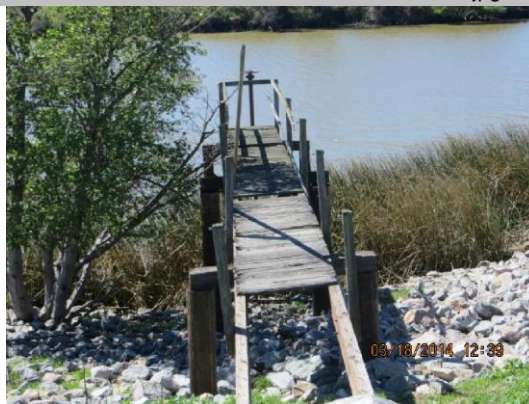
Photo 2 of 3 : UCIP_SP_2017_32290_58763.jpg

Delapidated wooden pier on WS shoulder.

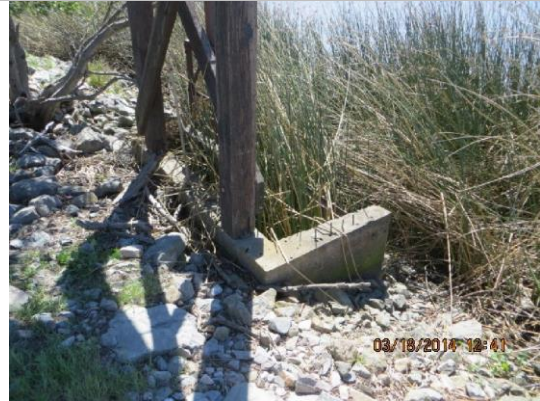
Photo 3 of 3 : UCIP_SP_2017_32290_58762.jpg

Concrete U-shaped headwall on WS toe.

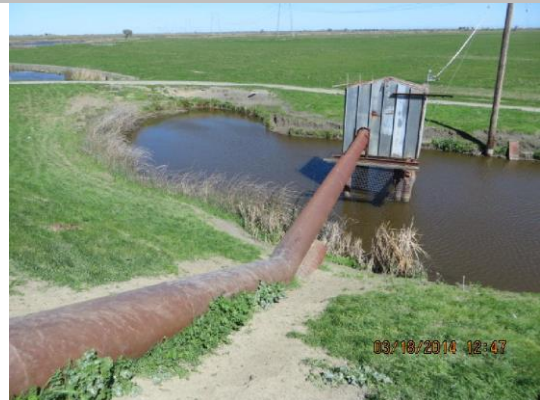
Photo 1 of 3 : UCIP_SP_2017_32303_58782.jpg

Pipe visible under new pipe on LS slope.

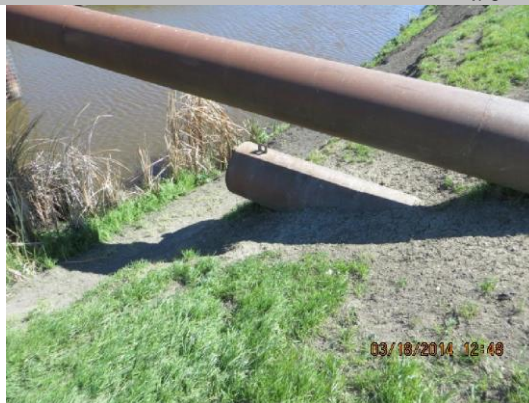
Photo 2 of 3 : UCIP_SP_2017_32303_58781.jpg

Pipe visible under new pipe on LS slope.

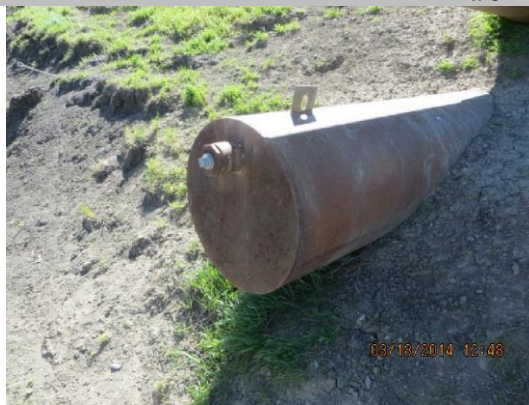
Photo 3 of 3 : UCIP_SP_2017_32303_58780.jpg

Welded steel cap over LS end of pipe.

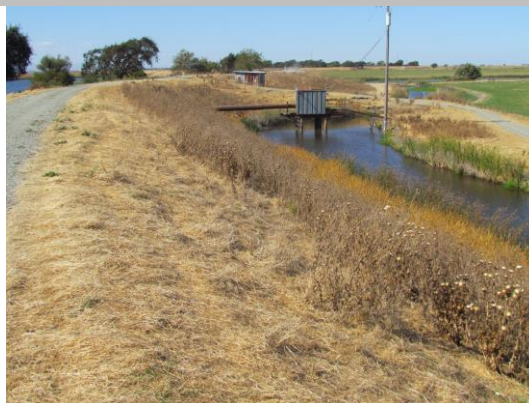
Photo 2 of 2 : SP_2017_RD2098_247_2_20170404_00004.jpg

RD 2098 Looking downstream from levee mile 7.19 landside slope.

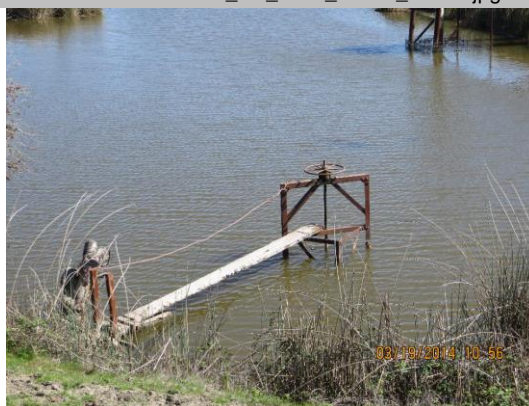
Photo 1 of 2 : UCIP_SP_2017_32384_58883.jpg

Slide gate at LS toe.

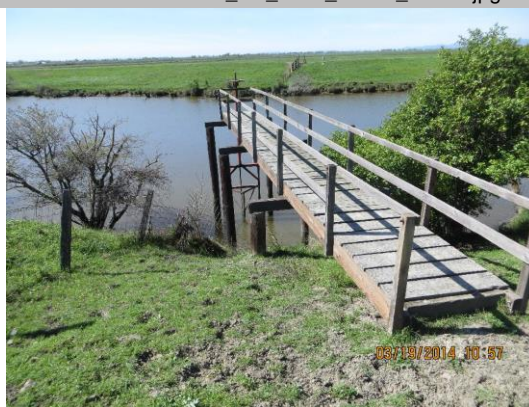
Photo 2 of 2 : UCIP_SP_2017_32384_58882.jpg

Walkway with slide gate on WS toe.

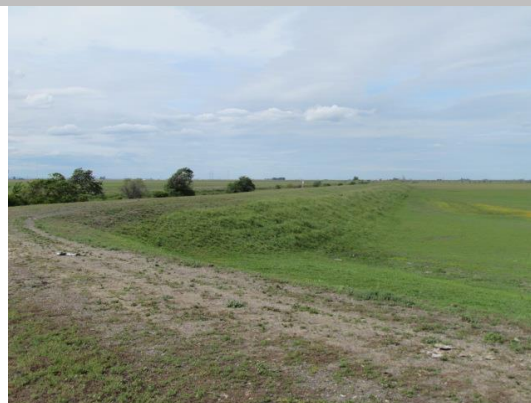
Photo 1 of 1 : SP_2017_RD2098_248_10_20170523_00019.jpg

RD 2098 Landside levee mile 9.17-12.06.

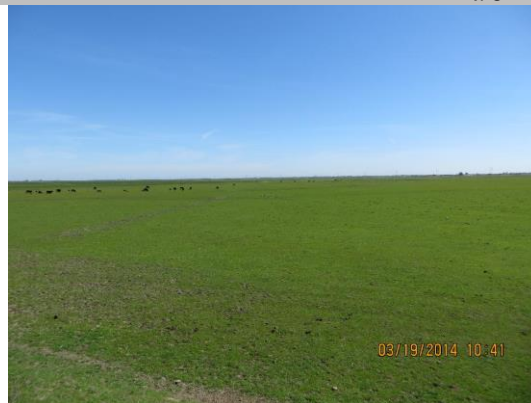
Photo 1 of 2 : UCIP_SP_2017_32383_58881.jpg

Shutoff valve visible 370-feet off LS toe.

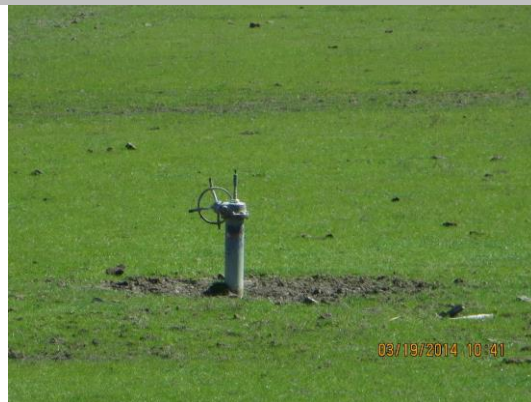
Photo 2 of 2 : UCIP_SP_2017_32383_58880.jpg

Shutoff valve visible 370-feet off LS toe.

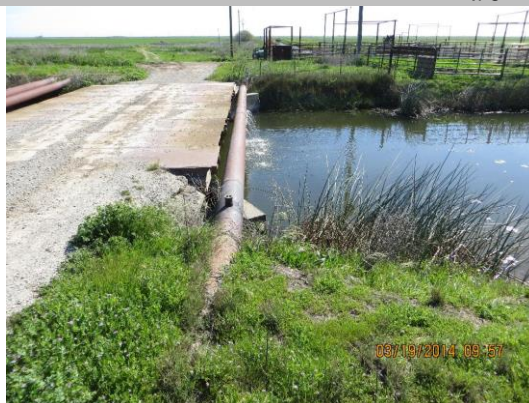
Photo 1 of 3 : UCIP_SP_2017_32403_58905.jpg

Pipe and siphon breaker visible on LS at canal crossing.

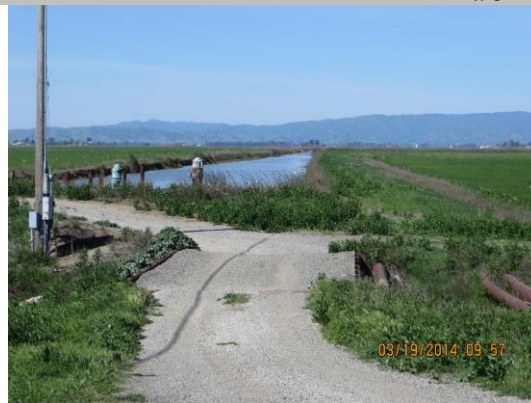
Photo 2 of 3 : UCIP_SP_2017_32403_58904.jpg

Pump on pier in irrigation canal off WS toe.

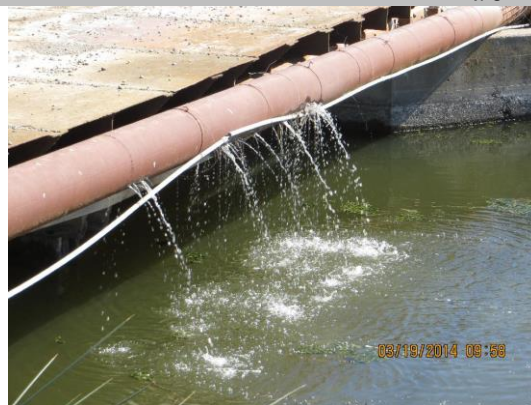
Photo 3 of 3 : UCIP_SP_2017_32403_58903.jpg

Holes in pipe next to bridge. PVC electrical conduit shown.

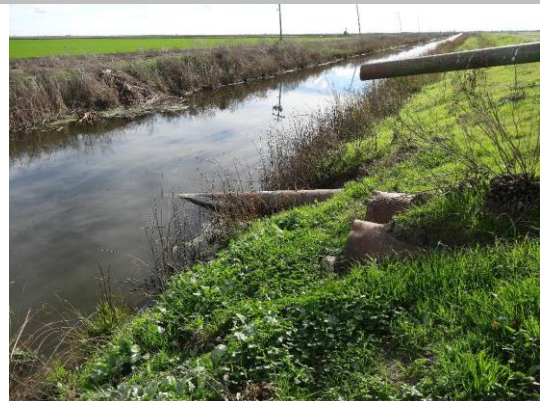
Photo 2 of 3 : UCIP_SP_2017_51455_76876.jpg

View of LS--damaged concrete distribution box has been removed.

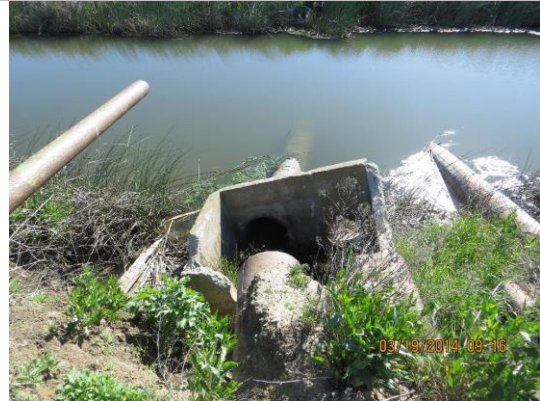
Photo 3 of 3 : UCIP_SP_2017_51455_58817.jpg

Concrete distribution box on LS slope has slipped into canal.

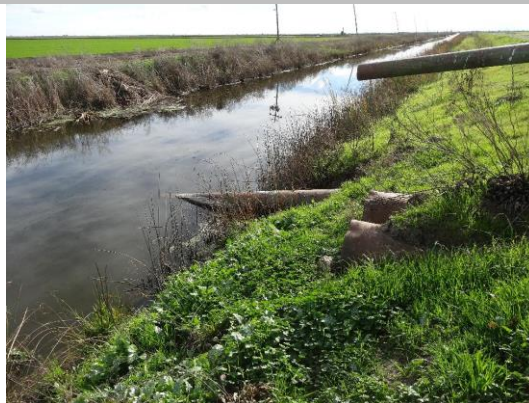
Photo 2 of 3 : UCIP_SP_2017_51456_76884.jpg

View of LS--damage distribution box noted in last inspection has been removed.

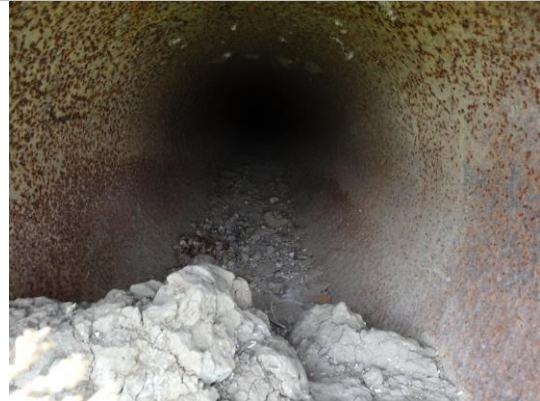
Photo 3 of 3 : UCIP_SP_2017_51456_76885.jpg

Inside view of pipe from LS.

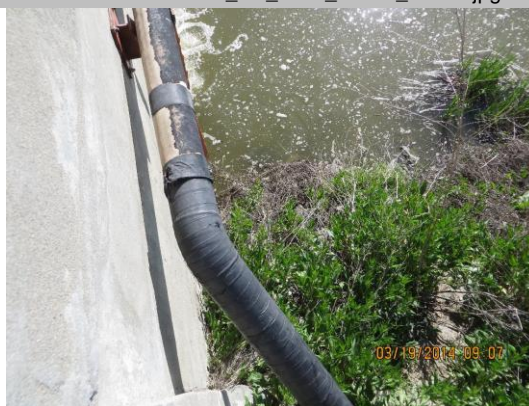
Photo 1 of 3 : UCIP_SP_2017_32566_59110.jpg

Pipe visible on South side of Bridge at Swan Road.

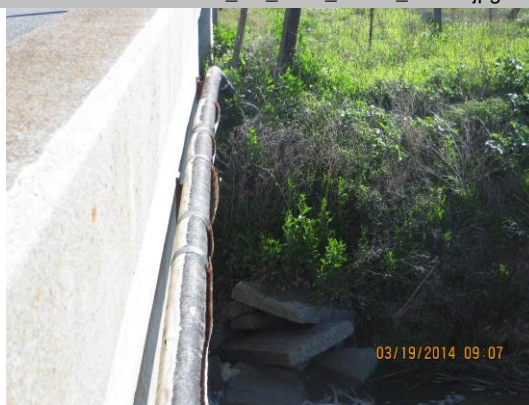
Photo 2 of 3 : UCIP_SP_2017_32566_59109.jpg

Pipe visible on South side of Bridge at Swan Road.
