**Flood Control Project Maintenance
Levee Inspections**
LMA District Cover Sheet
Spring 2018 Levee Inspection Results

Reclamation District No. 2098 Cache and Haas Slough

Spring 2018 Levee Inspection Results

Waterway			Bank	Unit Miles
Unit No. 01 Yolo Bypass			Right	3.60
	Spring (March - May)	Summer (June - August)	(September - November) Fall	Winter (December - February)
Unit Maintenance Rating (Fall Only)				
Date of Inspection	3/15/2018 - 3/15/2018			
DWR Inspector	Keith Millard			
Accompanied By	Bryan Busch RD 2098

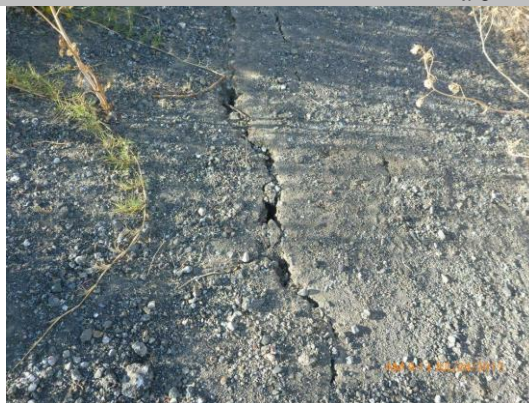
Photo 1 of 3 : LEVAL_SP_2018_414_3594.jpg

LM Start	0.96	Rating **	A/W	Issue No.	19
LM End	0.96	Issue Type +	Ma	Location *	
Category	Supplemental			GPS Latitude/Longitude	
				Start	End
Item	2017 Storm Damage			38.315200 °	38.315100 °
				-121.694100 °	-121.694100 °
DWR ID	DWR_RD2098_01_s_2018_19				
Comment Code					
Inspector Comment					
Levee Evaluation Comments					
Description:The damage consists of cracking and sloughing of the lower landside levee slope.					
Site ID No:414					
Site Designation:LMA-241					
Repair Type: Erosion					
Rating:Area of Concern					
Field Date:7/24/2017					
Notes: Landside sloughing about 2' deep and extends to toe ditch.

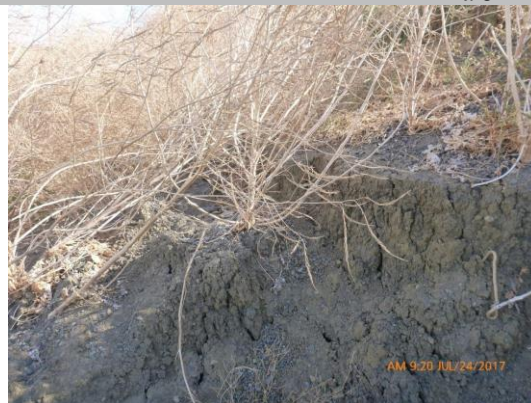
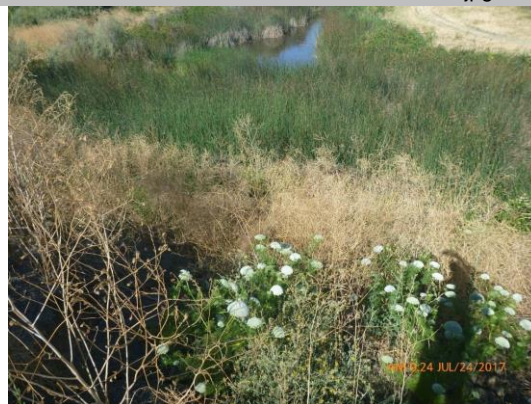
LM Start	0.96	Rating **	A/W	Issue No.	19 (cont)
LM End	0.96	Issue Type +	Ma	Location *	
Category	Supplemental			GPS Latitude/Longitude	
				Start	End
Item	2017 Storm Damage			38.315200 °	38.315100 °
				-121.694100 °	-121.694100 °
DWR ID	DWR_RD2098_01_s_2018_19				
Comment Code					
Inspector Comment					
Levee Evaluation Comments					
Description:The damage consists of cracking and sloughing of the lower landside levee slope.					
Site ID No:414					
Site Designation:LMA-241					
Repair Type: Erosion					
Rating:Area of Concern					
Field Date:7/24/2017					
Notes: Landside sloughing about 2' deep and extends to toe ditch.

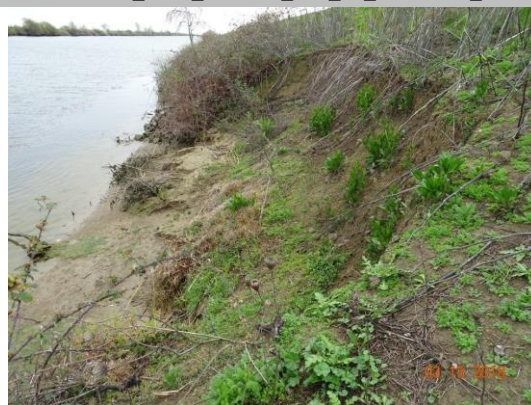
Photo 1 of 1 : SP_2018_RD2098_244_18_20180315_00089.jpg

LM Start	1.76	Rating **	M	Issue No.	18
LM End	1.76	Issue Type +	Ma	Location *	WS
Category	Earthen Levee			GPS Latitude/Longitude	
				Start	End
Item	Erosion / Bank Caving			38.303611 °	38.303611 °
				-121.693607 °	-121.693607 °
DWR ID	DWR_RD2098_01_s_2018_18				
Comment Code					
E2 : Schedule repair of erosion site prior to the next inspection.					
Inspector Comment

Monitor and repair erosion.

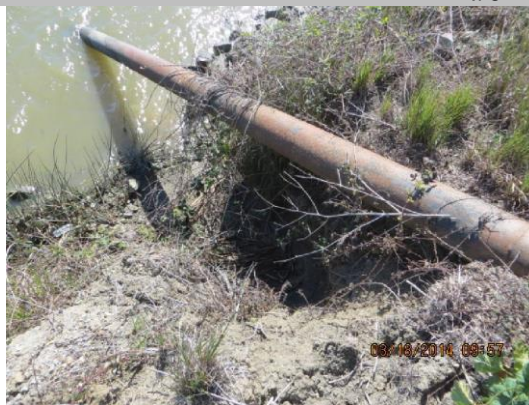
Photo 3 of 3 : UCIP_SP_2018_32197_58660.jpg

LM Start	1.82	Rating **	M	Issue No.	41 (cont)	
LM End	1.82	Issue Type +	En	Location *		
Category	Supplemental			GPS Latitude/Longitude		
				Start	End	
Item	DWR UCIP Field Study			38.302770 °	38.302770 °	
				-121.693640 °	-121.693640 °	
DWR ID						
Comment Code						
Inspector Comment						
FS_ID:32197 DS_ID:20965 EP_NO: 10168 Repair Type: Non-Urgent Crossing Status: Found UCIP Comments: Erosion under pipe at WS toe. FIELD_STRUCT_DESC: 10-inch steel drainage pipe through the levee, 2.8 feet below the crown. Pump in pump house off the landside (LS). (This pipe was retained under Automatic Board Order (ABO) issued as Permit No. 10168, 1974 - Moresco Brothers). [Additional Reference(s): DWR Levee Log, 2003. USACE Sacramento O&M Manual 109, April 1962, (HLM 1.80)]. FS Date: 3/18/2014

Erosion under pipe at WS toe.

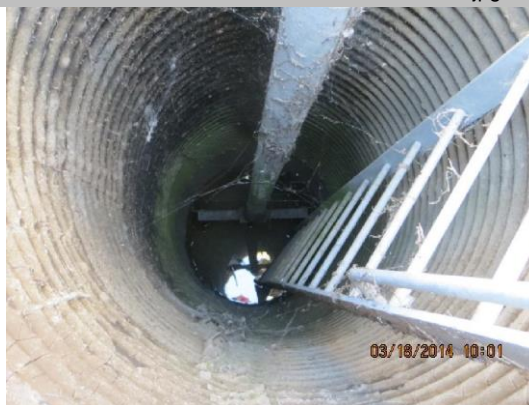
Photo 2 of 3 : UCIP_SP_2018_32207_58664.jpg

Comment Code						
Inspector Comment						
FS_ID:32207 DS_ID:20966 EP_NO: 10168 Repair Type: Non-Urgent Crossing Status: Found UCIP Comments: Slide gate actuator bent but appears to be in closed position. No lid on standpipe. Appears abandoned and if so should be done so properly. FIELD_STRUCT_DESC: 24-inch irrigation pipe of an unknown material through the levee, 24.5 feet below the crown. Two corrugated metal cutoff walls around the pipe at the center of the levee. Slide gate in a 36-inch corrugated metal pipe (CMP) riser on the waterside (WS) slope. Concrete saddle and apron on the WS end. Flap gate and U-shaped headwall on the landside (LS) end. (This pipe was retained under Automatic Board Order (ABO) issued as Permit No. 10168, 1974 - Moresco Brothers). [Additional Reference(s): DWR Levee Log, 2003]. FS Date: 3/18/2014

No lid on CMP riser that is 24-feet deep.

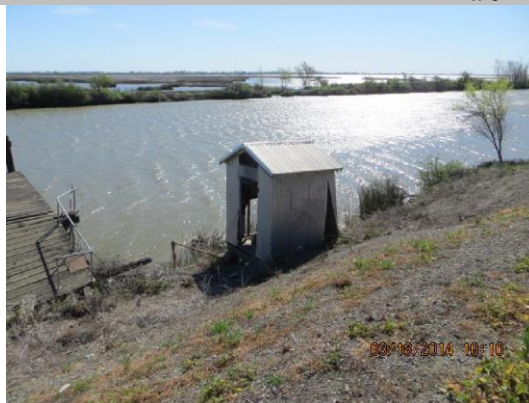
Photo 1 of 3 : UCIP_SP_2018_32225_58687.jpg

Comment Code					
Inspector Comment					
FS_ID:32225 DS_ID:20967 EP_NO: 10168 Repair Type: Non-Urgent Crossing Status: Found UCIP Comments: Pipe appears abandoned and if so should be done so properly. Pipe open on WS at pumphouse as there is no connection to pump. FIELD_STRUCT_DESC: 2-inch galvanized iron irrigation pipe through the levee, 10 feet below the crown. Pump in pump house on the waterside (WS) slope next to fishing dock. Power pole and meter at the landside (LS) toe, next to hose bib. 1-inch steel electrical conduit at the same location. (This pipe was retained under Automatic Board Order (ABO) issued as Permit No. 10168, 1974 - Moresco Brothers). [Additional Reference(s): DWR Levee Log, 2003]. FS Date: 3/18/2014

Pumphouse next to fishing dock on WS slope.

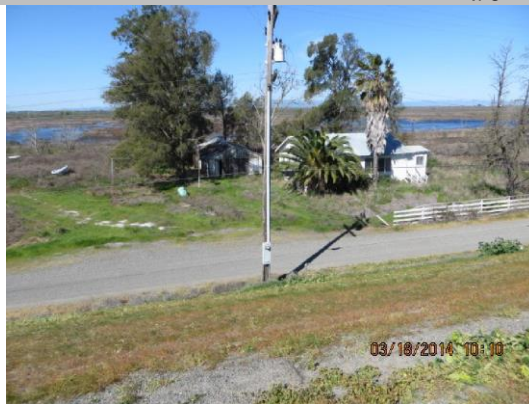
Photo 2 of 3 : UCIP_SP_2018_32225_58686.jpg

Power pole and meter next to spigot on LS toe.

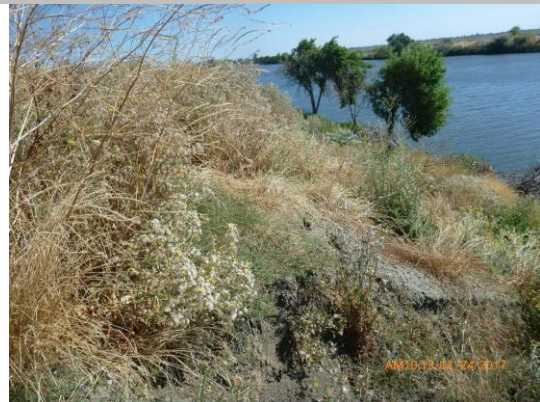
Photo 3 of 3 : LEVAL_SP_2018_416_2728.jpg

Levee Evaluation Comments
Description: The damage consists of erosion, cracking, and sloughing of the waterside levee slope.
Site ID No: 416
Site Designation: LMA-243
Repair Type: Erosion
Rating: Serious
Field Date: 7/24/2017
Notes: Erosion with sloughing. About 2' vertical cut at top of erosion.

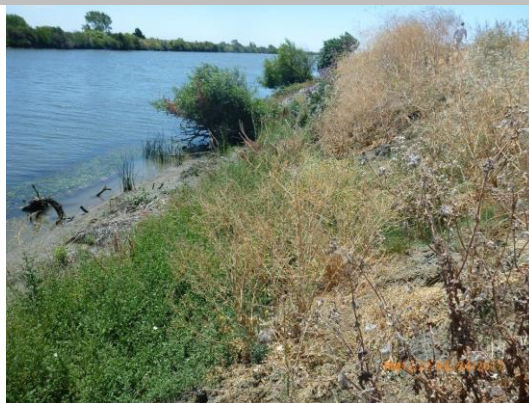
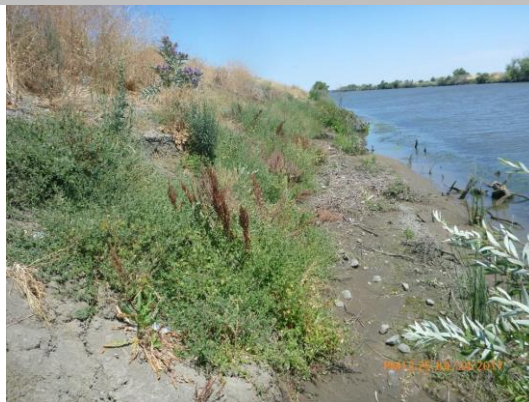
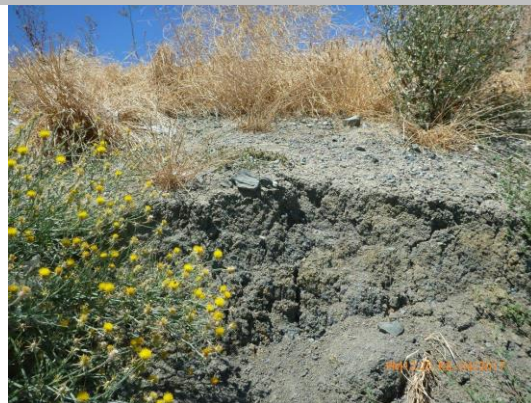
LM Start	2.29	Rating **	A/W	Issue No.	27
LM End	2.31	Issue Type +	Ma	Location *	
Category	Supplemental			GPS Latitude/Longitude	
				Start	End
Item	2017 Storm Damage			38.295900 °	38.295700 °
				-121.693500 °	-121.693500 °
DWR ID	DWR_RD2098_01_f_2017_27				
Comment Code					
Inspector Comment					
Levee Evaluation Comments					
Description:The damage consists of scour and sloughing of the waterside levee slope.					
Site ID No:421					
Site Designation:LMA-248					
Repair Type: Erosion					
Rating:Serious					
Field Date:7/24/2017					
Notes: Toe of slope has eroded and minor sloughing has started.					
10/26/17: Dutra repairs in progress.

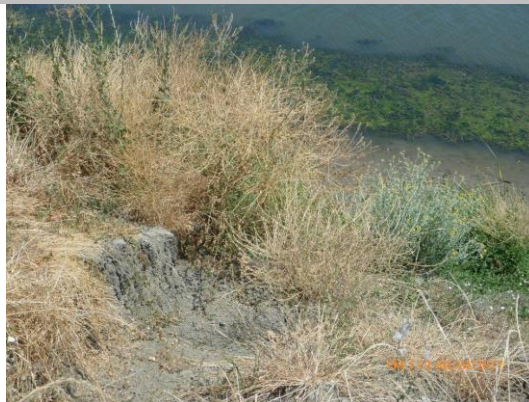
Photo 2 of 3 : SP_2018_RD2098_244_28_20180305_00022.jpg

LM Start	2.35	Rating **	M	Issue No.	28
LM End	2.39	Issue Type +	Ma	Location *	
Category	Supplemental			GPS Latitude/Longitude	
				Start	End
Item	2017 Storm Damage			38.295100 °	38.294500 °
				-121.693400 °	-121.693400 °
DWR ID	DWR_RD2098_01_f _ 2017_28				
Comment Code					
Inspector Comment					
Levee Evaluation Comments					
Description:The damage consists of scour, sloughing, and cracking of the lower and mid waterside levee slope.					
Site ID No:423					
Site Designation:LMA-250					
Repair Type: Erosion					
Rating:Area of Concern					
Field Date:7/24/2017					
Notes: 2' of sloughing about half way up the slope.

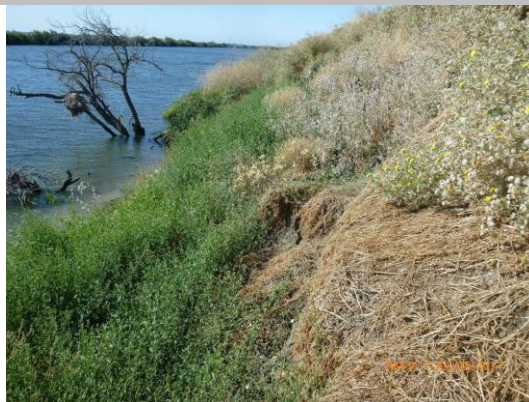
Photo 3 of 3 : SP_2018_RD2098_244_34_20180305_00038.jpg

LM Start	2.75	Rating **	A/W	Issue No.	34 (cont)	
LM End	2.78	Issue Type +	Ma	Location *		
Category	Supplemental			GPS Latitude/Longitude		
				Start	End	
Item	2017 Storm Damage			38.289200 °	38.288800 °	
				-121.693500 °	-121.693500 °	
DWR ID	DWR_RD2098_01_f_2017_34					
Comment Code						
Inspector Comment						
Levee Evaluation Comments						
Description:The damage consists of scour and sloughing of the waterside levee slope.						
Site ID No:429						
Site Designation:LMA-256						
Repair Type: Erosion						
Rating:Serious						
Field Date:7/25/2017						
Notes: Erosion at WS toe, causing sloughing half-way down WS slope.						
10/26/17: Dutra repairs in progress.

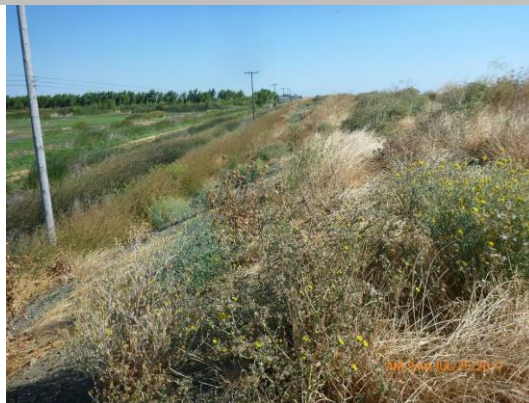
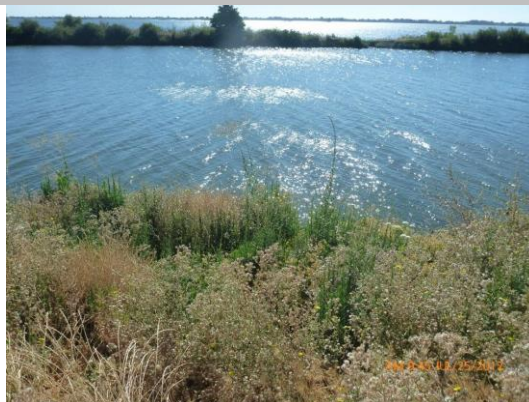
LM Start	2.78	Rating **	A/W	Issue No.	35
LM End	2.81	Issue Type +	Ma	Location *	
Category	Supplemental			GPS Latitude/Longitude	
				Start	End
Item	2017 Storm Damage			38.288800 °	38.288400 °
				-121.693500 °	-121.693500 °
DWR ID	DWR_RD2098_01_f_2017_35				
Comment Code					
Inspector Comment					
Levee Evaluation Comments					
Description:The damage consists of scour and sloughing of the waterside levee slope.					
Site ID No:430					
Site Designation:LMA-257					
Repair Type: Erosion					
Rating:Serious					
Field Date:7/25/2017					
Notes: Erosion at waterside toe, causing sloughing 2/3 down waterside slope.10/26/17: Dutra repairs in progress.

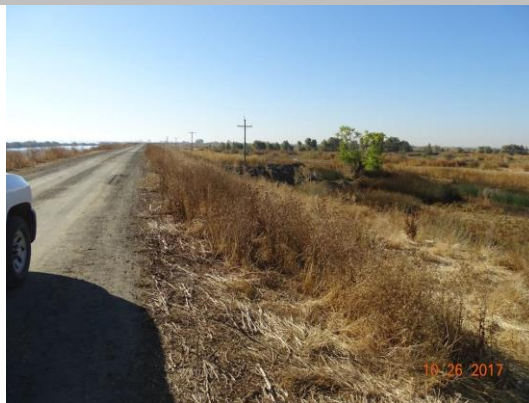
Photo 1 of 1 : SP_2018_RD2098_244_12_20180305_00002.jpg

Nearby construction operations forced termination of goat grazing.
Vegetation should be cleared.

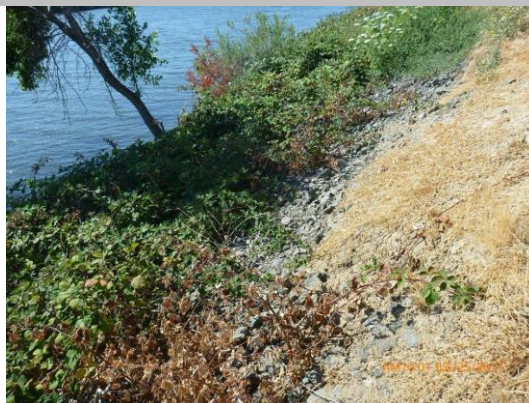
Photo 1 of 3 : SP_2018_RD2098_244_36_20180305_00042.jpg

LM Start	2.91	Rating **	A/W	Issue No.	36
LM End	2.93	Issue Type +	Ma	Location *	
Category	Supplemental			GPS Latitude/Longitude	
				Start	End
Item	2017 Storm Damage			38.286900 °	38.286700 °
				-121.693500 °	-121.693500 °
DWR ID	DWR_RD2098_01_f_2017_36				
Comment Code					
Inspector Comment					
Levee Evaluation Comments					
Description:The damage consists of scour and sloughing of the waterside levee slope.					
Site ID No:431					
Site Designation:LMA-258					
Repair Type: Erosion					
Rating:Serious					
Field Date:7/25/2017					
Notes: Erosion of WS toe, resulting in 8' verticle wall. 10/26/17: Dutra repairs in progress.

Description: The damage consists of scour and sloughing of the waterside levee slope.

Notes: Erosion of WS toe, resulting in 8' vertical wall. 10/26/17: Dutra repairs in progress.

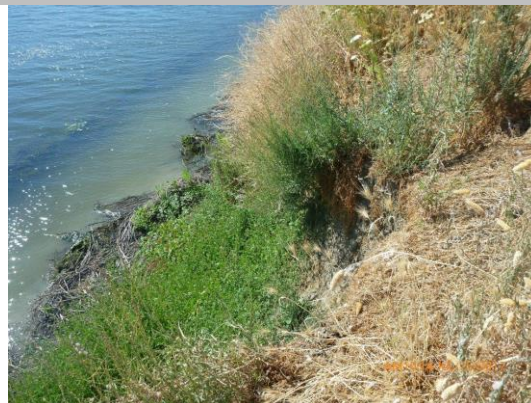
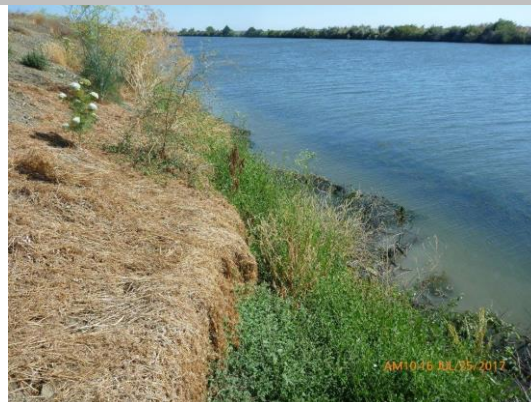
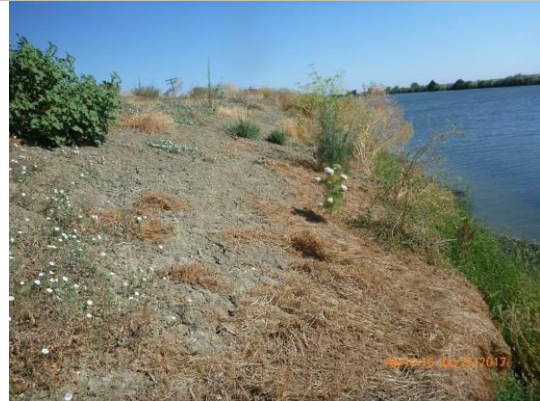
LM Start	2.99	Rating **	A/W	Issue No.	37
LM End	3.29	Issue Type +	Ma	Location *	
Category	Supplemental			GPS Latitude/Longitude	
				Start	End
Item	2017 Storm Damage			38.285700 °	38.281500 °
				-121.693500 °	-121.694300 °
DWR ID	DWR_RD2098_01_f_2017_37				
Comment Code					
Inspector Comment					
Levee Evaluation Comments					
Description:The damage consists of scour and sloughing of the waterside levee slope.					
Site ID No:432					
Site Designation:LMA-259					
Repair Type: Erosion					
Rating:Serious					
Field Date:7/25/2017					
Notes: Varying erosion and sloughing at WS toe. Revetment at end of levee section. 10/26/17: Dutra repairs in progress.

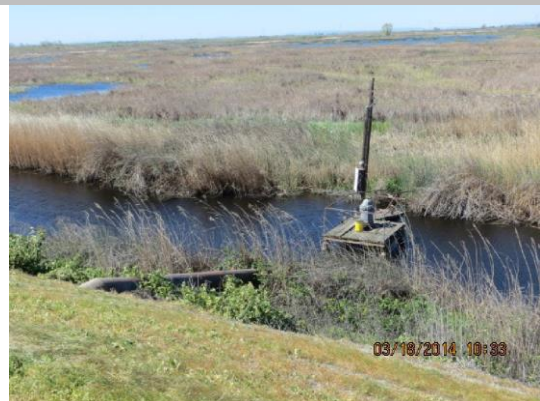
Photo 1 of 3 : UCIP_SP_2018_32227_58692.jpg

Pump on pile structure in drainage channel on LS toe.

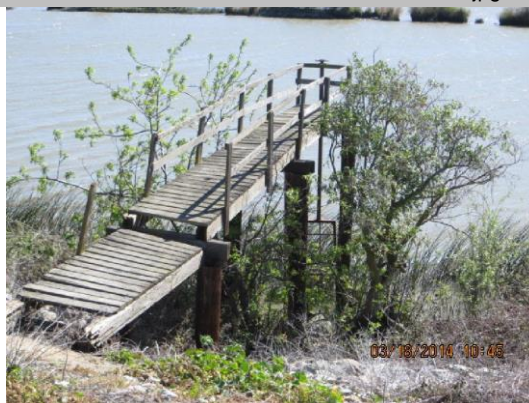
Photo 1 of 3 : UCIP_SP_2018_32243_58702.jpg

Walkway to slide gate actuator on WS toe.

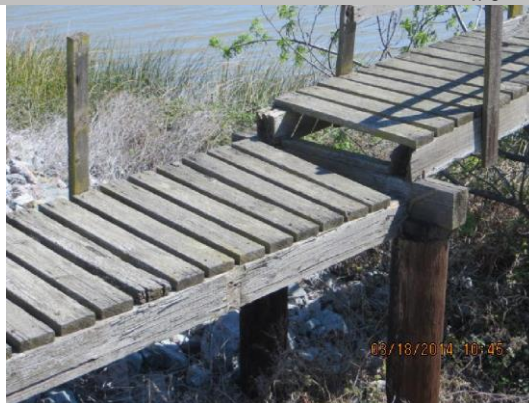
Photo 2 of 3 : UCIP_SP_2018_32243_58701.jpg

Walkway may not be structurally sound.

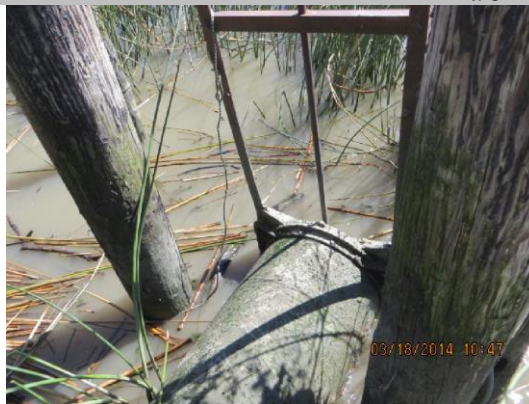
Photo 3 of 3 : UCIP_SP_2018_32243_58700.jpg

Slidegate on WS toe at pipe.

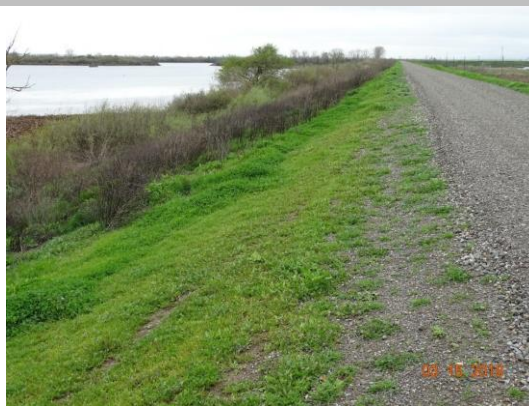
Photo 1 of 1 : SP_2018_RD2098_245_2_20180315_00002.jpg

Thick vegetation on waterside slope.

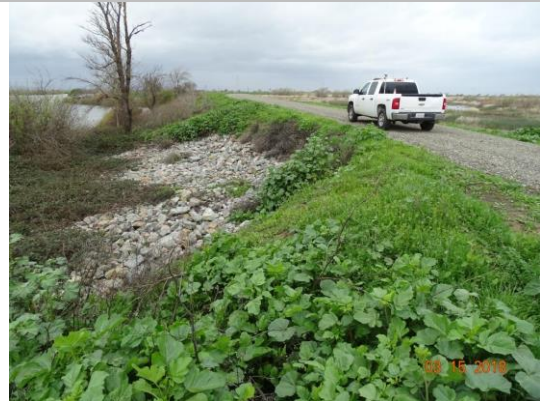
Photo 1 of 1 : SP_2018_RD2098_246_11_20180315_00049.jpg

Monitor slumping on waterside slope.

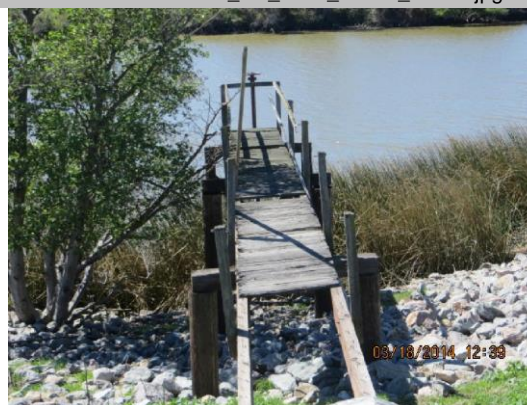
Photo 2 of 3 : UCIP_SP_2018_32290_58763.jpg

Delapidated wooden pier on WS shoulder.

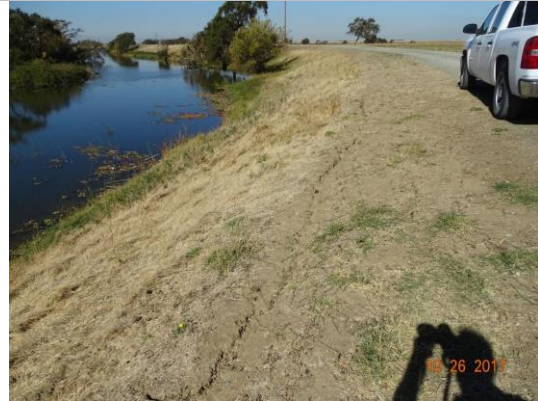
Photo 1 of 1 : SP_2018_RD2098_247_5_20180305_00005.jpg

View upstream of cracks in waterside shoulder.

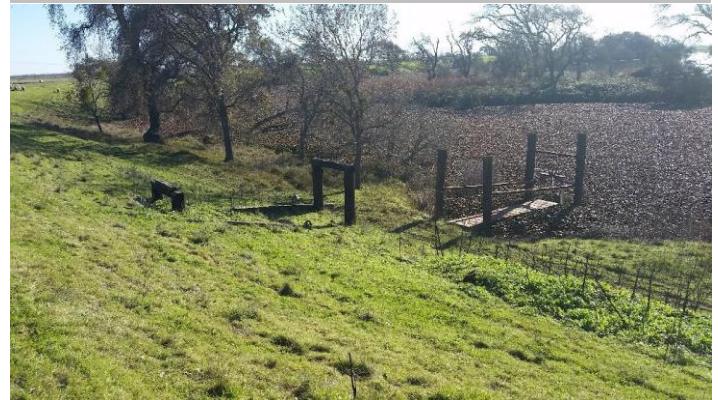
Photo 1 of 3 : UCIP_SP_2018_51453_76858.jpg

Walkway has been re-built, photo 1 of 2.

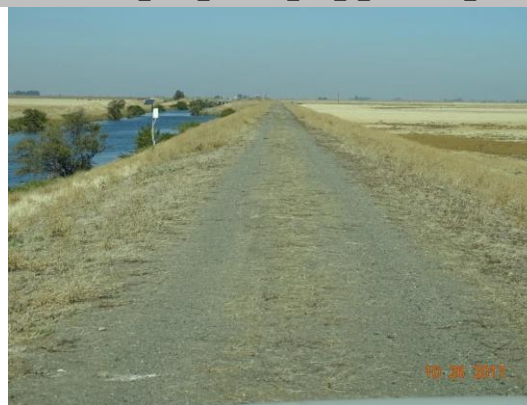
Photo 1 of 1 : SP_2018_RD2098_248_8_20180305_00001.jpg

Several areas of scalloped erosion at waterside toe. Largest area is visible in distance in this photo.

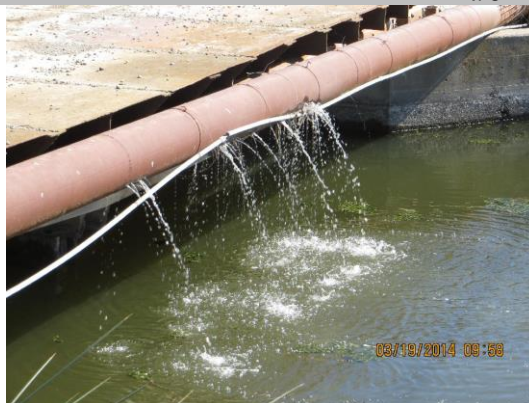
Photo 3 of 3 : UCIP_SP_2018_32403_58903.jpg

Holes in pipe next to bridge. PVC electrical conduit shown.

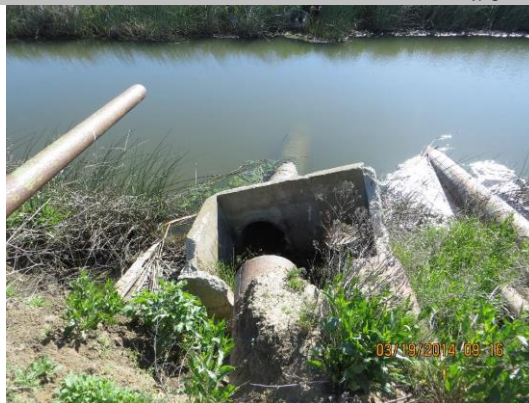
Photo 3 of 3 : UCIP_SP_2018_51455_58817.jpg

Concrete distribution box on LS slope has slipped into canal.
