**Flood Control Project Maintenance
Levee Inspections**
LMA District Cover Sheet
Spring 2019 Levee Inspection Results

Reclamation District No. 2098 Cache and Haas Slough

Spring 2019 Levee Inspection Results

Waterway			Bank	Unit Miles
Unit No. 01 Yolo Bypass			Right	3.60
	Spring (March - May)	Summer (June - August)	(September - November) Fall	Winter (December - February)
Unit Maintenance Rating (Fall Only)				
Date of Inspection	3/26/2019 -			
DWR Inspector	David Julian			
Accompanied By	Bryan Busch RD 2098

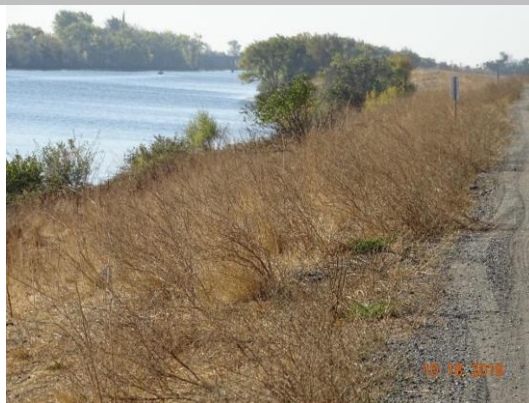
Photo 2 of 2 : SP_2019_RD2098_244_22_20190311_00013.jpg

View of vegetation on the waterside slope. The vegetation is spread enough that can still see the levee but is thick enough that it should be removed (October 2018).

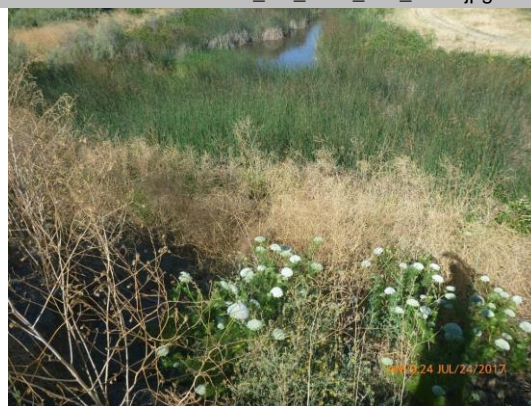
Photo 3 of 3 : LEVAL_SP_2019_414_3603.jpg

LM Start	0.96	Rating **	A/W	Issue No.	19 (cont)
LM End	0.96	Issue Type +	Ma	Location *	
Category	Supplemental			GPS Latitude/Longitude	
				Start	End
Item	2017 Storm Damage			38.315200 °	38.315100 °
				-121.694100 °	-121.694100 °
DWR ID	DWR_RD2098_01_s_2018_19				
Comment Code					
Inspector Comment					
Levee Evaluation Comments					
Description:The damage consists of cracking and sloughing of the lower landside levee slope.					
Site ID No:414					
Site Designation:LMA-241					
Repair Type: Erosion					
Rating:Area of Concern					
Field Date:7/24/2017					
Notes: Landside sloughing about 2' deep and extends to toe ditch.

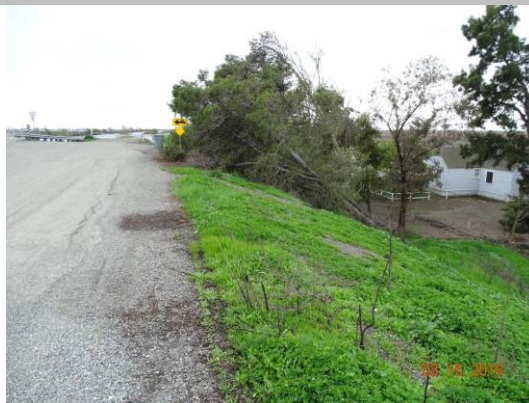
Photo 1 of 1 : SP_2019_RD2098_244_14_20190311_00004.jpg

View of fallen tree and other trees on waterside slope.

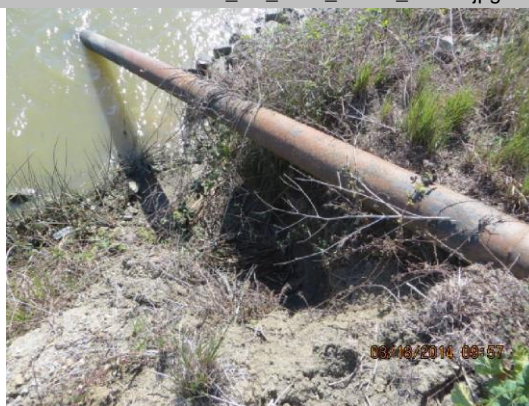
Photo 3 of 3 : UCIP_SP_2019_32197_58660.jpg

Erosion under pipe at WS toe.

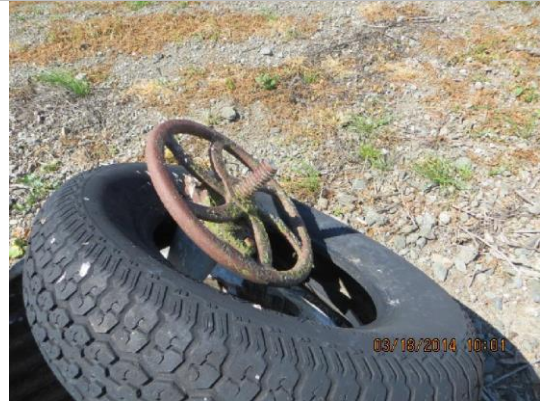
Photo 3 of 3 : UCIP_SP_2019_32207_58663.jpg

bent actuator on WS slope.

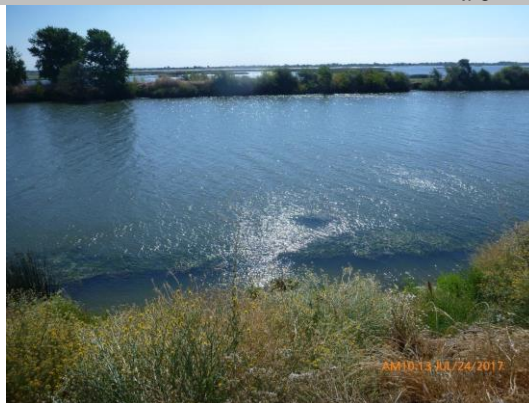
Photo 1 of 3 : LEVAL_SP_2019_416_2726.jpg

LM Start	2.21	Rating **	A/W	Issue No.	21
LM End	2.22	Issue Type +	Ma	Location *	
Category	Supplemental			GPS Latitude/Longitude	
				Start	End
Item	2017 Storm Damage			38.297100 °	38.297000 °
				-121.693300 °	-121.693300 °
DWR ID	DWR_RD2098_01_s_2018_21				
Comment Code					
Inspector Comment					
Levee Evaluation Comments					
Description:The damage consists of erosion, cracking, and sloughing of the waterside levee slope.					
Site ID No:416					
Site Designation:LMA-243					
Repair Type: Erosion					
Rating:Serious					
Field Date:7/24/2017					
Notes: Erosion with sloughing. About 2' vertical cut at top of erosion.

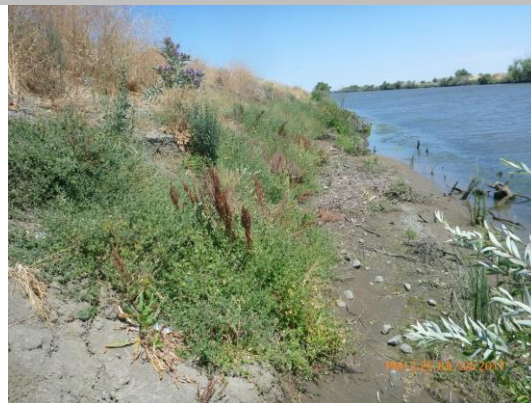
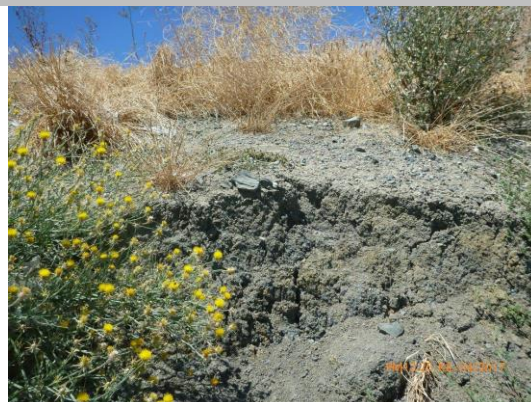
LM Start	2.29	Rating **	A/W	Issue No.	27 (cont)
LM End	2.31	Issue Type +	Ma	Location *	
Category	Supplemental			GPS Latitude/Longitude	
				Start	End
Item	2017 Storm Damage			38.295900 °	38.295700 °
				-121.693500 °	-121.693500 °
DWR ID	DWR_RD2098_01_f _ 2017_27				
Comment Code					
Inspector Comment					
Levee Evaluation Comments					
Description:The damage consists of scour and sloughing of the waterside levee slope.					
Site ID No:421					
Site Designation:LMA-248					
Repair Type: Erosion					
Rating:Serious					
Field Date:7/24/2017					
Notes: Toe of slope has eroded and minor sloughing has started.

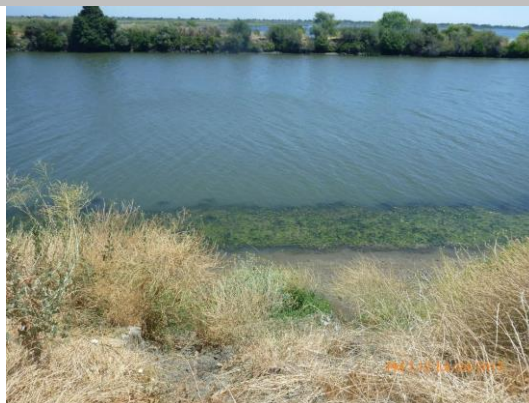
Photo 1 of 3 : SP_2019_RD2098_244_28_20190311_00017.jpg

LM Start	2.35	Rating **	A/W	Issue No.	28
LM End	2.39	Issue Type +	Ma	Location *	
Category	Supplemental			GPS Latitude/Longitude	
				Start	End
Item	2017 Storm Damage			38.295100 °	38.294500 °
				-121.693400 °	-121.693400 °
DWR ID	DWR_RD2098_01_f_2017_28				
Comment Code					
Inspector Comment					
Levee Evaluation Comments					
Description:The damage consists of scour, sloughing, and cracking of the lower and mid waterside levee slope.					
Site ID No:423					
Site Designation:LMA-250					
Repair Type: Erosion					
Rating:Area of Concern					
Field Date:7/24/2017					
Notes: 2' of sloughing about half way up the slope.

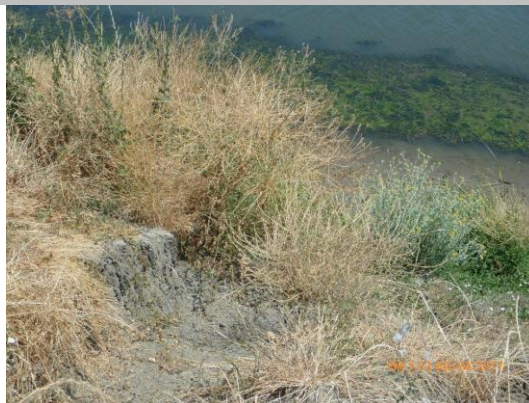
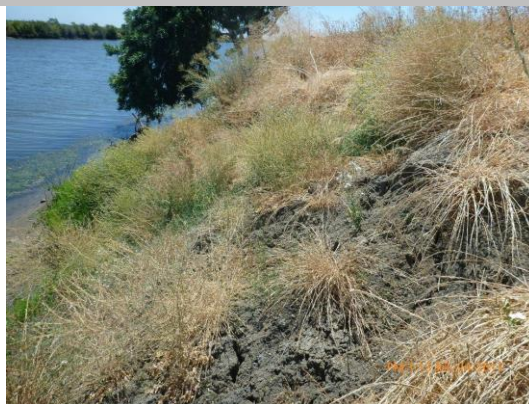
LM Start	2.35	Rating **	A/W	Issue No.	28 (cont)	
LM End	2.39	Issue Type +	Ma	Location *		
Category	Supplemental			GPS Latitude/Longitude		
				Start	End	
Item	2017 Storm Damage			38.295100 °	38.294500 °	
				-121.693400 °	-121.693400 °	
DWR ID	DWR_RD2098_01_f _ 2017_28					
Comment Code						
Inspector Comment						
Levee Evaluation Comments						
Description:The damage consists of scour, sloughing, and cracking of the lower and mid waterside levee slope.						
Site ID No:423						
Site Designation:LMA-250						
Repair Type: Erosion						
Rating:Area of Concern						
Field Date:7/24/2017						
Notes: 2' of sloughing about half way up the slope.

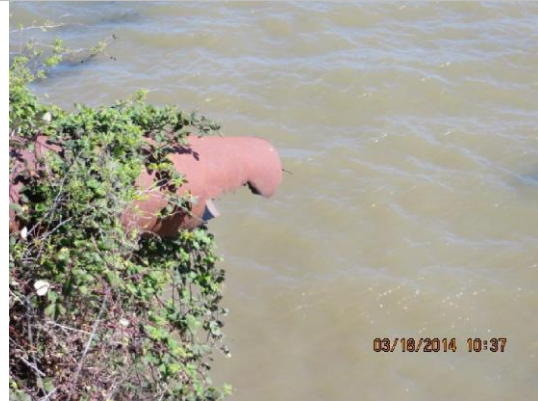
Photo 3 of 3 : UCIP_SP_2019_32227_58690.jpg

Pipe rusted through at outlet on WS slope.

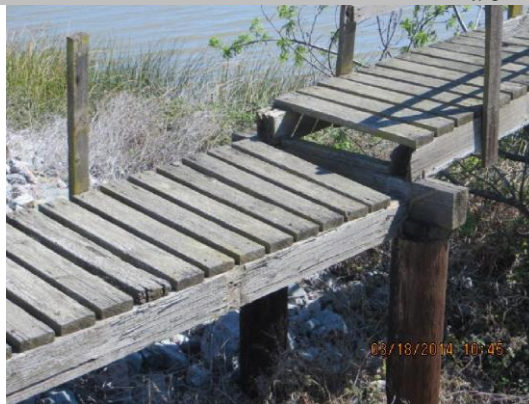
Photo 2 of 3 : UCIP_SP_2019_32243_58701.jpg

Walkway may not be structurally sound.

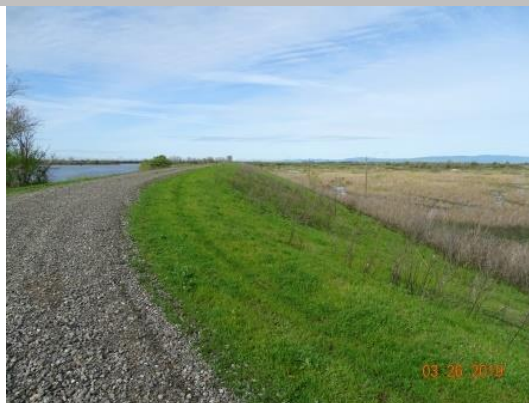
Photo 1 of 1 : SP_2019_RD2098_245_1_20190329_00005.jpg

View looking upstream at annual vegetation on the landside slope (Spring 2019).

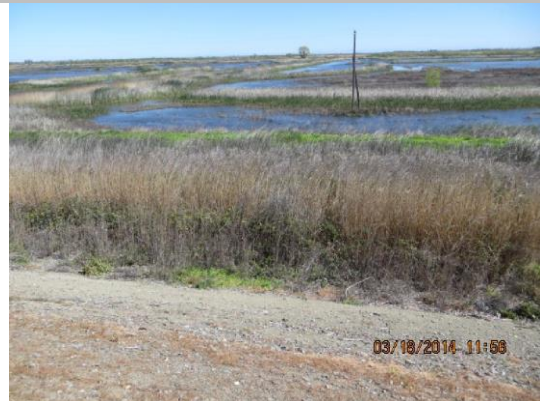
Photo 1 of 3 : UCIP_SP_2019_32287_58755.jpg

LS - no pipe visible.

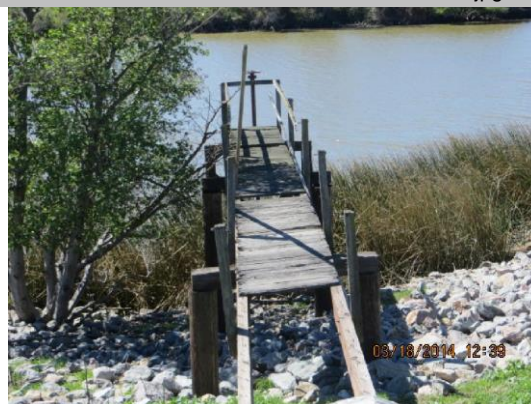
Photo 2 of 3 : UCIP_SP_2019_32290_58763.jpg

Dilapidated wooden pier on WS shoulder.

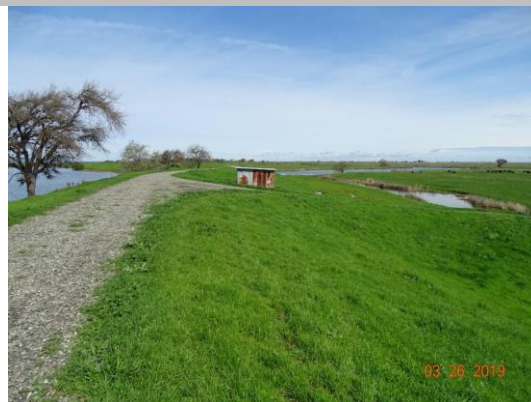
Photo 1 of 1 : SP_2019_RD2098_247_6_20190326_00021.jpg

View looking upstream at annual vegetation on the landside slope (Spring 2019).

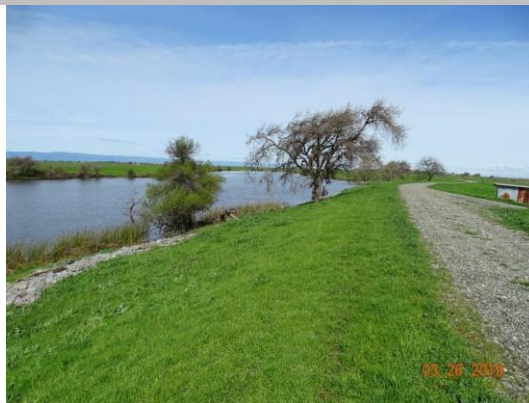
Photo 1 of 1 : SP_2019_RD2098_247_8_20190326_00020.jpg

View looking upstream at annual vegetation on the waterside slope (Spring 2019).

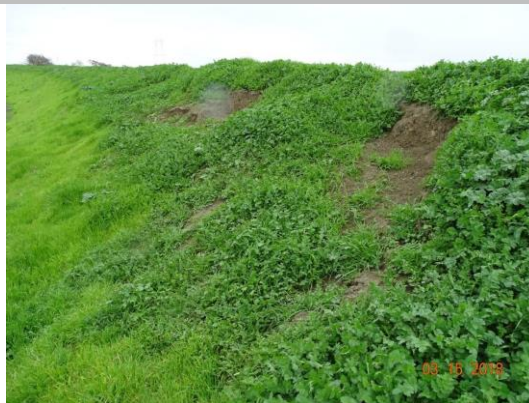
Photo 3 of 3 : SP_2019_RD2098_247_1_20190311_00003.jpg

Erosion site on 03/15/18.

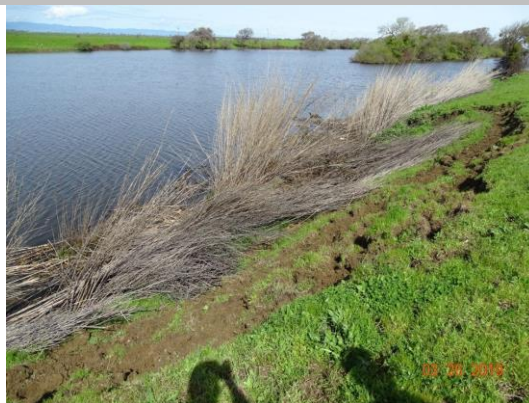
Photo 1 of 4 : SP_2019_RD2098_247_15_20190326_00024.jpg

View looking upstream at erosion at the storm damage site that has worsened over January and February of 2019 (Spring 2019).
