**Flood Control Project Maintenance
Levee Inspections**
LMA District Cover Sheet
Spring 2020 Levee Inspection Results

Reclamation District No. 2098 Cache and Haas Slough

Spring 2020 Levee Inspection Results

Waterway			Bank	Unit Miles
Unit No. 01 Yolo Bypass			Right	3.60
	Spring (March - May)	Summer (June - August)	(September - November) Fall	Winter (December - February)
Unit Maintenance Rating (Fall Only)				
Date of Inspection	4/24/2020 - 4/24/2020			
DWR Inspector	David Julian			
Accompanied By

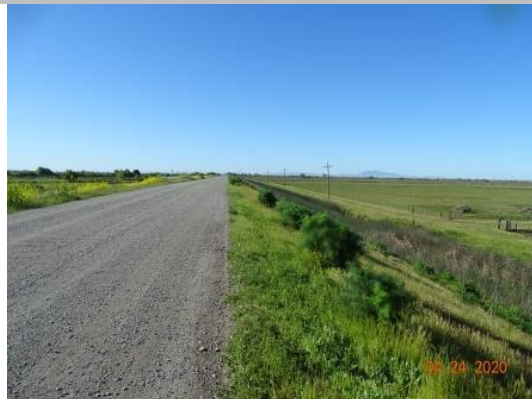
Photo 1 of 1 : SP_2020_RD2098_244_11_20200424_00051.jpg

View looking downstream at annual vegetation on the landside slope (Spring 2020).

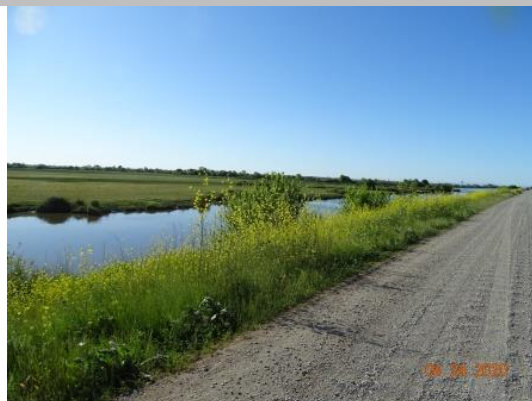
Photo 1 of 1 : SP_2020_RD2098_244_16_20200424_00050.jpg

LM Start	0.02	Rating **	M	Issue No.	16
LM End	1.07	Issue Type +	Ma	Location *	WS
Category	Earthen Levee			GPS Latitude/Longitude	
				Start	End
Item	Vegetation			38.328859 °	38.313540 °
				-121.694072 °	-121.693678 °
DWR ID	DWR_RD2098_01_s_2020_16				
Comment Code					
V1 : Control annual grass and weeds on the levee slopes and easements.					
Inspector Comment

View looking downstream at annual vegetation on the waterside slope (Spring 2020).

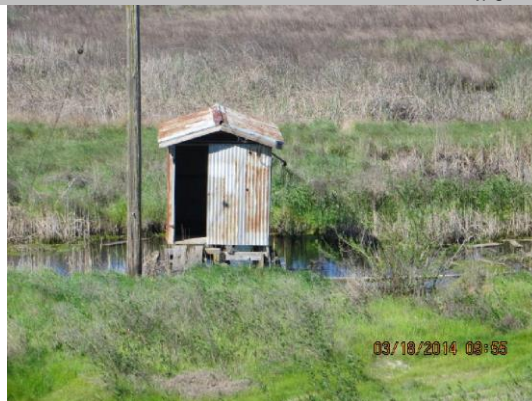
Photo 2 of 3 : UCIP_SP_2020_32197_58661.jpg

Pumphouse at lowpoint off LS toe.

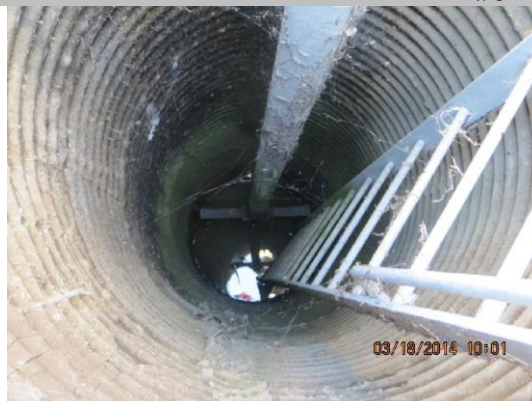
Photo 2 of 3 : UCIP_SP_2020_32207_58664.jpg

No lid on CMP riser that is 24-feet deep.

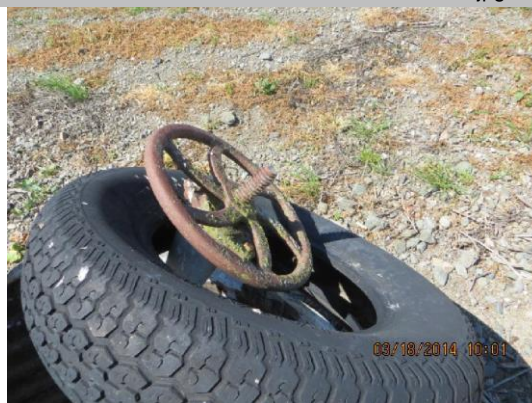
Photo 3 of 3 : UCIP_SP_2020_32207_58663.jpg

bent actuator on WS slope.

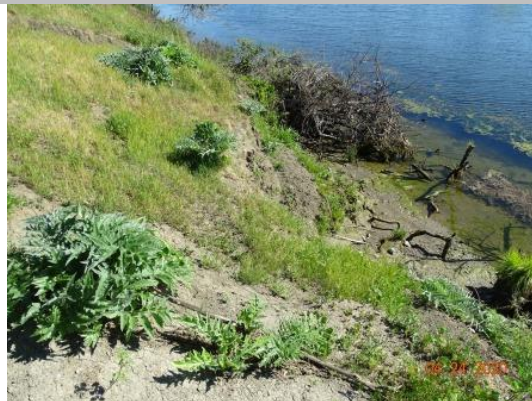
Photo 1 of 2 : SP_2020_RD2098_244_28_20200424_00054.jpg

LM Start	2.35	Rating **	U	Issue No.	28
LM End	2.39	Issue Type +	Ma	Location *	WS
Category	Earthen Levee			GPS Latitude/Longitude	
				Start	End
Item	Erosion / Bank Caving			38.295100 °	38.294500 °
				-121.693400 °	-121.693400 °
DWR ID	LMA-250				
Comment Code					
E2 : Schedule repair of erosion site prior to the next inspection.					
Inspector Comment					
This was a 2017 Storm Damage site. The damage consists of scour, sloughing, and cracking of the lower and mid waterside levee slope. Site ID No:423 Site Designation:LMA-250

View looking downslope at erosion into the waterside toe and slope (Spring 2020).

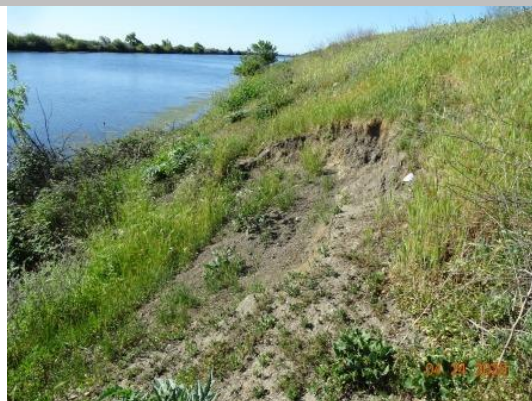
Photo 2 of 2 : SP_2020_RD2098_244_28_20200424_00055.jpg

View looking upstream at erosion into the waterside slope (Spring 2020).

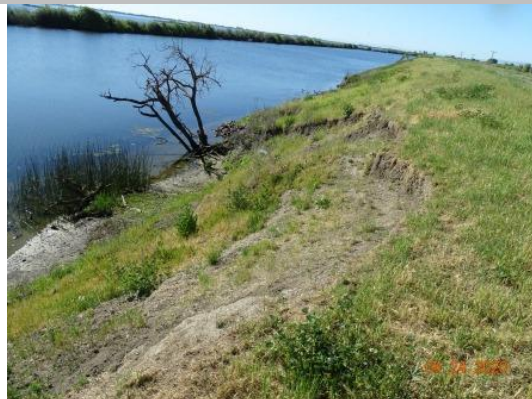
Photo 1 of 1 : SP_2020_RD2098_244_34_20200424_00056.jpg

LM Start	2.75	Rating **	U	Issue No.	34
LM End	2.81	Issue Type +	Ma	Location *	WS
Category	Earthen Levee			GPS Latitude/Longitude	
				Start	End
Item	Erosion / Bank Caving			38.289200 °	38.288405 °
				-121.693500 °	-121.693617 °
DWR ID	LMA-256				
Comment Code					
E2 : Schedule repair of erosion site prior to the next inspection.					
Inspector Comment					
This was a 2017 Storm Damage site. The damage consists of scour and sloughing of the waterside levee slope. Site ID No:429 & 430 Site Designation:LMA-256, LMA-257

View looking downstream at erosion into the waterside slope (Spring 2020).

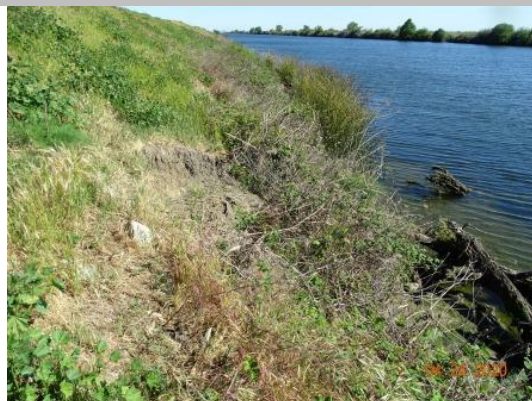
Photo 1 of 1 : SP_2020_RD2098_244_36_20200424_00057.jpg

LM Start	2.91	Rating **	U	Issue No.	36
LM End	2.93	Issue Type +	Ma	Location *	WS
Category	Earthen Levee			GPS Latitude/Longitude	
				Start	End
Item	Erosion / Bank Caving			38.286900 °	38.286700 °
				-121.693500 °	-121.693500 °
DWR ID	LMA-258				
Comment Code					
E2 : Schedule repair of erosion site prior to the next inspection.					
Inspector Comment					
This was a 2017 Storm Damage site. The damage consists of scour and sloughing of the waterside levee slope. Site ID No:431 Site Designation:LMA-258

View looking upstream at erosion into the waterside slope (Spring 2020).

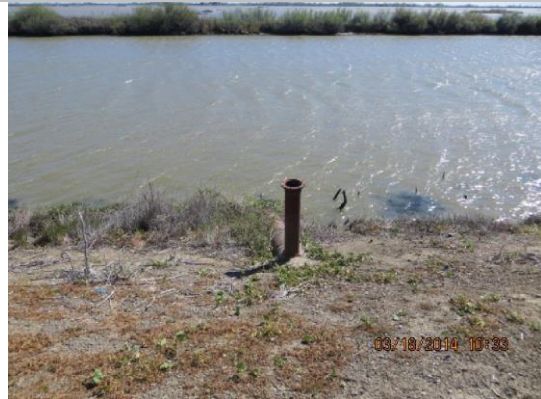
Photo 2 of 3 : UCIP_SP_2020_32227_58691.jpg

Siphon breaker in steel riser on WS slope.

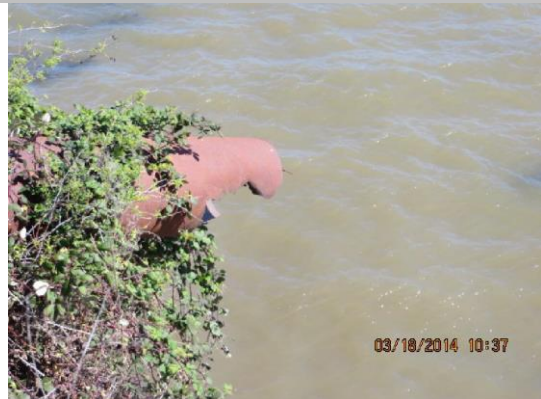
Photo 3 of 3 : UCIP_SP_2020_32227_58690.jpg

Pipe rusted through at outlet on WS slope.

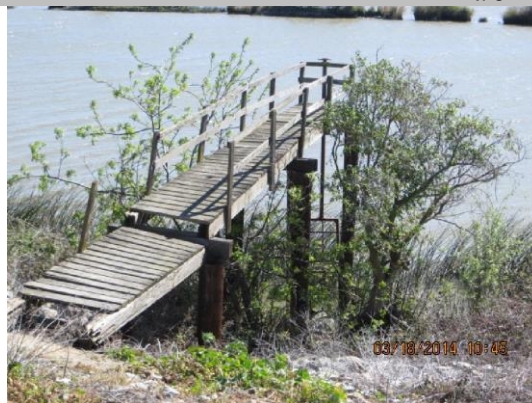
Photo 1 of 3 : UCIP_SP_2020_32243_58702.jpg

Comment Code					
Inspector Comment					
DS_ID:20970 FS_ID:32243 EP_NO: 10168 Repair Type: Non-Urgent Crossing Status: Found UCIP Comments: 03/18/2014 Walkway to slidegate on WS toe is in poor structural condition and may not be safe for accessing the slide gate actuator. Pipe appears abandoned and if so should be done so properly. Outlet on LS toe may be buried. (W. Wylie - DWR UCIP) FIELD_STRUCT_DESC: 24-inch steel irrigation pipe through the levee, 22.3 feet below the crown. Slide gate on the waterside (WS) end. Walkway from the WS shoulder to the slide gate control. Flap gate on the landside (LS) end. (This pipe was retained under Automatic Board Order (ABO) issued as Permit No. 10168, 1974 - Moresco Brothers). [Additional Reference(s): DWR Levee Log, 2003]. FS Date: 3/18/2014

Walkway to slide gate actuator on WS toe.

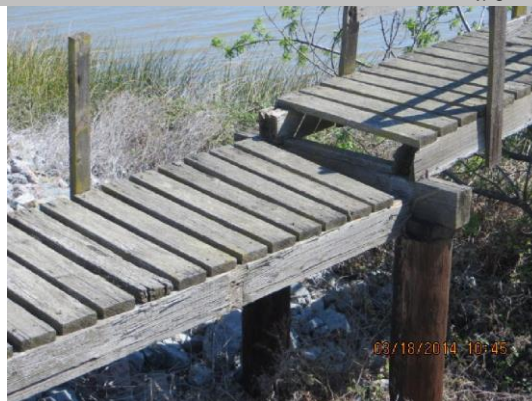
Photo 2 of 3 : UCIP_SP_2020_32243_58701.jpg

Walkway may not be structurally sound.

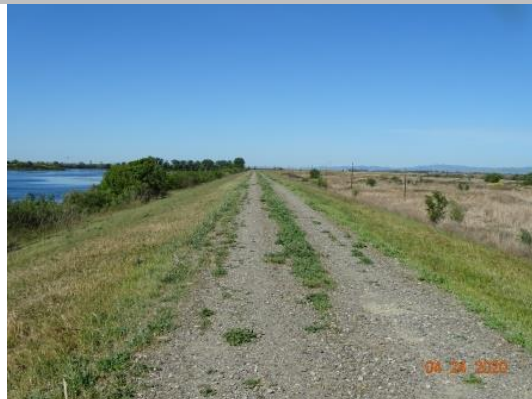
Photo 1 of 1 : SP_2020_RD2098_245_2_20200424_00001.jpg

View looking upstream at vegetation on the crown (Spring 2020).

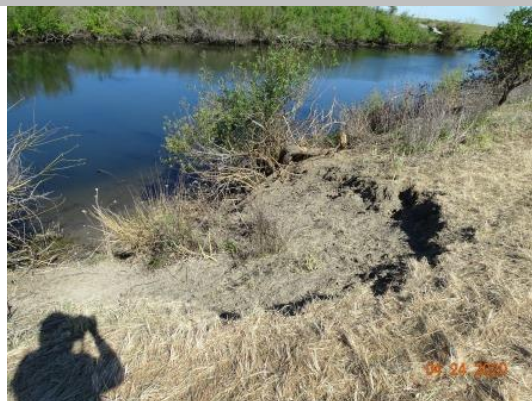
Photo 1 of 1 : SP_2020_RD2098_246_7_20200424_00035.jpg

View looking upstream at erosion into the waterside slope (Spring 2020).

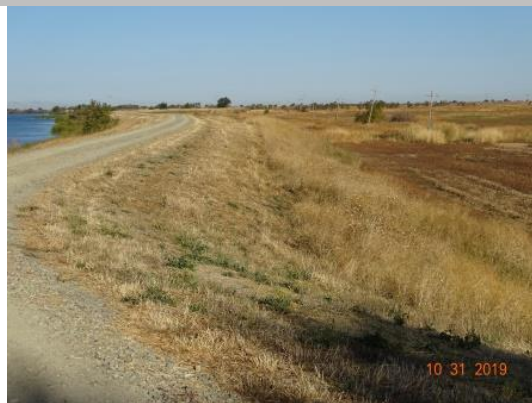
Photo 1 of 1 : SP_2020_RD2098_246_6_20200304_00001.jpg

View looking upstream at vegetation on the landside slope (Fall 2019).

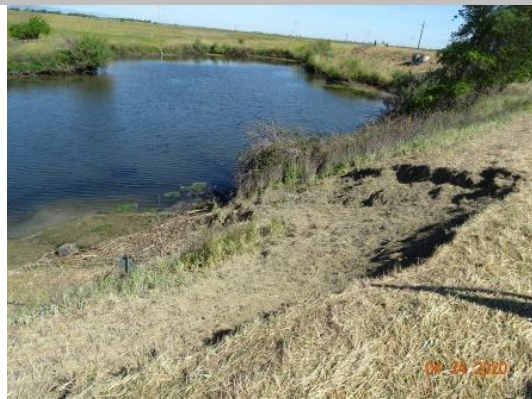
Photo 1 of 1 : SP_2020_RD2098_246_18_20200424_00037.jpg

LM Start	6.64	Rating **	U	Issue No.	18
LM End	6.65	Issue Type +	Ma	Location *	WS
Category	Earthen Levee			GPS Latitude/Longitude	
				Start	End
Item	Erosion / Bank Caving			38.291300 °	38.291400 °
				-121.716100 °	-121.716000 °
DWR ID	LMA-269				
Comment Code					
E2 : Schedule repair of erosion site prior to the next inspection.					
Inspector Comment					
This was a 2017 Storm Damage site. The damage consists of scour, cracking, instability, and sloughing of the waterside levee slope. Site ID No:442 Site Designation:LMA-269

View looking upstream at erosion into the waterside slope (Spring 2020).

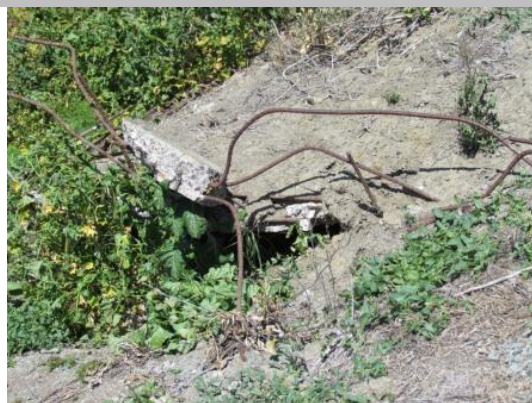
Photo 1 of 1 : SP_2020_RD2098_246_10_20200304_00002.jpg

There is some slope damage at this location under this concrete.

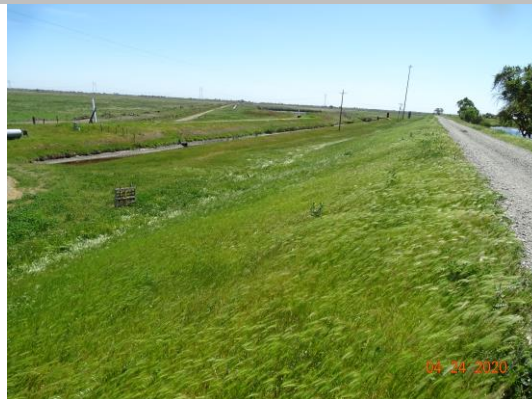
Photo 1 of 1 : SP_2020_RD2098_247_6_20200424_00021.jpg

View looking downstream at annual vegetation on the landside slope (Spring 2020).

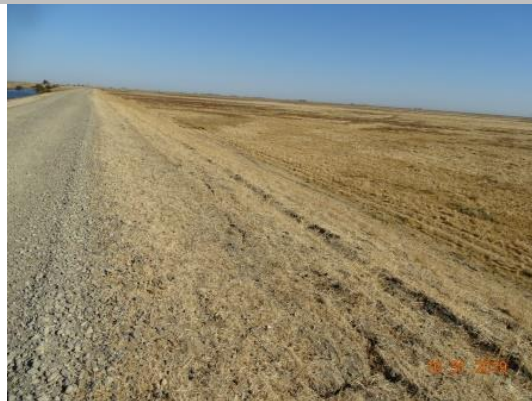
Photo 1 of 1 : SP_2020_RD2098_248_10_20200304_00004.jpg

View looking upstream at depressions in the landside slope due to cows (Fall 2019).

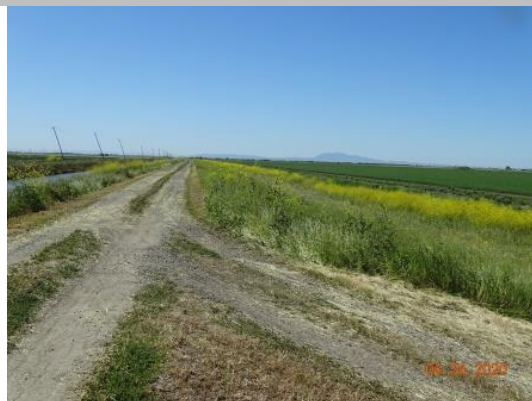
Photo 1 of 1 : SP_2020_RD2098_248_8_20200424_00024.jpg

View looking downstream at annual vegetation on the waterside slope (Spring 2020).

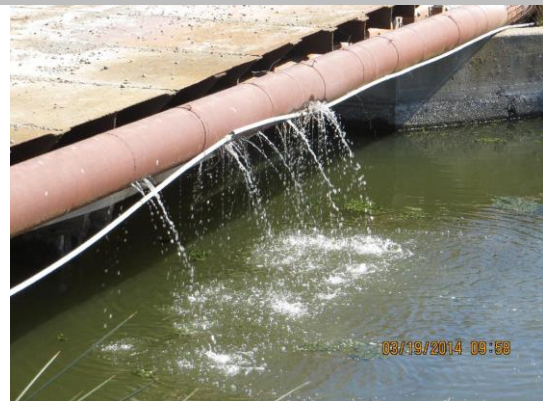
Photo 3 of 3 : UCIP_SP_2020_32403_58903.jpg

Holes in pipe next to bridge. PVC electrical conduit shown.

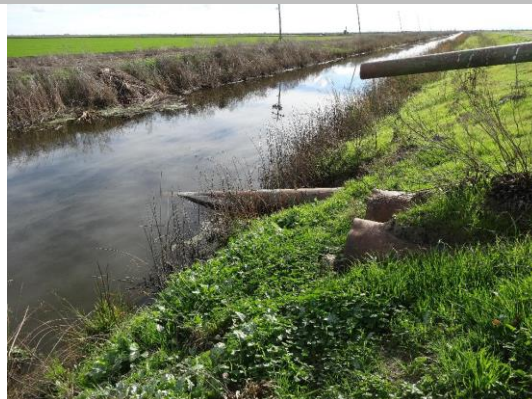
Photo 2 of 3 : UCIP_SP_2020_53382_76876.jpg

View of LS--damaged concrete distribution box has been removed.

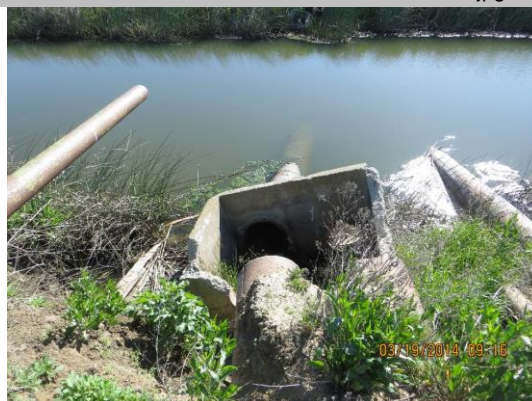
Photo 3 of 3 : UCIP_SP_2020_53382_58817.jpg

Concrete distribution box on LS slope has slipped into canal.
