**Flood Control Project Maintenance
Levee Inspections
Unit Cover Sheet**

Reclamation District No. 2098 Cache and Haas Slough

Levee Inspection Report By Mile - Spring 2021

Waterway	Bank	Unit Miles	Inspection Start/End	Inspector
Unit No. 01 Yolo Bypass	Right	3.60	03/19/2021 03/19/2021	David Julian

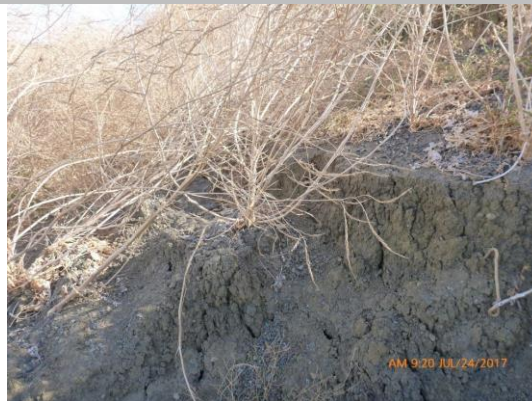
Photo 1 of 1 : LEVAL_SP_2021_414_3596.jpg

LM Start	0.96	Rating **	A/W	Issue No.	19
LM End	0.96	Issue Type +	Ma	Location *	LS
Category	Earthen Levee			GPS Latitude/Longitude	
				Start	End
Item	Erosion / Bank Caving			38.315200 °	38.315100 °
				-121.694100 °	-121.694100 °
DWR ID	DWR_RD2098_01_s_2021_19				
Comment Code					
E1 : Note and monitor erosion site.					
Inspector Comment					
This was a 2017 Storm Damage site. The damage consists of cracking and sloughing of the lower landside levee slope. Site ID No:414 Site Designation:LMA-241 4/24/2020 Field Notes: Vegetation is to thick to see. Verify in fall when vegetation less.

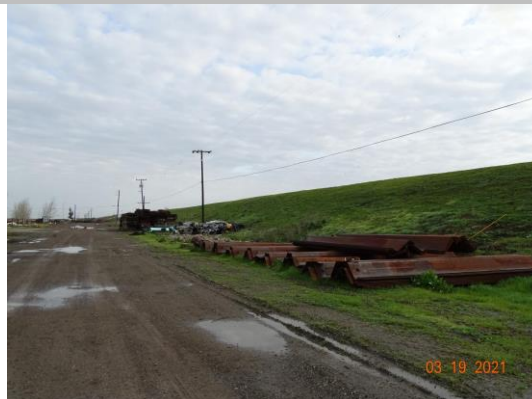
Photo 1 of 1 : SP_2021_RD2098_244_12_20210319_00033.jpg

View of material piles on the landside toe (Spring 2021).

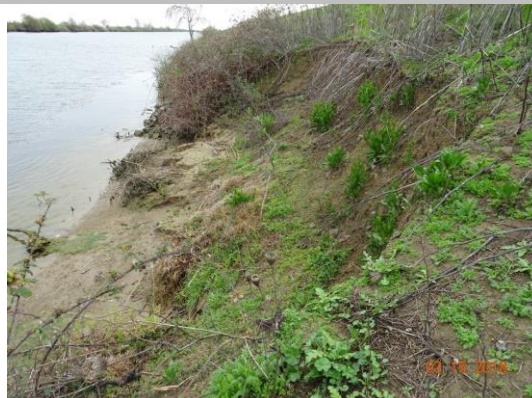
Photo 1 of 1 : SP_2021_RD2098_244_18_20210301_00004.jpg

LM Start	1.76	Rating **	M	Issue No.	18
LM End	1.76	Issue Type +	Ma	Location *	WS
Category	Earthen Levee			GPS Latitude/Longitude	
				Start	End
Item	Erosion / Bank Caving			38.303611 °	38.303611 °
				-121.693607 °	-121.693607 °
DWR ID	DWR_RD2098_01_s_2018_18				
Comment Code					
E2 : Schedule repair of erosion site prior to the next inspection.					
Inspector Comment					
There is erosion at the waterside toe.

View of erosion.

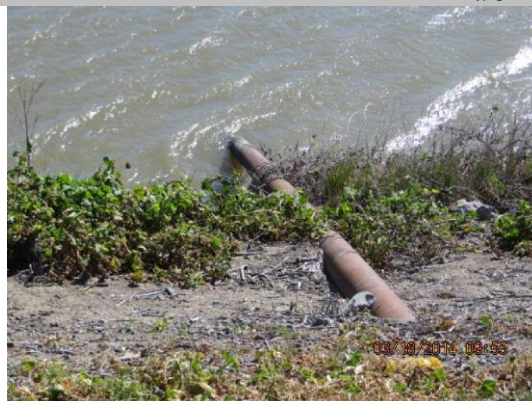
Photo 1 of 3 : UCIP_SP_2021_32197_58662.jpg

Pipe on WS slope.

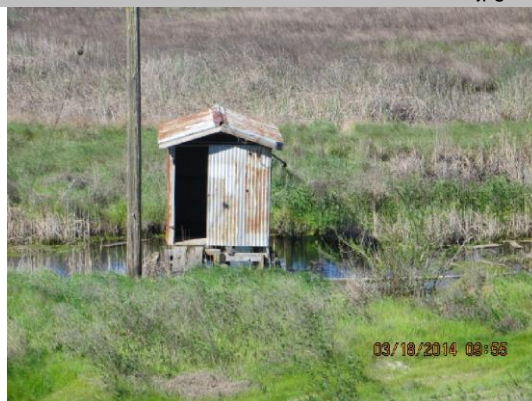
Photo 2 of 3 : UCIP_SP_2021_32197_58661.jpg

Pumphouse at lowpoint off LS toe.

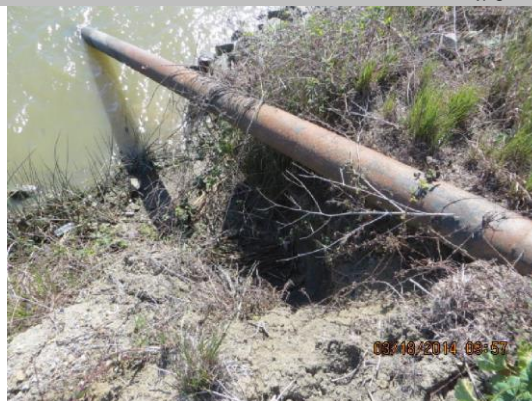
Photo 3 of 3 : UCIP_SP_2021_32197_58660.jpg

Erosion under pipe at WS toe.

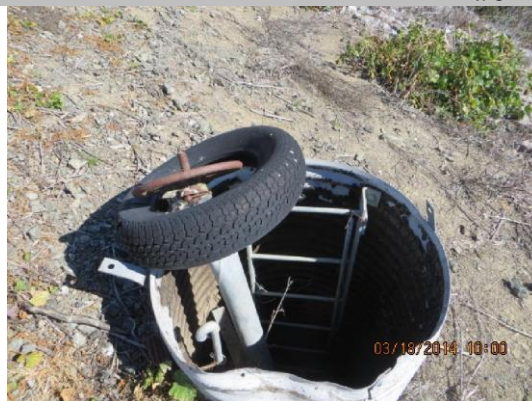
Photo 1 of 3 : UCIP_SP_2021_32207_58665.jpg

36-inch CMP riser with bent slide gate actuator on WS slope.

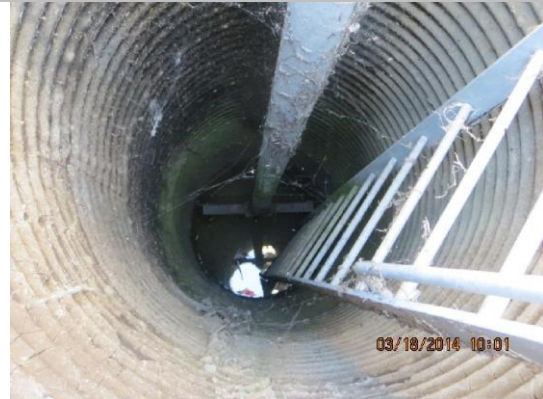
Photo 2 of 3 : UCIP_SP_2021_32207_58664.jpg

No lid on CMP riser that is 24-feet deep.

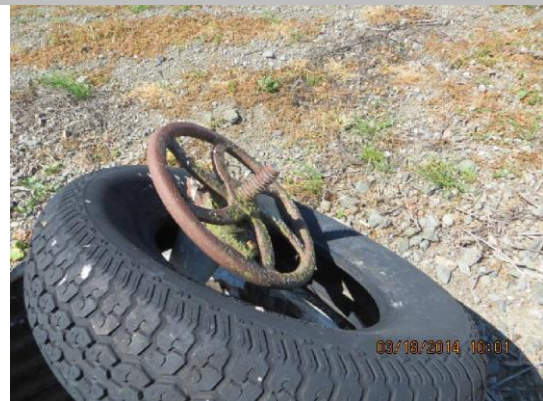
Photo 3 of 3 : UCIP_SP_2021_32207_58663.jpg

bent actuator on WS slope.

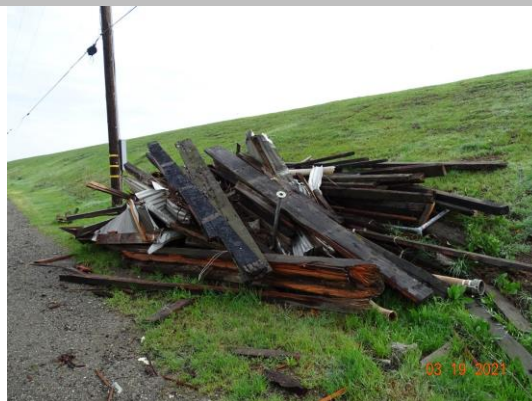
Photo 1 of 1 : SP_2021_RD2098_244_11_20210319_00034.jpg

LM Start	2.00	Rating **	U	Issue No.	11
LM End	2.00	Issue Type +	En	Location *	LS
Category	Earthen Levee			GPS Latitude/Longitude	
				Start	End
Item	Encroachments			38.300132 °	38.300132 °
				-121.693886 °	-121.693886 °
DWR ID	DWR_RD2098_01_s_2021_11				
Comment Code					
DE : Debris					
Inspector Comment					
Remove debris from landside toe.

View of debris pile on the landside toe (Spring 2021).

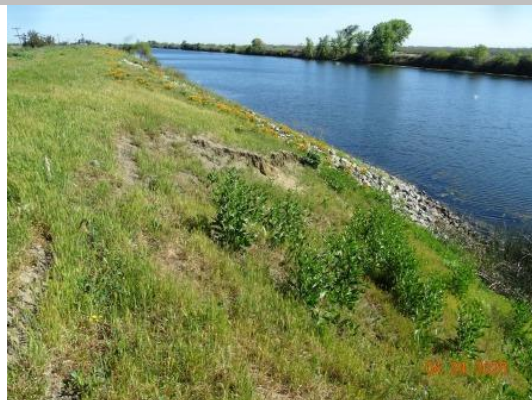
Photo 1 of 1 : SP_2021_RD2098_244_27_20210301_00007.jpg

LM Start	2.29	Rating **	U	Issue No.	27
LM End	2.32	Issue Type +	Ma	Location *	WS
Category	Earthen Levee			GPS Latitude/Longitude	
				Start	End
Item	Erosion / Bank Caving			38.295900 °	38.295468 °
				-121.693500 °	-121.693619 °
DWR ID	LMA-248				
Comment Code					
E2 : Schedule repair of erosion site prior to the next inspection.					
Inspector Comment					
This was a 2017 Storm Damage site. The damage consists of scour and sloughing of the waterside levee slope. Site ID No:421 Site Designation:LMA-248

View looking upstream at erosion in the waterside slope (Spring 2020).

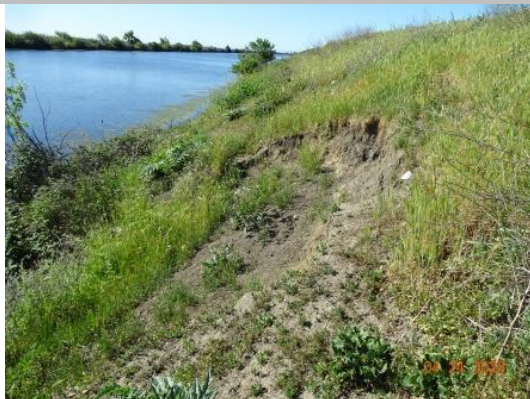
Photo 1 of 1 : SP_2021_RD2098_244_28_20210301_00008.jpg

LM Start	2.35	Rating **	U	Issue No.	28
LM End	2.39	Issue Type +	Ma	Location *	WS
Category	Earthen Levee			GPS Latitude/Longitude	
				Start	End
Item	Erosion / Bank Caving			38.295100 °	38.294500 °
				-121.693400 °	-121.693400 °
DWR ID	LMA-250				
Comment Code					
E2 : Schedule repair of erosion site prior to the next inspection.					
Inspector Comment					
This was a 2017 Storm Damage site. The damage consists of scour, sloughing, and cracking of the lower and mid waterside levee slope. Site ID No:423 Site Designation:LMA-250

View looking upstream at erosion into the waterside slope (Spring 2020).

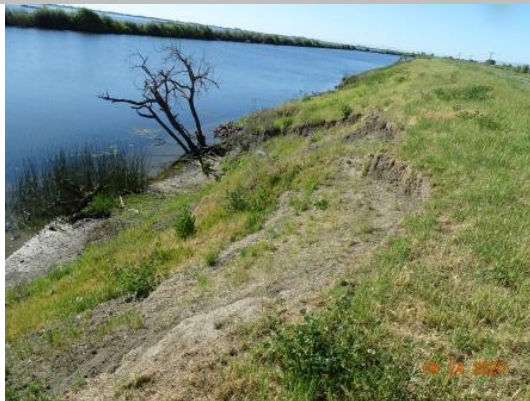
Photo 1 of 1 : SP_2021_RD2098_244_34_20210301_00009.jpg

LM Start	2.75	Rating **	U	Issue No.	34
LM End	2.81	Issue Type +	Ma	Location *	WS
Category	Earthen Levee			GPS Latitude/Longitude	
				Start	End
Item	Erosion / Bank Caving			38.289200 °	38.288405 °
				-121.693500 °	-121.693617 °
DWR ID	LMA-256				
Comment Code					
E2 : Schedule repair of erosion site prior to the next inspection.					
Inspector Comment					
This was a 2017 Storm Damage site. The damage consists of scour and sloughing of the waterside levee slope. Site ID No:429 & 430 Site Designation:LMA-256, LMA-257

View looking downstream at erosion into the waterside slope (Spring 2020).

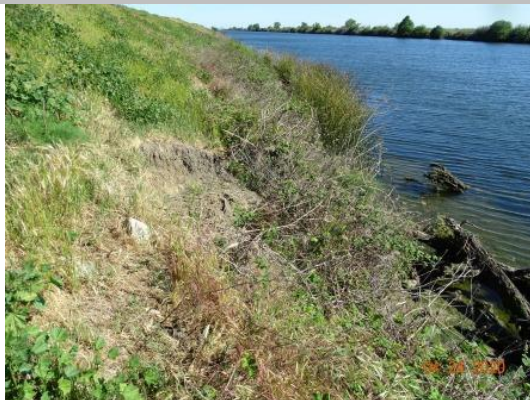
Photo 1 of 1 : SP_2021_RD2098_244_36_20210301_00010.jpg

LM Start	2.91	Rating **	U	Issue No.	36
LM End	2.93	Issue Type +	Ma	Location *	WS
Category	Earthen Levee			GPS Latitude/Longitude	
				Start	End
Item	Erosion / Bank Caving			38.286900 °	38.286700 °
				-121.693500 °	-121.693500 °
DWR ID	LMA-258				
Comment Code					
E2 : Schedule repair of erosion site prior to the next inspection.					
Inspector Comment					
This was a 2017 Storm Damage site. The damage consists of scour and sloughing of the waterside levee slope. Site ID No:431 Site Designation:LMA-258

View looking upstream at erosion into the waterside slope (Spring 2020).

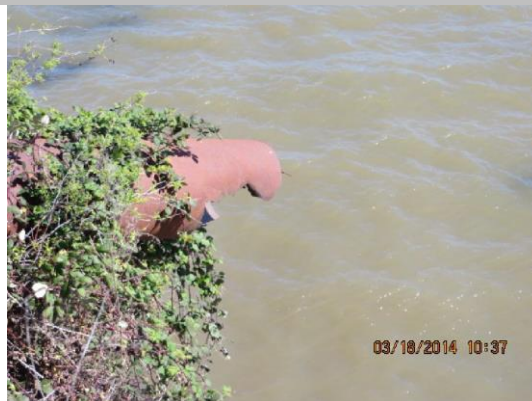
Photo 3 of 3 : UCIP_SP_2021_32227_58690.jpg

Comment Code						
Inspector Comment						
FS_ID:32227 DS_ID:20969 EP_NO: 13222 Repair Type: Non-Urgent Crossing Status: Found UCIP Comments: 03/18/2014 Pipe rusted through at outlet on WS slope, may indicate further degradation of pipe within levee. Good candidate for video inspection. (W. Wylie - DWR UCIP) FIELD_STRUCT_DESC: 20-inch steel drainage pipe through the levee, 7.5 feet below the crown. Siphon breaker on the waterside (WS) shoulder. Pump on pile structure in drainage ditch on the landside (LS). (This pipe was retained under Automatic Board Order (ABO) issued as Permit No. 10168, 1974 - Moresco Brothers. Pipe removed and replaced with a 19-inch steel pipe under the crown and along the LS slope under Permit No. 13222, 1981 - Prudential Insurance Company of America). [Additional Reference(s): DWR Levee Log, 2003. USACE Sacramento O&M Manual 109, April 1962, (HLM 2.98)]. FS Date: 3/18/2014

Pipe rusted through at outlet on WS slope.

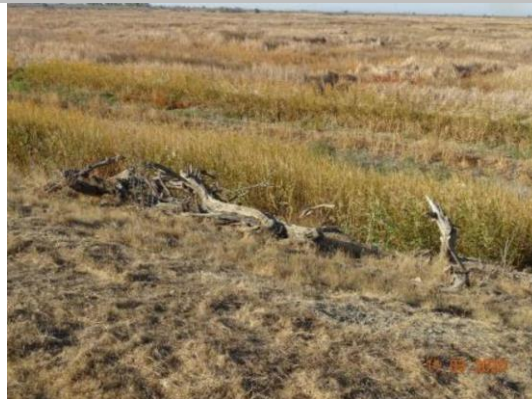
Photo 1 of 1 : SP_2021_RD2098_244_20_20210301_00006.jpg

View of tree limb on the landside slope (Fall 2020).

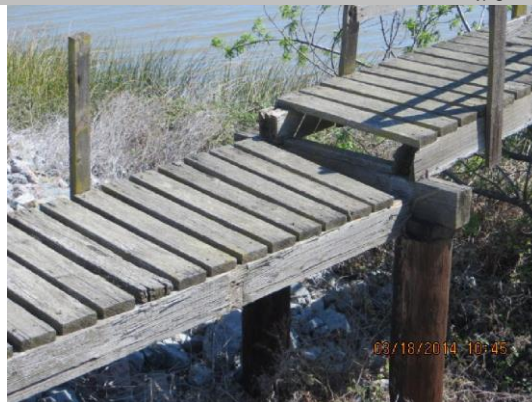
Photo 2 of 3 : UCIP_SP_2021_32243_58701.jpg

Comment Code						
Inspector Comment						
FS_ID:32243 DS_ID:20970 EP_NO: 10168 Repair Type: Non-Urgent Crossing Status: Found UCIP Comments: 03/18/2014 Walkway to slidegate on WS toe is in poor structural condition and may not be safe for accessing the slide gate actuator. Pipe appears abandoned and if so should be done so properly. Outlet on LS toe may be buried. (W. Wylie - DWR UCIP) FIELD_STRUCT_DESC: 24-inch steel irrigation pipe through the levee, 22.3 feet below the crown. Slide gate on the waterside (WS) end. Walkway from the WS shoulder to the slide gate control. Flap gate on the landside (LS) end. (This pipe was retained under Automatic Board Order (ABO) issued as Permit No. 10168, 1974 - Moresco Brothers). [Additional Reference(s): DWR Levee Log, 2003]. FS Date: 3/18/2014

Walkway may not be structurally sound.

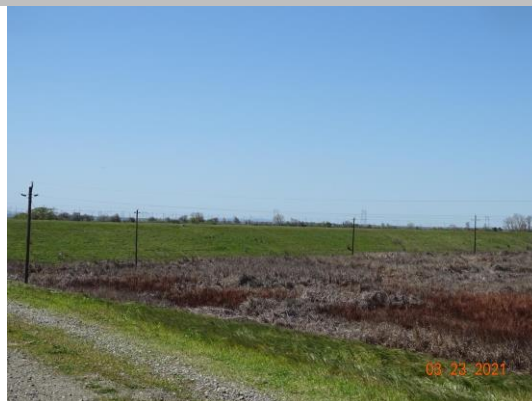
Photo 1 of 1 : SP_2021_RD2098_245_1_20210323_00001.jpg

View of vegetation on the landside slope off in the distance (Spring 2021).

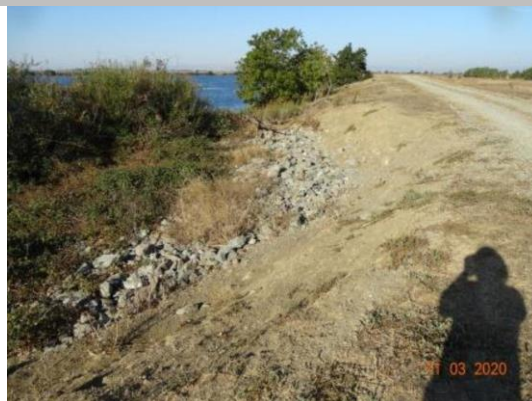
Photo 1 of 1 : SP_2021_RD2098_246_11_20210301_00002.jpg

View looking upstream at erosion into waterside slope (Fall 2020).

E2 : Schedule repair of erosion site prior to the next inspection.

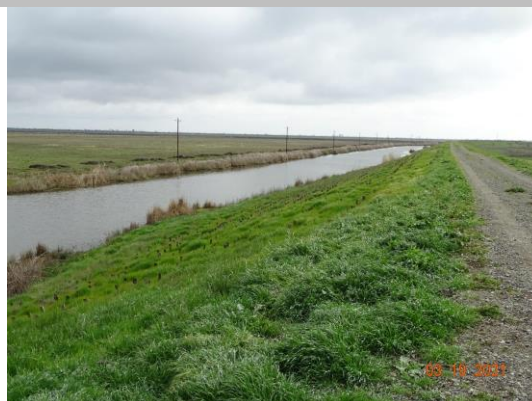
Photo 1 of 1 : SP_2021_RD2098_246_6_20210319_00023.jpg

View looking downstream at vegetation on the landside slope (Spring 2021).

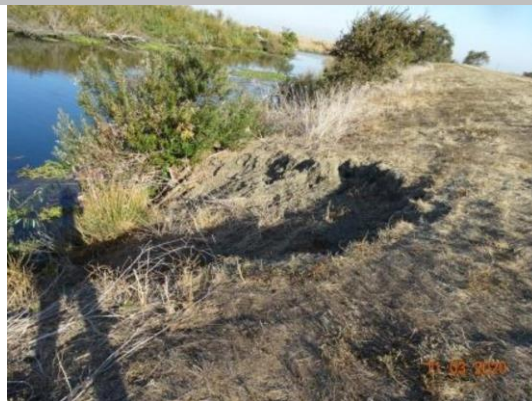
Photo 1 of 1 : SP_2021_RD2098_246_15_20210301_00004.jpg

LM Start	6.46	Rating **	U	Issue No.	15
LM End	6.48	Issue Type +	Ma	Location *	WS
Category	Earthen Levee			GPS Latitude/Longitude	
				Start	End
Item	Erosion / Bank Caving			38.288700 °	38.289061 °
				-121.717000 °	-121.716885 °
DWR ID	LMA-267				
Comment Code					
E2 : Schedule repair of erosion site prior to the next inspection.					
Inspector Comment					
This was a 2017 Storm Damage site. The damage consists of scour of the lower and mid waterside levee slope. Site ID No:440 & 441 Site Designation:LMA-267 & LMA-268

View looking upstream at erosion into the waterside slope (Fall 2020).

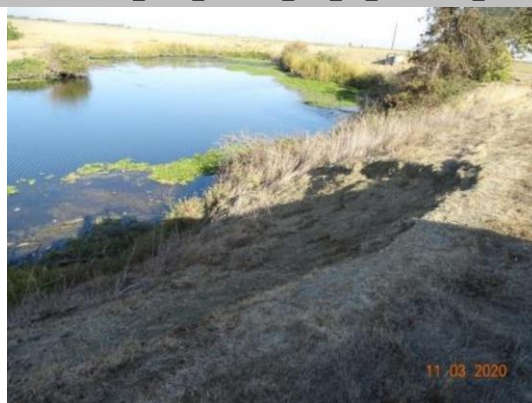
Photo 1 of 1 : SP_2021_RD2098_246_18_20210301_00005.jpg

LM Start	6.64	Rating **	U	Issue No.	18
LM End	6.65	Issue Type +	Ma	Location *	WS
Category	Earthen Levee			GPS Latitude/Longitude	
				Start	End
Item	Erosion / Bank Caving			38.291300 °	38.291400 °
				-121.716100 °	-121.716000 °
DWR ID	LMA-269				
Comment Code					
E2 : Schedule repair of erosion site prior to the next inspection.					
Inspector Comment					
This was a 2017 Storm Damage site. The damage consists of scour, cracking, instability, and sloughing of the waterside levee slope. Site ID No:442 Site Designation:LMA-269

View looking upstream at erosion into the waterside slope (Fall 2020).

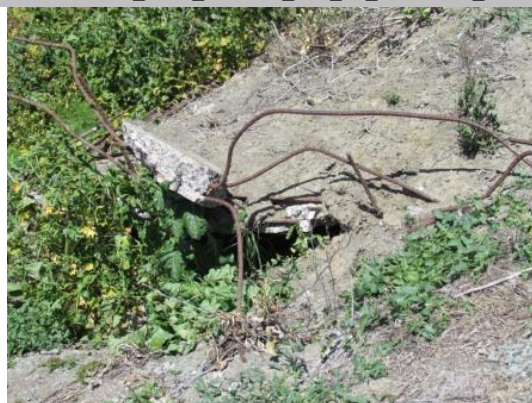
Photo 1 of 1 : SP_2021_RD2098_246_10_20210301_00001.jpg

There is some slope damage at this location under this concrete.

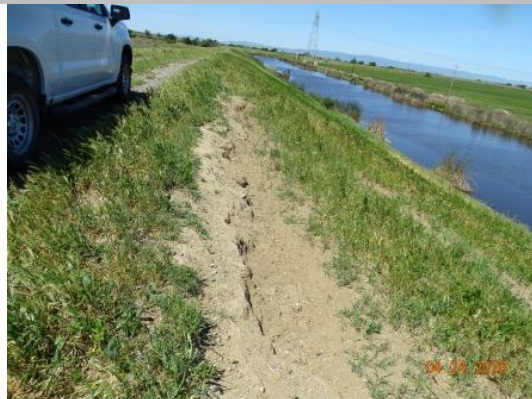
Photo 1 of 1 : SP_2021_RD2098_246_12_20210301_00003.jpg

View looking upstream at erosion at the top of the landside slope (Spring 2020).

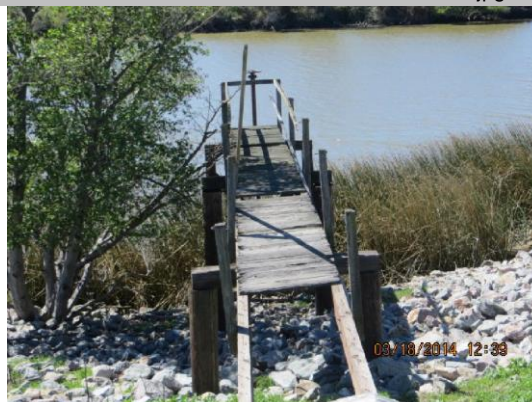
Photo 2 of 3 : UCIP_SP_2021_32290_58763.jpg

Dilapidated wooden pier on WS shoulder.

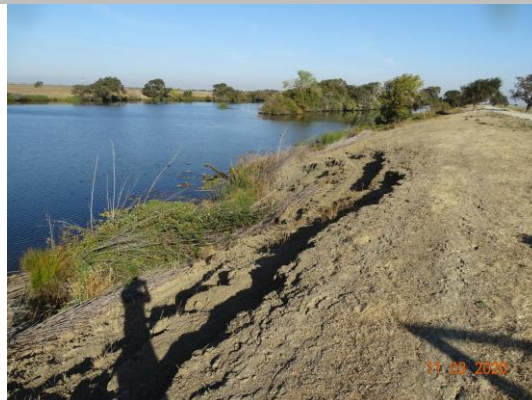
Photo 1 of 1 : SP_2021_RD2098_247_7_20210301_00001.jpg

View looking upstream at erosion into the waterside slope (Fall 2020).

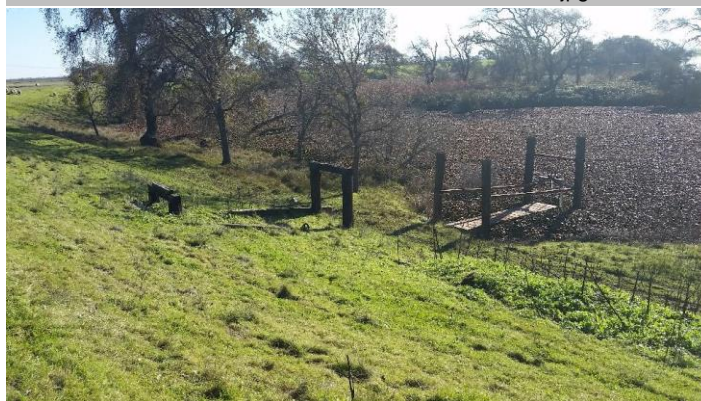
Photo 1 of 3 : UCIP_SP_2021_51453_76858.jpg

Walkway has been re-built, photo 1 of 2.

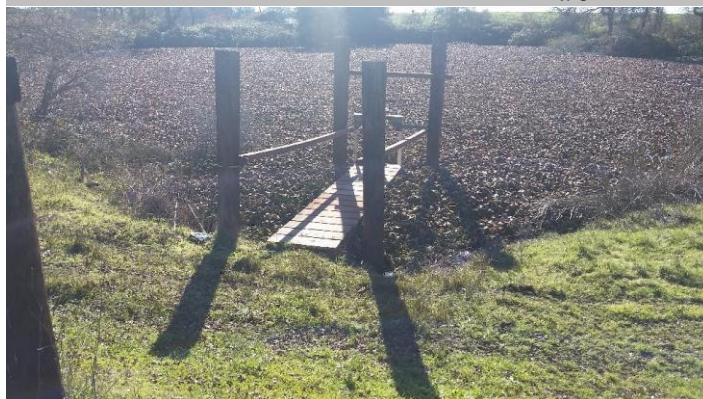
Photo 2 of 3 : UCIP_SP_2021_51453_76861.jpg

Walkway has been re-built, photo 2 of 2.

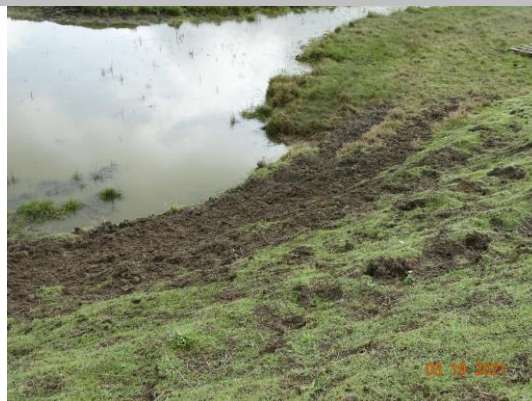
Photo 1 of 1 : SP_2021_RD2098_247_4_20210319_00007.jpg

View of slope terracing caused by cattle on the landside slope (Spring 2021).

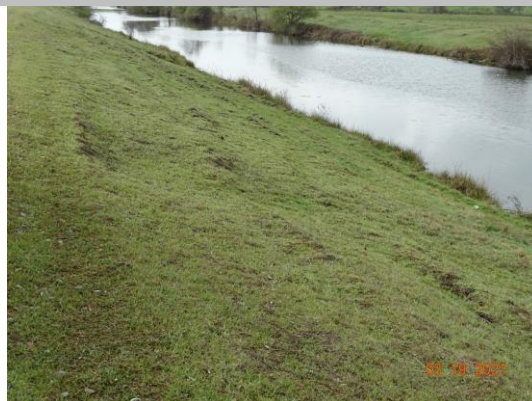
Photo 1 of 1 : SP_2021_RD2098_248_11_20210319_00021.jpg

View of terracing due to cows on the landside slope (Spring 2021).

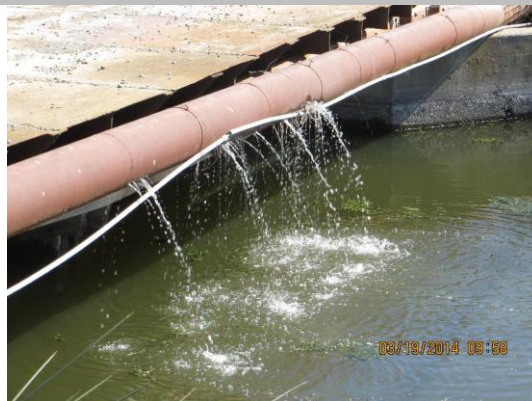
Photo 3 of 3 : UCIP_SP_2021_32403_58903.jpg

Holes in pipe next to bridge. PVC electrical conduit shown.

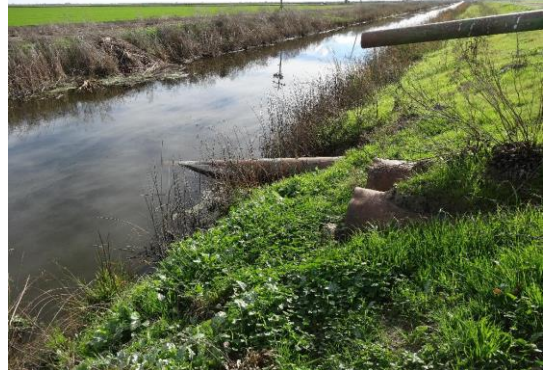
Photo 2 of 3 : UCIP_SP_2021_53382_76876.jpg

View of LS--damaged concrete distribution box has been removed.

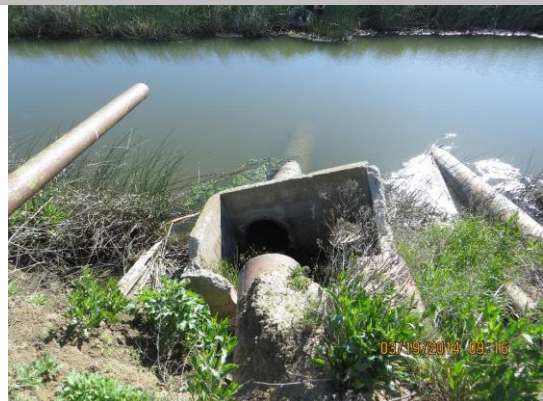
Photo 3 of 3 : UCIP_SP_2021_53382_58817.jpg

Concrete distribution box on LS slope has slipped into canal.

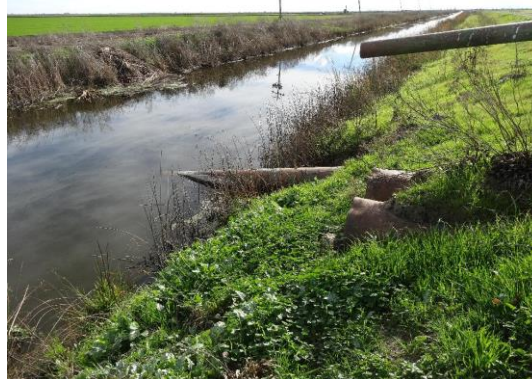
Photo 2 of 3 : UCIP_SP_2021_53383_76884.jpg

View of LS--damage distribution box noted in last inspection has been removed.
