**Flood Control Project Maintenance
Levee Inspections
LMA District Cover Sheet**

Reclamation District No. 2098 Cache and Haas Slough

**Flood Control Project Maintenance
Levee Inspections
Unit Cover Sheet**

Waterway			Bank	Unit Miles
Unit No. 01 Yolo Bypass			Right	3.60
	Spring (March - May)	Summer (June - August)	(September - November) Fall	Winter (December - February)
Unit Maintenance Rating (Fall Only)				
Date of Inspection	3/18/2022 - 3/18/2022			
DWR Inspector	David Julian			
Accompanied By			Bryan Busch RD 2098

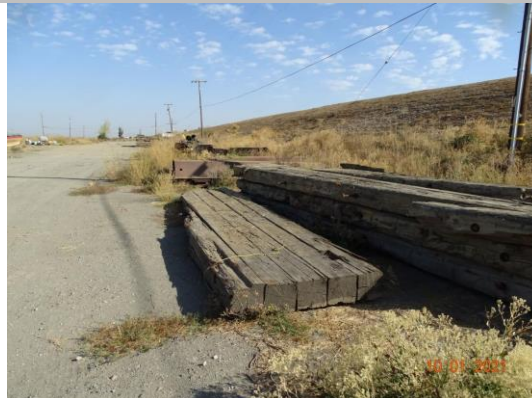
Photo 1 of 1 : SP_2022_RD2098_244_12_20220310_00002.jpg

LM Start	1.72	Rating **	U	Issue No.	12
LM End	1.72	Issue Type +	En	Location *	LS
Category	Earthen Levee			GPS Latitude/Longitude	
				Start	End
Item	Encroachments			38.304209 °	38.304209 °
				-121.693997 °	-121.693997 °
DWR ID	DWR_RD2098_01_f_2021_12				
Comment Code					
MA : Material					
Inspector Comment

View of demolition debris on the landside toe (Fall 2021).

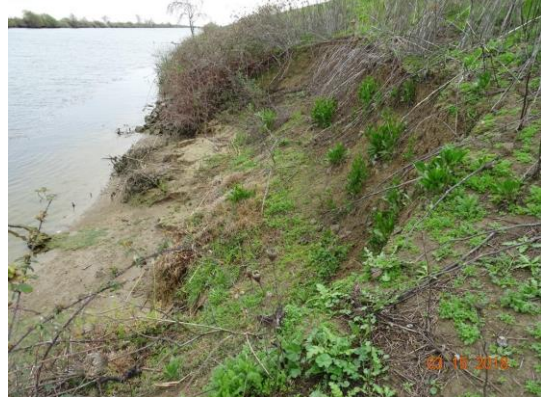
Photo 1 of 1 : SP_2022_RD2098_244_18_20220310_00003.jpg

LM Start	1.76	Rating **	M	Issue No.	18
LM End	1.76	Issue Type +	Ma	Location *	WS
Category	Earthen Levee			GPS Latitude/Longitude	
				Start	End
Item	Erosion / Bank Caving			38.303611 °	38.303611 °
				-121.693607 °	-121.693607 °
DWR ID	DWR_RD2098_01_s_2018_18				
Comment Code					
E2 : Schedule repair of erosion site prior to the next inspection.					
Inspector Comment					
There is erosion at the waterside toe.

View of erosion.

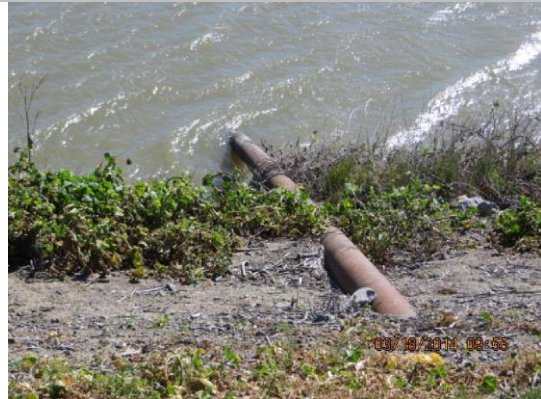
Photo 1 of 3 : UCIP_SP_2022_32197_58662.jpg

Comment Code						
Inspector Comment						
FS_ID:32197 DS_ID:20965 EP_NO: 10168 Repair Type: Non-Urgent Crossing Status: Found UCIP Comments: 12/22/2016 Met with Mike Hadesty, LMA Superintendent, and Brian Bush, LMA General Manager, to go over the list of pipes in RD2098. Per LMA records, this pipe has a different owner. (O. Magana - DWR UCIP) 03/18/2014 Erosion under pipe at WS toe. (W. Wylie - DWR UCIP) FIELD_STRUCT_DESC: 10-inch steel drainage pipe through the levee, 2.8 feet below the crown. Pump in pump house off the landside (LS). (This pipe was retained under Automatic Board Order (ABO) issued as Permit No. 10168, 1974 - Moresco Brothers). [Additional Reference(s): DWR Levee Log, 2003. USACE Sacramento O&M Manual 109, April 1962, (HLM 1.80)]. FS Date: 3/18/2014

Pipe on WS slope.

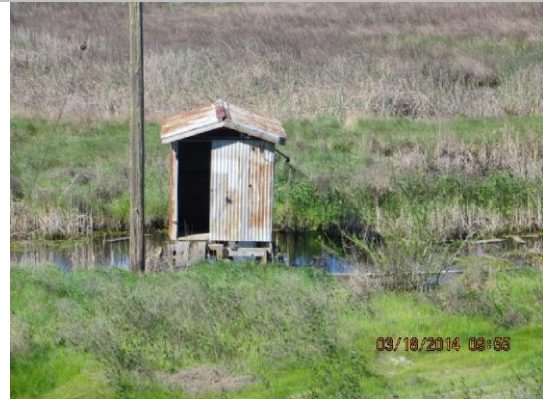
Photo 2 of 3 : UCIP_SP_2022_32197_58661.jpg

Pumphouse at lowpoint off LS toe.

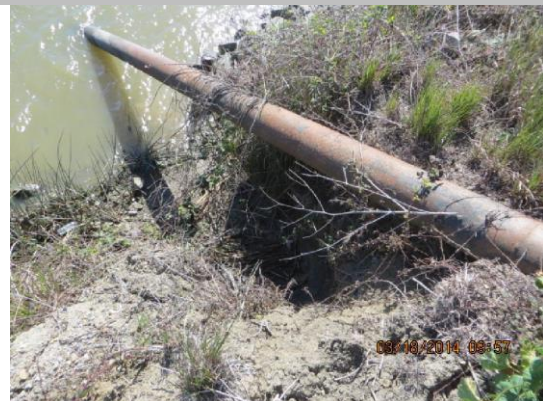
Photo 3 of 3 : UCIP_SP_2022_32197_58660.jpg

Erosion under pipe at WS toe.

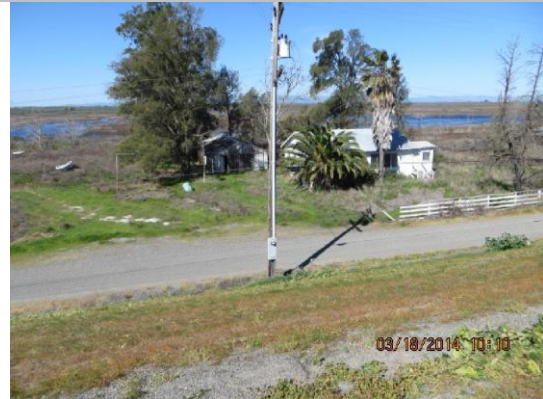
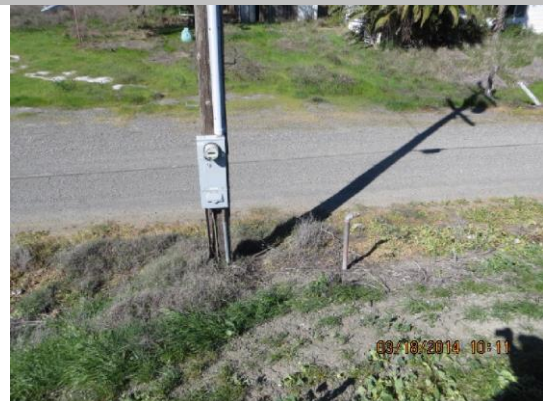
Power pole and meter next to spigot on LS toe.

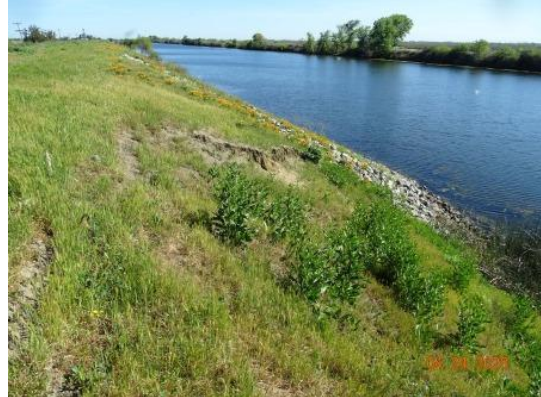
Photo 1 of 1 : SP_2022_RD2098_244_27_20220310_00006.jpg

LM Start	2.29	Rating **	U	Issue No.	27
LM End	2.32	Issue Type +	Ma	Location *	WS
Category	Earthen Levee			GPS Latitude/Longitude	
				Start	End
Item	Erosion / Bank Caving			38.295900 °	38.295468 °
				-121.693500 °	-121.693619 °
DWR ID	LMA-248				
Comment Code					
E2 : Schedule repair of erosion site prior to the next inspection.					
Inspector Comment					
This was a 2017 Storm Damage site. The damage consists of scour and sloughing of the waterside levee slope. Site ID No:421 Site Designation:LMA-248

View looking upstream at erosion in the waterside slope (Spring 2020).

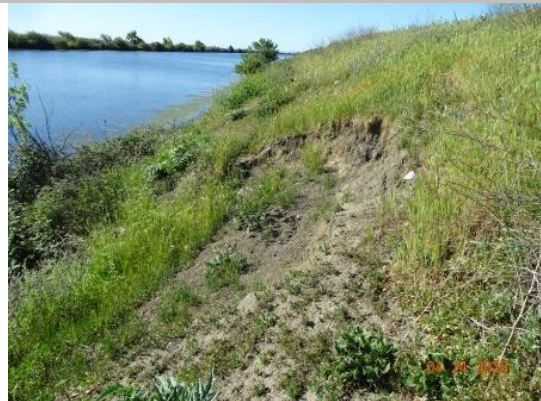
Photo 1 of 1 : SP_2022_RD2098_244_28_20220310_00007.jpg

LM Start	2.35	Rating **	U	Issue No.	28
LM End	2.39	Issue Type +	Ma	Location *	WS
Category	Earthen Levee			GPS Latitude/Longitude	
				Start	End
Item	Erosion / Bank Caving			38.295100 °	38.294500 °
				-121.693400 °	-121.693400 °
DWR ID	LMA-250				
Comment Code					
E2 : Schedule repair of erosion site prior to the next inspection.					
Inspector Comment					
This was a 2017 Storm Damage site. The damage consists of scour, sloughing, and cracking of the lower and mid waterside levee slope. Site ID No:423 Site Designation:LMA-250

View looking upstream at erosion into the waterside slope (Spring 2020).

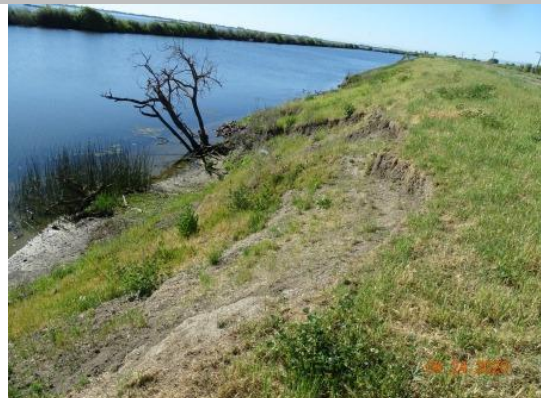
Photo 1 of 1 : SP_2022_RD2098_244_34_20220310_00008.jpg

LM Start	2.75	Rating **	U	Issue No.	34
LM End	2.81	Issue Type +	Ma	Location *	WS
Category	Earthen Levee			GPS Latitude/Longitude	
				Start	End
Item	Erosion / Bank Caving			38.289200 °	38.288405 °
				-121.693500 °	-121.693617 °
DWR ID	LMA-256				
Comment Code					
E2 : Schedule repair of erosion site prior to the next inspection.					
Inspector Comment					
This was a 2017 Storm Damage site. The damage consists of scour and sloughing of the waterside levee slope. Site ID No:429 & 430 Site Designation:LMA-256, LMA-257

View looking downstream at erosion into the waterside slope (Spring 2020).

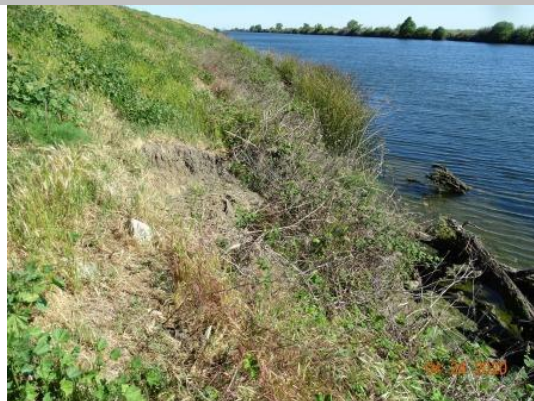
Photo 1 of 1 : SP_2022_RD2098_244_36_20220310_00009.jpg

LM Start	2.91	Rating **	U	Issue No.	36
LM End	2.93	Issue Type +	Ma	Location *	WS
Category	Earthen Levee			GPS Latitude/Longitude	
				Start	End
Item	Erosion / Bank Caving			38.286900 °	38.286700 °
				-121.693500 °	-121.693500 °
DWR ID	LMA-258				
Comment Code					
E2 : Schedule repair of erosion site prior to the next inspection.					
Inspector Comment					
This was a 2017 Storm Damage site. The damage consists of scour and sloughing of the waterside levee slope. Site ID No:431 Site Designation:LMA-258

View looking upstream at erosion into the waterside slope (Spring 2020).

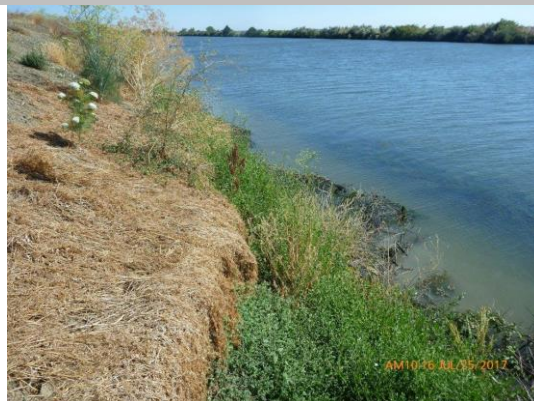
Photo 1 of 1 : SP_2022_RD2098_244_37_20220310_00010.jpg

LM Start	2.99	Rating **	M	Issue No.	37
LM End	3.29	Issue Type +	Ma	Location *	WS
Category	Earthen Levee			GPS Latitude/Longitude	
				Start	End
Item	Erosion / Bank Caving			38.285700 °	38.281500 °
				-121.693500 °	-121.694300 °
DWR ID	LMA-259				
Comment Code					
E2 : Schedule repair of erosion site prior to the next inspection.					
Inspector Comment					
This was a 2017 Storm Damage site. The damage consists of scour and sloughing of the waterside levee slope. Site ID No:432 Site Designation:LMA-259

View of erosion on the waterside slope. Photo was taken in 2017.

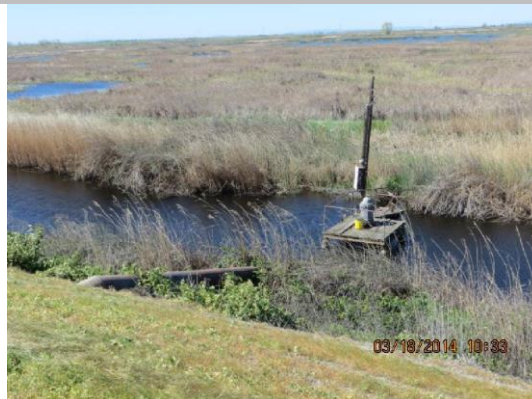
Photo 1 of 3 : UCIP_SP_2022_32227_58692.jpg

Pump on pile structure in drainage channel on LS toe.

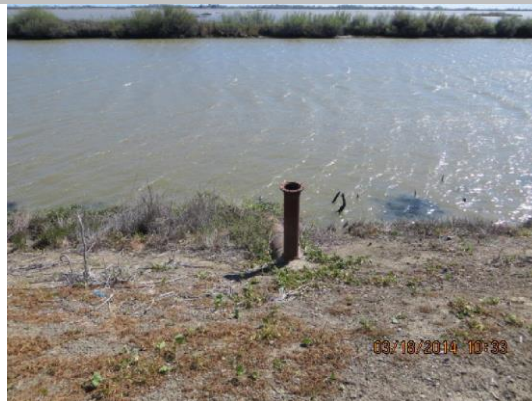
Photo 2 of 3 : UCIP_SP_2022_32227_58691.jpg

Siphon breaker in steel riser on WS slope.

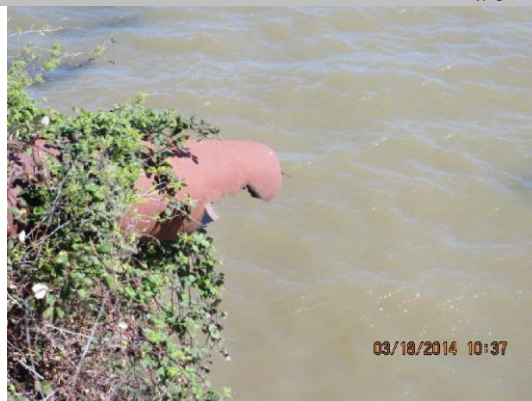
Photo 3 of 3 : UCIP_SP_2022_32227_58690.jpg

Comment Code						
Inspector Comment						
FS_ID:32227 DS_ID:20969 EP_NO: 13222 Repair Type: Non-Urgent Crossing Status: Found UCIP Comments: 03/18/2014 Pipe rusted through at outlet on WS slope, may indicate further degradation of pipe within levee. Good candidate for video inspection. (W. Wylie - DWR UCIP) FIELD_STRUCT_DESC: 20-inch steel drainage pipe through the levee, 7.5 feet below the crown. Siphon breaker on the waterside (WS) shoulder. Pump on pile structure in drainage ditch on the landside (LS). (This pipe was retained under Automatic Board Order (ABO) issued as Permit No. 10168, 1974 - Moresco Brothers. Pipe removed and replaced with a 19-inch steel pipe under the crown and along the LS slope under Permit No. 13222, 1981 - Prudential Insurance Company of America). [Additional Reference(s): DWR Levee Log, 2003. USACE Sacramento O&M Manual 109, April 1962, (HLM 2.98)]. FS Date: 3/18/2014

Pipe rusted through at outlet on WS slope.

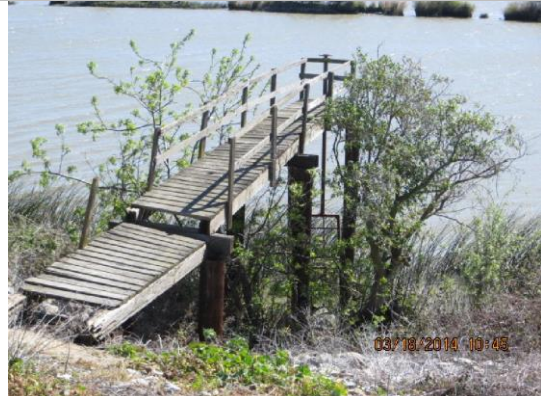
Photo 1 of 3 : UCIP_SP_2022_32243_58702.jpg

Comment Code						
Inspector Comment						
FS_ID:32243 DS_ID:20970 EP_NO: 10168 Repair Type: Non-Urgent Crossing Status: Found UCIP Comments: 03/18/2014 Walkway to slidegate on WS toe is in poor structural condition and may not be safe for accessing the slide gate actuator. Pipe appears abandoned and if so should be done so properly. Outlet on LS toe may be buried. (W. Wylie - DWR UCIP) FIELD_STRUCT_DESC: 24-inch steel irrigation pipe through the levee, 22.3 feet below the crown. Slide gate on the waterside (WS) end. Walkway from the WS shoulder to the slide gate control. Flap gate on the landside (LS) end. (This pipe was retained under Automatic Board Order (ABO) issued as Permit No. 10168, 1974 - Moresco Brothers). [Additional Reference(s): DWR Levee Log, 2003]. FS Date: 3/18/2014

Walkway to slide gate actuator on WS toe.

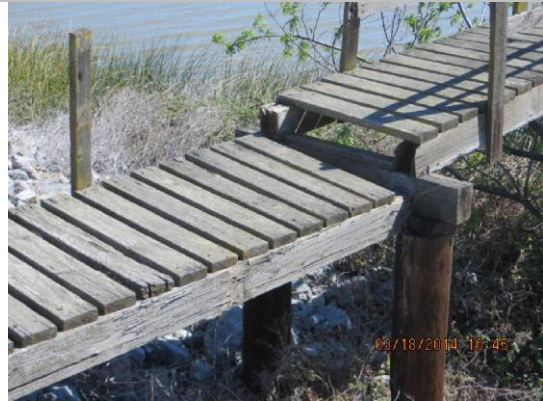
Photo 2 of 3 : UCIP_SP_2022_32243_58701.jpg

Walkway may not be structurally sound.

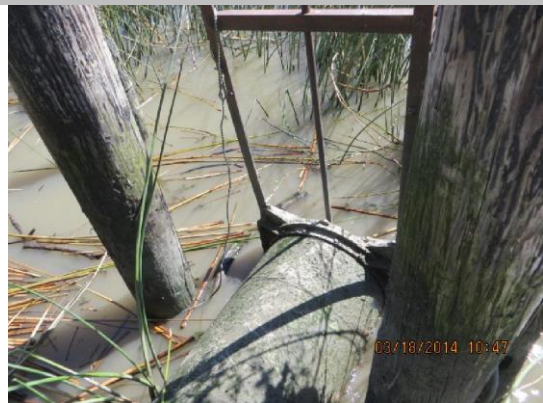
Photo 3 of 3 : UCIP_SP_2022_32243_58700.jpg

Slidegate on WS toe at pipe.

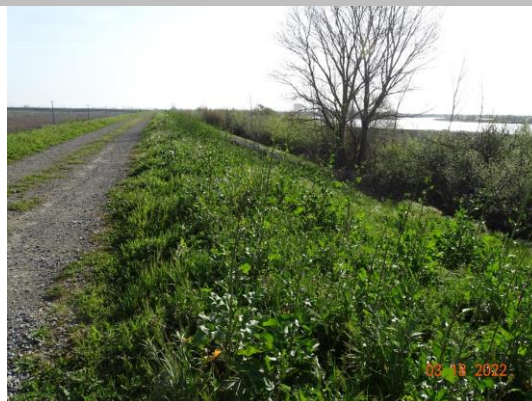
Photo 1 of 1 : SP_2022_RD2098_245_2_20220318_00002.jpg

View looking downstream at vegetation on the waterside slope (Spring 2022).

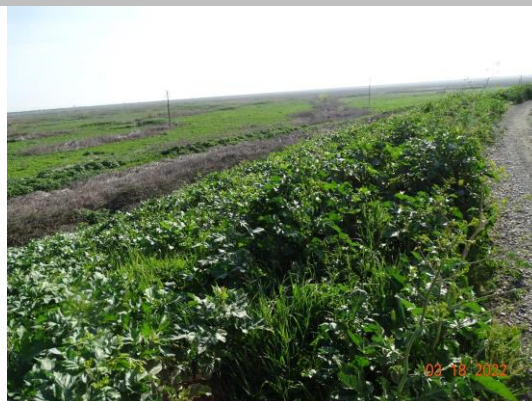
Photo 1 of 1 : SP_2022_RD2098_246_7_20220318_00026.jpg

View looking downstream at vegetation on the landside slope (Spring 2022).

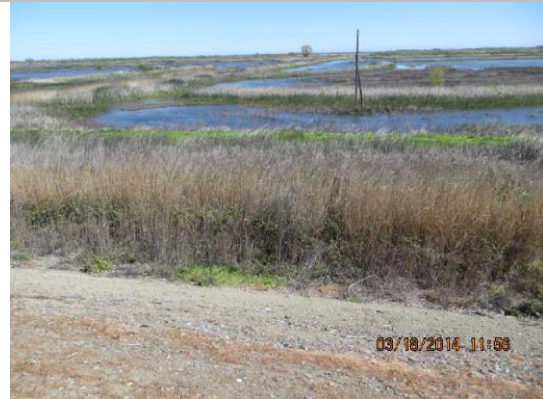
Photo 1 of 3 : UCIP_SP_2022_32287_58755.jpg

LS - no pipe visible.

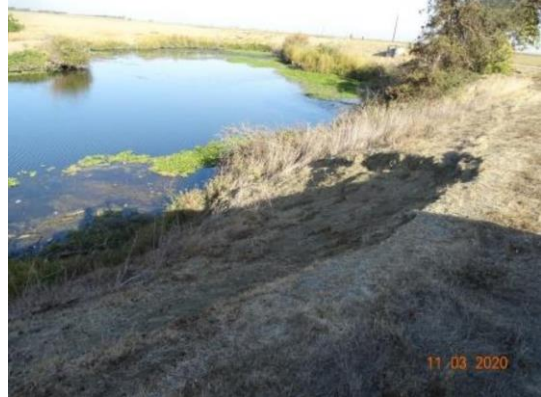
Photo 1 of 1 : SP_2022_RD2098_246_18_20220310_00007.jpg

LM Start	6.64	Rating **	U	Issue No.	18
LM End	6.65	Issue Type +	Ma	Location *	WS
Category	Earthen Levee			GPS Latitude/Longitude	
				Start	End
Item	Erosion / Bank Caving			38.291300 °	38.291400 °
				-121.716100 °	-121.716000 °
DWR ID	LMA-269				
Comment Code					
E2 : Schedule repair of erosion site prior to the next inspection.					
Inspector Comment					
This was a 2017 Storm Damage site. The damage consists of scour, cracking, instability, and sloughing of the waterside levee slope. Site ID No:442 Site Designation:LMA-269

View looking upstream at erosion into the waterside slope (Fall 2020).

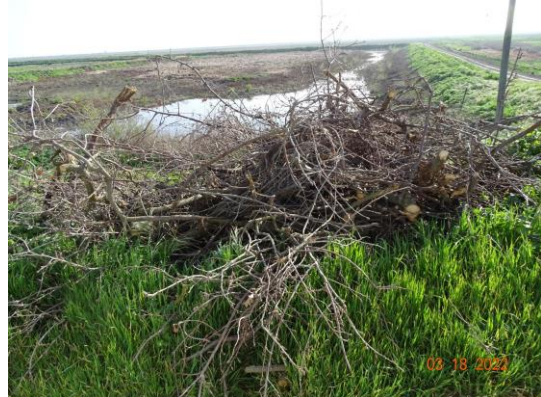
Photo 1 of 1 : SP_2022_RD2098_246_9_20220318_00025.jpg

View of cut up tree limbs on the landside shoulder (Spring 2022).

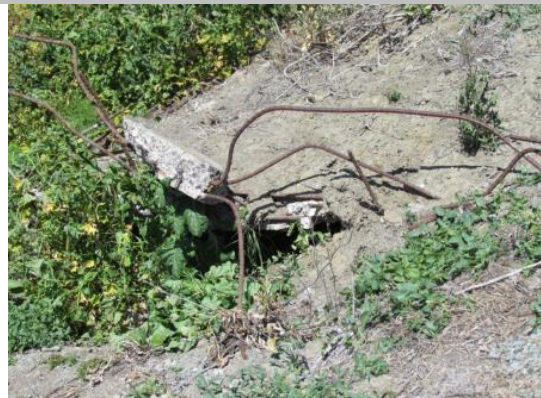
Photo 1 of 1 : SP_2022_RD2098_246_10_20220310_00003.jpg

There is some slope damage at this location under this concrete.

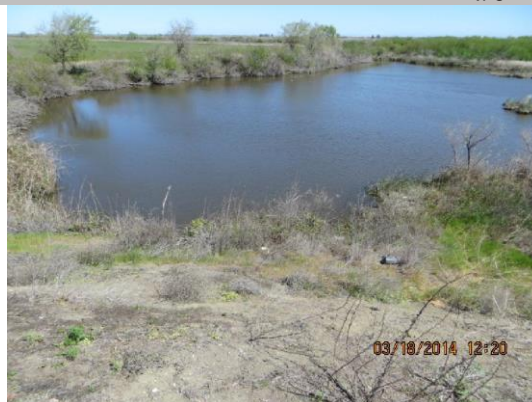
Photo 2 of 3 : UCIP_SP_2022_33784_61161.jpg

Inlet not visible on LS toe.

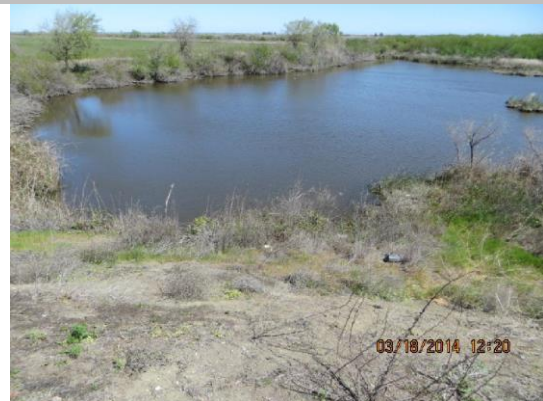
Photo 1 of 3 : UCIP_SP_2022_32285_58749.jpg

Inlet not visible on LS toe.

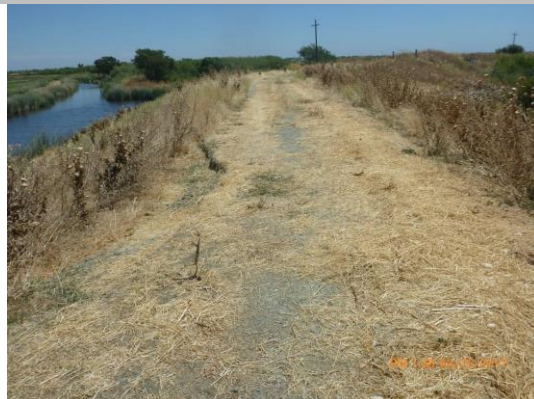
Photo 1 of 1 : SP_2022_RD2098_246_20_20220310_00009.jpg

View of erosion on the landside levee crest. Photo taken in 2017.

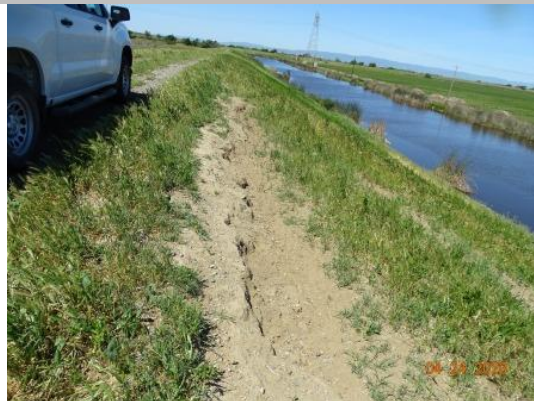
Photo 1 of 1 : SP_2022_RD2098_246_12_20220310_00005.jpg

View looking upstream at erosion at the top of the landside slope (Spring 2020).

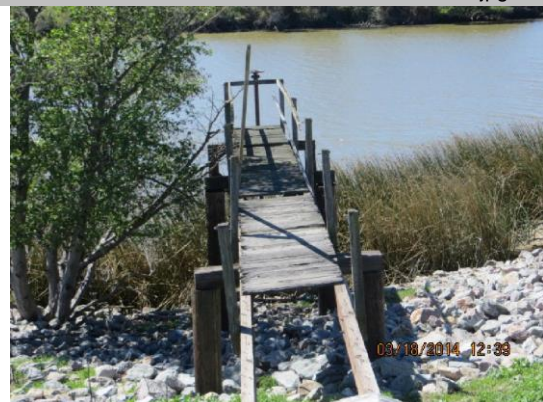
Photo 2 of 3 : UCIP_SP_2022_32290_58763.jpg

Delapidated wooden pier on WS shoulder.

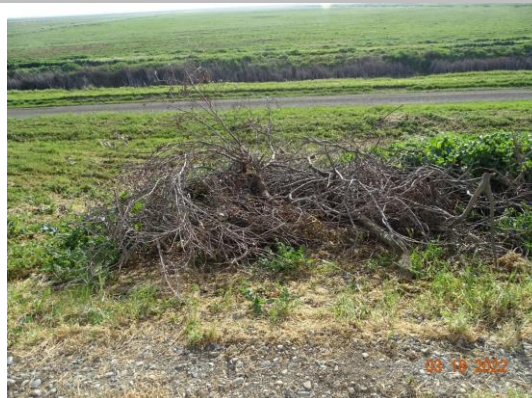
Photo 1 of 1 : SP_2022_RD2098_247_14_20220318_00013.jpg

View of cut up tree branches on the landside shoulder (Spring 2022).

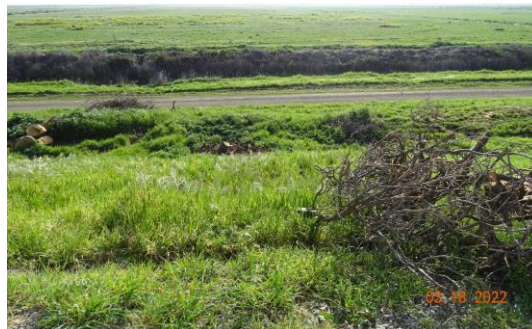
Photo 1 of 1 : SP_2022_RD2098_247_5_20220318_00012.jpg

View of cut up tree limbs and trunks on the landside shoulder and toe (Spring 2022).

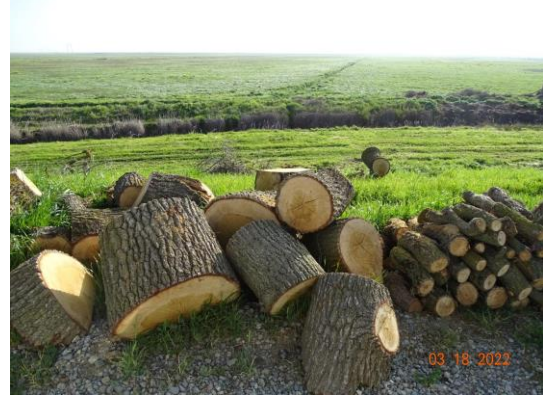
Photo 1 of 1 : SP_2022_RD2098_247_13_20220318_00011.jpg

View of cut up tree trunk and limbs on the landside shoulder (Spring 2022).

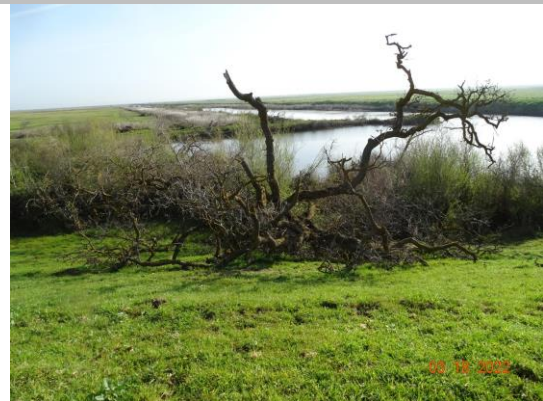
Photo 1 of 1 : SP_2022_RD2098_247_12_20220318_00010.jpg

View of down tree on the landside slope (Spring 2022).

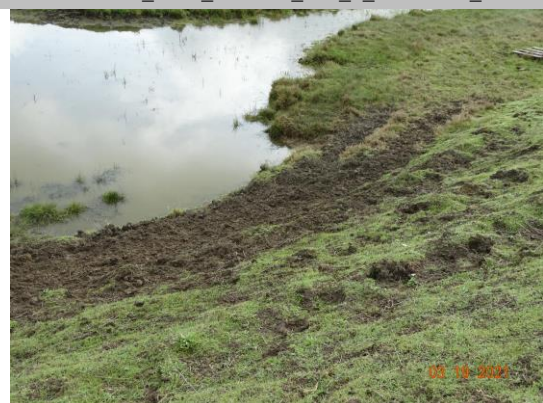
Photo 1 of 1 : SP_2022_RD2098_247_4_20220310_00001.jpg

View of slope terracing caused by cattle on the landside slope (Spring 2021).

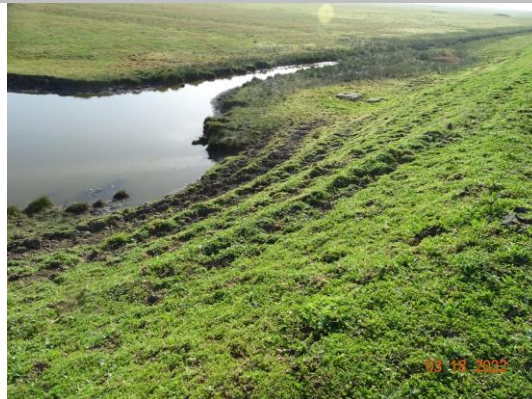
Photo 1 of 1 : SP_2022_RD2098_247_10_20220318_00009.jpg

View looking downstream erosion due to livestock into the landside slope (Spring 2022).

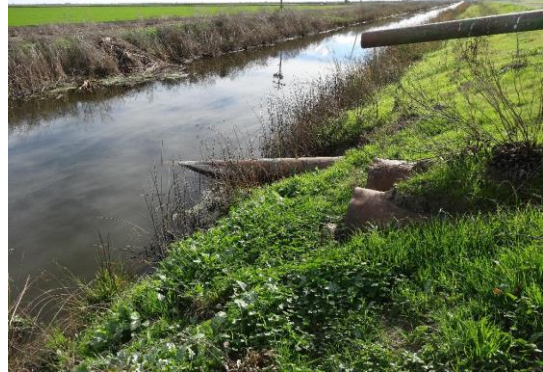
Photo 2 of 3 : UCIP_SP_2022_53382_76876.jpg

View of LS--damaged concrete distribution box has been removed.

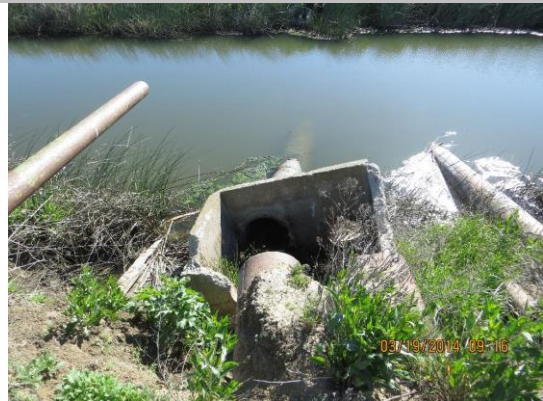
Photo 3 of 3 : UCIP_SP_2022_53382_58817.jpg

Concrete distribution box on LS slope has slipped into canal.

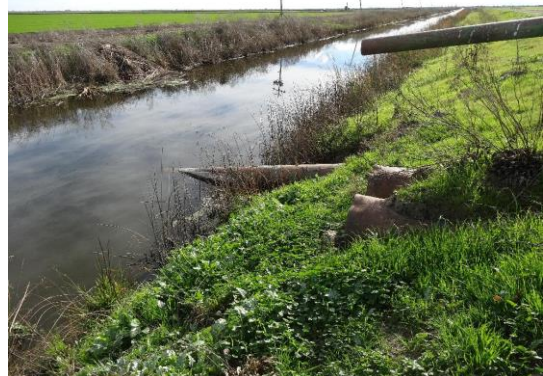
Photo 2 of 3 : UCIP_SP_2022_53383_76884.jpg

View of LS--damage distribution box noted in last inspection has been removed.

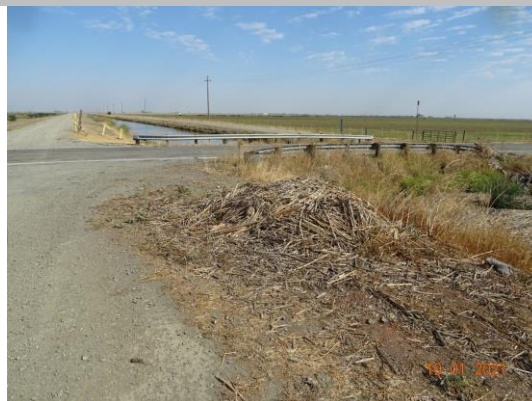
Photo 1 of 1 : SP_2022_RD2098_248_13_20220310_00004.jpg

View of cattails on the landside hinge (Fall 2021).
