**Flood Control Project Maintenance
Levee Inspections
LMA District Cover Sheet**

Reclamation District No. 2098 Cache and Haas Slough

**Flood Control Project Maintenance
Levee Inspections
Unit Cover Sheet**

Waterway			Bank	Unit Miles
Unit No. 01 Yolo Bypass			Right	3.60
	Spring (March - May)	Summer (June - August)	(September - November) Fall	Winter (December - February)
Unit Maintenance Rating (Fall Only)				
Date of Inspection	5/17/2023 - 5/17/2023			
DWR Inspector	Saskia Donovan			
Accompanied By	Justin Noutary Reclamation District 2098

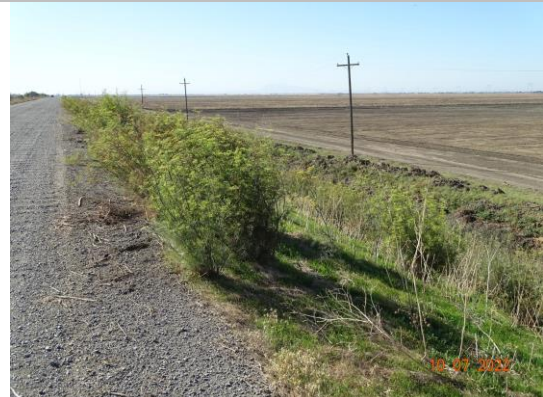
Photo 1 of 1 : SP_2023_RD2098_244_24_20230206_00006.jpg

LM Start	0.00	Rating **	A/W	Issue No.	10
LM End	3.60	Issue Type +	En	Location *	CR
Category	Earthen Levee			GPS Latitude/Longitude	
				Start	End
Item	Encroachments			38.329084°	38.277407°
				-121.694047°	-121.696281°
DWR ID	DWR_RD2098_01_s_2023_10				
Comment Code					
LC : Authorized Levee Construction					
Inspector Comment					
Unit 1 is part of the Lookout Slough Tidal Habitat Restoration and Flood Improvement Project (in progress). The levee will be breached in several locations and degraded. Existing maintenance issues in Unit 1 are rated A/W.

View of the annual vegetation on the LS slope (Fall 2022).

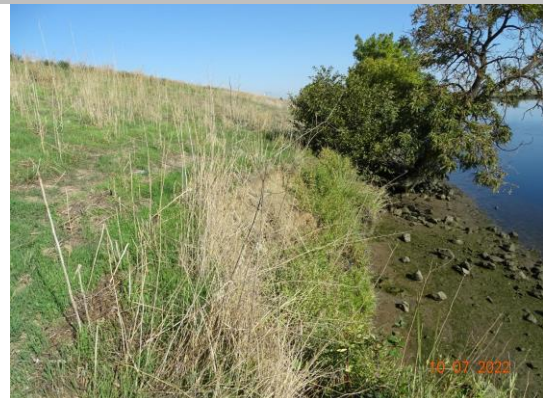
Photo 1 of 1 : SP_2023_RD2098_244_13_20230206_00002.jpg

LM Start	0.57	Rating **	A/W	Issue No.	13
LM End	1.06	Issue Type +	Ma	Location *	WS
Category	Earthen Levee			GPS Latitude/Longitude	
				Start	End
Item	Erosion / Bank Caving			38.320755°	38.313700°
				-121.693982°	-121.693639°
DWR ID	DWR_RD2098_01_s_2017_13				
Comment Code					
E2 : Schedule repair of erosion site prior to the next inspection.					
Inspector Comment					
There is erosion on the waterside slope. Several areas of pocket erosion on the bank are encroaching into the extended levee prism. There is some riprap protection on the lower slope in some areas. Spring 2023: Rated A/W due to ongoing habitat restoration and flood improvement project.

View of the erosion on the WS bank (Fall 2022).

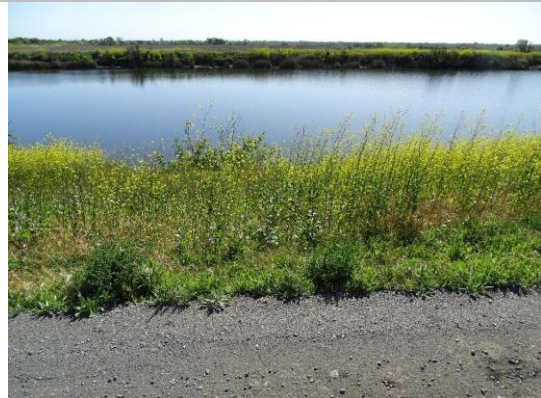
Photo 2 of 3 : UCIP_SP_2023_74264_111251.jpg

View of WS slope.

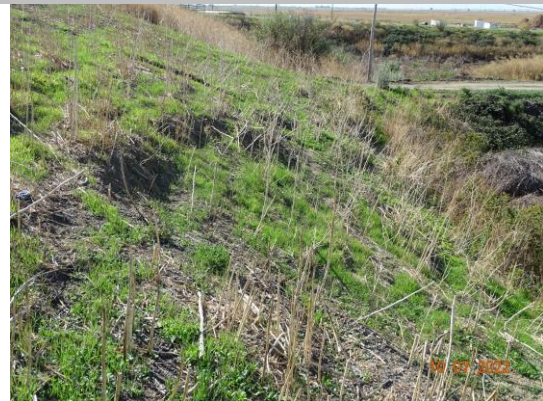
Photo 1 of 1 : SP_2023_RD2098_244_19_20230206_00004.jpg

LM Start	0.96	Rating **	A/W	Issue No.	19
LM End	0.96	Issue Type +	Ma	Location *	LS
Category	Earthen Levee			GPS Latitude/Longitude	
				Start	End
Item	Erosion / Bank Caving			38.315200°	38.315100°
				-121.694100°	-121.694100°
DWR ID	DWR_RD2098_01_s_2021_19				
Comment Code					
E1 : Note and monitor erosion site.					
Inspector Comment					
This was a 2017 Storm Damage site. The damage consists of cracking and sloughing of the lower landside levee slope.					
Site ID No:414					
Site Designation:LMA-241 Spring 2023: Rated A/W due to ongoing habitat restoration and flood improvement project.

View of the sloughing/caving on the LS slope (Fall 2022).

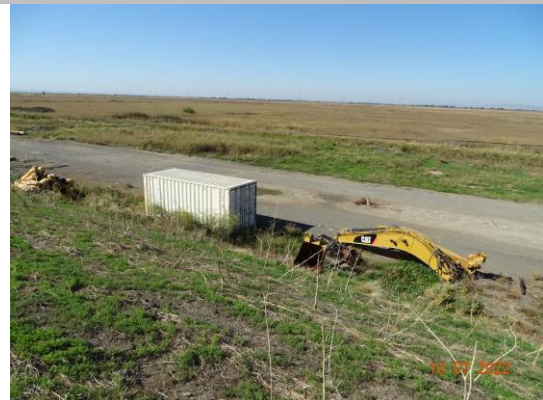
Photo 1 of 1 : SP_2023_RD2098_244_12_20230206_00001.jpg

LM Start	1.66	Rating **	A/W	Issue No.	12
LM End	1.72	Issue Type +	En	Location *	LS
Category	Earthen Levee			GPS Latitude/Longitude	
				Start	End
Item	Encroachments			38.305059 °	38.304209 °
				-121.693631 °	-121.693997 °
DWR ID	DWR_RD2098_01_f_2021_12				
Comment Code					
MA : Material					
Inspector Comment					
There is additional material and equipment on the LS toe. Spring 2023: Rated A/W due to ongoing habitat restoration and flood improvement project.

View of material and equipment on the LS toe (Fall 2022).

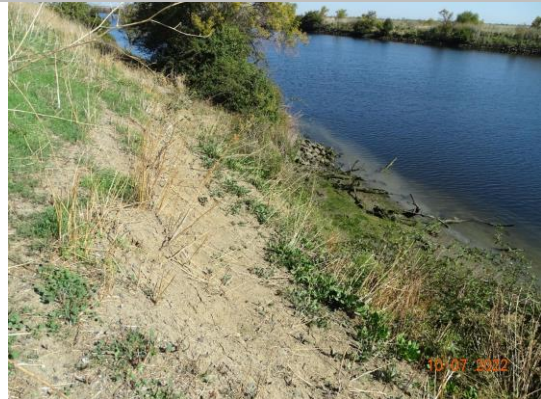
Photo 1 of 1 : SP_2023_RD2098_244_18_20230206_00003.jpg

LM Start	1.76	Rating **	A/W	Issue No.	18
LM End	1.76	Issue Type +	Ma	Location *	WS
Category	Earthen Levee			GPS Latitude/Longitude	
				Start	End
Item	Erosion / Bank Caving			38.303611°	38.303611°
				-121.693607°	-121.693607°
DWR ID	DWR_RD2098_01_s_2018_18				
Comment Code					
E2 : Schedule repair of erosion site prior to the next inspection.					
Inspector Comment					
There is erosion at the waterside toe. Spring 2023: Rated A/W due to ongoing habitat restoration and flood improvement project.

View of the erosion on the WS toe (Fall 2022).

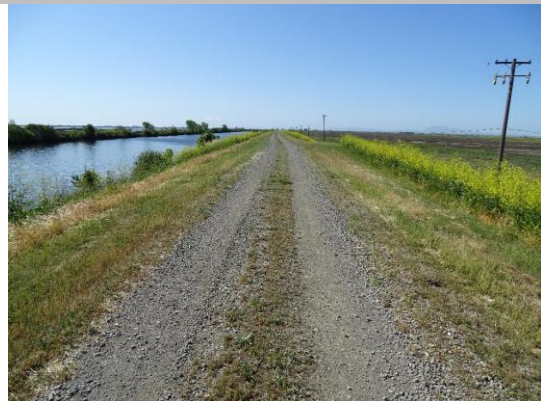
Photo 1 of 3 : UCIP_SP_2023_74544_111287.jpg

Comment Code						
Inspector Comment						
DS_ID:20965 FS_ID:74544 EP_NO: 10168 Repair Type: Non-Urgent EVAL Issue: 6, Levee Damage or Threat for Levee Damage Crossing Status: Found UCIP Comments: 04/12/2022 Record remains Non-Urgent. Threat for levee damage with same erosion under pipe at WS toe. System Feature. (D.Sanoski - DWR UCIP) 12/22/2016 Met with Mike Hadesty, LMA Superintendent, and Brian Bush, LMA General Manager, to go over the list of pipes in RD2098. Per LMA records, this pipe has a different owner. (O. Magana - DWR UCIP) 03/18/2014 Erosion under pipe at WS toe. (W. Wylie - DWR UCIP) FIELD_STRUCT_DESC: 10-inch steel drainage pipe through the levee, 2.8 feet below the crown. Pump in pump house off the landside (LS). (This pipe was retained under Automatic Board Order (ABO) issued as Permit No. 10168, 1974 - Moresco Brothers). [Additional Reference(s): DWR Levee Log, 2003. USACE Sacramento O&M Manual 109, April 1962, (HLM 1.80)]. FS Date: 4/12/2022 12:51:06 PM

View of levee crown.

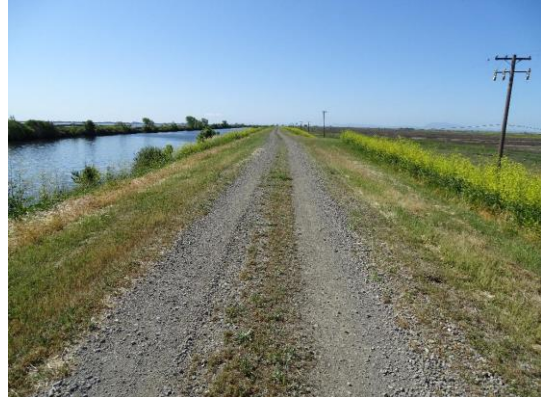
Photo 1 of 3 : UCIP_SP_2023_74545_111292.jpg

Comment Code						
Inspector Comment						
DS_ID:20998 FS_ID:74545 EP_NO: N/A Repair Type: Non-Urgent EVAL Issue: Crossing Status: Not Found UCIP Comments: 04/12/2022 Record remains Non-Urgent. Geophysical results did not confirm presence of pipe through levee. Record will remain in UCIP's inspection records until future Levee Improvement Project can confirm no crossing was found through the levee. System Feature. (D.Sanoski - DWR UCIP) FIELD_STRUCT_DESC: 18-inch drainage pipe of an unknown material through the levee, 24.5 feet below the crown. Slide gate on the waterside (WS). [Additional Reference(s): USACE Sacramento O&M Manual 109, April 1962, (HLM 1.81)]. FS Date: 4/12/2022 12:51:27 PM

View of levee crown.

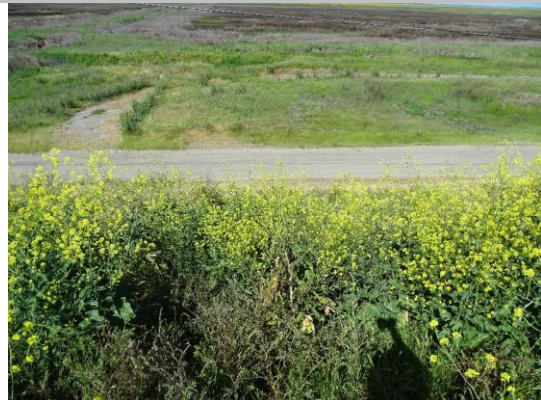
Photo 2 of 3 : UCIP_SP_2023_74545_111291.jpg

View of LS slope.

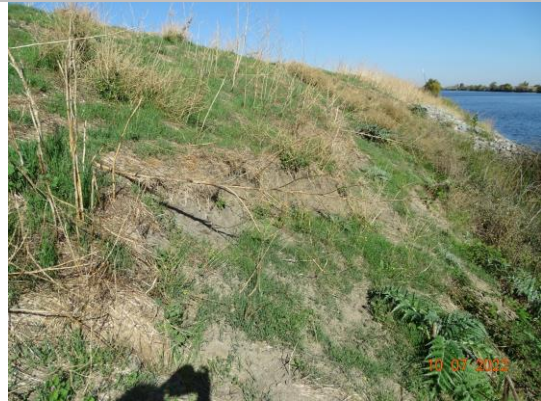
Photo 1 of 1 : SP_2023_RD2098_244_27_20230206_00007.jpg

LM Start	2.29	Rating **	A/W	Issue No.	27
LM End	2.32	Issue Type +	Ma	Location *	WS
Category	Earthen Levee			GPS Latitude/Longitude	
				Start	End
Item	Erosion / Bank Caving			38.295900°	38.295468°
				-121.693500°	-121.693619°
DWR ID	LMA-248				
Comment Code					
E2 : Schedule repair of erosion site prior to the next inspection.					
Inspector Comment					
This was a 2017 Storm Damage site. The damage consists of scour and sloughing of the waterside levee slope. Site ID No:421 Site Designation:LMA-248 Spring 2023: Rated A/W due to ongoing habitat restoration and flood improvement project.

View of the erosion on the WS slope (Fall 2022).

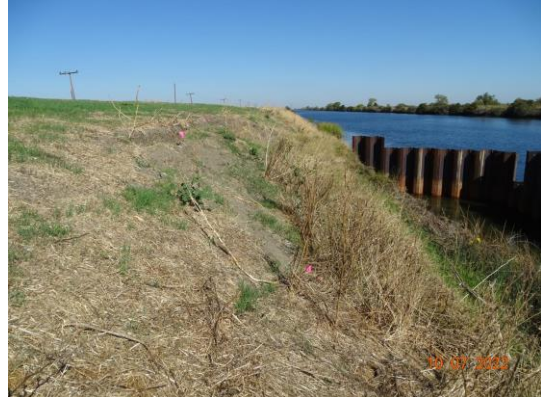
Photo 1 of 1 : SP_2023_RD2098_244_34_20230206_00009.jpg

LM Start	2.75	Rating **	A/W	Issue No.	34
LM End	2.81	Issue Type +	Ma	Location *	WS
Category	Earthen Levee			GPS Latitude/Longitude	
				Start	End
Item	Erosion / Bank Caving			38.289200°	38.288405°
				-121.693500°	-121.693617°
DWR ID	LMA-256				
Comment Code					
E2 : Schedule repair of erosion site prior to the next inspection.					
Inspector Comment					
Fall 2022: Site is pending repair. This was a 2017 Storm Damage site. The damage consists of scour and sloughing of the waterside levee slope.					
Site ID No:429 & 430					
Site Designation:LMA-256, LMA-257 Spring 2023: Rated A/W due to ongoing habitat restoration and flood improvement project.

View of the erosion on the WS slope (Fall 2022).

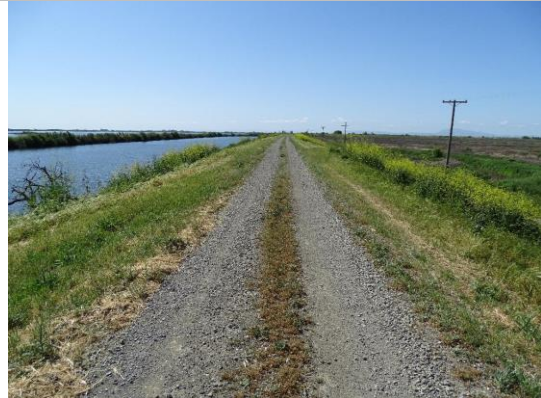
Photo 1 of 3 : UCIP_SP_2023_74561_111323.jpg

Comment Code					
Inspector Comment					
DS_ID:20999					
FS_ID:74561					
EP_NO: N/A					
Repair Type: Non-Urgent					
EVAL Issue:					
Crossing Status: Not Found					
UCIP Comments: 04/12/2022 Record remains Non-Urgent. Geophysical results did not confirm presence of pipe through levee. Record will remain in UCIP's inspection records until future Levee Improvement Project can confirm no crossing was found through the levee. System Feature. (D.Sanoski - DWR UCIP)					
FIELD_STRUCT_DESC: 42-inch drainage pipe of an unknown material through the levee, 19.3 feet below the crown. Flap gate on the waterside (WS). [Additional Reference(s): USACE Sacramento O&M Manual 109, April 1962, (HLM 2.75)].					
FS Date: 4/12/2022 12:52:52 PM

View of levee crown.

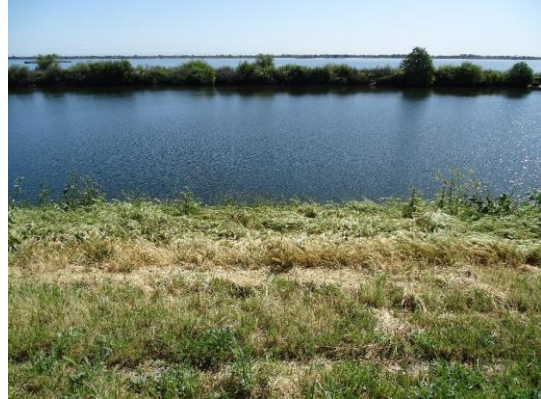
Photo 2 of 3 : UCIP_SP_2023_74561_111322.jpg

View of WS slope.

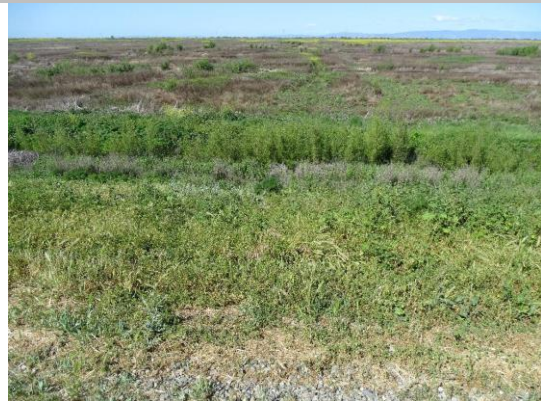
Photo 3 of 3 : UCIP_SP_2023_74561_111324.jpg

View of LS slope.

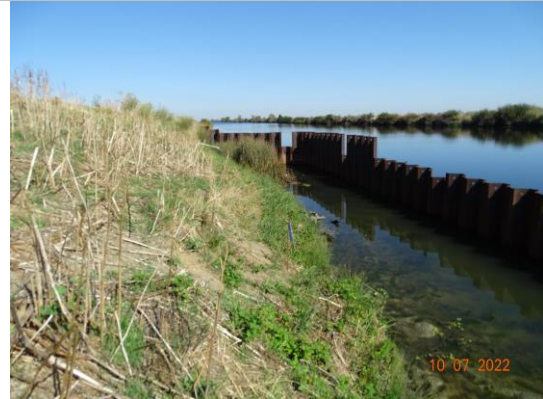
Photo 1 of 1 : SP_2023_RD2098_244_37_20230206_00011.jpg

LM Start	2.99	Rating **	A/W	Issue No.	37
LM End	3.29	Issue Type +	Ma	Location *	WS
Category	Earthen Levee			GPS Latitude/Longitude	
				Start	End
Item	Erosion / Bank Caving			38.285700°	38.281500°
				-121.693500°	-121.694300°
DWR ID	LMA-259				
Comment Code					
E2 : Schedule repair of erosion site prior to the next inspection.					
Inspector Comment					
Fall 2022: Site is pending repair. This was a 2017 Storm Damage site. The damage consists of scour and sloughing of the waterside levee slope.					
Site ID No:432					
Site Designation:LMA-259 Spring 2023: Rated A/W due to ongoing habitat restoration and flood improvement project.

View of the erosion on the WS slope (Fall 2022).

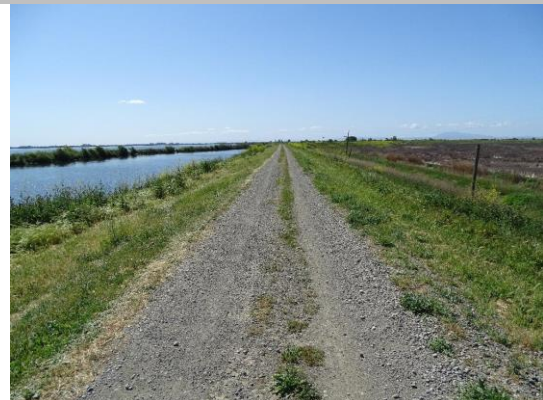
Photo 1 of 3 : UCIP_SP_2023_74562_111326.jpg

Comment Code					
Inspector Comment					
DS_ID:20969 FS_ID:74562 EP_NO: 13222 Repair Type: Non-Urgent EVAL Issue: 5, Pipe Damage Crossing Status: Found UCIP Comments: 04/12/2022 Record remains Non-Urgent. Pipe rusted out on WS slope at toe. (D.Sanoski - DWR UCIP) 03/18/2014 Pipe rusted through at outlet on WS slope, may indicate further degradation of pipe within levee. Good candidate for video inspection. (W. Wylie - DWR UCIP) FIELD_STRUCT_DESC: 20-inch steel drainage pipe through the levee, 7.5 feet below the crown. Siphon breaker on the waterside (WS) shoulder. Pump on pile structure in drainage ditch on the landside (LS). (This pipe was retained under Automatic Board Order (ABO) issued as Permit No. 10168, 1974 - Moresco Brothers. Pipe removed and replaced with a 19-inch steel pipe under the crown and along the LS slope under Permit No. 13222, 1981 - Prudential Insurance Company of America). [Additional Reference(s): DWR Levee Log, 2003. USACE Sacramento O&M Manual 109, April 1962, (HLM 2.98)]. FS Date: 4/12/2022 12:53:15 PM

View of levee crown.

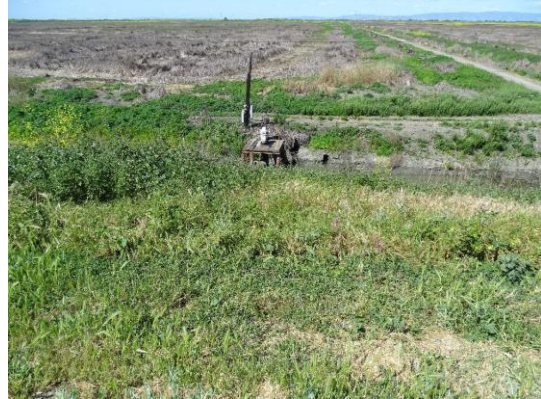
Photo 2 of 3 : UCIP_SP_2023_74562_111327.jpg

View of LS slope and pump on toe.

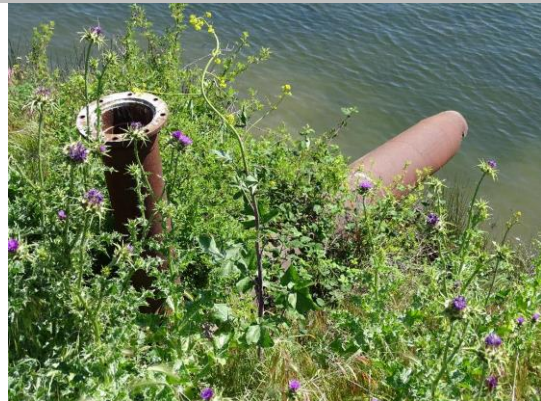
Photo 3 of 3 : UCIP_SP_2023_74562_111329.jpg

View of pipe out of WS slope near toe.

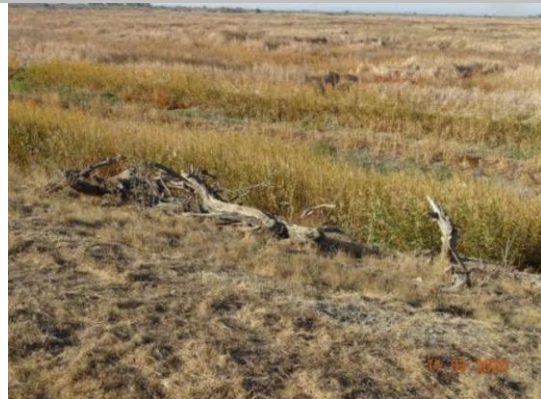
Photo 1 of 1 : SP_2023_RD2098_244_20_20230206_00005.jpg

View of tree limb on the landside slope (Fall 2020).

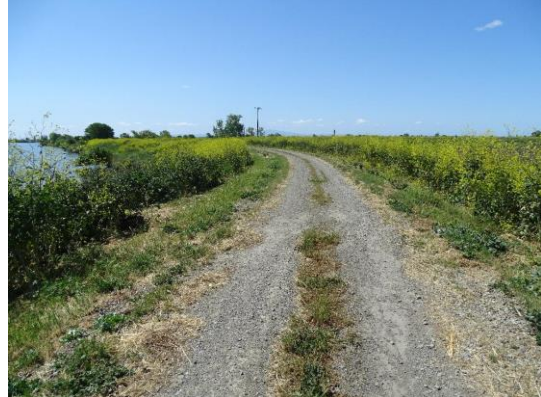
Photo 1 of 3 : UCIP_SP_2023_74573_111373.jpg

Comment Code						
Inspector Comment						
DS_ID:20959 FS_ID:74573 EP_NO: 15169 Repair Type: Non-Urgent EVAL Issue: 11, Maintenance Compliance Issue Crossing Status: Found UCIP Comments: 04/12/2022 Record remains Non-Urgent. Maintenance compliant issue with siphon breaker riser broken on WS shoulder. Otherwise, all good besides the overgrown vegetation, but looks like same conditions as last inspection. (D.Sanoski - DWR UCIP) 12/22/2016 Met with Mike Hadesty, LMA Superintendent, and Brian Bush, LMA General Manager, to go over the list of pipes in RD2098. Per LMA, pipe is a drainage pipe. New property owner is John Anderson. (O. Magana - DWR UCIP) 03/18/2014 Soil and debris buildup in steel riser on WS shoulder may prevent proper function of siphon breaker. (W. Wylie - DWR UCIP) FIELD_STRUCT_DESC: 2 of 2: 24-inch coated steel drainage pipe through the levee, 5.6 feet below the crown. Cutoff wall around the pipe at the center of the levee. Siphon breaker on the waterside (WS) shoulder. Flap gate on the WS end. Pump in pump house on piling structure on the landside (LS). (Permit No. 15169, 1989 - Maxim Development). [Additional Reference(s): DWR Levee Log, 2003]. FS Date: 4/12/2022 12:54:15 PM

View of levee crown.

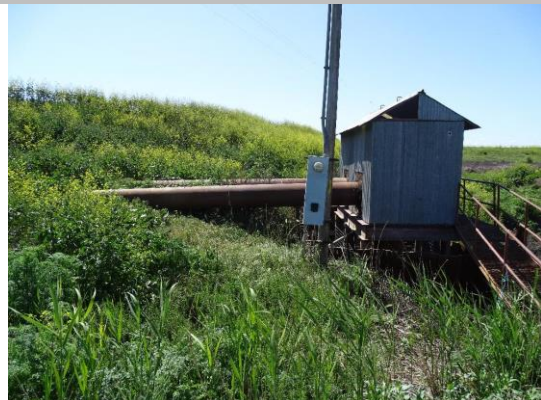
Photo 2 of 3 : UCIP_SP_2023_74573_111372.jpg

View of pipe into pumphouse on LS toe.

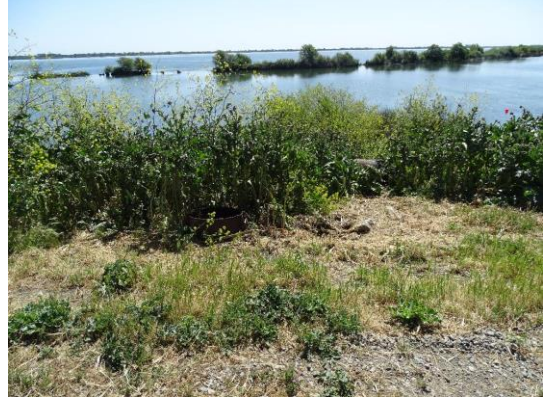
Photo 3 of 3 : UCIP_SP_2023_74573_111374.jpg

View of WS shoulder with siphon breaker.

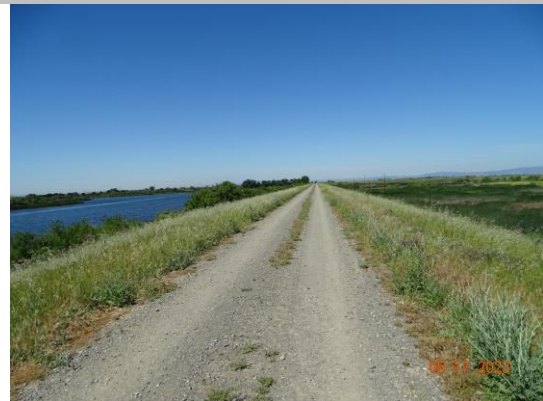
Photo 1 of 1 : SP_2023_RD2098_245_1_20230519_00002.jpg

LM Start	0.00	Rating **	A/W	Issue No.	2
LM End	0.53	Issue Type +	En	Location *	CR
Category	Earthen Levee			GPS Latitude/Longitude	
				Start	End
Item	Encroachments			38.277410°	38.275707°
				-121.696280°	-121.705705°
DWR ID	DWR_RD2098_01A_s_2023_2				
Comment Code					
LC : Authorized Levee Construction					
Inspector Comment					
Unit 1A is part of the Lookout Slough Tidal Habitat Restoration and Flood Improvement Project (in progress) and will be degraded. Existing maintenance issues in Unit 1A are rated A/W.

View of the annual vegetation looking west (Spring 2023).

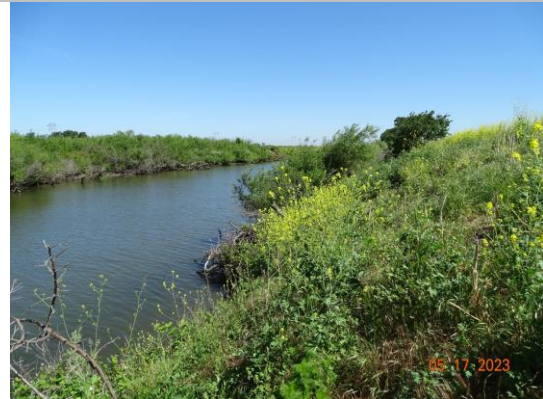
Photo 1 of 1 : SP_2023_RD2098_246_15_20230519_00011.jpg

LM Start	6.46	Rating **	A/W	Issue No.	15
LM End	6.48	Issue Type +	Ma	Location *	WS
Category	Earthen Levee			GPS Latitude/Longitude	
				Start	End
Item	Erosion / Bank Caving			38.288700°	38.289061°
				-121.717000°	-121.716885°
DWR ID	LMA-267				
Comment Code					
E2 : Schedule repair of erosion site prior to the next inspection.					
Inspector Comment					
This was a 2017 Storm Damage site. The damage consists of scour of the lower and mid waterside levee slope. Site ID No:440 & 441 Site Designation:LMA-267 & LMA-268 Spring 2023: Rated A/W due to ongoing habitat restoration and flood improvement project.

View of the erosion on the WS (Spring 2023).

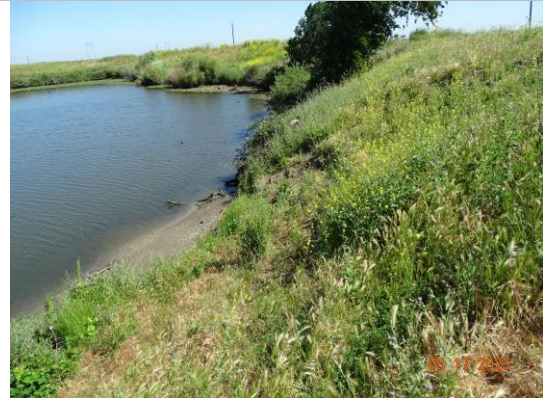
Photo 1 of 1 : SP_2023_RD2098_246_18_20230519_00012.jpg

LM Start	6.64	Rating **	A/W	Issue No.	18
LM End	6.65	Issue Type +	Ma	Location *	WS
Category	Earthen Levee			GPS Latitude/Longitude	
				Start	End
Item	Erosion / Bank Caving			38.291300°	38.291400°
				-121.716100°	-121.716000°
DWR ID	LMA-269				
Comment Code					
E2 : Schedule repair of erosion site prior to the next inspection.					
Inspector Comment					
This was a 2017 Storm Damage site. The damage consists of scour, cracking, instability, and sloughing of the waterside levee slope. Site ID No:442 Site Designation:LMA-269 Spring 2023: Rated A/W due to ongoing habitat restoration and flood improvement project.

View of the erosion on the WS (Spring 2023).

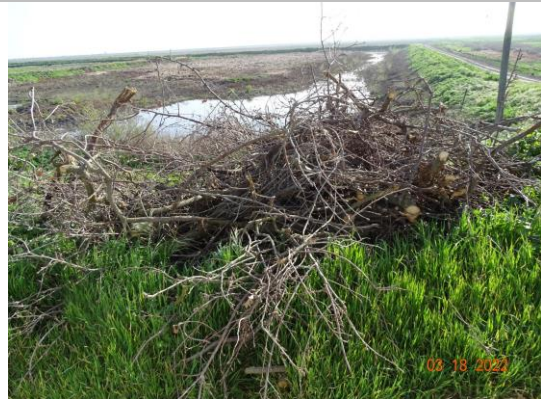
Photo 1 of 1 : SP_2023_RD2098_246_9_20230206_00001.jpg

View of cut up tree limbs on the landside shoulder (Spring 2022).

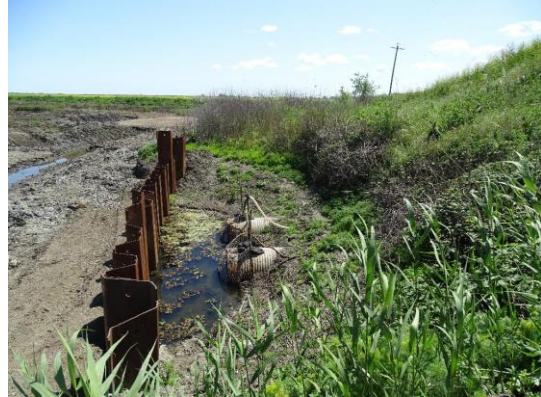
Photo 2 of 3 : UCIP_SP_2023_74585_111406.jpg

View of pipe out of LS slope with metal retaining wall.

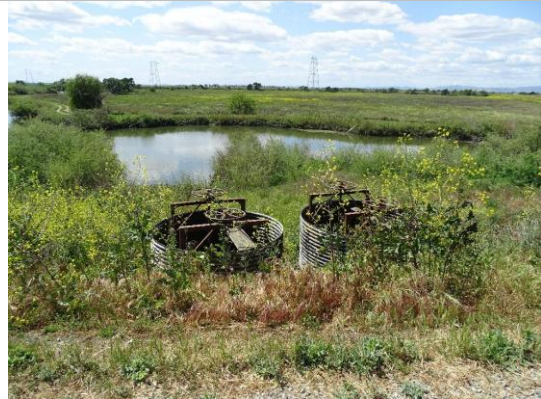
Photo 3 of 3 : UCIP_SP_2023_74585_111409.jpg

View of WS shoulder with CMP riser on slope.

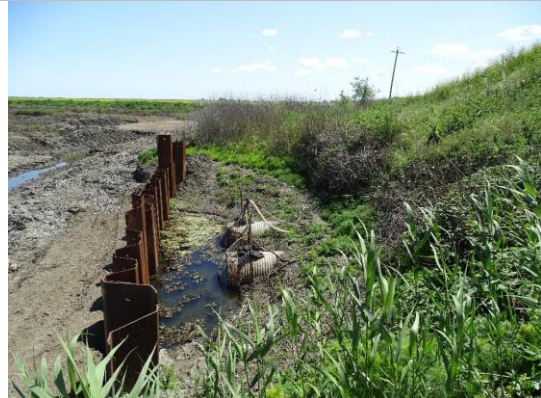
Photo 2 of 3 : UCIP_SP_2023_74586_111420.jpg

View of pipe out of LS slope with metal retaining wall.

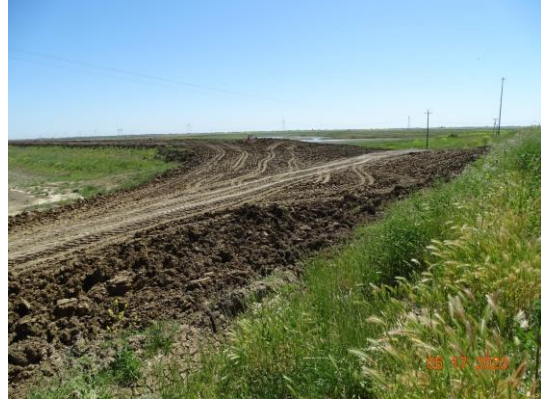
Photo 1 of 1 : SP_2023_RD2098_247_6_20230522_00016.jpg

View of the newly constructed setback levee along Duck Slough connecting to Unit 3 at LM 8.31, looking east-southeast (Spring 2023).

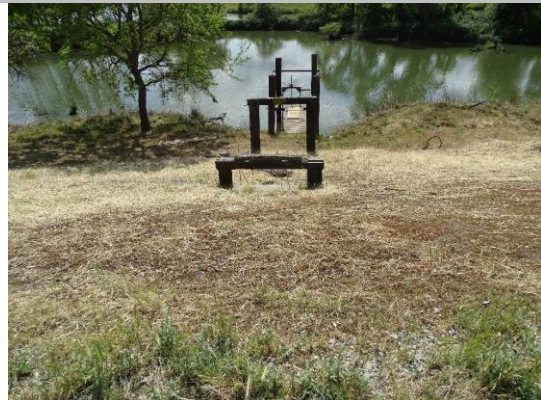
Photo 2 of 3 : UCIP_SP_2023_74598_111455.jpg

View of WS slope and abandoned pier on toe.

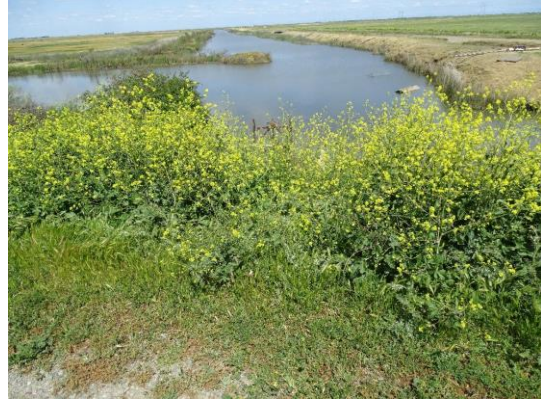
Photo 2 of 3 : UCIP_SP_2023_74612_111495.jpg

View of LS shoulder and overgrown slope.

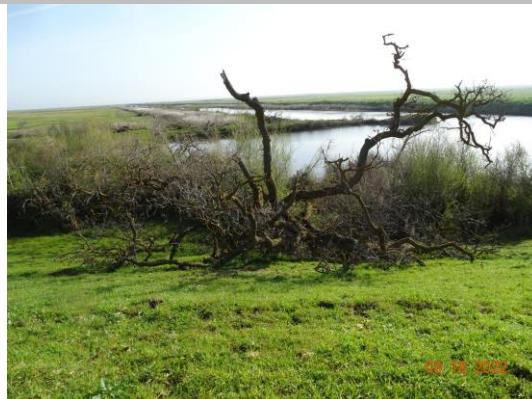
Photo 1 of 1 : SP_2023_RD2098_247_12_20230206_00003.jpg

View of down tree on the landside slope (Spring 2022).

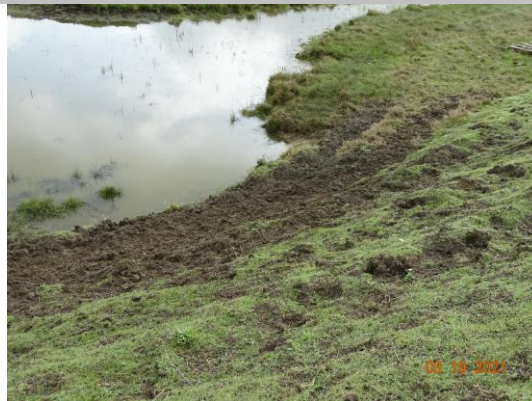
Photo 1 of 1 : SP_2023_RD2098_247_4_20230206_00001.jpg

View of slope terracing caused by cattle on the landside slope (Spring 2021).

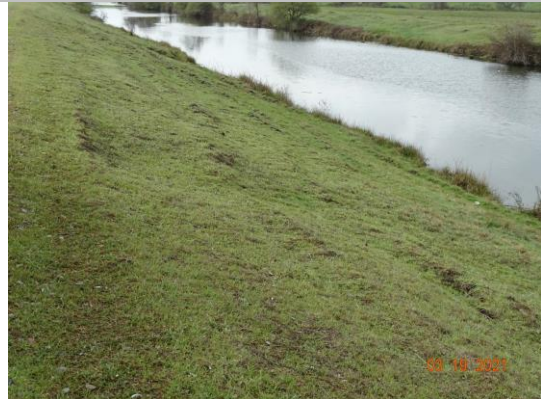
Photo 1 of 1 : SP_2023_RD2098_248_11_20230206_00003.jpg

View of terracing due to cows on the landside slope (Spring 2021).

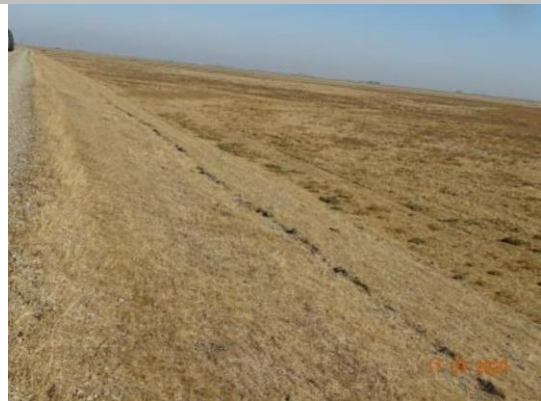
Photo 1 of 1 : SP_2023_RD2098_248_10_20230206_00002.jpg

View looking upstream at depressions in the landside slope due to cows (Fall 2020).

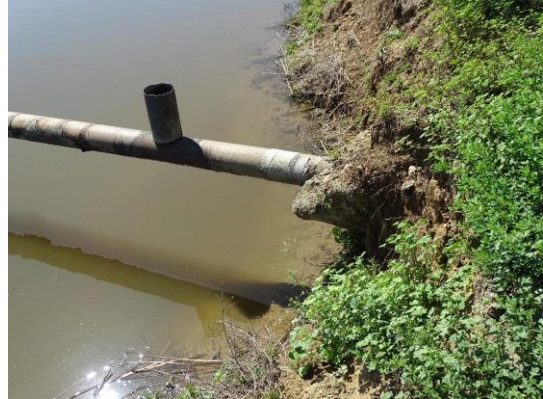
Photo 2 of 3 : UCIP_SP_2023_74679_111678.jpg

View of serious scour around pipe on LS slope.

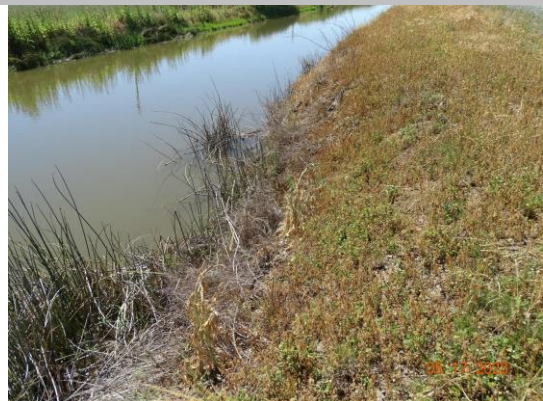
Photo 1 of 1 : SP_2023_RD2098_248_14_20230519_00020.jpg

View of the erosion on the LS (Spring 2023).

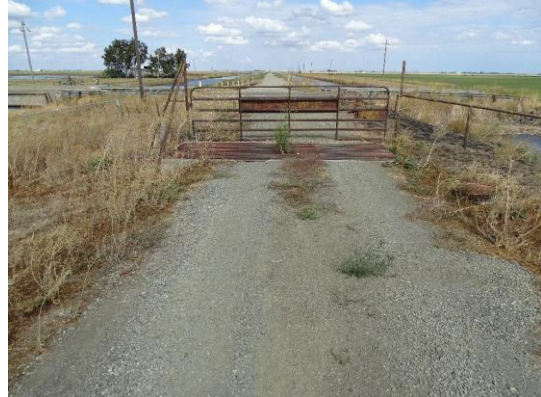
Photo 1 of 3 : UCIP_SP_2023_74696_78546.jpg

Crown view - looks in good condition.
