Flood Control Project Maintenance
Levee Inspections
LMA District Cover Sheet

Reclamation District No. 2098 Cache and Haas Slough

**Flood Control Project Maintenance
Levee Inspections
Unit Cover Sheet**

Waterway	Bank	Unit Miles
Unit No. 01 Yolo Bypass	Right	3.60

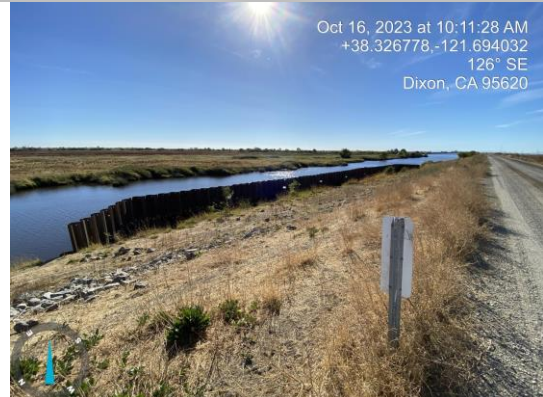
Photo 1 of 2 : SP_2024_RD2098_244_10_20240301_00001.jpg

LM Start	0.00	Rating **	A/W	Issue No.	10
LM End	3.60	Issue Type +	En	Location *	CR
Category	Earthen Levee			GPS Latitude/Longitude	
				Start	End
Item	Encroachments			38.329084°	38.277407°
				-121.694047°	-121.696281°
DWR ID	DWR_RD2098_01_s_2023_10				
Comment Code					
LC : Authorized Levee Construction					
Inspector Comment					
Unit 1 is part of the Lookout Slough Tidal Habitat Restoration and Flood Improvement Project (in progress). The levee will be breached in several locations and degraded. Existing maintenance issues in Unit 1 are rated A/W.

View of location that will be breached as part of the project (Fall 2023).

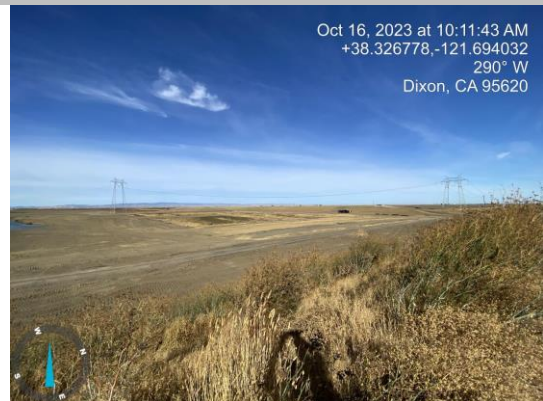
Photo 2 of 2 : SP_2024_RD2098_244_10_20240301_00002.jpg

View of construction of the new levees (Fall 2023).

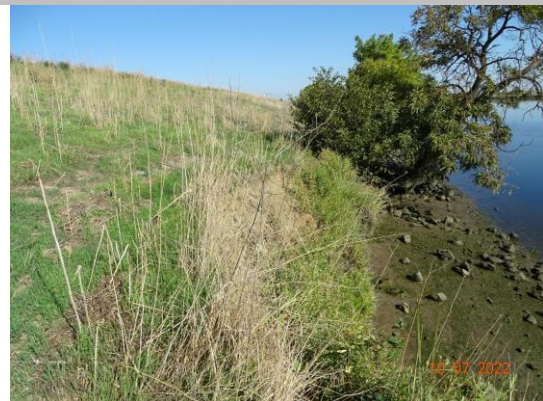
Photo 1 of 1 : SP_2024_RD2098_244_13_20240301_00004.jpg

LM Start	0.57	Rating **	A/W	Issue No.	13
LM End	1.06	Issue Type +	Ma	Location *	WS
Category	Earthen Levee			GPS Latitude/Longitude	
				Start	End
Item	Erosion / Bank Caving			38.320755°	38.313700°
				-121.693982°	-121.693639°
DWR ID	DWR_RD2098_01_s_2017_13				
Comment Code					
E2 : Schedule repair of erosion site prior to the next inspection.					
Inspector Comment					
There is erosion on the waterside slope. Several areas of pocket erosion on the bank are encroaching into the extended levee prism. There is some riprap protection on the lower slope in some areas. Spring 2023: Rated A/W due to ongoing habitat restoration and flood improvement project.

View of the erosion on the WS bank (Fall 2022).

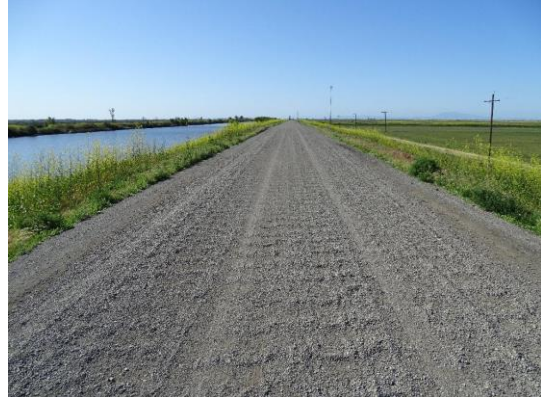
Photo 1 of 3 : UCIP_SP_2024_74264_111252.jpg

Comment Code						
Inspector Comment						
DS_ID:20997						
FS_ID:74264						
EP_NO: N/A						
Repair Type: Non-Urgent						
EVAL Issue:						
Crossing Status: Not Found						
UCIP Comments: 04/12/2022 Record remains Non-Urgent. Geophysical results did not confirm presence of pipe through levee. Record will remain in UCIP's inspection records until future Levee Improvement Project can confirm no crossing was found through the levee. System Feature. (D.Sanoski - DWR UCIP)						
FIELD_STRUCT_DESC: 42-inch drainage pipe of an unknown material through the levee, 21 feet below the crown. [Additional Reference(s): USACE Sacramento O&M Manual, Unit 109, April 1962, Revised 29 December 2016, (HLM 0.69), listed as 42-inch pipe].						
FS Date: 4/12/2022 10:30:41 AM

View of levee crown.

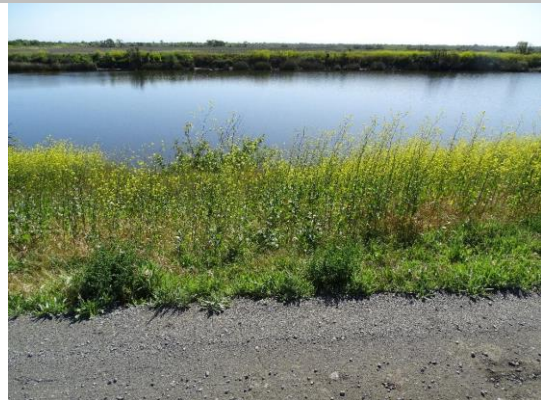
Photo 2 of 3 : UCIP_SP_2024_74264_111251.jpg

View of WS slope.

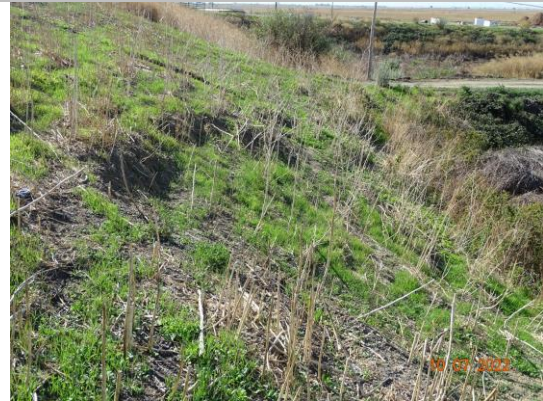
Photo 1 of 1 : SP_2024_RD2098_244_19_20240301_00006.jpg

LM Start	0.96	Rating **	A/W	Issue No.	19
LM End	0.96	Issue Type +	Ma	Location *	LS
Category	Earthen Levee			GPS Latitude/Longitude	
				Start	End
Item	Erosion / Bank Caving			38.315200°	38.315100°
				-121.694100°	-121.694100°
DWR ID	DWR_RD2098_01_s_2021_19				
Comment Code					
E1 : Note and monitor erosion site.					
Inspector Comment					
This was a 2017 Storm Damage site. The damage consists of cracking and sloughing of the lower landside levee slope.					
Site ID No:414					
Site Designation:LMA-241 Spring 2023: Rated A/W due to ongoing habitat restoration and flood improvement project.

View of the sloughing/caving on the LS slope (Fall 2022).

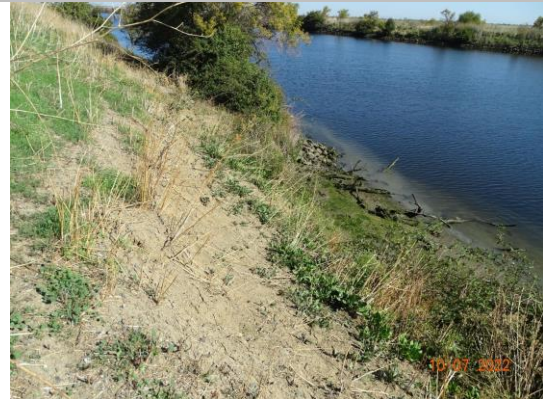
Photo 1 of 1 : SP_2024_RD2098_244_18_20240301_00005.jpg

LM Start	1.76	Rating **	A/W	Issue No.	18
LM End	1.76	Issue Type +	Ma	Location *	WS
Category	Earthen Levee			GPS Latitude/Longitude	
				Start	End
Item	Erosion / Bank Caving			38.303611°	38.303611°
				-121.693607°	-121.693607°
DWR ID	DWR_RD2098_01_s_2018_18				
Comment Code					
E2 : Schedule repair of erosion site prior to the next inspection.					
Inspector Comment					
There is erosion at the waterside toe. Spring 2023: Rated A/W due to ongoing habitat restoration and flood improvement project.

View of the erosion on the WS toe (Fall 2022).

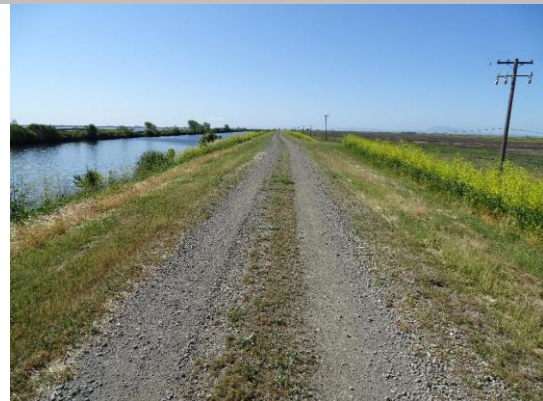
Photo 1 of 3 : UCIP_SP_2024_82369_111287.jpg

Comment Code					
Inspector Comment					
DS_ID:20965 FS_ID:82369 EP_NO: 10168 Repair Type: Non-Urgent EVAL Issue: 6, Levee Damage or Threat for Levee Damage Crossing Status: Found UCIP Comments: 04/12/2022 Record remains Non-Urgent. Threat for levee damage with same erosion under pipe at WS toe. System Feature. (D.Sanoski - DWR UCIP) 12/22/2016 Met with Mike Hadesty, LMA Superintendent, and Brian Bush, LMA General Manager, to go over the list of pipes in RD2098. Per LMA records, this pipe has a different owner. (O. Magana - DWR UCIP) 03/18/2014 Erosion under pipe at WS toe. (W. Wylie - DWR UCIP) FIELD_STRUCT_DESC: 10-inch steel drainage pipe through the levee, 2.8 feet below the crown. Pump in pump house off the landside (LS). (10-inch pipe [HLM 1.80] authorized under Automatic Board Order (ABO) issued as Permit No. 10168, 1974 - Moresco Brothers). [Additional Reference(s): DWR Levee Log, 2003 (HLM 1.80). USACE Sacramento O&M Manual, Unit 109, April 1962, Revised 29 December 2016, (HLM 1.80), listed as 10-inch pipe]. FS Date: 4/12/2022 12:51:06 PM

View of levee crown.

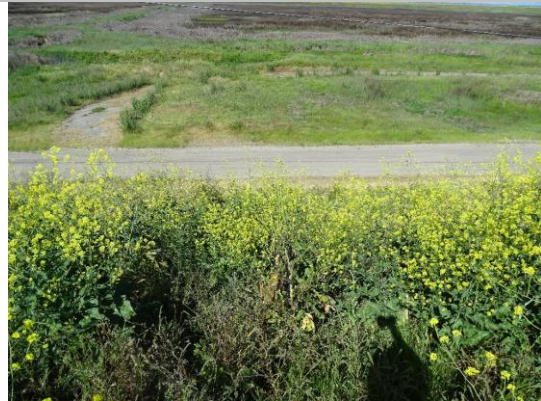
Photo 2 of 3 : UCIP_SP_2024_82369_111286.jpg

View of LS slope and no sign of pumphouse off toe.

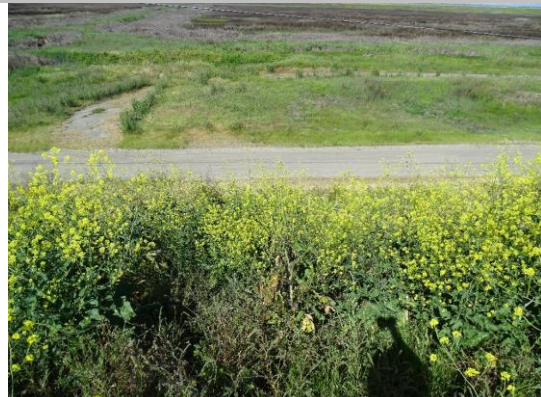
Photo 2 of 3 : UCIP_SP_2024_74545_111291.jpg

View of LS slope.

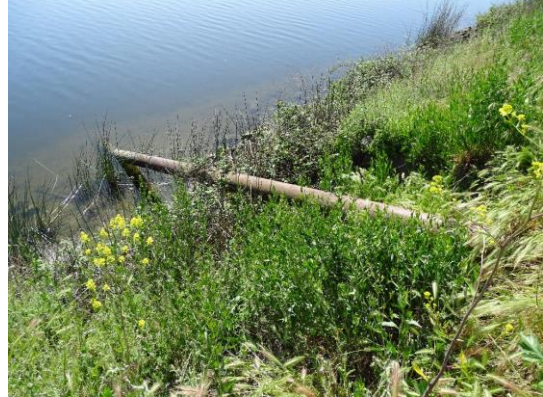
Photo 3 of 3 : UCIP_SP_2024_74545_111295.jpg

View of WS slope.

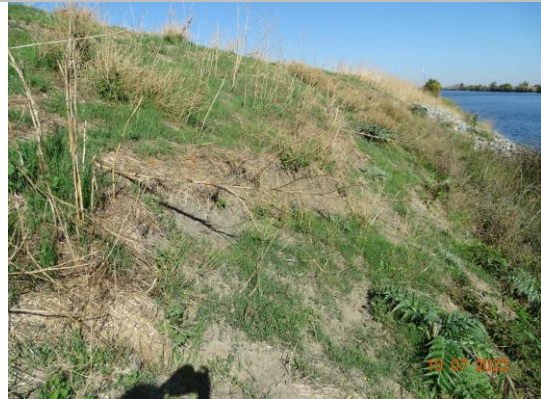
Photo 1 of 1 : SP_2024_RD2098_244_27_20240301_00008.jpg

LM Start	2.29	Rating **	A/W	Issue No.	27
LM End	2.32	Issue Type +	Ma	Location *	WS
Category	Earthen Levee			GPS Latitude/Longitude	
				Start	End
Item	Erosion / Bank Caving			38.295900°	38.295468°
				-121.693500°	-121.693619°
DWR ID	LMA-248				
Comment Code					
E2 : Schedule repair of erosion site prior to the next inspection.					
Inspector Comment					
This was a 2017 Storm Damage site. The damage consists of scour and sloughing of the waterside levee slope. Site ID No:421 Site Designation:LMA-248 Spring 2023: Rated A/W due to ongoing habitat restoration and flood improvement project.

View of the erosion on the WS slope (Fall 2022).

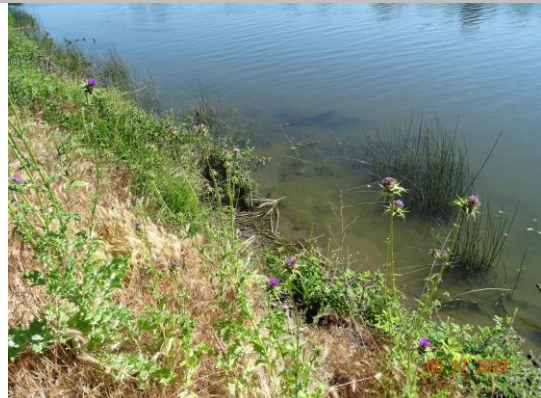
Photo 1 of 1 : SP_2024_RD2098_244_28_20240301_00009.jpg

LM Start	2.35	Rating **	A/W	Issue No.	28
LM End	2.39	Issue Type +	Ma	Location *	WS
Category	Earthen Levee			GPS Latitude/Longitude	
				Start	End
Item	Erosion / Bank Caving			38.295100°	38.294500°
				-121.693400°	-121.693400°
DWR ID	LMA-250				
Comment Code					
E2 : Schedule repair of erosion site prior to the next inspection.					
Inspector Comment					
This was a 2017 Storm Damage site. The damage consists of scour, sloughing, and cracking of the lower and mid waterside levee slope. Site ID No:423 Site Designation:LMA-250 Spring 2023: Rated A/W due to ongoing habitat restoration and flood improvement project.

View of the erosion on the WS slope (Spring 2023).

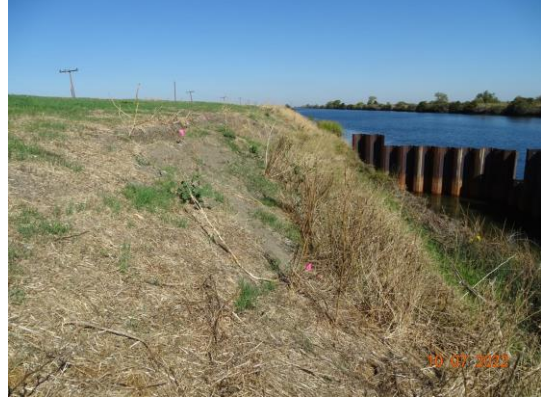
Photo 1 of 1 : SP_2024_RD2098_244_34_20240301_00010.jpg

LM Start	2.75	Rating **	A/W	Issue No.	34
LM End	2.81	Issue Type +	Ma	Location *	WS
Category	Earthen Levee			GPS Latitude/Longitude	
				Start	End
Item	Erosion / Bank Caving			38.289200°	38.288405°
				-121.693500°	-121.693617°
DWR ID	LMA-256				
Comment Code					
E2 : Schedule repair of erosion site prior to the next inspection.					
Inspector Comment					
Fall 2022: Site is pending repair. This was a 2017 Storm Damage site. The damage consists of scour and sloughing of the waterside levee slope.					
Site ID No:429 & 430					
Site Designation:LMA-256, LMA-257 Spring 2023: Rated A/W due to ongoing habitat restoration and flood improvement project.

View of the erosion on the WS slope (Fall 2022).

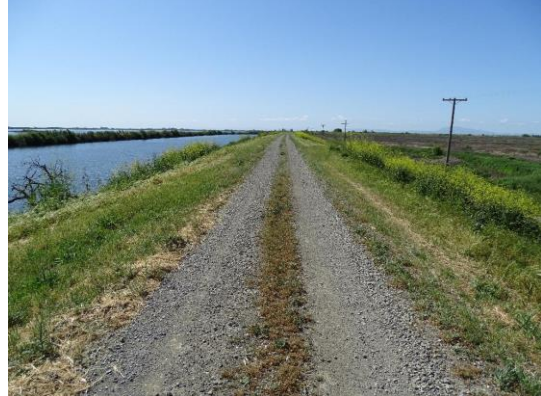
Photo 1 of 3 : UCIP_SP_2024_74561_111323.jpg

Comment Code					
Inspector Comment					
DS_ID:20999 FS_ID:74561 EP_NO: N/A Repair Type: Non-Urgent EVAL Issue: Crossing Status: Not Found UCIP Comments: 04/12/2022 Record remains Non-Urgent. Geophysical results did not confirm presence of pipe through levee. Record will remain in UCIP's inspection records until future Levee Improvement Project can confirm no crossing was found through the levee. System Feature. (D.Sanoski - DWR UCIP) FIELD_STRUCT_DESC: 42-inch drainage pipe of an unknown material through the levee, 19.3 feet below the crown. Flap gate on the waterside (WS). [Additional Reference(s): USACE Sacramento O&M Manual, Unit 109, April 1962, Revised 29 December 2016, (HLM 2.75), listed as 42-inch pipe]. FS Date: 4/12/2022 12:52:52 PM

View of levee crown.

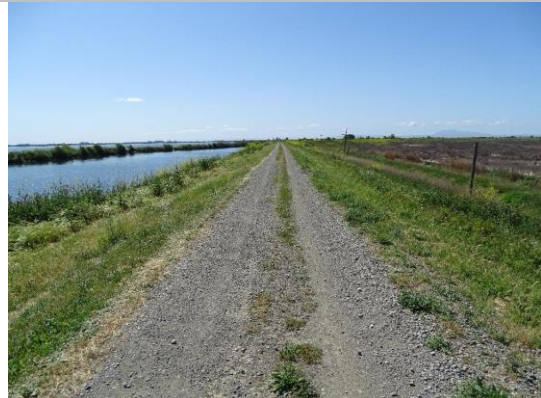
Photo 1 of 3 : UCIP_SP_2024_74562_111326.jpg

Comment Code					
Inspector Comment					
DS_ID:20969 FS_ID:74562 EP_NO: 13222 Repair Type: Non-Urgent EVAL Issue: 5, Pipe Damage Crossing Status: Found UCIP Comments: 04/12/2022 Record remains Non-Urgent. Pipe rusted out on WS slope at toe. (D.Sanoski - DWR UCIP) 03/18/2014 Pipe rusted through at outlet on WS slope, may indicate further degradation of pipe within levee. Good candidate for video inspection. (W. Wylie - DWR UCIP) FIELD_STRUCT_DESC: 20-inch steel drainage pipe through the levee, 7.5 feet below the crown. Siphon breaker on the waterside (WS) shoulder. Pump on pile structure in drainage ditch on the landside (LS). This crossing replaces 20-inch pipe (see DSID 25945). (Pipe removed and replaced with a 19-inch steel pipe under the crown and along the LS slope under Permit No. 13222, 1981 - Prudential Insurance Company of America). [Additional Reference(s): DWR Levee Log, 2003 (HLM 2.98), listed as 20-inch pipe]. FS Date: 4/12/2022 12:53:15 PM

View of levee crown.

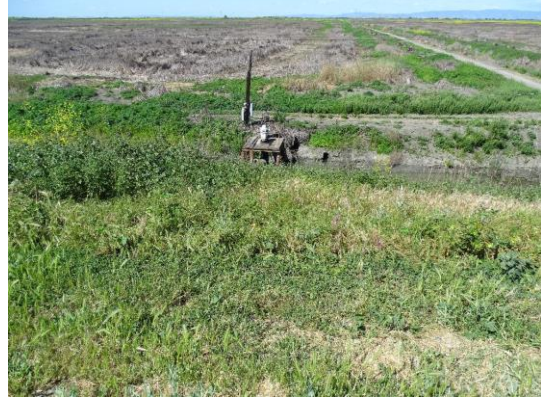
Photo 2 of 3 : UCIP_SP_2024_74562_111327.jpg

View of LS slope and pump on toe.

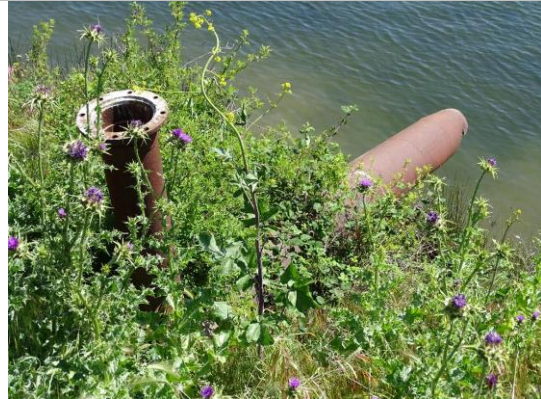
Photo 3 of 3 : UCIP_SP_2024_74562_111329.jpg

View of pipe out of WS slope near toe.

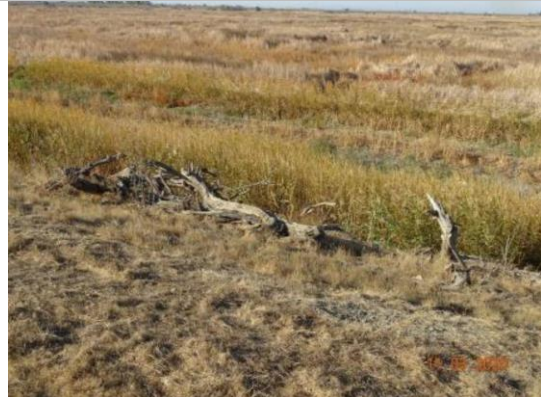
Photo 1 of 1 : SP_2024_RD2098_244_20_20240301_00007.jpg

View of tree limb on the landside slope (Fall 2020).

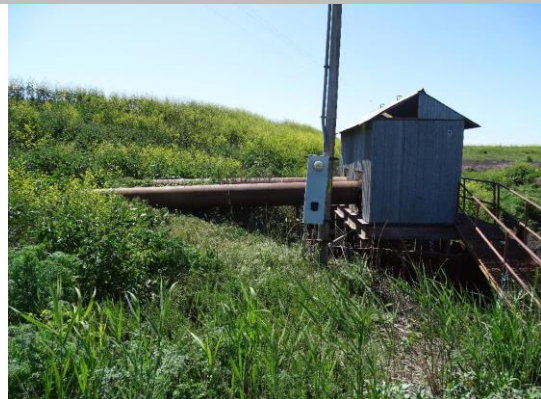
Photo 2 of 3 : UCIP_SP_2024_74573_111372.jpg

Comment Code						
Inspector Comment						
DS_ID:20959 FS_ID:74573 EP_NO: 15169 Repair Type: Non-Urgent EVAL Issue: 11, Maintenance Compliance Issue Crossing Status: Found UCIP Comments: 04/12/2022 Record remains Non-Urgent. Maintenance compliant issue with siphon breaker riser broken on WS shoulder. Otherwise, all good besides the overgrown vegetation, but looks like same conditions as last inspection. (D.Sanoski - DWR UCIP) 12/22/2016 Met with Mike Hadesty, LMA Superintendent, and Brian Bush, LMA General Manager, to go over the list of pipes in RD2098. Per LMA, pipe is a drainage pipe. New property owner is John Anderson. (O. Magana - DWR UCIP) 03/18/2014 Soil and debris buildup in steel riser on WS shoulder may prevent proper function of siphon breaker. (W. Wylie - DWR UCIP) FIELD_STRUCT_DESC: 2 of 2: 24-inch coated steel drainage pipe through the levee, 5.6 feet below the crown. Cutoff wall around the pipe at the center of the levee. Siphon breaker on the waterside (WS) shoulder. Flap gate on the WS end. Pump in pump house on piling structure on the landside (LS). (24-inch pipe authorized under Permit No. 15169, 1989 - Maxim Development). [Additional Reference(s): DWR Levee Log, 2003 (HLM 3.48)]. FS Date: 4/12/2022 12:54:15 PM

View of pipe into pumphouse on LS toe.

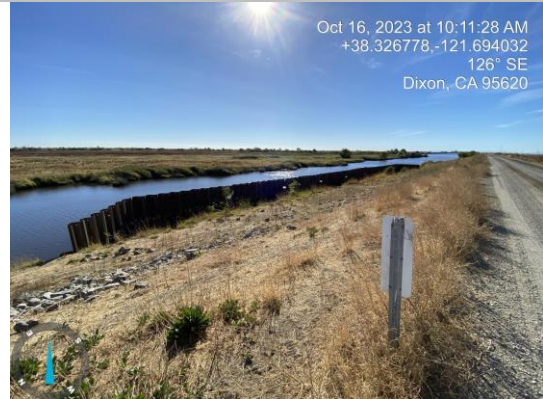
Photo 1 of 1 : SP_2024_RD2098_245_2_20240301_00001.jpg

LM Start	0.00	Rating **	A/W	Issue No.	2
LM End	0.53	Issue Type +	En	Location *	CR
Category	Earthen Levee			GPS Latitude/Longitude	
				Start	End
Item	Encroachments			38.277410°	38.275707°
				-121.696280°	-121.705705°
DWR ID	DWR_RD2098_01A_s _ 2023_2				
Comment Code					
LC : Authorized Levee Construction					
Inspector Comment					
Unit 1A is part of the Lookout Slough Tidal Habitat Restoration and Flood Improvement Project (in progress) and will be degraded.

View of construction area on Unit 1 that extends through Unit 1A (Fall 2023).

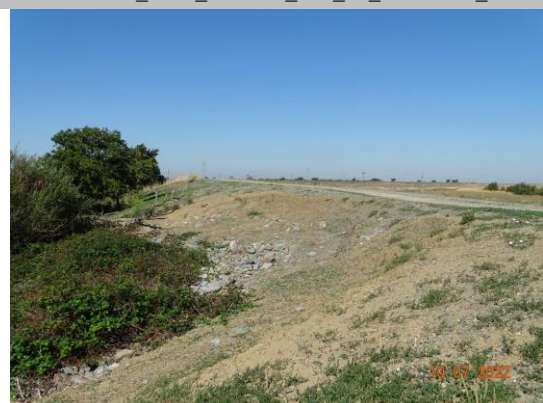
Photo 1 of 1 : SP_2024_RD2098_246_11_20240301_00002.jpg

LM Start	5.88	Rating **	A/W	Issue No.	11
LM End	5.88	Issue Type +	Ma	Location *	WS
Category	Earthen Levee			GPS Latitude/Longitude	
				Start	End
Item	Erosion / Bank Caving			38.282946°	38.282946°
				-121.710902°	-121.710902°
DWR ID	DWR_RD2098_02_f_2020_11				
Comment Code					
E2 : Schedule repair of erosion site prior to the next inspection.					
Inspector Comment					
This waterside slump site is not new, and is somewhat protected by riprap and thick brushy vegetation, but it has the potential to erode into crown during high water with a strong south wind. It currently has a two-foot vertical scarp at the levee shoulder. Spring 2023: Rated A/W due to ongoing habitat restoration and flood improvement project.

View of the erosion on the WS slope (Fall 2022).

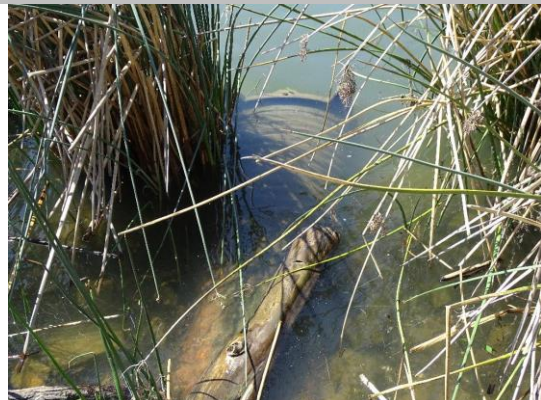
Photo 2 of 3 : UCIP_SP_2024_74580_111389.jpg

Comment Code						
Inspector Comment						
DS_ID:20974 FS_ID:74580 EP_NO: 10172 Repair Type: No Action Needed EVAL Issue: Crossing Status: Found UCIP Comments: 04/12/2022 Record remains No Action Needed. No issues observed during inspection except minor issue of half broken lid on riser. System Feature. (D.Sanoski - DWR UCIP) 12/22/2016 Met with Mike Hadesty, LMA Superintendent, and Brian Bush, LMA General Manager, to go over the list of pipes in RD2098. Per LMA, pipe is a drainage pipe. (O. Magana - DWR UCIP) FIELD_STRUCT_DESC: 24-inch corrugated metal drainage pipe through the levee, 21.5 feet below the crown. Two cutoff walls around the pipe at the levee shoulders. Slide gate in corrugated metal pipe (CMP) riser on the waterside (WS) slope. Flap gate and concrete U-shaped headwall on the landside (LS) end. (24-inch pipe [HLM 6.21] authorized under Automatic Board Order (ABO) issued as Permit No. 10172, 1974 - Moresco Brothers). [Additional Reference(s): DWR Levee Log, 2003 (HLM 6.21). USACE Sacramento O&M Manual, Unit 109, April 1962, Revised 29 December 2016, (HLM 6.21), listed as 24-inch pipe]. FS Date: 4/12/2022 12:55:23 PM

View of pipe with flap gate out of WS toe.

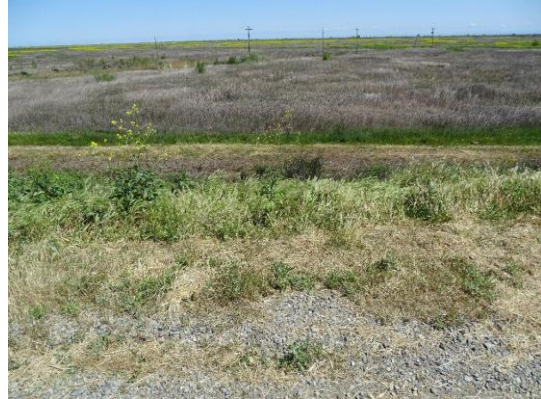
Photo 3 of 3 : UCIP_SP_2024_74580_111392.jpg

View of LS shoulder and slope.

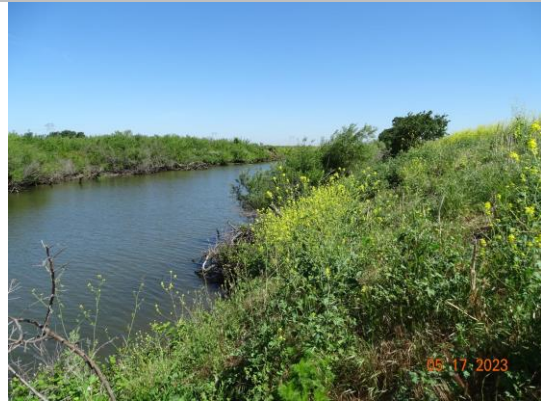
Photo 1 of 1 : SP_2024_RD2098_246_15_20240301_00003.jpg

View of the erosion on the WS (Spring 2023).

E2 : Schedule repair of erosion site prior to the next inspection.

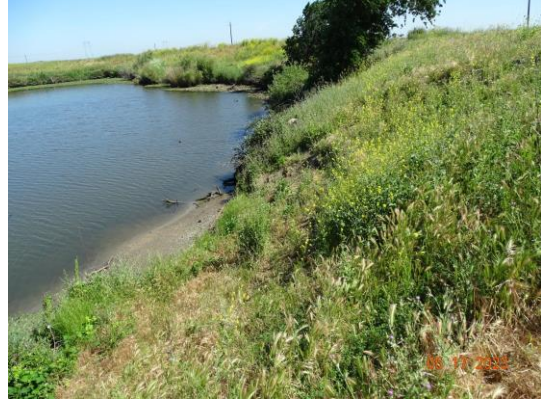
Photo 1 of 1 : SP_2024_RD2098_246_18_20240301_00004.jpg

View of the erosion on the WS (Spring 2023).

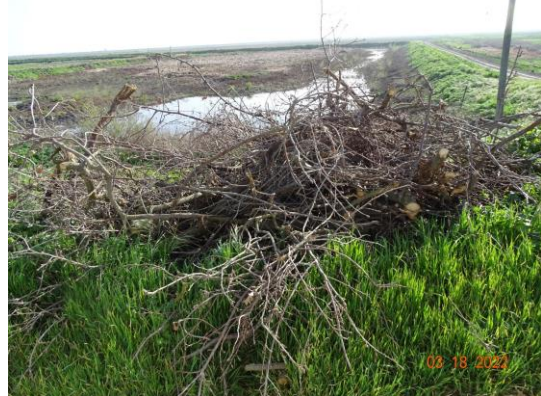
Photo 1 of 1 : SP_2024_RD2098_246_9_20240301_00001.jpg

View of cut up tree limbs on the landside shoulder (Spring 2022).

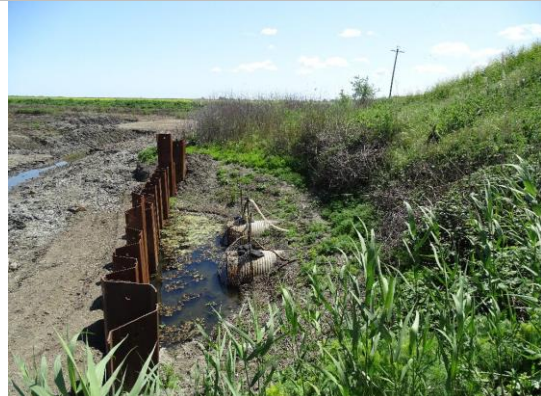
Photo 2 of 3 : UCIP_SP_2024_74585_111406.jpg

View of pipe out of LS slope with metal retaining wall.

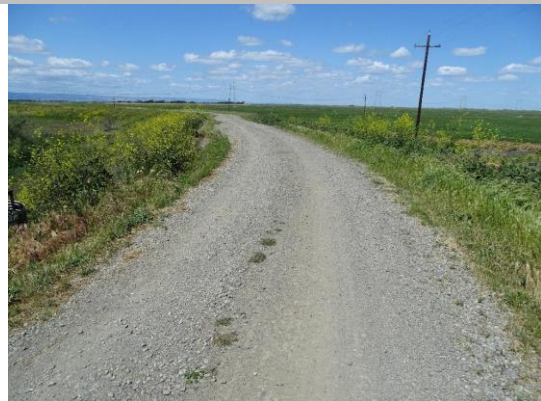
Photo 1 of 3 : UCIP_SP_2024_74586_111417.jpg

View of levee crown.

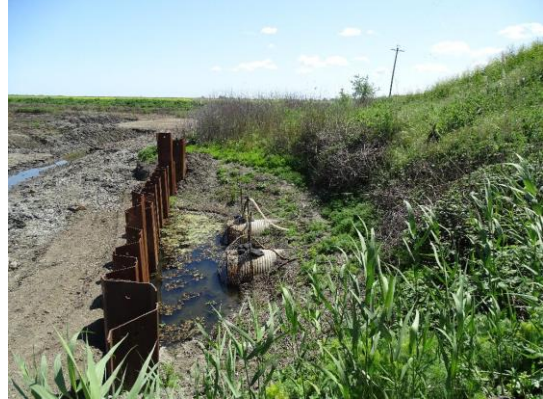
Photo 2 of 3 : UCIP_SP_2024_74586_111420.jpg

View of pipe out of LS slope with metal retaining wall.

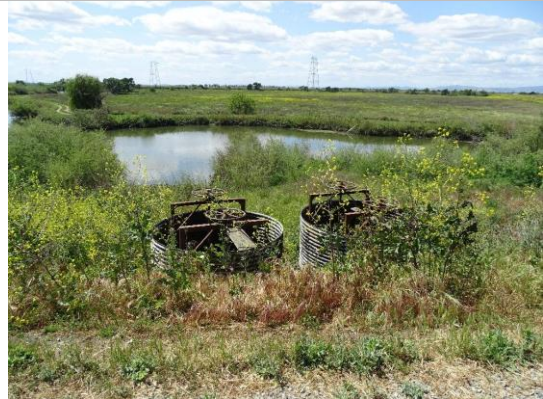
Photo 3 of 3 : UCIP_SP_2024_74586_111418.jpg

View of WS shoulder with CMP riser on slope.

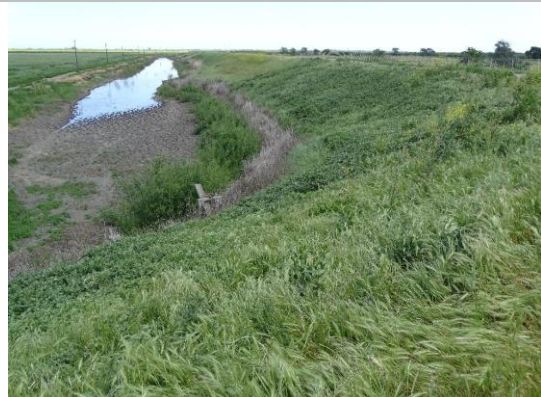
Photo 2 of 3 : UCIP_SP_2024_74588_111425.jpg

View of LS slope and slide gate on toe.

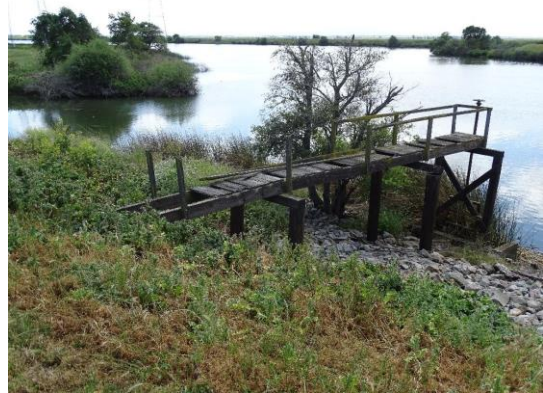
Photo 3 of 3 : UCIP_SP_2024_74588_111424.jpg

View of WS slope and abandoned walkway.

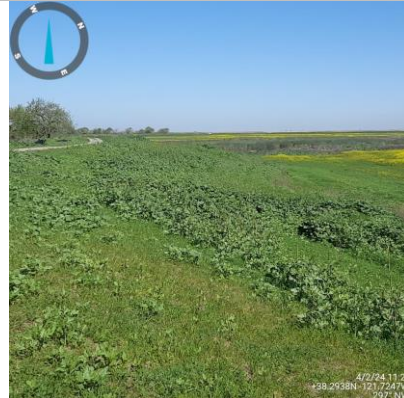
Photo 1 of 1 : SP_2024_RD2098_247_14_20240404_00017.jpg

View of vegetation blocking visibility to LS slope. (Spring 2024)

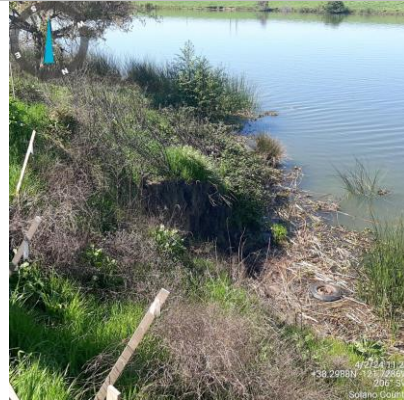
Photo 1 of 1 : SP_2024_RD2098_247_15_20240404_00018.jpg

View of erosion on the WS slope. (Spring 2024)

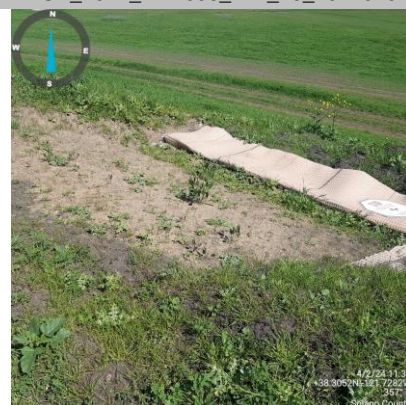
Photo 1 of 1 : SP_2024_RD2098_247_16_20240404_00016.jpg

View of turnout or staging area cut into levee slope. (Spring 2024)

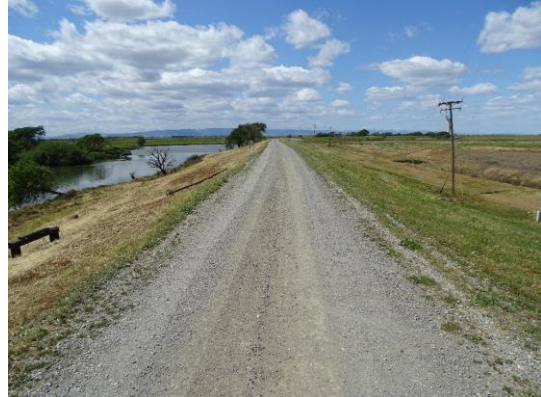
Photo 1 of 3 : UCIP_SP_2024_74598_111454.jpg

View of levee crown.

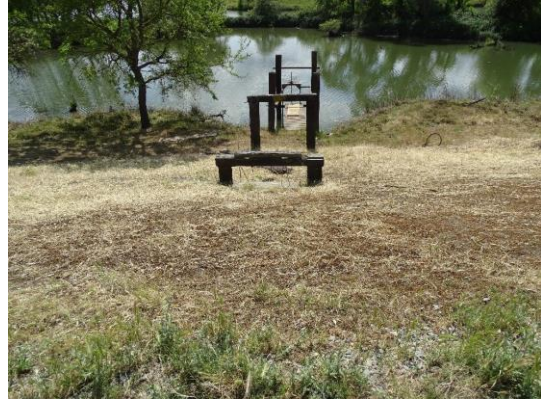
Photo 2 of 3 : UCIP_SP_2024_74598_111455.jpg

View of WS slope and abandoned pier on toe.

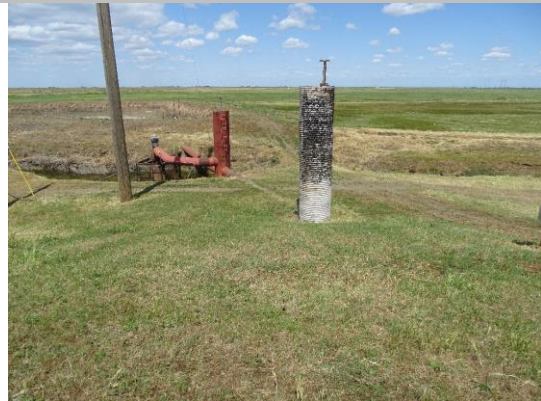
Photo 3 of 3 : UCIP_SP_2024_74598_111456.jpg

View of LS slope and toe.

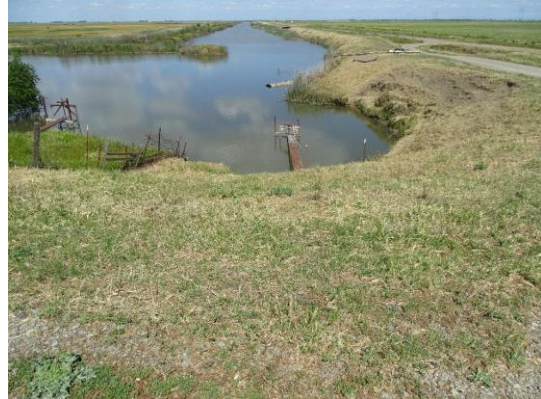
Photo 2 of 3 : UCIP_SP_2024_74611_111489.jpg

View of LS slope and slide gate at toe.

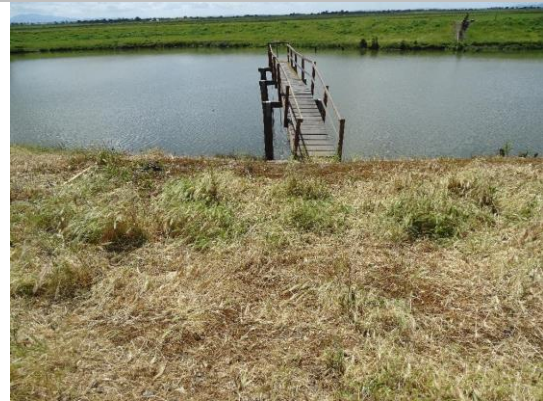
Photo 3 of 3 : UCIP_SP_2024_74611_111488.jpg

View of WS slope and walkway on toe.

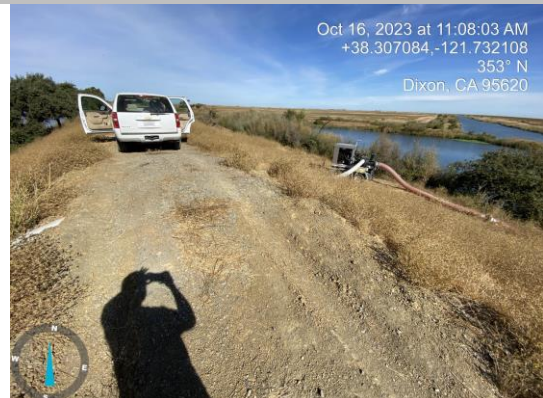
Photo 1 of 1 : SP_2024_RD2098_247_5_20240301_00002.jpg

View of pipe crossing the levee crown (Fall 2023).

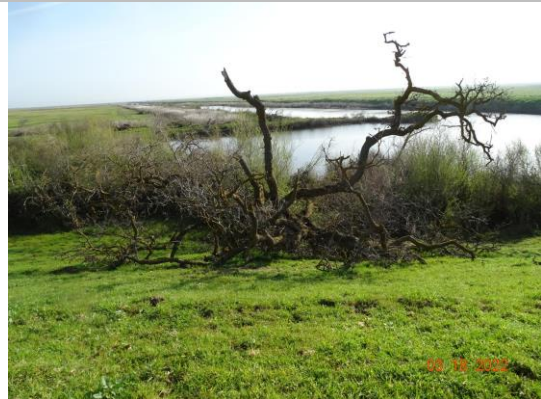
Photo 1 of 1 : SP_2024_RD2098_247_12_20240301_00006.jpg

View of downed tree on the landside slope (Spring 2022).

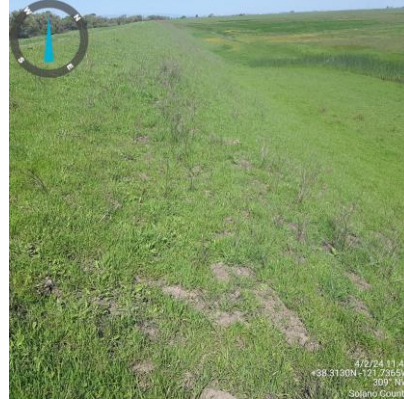
Photo 1 of 1 : SP_2024_RD2098_247_4_20240404_00019.jpg

View of slope terracing caused by cattle on the landside slope (Spring 2024).

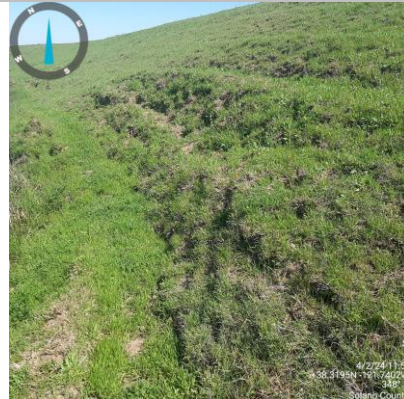
Photo 1 of 1 : SP_2024_RD2098_248_11_20240404_00020.jpg

View of terracing due to cows on the waterside slope (Spring 2024).

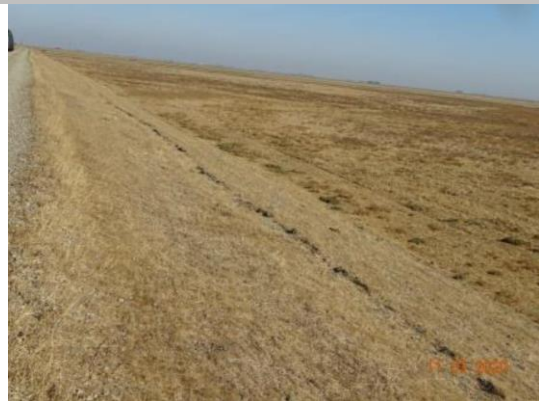
Photo 1 of 1 : SP_2024_RD2098_248_10_20240301_00004.jpg

View looking upstream at depressions in the landside slope due to cows (Fall 2020).

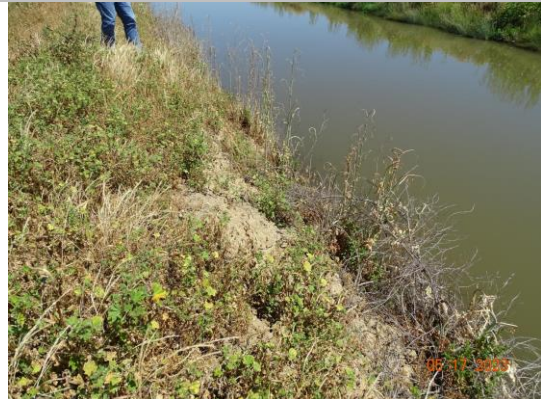
Photo 1 of 1 : SP_2024_RD2098_248_15_20240301_00007.jpg

View of the erosion on the LS (Spring 2023).

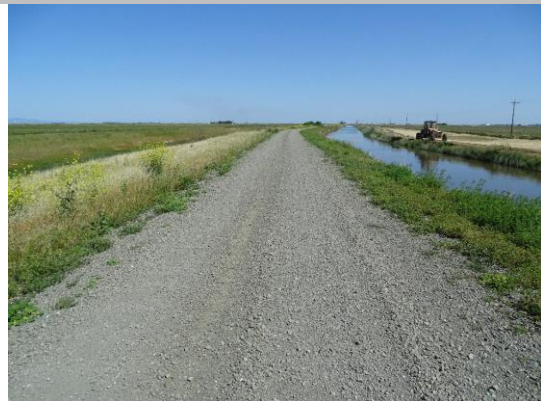
Photo 1 of 3 : UCIP_SP_2024_74679_111675.jpg

View of levee crown.

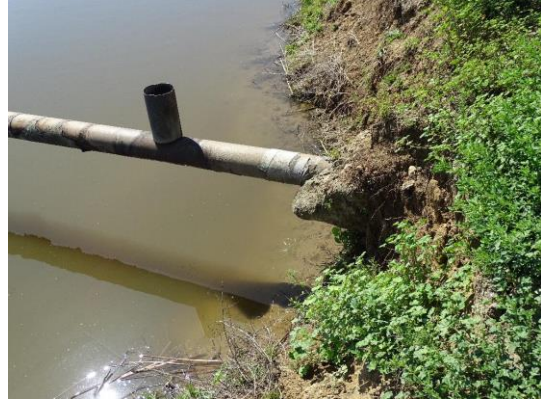
Photo 2 of 3 : UCIP_SP_2024_74679_111678.jpg

View of serious scour around pipe on LS slope.

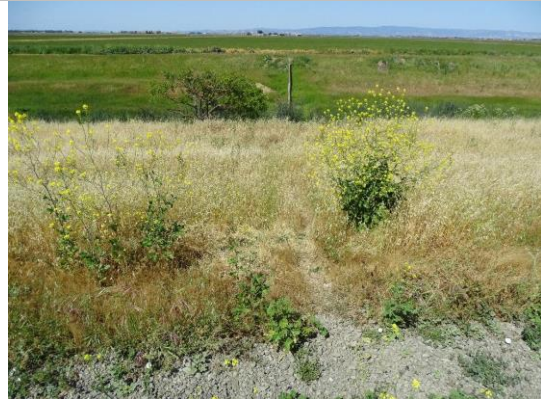
Photo 3 of 3 : UCIP_SP_2024_74679_111677.jpg

View of WS slope with pipe in distance.

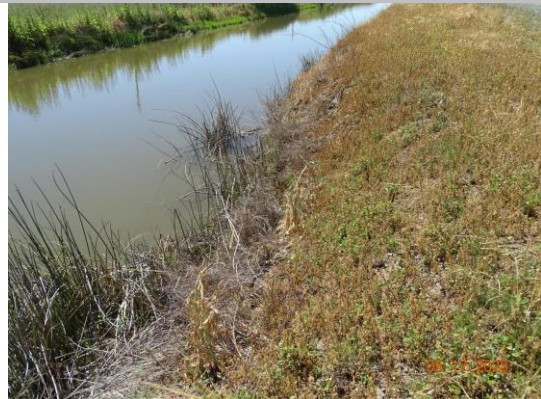
Photo 1 of 1 : SP_2024_RD2098_248_14_20240301_00006.jpg

View of the erosion on the LS (Spring 2023).

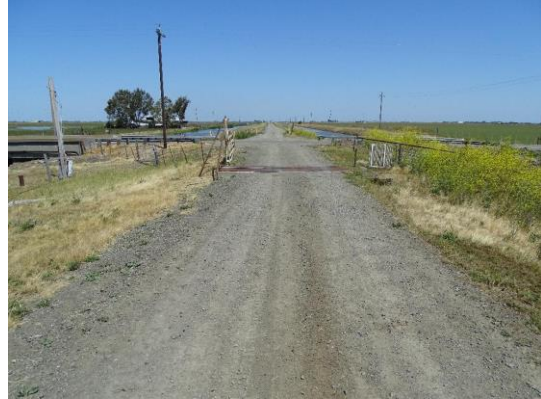
Photo 1 of 3 : UCIP_SP_2024_75241_111733.jpg

View of levee crown.

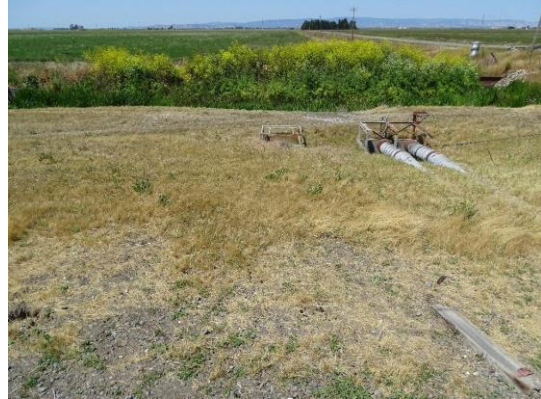
Photo 2 of 3 : UCIP_SP_2024_75241_111734.jpg

View of WS slope and concrete distribution box.

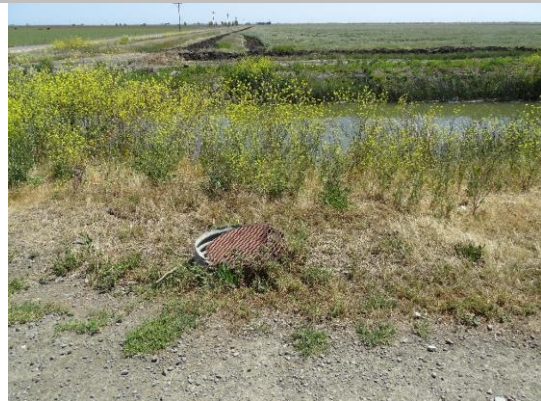
Photo 3 of 3 : UCIP_SP_2024_75241_111735.jpg

View of LS slope and CMP riser.

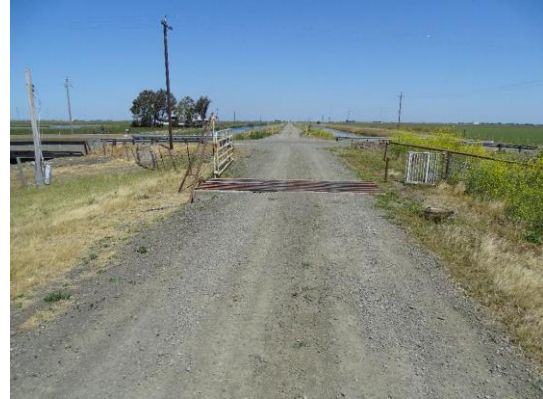
Photo 1 of 3 : UCIP_SP_2024_74695_111744.jpg

View of levee crown.

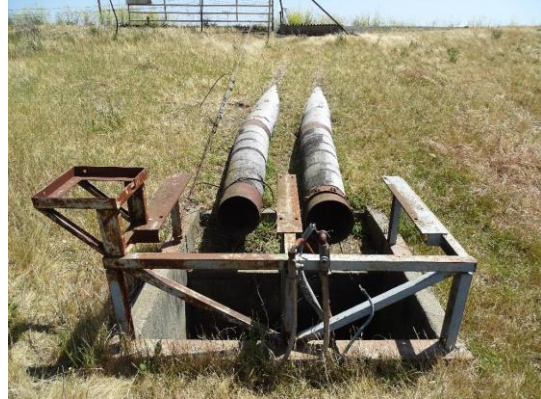
Photo 2 of 3 : UCIP_SP_2024_74695_111743.jpg

View of pipe out of WS slope into distribution box.

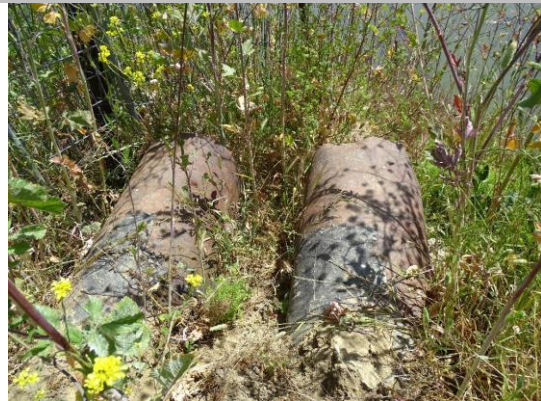
Photo 3 of 3 : UCIP_SP_2024_74695_111747.jpg

View of pipe out of LS slope.

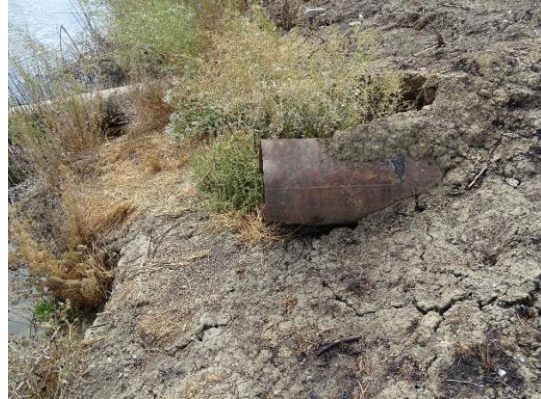
Photo 2 of 3 : UCIP_SP_2024_74696_78547.jpg

LS view - erosion around bottom of pipe.

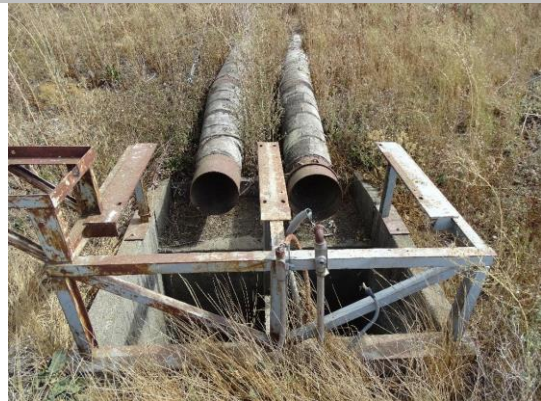
Photo 3 of 3 : UCIP_SP_2024_74696_78548.jpg

WS view - looks in good condition.
