**Flood Control Project Maintenance  
Levee Inspections**

**Maintenance Issue Types Only, Levee Inspection Report By Mile - Fall 2014**

**Reclamation District No. 2098 Cache and Haas Slough**

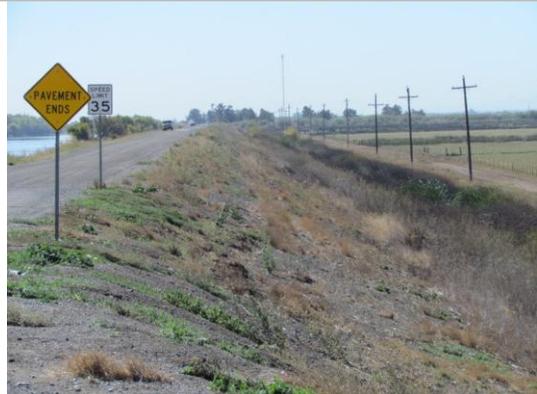
Photo 1 of 1 : FA\_2014\_RD2098\_244\_2\_20141126\_00001.jpg

LM Start	<b>0.02</b>	Rating **	A	Issue No.	<b>2</b>
LM End	<b>3.58</b>	Issue Type +	Ma	Location *	LS
Category	Earthen Levee		GPS Latitude/Longitude		
			Start	End	
Item	Vegetation		38.328788 °	38.329117 °	
			-121.694072 °	-121.694060 °	
DWR ID	DWR_RD2098_01_f_2014_2				
Action/Comments					
Control annual grass and weeds on the levee slopes and easements.

RD 2098 Unit 1 looking downstream from landside slope. Goats were used to remove vegetation.

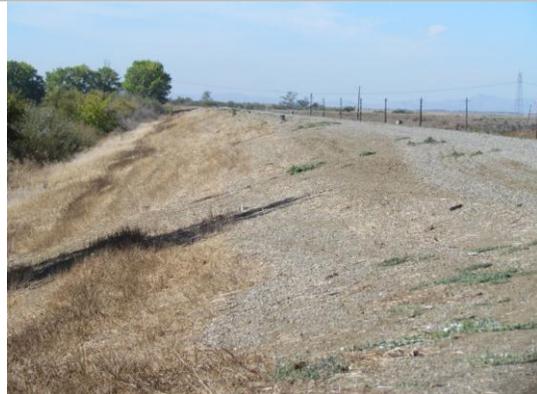
Photo 1 of 1 : FA\_2014\_RD2098\_245\_3\_20141126\_00002.jpg

LM Start	<b>0.02</b>	Rating **	A	Issue No.	<b>3</b>
LM End	<b>0.55</b>	Issue Type +	Ma	Location *	WS
Category	Earthen Levee		GPS Latitude/Longitude		
			Start	End	
Item	Vegetation		38.277411 °	38.275735 °	
			-121.690280 °	-121.705765 °	
DWR ID	DWR_RD2098_01A_f_2014_3				
Action/Comments					
Control annual grass and weeds on the levee slopes and easements. Inspector Comments: Waterside levee slope has been mowed.

Looking downstream from waterside slope levee mile 0.02 to 0.55.

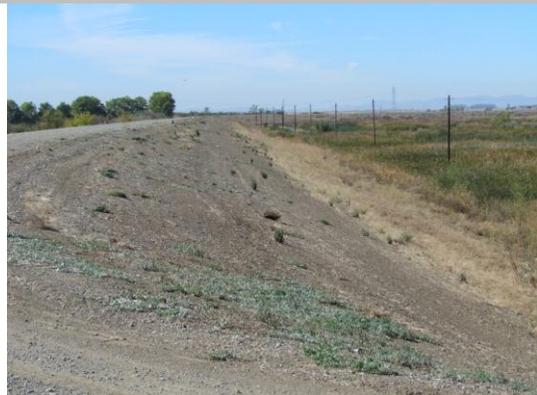
Photo 1 of 1 : FA\_2014\_RD2098\_245\_2\_20141126\_00001.jpg

LM Start	<b>0.02</b>	Rating **	A	Issue No.	<b>2</b>
LM End	<b>0.55</b>	Issue Type +	Ma	Location *	LS
Category	Earthen Levee		GPS Latitude/Longitude		
			Start	End	
Item	Vegetation		38.277325 °	38.275735 °	
			-121.696650 °	-121.705765 °	
DWR ID	DWR_RD2098_01A_f_2014_2				
Action/Comments					
Control annual grass and weeds on the levee slopes and easements. Inspector Comments: Goats has cleared all vegetation from landward levee slope.

Looking downstream from Unit 1A RD 2098 Landside slope.

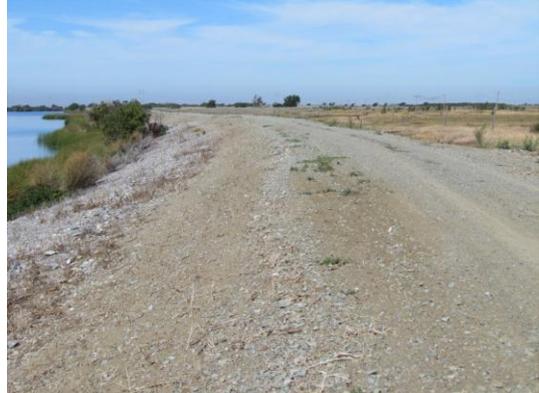
Photo 1 of 1 : FA\_2014\_RD2098\_246\_15\_20141126\_00003.jpg

LM Start	<b>5.29</b>	Rating **	A	Issue No.	<b>15</b>
LM End	<b>7.30</b>	Issue Type +	Ma	Location *	LS
Category	Earthen Levee		GPS Latitude/Longitude		
			Start	End	
Item	Vegetation		38.275706 °	38.294171 °	
			-121.705698 °	-121.725037 °	
DWR ID	DWR_RD2098_02_f_2014_15				
Action/Comments					
Control annual grass and weeds on the levee slopes and easements. Inspector Comments: Goats has done a great job of removing the vegetation.

RD 2098 Unit 2 looking downstream from waterside slope. Goats have removed vegetation from the slope.

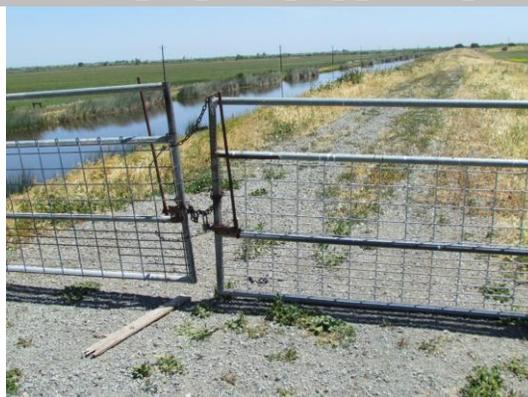
Photo 1 of 1 : FA\_2014\_RD2098\_246\_4\_20141008\_00001.jpg

LM Start	<b>6.71</b>	Rating **	<b>U</b>	Issue No.	<b>4</b>
LM End	<b>6.71</b>	Issue Type +	<b>Ma</b>	Location *	<b>CR</b>
Category	Earthen Levee		GPS Latitude/Longitude		
			Start	End	
Item	Repair Gates		38.289452 °	38.289452 °	
			-121.716814 °	-121.716814 °	
DWR ID	DWR_RD2098_02_f_2013_4				
Action/Comments					
Inspector Comments: This gate is damaged and requires replacement.

This gate has no hinges. No new photo; no repairs done.

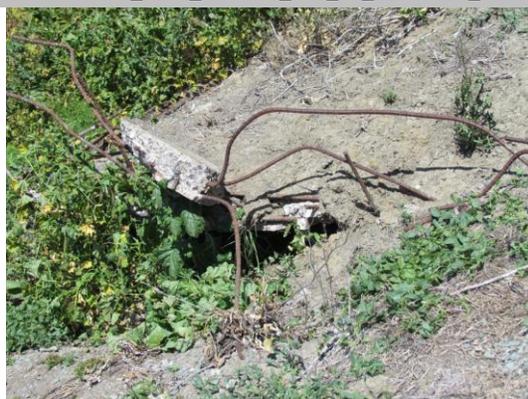
Photo 1 of 1 : FA\_2014\_RD2098\_246\_10\_20141008\_00002.jpg

LM Start	<b>6.72</b>	Rating **	<b>U</b>	Issue No.	<b>10</b>
LM End	<b>6.72</b>	Issue Type +	<b>Ma</b>	Location *	<b>WS</b>
Category	Earthen Levee		GPS Latitude/Longitude		
			Start	End	
Item	Slope Stability		38.292076 °	38.292076 °	
			-121.715792 °	-121.715792 °	
DWR ID	DWR_RD2098_02_s_2014_10				
Action/Comments					
Repair slope instability. Inspector Comments: RD 2098 will send out crew to inspect site and make repairs as needed.

There is some slope damage at this location under this concrete. No new photo; RD will send crew out to check area out.

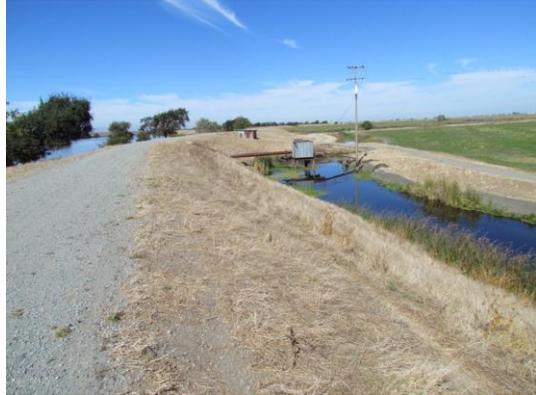
Photo 1 of 1 : FA\_2014\_RD2098\_247\_17\_20141126\_00008.jpg

LM Start	<b>7.30</b>	Rating **	M	Issue No.	<b>17</b>
LM End	<b>9.19</b>	Issue Type +	Ma	Location *	LS
Category	Earthen Levee		GPS Latitude/Longitude		
			Start	End	
Item	Vegetation		38.294171 °	38.316093 °	
			-121.725037 °	-121.704014 °	
DWR ID	DWR_RD2098_03_f_2014_17				
Action/Comments					
Control annual grass and weeds on the levee slopes and easements.

Looking downstream from levee mile 7.30 Unit 3 landside slope.

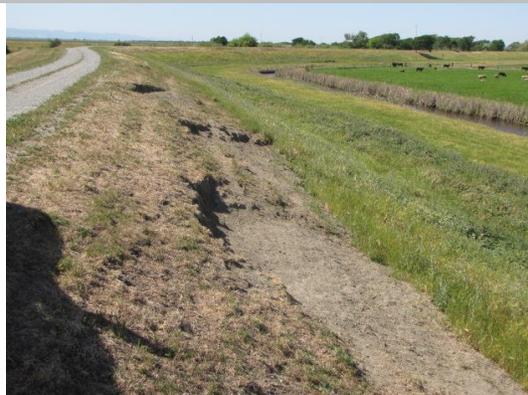
Photo 1 of 1 : FA\_2014\_RD2098\_247\_4\_20141008\_00001.jpg

LM Start	<b>7.50</b>	Rating **	M	Issue No.	<b>4</b>
LM End	<b>7.61</b>	Issue Type +	Ma	Location *	WS
Category	Earthen Levee		GPS Latitude/Longitude		
			Start	End	
Item	Slope Stability		38.295930 °	38.298142 °	
			-121.727043 °	-121.739715 °	
DWR ID	DWR_RD2098_03_s_2013_4				
Action/Comments					
Repair slope instability. Inspector Comments: There is erosion on waterside covered by tullies. This is not a new site. Monitor but it appears to be stable at this time, 4-23-2013. During inspection 5-14-2014 no movement at site.

RD 2098 Unit 3 landside slope erosion levee mile 7.50-7.61. Photo taken 4-23-2013.

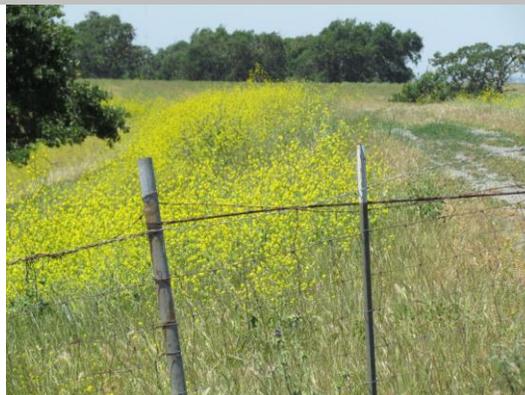
Photo 1 of 1 : FA\_2014\_RD2098\_247\_14\_20141008\_00005.jpg

LM Start	<b>8.37</b>	Rating **	<b>U</b>	Issue No.	<b>14</b>
LM End	<b>9.07</b>	Issue Type +	<b>Ma</b>	Location *	<b>WS</b>
Category	Earthen Levee		GPS Latitude/Longitude		
			Start	End	
Item	Vegetation		38.306778 °	38.314746 °	
			-121.731875 °	-121.738696 °	
DWR ID	DWR_RD2098_03_s_2014_14				
Action/Comments					
Remove the wild growth other than native grasses from the levee slopes. Inspector Comments: No new photo taken, this area has all native grasses. Land owner has not removed any from levee sections water ward nor landward.

Unsatisfactory growth of tall mustard grass completely covering the waterward levee slope. No new photo taken here during Fall inspection. No change.

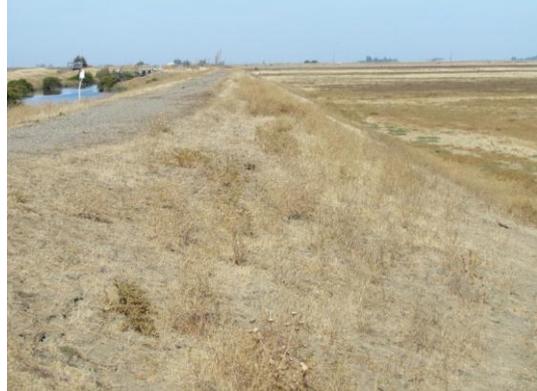
Photo 1 of 1 : FA\_2014\_RD2098\_248\_4\_20141126\_00005.jpg

LM Start	<b>9.20</b>	Rating **	M	Issue No.	<b>4</b>
LM End	<b>9.20</b>	Issue Type +	Ma	Location *	LS
Category	Earthen Levee		GPS Latitude/Longitude		
			Start	End	
Item	Vegetation		38.316167 °	38.316167 °	
			-121.740115 °	-121.740120 °	
DWR ID	DWR_RD2098_04_s_2014_4				
Action/Comments					
Remove the wild growth other than native grasses from the levee slopes.

RD 2098 Unit 4 looking downstream along the landside at levee mile 9.20.
