**Flood Control Project Maintenance  
Levee Inspections**

## Maintenance Issue Types Only, Levee Inspection Report By Mile - Spring 2015

### Reclamation District No. 2098 Cache and Haas Slough

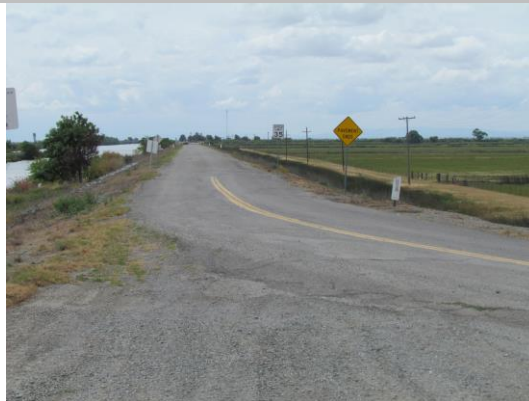
Photo 1 of 1 : SP\_2015\_RD2098\_244\_10\_20150604\_00002.jpg

LM Start	0.14	Rating **	A	Issue No.	10
LM End	3.58	Issue Type +	Ma	Location *	WS
Category	Earthen Levee			GPS Latitude/Longitude	
				Start	End
Item	Vegetation			38.327017 °	38.277623 °
				-121.694053 °	-121.696213 °
DWR ID	DWR_RD2098_01_s_2015_10				
Action/Comments					
Control annual grass and weeds on the levee slopes and easements.

Looking downstream at the waterside levee slope.

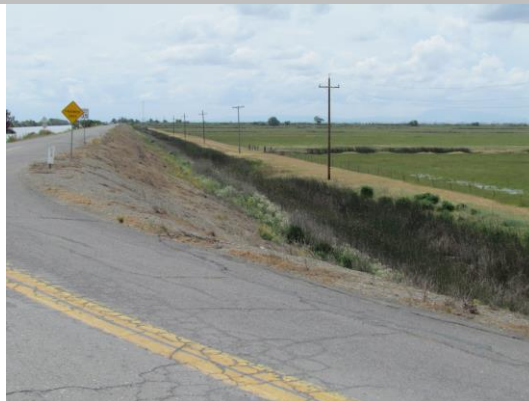
Photo 1 of 1 : SP\_2015\_RD2098\_244\_11\_20150604\_00001.jpg

LM Start	0.14	Rating **	A	Issue No.	11
LM End	3.58	Issue Type +	Ma	Location *	LS
Category	Earthen Levee			GPS Latitude/Longitude	
				Start	End
Item	Vegetation			38.327010 °	38.277623 °
				-121.694055 °	-121.696213 °
DWR ID	DWR_RD2098_01_s_2015_11				
Action/Comments					
Control annual grass and weeds on the levee slopes and easements.

View looking downstream at the landside levee slope.

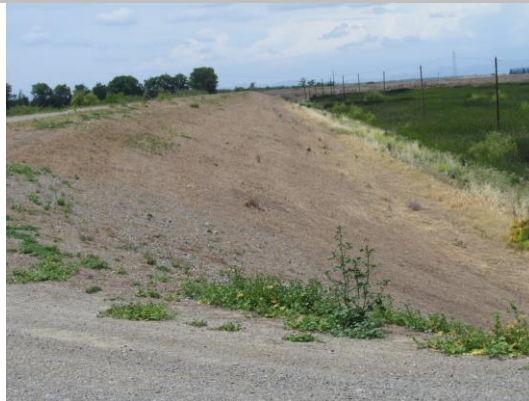
Photo 1 of 1 : SP\_2015\_RD2098\_245\_2\_20150604\_00001.jpg

LM Start	0.00	Rating **	A	Issue No.	2
LM End	0.53	Issue Type +	Ma	Location *	LS
Category	Earthen Levee			GPS Latitude/Longitude	
				Start	End
Item	Vegetation			38.277408 °	38.275722 °
				-121.696282 °	-121.705772 °
DWR ID	DWR_RD2098_01A_s_2015_2				
Action/Comments					
Control annual grass and weeds on the levee slopes and easements.

View looking at the landside slope.

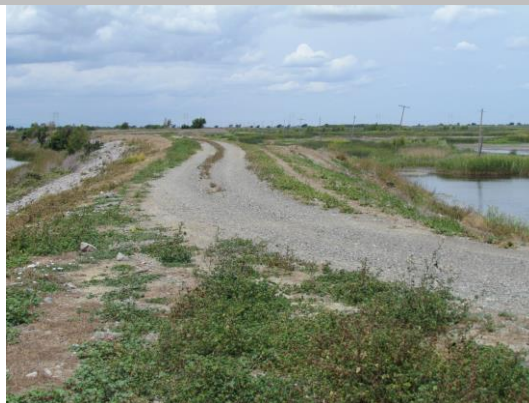
Photo 1 of 1 : SP\_2015\_RD2098\_246\_11\_20150604\_00003.jpg

LM Start	5.31	Rating **	A	Issue No.	11
LM End	6.74	Issue Type +	Ma	Location *	LS
Category	Earthen Levee			GPS Latitude/Longitude	
				Start	End
Item	Vegetation			38.275935 °	38.292505 °
				-121.705900 °	-121.716120 °
DWR ID	DWR_RD2098_02_s _ 2015_11				
Action/Comments					
Control annual grass and weeds on the levee slopes and easements.

View looking downstream at levee section.

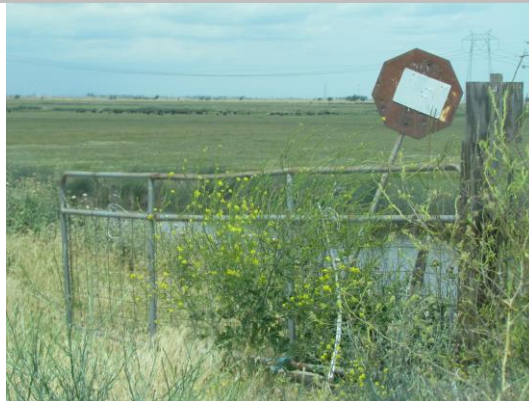
Photo 1 of 1 : SP\_2015\_RD2098\_246\_4\_20150604\_00004.jpg

LM Start	6.73	Rating **	U	Issue No.	4
LM End	6.73	Issue Type +	Ma	Location *	CR
Category	Earthen Levee			GPS Latitude/Longitude	
				Start	End
Item	Repair Gates			38.292428 °	38.292428 °
				-121.716062 °	-121.716062 °
DWR ID	DWR_RD2098_02_f_2013_4				
Action/Comments					
Inspector Comments: This gate is damaged and requires replacement.

View of the broken gate.

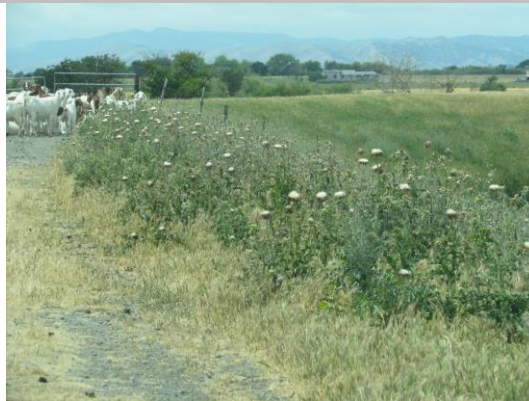
Photo 1 of 1 : SP\_2015\_RD2098\_246\_17\_20150604\_00008.jpg

LM Start	7.09	Rating **	U	Issue No.	17
LM End	7.15	Issue Type +	Ma	Location *	LS
Category	Earthen Levee			GPS Latitude/Longitude	
				Start	End
Item	Vegetation			38.292975 °	38.293008 °
				-121.722357 °	-121.723457 °
DWR ID	DWR_RD2098_02_s_2015_17				
Action/Comments					
Remove the wild growth other than native grasses from the levee slopes.					
Inspector Comments: Remove the unacceptable weeds from the landside slope.

View of unacceptable weeds on the landside levee slope.

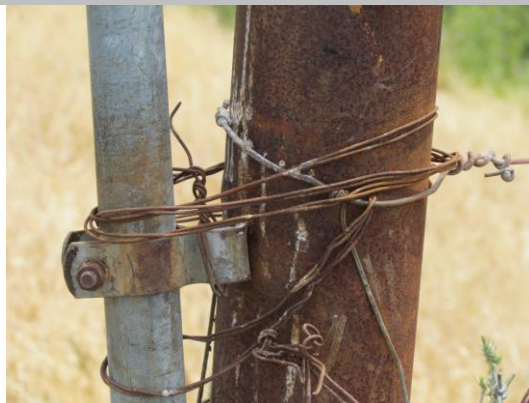
Photo 1 of 2 : SP\_2015\_RD2098\_246\_19\_20150604\_00006.jpg

LM Start	7.15	Rating **	U	Issue No.	19
LM End	7.15	Issue Type +	Ma	Location *	CR
Category	Earthen Levee			GPS Latitude/Longitude	
				Start	End
Item	Repair Gates			38.293008 °	38.293008 °
				-121.723457 °	-121.723457 °
DWR ID	DWR_RD2098_02_s_2015_19				
Action/Comments					
Inspector Comments: Repair the broken gate.

View of the broken gate hinge.

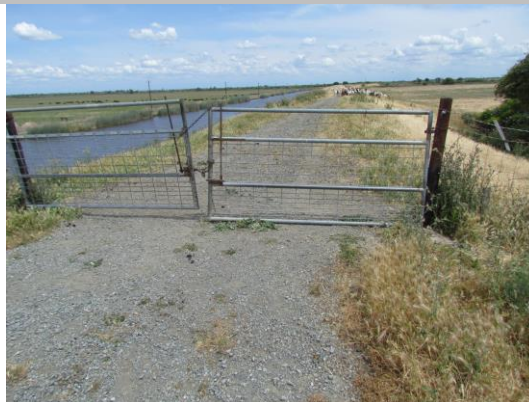
Photo 2 of 2 : SP\_2015\_RD2098\_246\_19\_20150604\_00007.jpg

View of the broken gate crossing levee crown.

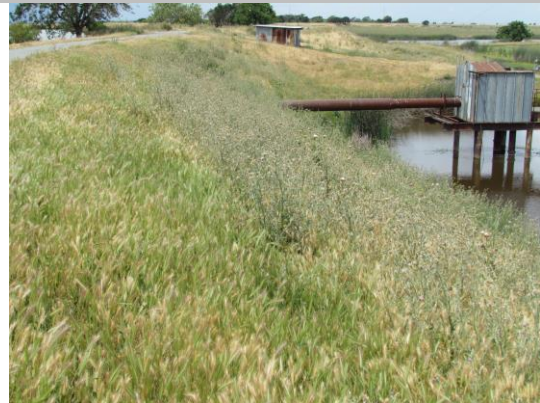
Photo 1 of 1 : SP\_2015\_RD2098\_247\_8\_20150604\_00007.jpg

LM Start	7.22	Rating **	U	Issue No.	8
LM End	7.77	Issue Type +	Ma	Location *	LS
Category	Earthen Levee			GPS Latitude/Longitude	
				Start	End
Item	Vegetation			38.293483 °	38.300218 °
				-121.724547 °	-121.728303 °
DWR ID	DWR_RD2098_03_s_2015_8				
Action/Comments					
Remove the wild growth other than native grasses from the levee slopes.					
Inspector Comments: Remove the tall weeds from the landside slope.

View of unacceptable tall weeds on the landside levee slope.

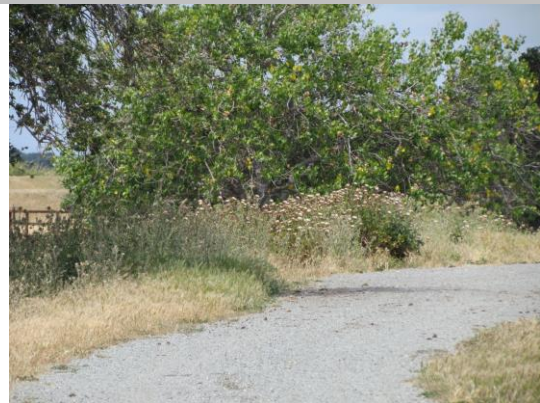
Photo 1 of 1 : SP\_2015\_RD2098\_247\_10\_20150604\_00008.jpg

LM Start	7.25	Rating **	U	Issue No.	10
LM End	7.60	Issue Type +	Ma	Location *	WS
Category	Earthen Levee			GPS Latitude/Longitude	
				Start	End
Item	Vegetation			38.293902 °	38.297882 °
				-121.724890 °	-121.728647 °
DWR ID	DWR_RD2098_03_s_2015_10				
Action/Comments					
Remove the wild growth other than native grasses from the levee slopes.					
Inspector Comments: Remove the unacceptable tall weeds from the waterside slope.

View of unacceptable tall weeds on the waterside levee shoulder and slope.

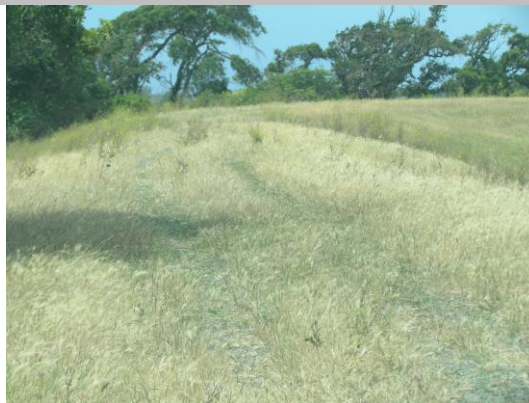
Photo 1 of 1 : SP\_2015\_RD2098\_247\_19\_20150604\_00009.jpg

LM Start	8.46	Rating **	U	Issue No.	19
LM End	8.69	Issue Type +	Ma	Location *	CR
Category	Earthen Levee			GPS Latitude/Longitude	
				Start	End
Item	Vegetation			38.308293 °	38.311033 °
				-121.732993 °	-121.734652 °
DWR ID	DWR_RD2098_03_s _ 2015_19				
Action/Comments					
Keep the crown roadway free of vegetation.					
Inspector Comments: Control the weeds off the crown roadway.

View of unacceptable weeds on the crown roadway.

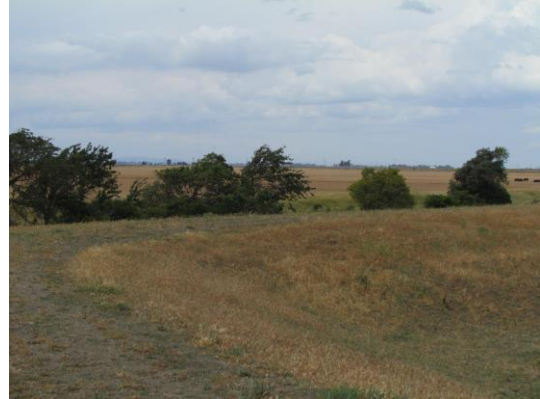
Photo 1 of 1 : SP\_2015\_RD2098\_248\_4\_20150604\_00002.jpg

LM Start	9.15	Rating **	M	Issue No.	4
LM End	9.15	Issue Type +	Ma	Location *	LS
Category	Earthen Levee			GPS Latitude/Longitude	
				Start	End
Item	Vegetation			38.316167 °	38.316167 °
				-121.740120 °	-121.740115 °
DWR ID	DWR_RD2098_04_s _ 2014_4				
Action/Comments					
Remove the wild growth other than native grasses from the levee slopes.

View looking downstream along the landside slope.

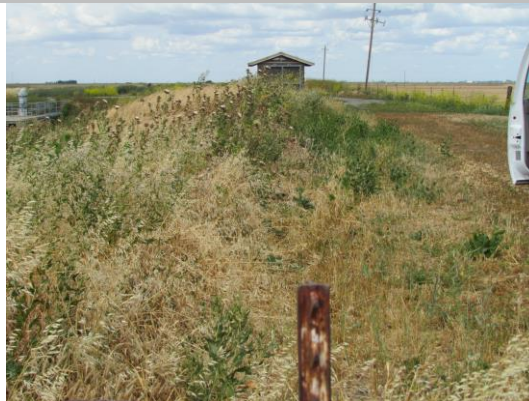
Photo 1 of 1 : SP\_2015\_RD2098\_248\_12\_20150604\_00003.jpg

LM Start	9.77	Rating **	U	Issue No.	12
LM End	9.78	Issue Type +	Ma	Location *	WS
Category	Earthen Levee			GPS Latitude/Longitude	
				Start	End
Item	Vegetation			38.325062 °	38.325265 °
				-121.740128 °	-121.740100 °
DWR ID	DWR_RD2098_04_s_2015_12				
Action/Comments					
Control annual grass and weeds on the levee slopes and easements. Inspector Comments: Remove the unacceptable vegetation.

View of unacceptable tall weeds on the waterside levee slope.
