**Flood Control Project Maintenance
Levee Inspections**

Maintenance Issue Types Only, Levee Inspection Report By Mile - Spring 2016

Reclamation District No. 2098 Cache and Haas Slough

Waterway	Bank	Unit Miles	Inspection Start/End	Inspector
Unit No. 01 Yolo Bypass	Right	3.60	04/06/2016 04/06/2016	Herman Phillips

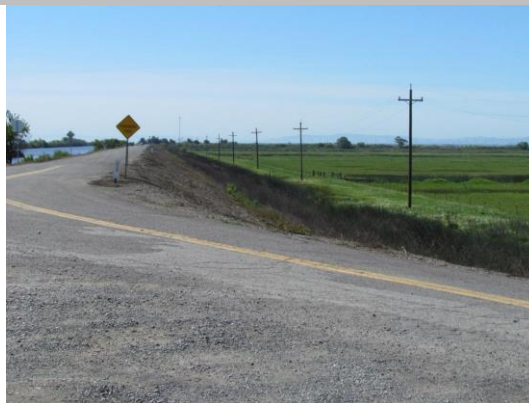
Photo 1 of 1 : SP_2016_RD2098_244_12_20160511_00024.jpg

LM Start	0.02	Rating **	A	Issue No.	12
LM End	3.60	Issue Type +	Ma	Location *	LS
Category	Earthen Levee			GPS Latitude/Longitude	
				Start	End
Item	Vegetation			38.328818 °	38.277379 °
				-121.694102 °	-121.696292 °
DWR ID	DWR_RD2098_01_s_2016_12				
Comment Code					
V1 : Control annual grass and weeds on the levee slopes and easements.					
Inspector Comment					
No unwanted weeds on the landside slope from levee mile 0.02-3.60.

Looking downstream from levee mile 0.02-3.60 Unit 1 RD 2098.

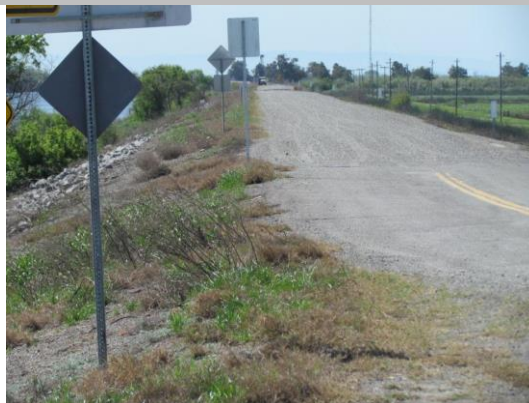
Photo 1 of 1 : SP_2016_RD2098_244_13_20160511_00023.jpg

LM Start	0.02	Rating **	M	Issue No.	13
LM End	3.60	Issue Type +	Ma	Location *	WS
Category	Earthen Levee			GPS Latitude/Longitude	
				Start	End
Item	Vegetation			38.328818 °	38.277379 °
				-121.694102 °	-121.696292 °
DWR ID	DWR_RD2098_01_s_2016_13				
Comment Code					
V1 : Control annual grass and weeds on the levee slopes and easements.					
Inspector Comment					
Some scattered weeds present on the waterside slope.

RD 2098 Looking downstream from levee mile 0.02 -3.60 waterside levee slope.

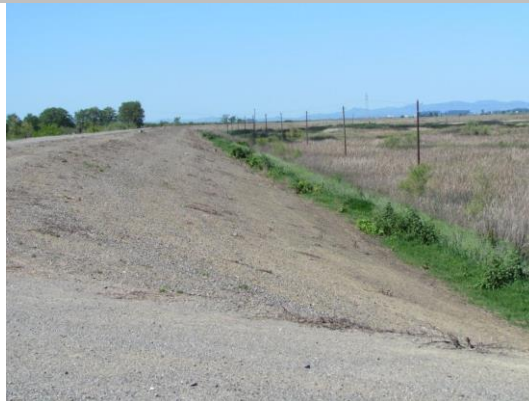
Photo 1 of 1 : SP_2016_RD2098_245_2_20160511_00003.jpg

LM Start	0.00	Rating **	A/W	Issue No.	2
LM End	0.52	Issue Type +	Ma	Location *	LS
Category	Earthen Levee			GPS Latitude/Longitude	
				Start	End
Item	Vegetation			38.277392 °	38.275692 °
				-121.696303 °	-121.705667 °
DWR ID	DWR_RD2098_01A_f_2015_2				
Comment Code					
V1 : Control annual grass and weeds on the levee slopes and easements.					
Inspector Comment					
Slopes are maintained.

RD 2098 Unit 1A looking downstream of the landside slope levee mile 0.52.

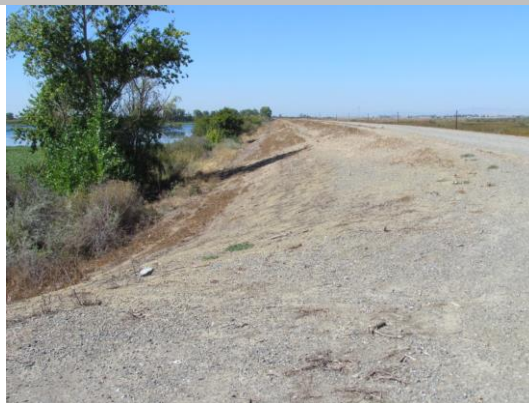
Photo 1 of 1 : SP_2016_RD2098_245_3_20160223_00002.jpg

LM Start	0.00	Rating **	A/W	Issue No.	3
LM End	0.52	Issue Type +	Ma	Location *	WS
Category	Earthen Levee			GPS Latitude/Longitude	
				Start	End
Item	Vegetation			38.277392 °	38.275692 °
				-121.696303 °	-121.705667 °
DWR ID	DWR_RD2098_01A_f_2015_3				
Comment Code					
V1 : Control annual grass and weeds on the levee slopes and easements.					
Inspector Comment					
Grasses maintained on water ward levee slope. No new picture.

RD 2098 Unit 1A looking downstream from the waterside slope. No new picture.

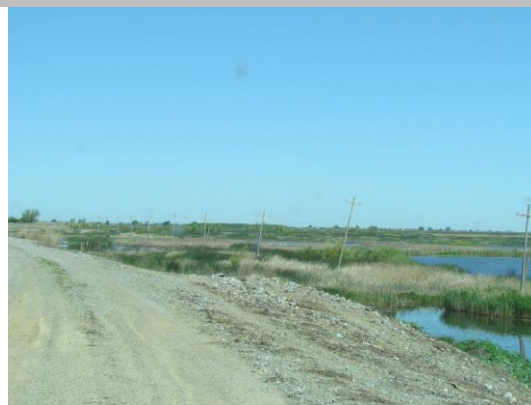
Photo 1 of 1 : SP_2016_RD2098_246_9_20160511_00018.jpg

LM Start	5.32	Rating **	A	Issue No.	9
LM End	6.73	Issue Type +	Ma	Location *	LS
Category	Earthen Levee			GPS Latitude/Longitude	
				Start	End
Item	Vegetation			38.276103 °	38.292367 °
				-121.706043 °	-121.715987 °
DWR ID	DWR_RD2098_02_s_2016_9				
Comment Code					
V1 : Control annual grass and weeds on the levee slopes and easements.					
Inspector Comment					
This section of levee has no unwanted vegetation.

RD 2098 Unit 2 looking downstream from levee mile 5.32.

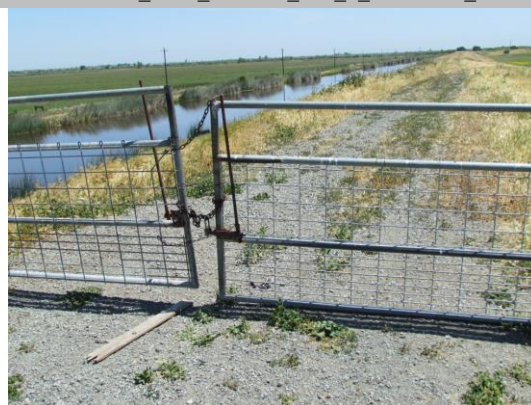
Photo 1 of 1 : SP_2016_RD2098_246_4_20160223_00001.jpg

LM Start	6.51	Rating **	U	Issue No.	4
LM End	6.51	Issue Type +	Ma	Location *	CR
Category	Earthen Levee			GPS Latitude/Longitude	
				Start	End
Item	Repair Gates			38.289452 °	38.289452 °
				-121.716814 °	-121.716814 °
DWR ID	DWR_RD2098_02_f_2013_4				
Comment Code					
Inspector Comment					
This gate is damaged and requires replacement.

This gate has no hinges. No new photo; no repairs done.

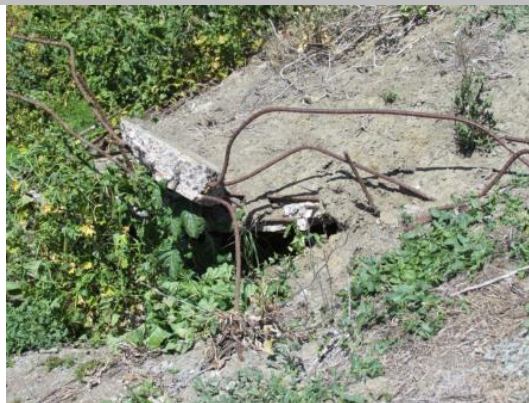
Photo 1 of 1 : SP_2016_RD2098_246_10_20160223_00002.jpg

LM Start	6.70	Rating **	M	Issue No.	10
LM End	6.70	Issue Type +	Ma	Location *	WS
Category	Earthen Levee			GPS Latitude/Longitude	
				Start	End
Item	Slope Stability			38.292076 °	38.292076 °
				-121.715792 °	-121.715792 °
DWR ID	DWR_RD2098_02_s_2014_10				
Comment Code					
S1 : Repair slope instability.					
Inspector Comment					
RD 2098 will send out crew to inspect site and make repairs as needed.

There is some slope damage at this location under this concrete. No new photo; RD will send crew out to check area out.

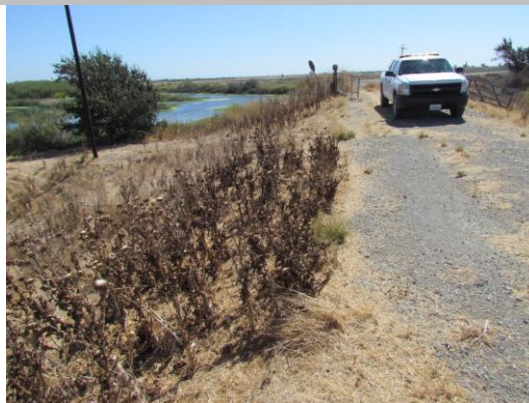
Photo 1 of 1 : SP_2016_RD2098_246_13_20160223_00003.jpg

LM Start	6.73	Rating **	M	Issue No.	13	
LM End	6.74	Issue Type +	Ma	Location *	LS	
Category	Earthen Levee			GPS Latitude/Longitude		
				Start		End
Item	Vegetation			38.292358 °		38.292500 °
				-121.716040 °		-121.716140 °
DWR ID	DWR_RD2098_02_f_2015_13					
Comment Code						
V1 : Control annual grass and weeds on the levee slopes and easements.						
Inspector Comment						
Tall star thistle on the landside slope.

Unsatisfactory tall weeds on the landside shoulder and slope.

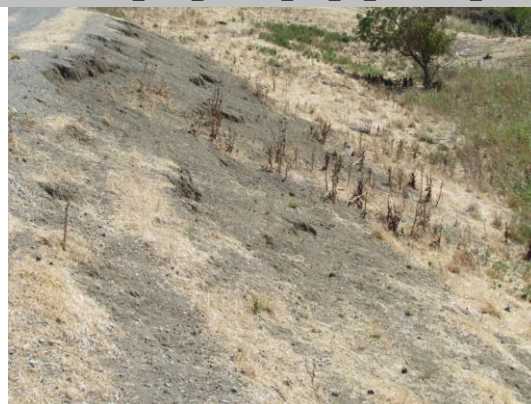
Photo 1 of 1 : SP_2016_RD2098_246_15_20160223_00004.jpg

LM Start	6.78	Rating **	M	Issue No.	15
LM End	6.80	Issue Type +	Ma	Location *	WS
Category	Earthen Levee			GPS Latitude/Longitude	
				Start	End
Item	Erosion / Bank Caving			38.292838 °	38.292917 °
				-121.716733 °	-121.717160 °
DWR ID	DWR_RD2098_02_f_2015_15				
Comment Code					
E1 : Note and monitor erosion site.					
Inspector Comment					
Need to add material to the damaged slope caused by goats.

Slope damage caused by goats.

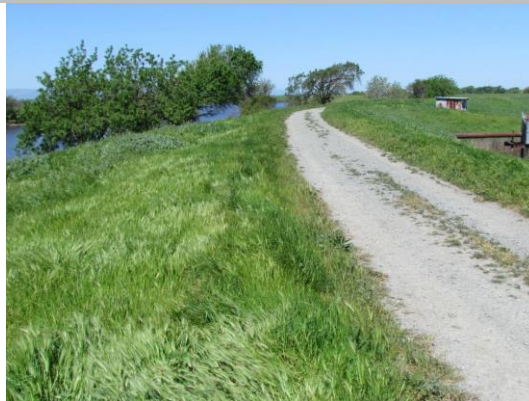
Photo 1 of 1 : SP_2016_RD2098_247_15_20160511_00009.jpg

LM Start	7.19	Rating **	U	Issue No.	15
LM End	7.43	Issue Type +	Ma	Location *	WS
Category	Earthen Levee			GPS Latitude/Longitude	
				Start	End
Item	Vegetation			38.293208 °	38.296043 °
				-121.724258 °	-121.726530 °
DWR ID	DWR_RD2098_03_s_2016_15				
Comment Code					
V1 : Control annual grass and weeds on the levee slopes and easements.					
Inspector Comment					
Spray or mow the tall weeds from the waterside levee slope.

RD 2098 Unit 3 levee mile 7.19-7.43 looking downstream tall weeds covering the waterside levee slope.

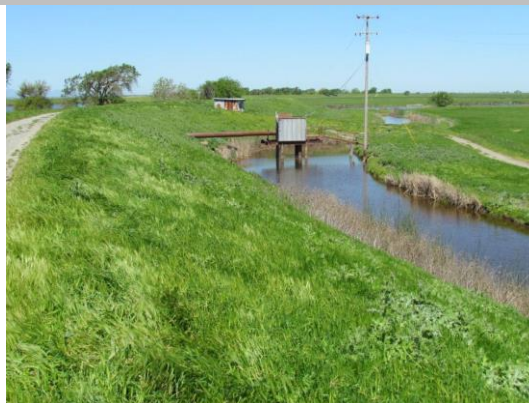
Photo 1 of 1 : SP_2016_RD2098_247_14_20160511_00010.jpg

LM Start	7.19	Rating **	U	Issue No.	14
LM End	7.44	Issue Type +	Ma	Location *	LS
Category	Earthen Levee			GPS Latitude/Longitude	
				Start	End
Item	Vegetation			38.293208 °	38.296122 °
				-121.724258 °	-121.726648 °
DWR ID	DWR_RD2098_03_s_2016_14				
Comment Code					
V1 : Control annual grass and weeds on the levee slopes and easements.					
Inspector Comment					
Spray or mow the landside levee slope.

Looking downstream from the landside levee mile 7.19-7.44 tall weeds covering the levee slope.

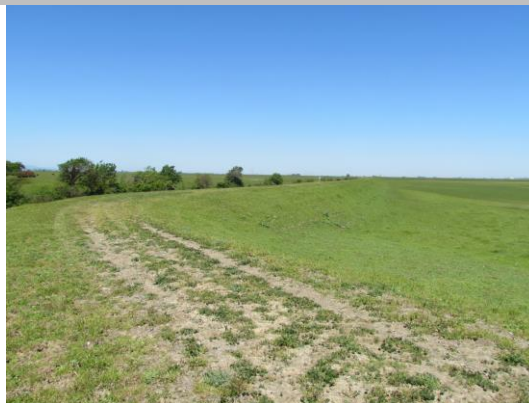
Photo 1 of 1 : SP_2016_RD2098_248_13_20160512_00020.jpg

LM Start	9.12	Rating **	A/W	Issue No.	13
LM End	9.84	Issue Type +	Ma	Location *	LS
Category	Earthen Levee			GPS Latitude/Longitude	
				Start	End
Item	Vegetation			38.315787 °	38.325830 °
				-121.739888 °	-121.740655 °
DWR ID	DWR_RD2098_04_s_2016_13				
Comment Code					
V1 : Control annual grass and weeds on the levee slopes and easements.					
Inspector Comment					
No unwanted growth on the levee slopes, both landside and waterside.

Looking downstream from levee mile 9.12 Unit 4 (Back Levee) RD 2098.
The vegetation on both slopes is acceptable.
