**Flood Control Project Maintenance  
Levee Inspections**

## Maintenance Issue Types Only, Levee Inspection Report By Mile - Spring 2017

### Reclamation District No. 2098 Cache and Haas Slough

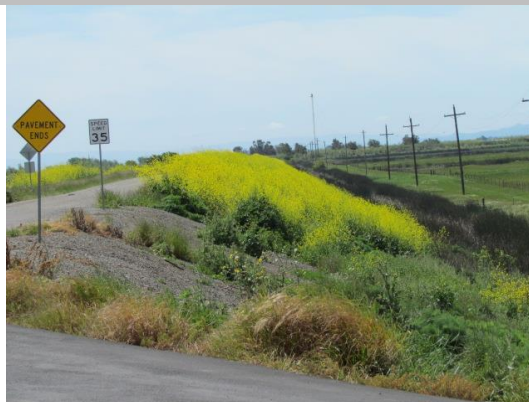
Photo 1 of 1 : SP\_2017\_RD2098\_244\_11\_20170523\_00022.jpg

RD 2098 Unit 1 landside looking upstream from the landside shoulder tall unwanted mustard grass and other vegetation present on the levee slope.

| V2 : Remove the wild growth other than native grasses from the levee slopes. | | | | | |
| Remove the wild growth other than annual grasses from the levee slope. | | | | | |

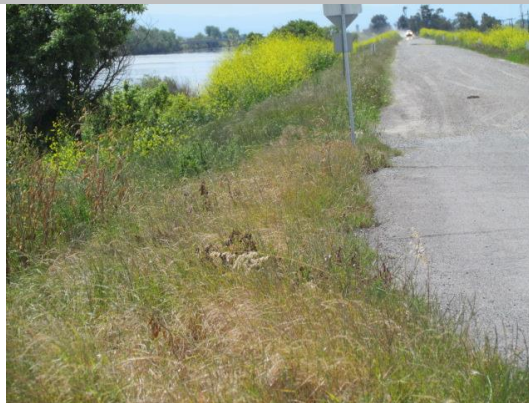
Photo 1 of 1 : SP\_2017\_RD2098\_244\_12\_20170523\_00023.jpg

RD 2098 Unit 1 looking upstream from the waterside levee slope levee mile 0.03-3.58, tall unwanted mustard and weeds growth covering the levee slope.

| V2 : Remove the wild growth other than native grasses from the levee slopes. | | | | | |

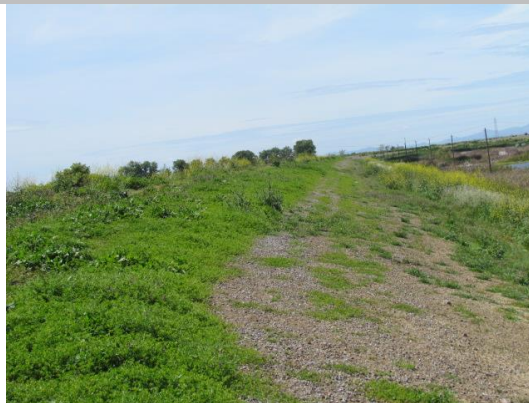
Photo 1 of 1 : SP\_2017\_RD2098\_245\_1\_20170523\_00002.jpg

RD 2098 1A Looking upstream from levee mile 0.00-0.52 landside slope.

| Remove the wild grasses other than native from the levee slope. | | | | | |

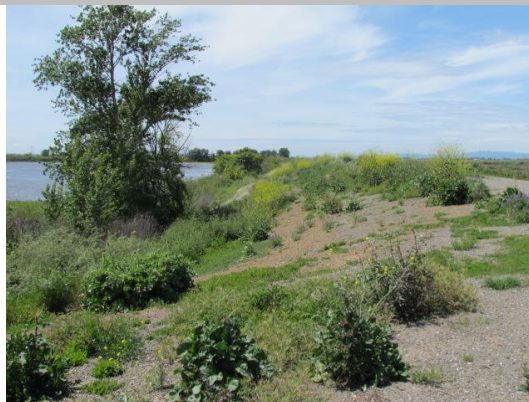
Photo 1 of 1 : SP\_2017\_RD2098\_245\_2\_20170523\_00001.jpg

RD 2098 Unit 1A looking upstream from the waterside slope.

| Remove the wild grasses other than native from the levee section. | | | | | |

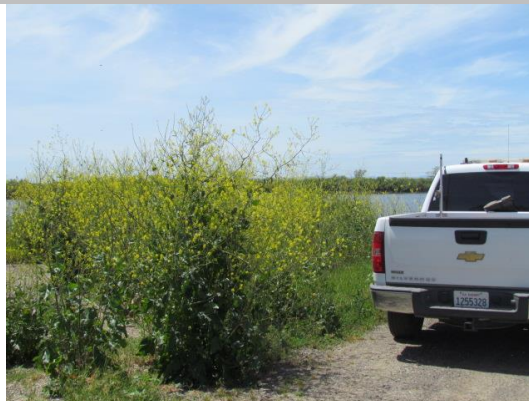
Photo 1 of 1 : SP\_2017\_RD2098\_245\_3\_20170523\_00003.jpg

RD 2098 1A Levee mile 0.52 crown roadway. Unwanted tall weeds present on the crown roadway.

| Keep the crown roadway free of vegetation. | | | | | |

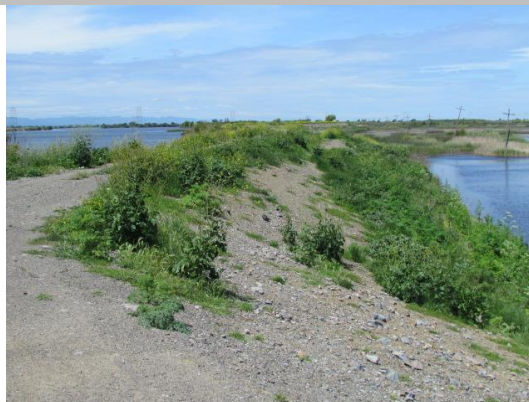
Photo 1 of 1 : SP\_2017\_RD2098\_246\_8\_20170523\_00028.jpg

RD 2098 Unit 2 Levee mile 5.30-7.14 wild growth on the landside slope.

| Remove the wild weed growth from the landside levee slope and berm. | | | | | |

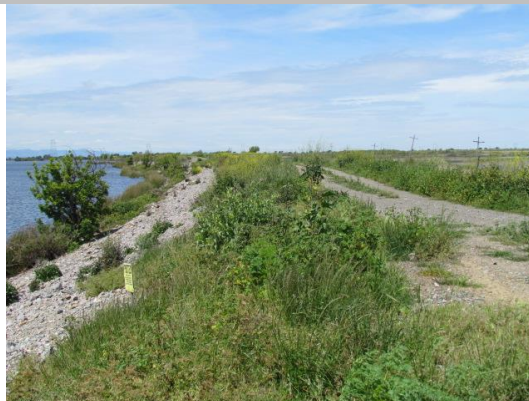
Photo 1 of 1 : SP\_2017\_RD2098\_246\_9\_20170523\_00029.jpg

RD 2098 Unit 2 levee mile 5.30- 7.14 waterside levee slope and shoulder.

| Remove the wild weed growth from the waterside levee slope. | | | | | |

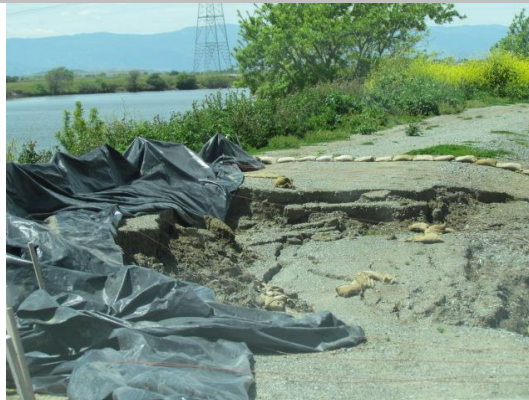
Photo 1 of 3 : SP\_2017\_RD2098\_246\_26\_20170523\_00031.jpg

RD 2098 LEVEE MILE 6.03 MAJOR CROWN/SLOPE DAMAGE.

| S1 : Repair slope instability. | | | | | |
| Repair the levee damage. | | | | | |

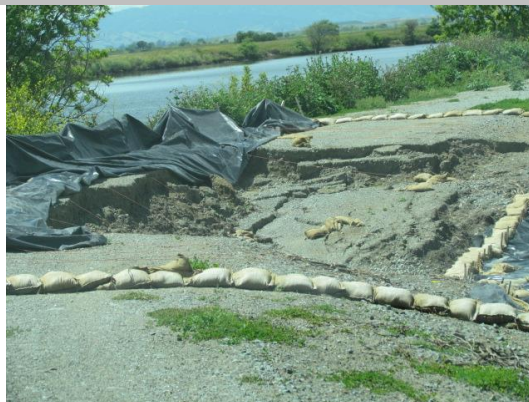
Photo 2 of 3 : SP\_2017\_RD2098\_246\_26\_20170523\_00032.jpg

RD 2098 Levee damage crown roadway and landside slope damage.

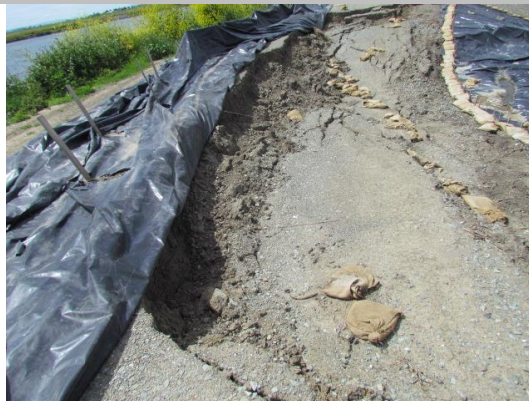
Photo 3 of 3 : SP\_2017\_RD2098\_246\_26\_20170523\_00033.jpg

Close up of damage.

| S1 : Repair slope instability. | | | | | | |
| Repair the levee damage. | | | | | | |

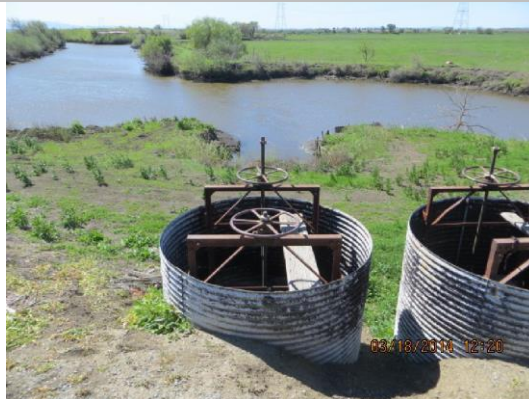
Photo 1 of 3 : UCIP\_SP\_2017\_33784\_61162.jpg

| FS_ID:33784<br>DS_ID:20976<br>EP_NO: 10172<br>Repair Type: Non-Urgent<br>Crossing Status: Found<br>UCIP Comments: Headwalls on WS toe failing at outlet. It is unclear if these were permanent installations or something that was installed as a temporary fix.<br>FIELD_STRUCT_DESC: 1 of 2: 48-inch CM drainpipe through the levee, 29.0 feet below the crown. Two slide gates in 7-foot diameter CMP riser on waterward slope. (USACE-1962). This entry matches the Drainage or Irrigation Structure referenced in O&M manual (HLM 6.75). This pipe was retained under ABO No. 10172 (1974).<br>FS Date: 3/18/2014 | | | | | |

Two slide gates in 7-foot diameter CMP riser on waterward slope.

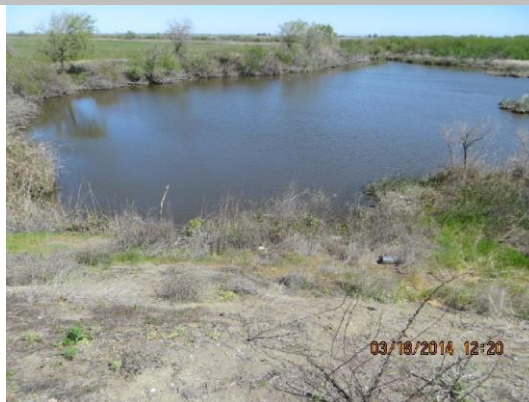
Photo 2 of 3 : UCIP\_SP\_2017\_33784\_61161.jpg

Inlet not visible on LS toe.

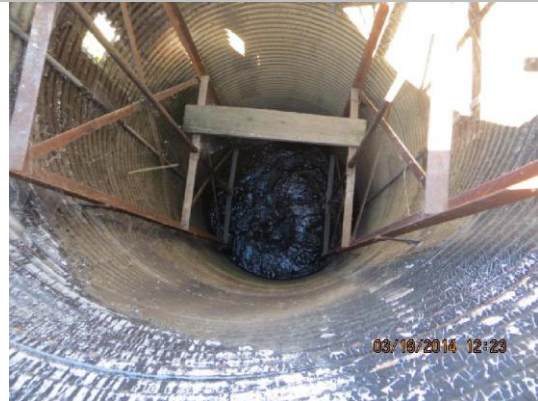
Photo 3 of 3 : UCIP\_SP\_2017\_33784\_61160.jpg

| FS_ID:33784<br>DS_ID:20976<br>EP_NO: 10172<br>Repair Type: Non-Urgent<br>Crossing Status: Found<br>UCIP Comments: Headwalls on WS toe failing at outlet. It is unclear if these were permanent installations or something that was installed as a temporary fix.<br>FIELD_STRUCT_DESC: 1 of 2: 48-inch CM drainpipe through the levee, 29.0 feet below the crown. Two slide gates in 7-foot diameter CMP riser on waterward slope. (USACE-1962). This entry matches the Drainage or Irrigation Structure referenced in O&M manual (HLM 6.75). This pipe was retained under ABO No. 10172 (1974).<br>FS Date: 3/18/2014 | | | | | |

View inside CMP riser on WS shoulder.

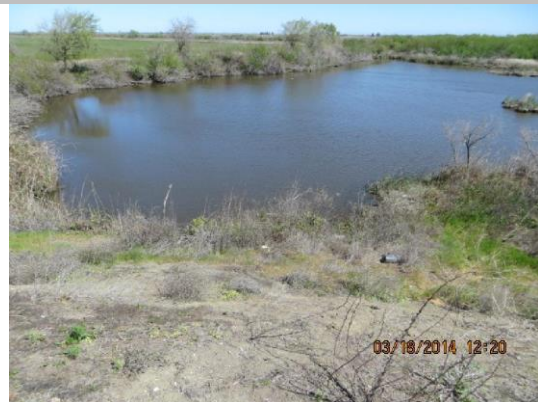
Photo 1 of 3 : UCIP\_SP\_2017\_32285\_58749.jpg

| FS_ID:32285<br>DS_ID:20961<br>EP_NO: 10172<br>Repair Type: Non-Urgent<br>Crossing Status: Found<br>UCIP Comments: Headwalls at WS toe failing. It is uncertain if these retaining walls were a permanent fixture or a temporary fix that failed.<br>FIELD_STRUCT_DESC: 2 of 2: 48-inch CM drainpipe through the levee, 29.0 feet below the crown. Two slidegates in a 7-foot diameter CMP riser on WS shoulder (USACE-1962). This entry matches the Drainage or Irrigation Structure referenced in O&M manual (HLM 6.75). This pipe was retained under ABO No. 10172 (1974).<br>FS Date: 3/18/2014 | | | | | |

Inlet not visible on LS toe.

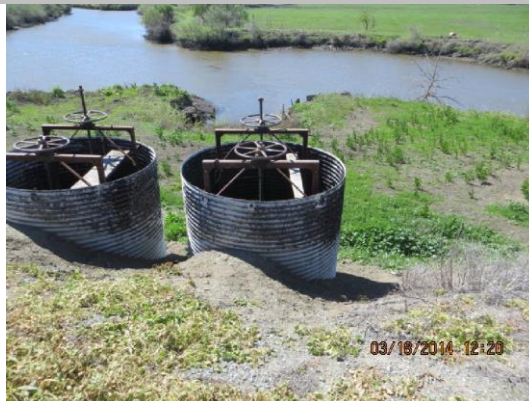
Photo 2 of 3 : UCIP\_SP\_2017\_32285\_58748.jpg

| FS_ID:32285<br>DS_ID:20961<br>EP_NO: 10172<br>Repair Type: Non-Urgent<br>Crossing Status: Found<br>UCIP Comments: Headwalls at WS toe failing. It is uncertain if these retaining walls were a permanent fixture or a temporary fix that failed.<br>FIELD_STRUCT_DESC: 2 of 2: 48-inch CM drainpipe through the levee, 29.0 feet below the crown. Two slidegates in a 7-foot diameter CMP riser on WS shoulder (USACE-1962). This entry matches the Drainage or Irrigation Structure referenced in O&M manual (HLM 6.75). This pipe was retained under ABO No. 10172 (1974).<br>FS Date: 3/18/2014 | | | | | | |

7-foot diameter CMP riser with two slide gates inside.

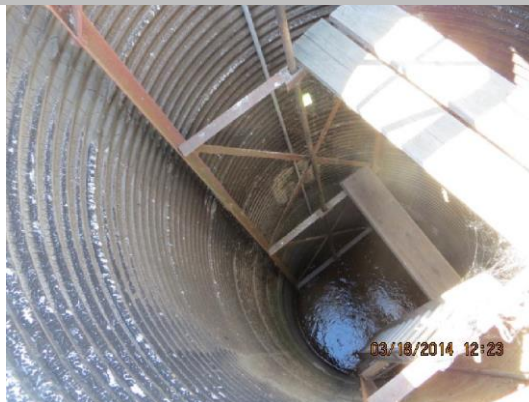
Photo 3 of 3 : UCIP\_SP\_2017\_32285\_58747.jpg

7-foot diameter CMP riser with two slide gates inside.

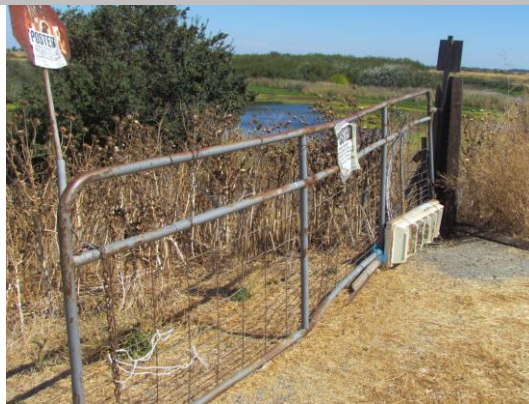
Photo 1 of 1 : SP\_2017\_RD2098\_246\_16\_20170404\_00010.jpg

Levee mile 6.74 crown roadway gate crossing.

| Repair this gate that has been damaged. | | | | | |

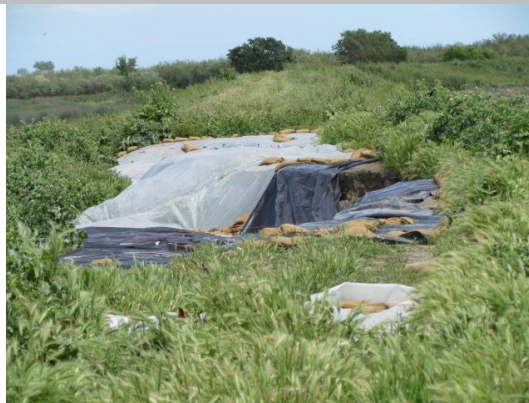
Photo 1 of 1 : SP\_2017\_RD2098\_246\_11\_20170523\_00030.jpg

| Major damage to levee section, no vehicle passage, repairs are needed. | | | | | |

RD 2098 Levee mile 7.12 major levee damage crown roadway and landside slope.

| E2 : Schedule repair of erosion site prior to the next inspection. | | | | | |

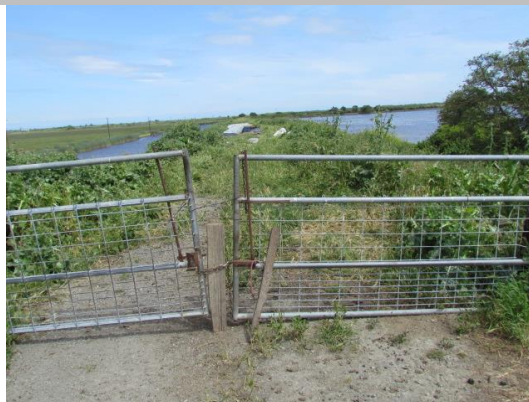
Photo 1 of 1 : SP\_2017\_RD2098\_246\_5\_20170523\_00034.jpg

| Gate damage, make repairs to this gate. This gate could cause injury to someone. | | | | | |

RD 2098 Levee mile 7.14.

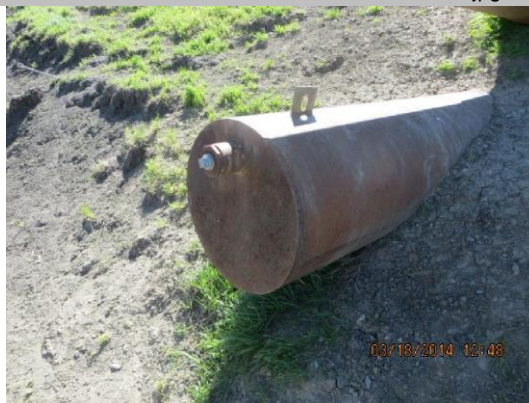
Photo 3 of 3 : UCIP\_SP\_2017\_32303\_58780.jpg

| FS_ID:32303<br>DS_ID:20978<br>EP_NO: 10171<br>Repair Type: No Action Needed<br>Crossing Status: Found<br>UCIP Comments:<br>FIELD_STRUCT_DESC: *ABANDONED* 24-inch steel pipe through the levee, 4.5 feet below the crown. CM cutoff wall around pipe. Pipe has welded steel plate over end on LS slope and is not visible on WS slope. This entry matches the Drainage or Irrigation Structure referenced in O&M manual (HLM 7.28). This pipe was retained under ABO No. 10171 (1974).<br>FS Date: 3/18/2014 7:07:14 AM | | | | | |

Welded steel cap over LS end of pipe.

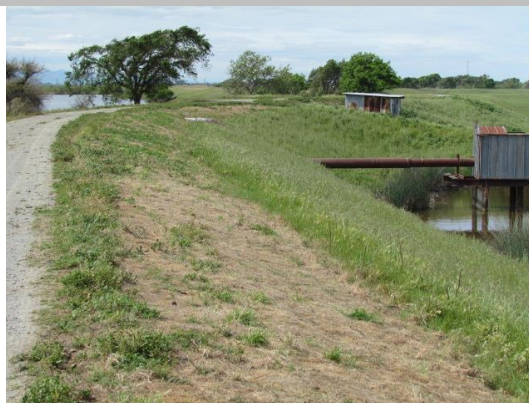
Photo 1 of 2 : SP\_2017\_RD2098\_247\_2\_20170523\_00011.jpg

RD 2098 Looking downstream from levee mile 7.19-7.31

| Remove the tall vegetation from the landside slope. | | | | | |

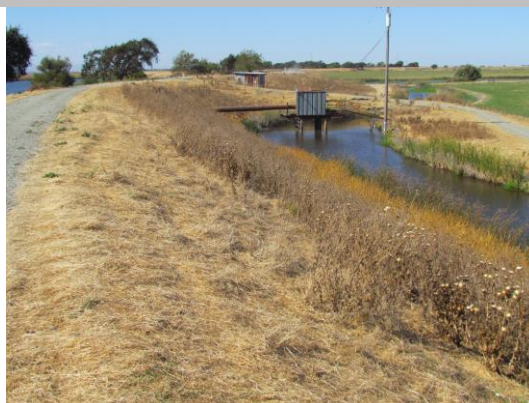
Photo 2 of 2 : SP\_2017\_RD2098\_247\_2\_20170404\_00004.jpg

RD 2098 Looking downstream from levee mile 7.19 landside slope.

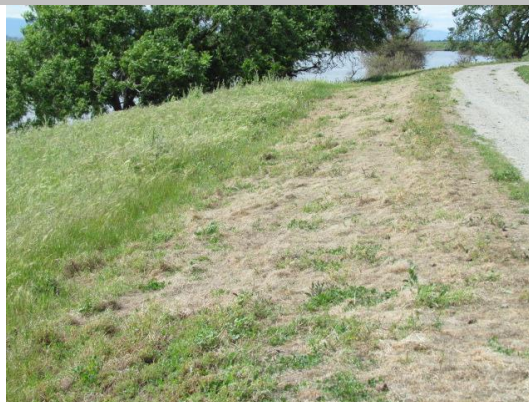
Photo 1 of 1 : SP\_2017\_RD2098\_247\_8\_20170523\_00012.jpg

RD 2098 Unit 3 levee mile 7.19-7.31 waterside slope.

| Remove the tall vegetation from the water side slope. | | | | | |

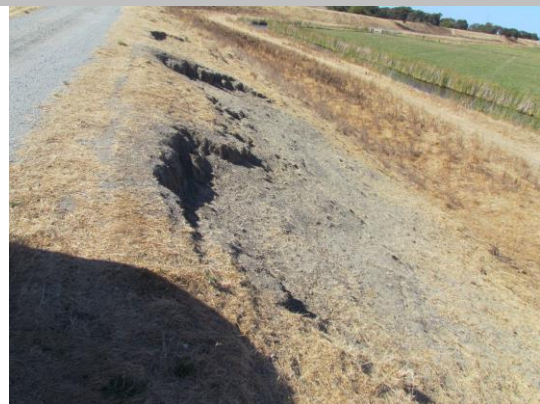
Photo 1 of 2 : SP\_2017\_RD2098\_247\_1\_20170404\_00002.jpg

Close up. Looking downstream.

| S2 : Repair the levee slope damaged by foot traffic and prevent access where possible. | | | | | |
| Make the repairs to the erosion site listed. | | | | | |

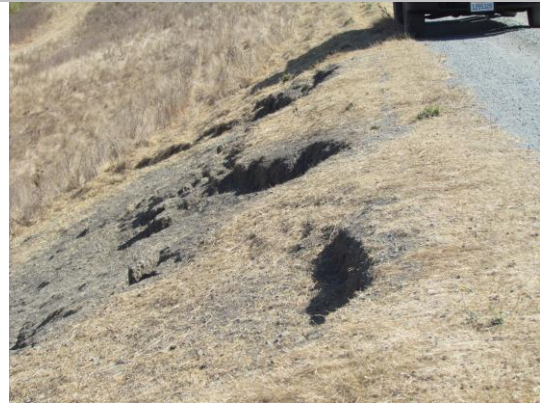
Photo 2 of 2 : SP\_2017\_RD2098\_247\_1\_20170404\_00003.jpg

Looking upstream.

| S2 : Repair the levee slope damaged by foot traffic and prevent access where possible. | | | | | | |
| Make the repairs to the erosion site listed. | | | | | | |

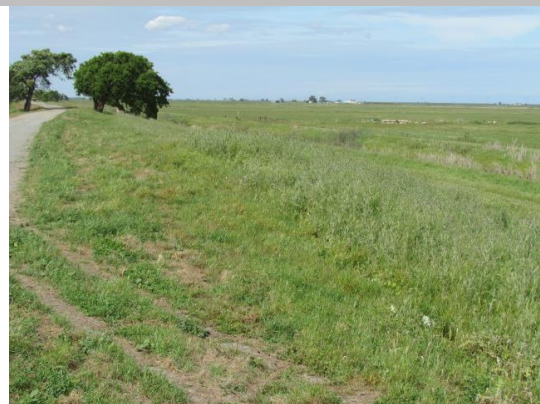
Photo 1 of 1 : SP\_2017\_RD2098\_247\_13\_20170523\_00013.jpg

RD 2098 Unit 3 levee mile 7.77-8.66 landside slope.

| Control annual grasses and weeds from the slope and berm. | | | | | |

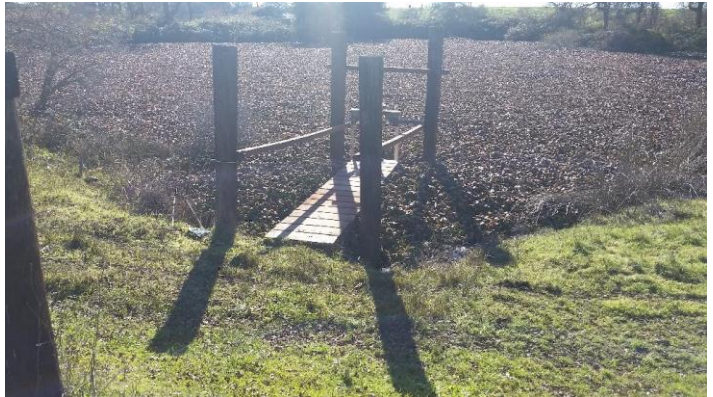
Photo 2 of 3 : UCIP\_SP\_2017\_51453\_76861.jpg

FS\_ID:51453  
DS\_ID:20981  
EP\_NO: 10174  
Repair Type: No Action Needed  
Crossing Status: Found  
UCIP Comments: 12/22/2016 Crossing has been downgraded from Urgent to No Action Needed walkways on both WS and LS have been rebuilt and the WS gate has been upgraded to stainless steel where previous corrodable material was present. (O. Magana - DWR UCIP)03/19/2014 Current walkway to slidegate on WS toe does not provide safe access to operate slidegate. (W. Wylie - DWR UCIP) FIELD\_STRUCT\_DESC: 36-inch steel dual purpose irrigation and drainage pipe through the levee, 26 feet below the crown. Two CM cutoff walls around pipe. Walkway to slide gate is located on the waterside (WS) end. Combination slide and flap gate located on the landside (LS) end. 48-inch corrugated metal pipe (CMP) riser and an adjoining pump on a metal pier at LS toe. (36-inch pipe authorized [HLM 8.20] under Automatic Board Order (ABO) issued as Permit No. 10174, 1974 - Bowsbey) [Additional Reference(s): DWR Levee Log, 2003. USACE Sacramento O&M Manual Unit 109, April 1962, (HLM 8.20)].

Walkway has been re-built, photo 2 of 2.

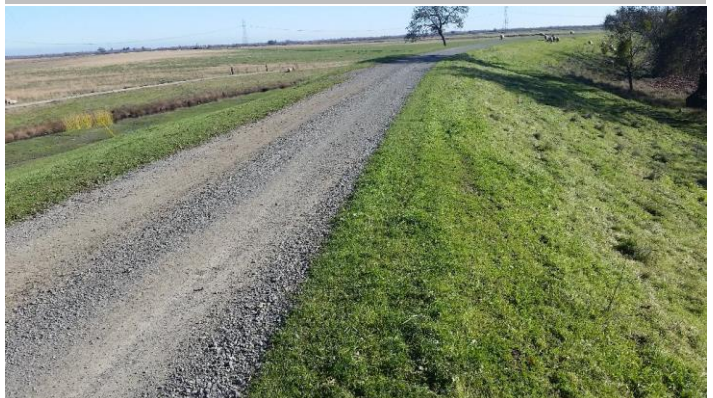
Photo 3 of 3 : UCIP\_SP\_2017\_51453\_76859.jpg

View of levee crown at pipe crossing.

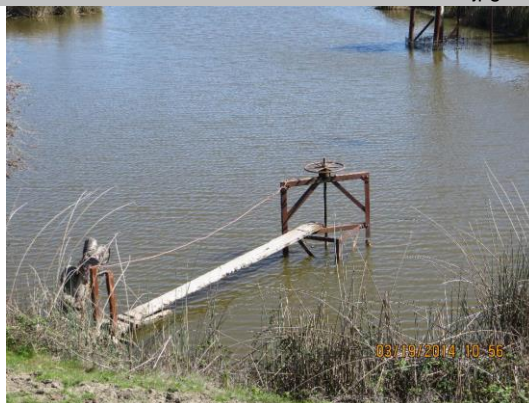
Photo 1 of 2 : UCIP\_SP\_2017\_32384\_58883.jpg

Slide gate at LS toe.

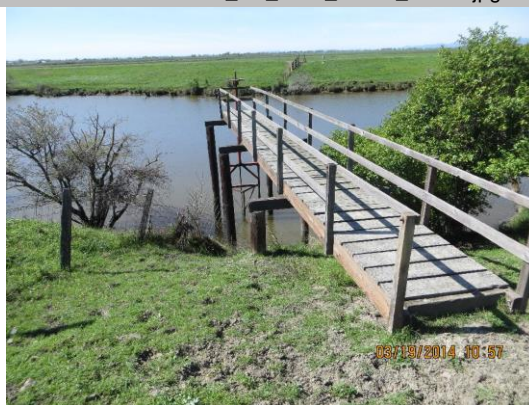
Photo 2 of 2 : UCIP\_SP\_2017\_32384\_58882.jpg

Walkway with slide gate on WS toe.

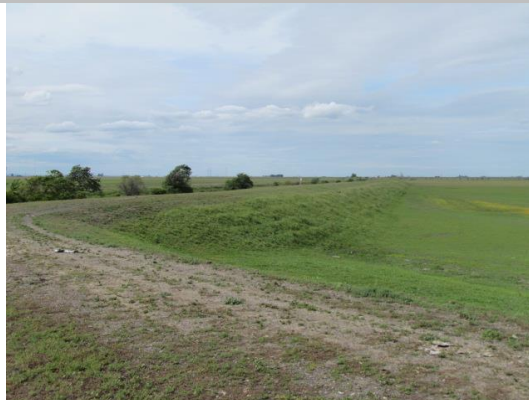
Photo 1 of 1 : SP\_2017\_RD2098\_248\_10\_20170523\_00019.jpg

RD 2098 Landside levee mile 9.17-12.06.

| Control the annual grasses and weeds on the landside levee slope. | | | | | |
