**Flood Control Project Maintenance  
Levee Inspections**

## Maintenance Issue Types Only, Levee Inspection Report By Mile - Spring 2018

### Reclamation District No. 2098 Cache and Haas Slough

Waterway	Bank	Unit Miles	Inspection Start/End	Inspector
Unit No. 01 Yolo Bypass	Right	3.60	03/15/2018 03/15/2018	Keith Millard

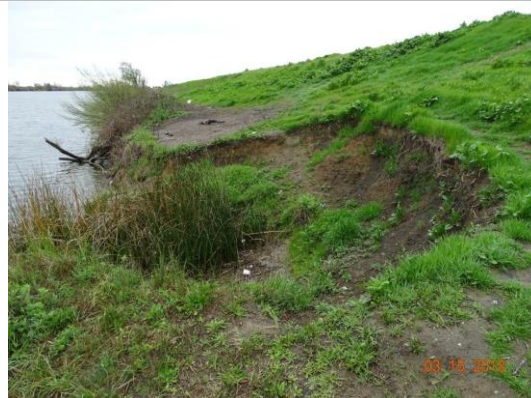
Photo 1 of 1 : SP\_2018\_RD2098\_244\_13\_20180315\_00087.jpg

LM Start	<b>0.57</b>	Rating **	M	Issue No.	<b>13</b>
LM End	<b>1.06</b>	Issue Type +	Ma	Location *	WS
Category	Earthen Levee		GPS Latitude/Longitude		
			Start	End	
Item	Erosion / Bank Caving		38.320755 °	38.313700 °	
			-121.693982 °	-121.693639 °	
DWR ID	DWR_RD2098_01_s_2017_13				
Comment Code					
E2 : Schedule repair of erosion site prior to the next inspection.					
Inspector Comment

Monitor and repair erosion on waterside.

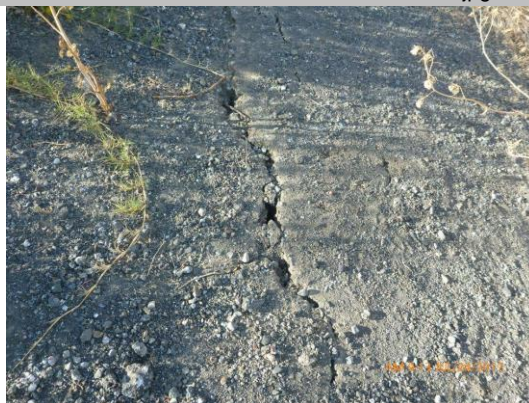
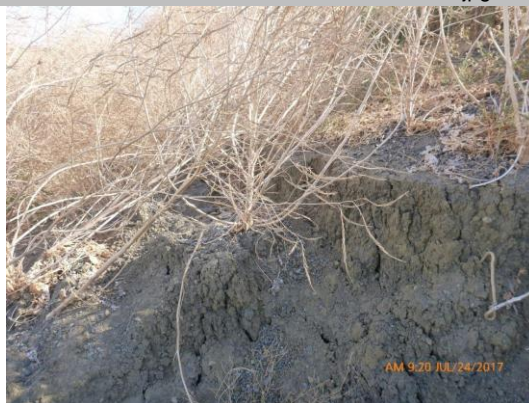
LM Start	<b>0.96</b>	Rating **	A/W	Issue No.	<b>19</b>
LM End	<b>0.96</b>	Issue Type +	Ma	Location *	
Category	Supplemental		GPS Latitude/Longitude		
			Start	End	
Item	2017 Storm Damage		38.315200 °	38.315100 °	
			-121.694100 °	-121.694100 °

Description: The damage consists of cracking and sloughing of the lower landside levee slope.

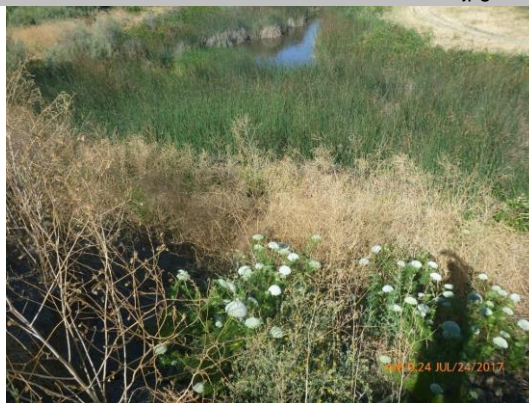
Photo 3 of 3 : LEVAL\_SP\_2018\_414\_3603.jpg

LM Start	0.96	Rating **	A/W	Issue No.	19 (cont)
LM End	0.96	Issue Type +	Ma	Location *	
Category	Supplemental			GPS Latitude/Longitude	
				Start	End
Item	2017 Storm Damage			38.315200 °	38.315100 °
				-121.694100 °	-121.694100 °
DWR ID	DWR_RD2098_01_s_2018_19				
Comment Code					
Inspector Comment					
Levee Evaluation Comments					
Description:The damage consists of cracking and sloughing of the lower landside levee slope.					
Site ID No:414					
Site Designation:LMA-241					
Repair Type: Erosion					
Rating:Area of Concern					
Field Date:7/24/2017					
Notes: Landside sloughing about 2' deep and extends to toe ditch.

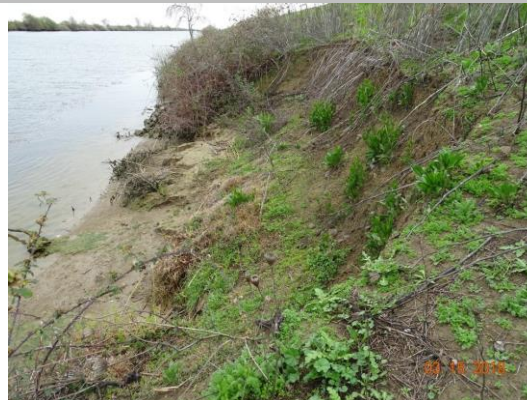
Photo 1 of 1 : SP\_2018\_RD2098\_244\_18\_20180315\_00089.jpg

LM Start	1.76	Rating **	M	Issue No.	18
LM End	1.76	Issue Type +	Ma	Location *	WS
Category	Earthen Levee			GPS Latitude/Longitude	
				Start	End
Item	Erosion / Bank Caving			38.303611 °	38.303611 °
				-121.693607 °	-121.693607 °
DWR ID	DWR_RD2098_01_s_2018_18				
Comment Code					
E2 : Schedule repair of erosion site prior to the next inspection.					
Inspector Comment

Monitor and repair erosion.

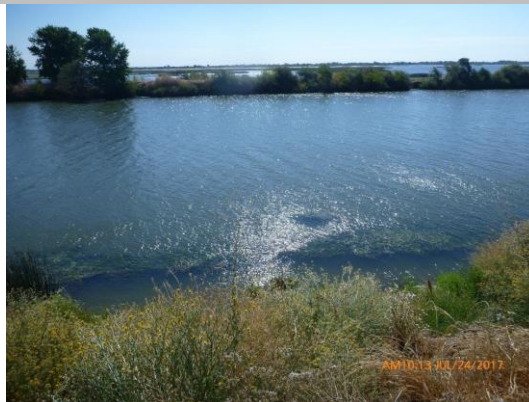
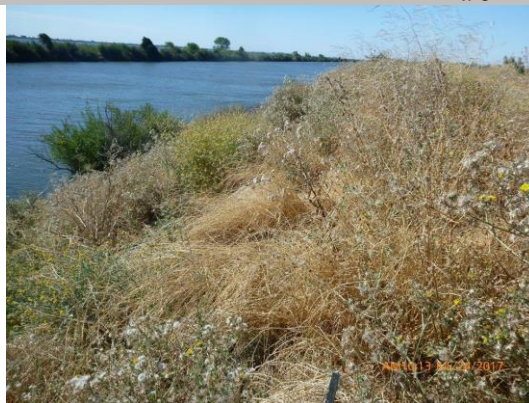
LM Start	2.21	Rating **	A/W	Issue No.	21
LM End	2.22	Issue Type +	Ma	Location *	
Category	Supplemental			GPS Latitude/Longitude	
				Start	End
Item	2017 Storm Damage			38.297100 °	38.297000 °
				-121.693300 °	-121.693300 °
DWR ID	DWR_RD2098_01_s_2018_21				
Comment Code					
Inspector Comment					
Levee Evaluation Comments					
Description: The damage consists of erosion, cracking, and sloughing of the waterside levee slope.					
Site ID No: 416					
Site Designation: LMA-243					
Repair Type: Erosion					
Rating: Serious					
Field Date: 7/24/2017					
Notes: Erosion with sloughing. About 2' vertical cut at top of erosion.

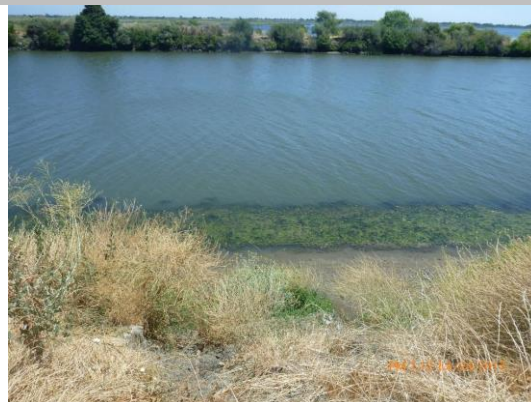
Photo 1 of 3 : SP\_2018\_RD2098\_244\_28\_20180305\_00021.jpg

LM Start	2.35	Rating **	M	Issue No.	28
LM End	2.39	Issue Type +	Ma	Location *	
Category	Supplemental			GPS Latitude/Longitude	
				Start	End
Item	2017 Storm Damage			38.295100 °	38.294500 °
				-121.693400 °	-121.693400 °
DWR ID	DWR_RD2098_01_f_2017_28				
Comment Code					
Inspector Comment					
Levee Evaluation Comments					
Description:The damage consists of scour, sloughing, and cracking of the lower and mid waterside levee slope.					
Site ID No:423					
Site Designation:LMA-250					
Repair Type: Erosion					
Rating:Area of Concern					
Field Date:7/24/2017					
Notes: 2' of sloughing about half way up the slope.

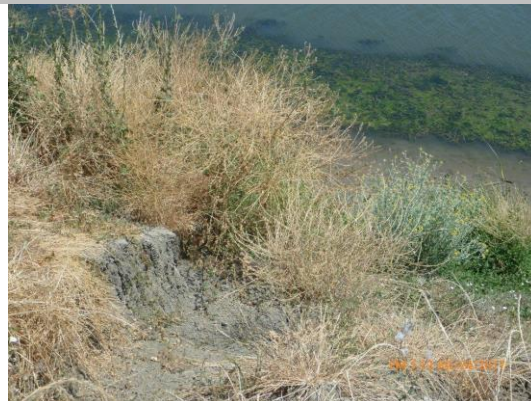
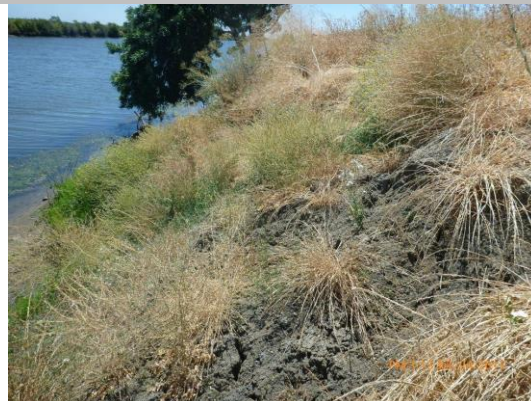
LM Start	2.35	Rating **	M	Issue No.	28 (cont)	
LM End	2.39	Issue Type +	Ma	Location *		
Category	Supplemental			GPS Latitude/Longitude		
				Start	End	
Item	2017 Storm Damage			38.295100 °	38.294500 °	
				-121.693400 °	-121.693400 °	
DWR ID	DWR_RD2098_01_f_2017_28					
Comment Code						
Inspector Comment						
Levee Evaluation Comments						
Description:The damage consists of scour, sloughing, and cracking of the lower and mid waterside levee slope.						
Site ID No:423						
Site Designation:LMA-250						
Repair Type: Erosion						
Rating:Area of Concern						
Field Date:7/24/2017						
Notes: 2' of sloughing about half way up the slope.

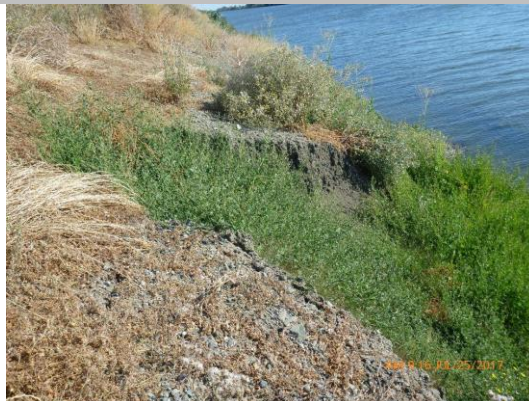
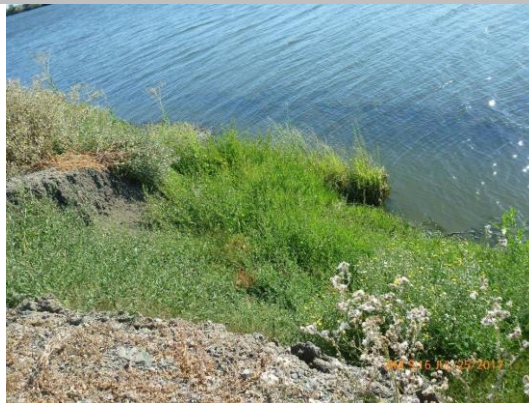
LM Start	2.75	Rating **	A/W	Issue No.	34
LM End	2.78	Issue Type +	Ma	Location *	
Category	Supplemental			GPS Latitude/Longitude	
				Start	End
Item	2017 Storm Damage			38.289200 °	38.288800 °
				-121.693500 °	-121.693500 °
DWR ID	DWR_RD2098_01_f_2017_34				
Comment Code					
Inspector Comment					
Levee Evaluation Comments					
Description:The damage consists of scour and sloughing of the waterside levee slope.					
Site ID No:429					
Site Designation:LMA-256					
Repair Type: Erosion					
Rating:Serious					
Field Date:7/25/2017					
Notes: Erosion at WS toe, causing sloughing half-way down WS slope.					
10/26/17: Dutra repairs in progress.

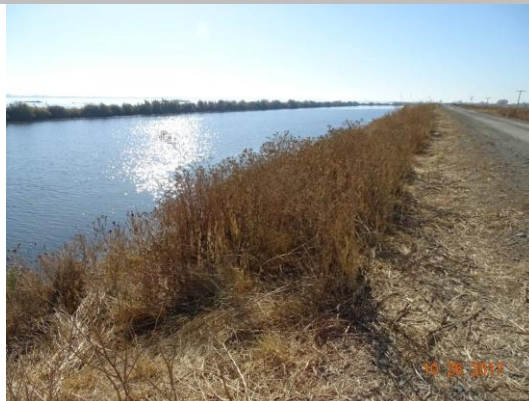
Photo 1 of 1 : SP\_2018\_RD2098\_244\_11\_20180305\_00001.jpg

Nearby construction operations forced termination of goat grazing.  
Vegetation should be cleared.

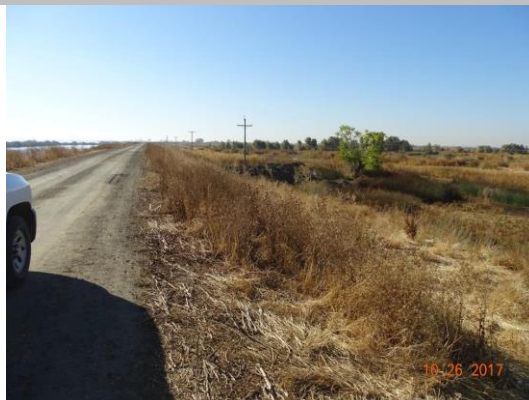
Photo 1 of 1 : SP\_2018\_RD2098\_244\_12\_20180305\_00002.jpg

Nearby construction operations forced termination of goat grazing.  
Vegetation should be cleared.

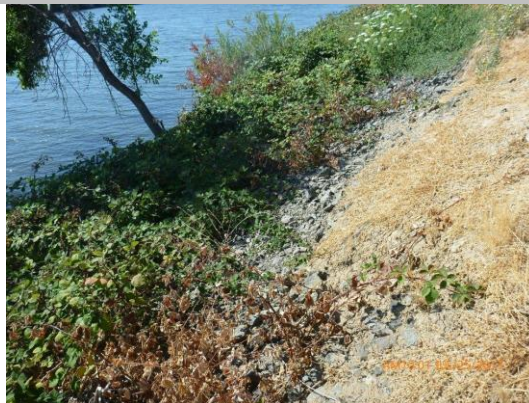
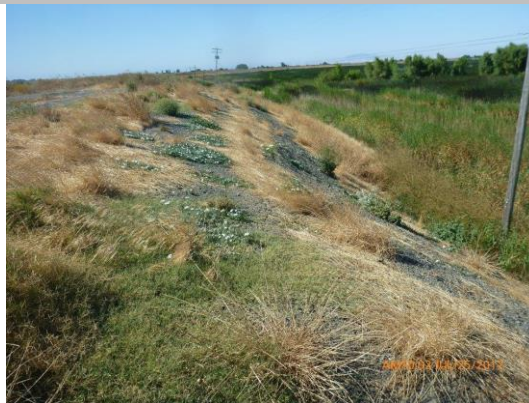
LM Start	2.91	Rating **	A/W	Issue No.	36
LM End	2.93	Issue Type +	Ma	Location *	
Category	Supplemental			GPS Latitude/Longitude	
				Start	End
Item	2017 Storm Damage			38.286900 °	38.286700 °
				-121.693500 °	-121.693500 °
DWR ID	DWR_RD2098_01_f_2017_36				
Comment Code					
Inspector Comment					
Levee Evaluation Comments					
Description:The damage consists of scour and sloughing of the waterside levee slope.					
Site ID No:431					
Site Designation:LMA-258					
Repair Type: Erosion					
Rating:Serious					
Field Date:7/25/2017					
Notes: Erosion of WS toe, resulting in 8' verticle wall. 10/26/17: Dutra repairs in progress.

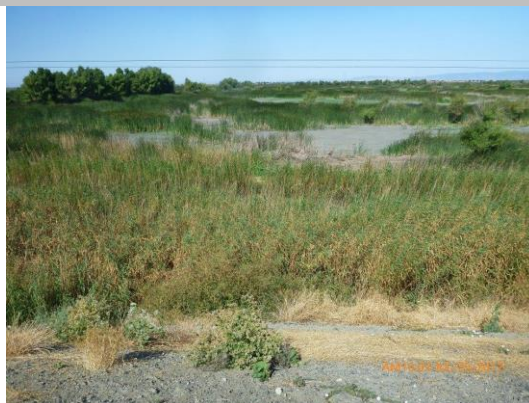
Photo 3 of 3 : SP\_2018\_RD2098\_244\_36\_20180305\_00044.jpg

LM Start	2.91	Rating **	A/W	Issue No.	36 (cont)
LM End	2.93	Issue Type +	Ma	Location *	
Category	Supplemental			GPS Latitude/Longitude	
				Start	End
Item	2017 Storm Damage			38.286900 °	38.286700 °
				-121.693500 °	-121.693500 °
DWR ID	DWR_RD2098_01_f_2017_36				
Comment Code					
Inspector Comment					
Levee Evaluation Comments					
Description:The damage consists of scour and sloughing of the waterside levee slope.					
Site ID No:431					
Site Designation:LMA-258					
Repair Type: Erosion					
Rating:Serious					
Field Date:7/25/2017					
Notes: Erosion of WS toe, resulting in 8' verticle wall. 10/26/17: Dutra repairs in progress.

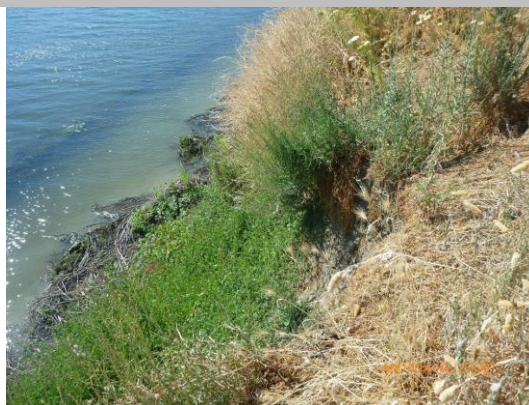
Photo 1 of 3 : SP\_2018\_RD2098\_244\_37\_20180305\_00045.jpg

LM Start	2.99	Rating **	A/W	Issue No.	37
LM End	3.29	Issue Type +	Ma	Location *	
Category	Supplemental			GPS Latitude/Longitude	
				Start	End
Item	2017 Storm Damage			38.285700 °	38.281500 °
				-121.693500 °	-121.694300 °
DWR ID	DWR_RD2098_01_f_2017_37				
Comment Code					
Inspector Comment					
Levee Evaluation Comments					
Description:The damage consists of scour and sloughing of the waterside levee slope.					
Site ID No:432					
Site Designation:LMA-259					
Repair Type: Erosion					
Rating:Serious					
Field Date:7/25/2017					
Notes: Varying erosion and sloughing at WS toe. Revetment at end of levee section. 10/26/17: Dutra repairs in progress.

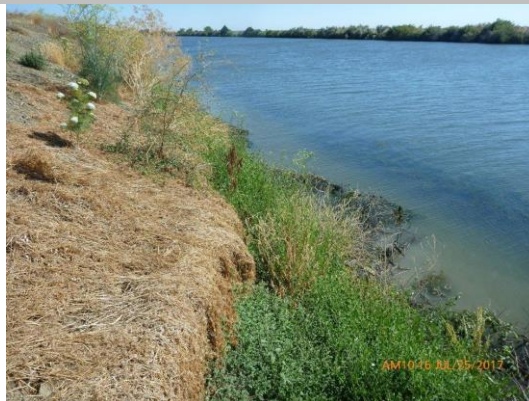
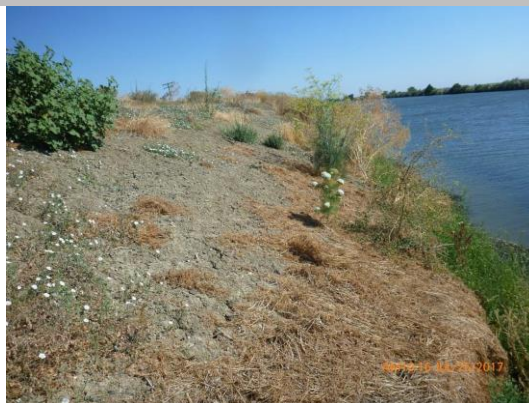
LM Start	2.99	Rating **	A/W	Issue No.	37 (cont)
LM End	3.29	Issue Type +	Ma	Location *	
Category	Supplemental			GPS Latitude/Longitude	
				Start	End
Item	2017 Storm Damage			38.285700 °	38.281500 °
				-121.693500 °	-121.694300 °
DWR ID	DWR_RD2098_01_f_2017_37				
Comment Code					
Inspector Comment					
Levee Evaluation Comments Description: The damage consists of scour and sloughing of the waterside levee slope. Site ID No: 432 Site Designation: LMA-259 Repair Type: Erosion Rating: Serious Field Date: 7/25/2017 Notes: Varying erosion and sloughing at WS toe. Revetment at end of levee section. 10/26/17: Dutra repairs in progress.

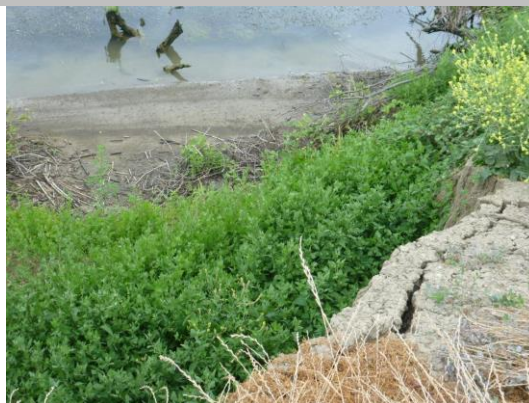
Photo 3 of 3 : SP\_2018\_RD2098\_244\_38\_20180305\_00050.jpg

LM Start	3.15	Rating **	M	Issue No.	38 (cont)	
LM End	3.15	Issue Type +	Ma	Location *		
Category	Supplemental			GPS Latitude/Longitude		
				Start		End
Item	2017 Storm Damage			38.283472 °		38.283472 °
				-121.693600 °		-121.693600 °
DWR ID	DWR_RD2098_01_f_2017_38					
Comment Code						
Inspector Comment						
Levee Evaluation Comments						
Description:						
Site ID No:115						
Site Designation:DWR_RD2098_01_s_2012_12						
Repair Type: Erosion						
Rating:Critical						
Field Date:6/9/2017						
Notes: noticable sloughing along Wsslope for entire levee reach						
10/26/17: Dutra has repaired erosion at 3.12-3.14.

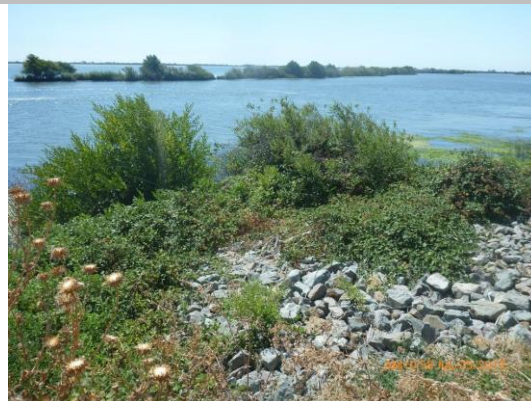
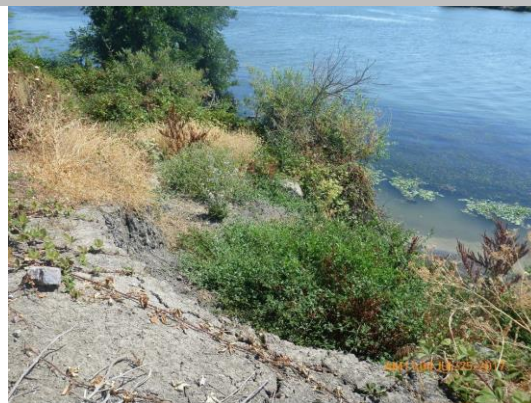
LM Start	3.50	Rating **	M	Issue No.	40 (cont)	
LM End	3.56	Issue Type +	Ma	Location *		
Category	Supplemental			GPS Latitude/Longitude		
				Start	End	
Item	2017 Storm Damage			38.278700 °	38.278000 °	
				-121.695900 °	-121.696100 °	
DWR ID	DWR_RD2098_01_f_2017_40					
Comment Code						
Inspector Comment						
Levee Evaluation Comments						
Description:The damage consists of scour and sloughing of the lower and mid waterside levee slope.						
Site ID No:435						
Site Designation:LMA-262						
Repair Type: Erosion						
Rating:Area of Concern						
Field Date:7/25/2017						
Notes: Two combined sloughing sites adjacent to each other on lower waterside slope. Existing rip rap on beginning 100' section of site 262.						
This site is combined with site 263.

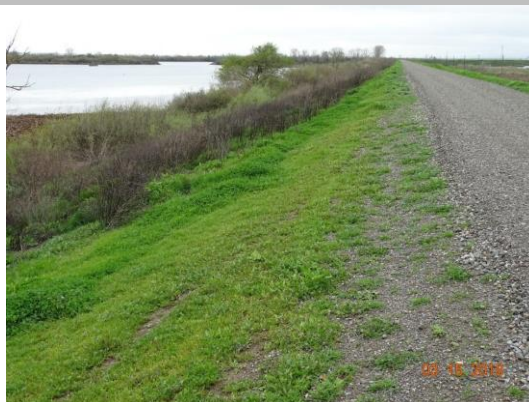
Photo 1 of 1 : SP\_2018\_RD2098\_245\_2\_20180315\_00002.jpg

Thick vegetation on waterside slope.

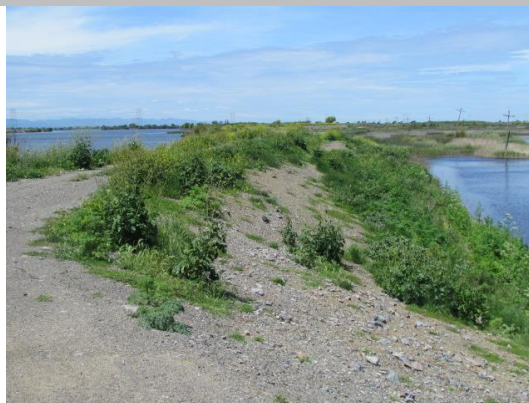
Photo 1 of 1 : SP\_2018\_RD2098\_246\_8\_20180305\_00002.jpg

RD 2098 Unit 2 Levee mile 5.30-7.14 wild growth on the landside slope.

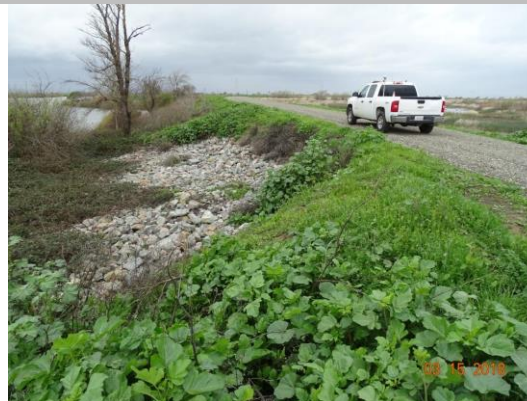
Photo 1 of 1 : SP\_2018\_RD2098\_246\_11\_20180315\_00049.jpg

Monitor slumping on waterside slope.

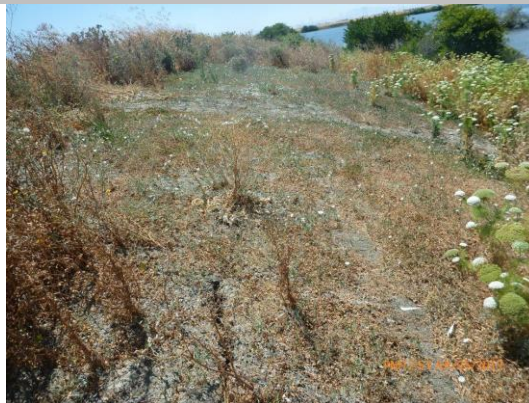
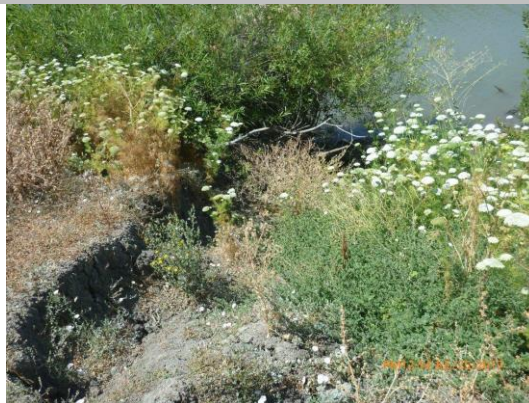
LM Start	6.47	Rating **	A/W	Issue No.	17 (cont)
LM End	6.48	Issue Type +	Ma	Location *	
Category	Supplemental			GPS Latitude/Longitude	
				Start	End
Item	2017 Storm Damage			38.288900 °	38.289000 °
				-121.717000 °	-121.717000 °
DWR ID	DWR_RD2098_02_f _ 2017_17				
Comment Code					
Inspector Comment					
Levee Evaluation Comments					
Description:The damage consists of scour and sloughing of the lower and mid waterside levee slope.					
Site ID No:441					
Site Designation:LMA-268					
Repair Type: Erosion					
Rating:Area of Concern					
Field Date:7/25/2017					
Notes: Sloughing on waterside slope due to toe erosion.

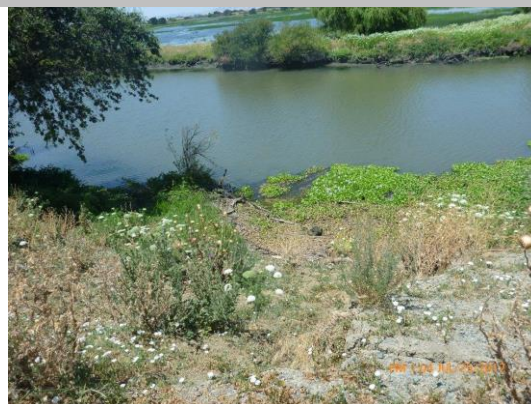
Photo 1 of 3 : SP\_2018\_RD2098\_246\_18\_20180305\_00015.jpg

LM Start	<b>6.64</b>	Rating **	A/W	Issue No.	<b>18</b>
LM End	<b>6.65</b>	Issue Type +	Ma	Location *	
Category	Supplemental		GPS Latitude/Longitude		
			Start	End	
Item	2017 Storm Damage		38.291300 °	38.291400 °	
			-121.716100 °	-121.716000 °	
DWR ID	DWR_RD2098_02_f_2017_18				
Comment Code					
Inspector Comment					
Levee Evaluation Comments Description: The damage consists of scour, cracking, instability, and sloughing of the waterside levee slope. Site ID No: 442 Site Designation: LMA-269 Repair Type: Erosion Rating: Serious Field Date: 7/25/2017 Notes: Two sloughing sections along waterside slope due to toe erosion.

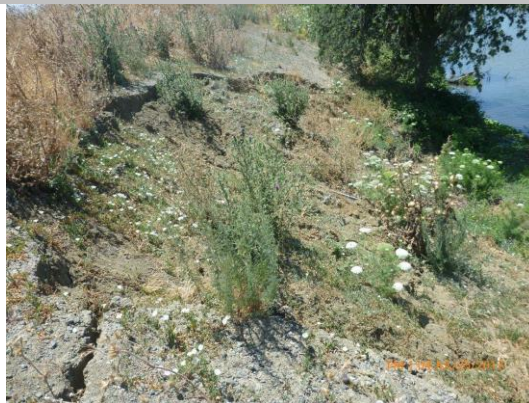
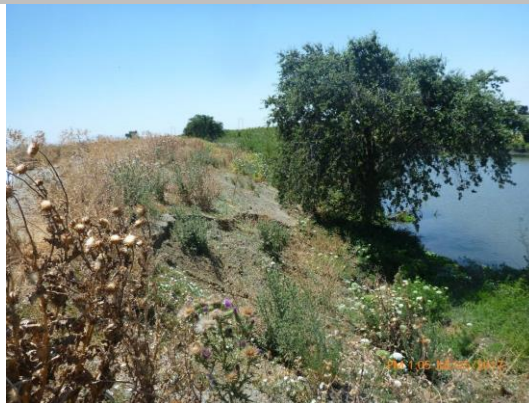
Description: The damage consists of scour, cracking, instability, and sloughing of the waterside levee slope.

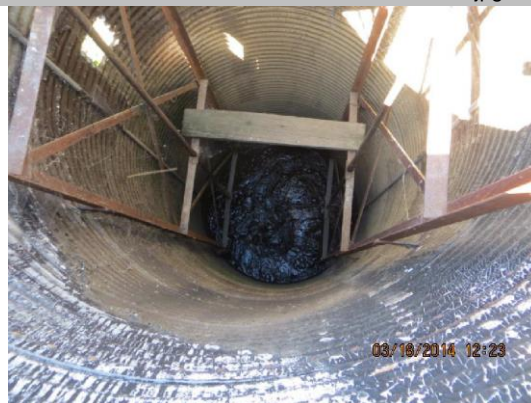
Photo 3 of 3 : UCIP\_SP\_2018\_33784\_61160.jpg

Comment Code					
Inspector Comment					
FS_ID:33784 DS_ID:20976 EP_NO: 10172 Repair Type: Non-Urgent Crossing Status: Found UCIP Comments: Headwalls on WS toe failing at outlet. It is unclear if these were permanent installations or something that was installed as a temporary fix. FIELD_STRUCT_DESC: 1 of 2: 48-inch corrugated metal drainage pipe through the levee, 29 feet below the crown. Two slide gates in a 7-foot-diameter corrugated metal pipe (CMP) riser on the waterside (WS) slope. (two 48-inch [HLM 6.75] authorized under Automatic Board Order (ABO) issued as Permit No. 10172, 1974 - Moresco Brothers). [Additional Reference(s): DWR Levee Log, 2003. USACE Sacramento O&M Manual 109, April 1962, (HLM 6.75)]. FS Date: 3/18/2014

View inside CMP riser on WS shoulder.

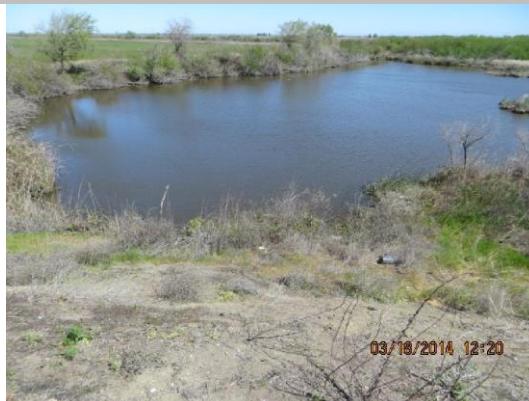
Photo 1 of 3 : UCIP\_SP\_2018\_32285\_58749.jpg

Inlet not visible on LS toe.

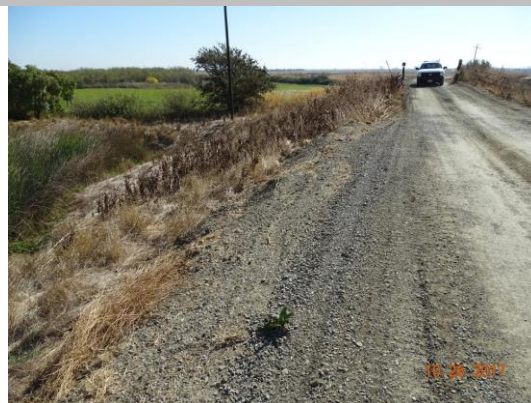
Photo 4 of 4 : SP\_2018\_RD2098\_246\_20\_20180305\_00024.jpg

10/26/17: Notice depression in crown road and slumping toward the left/landside (bulge at toe of levee).

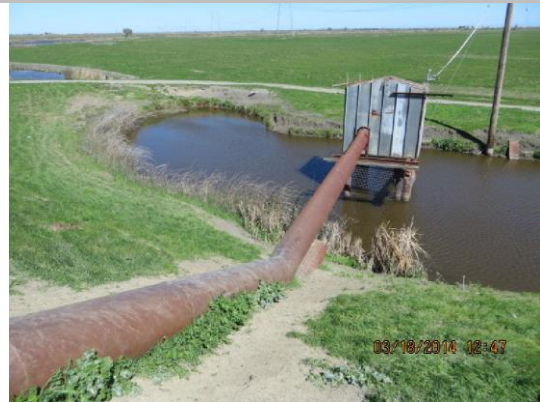
Photo 1 of 3 : UCIP\_SP\_2018\_32303\_58782.jpg

Pipe visible under new pipe on LS slope.

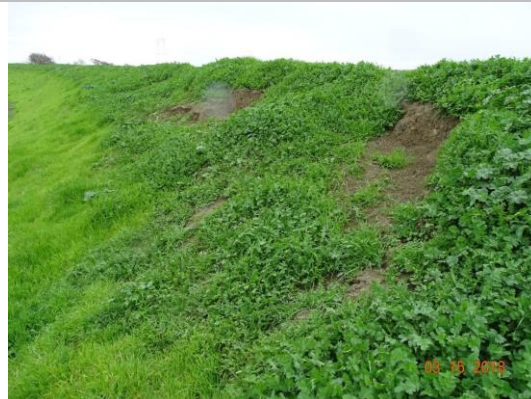
Photo 3 of 3 : SP\_2018\_RD2098\_247\_1\_20180315\_00027.jpg

Erosion site on 03/15/18.

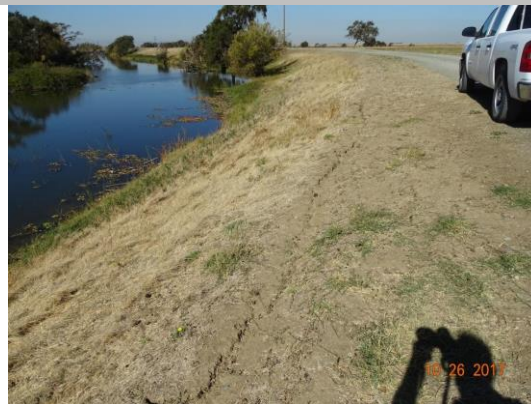
Photo 1 of 1 : SP\_2018\_RD2098\_247\_5\_20180305\_00005.jpg

View upstream of cracks in waterside shoulder.

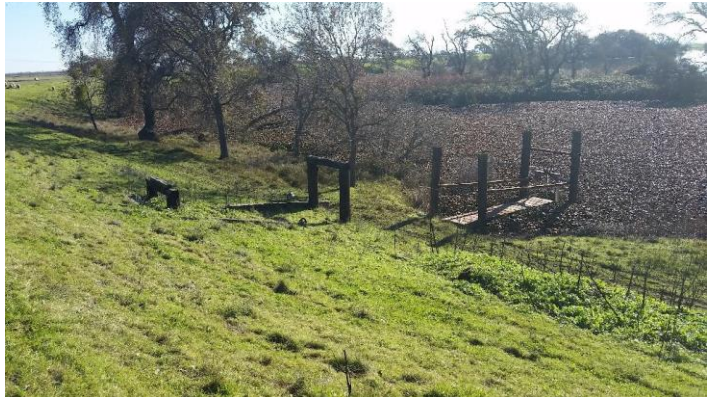
Photo 1 of 3 : UCIP\_SP\_2018\_51453\_76858.jpg

Walkway has been re-built, photo 1 of 2.

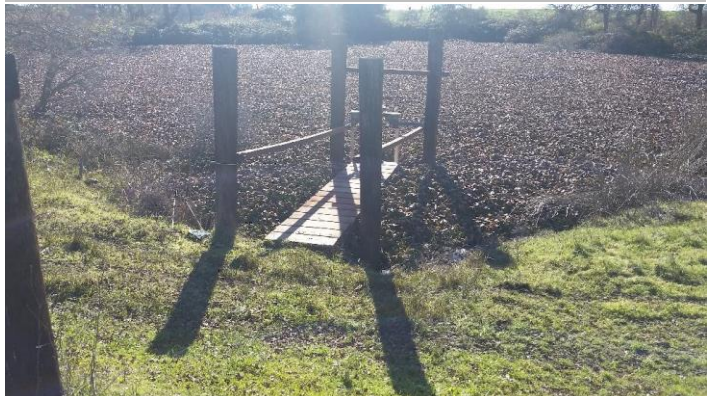
Photo 2 of 3 : UCIP\_SP\_2018\_51453\_76861.jpg

Walkway has been re-built, photo 2 of 2.

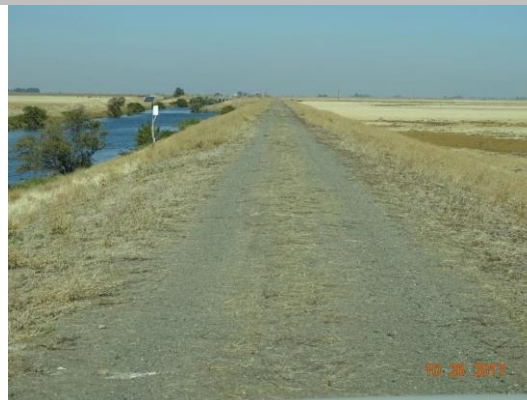
Photo 1 of 1 : SP\_2018\_RD2098\_248\_8\_20180305\_00001.jpg

Several areas of scalloped erosion at waterside toe. Largest area is visible in distance in this photo.

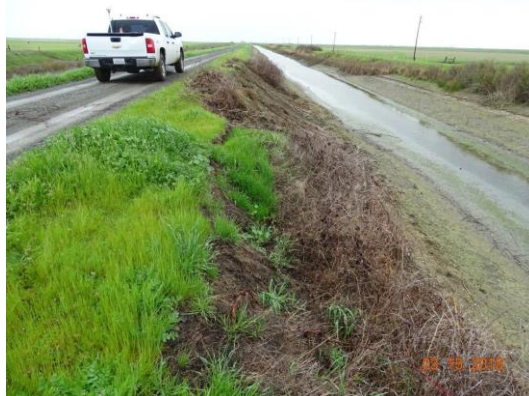
Photo 1 of 1 : SP\_2018\_RD2098\_248\_17\_20180315\_00021.jpg

Slumping landside slope should be monitored and repaired as needed.
