**Flood Control Project Maintenance
Levee Inspections**

Maintenance Issue Types Only, Levee Inspection Report By Mile - Spring 2019

Reclamation District No. 2098 Cache and Haas Slough

Waterway	Bank	Unit Miles	Inspection Start/End	Inspector
Unit No. 01 Yolo Bypass	Right	3.60	03/26/2019	David Julian

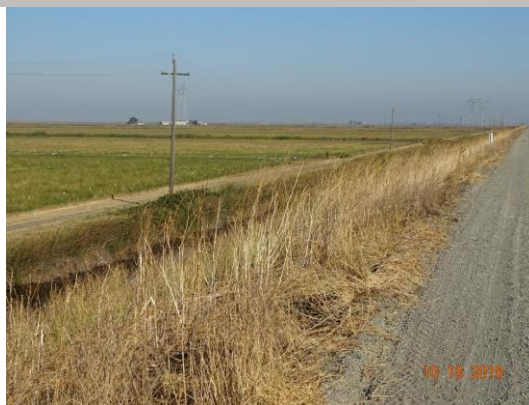
Photo 2 of 2 : SP_2019_RD2098_244_16_20190311_00005.jpg

View looking upstream at vegetation on the landside slope. Vegetation is spaced enough that still can partially see the levee slope but still should be removed (October 2018).

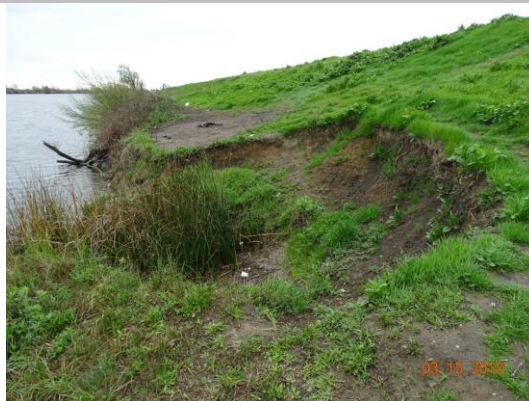
Photo 1 of 1 : SP_2019_RD2098_244_13_20190311_00003.jpg

LM Start	0.57	Rating **	M	Issue No.	13
LM End	1.06	Issue Type +	Ma	Location *	WS
Category	Earthen Levee			GPS Latitude/Longitude	
				Start	End
Item	Erosion / Bank Caving			38.320755 °	38.313700 °
				-121.693982 °	-121.693639 °
DWR ID	DWR_RD2098_01_s_2017_13				
Comment Code					
E2 : Schedule repair of erosion site prior to the next inspection.					
Inspector Comment					
Monitor and repair erosion on waterside.

View of erosion on waterside.

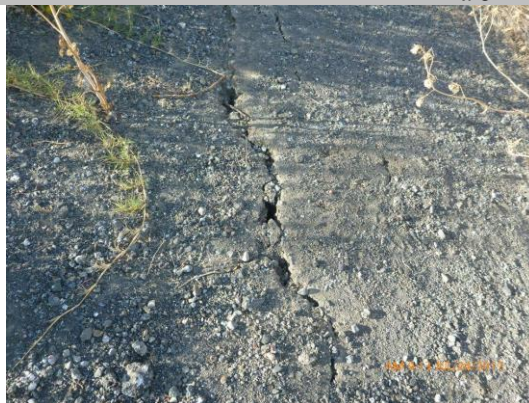
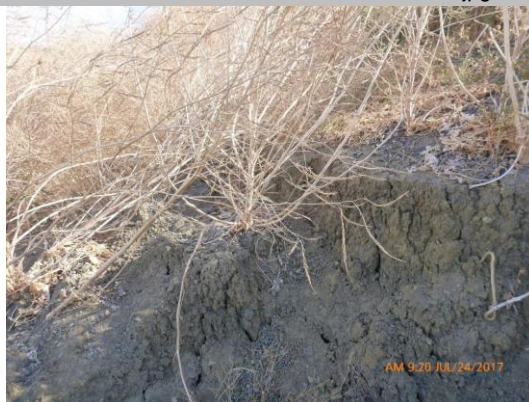
LM Start	0.96	Rating **	A/W	Issue No.	19
LM End	0.96	Issue Type +	Ma	Location *	
Category	Supplemental			GPS Latitude/Longitude	
				Start	End
Item	2017 Storm Damage			38.315200 °	38.315100 °
				-121.694100 °	-121.694100 °
DWR ID	DWR_RD2098_01_s_2018_19				
Comment Code					
Inspector Comment					
Levee Evaluation Comments					
Description:The damage consists of cracking and sloughing of the lower landside levee slope.					
Site ID No:414					
Site Designation:LMA-241					
Repair Type: Erosion					
Rating:Area of Concern					
Field Date:7/24/2017					
Notes: Landside sloughing about 2' deep and extends to toe ditch.

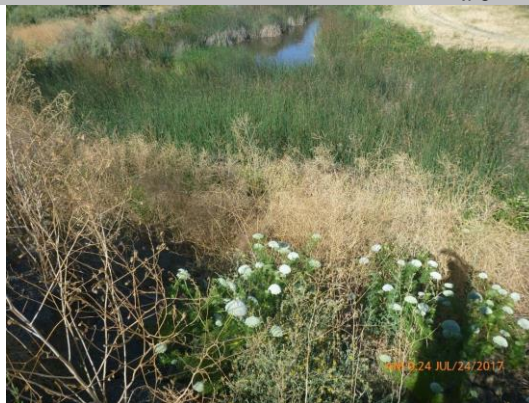
Photo 3 of 3 : LEVAL_SP_2019_414_3603.jpg

LM Start	0.96	Rating **	A/W	Issue No.	19 (cont)
LM End	0.96	Issue Type +	Ma	Location *	
Category	Supplemental			GPS Latitude/Longitude	
				Start	End
Item	2017 Storm Damage			38.315200 °	38.315100 °
				-121.694100 °	-121.694100 °
DWR ID	DWR_RD2098_01_s_2018_19				
Comment Code					
Inspector Comment					
Levee Evaluation Comments					
Description:The damage consists of cracking and sloughing of the lower landside levee slope.					
Site ID No:414					
Site Designation:LMA-241					
Repair Type: Erosion					
Rating:Area of Concern					
Field Date:7/24/2017					
Notes: Landside sloughing about 2' deep and extends to toe ditch.

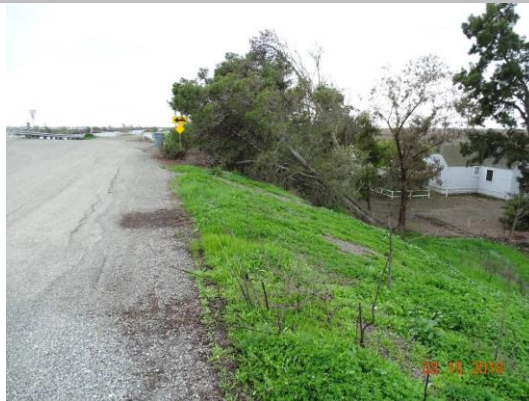
Photo 1 of 1 : SP_2019_RD2098_244_14_20190311_00004.jpg

View of fallen tree and other trees on waterside slope.

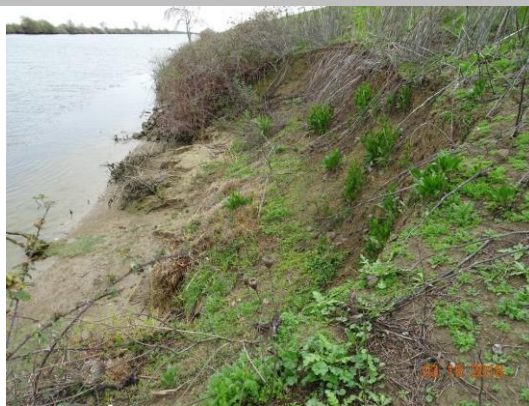
Photo 1 of 1 : SP_2019_RD2098_244_18_20190311_00006.jpg

LM Start	1.76	Rating **	M	Issue No.	18
LM End	1.76	Issue Type +	Ma	Location *	WS
Category	Earthen Levee			GPS Latitude/Longitude	
				Start	End
Item	Erosion / Bank Caving			38.303611 °	38.303611 °
				-121.693607 °	-121.693607 °
DWR ID	DWR_RD2098_01_s_2018_18				
Comment Code					
E1 : Note and monitor erosion site.					
Inspector Comment					
Monitor and repair erosion.

View of erosion.

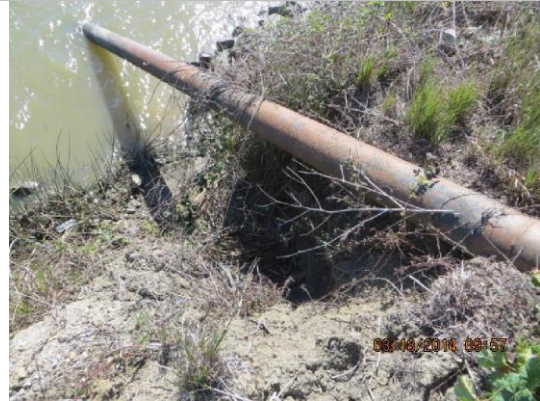
Photo 3 of 3 : UCIP_SP_2019_32197_58660.jpg

Erosion under pipe at WS toe.

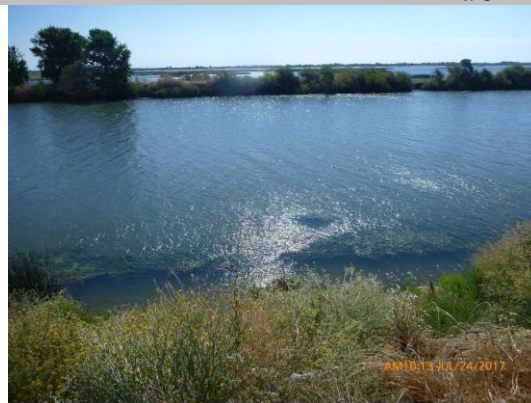
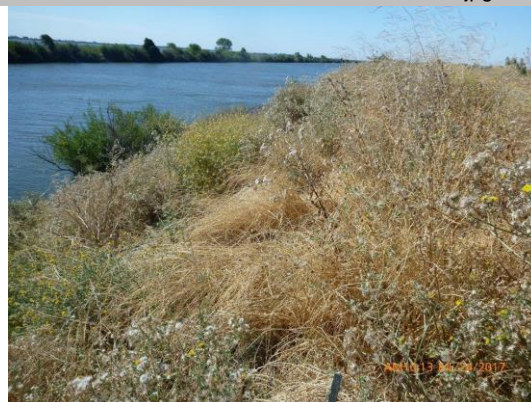
LM Start	2.21	Rating **	A/W	Issue No.	21
LM End	2.22	Issue Type +	Ma	Location *	
Category	Supplemental			GPS Latitude/Longitude	
				Start	End
Item	2017 Storm Damage			38.297100 °	38.297000 °
				-121.693300 °	-121.693300 °
DWR ID	DWR_RD2098_01_s_2018_21				
Comment Code					
Inspector Comment					
Levee Evaluation Comments					
Description:The damage consists of erosion, cracking, and sloughing of the waterside levee slope.					
Site ID No:416					
Site Designation:LMA-243					
Repair Type: Erosion					
Rating:Serious					
Field Date:7/24/2017					
Notes: Erosion with sloughing. About 2' vertical cut at top of erosion.

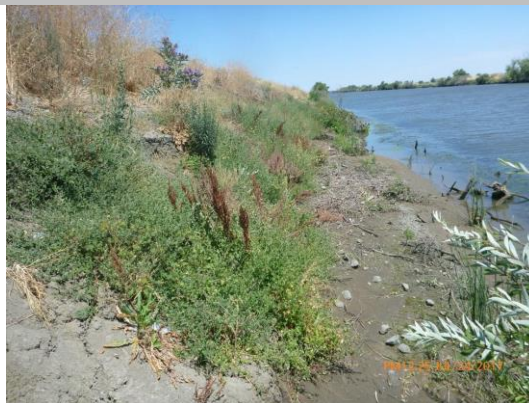
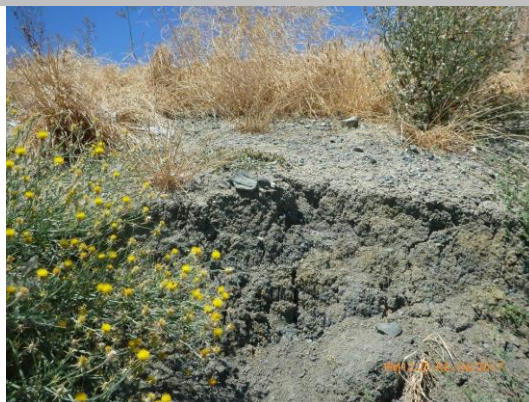
LM Start	2.29	Rating **	A/W	Issue No.	27 (cont)	
LM End	2.31	Issue Type +	Ma	Location *		
Category	Supplemental			GPS Latitude/Longitude		
				Start	End	
Item	2017 Storm Damage			38.295900 °	38.295700 °	
				-121.693500 °	-121.693500 °	
DWR ID	DWR_RD2098_01_f_2017_27					
Comment Code						
Inspector Comment						
Levee Evaluation Comments						
Description:The damage consists of scour and sloughing of the waterside levee slope.						
Site ID No:421						
Site Designation:LMA-248						
Repair Type: Erosion						
Rating:Serious						
Field Date:7/24/2017						
Notes: Toe of slope has eroded and minor sloughing has started.

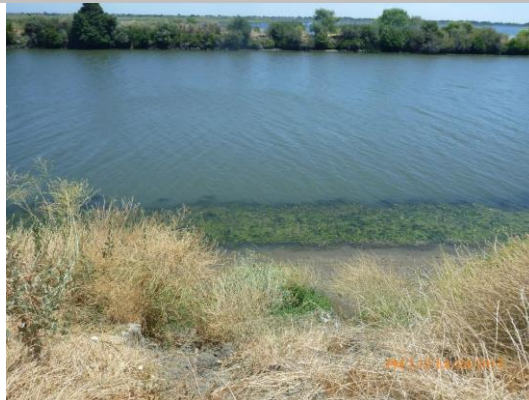
Photo 1 of 3 : SP_2019_RD2098_244_28_20190311_00017.jpg

LM Start	2.35	Rating **	A/W	Issue No.	28
LM End	2.39	Issue Type +	Ma	Location *	
Category	Supplemental			GPS Latitude/Longitude	
				Start	End
Item	2017 Storm Damage			38.295100 °	38.294500 °
				-121.693400 °	-121.693400 °
DWR ID	DWR_RD2098_01_f_2017_28				
Comment Code					
Inspector Comment					
Levee Evaluation Comments					
Description:The damage consists of scour, sloughing, and cracking of the lower and mid waterside levee slope.					
Site ID No:423					
Site Designation:LMA-250					
Repair Type: Erosion					
Rating:Area of Concern					
Field Date:7/24/2017					
Notes: 2' of sloughing about half way up the slope.

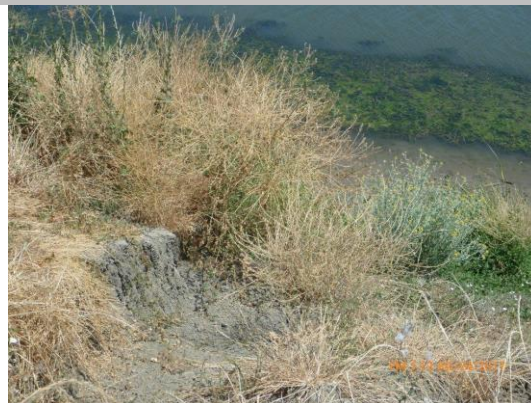
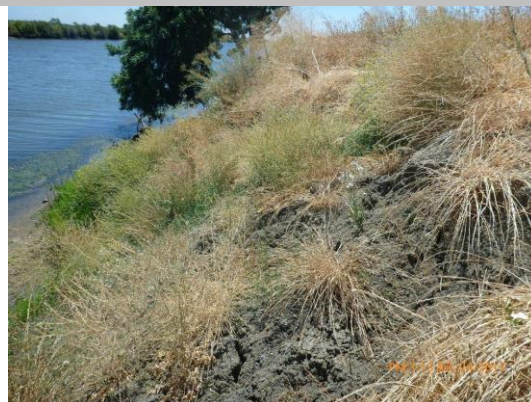
LM Start	2.35	Rating **	A/W	Issue No.	28 (cont)	
LM End	2.39	Issue Type +	Ma	Location *		
Category	Supplemental			GPS Latitude/Longitude		
				Start		End
Item	2017 Storm Damage			38.295100 °		38.294500 °
				-121.693400 °		-121.693400 °
DWR ID	DWR_RD2098_01_f_2017_28					
Comment Code						
Inspector Comment						
Levee Evaluation Comments						
Description:The damage consists of scour, sloughing, and cracking of the lower and mid waterside levee slope.						
Site ID No:423						
Site Designation:LMA-250						
Repair Type: Erosion						
Rating:Area of Concern						
Field Date:7/24/2017						
Notes: 2' of sloughing about half way up the slope.

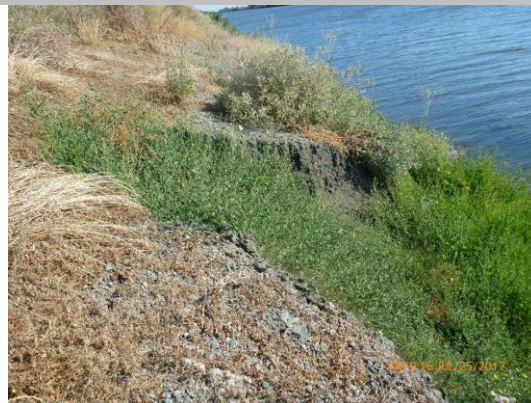
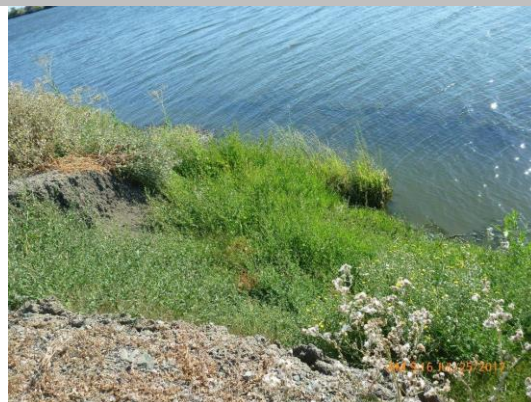
LM Start	2.75	Rating **	A/W	Issue No.	34
LM End	2.78	Issue Type +	Ma	Location *	
Category	Supplemental			GPS Latitude/Longitude	
				Start	End
Item	2017 Storm Damage			38.289200 °	38.288800 °
				-121.693500 °	-121.693500 °
DWR ID	DWR_RD2098_01_f _ 2017_34				
Comment Code					
Inspector Comment					
Levee Evaluation Comments					
Description:The damage consists of scour and sloughing of the waterside levee slope.					
Site ID No:429					
Site Designation:LMA-256					
Repair Type: Erosion					
Rating:Serious					
Field Date:7/25/2017					
Notes: Erosion at WS toe, causing sloughing half-way down WS slope.

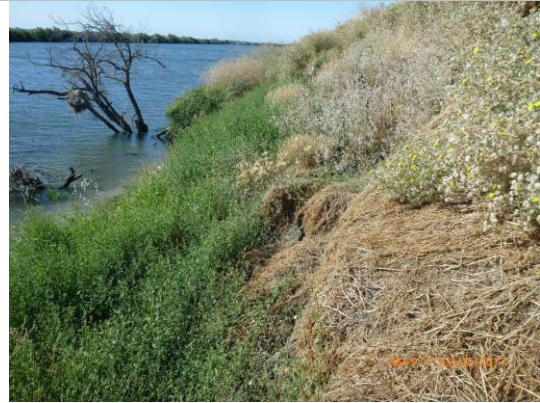
Photo 3 of 3 : SP_2019_RD2098_244_34_20190311_00022.jpg

LM Start	2.75	Rating **	A/W	Issue No.	34 (cont)
LM End	2.78	Issue Type +	Ma	Location *	
Category	Supplemental			GPS Latitude/Longitude	
				Start	End
Item	2017 Storm Damage			38.289200 °	38.288800 °
				-121.693500 °	-121.693500 °
DWR ID	DWR_RD2098_01_f_2017_34				
Comment Code					
Inspector Comment					
Levee Evaluation Comments					
Description:The damage consists of scour and sloughing of the waterside levee slope.					
Site ID No:429					
Site Designation:LMA-256					
Repair Type: Erosion					
Rating:Serious					
Field Date:7/25/2017					
Notes: Erosion at WS toe, causing sloughing half-way down WS slope.

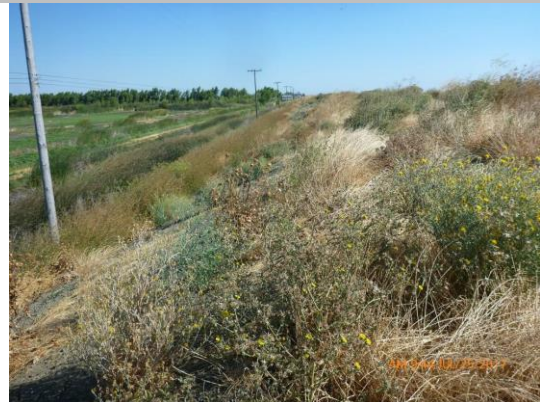
Photo 1 of 3 : SP_2019_RD2098_244_35_20190311_00023.jpg

LM Start	2.78	Rating **	A/W	Issue No.	35
LM End	2.81	Issue Type +	Ma	Location *	
Category	Supplemental			GPS Latitude/Longitude	
				Start	End
Item	2017 Storm Damage			38.288800 °	38.288400 °
				-121.693500 °	-121.693500 °
DWR ID	DWR_RD2098_01_f_2017_35				
Comment Code					
Inspector Comment					
Levee Evaluation Comments					
Description:The damage consists of scour and sloughing of the waterside levee slope.					
Site ID No:430					
Site Designation:LMA-257					
Repair Type: Erosion					
Rating:Serious					
Field Date:7/25/2017					
Notes: Erosion at waterside toe, causing sloughing 2/3 down waterside slope.

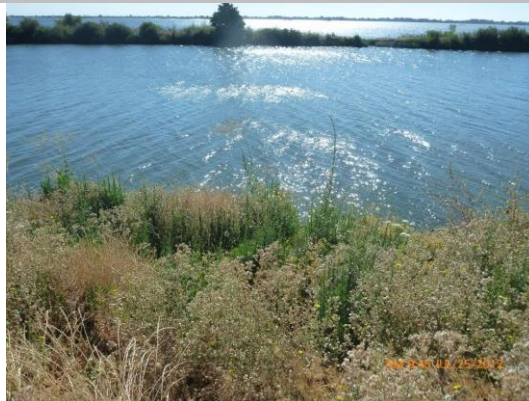
Photo 2 of 3 : SP_2019_RD2098_244_35_20190311_00024.jpg

LM Start	2.78	Rating **	A/W	Issue No.	35 (cont)	
LM End	2.81	Issue Type +	Ma	Location *		
Category	Supplemental			GPS Latitude/Longitude		
				Start		End
Item	2017 Storm Damage			38.288800 °		38.288400 °
				-121.693500 °		-121.693500 °
DWR ID	DWR_RD2098_01_f_2017_35					
Comment Code						
Inspector Comment						
Levee Evaluation Comments						
Description:The damage consists of scour and sloughing of the waterside levee slope.						
Site ID No:430						
Site Designation:LMA-257						
Repair Type: Erosion						
Rating:Serious						
Field Date:7/25/2017						
Notes: Erosion at waterside toe, causing sloughing 2/3 down waterside slope.

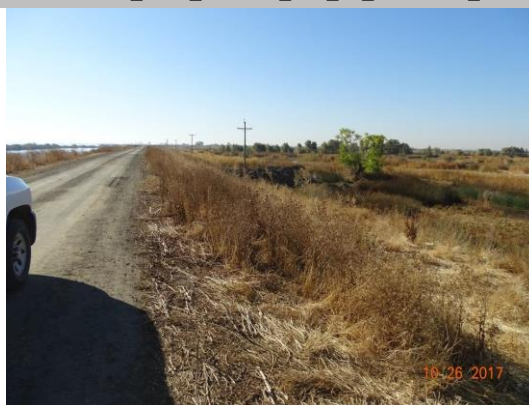
Photo 1 of 1 : SP_2019_RD2098_244_12_20190311_00002.jpg

View of vegetation on landside slope.

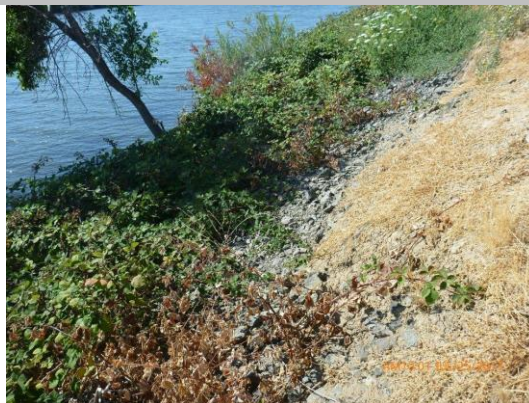
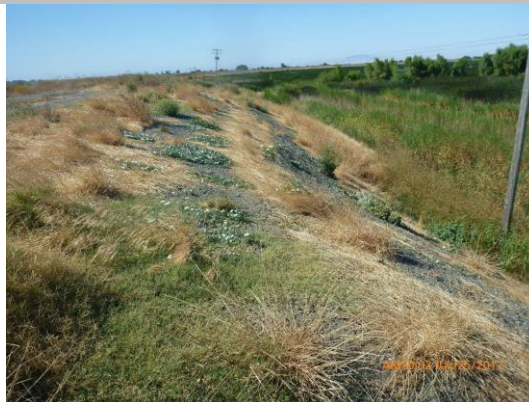
LM Start	2.91	Rating **	A/W	Issue No.	36
LM End	2.93	Issue Type +	Ma	Location *	
Category	Supplemental			GPS Latitude/Longitude	
				Start	End
Item	2017 Storm Damage			38.286900 °	38.286700 °
				-121.693500 °	-121.693500 °
DWR ID	DWR_RD2098_01_f_2017_36				
Comment Code					
Inspector Comment					
Levee Evaluation Comments					
Description:The damage consists of scour and sloughing of the waterside levee slope.					
Site ID No:431					
Site Designation:LMA-258					
Repair Type: Erosion					
Rating:Serious					
Field Date:7/25/2017					
Notes: Erosion of WS toe, resulting in 8' verticle wall.

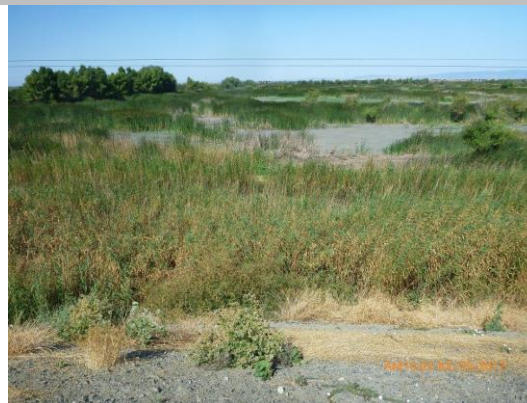
Photo 3 of 3 : SP_2019_RD2098_244_36_20190311_00028.jpg

LM Start	2.91	Rating **	A/W	Issue No.	36 (cont)
LM End	2.93	Issue Type +	Ma	Location *	
Category	Supplemental			GPS Latitude/Longitude	
				Start	End
Item	2017 Storm Damage			38.286900 °	38.286700 °
				-121.693500 °	-121.693500 °
DWR ID	DWR_RD2098_01_f_2017_36				
Comment Code					
Inspector Comment					
Levee Evaluation Comments					
Description:The damage consists of scour and sloughing of the waterside levee slope.					
Site ID No:431					
Site Designation:LMA-258					
Repair Type: Erosion					
Rating:Serious					
Field Date:7/25/2017					
Notes: Erosion of WS toe, resulting in 8' verticle wall.

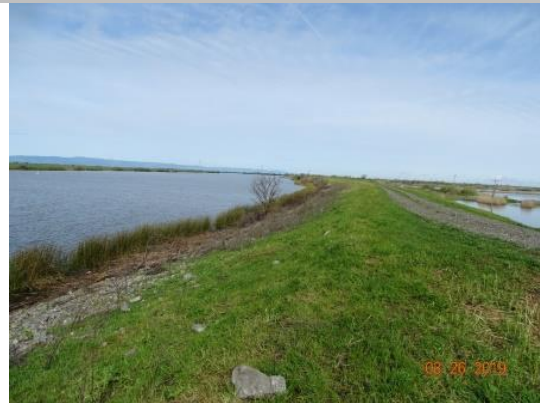
Photo 1 of 1 : SP_2019_RD2098_246_6_20190329_00038.jpg

View looking upstream at annual vegetation on the waterside slope (Spring 2019).

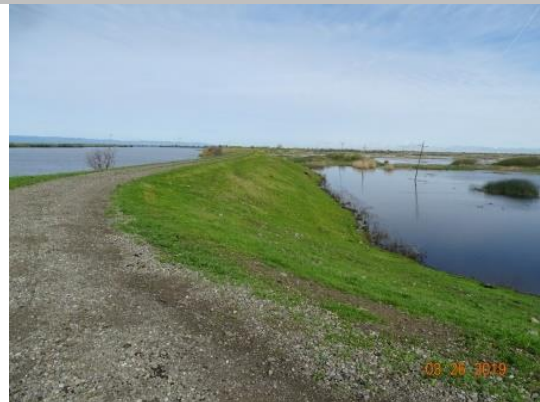
Photo 1 of 1 : SP_2019_RD2098_246_14_20190329_00039.jpg

View looking upstream at annual vegetation on the landside slope (Spring 2019).

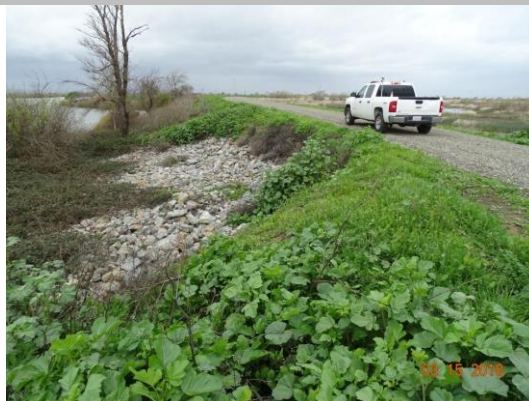
Photo 1 of 1 : SP_2019_RD2098_246_11_20190311_00004.jpg

Repair slumping on waterside slope.

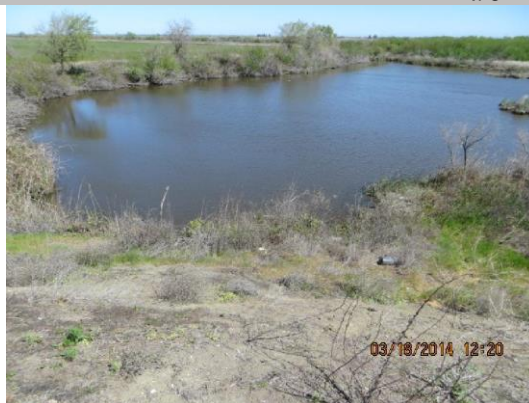
Photo 2 of 3 : UCIP_SP_2019_33784_61161.jpg

Inlet not visible on LS toe.

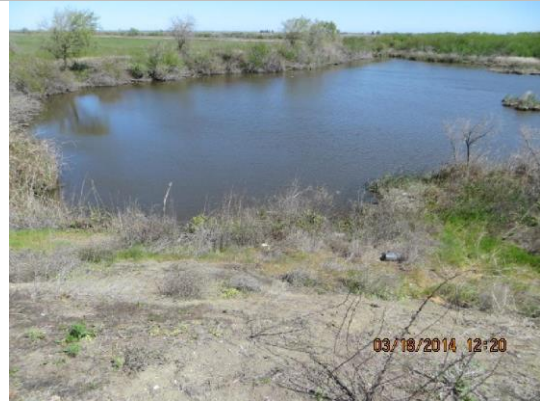
Photo 1 of 3 : UCIP_SP_2019_32285_58749.jpg

Inlet not visible on LS toe.

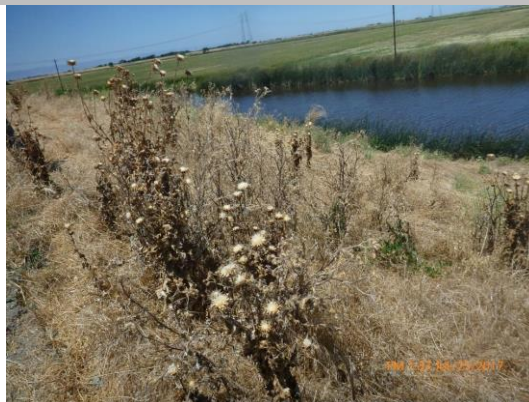
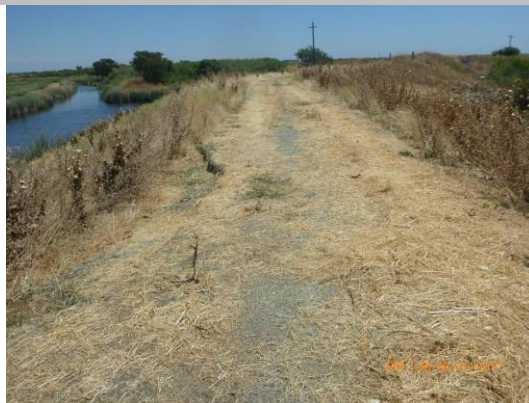
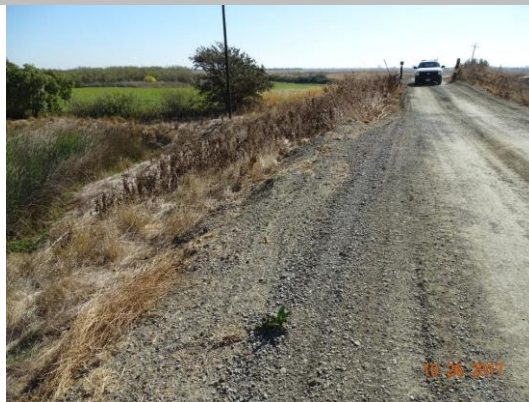
LM Start	6.77	Rating **	A/W	Issue No.	20
LM End	6.80	Issue Type +	Ma	Location *	LS
Category	Supplemental			GPS Latitude/Longitude	
				Start	End
Item	2017 Storm Damage			38.292900 °	38.293000 °
				-121.716600 °	-121.717000 °
DWR ID	DWR_RD2098_02 f _ 2017_20

10/26/17: Notice depression in crown road and slumping toward the left/landside (bulge at toe of levee).

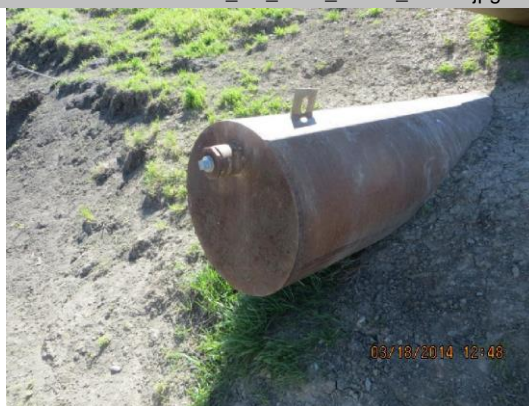
Photo 3 of 3 : UCIP_SP_2019_32303_58780.jpg

Welded steel cap over LS end of pipe.

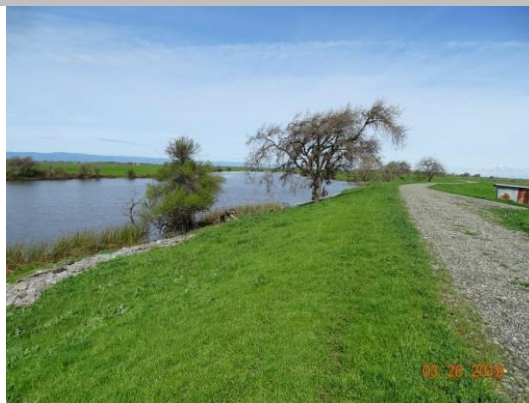
Photo 1 of 1 : SP_2019_RD2098_247_8_20190326_00020.jpg

View looking upstream at annual vegetation on the waterside slope (Spring 2019).

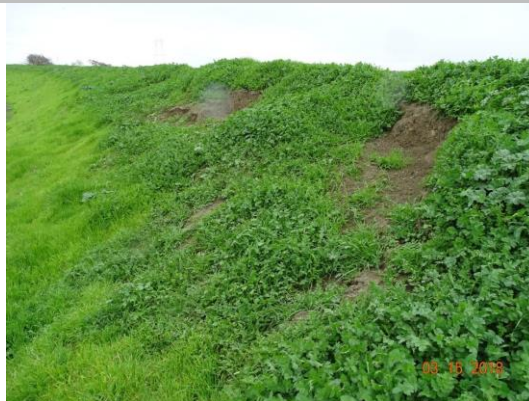
Photo 3 of 3 : SP_2019_RD2098_247_1_20190311_00003.jpg

Erosion site on 03/15/18.

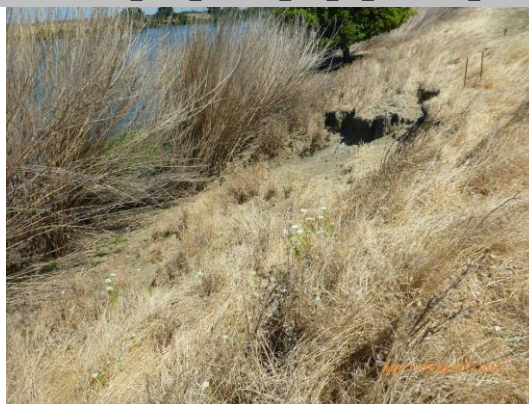
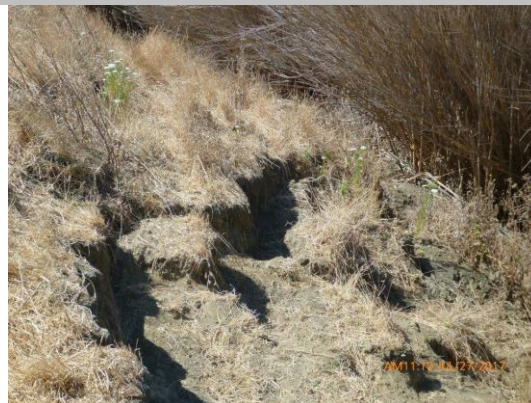
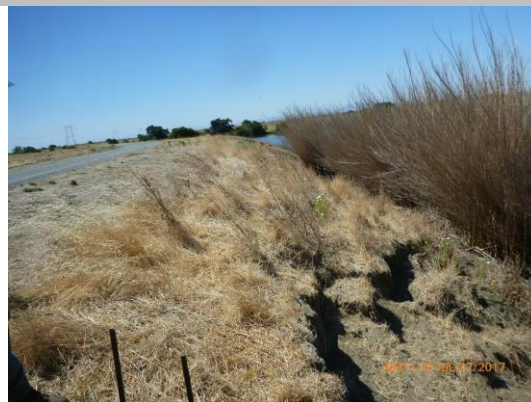
LM Start	7.63	Rating **	A/W	Issue No.	13
LM End	7.64	Issue Type +	Ma	Location *	
Category	Supplemental			GPS Latitude/Longitude	
				Start	End
Item	2017 Storm Damage			38.298300 °	38.298400 °
				-121.728800 °	-121.728800 °
DWR ID	DWR_RD2098_03_f_2017_13				
Comment Code					
Inspector Comment					
Levee Evaluation Comments					
Description:The damage consists of scour and sloughing of the waterside levee slope.					
Site ID No:450					
Site Designation:LMA-277					
Repair Type: Erosion					
Rating:Area of Concern					
Field Date:7/27/2017					
Notes: Sloughing on waterside due to waterside toe erosion.

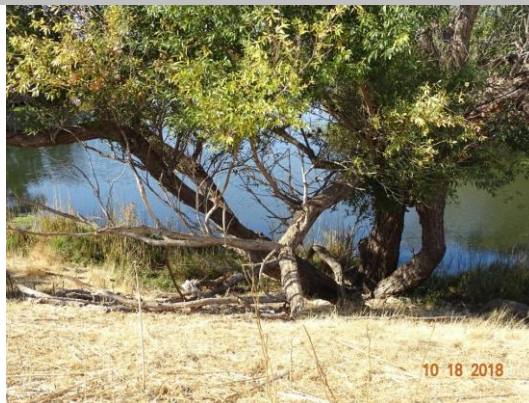
Photo 1 of 1 : SP_2019_RD2098_247_9_20190311_00005.jpg

View of fallen tree limb on the water side slope (October 2018).

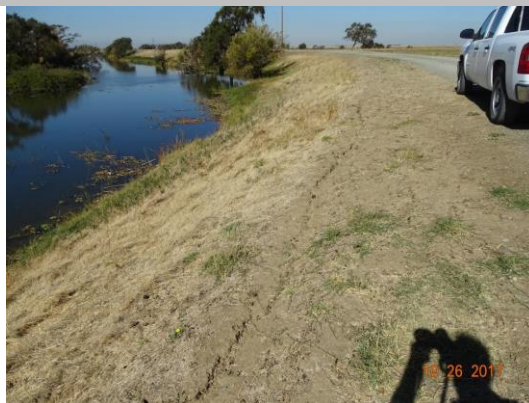
View upstream of cracks in waterside shoulder.

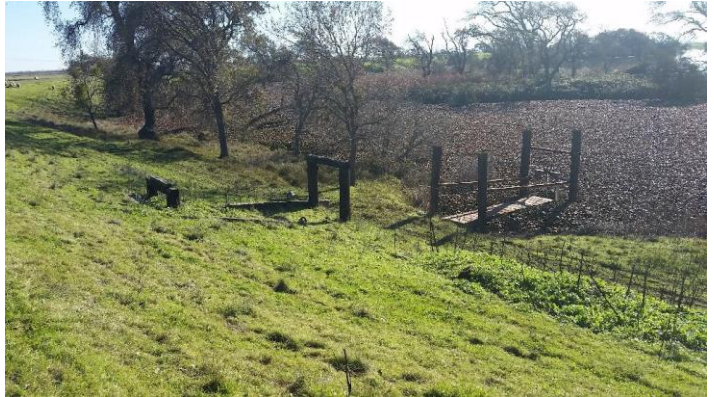
Photo 1 of 3 : UCIP_SP_2019_51453_76858.jpg

Walkway has been re-built, photo 1 of 2.

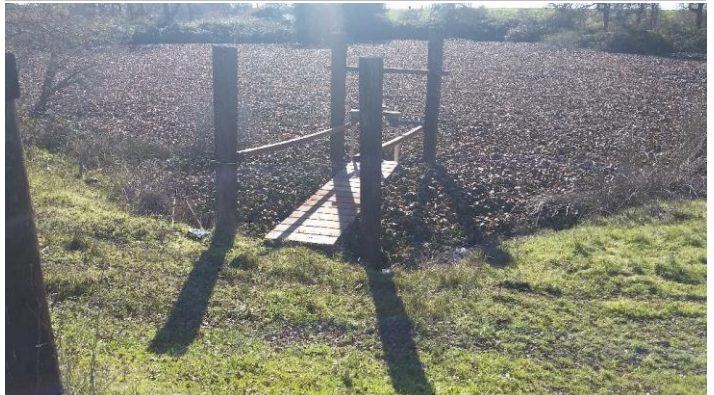
Walkway has been re-built, photo 2 of 2.

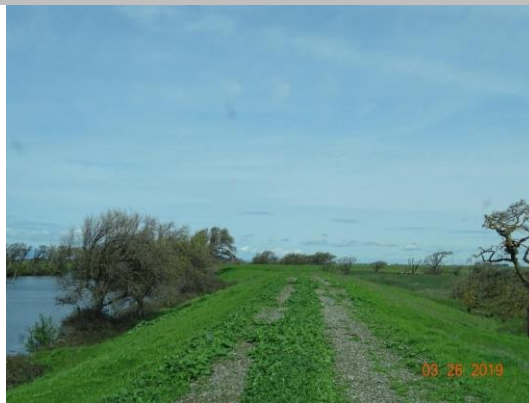
View looking upstream at annual vegetation on the crown (Spring 2019).

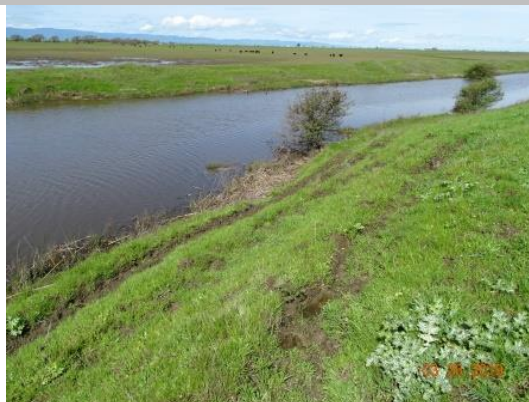
View looking upstream at deep ruts in the waterside slope made by cows (Spring 2019).

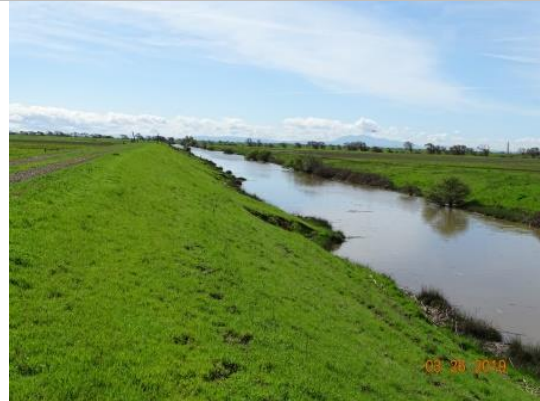
View looking downstream at worst section of the erosion on the waterside slope (Spring 2019).

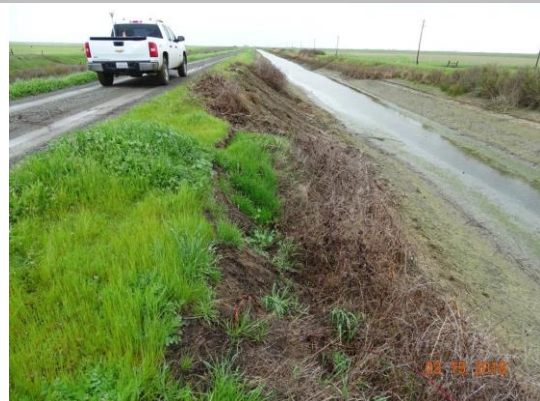
Slumping landside slope should be monitored and repaired as needed.
