**Flood Control Project Maintenance
Levee Inspections**

Maintenance Issue Types Only, Levee Inspection Report By Mile - Spring 2020

Reclamation District No. 2098 Cache and Haas Slough

Waterway	Bank	Unit Miles	Inspection Start/End	Inspector
Unit No. 01 Yolo Bypass	Right	3.60	04/24/2020 04/24/2020	David Julian

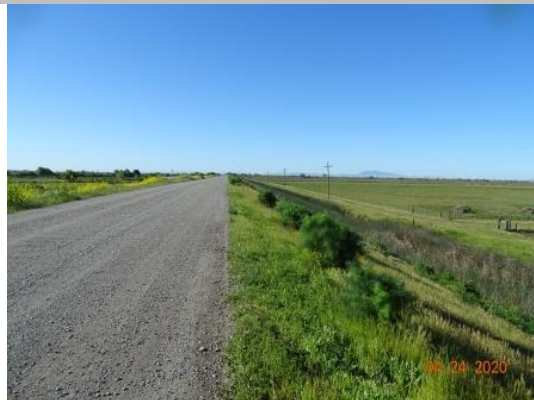
Photo 1 of 1 : SP_2020_RD2098_244_11_20200424_00051.jpg

LM Start	0.02	Rating **	M	Issue No.	11
LM End	1.04	Issue Type +	Ma	Location *	LS
Category	Earthen Levee			GPS Latitude/Longitude	
				Start	End
Item	Vegetation			38.328859 °	38.313957 °
				-121.694072 °	-121.693790 °
DWR ID	DWR_RD2098_01_s_2020_11				
Comment Code					
V1 : Control annual grass and weeds on the levee slopes and easements.					
Inspector Comment

View looking downstream at annual vegetation on the landside slope (Spring 2020).

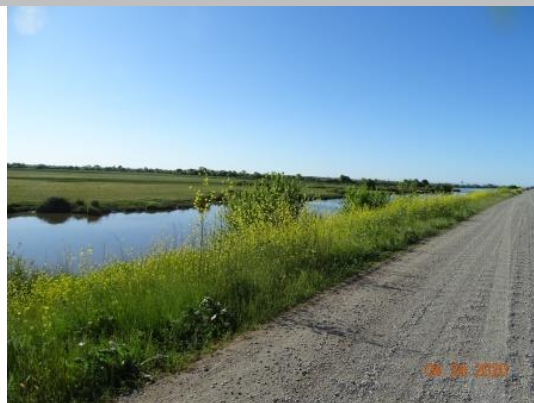
Photo 1 of 1 : SP_2020_RD2098_244_16_20200424_00050.jpg

LM Start	0.02	Rating **	M	Issue No.	16
LM End	1.07	Issue Type +	Ma	Location *	WS
Category	Earthen Levee			GPS Latitude/Longitude	
				Start	End
Item	Vegetation			38.328859 °	38.313540 °
				-121.694072 °	-121.693678 °
DWR ID	DWR_RD2098_01_s_2020_16				
Comment Code					
V1 : Control annual grass and weeds on the levee slopes and easements.					
Inspector Comment

View looking downstream at annual vegetation on the waterside slope (Spring 2020).

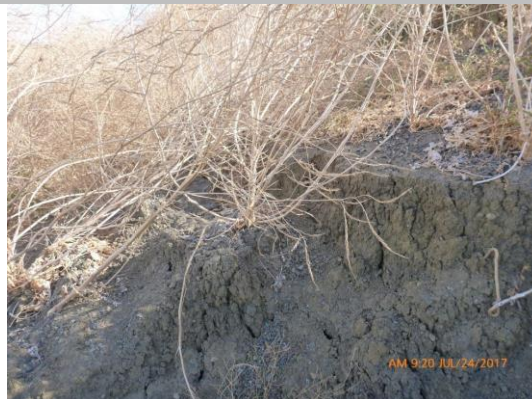
Photo 1 of 1 : LEVAL_SP_2020_414_3596.jpg

LM Start	0.96	Rating **	A/W	Issue No.	19
LM End	0.96	Issue Type +	Ma	Location *	LS
Category	Earthen Levee			GPS Latitude/Longitude	
				Start	End
Item	Erosion / Bank Caving			38.315200 °	38.315100 °
				-121.694100 °	-121.694100 °
DWR ID	LMA-241				
Comment Code					
E1 : Note and monitor erosion site.					
Inspector Comment					
This was a 2017 Storm Damage site. The damage consists of cracking and sloughing of the lower landside levee slope. Site ID No:414 Site Designation:LMA-241 4/24/2020 Field Notes: Vegetation is to thick to see. Verify in fall when vegetation less.

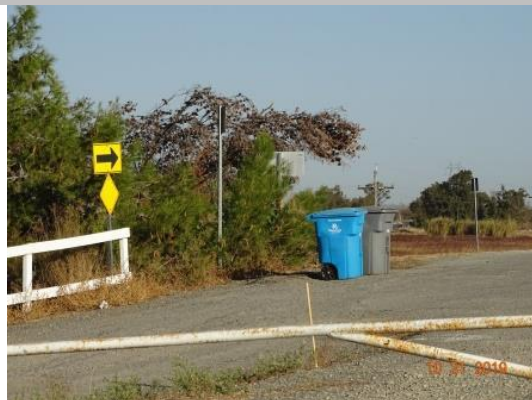
Photo 1 of 1 : SP_2020_RD2098_244_14_20200304_00003.jpg

LM Start	1.55	Rating **	M	Issue No.	14
LM End	1.55	Issue Type +	Ma	Location *	LS
Category	Earthen Levee			GPS Latitude/Longitude	
				Start	End
Item	Trim / Thin Trees			38.306628 °	38.306628 °
				-121.693632 °	-121.693632 °
DWR ID	DWR_RD2098_01_f _ 2018_14				
Comment Code					
T1 : Trim trees to at least five feet above ground level.					
Inspector Comment					
Trim and thin trees to allow inspection and access to landside slope and toe.

View looking upstream at untrimmed trees on the landside slope (Fall 2019).

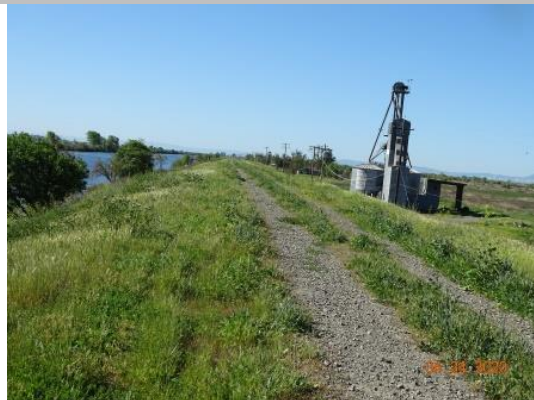
Photo 1 of 1 : SP_2020_RD2098_244_17_20200424_00052.jpg

LM Start	1.58	Rating **	M	Issue No.	17
LM End	3.58	Issue Type +	Ma	Location *	CR
Category	Earthen Levee			GPS Latitude/Longitude	
				Start	End
Item	Vegetation			38.306205 °	38.277686 °
				-121.693596 °	-121.696225 °
DWR ID	DWR_RD2098_01_s_2020_17				
Comment Code					
V9 : Keep the crown roadway free of vegetation.					
Inspector Comment

View looking downstream at vegetation on the crown (Spring 2020).

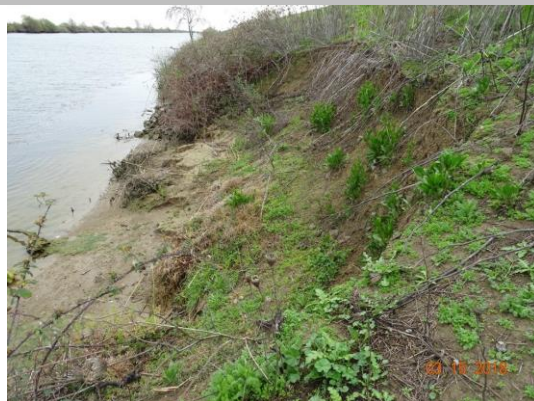
Photo 1 of 1 : SP_2020_RD2098_244_18_20200304_00004.jpg

LM Start	1.76	Rating **	M	Issue No.	18
LM End	1.76	Issue Type +	Ma	Location *	WS
Category	Earthen Levee			GPS Latitude/Longitude	
				Start	End
Item	Erosion / Bank Caving			38.303611 °	38.303611 °
				-121.693607 °	-121.693607 °
DWR ID	DWR_RD2098_01_s_2018_18				
Comment Code					
E2 : Schedule repair of erosion site prior to the next inspection.					
Inspector Comment					
Erosion at the waterside toe.

View of erosion.

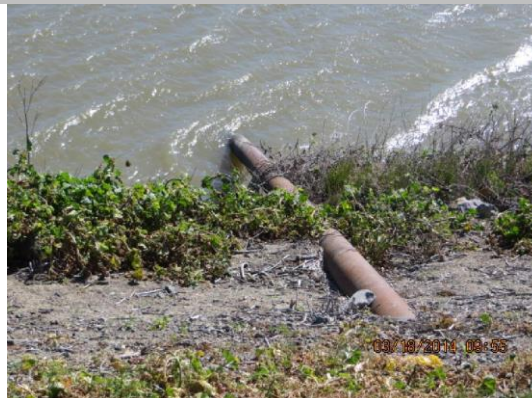
Photo 1 of 3 : UCIP_SP_2020_32197_58662.jpg

Comment Code						
Inspector Comment						
DS_ID:20965 FS_ID:32197 EP_NO: 10168 Repair Type: Non-Urgent Crossing Status: Found UCIP Comments: 12/22/2016 Met with Mike Hadesty, LMA Superintendent, and Brian Bush, LMA General Manager, to go over the list of pipes in RD2098. Per LMA records, this pipe has a different owner. (O. Magana - DWR UCIP) 03/18/2014 Erosion under pipe at WS toe. (W. Wylie - DWR UCIP) FIELD_STRUCT_DESC: 10-inch steel drainage pipe through the levee, 2.8 feet below the crown. Pump in pump house off the landside (LS). (This pipe was retained under Automatic Board Order (ABO) issued as Permit No. 10168, 1974 - Moresco Brothers). [Additional Reference(s): DWR Levee Log, 2003. USACE Sacramento O&M Manual 109, April 1962, (HLM 1.80)]. FS Date: 3/18/2014

Pipe on WS slope.

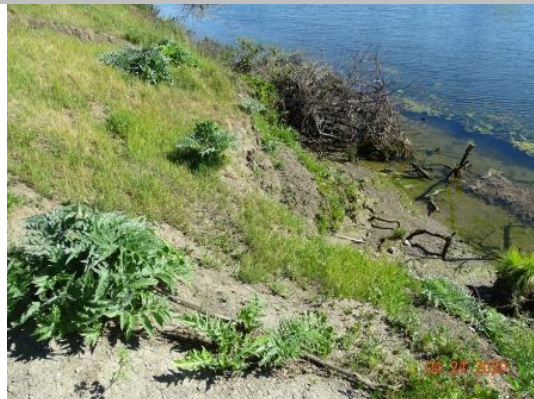
Photo 1 of 2 : SP_2020_RD2098_244_28_20200424_00054.jpg

LM Start	2.35	Rating **	U	Issue No.	28
LM End	2.39	Issue Type +	Ma	Location *	WS
Category	Earthen Levee			GPS Latitude/Longitude	
				Start	End
Item	Erosion / Bank Caving			38.295100 °	38.294500 °
				-121.693400 °	-121.693400 °
DWR ID	LMA-250				
Comment Code					
E2 : Schedule repair of erosion site prior to the next inspection.					
Inspector Comment					
This was a 2017 Storm Damage site. The damage consists of scour, sloughing, and cracking of the lower and mid waterside levee slope. Site ID No:423 Site Designation:LMA-250

View looking downslope at erosion into the waterside toe and slope (Spring 2020).

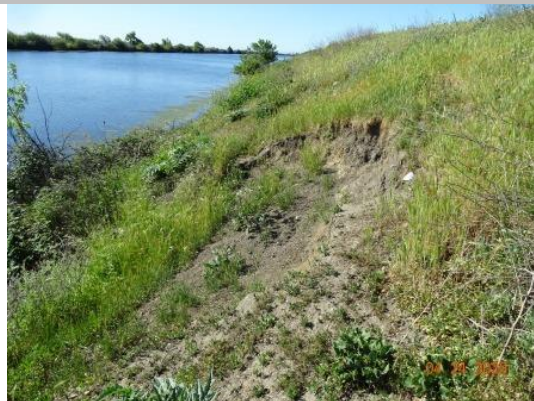
Photo 2 of 2 : SP_2020_RD2098_244_28_20200424_00055.jpg

View looking upstream at erosion into the waterside slope (Spring 2020).

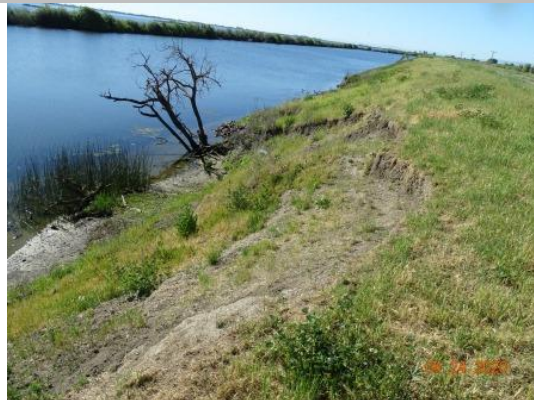
Photo 1 of 1 : SP_2020_RD2098_244_34_20200424_00056.jpg

LM Start	2.75	Rating **	U	Issue No.	34
LM End	2.81	Issue Type +	Ma	Location *	WS
Category	Earthen Levee			GPS Latitude/Longitude	
				Start	End
Item	Erosion / Bank Caving			38.289200 °	38.288405 °
				-121.693500 °	-121.693617 °
DWR ID	LMA-256				
Comment Code					
E2 : Schedule repair of erosion site prior to the next inspection.					
Inspector Comment					
This was a 2017 Storm Damage site. The damage consists of scour and sloughing of the waterside levee slope. Site ID No:429 & 430 Site Designation:LMA-256, LMA-257

View looking downstream at erosion into the waterside slope (Spring 2020).

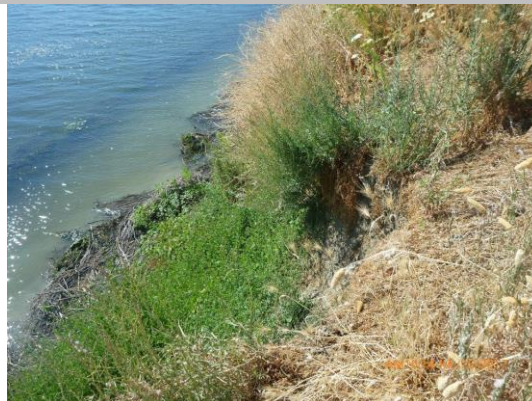
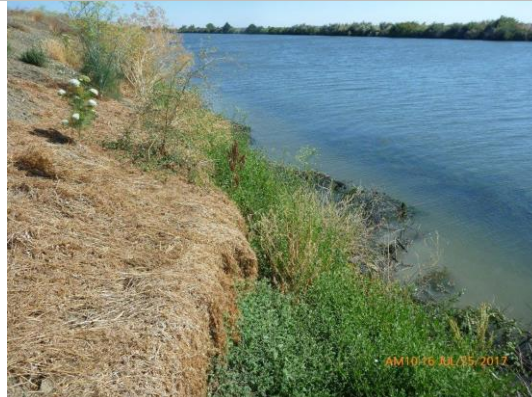
LM Start	2.99	Rating **	M	Issue No.	37
LM End	3.29	Issue Type +	Ma	Location *	WS
Category	Earthen Levee			GPS Latitude/Longitude	
				Start	End
Item	Erosion / Bank Caving			38.285700 °	38.281500 °
				-121.693500 °	-121.694300 °
DWR ID	LMA-259				
Comment Code					
E2 : Schedule repair of erosion site prior to the next inspection.					
Inspector Comment					
This was a 2017 Storm Damage site. The damage consists of scour and sloughing of the waterside levee slope. Site ID No:432 Site Designation:LMA-259

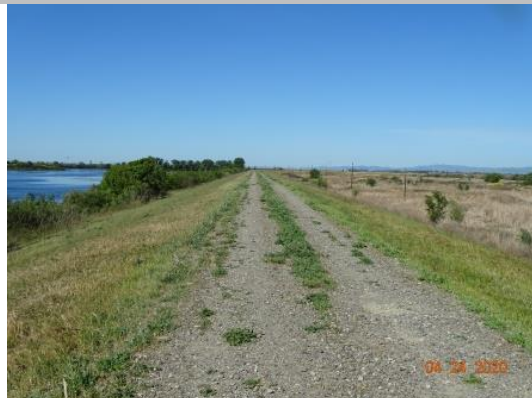
Photo 1 of 1 : SP_2020_RD2098_245_2_20200424_00001.jpg

View looking upstream at vegetation on the crown (Spring 2020).

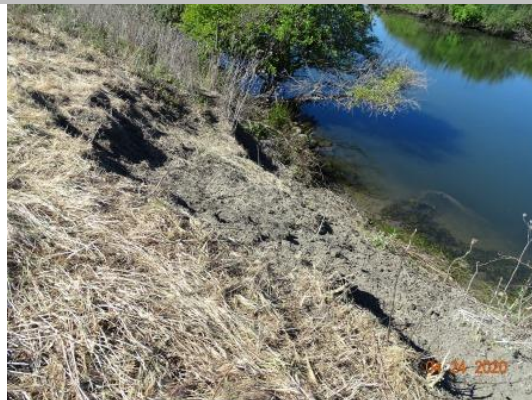
Photo 1 of 1 : SP_2020_RD2098_246_15_20200424_00036.jpg

LM Start	6.46	Rating **	U	Issue No.	15
LM End	6.48	Issue Type +	Ma	Location *	WS
Category	Earthen Levee			GPS Latitude/Longitude	
				Start	End
Item	Erosion / Bank Caving			38.288700 °	38.289061 °
				-121.717000 °	-121.716885 °
DWR ID	LMA-267				
Comment Code					
E2 : Schedule repair of erosion site prior to the next inspection.					
Inspector Comment					
This was a 2017 Storm Damage site. The damage consists of scour of the lower and mid waterside levee slope. Site ID No:440 & 441 Site Designation:LMA-267 & LMA-268

View looking downstream at erosion into the waterside slope (Spring 2020).

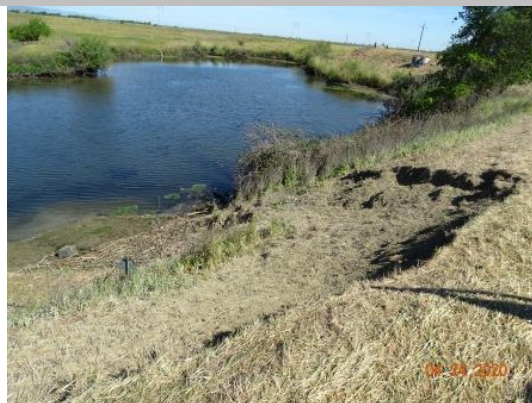
Photo 1 of 1 : SP_2020_RD2098_246_18_20200424_00037.jpg

LM Start	6.64	Rating **	U	Issue No.	18
LM End	6.65	Issue Type +	Ma	Location *	WS
Category	Earthen Levee			GPS Latitude/Longitude	
				Start	End
Item	Erosion / Bank Caving			38.291300 °	38.291400 °
				-121.716100 °	-121.716000 °
DWR ID	LMA-269				
Comment Code					
E2 : Schedule repair of erosion site prior to the next inspection.					
Inspector Comment					
This was a 2017 Storm Damage site. The damage consists of scour, cracking, instability, and sloughing of the waterside levee slope. Site ID No:442 Site Designation:LMA-269

View looking upstream at erosion into the waterside slope (Spring 2020).

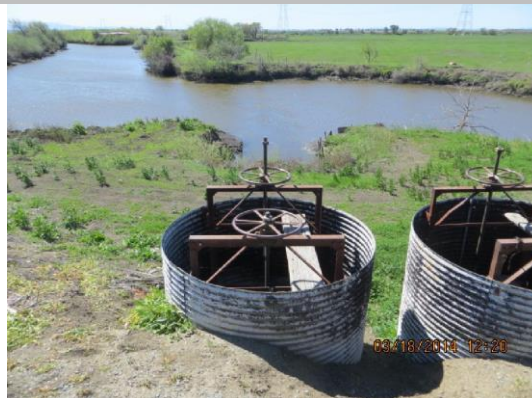
Photo 1 of 3 : UCIP_SP_2020_33784_61162.jpg

Comment Code						
Inspector Comment						
DS_ID:20976 FS_ID:33784 EP_NO: 10172 Repair Type: Non-Urgent Crossing Status: Found UCIP Comments: 03/18/2014 Headwalls on WS toe failing at outlet. It is unclear if these were permanent installations or something that was installed as a temporary fix. (W. Wylie - DWR UCIP) FIELD_STRUCT_DESC: 1 of 2: 48-inch corrugated metal drainage pipe through the levee, 29 feet below the crown. Two slide gates in a 7-foot-diameter corrugated metal pipe (CMP) riser on the waterside (WS) slope. (two 48-inch [HLM 6.75] authorized under Automatic Board Order (ABO) issued as Permit No. 10172, 1974 - Moresco Brothers). [Additional Reference(s): DWR Levee Log, 2003. USACE Sacramento O&M Manual 109, April 1962, (HLM 6.75)]. FS Date: 3/18/2014

Two slide gates in 7-foot diameter CMP riser on waterward slope.

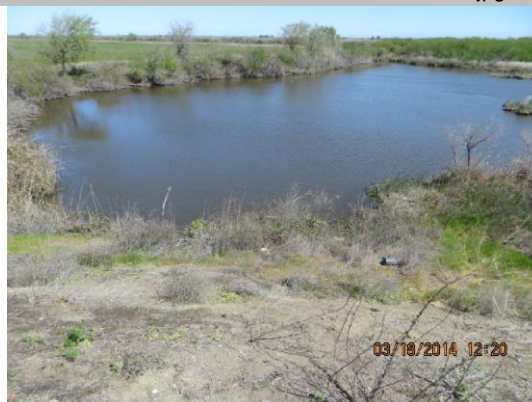
Photo 2 of 3 : UCIP_SP_2020_33784_61161.jpg

Inlet not visible on LS toe.

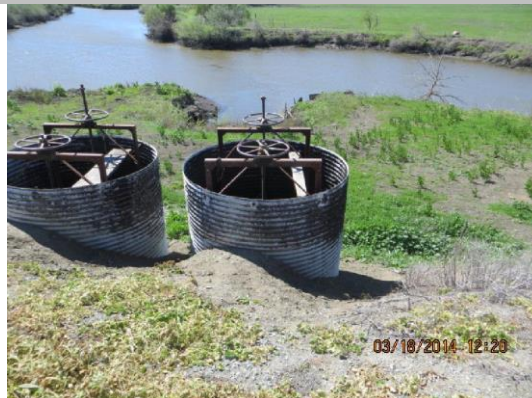
7-foot diameter CMP riser with two slide gates inside.

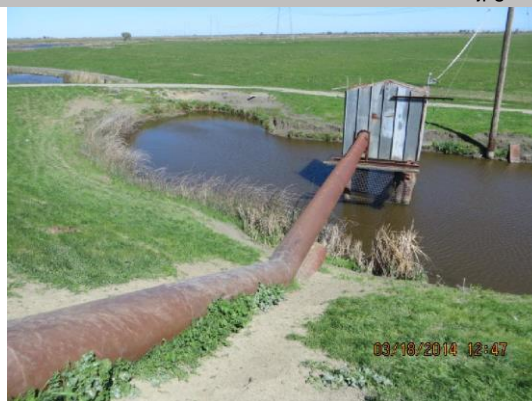
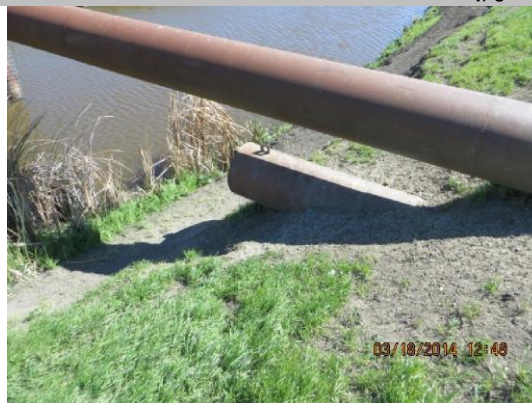
DS_ID:20978
FS_ID:32303
EP_NO: 10171
Repair Type: No Action Needed
Crossing Status: Found
UCIP Comments: 09/14/2017 Permit review indicates this 24-inch pipe was authorized as an irrigation and drainage pipe under ABO issued as Permit No. 10171, structure description was updated. Structure type logged as drainage. (DWR UCIP - O. Magana)
FIELD_STRUCT_DESC: *ABANDONED* 24-inch steel dual-purpose irrigation and drainage pipe through the levee, 4.5 feet below the crown. Corrugated metal cutoff wall around the pipe. Pipe has welded steel plate over end on the landside (LS) slope and is not visible on the waterside (WS) slope. (24-inch pipe [HLM 7.23] authorized under Automatic Board Order (ABO) issued as Permit No. 10171, 1974 - Glenn A. Bowlsbey). [Additional Reference(s): DWR Levee Log, 2003. USACE Sacramento O&M Manual 109, April 1962, (HLM 7.28)].
FS Date: 3/18/2014 7:07:14 AM

Pipe visible under new pipe on LS slope.

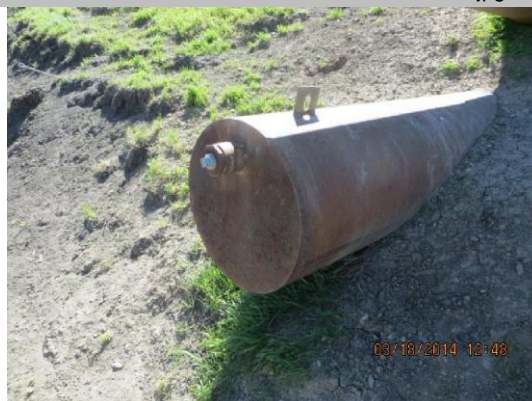
Photo 3 of 3 : UCIP_SP_2020_32303_58780.jpg

Welded steel cap over LS end of pipe.

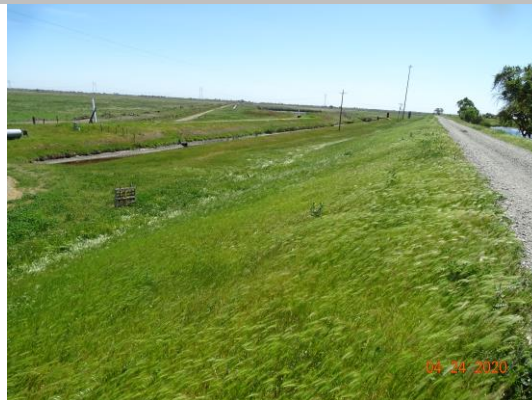
Photo 1 of 1 : SP_2020_RD2098_247_6_20200424_00021.jpg

View looking downstream at annual vegetation on the landside slope (Spring 2020).

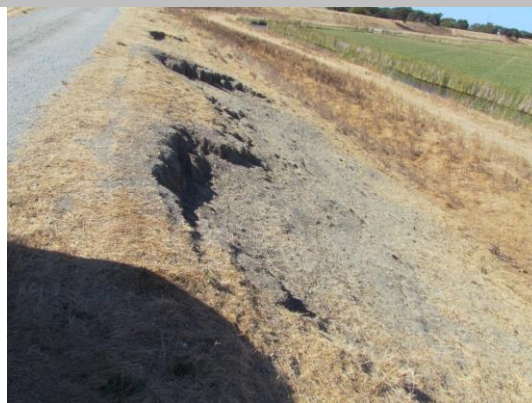
Photo 1 of 1 : SP_2020_RD2098_247_1_20200304_00002.jpg

LM Start	7.51	Rating **	M	Issue No.	1
LM End	7.51	Issue Type +	Ma	Location *	LS
Category	Earthen Levee			GPS Latitude/Longitude	
				Start	End
Item	Erosion / Bank Caving			38.296846 °	38.296846 °
				-121.727546 °	-121.727546 °
DWR ID	DWR_RD2098_03_f_2016_1				
Comment Code					
E2 : Schedule repair of erosion site prior to the next inspection.					
Inspector Comment					
Erosion on landside slope is caused by livestock activity and needs repair.

Close up. Looking upstream.

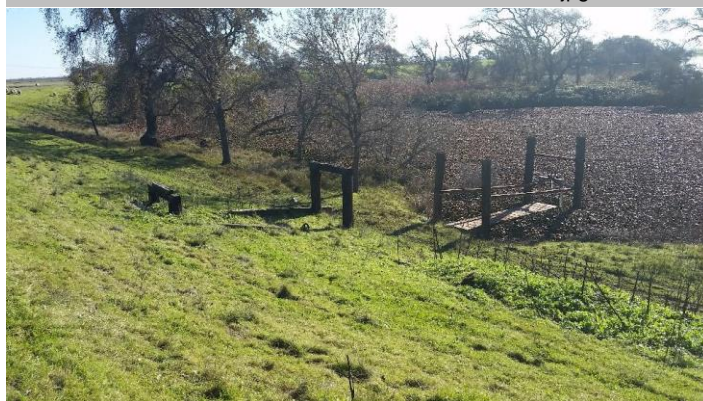
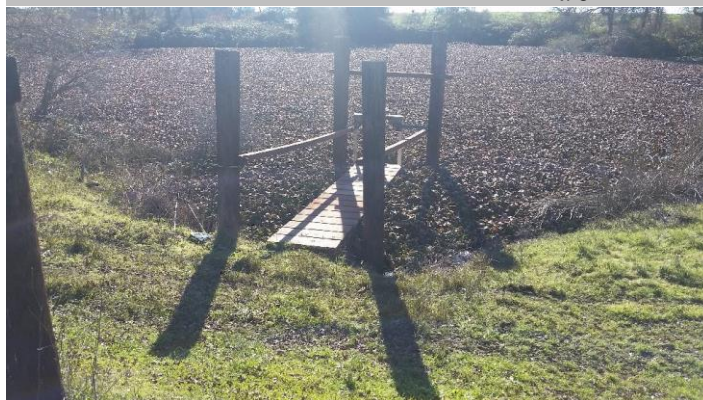
Comment Code					
Inspector Comment					
DS_ID:20981 FS_ID:51453 EP_NO: 10174 Repair Type: No Action Needed Crossing Status: Found UCIP Comments: 12/22/2016 Crossing has been downgraded from Urgent to No Action Needed walkways on both WS and LS have been rebuilt and the WS gate has been upgraded to stainless steel where previous corrodable material was present. (O. Magana - DWR UCIP)03/19/2014 Current walkway to slidegate on WS toe does not provide safe access to operate slidegate. (W. Wylie - DWR UCIP) FIELD_STRUCT_DESC: 36-inch steel dual-purpose irrigation and drainage pipe through the levee, 26 feet below the crown. Two corrugated metal cutoff walls around the pipe. Walkway to the slide gate on the waterside (WS) end. Combination slide and flap gate on the landside (LS) end. 48-inch corrugated metal pipe (CMP) riser and an adjoining pump on a metal pier at the LS toe. (36-inch pipe [HLM 8.20] authorized under Automatic Board Order (ABO) issued as Permit No. 10174, 1974 - Glen A. Bowsbey). [Additional Reference(s): DWR Levee Log, 2003. USACE Sacramento O&M Manual 109, April 1962, (HLM 8.20)]. FS Date: 12/22/2016

Walkway has been re-built, photo 1 of 2.

Walkway has been re-built, photo 2 of 2.

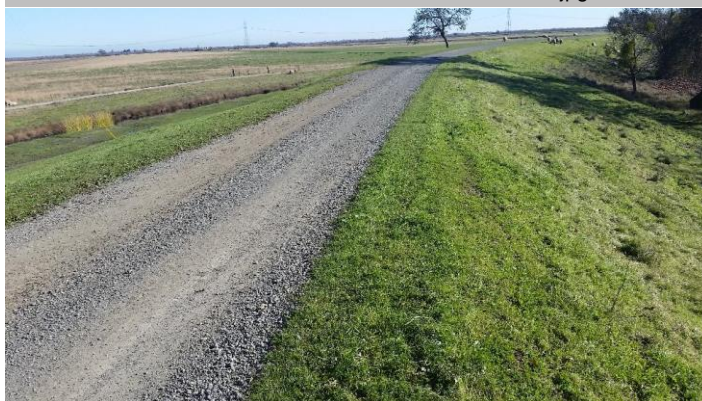
Photo 3 of 3 : UCIP_SP_2020_51453_76859.jpg

View of levee crown at pipe crossing.

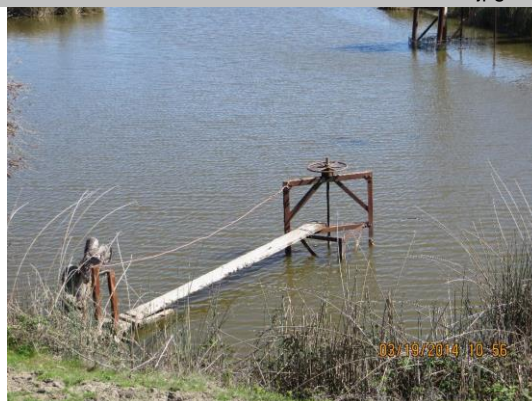
Photo 1 of 2 : UCIP_SP_2020_32384_58883.jpg

LM Start	8.35	Rating **	A/W	Issue No.	15
LM End	8.35	Issue Type +	Ma	Location *	
Category	Supplemental			GPS Latitude/Longitude	
				Start	End
Item	DWR UCIP LMA Responsibility			38.306916 °	38.306916 °
				-121.731984 °	-121.731984 °
DWR ID	20962				
Comment Code					
Inspector Comment					
DS_ID:20962 FS_ID:32384 EP_NO: 10174 Repair Type: No Action Needed Crossing Status: Found UCIP Comments: FIELD_STRUCT_DESC: 60-inch corrugated metal drainage pipe through the levee, 25.5 feet below the crown. Walkway to the slide gates at both ends of the pipe. (Permit No. 1607, 1951 - R. F. Moore and Lorraine W. Zanetti. This pipe was retained under Automatic Board Order (ABO) issued as Permit No. 10174, 1974 - Glen A. Bowlsbey). [Additional Reference(s): DWR Levee Log, 2003. USACE Sacramento O&M Manual 109, April 1962, (HLM 8.40)]. FS Date: 3/19/2014

Slide gate at LS toe.

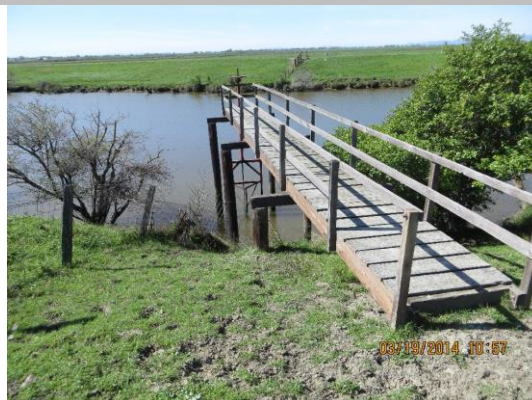
Photo 2 of 2 : UCIP_SP_2020_32384_58882.jpg

Walkway with slide gate on WS toe.

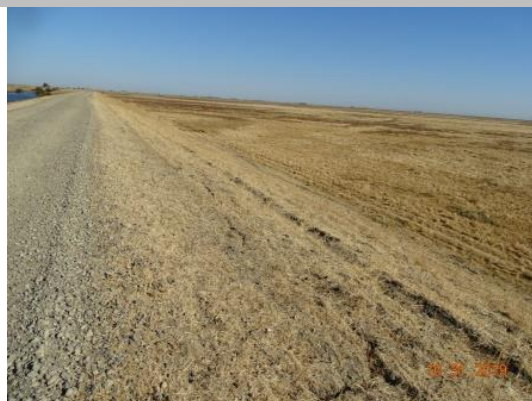
Photo 1 of 1 : SP_2020_RD2098_248_10_20200304_00004.jpg

LM Start	9.28	Rating **	M	Issue No.	10
LM End	9.28	Issue Type +	Ma	Location *	LS
Category	Earthen Levee		GPS Latitude/Longitude		
			Start	End	
Item	Animal Control		38.317940 °	38.317940 °	
			-121.740072 °	-121.740072 °	
DWR ID	DWR_RD2098_04_f_2019_10				
Comment Code					
A2 : Repair the levee slope damaged by livestock and prevent large animal access.					
Inspector Comment

View looking upstream at depressions in the landside slope due to cows (Fall 2019).

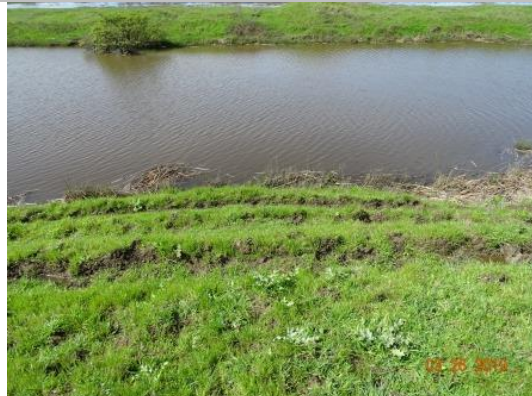
Photo 1 of 3 : SP_2020_RD2098_248_9_20200304_00001.jpg

View looking downslope at deep ruts in the waterside slope made by cows (Spring 2019).

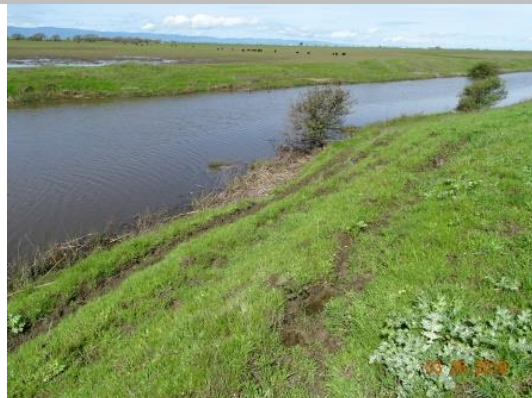
Photo 2 of 3 : SP_2020_RD2098_248_9_20200304_00002.jpg

View looking upstream at deep ruts in the waterside slope made by cows (Spring 2019).

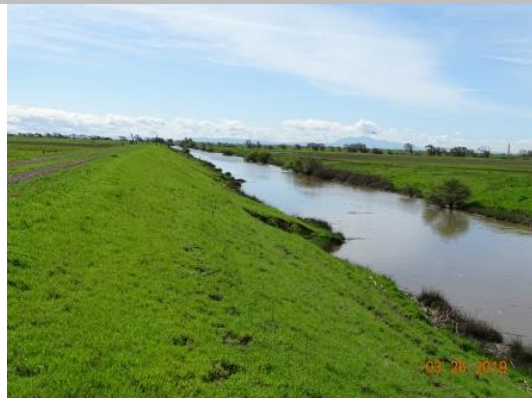
Photo 3 of 3 : SP_2020_RD2098_248_9_20200304_00003.jpg

View looking downstream at worst section of the erosion on the waterside slope (Spring 2019).

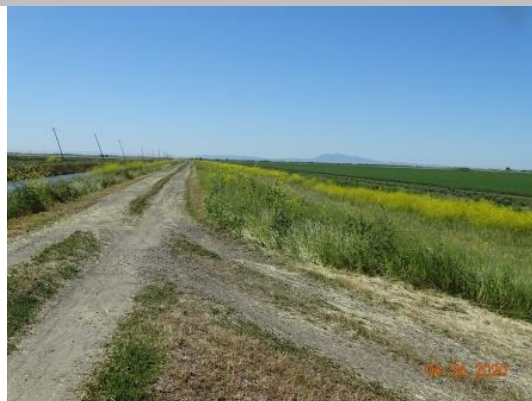
Photo 1 of 1 : SP_2020_RD2098_248_8_20200424_00024.jpg

LM Start	9.83	Rating **	U	Issue No.	8
LM End	12.05	Issue Type +	Ma	Location *	WS
Category	Earthen Levee			GPS Latitude/Longitude	
				Start	End
Item	Vegetation			38.325720 °	38.357779 °
				-121.740509 °	-121.740365 °
DWR ID	DWR_RD2098_04_s_2020_8

View looking downstream at annual vegetation on the waterside slope (Spring 2020).

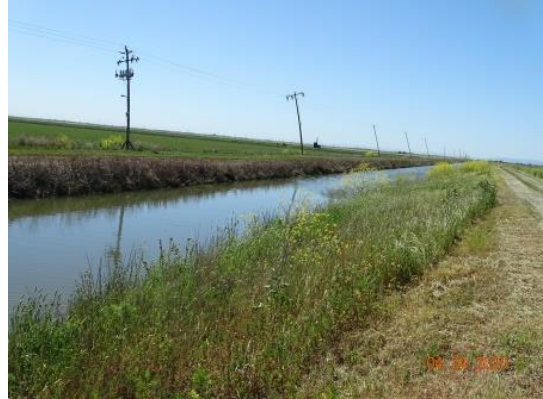
Photo 1 of 1 : SP_2020_RD2098_248_11_20200424_00025.jpg

View looking downstream at annual vegetation on the landside slope (Spring 2020).
