**Flood Control Project Maintenance
Levee Inspections**

Maintenance Issue Types Only, Levee Inspection Report By Mile - Spring 2021

Reclamation District No. 2098 Cache and Haas Slough

Waterway	Bank	Unit Miles	Inspection Start/End	Inspector
Unit No. 01 Yolo Bypass	Right	3.60	03/19/2021 03/19/2021	David Julian

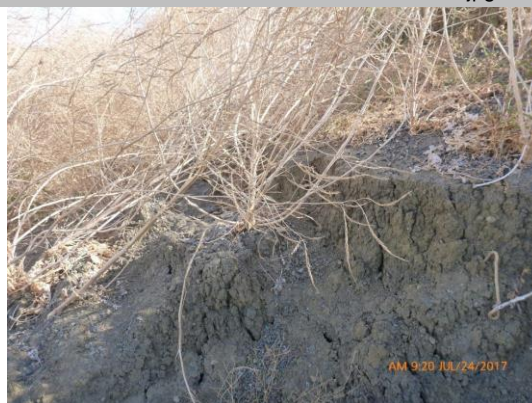
Photo 1 of 1 : LEVAL_SP_2021_414_3596.jpg

LM Start	0.96	Rating **	A/W	Issue No.	19
LM End	0.96	Issue Type +	Ma	Location *	LS
Category	Earthen Levee			GPS Latitude/Longitude	
				Start	End
Item	Erosion / Bank Caving			38.315200 °	38.315100 °
				-121.694100 °	-121.694100 °
DWR ID	DWR_RD2098_01_s_2021_19				
Comment Code					
E1 : Note and monitor erosion site.					
Inspector Comment					
This was a 2017 Storm Damage site. The damage consists of cracking and sloughing of the lower landside levee slope. Site ID No:414 Site Designation:LMA-241 4/24/2020 Field Notes: Vegetation is to thick to see. Verify in fall when vegetation less.

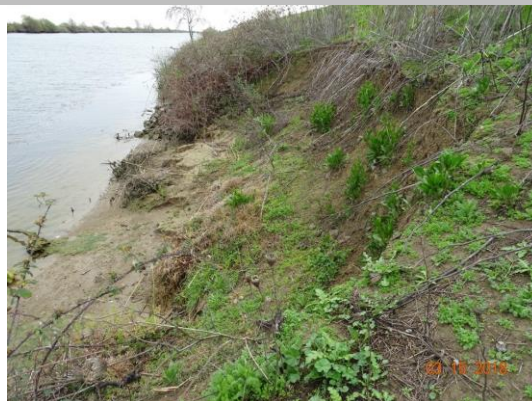
Photo 1 of 1 : SP_2021_RD2098_244_18_20210301_00004.jpg

LM Start	1.76	Rating **	M	Issue No.	18
LM End	1.76	Issue Type +	Ma	Location *	WS
Category	Earthen Levee			GPS Latitude/Longitude	
				Start	End
Item	Erosion / Bank Caving			38.303611 °	38.303611 °
				-121.693607 °	-121.693607 °
DWR ID	DWR_RD2098_01_s_2018_18				
Comment Code					
E2 : Schedule repair of erosion site prior to the next inspection.					
Inspector Comment					
There is erosion at the waterside toe.

View of erosion.

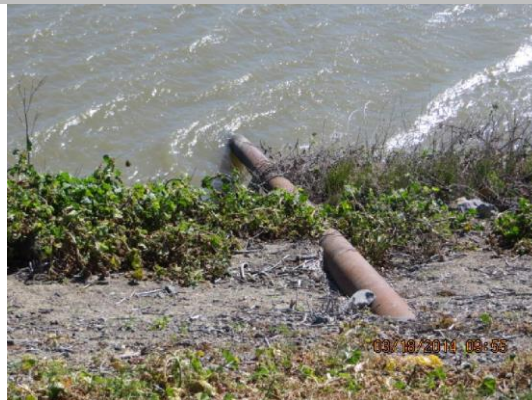
Photo 1 of 3 : UCIP_SP_2021_32197_58662.jpg

Comment Code					
Inspector Comment					
FS_ID:32197 DS_ID:20965 EP_NO: 10168 Repair Type: Non-Urgent Crossing Status: Found UCIP Comments: 12/22/2016 Met with Mike Hadesty, LMA Superintendent, and Brian Bush, LMA General Manager, to go over the list of pipes in RD2098. Per LMA records, this pipe has a different owner. (O. Magana - DWR UCIP) 03/18/2014 Erosion under pipe at WS toe. (W. Wylie - DWR UCIP) FIELD_STRUCT_DESC: 10-inch steel drainage pipe through the levee, 2.8 feet below the crown. Pump in pump house off the landside (LS). (This pipe was retained under Automatic Board Order (ABO) issued as Permit No. 10168, 1974 - Moresco Brothers). [Additional Reference(s): DWR Levee Log, 2003. USACE Sacramento O&M Manual 109, April 1962, (HLM 1.80)]. FS Date: 3/18/2014

Pipe on WS slope.

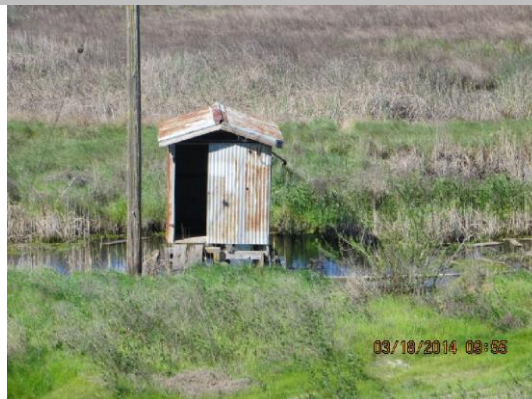
Photo 2 of 3 : UCIP_SP_2021_32197_58661.jpg

Pumphouse at lowpoint off LS toe.

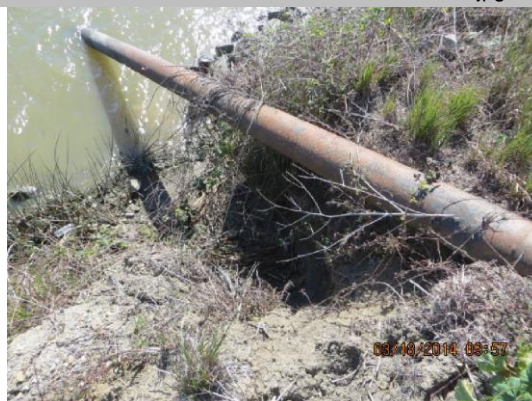
Photo 3 of 3 : UCIP_SP_2021_32197_58660.jpg

Erosion under pipe at WS toe.

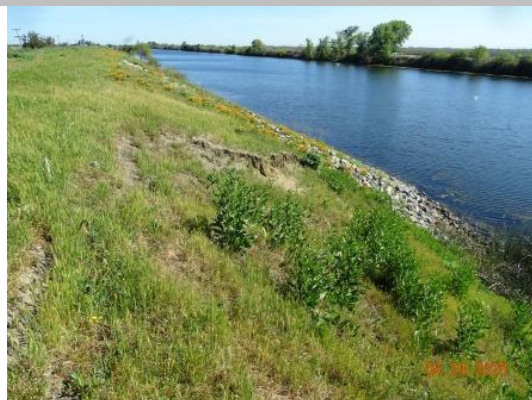
Photo 1 of 1 : SP_2021_RD2098_244_27_20210301_00007.jpg

LM Start	2.29	Rating **	U	Issue No.	27
LM End	2.32	Issue Type +	Ma	Location *	WS
Category	Earthen Levee			GPS Latitude/Longitude	
				Start	End
Item	Erosion / Bank Caving			38.295900 °	38.295468 °
				-121.693500 °	-121.693619 °
DWR ID	LMA-248				
Comment Code					
E2 : Schedule repair of erosion site prior to the next inspection.					
Inspector Comment					
This was a 2017 Storm Damage site. The damage consists of scour and sloughing of the waterside levee slope. Site ID No:421 Site Designation:LMA-248

View looking upstream at erosion in the waterside slope (Spring 2020).

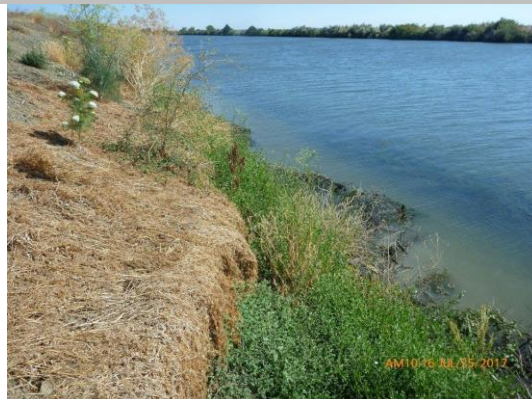
Photo 1 of 1 : SP_2021_RD2098_244_37_20210301_00011.jpg

LM Start	2.99	Rating **	M	Issue No.	37
LM End	3.29	Issue Type +	Ma	Location *	WS
Category	Earthen Levee			GPS Latitude/Longitude	
				Start	End
Item	Erosion / Bank Caving			38.285700 °	38.281500 °
				-121.693500 °	-121.694300 °
DWR ID	LMA-259				
Comment Code					
E2 : Schedule repair of erosion site prior to the next inspection.					
Inspector Comment					
This was a 2017 Storm Damage site. The damage consists of scour and sloughing of the waterside levee slope. Site ID No:432 Site Designation:LMA-259

View of erosion on the waterside slope. Photo was taken in 2017.

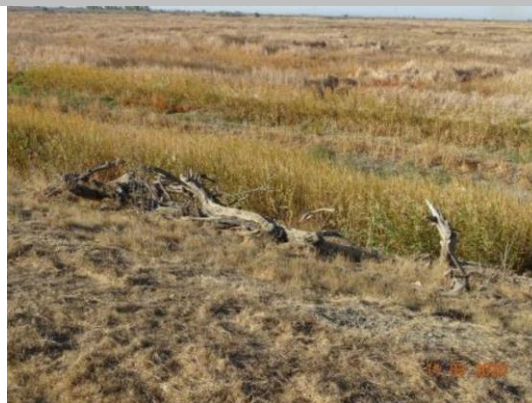
Photo 1 of 1 : SP_2021_RD2098_244_20_20210301_00006.jpg

LM Start	3.13	Rating **	M	Issue No.	20
LM End	3.13	Issue Type +	Ma	Location *	LS
Category	Earthen Levee			GPS Latitude/Longitude	
				Start	End
Item	Encroachments			38.283800 °	38.283800 °
				-121.693618 °	-121.693618 °
DWR ID	DWR_RD2098_01_s_2020_20				
Comment Code					
TR : Tree or limb					
Inspector Comment

View of tree limb on the landside slope (Fall 2020).

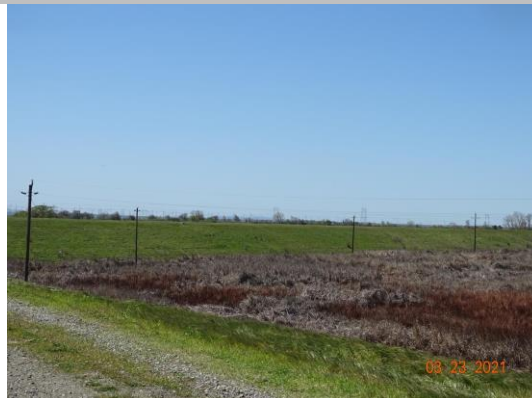
Photo 1 of 1 : SP_2021_RD2098_245_1_20210323_00001.jpg

LM Start	0.00	Rating **	A	Issue No.	1
LM End	0.52	Issue Type +	Ma	Location *	LS
Category	Earthen Levee			GPS Latitude/Longitude	
				Start	End
Item	Vegetation			38.277410 °	38.275700 °
				-121.696280 °	-121.705596 °
DWR ID	DWR_RD2098_01A_s_2021_1				
Comment Code					
V1 : Control annual grass and weeds on the levee slopes and easements.					
Inspector Comment

View of vegetation on the landside slope off in the distance (Spring 2021).

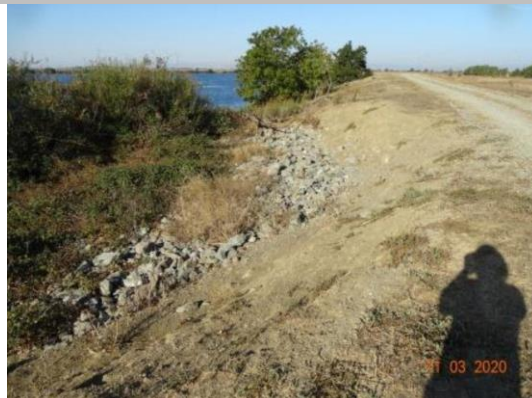
Photo 1 of 1 : SP_2021_RD2098_246_11_20210301_00002.jpg

LM Start	5.88	Rating **	U	Issue No.	11
LM End	5.88	Issue Type +	Ma	Location *	WS
Category	Earthen Levee			GPS Latitude/Longitude	
				Start	End
Item	Erosion / Bank Caving			38.282946 °	38.282946 °
				-121.710902 °	-121.710902 °
DWR ID	DWR_RD2098_02_f_2020_11				
Comment Code					
E2 : Schedule repair of erosion site prior to the next inspection.					
Inspector Comment					
This waterside slump site is not new, and is somewhat protected by riprap and thick brushy vegetation, but it has the potential to erode into crown during high water with a strong south wind. It currently has a two-foot vertical scarp at the levee shoulder.

View looking upstream at erosion into waterside slope (Fall 2020).

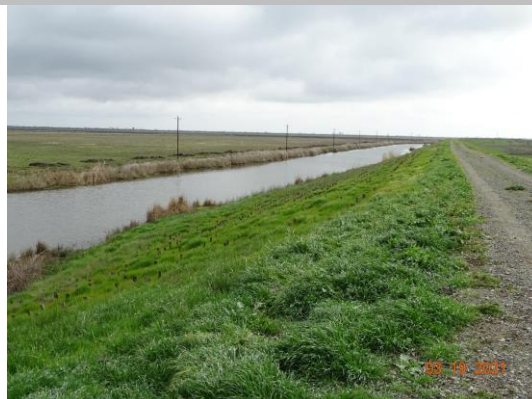
Photo 1 of 1 : SP_2021_RD2098_246_6_20210319_00023.jpg

LM Start	6.17	Rating **	M	Issue No.	6
LM End	7.14	Issue Type +	Ma	Location *	LS
Category	Earthen Levee			GPS Latitude/Longitude	
				Start	End
Item	Vegetation			38.284926 °	38.292979 °
				-121.715326 °	-121.723396 °
DWR ID	DWR_RD2098_02_s_2021_6				
Comment Code					
V1 : Control annual grass and weeds on the levee slopes and easements.					
Inspector Comment

View looking downstream at vegetation on the landside slope (Spring 2021).

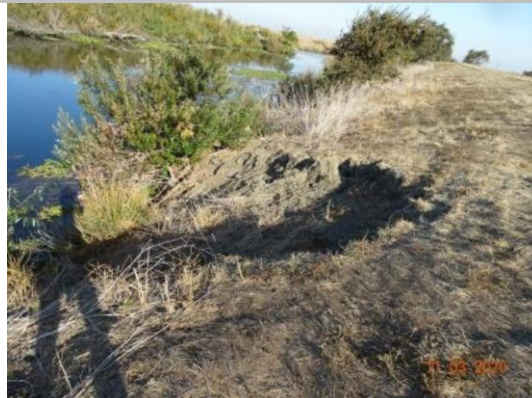
Photo 1 of 1 : SP_2021_RD2098_246_15_20210301_00004.jpg

LM Start	6.46	Rating **	U	Issue No.	15
LM End	6.48	Issue Type +	Ma	Location *	WS
Category	Earthen Levee			GPS Latitude/Longitude	
				Start	End
Item	Erosion / Bank Caving			38.288700 °	38.289061 °
				-121.717000 °	-121.716885 °
DWR ID	LMA-267				
Comment Code					
E2 : Schedule repair of erosion site prior to the next inspection.					
Inspector Comment					
This was a 2017 Storm Damage site. The damage consists of scour of the lower and mid waterside levee slope. Site ID No:440 & 441 Site Designation:LMA-267 & LMA-268

View looking upstream at erosion into the waterside slope (Fall 2020).

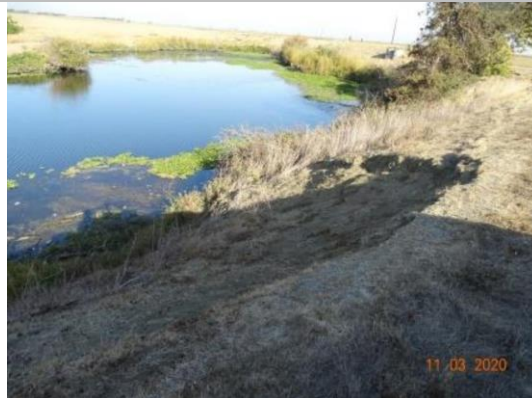
Photo 1 of 1 : SP_2021_RD2098_246_18_20210301_00005.jpg

LM Start	6.64	Rating **	U	Issue No.	18
LM End	6.65	Issue Type +	Ma	Location *	WS
Category	Earthen Levee			GPS Latitude/Longitude	
				Start	End
Item	Erosion / Bank Caving			38.291300 °	38.291400 °
				-121.716100 °	-121.716000 °
DWR ID	LMA-269				
Comment Code					
E2 : Schedule repair of erosion site prior to the next inspection.					
Inspector Comment					
This was a 2017 Storm Damage site. The damage consists of scour, cracking, instability, and sloughing of the waterside levee slope. Site ID No:442 Site Designation:LMA-269

View looking upstream at erosion into the waterside slope (Fall 2020).

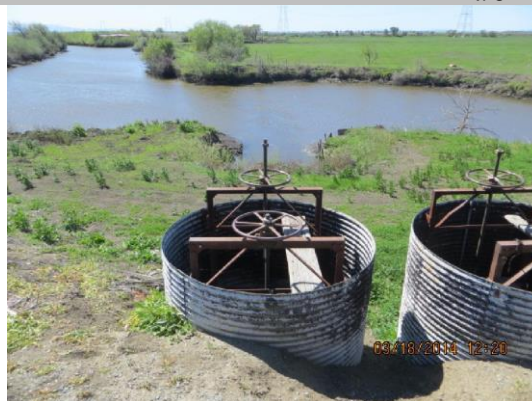
Photo 1 of 3 : UCIP_SP_2021_33784_61162.jpg

Comment Code						
Inspector Comment						
FS_ID:33784 DS_ID:20976 EP_NO: 10172 Repair Type: Non-Urgent Crossing Status: Found UCIP Comments: 03/18/2014 Headwalls on WS toe failing at outlet. It is unclear if these were permanent installations or something that was installed as a temporary fix. (W. Wylie - DWR UCIP) FIELD_STRUCT_DESC: 1 of 2: 48-inch corrugated metal drainage pipe through the levee, 29 feet below the crown. Two slide gates in a 7-foot-diameter corrugated metal pipe (CMP) riser on the waterside (WS) slope. (two 48-inch [HLM 6.75] authorized under Automatic Board Order (ABO) issued as Permit No. 10172, 1974 - Moresco Brothers). [Additional Reference(s): DWR Levee Log, 2003. USACE Sacramento O&M Manual 109, April 1962, (HLM 6.75)]. FS Date: 3/18/2014

Two slide gates in 7-foot diameter CMP riser on waterward slope.

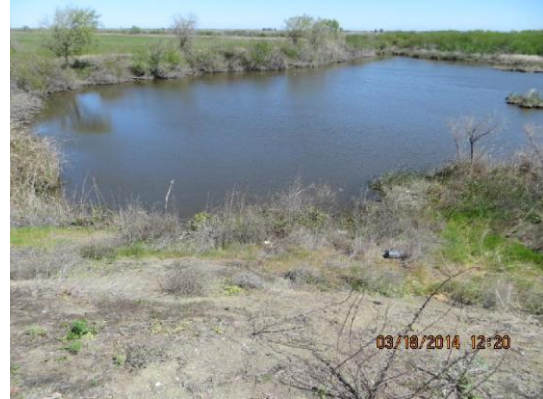
Photo 2 of 3 : UCIP_SP_2021_33784_61161.jpg

Inlet not visible on LS toe.

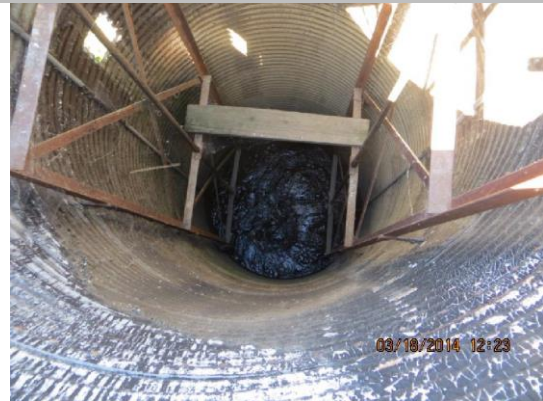
Photo 3 of 3 : UCIP_SP_2021_33784_61160.jpg

View inside CMP riser on WS shoulder.

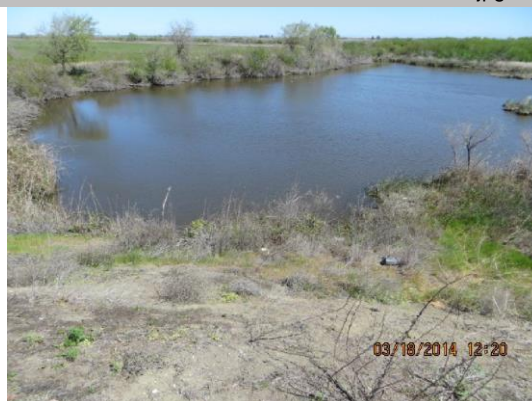
Photo 1 of 3 : UCIP_SP_2021_32285_58749.jpg

Comment Code						
Inspector Comment						
FS_ID:32285 DS_ID:20961 EP_NO: 10172 Repair Type: Non-Urgent Crossing Status: Found UCIP Comments: 03/18/2014 Headwalls at WS toe failing. It is uncertain if these retaining walls were a permanent fixture or a temporary fix that failed. (W. Wylie - DWR UCIP) FIELD_STRUCT_DESC: 2 of 2: 48-inch corrugated metal drainage pipe through the levee, 29 feet below the crown. Two slide gates in a 7-foot-diameter corrugated metal pipe (CMP) riser on the waterside (WS) slope. (two 48-inch pipes [HLM 6.75] authorized under Automatic Board Order (ABO) issued as Permit No. 10172, 1974 - Moresco Brothers). [Additional Reference(s): DWR Levee Log, 2003. USACE Sacramento O&M Manual 109, April 1962, (HLM 6.75)]. FS Date: 3/18/2014

Inlet not visible on LS toe.

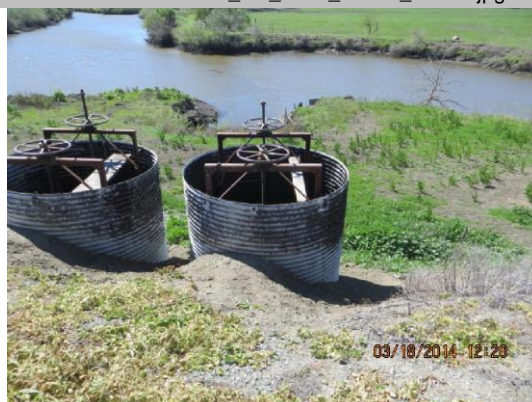
Photo 2 of 3 : UCIP_SP_2021_32285_58748.jpg

7-foot diameter CMP riser with two slide gates inside.

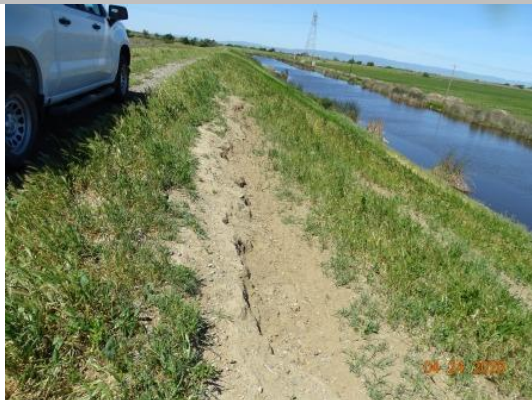
Photo 1 of 1 : SP_2021_RD2098_246_12_20210301_00003.jpg

LM Start	6.86	Rating **	M	Issue No.	12
LM End	6.86	Issue Type +	Ma	Location *	LS
Category	Earthen Levee			GPS Latitude/Longitude	
				Start	End
Item	Erosion / Bank Caving			38.292965 °	38.292965 °
				-121.718188 °	-121.718188 °
DWR ID	DWR_RD2098_02_s_2020_12				
Comment Code					
E2 : Schedule repair of erosion site prior to the next inspection.					
Inspector Comment					
Erosion at the top of the landside slope.

View looking upstream at erosion at the top of the landside slope (Spring 2020).

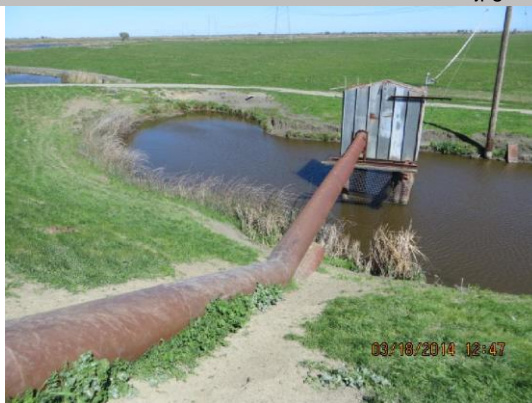
Photo 1 of 3 : UCIP_SP_2021_32303_58782.jpg

Comment Code						
Inspector Comment						
FS_ID:32303 DS_ID:20978 EP_NO: 10171 Repair Type: No Action Needed Crossing Status: Found UCIP Comments: 09/14/2017 Permit review indicates this 24-inch pipe was authorized as an irrigation and drainage pipe under ABO issued as Permit No. 10171, structure description was updated. Structure type logged as drainage. (DWR UCIP - O. Magana) FIELD_STRUCT_DESC: *ABANDONED* 24-inch steel dual-purpose irrigation and drainage pipe through the levee, 4.5 feet below the crown. Corrugated metal cutoff wall around the pipe. Pipe has welded steel plate over end on the landside (LS) slope and is not visible on the waterside (WS) slope. (24-inch pipe [HLM 7.23] authorized under Automatic Board Order (ABO) issued as Permit No. 10171, 1974 - Glenn A. Bowsbey). [Additional Reference(s): DWR Levee Log, 2003. USACE Sacramento O&M Manual 109, April 1962, (HLM 7.28)]. FS Date: 3/18/2014 7:07:14 AM

Pipe visible under new pipe on LS slope.

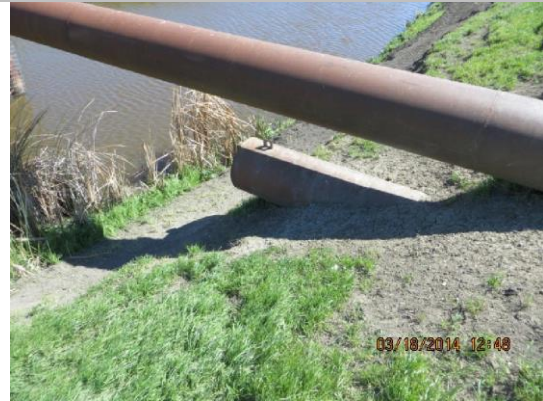
Photo 2 of 3 : UCIP_SP_2021_32303_58781.jpg

Pipe visible under new pipe on LS slope.

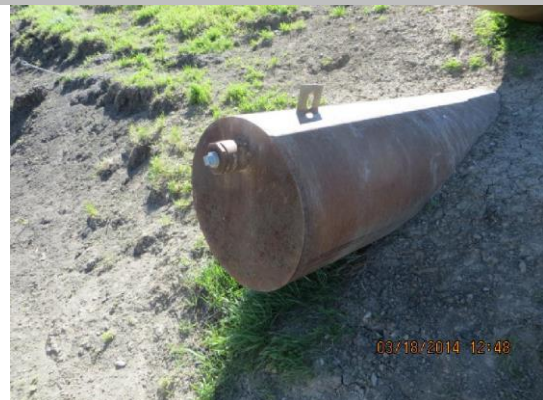
Photo 3 of 3 : UCIP_SP_2021_32303_58780.jpg

Welded steel cap over LS end of pipe.

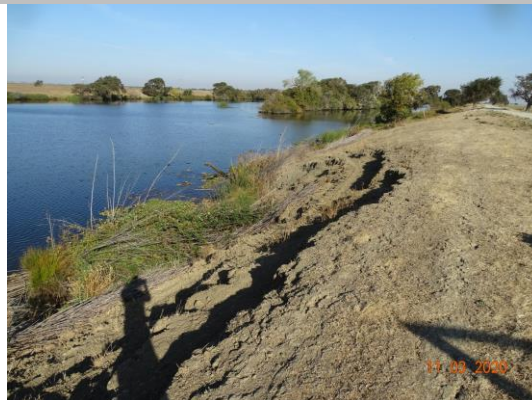
Photo 1 of 1 : SP_2021_RD2098_247_7_20210301_00001.jpg

LM Start	7.33	Rating **	M	Issue No.	7
LM End	7.72	Issue Type +	Ma	Location *	WS
Category	Supplemental			GPS Latitude/Longitude	
				Start	End
Item	2017 USACE Erosion Survey			38.294858 °	38.299606 °
				-121.725433 °	-121.728621 °
DWR ID	DWR_RD2098_03_f_2018_7				
Comment Code					
Inspector Comment					
2017 Site ID: HAS 7.9 L					
Status: Eroding					
2017 Field Notes: POSSIBLY BEING FIXED BY RD; deep cracks along bank and toe, intermittent slump.					
Site History: 2011 - Large vertical erosion pockets and bank slumping.					
Includes three 2017 Storm Damage Sites.					
Sites 449, 450, & 451. LMA-276, LMA-277, LMA-278.

View looking upstream at erosion into the waterside slope (Fall 2020).

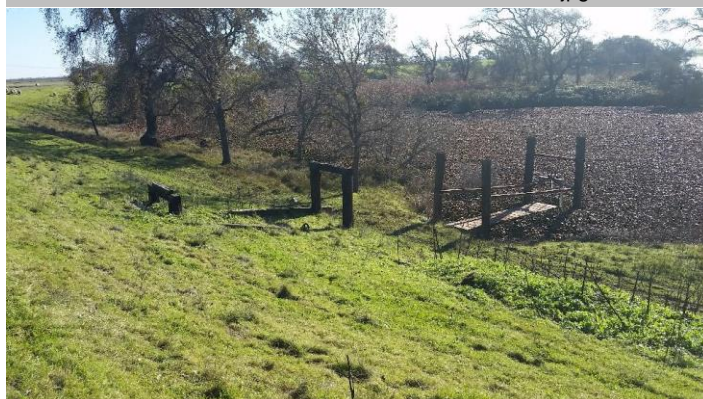
Photo 1 of 3 : UCIP_SP_2021_51453_76858.jpg

Comment Code						
Inspector Comment						
FS_ID:51453 DS_ID:20981 EP_NO: 10174 Repair Type: No Action Needed Crossing Status: Found UCIP Comments: 12/22/2016 Crossing has been downgraded from Urgent to No Action Needed walkways on both WS and LS have been rebuilt and the WS gate has been upgraded to stainless steel where previous corrodable material was present. (O. Magana - DWR UCIP)03/19/2014 Current walkway to slidegate on WS toe does not provide safe access to operate slidegate. (W. Wylie - DWR UCIP) FIELD_STRUCT_DESC: 36-inch steel dual-purpose irrigation and drainage pipe through the levee, 26 feet below the crown. Two corrugated metal cutoff walls around the pipe. Walkway to the slide gate on the waterside (WS) end. Combination slide and flap gate on the landside (LS) end. 48-inch corrugated metal pipe (CMP) riser and an adjoining pump on a metal pier at the LS toe. (36-inch pipe [HLM 8.20] authorized under Automatic Board Order (ABO) issued as Permit No. 10174, 1974 - Glen A. Bowsbey). [Additional Reference(s): DWR Levee Log, 2003. USACE Sacramento O&M Manual 109, April 1962, (HLM 8.20)]. FS Date: 12/22/2016

Walkway has been re-built, photo 1 of 2.

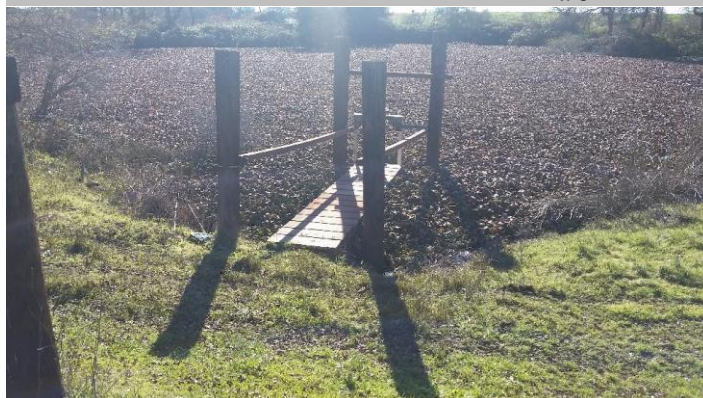
Photo 2 of 3 : UCIP_SP_2021_51453_76861.jpg

Walkway has been re-built, photo 2 of 2.

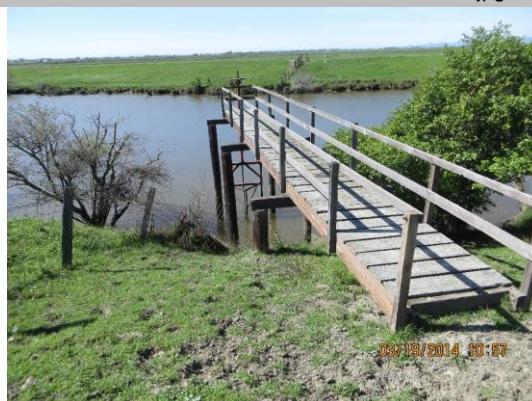
Photo 2 of 2 : UCIP_SP_2021_32384_58882.jpg

Walkway with slide gate on WS toe.

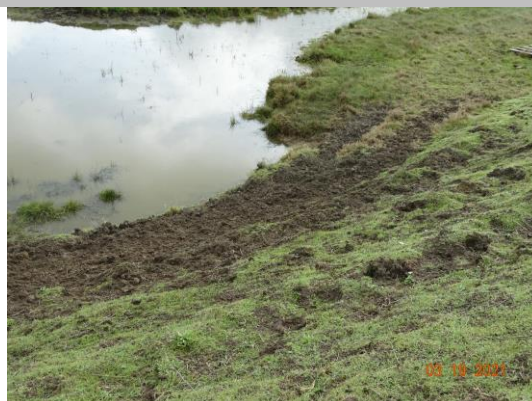
Photo 1 of 1 : SP_2021_RD2098_247_4_20210319_00007.jpg

LM Start	8.50	Rating **	U	Issue No.	4
LM End	9.07	Issue Type +	Ma	Location *	LS
Category	Earthen Levee			GPS Latitude/Longitude	
				Start	End
Item	Animal Control			38.308628 °	38.315222 °
				-121.733495 °	-121.739255 °
DWR ID	DWR_RD2098_03_s_2021_4				
Comment Code					
A2 : Repair the levee slope damaged by livestock and prevent large animal access.					
Inspector Comment

View of slope terracing caused by cattle on the landside slope (Spring 2021).

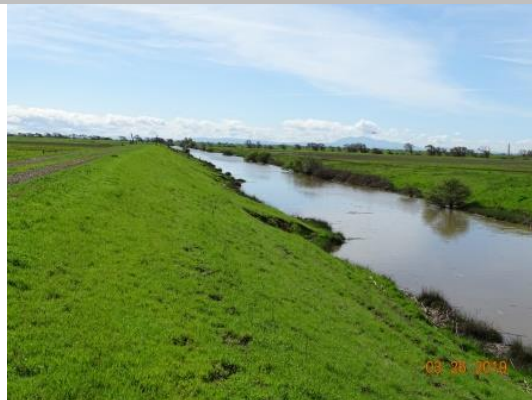
Photo 1 of 1 : SP_2021_RD2098_248_9_20210301_00001.jpg

View looking downstream at worst section of the erosion on the waterside slope (Spring 2019).
