**Flood Control Project Maintenance
Levee Inspections**

Maintenance Issue Types Only, Levee Inspection Report By Mile - Spring 2022

Reclamation District No. 2098 Cache and Haas Slough

Waterway	Bank	Unit Miles	Inspection Start/End	Inspector
Unit No. 01 Yolo Bypass	Right	3.60	03/18/2022 03/18/2022	David Julian

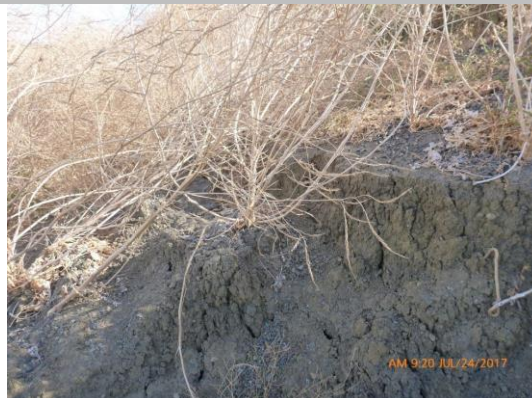
Photo 1 of 1 : LEVAL_SP_2022_414_3596.jpg

LM Start	0.96	Rating **	A/W	Issue No.	19
LM End	0.96	Issue Type +	Ma	Location *	LS
Category	Earthen Levee			GPS Latitude/Longitude	
				Start	End
Item	Erosion / Bank Caving			38.315200 °	38.315100 °
				-121.694100 °	-121.694100 °
DWR ID	DWR_RD2098_01_s_2021_19				
Comment Code					
E1 : Note and monitor erosion site.					
Inspector Comment					
This was a 2017 Storm Damage site. The damage consists of cracking and sloughing of the lower landside levee slope. Site ID No:414 Site Designation:LMA-241 4/24/2020 Field Notes: Vegetation is to thick to see. Verify in fall when vegetation less.

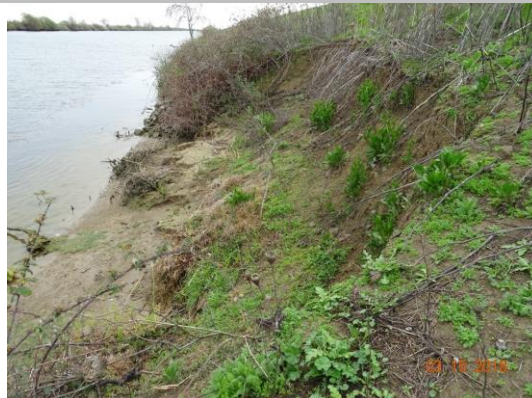
Photo 1 of 1 : SP_2022_RD2098_244_18_20220310_00003.jpg

LM Start	1.76	Rating **	M	Issue No.	18
LM End	1.76	Issue Type +	Ma	Location *	WS
Category	Earthen Levee			GPS Latitude/Longitude	
				Start	End
Item	Erosion / Bank Caving			38.303611 °	38.303611 °
				-121.693607 °	-121.693607 °
DWR ID	DWR_RD2098_01_s_2018_18				
Comment Code					
E2 : Schedule repair of erosion site prior to the next inspection.					
Inspector Comment					
There is erosion at the waterside toe.

View of erosion.

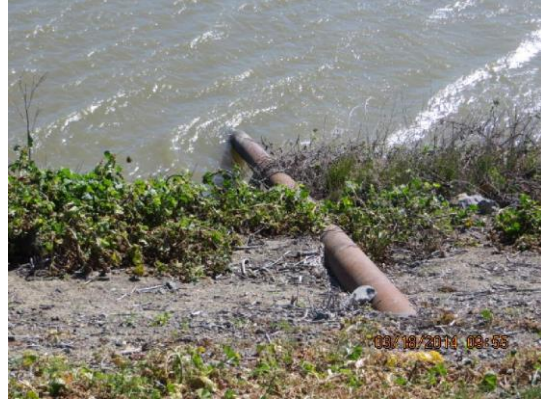
Photo 1 of 3 : UCIP_SP_2022_32197_58662.jpg

Comment Code						
Inspector Comment						
FS_ID:32197 DS_ID:20965 EP_NO: 10168 Repair Type: Non-Urgent Crossing Status: Found UCIP Comments: 12/22/2016 Met with Mike Hadesty, LMA Superintendent, and Brian Bush, LMA General Manager, to go over the list of pipes in RD2098. Per LMA records, this pipe has a different owner. (O. Magana - DWR UCIP) 03/18/2014 Erosion under pipe at WS toe. (W. Wylie - DWR UCIP) FIELD_STRUCT_DESC: 10-inch steel drainage pipe through the levee, 2.8 feet below the crown. Pump in pump house off the landside (LS). (This pipe was retained under Automatic Board Order (ABO) issued as Permit No. 10168, 1974 - Moresco Brothers). [Additional Reference(s): DWR Levee Log, 2003. USACE Sacramento O&M Manual 109, April 1962, (HLM 1.80)]. FS Date: 3/18/2014

Pipe on WS slope.

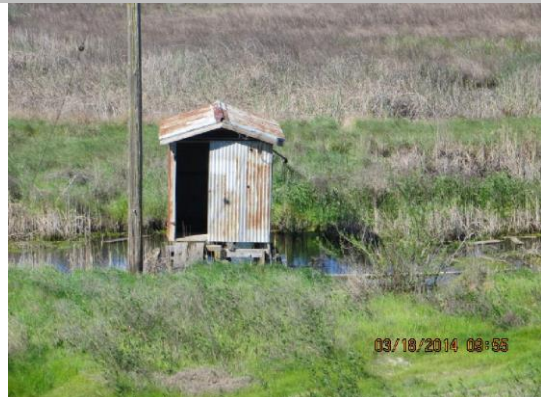
Photo 2 of 3 : UCIP_SP_2022_32197_58661.jpg

Pumphouse at lowpoint off LS toe.

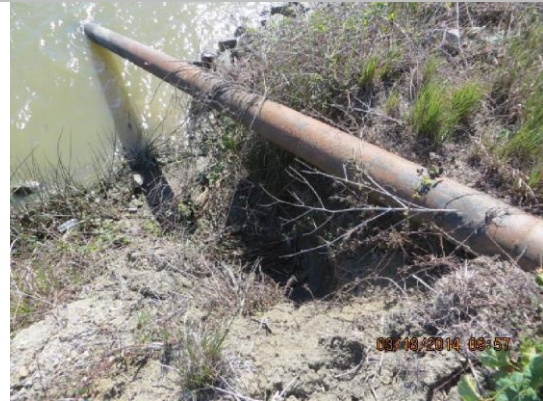
Photo 3 of 3 : UCIP_SP_2022_32197_58660.jpg

Erosion under pipe at WS toe.

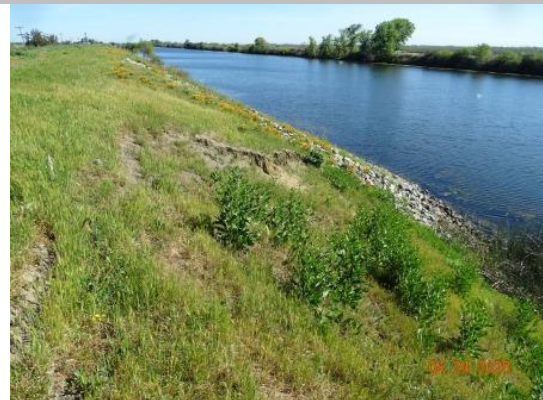
Photo 1 of 1 : SP_2022_RD2098_244_27_20220310_00006.jpg

LM Start	2.29	Rating **	U	Issue No.	27
LM End	2.32	Issue Type +	Ma	Location *	WS
Category	Earthen Levee			GPS Latitude/Longitude	
				Start	End
Item	Erosion / Bank Caving			38.295900 °	38.295468 °
				-121.693500 °	-121.693619 °
DWR ID	LMA-248				
Comment Code					
E2 : Schedule repair of erosion site prior to the next inspection.					
Inspector Comment					
This was a 2017 Storm Damage site. The damage consists of scour and sloughing of the waterside levee slope. Site ID No:421 Site Designation:LMA-248

View looking upstream at erosion in the waterside slope (Spring 2020).

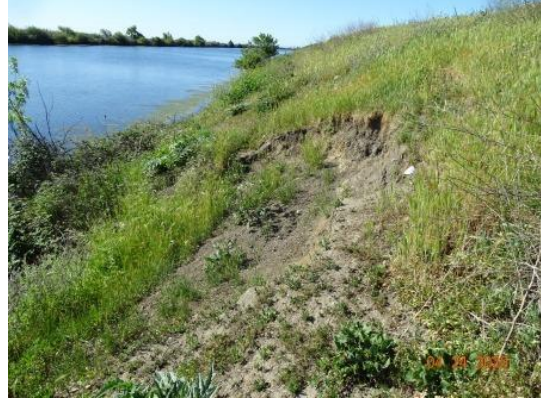
Photo 1 of 1 : SP_2022_RD2098_244_28_20220310_00007.jpg

LM Start	2.35	Rating **	U	Issue No.	28
LM End	2.39	Issue Type +	Ma	Location *	WS
Category	Earthen Levee			GPS Latitude/Longitude	
				Start	End
Item	Erosion / Bank Caving			38.295100 °	38.294500 °
				-121.693400 °	-121.693400 °
DWR ID	LMA-250				
Comment Code					
E2 : Schedule repair of erosion site prior to the next inspection.					
Inspector Comment					
This was a 2017 Storm Damage site. The damage consists of scour, sloughing, and cracking of the lower and mid waterside levee slope. Site ID No:423 Site Designation:LMA-250

View looking upstream at erosion into the waterside slope (Spring 2020).

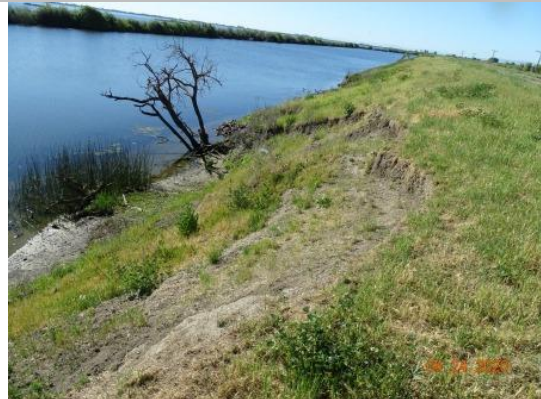
Photo 1 of 1 : SP_2022_RD2098_244_34_20220310_00008.jpg

LM Start	2.75	Rating **	U	Issue No.	34
LM End	2.81	Issue Type +	Ma	Location *	WS
Category	Earthen Levee			GPS Latitude/Longitude	
				Start	End
Item	Erosion / Bank Caving			38.289200 °	38.288405 °
				-121.693500 °	-121.693617 °
DWR ID	LMA-256				
Comment Code					
E2 : Schedule repair of erosion site prior to the next inspection.					
Inspector Comment					
This was a 2017 Storm Damage site. The damage consists of scour and sloughing of the waterside levee slope. Site ID No:429 & 430 Site Designation:LMA-256, LMA-257

View looking downstream at erosion into the waterside slope (Spring 2020).

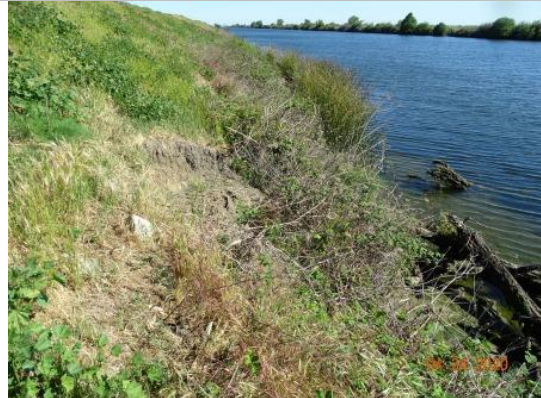
Photo 1 of 1 : SP_2022_RD2098_244_36_20220310_00009.jpg

LM Start	2.91	Rating **	U	Issue No.	36
LM End	2.93	Issue Type +	Ma	Location *	WS
Category	Earthen Levee			GPS Latitude/Longitude	
				Start	End
Item	Erosion / Bank Caving			38.286900 °	38.286700 °
				-121.693500 °	-121.693500 °
DWR ID	LMA-258				
Comment Code					
E2 : Schedule repair of erosion site prior to the next inspection.					
Inspector Comment					
This was a 2017 Storm Damage site. The damage consists of scour and sloughing of the waterside levee slope. Site ID No:431 Site Designation:LMA-258

View looking upstream at erosion into the waterside slope (Spring 2020).

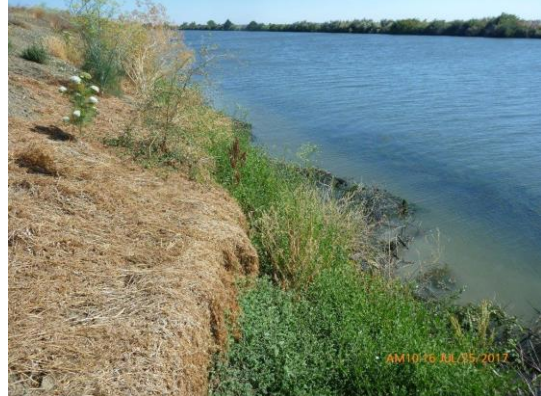
Photo 1 of 1 : SP_2022_RD2098_244_37_20220310_00010.jpg

LM Start	2.99	Rating **	M	Issue No.	37
LM End	3.29	Issue Type +	Ma	Location *	WS
Category	Earthen Levee			GPS Latitude/Longitude	
				Start	End
Item	Erosion / Bank Caving			38.285700 °	38.281500 °
				-121.693500 °	-121.694300 °
DWR ID	LMA-259				
Comment Code					
E2 : Schedule repair of erosion site prior to the next inspection.					
Inspector Comment					
This was a 2017 Storm Damage site. The damage consists of scour and sloughing of the waterside levee slope. Site ID No:432 Site Designation:LMA-259

View of erosion on the waterside slope. Photo was taken in 2017.

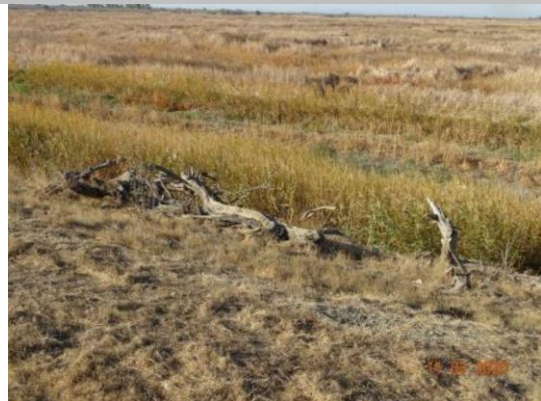
Photo 1 of 1 : SP_2022_RD2098_244_20_20220310_00005.jpg

LM Start	3.13	Rating **	M	Issue No.	20
LM End	3.13	Issue Type +	Ma	Location *	LS
Category	Earthen Levee			GPS Latitude/Longitude	
				Start	End
Item	Encroachments			38.283800 °	38.283800 °
				-121.693618 °	-121.693618 °
DWR ID	DWR_RD2098_01_s_2020_20				
Comment Code					
TR : Tree or limb					
Inspector Comment

View of tree limb on the landside slope (Fall 2020).

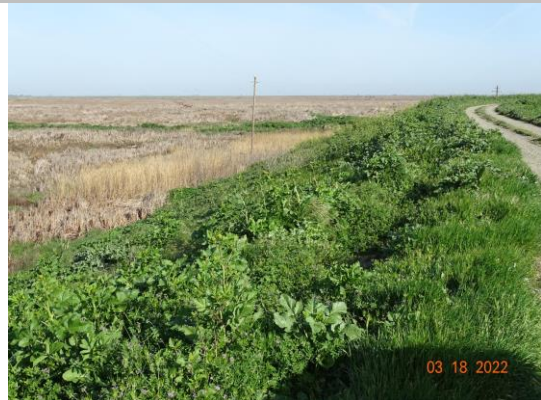
Photo 1 of 1 : SP_2022_RD2098_244_22_20220318_00033.jpg

LM Start	3.23	Rating **	U	Issue No.	22
LM End	3.59	Issue Type +	Ma	Location *	LS
Category	Earthen Levee			GPS Latitude/Longitude	
				Start	End
Item	Vegetation			38.282395 °	38.277577 °
				-121.693982 °	-121.696227 °
DWR ID	DWR_RD2098_01_s_2022_22				
Comment Code					
V1 : Control annual grass and weeds on the levee slopes and easements.					
Inspector Comment

View looking upstream at vegetation on the landside slope (Spring 2022).

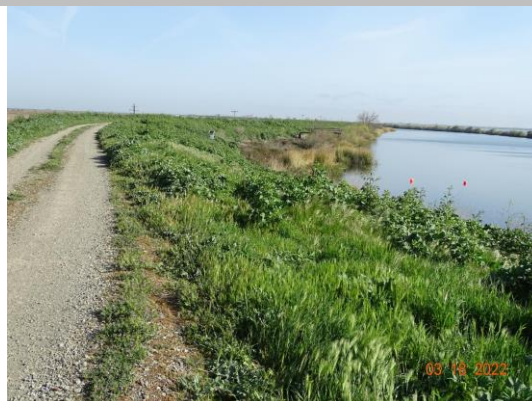
Photo 1 of 1 : SP_2022_RD2098_244_23_20220318_00032.jpg

View looking upstream at vegetation on the waterside slope (Spring 2022).

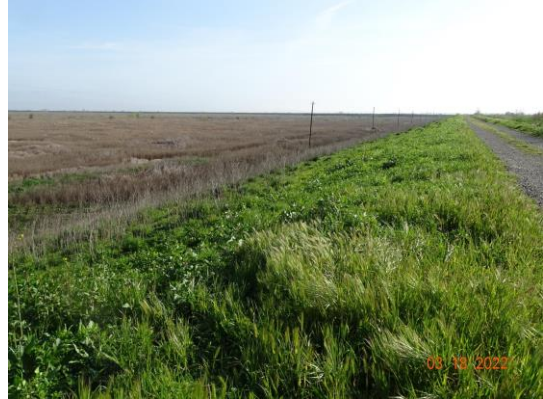
Photo 1 of 1 : SP_2022_RD2098_245_1_20220318_00001.jpg

View looking downstream at vegetation on the landside slope (Spring 2022).

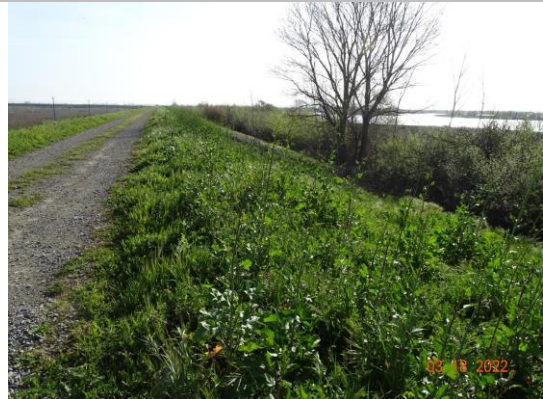
Photo 1 of 1 : SP_2022_RD2098_245_2_20220318_00002.jpg

LM Start	0.01	Rating **	M	Issue No.	2
LM End	0.52	Issue Type +	Ma	Location *	WS
Category	Earthen Levee		GPS Latitude/Longitude		
			Start	End	
Item	Vegetation		38.277392 °	38.275721 °	
			-121.696396 °	-121.705517 °	
DWR ID	DWR_RD2098_01A_s_2022_2				
Comment Code					
V1 : Control annual grass and weeds on the levee slopes and easements.					
Inspector Comment

View looking downstream at vegetation on the waterside slope (Spring 2022).

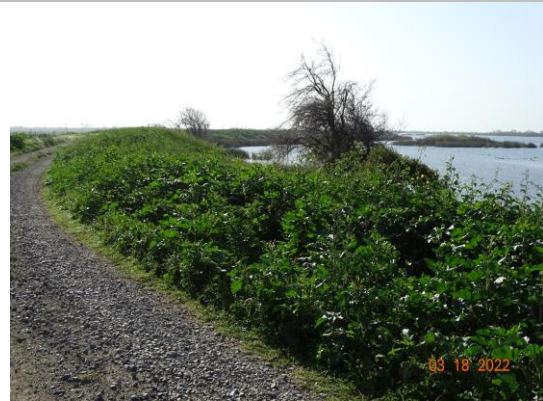
Photo 1 of 1 : SP_2022_RD2098_246_8_20220318_00027.jpg

View looking downstream at vegetation on the waterside slope (Spring 2022).

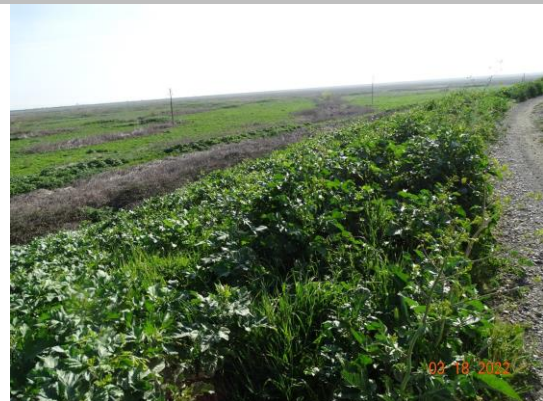
Photo 1 of 1 : SP_2022_RD2098_246_7_20220318_00026.jpg

LM Start	5.31	Rating **	U	Issue No.	7
LM End	7.16	Issue Type +	Ma	Location *	LS
Category	Earthen Levee			GPS Latitude/Longitude	
				Start	End
Item	Vegetation			38.275898 °	38.292986 °
				-121.705914 °	-121.723733 °
DWR ID	DWR_RD2098_02_f_2021_7				
Comment Code					
V1 : Control annual grass and weeds on the levee slopes and easements.					
Inspector Comment

View looking downstream at vegetation on the landside slope (Spring 2022).

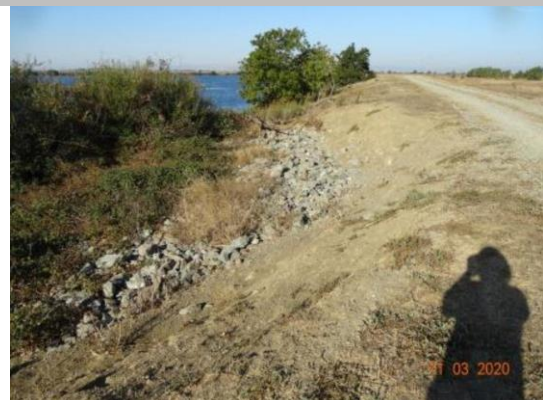
Photo 1 of 1 : SP_2022_RD2098_246_11_20220310_00004.jpg

LM Start	5.88	Rating **	U	Issue No.	11
LM End	5.88	Issue Type +	Ma	Location *	WS
Category	Earthen Levee			GPS Latitude/Longitude	
				Start	End
Item	Erosion / Bank Caving			38.282946 °	38.282946 °
				-121.710902 °	-121.710902 °
DWR ID	DWR_RD2098_02_f_2020_11				
Comment Code					
E2 : Schedule repair of erosion site prior to the next inspection.					
Inspector Comment					
This waterside slump site is not new, and is somewhat protected by riprap and thick brushy vegetation, but it has the potential to erode into crown during high water with a strong south wind. It currently has a two-foot vertical scarp at the levee shoulder.

View looking upstream at erosion into waterside slope (Fall 2020).

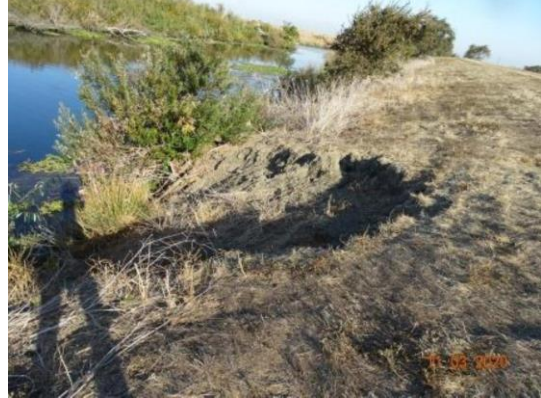
Photo 1 of 1 : SP_2022_RD2098_246_15_20220310_00006.jpg

LM Start	6.46	Rating **	U	Issue No.	15
LM End	6.48	Issue Type +	Ma	Location *	WS
Category	Earthen Levee			GPS Latitude/Longitude	
				Start	End
Item	Erosion / Bank Caving			38.288700 °	38.289061 °
				-121.717000 °	-121.716885 °
DWR ID	LMA-267				
Comment Code					
E2 : Schedule repair of erosion site prior to the next inspection.					
Inspector Comment					
This was a 2017 Storm Damage site. The damage consists of scour of the lower and mid waterside levee slope. Site ID No:440 & 441 Site Designation:LMA-267 & LMA-268

View looking upstream at erosion into the waterside slope (Fall 2020).

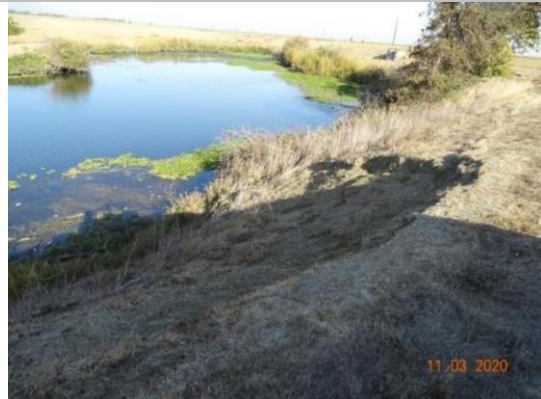
Photo 1 of 1 : SP_2022_RD2098_246_18_20220310_00007.jpg

LM Start	6.64	Rating **	U	Issue No.	18
LM End	6.65	Issue Type +	Ma	Location *	WS
Category	Earthen Levee			GPS Latitude/Longitude	
				Start	End
Item	Erosion / Bank Caving			38.291300 °	38.291400 °
				-121.716100 °	-121.716000 °
DWR ID	LMA-269				
Comment Code					
E2 : Schedule repair of erosion site prior to the next inspection.					
Inspector Comment					
This was a 2017 Storm Damage site. The damage consists of scour, cracking, instability, and sloughing of the waterside levee slope. Site ID No:442 Site Designation:LMA-269

View looking upstream at erosion into the waterside slope (Fall 2020).

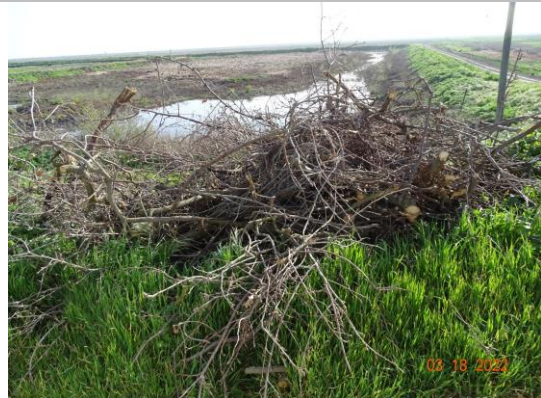
Photo 1 of 1 : SP_2022_RD2098_246_9_20220318_00025.jpg

View of cut up tree limbs on the landside shoulder (Spring 2022).

LM Start	6.68	Rating **	U	Issue No.	9
LM End	6.68	Issue Type +	Ma	Location *	LS
Category	Earthen Levee			GPS Latitude/Longitude	
				Start	End
Item	Encroachments			38.291779 °	38.291779 °
				-121.715727 °	-121.715727 °
DWR ID	DWR_RD2098_02_s_2022_9				
Comment Code					
PR : Prunings					
Inspector Comment					
Remove tree prunings on the landside shoulder.

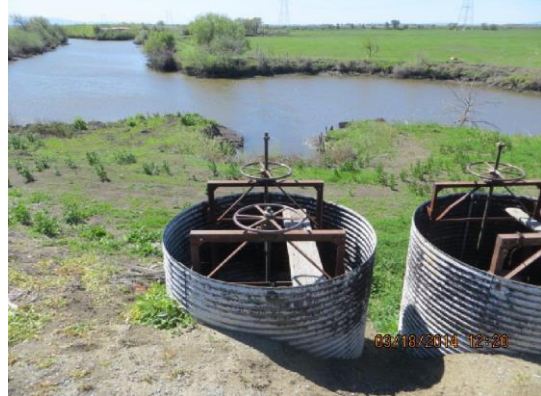
Photo 1 of 3 : UCIP_SP_2022_33784_61162.jpg

Comment Code						
Inspector Comment						
FS_ID:33784 DS_ID:20976 EP_NO: 10172 Repair Type: Non-Urgent Crossing Status: Found UCIP Comments: 03/18/2014 Headwalls on WS toe failing at outlet. It is unclear if these were permanent installations or something that was installed as a temporary fix. (W. Wylie - DWR UCIP) FIELD_STRUCT_DESC: 1 of 2: 48-inch corrugated metal drainage pipe through the levee, 29 feet below the crown. Two slide gates in a 7-foot-diameter corrugated metal pipe (CMP) riser on the waterside (WS) slope. (two 48-inch [HLM 6.75] authorized under Automatic Board Order (ABO) issued as Permit No. 10172, 1974 - Moresco Brothers). [Additional Reference(s): DWR Levee Log, 2003. USACE Sacramento O&M Manual 109, April 1962, (HLM 6.75)]. FS Date: 3/18/2014

Two slide gates in 7-foot diameter CMP riser on waterward slope.

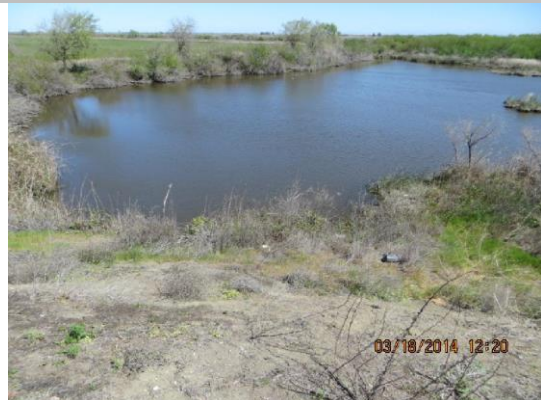
Photo 2 of 3 : UCIP_SP_2022_33784_61161.jpg

Inlet not visible on LS toe.

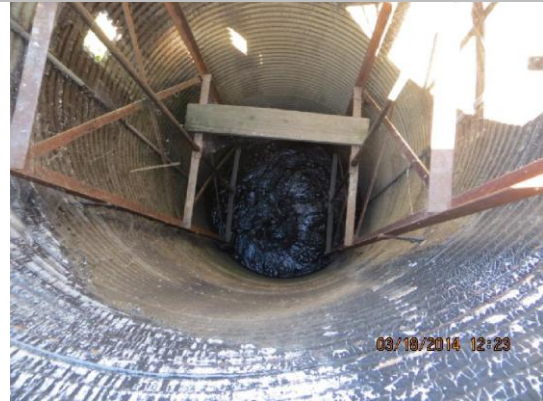
Photo 3 of 3 : UCIP_SP_2022_33784_61160.jpg

View inside CMP riser on WS shoulder.

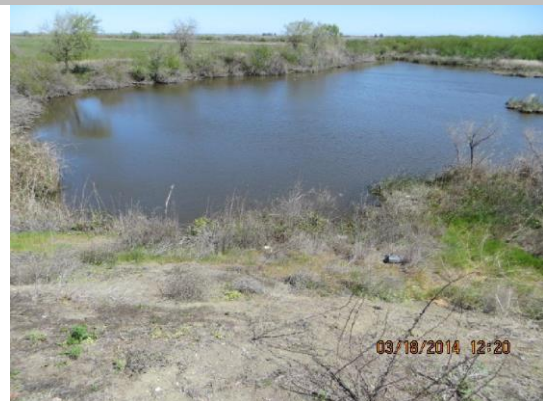
Photo 1 of 3 : UCIP_SP_2022_32285_58749.jpg

FS_ID:32285
 DS_ID:20961
 EP_NO: 10172
 Repair Type: Non-Urgent
 Crossing Status: Found
 UCIP Comments: 03/18/2014 Headwalls at WS toe failing. It is uncertain if these retaining walls were a permanent fixture or a temporary fix that failed. (W. Wylie - DWR UCIP)
 FIELD_STRUCT_DESC: 2 of 2: 48-inch corrugated metal drainage pipe through the levee, 29 feet below the crown. Two slide gates in a 7-foot-diameter corrugated metal pipe (CMP) riser on the waterside (WS) slope. (two 48-inch pipes [HLM 6.75] authorized under Automatic Board Order (ABO) issued as Permit No. 10172, 1974 - Moresco Brothers).
 [Additional Reference(s): DWR Levee Log, 2003. USACE Sacramento O&M Manual 109, April 1962, (HLM 6.75)].
 FS Date: 3/18/2014

Inlet not visible on LS toe.

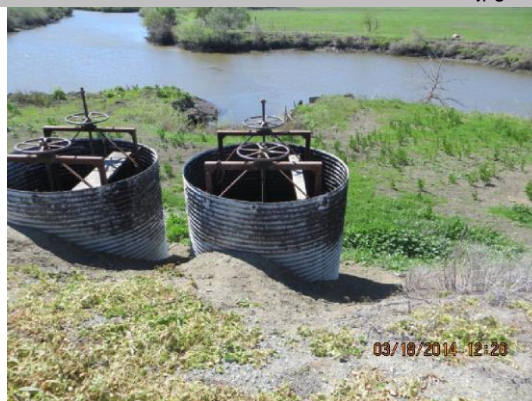
Photo 2 of 3 : UCIP_SP_2022_32285_58748.jpg

7-foot diameter CMP riser with two slide gates inside.

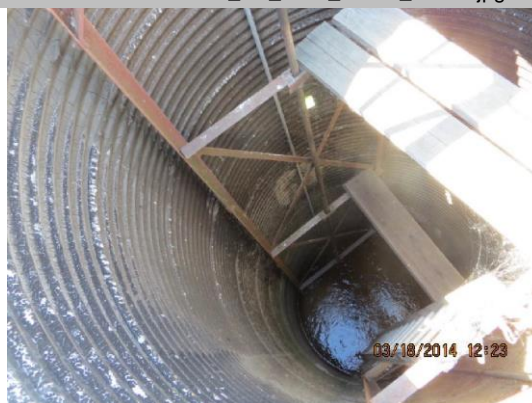
Photo 3 of 3 : UCIP_SP_2022_32285_58747.jpg

7-foot diameter CMP riser with two slide gates inside.

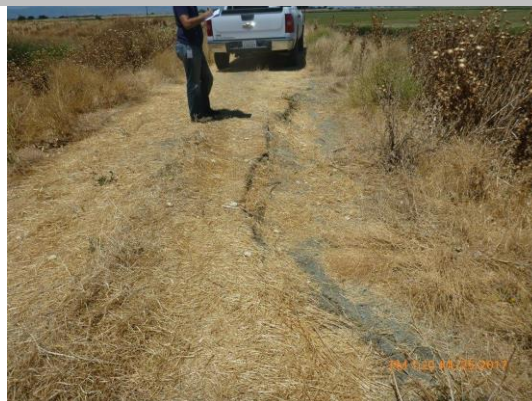
Photo 1 of 1 : SP_2022_RD2098_246_19_20220310_00008.jpg

LM Start	6.74	Rating **	M	Issue No.	19
LM End	6.75	Issue Type +	Ma	Location *	LS
Category	Earthen Levee			GPS Latitude/Longitude	
				Start	End
Item	Slope Stability			38.292500 °	38.292600 °
				-121.716100 °	-121.716200 °
DWR ID	LMA-270

View of landside sloughing. Photo taken in 2017.

Comment Code					
S1 : Repair slope instability.					
Inspector Comment					
This was a 2017 Storm Damage site. The damage consists of scour and sloughing of the landside levee slope. Site ID No:443 Site Designation:LMA-270

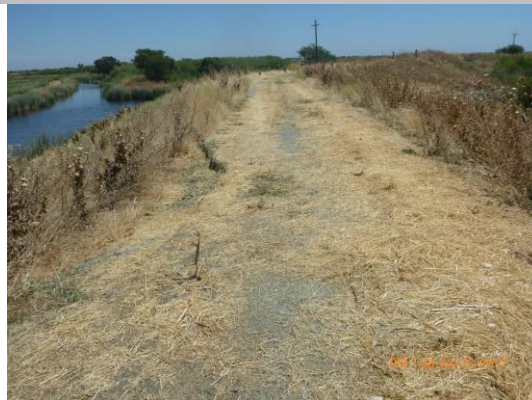
Photo 1 of 1 : SP_2022_RD2098_246_20_20220310_00009.jpg

LM Start	6.77	Rating **	A/W	Issue No.	20
LM End	6.80	Issue Type +	Ma	Location *	LS
Category	Earthen Levee			GPS Latitude/Longitude	
				Start	End
Item	Erosion / Bank Caving			38.292900 °	38.293000 °
				-121.716600 °	-121.717000 °
DWR ID	LMA-271				
Comment Code					
E2 : Schedule repair of erosion site prior to the next inspection.					
Inspector Comment					
This was a 2017 Storm Damage site. The damage consists of cracking of the levee crest. Site ID No:444 Site Designation:LMA-271 Spring 2022: Do not see any evidence of cracking.

View of erosion on the landside levee crest. Photo taken in 2017.

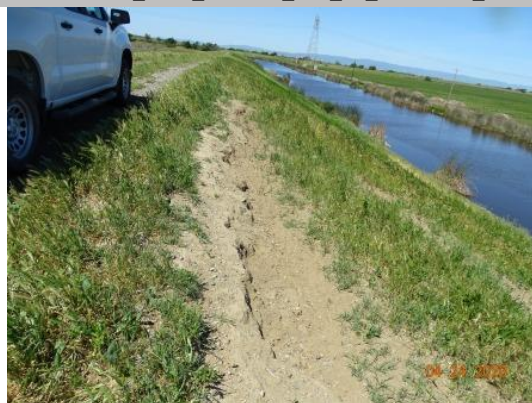
Photo 1 of 1 : SP_2022_RD2098_246_12_20220310_00005.jpg

LM Start	6.86	Rating **	M	Issue No.	12
LM End	6.86	Issue Type +	Ma	Location *	LS
Category	Earthen Levee			GPS Latitude/Longitude	
				Start	End
Item	Erosion / Bank Caving			38.292965 °	38.292965 °
				-121.718188 °	-121.718188 °
DWR ID	DWR_RD2098_02_s_2020_12				
Comment Code					
E2 : Schedule repair of erosion site prior to the next inspection.					
Inspector Comment					
Erosion at the top of the landside slope.

View looking upstream at erosion at the top of the landside slope (Spring 2020).

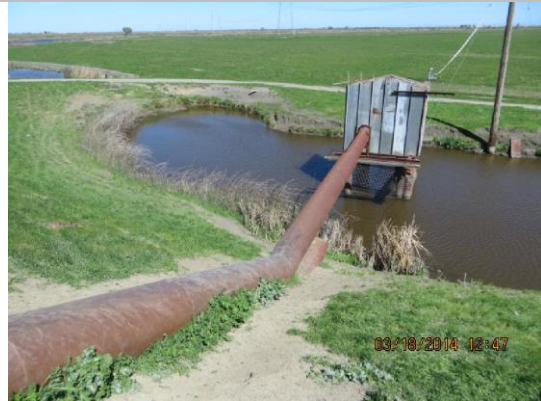
Photo 1 of 3 : UCIP_SP_2022_32303_58782.jpg

FS_ID:32303
DS_ID:20978
EP_NO: 10171
Repair Type: No Action Needed
Crossing Status: Found
UCIP Comments: 09/14/2017 Permit review indicates this 24-inch pipe was authorized as an irrigation and drainage pipe under ABO issued as Permit No. 10171, structure description was updated. Structure type logged as drainage. (DWR UCIP - O. Magana)
FIELD_STRUCT_DESC: *ABANDONED* 24-inch steel dual-purpose irrigation and drainage pipe through the levee, 4.5 feet below the crown. Corrugated metal cutoff wall around the pipe. Pipe has welded steel plate over end on the landside (LS) slope and is not visible on the waterside (WS) slope. (24-inch pipe [HLM 7.23] authorized under Automatic Board Order (ABO) issued as Permit No. 10171, 1974 - Glenn A. Bowlsbey). [Additional Reference(s): DWR Levee Log, 2003. USACE Sacramento O&M Manual 109, April 1962, (HLM 7.28)].
FS Date: 3/18/2014 7:07:14 AM

Pipe visible under new pipe on LS slope.

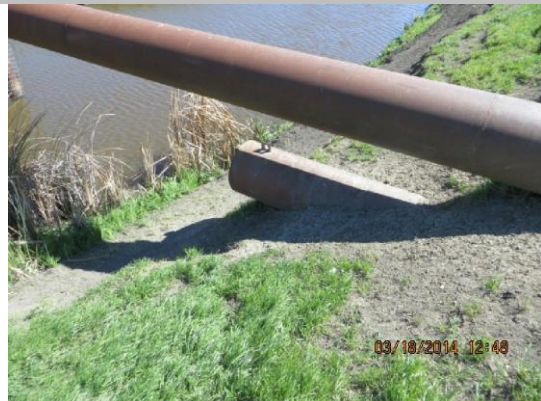
Photo 2 of 3 : UCIP_SP_2022_32303_58781.jpg

Pipe visible under new pipe on LS slope.

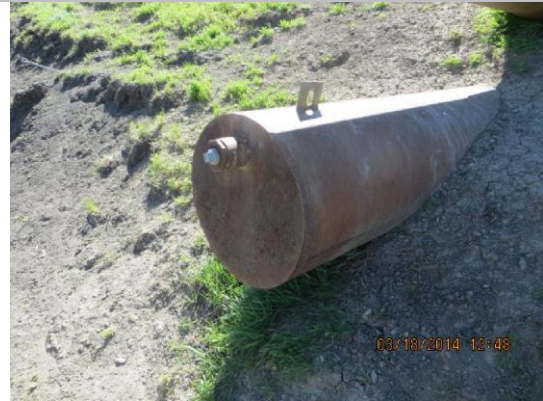
Photo 3 of 3 : UCIP_SP_2022_32303_58780.jpg

Welded steel cap over LS end of pipe.

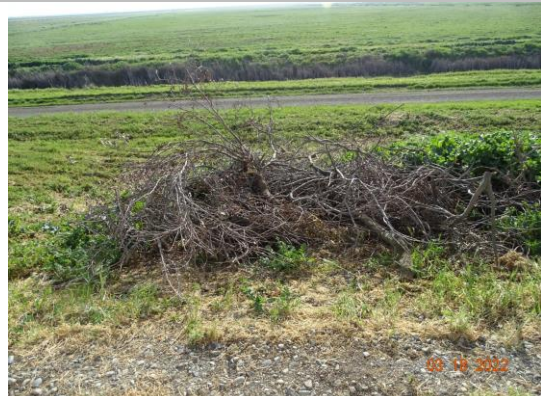
Photo 1 of 1 : SP_2022_RD2098_247_14_20220318_00013.jpg

View of cut up tree branches on the landside shoulder (Spring 2022).

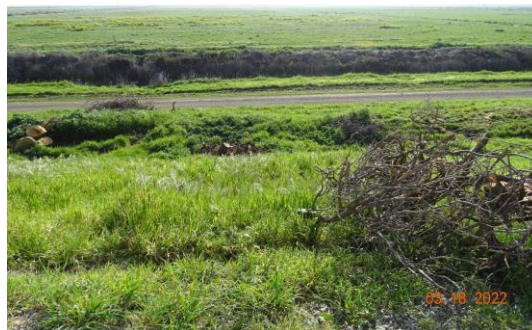
Photo 1 of 1 : SP_2022_RD2098_247_5_20220318_00012.jpg

View of cut up tree limbs and trunks on the landside shoulder and toe (Spring 2022).

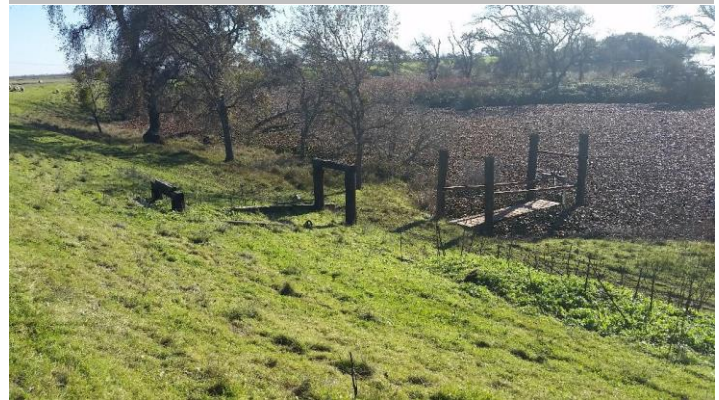
Photo 1 of 3 : UCIP_SP_2022_51453_76858.jpg

Comment Code						
Inspector Comment						
FS_ID:51453 DS_ID:20981 EP_NO: 10174 Repair Type: No Action Needed Crossing Status: Found UCIP Comments: 12/22/2016 Crossing has been downgraded from Urgent to No Action Needed walkways on both WS and LS have been rebuilt and the WS gate has been upgraded to stainless steel where previous corrodable material was present. (O. Magana - DWR UCIP)03/19/2014 Current walkway to slidegate on WS toe does not provide safe access to operate slidegate. (W. Wylie - DWR UCIP) FIELD_STRUCT_DESC: 36-inch steel dual-purpose irrigation and drainage pipe through the levee, 26 feet below the crown. Two corrugated metal cutoff walls around the pipe. Walkway to the slide gate on the waterside (WS) end. Combination slide and flap gate on the landside (LS) end. 48-inch corrugated metal pipe (CMP) riser and an adjoining pump on a metal pier at the LS toe. (36-inch pipe [HLM 8.20] authorized under Automatic Board Order (ABO) issued as Permit No. 10174, 1974 - Glen A. Bowsbey). [Additional Reference(s): DWR Levee Log, 2003. USACE Sacramento O&M Manual 109, April 1962, (HLM 8.20)]. FS Date: 12/22/2016

Walkway has been re-built, photo 1 of 2.

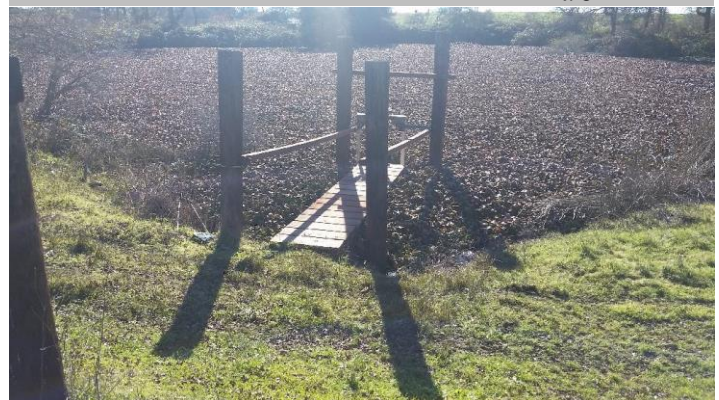
Photo 2 of 3 : UCIP_SP_2022_51453_76861.jpg

Walkway has been re-built, photo 2 of 2.

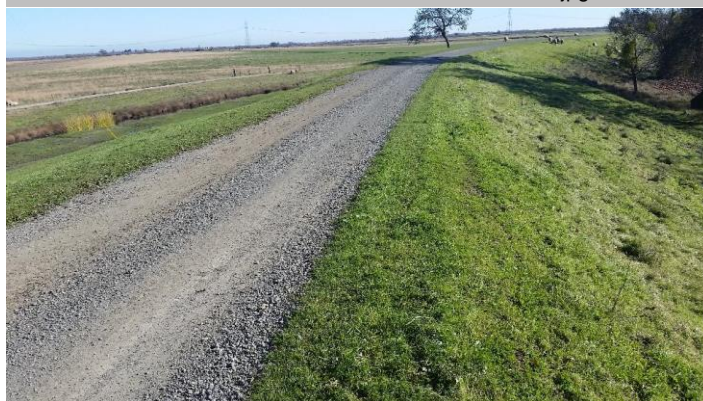
Photo 3 of 3 : UCIP_SP_2022_51453_76859.jpg

View of levee crown at pipe crossing.

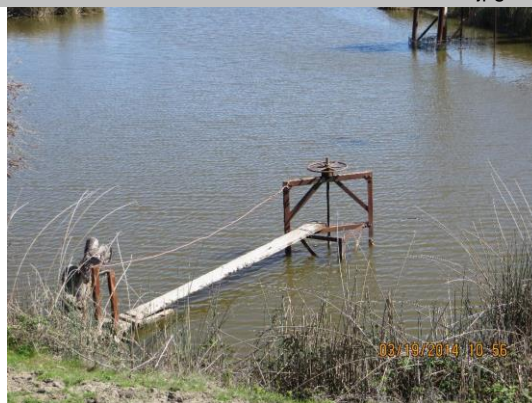
Photo 1 of 2 : UCIP_SP_2022_32384_58883.jpg

FS_ID:32384
 DS_ID:20962
 EP_NO: 10174
 Repair Type: No Action Needed
 Crossing Status: Found
 UCIP Comments:
 FIELD_STRUCT_DESC: 60-inch corrugated metal drainage pipe through the levee, 25.5 feet below the crown. Walkway to the slide gates at both ends of the pipe. (Permit No. 1607, 1951 - R. F. Moore and Lorraine W. Zanetti. This pipe was retained under Automatic Board Order (ABO) issued as Permit No. 10174, 1974 - Glen A. Bowlsbey).
 [Additional Reference(s): DWR Levee Log, 2003. USACE Sacramento O&M Manual 109, April 1962, (HLM 8.40)].
 FS Date: 3/19/2014

Slide gate at LS toe.

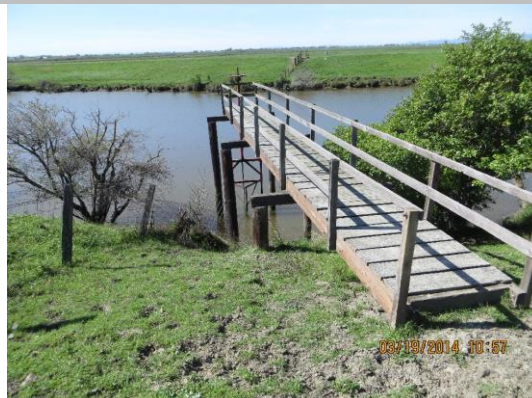
Photo 2 of 2 : UCIP_SP_2022_32384_58882.jpg

Walkway with slide gate on WS toe.

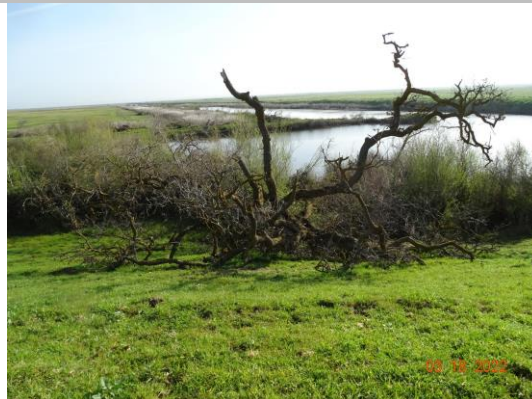
Photo 1 of 1 : SP_2022_RD2098_247_12_20220318_00010.jpg

View of down tree on the landside slope (Spring 2022).

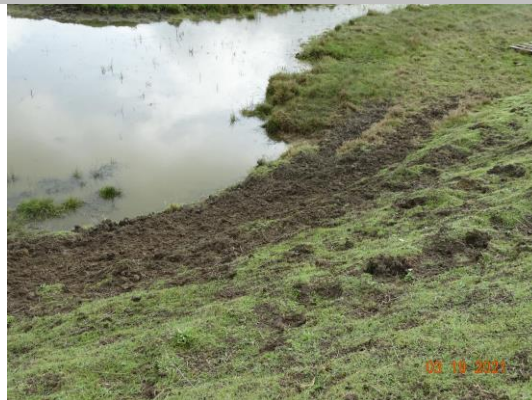
Photo 1 of 1 : SP_2022_RD2098_247_4_20220310_00001.jpg

LM Start	8.50	Rating **	M	Issue No.	4
LM End	9.06	Issue Type +	Ma	Location *	LS
Category	Earthen Levee			GPS Latitude/Longitude	
				Start	End
Item	Erosion / Livestock			38.308628 °	38.315096 °
				-121.733495 °	-121.739121 °
DWR ID	DWR_RD2098_03_s_2021_4				
Comment Code					
E4 : Repair the levee slope damaged by livestock and prevent large animal access.					
Inspector Comment

View of slope terracing caused by cattle on the landside slope (Spring 2021).

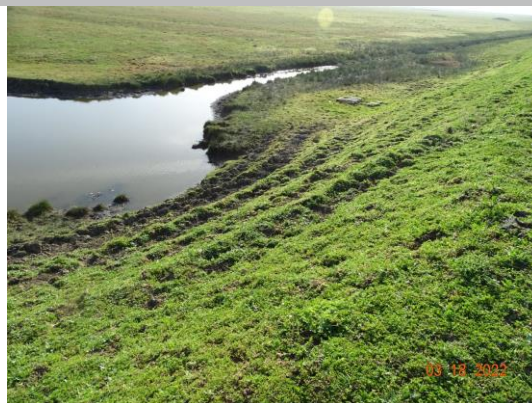
Photo 1 of 1 : SP_2022_RD2098_247_10_20220318_00009.jpg

View looking downstream erosion due to livestock into the landside slope (Spring 2022).

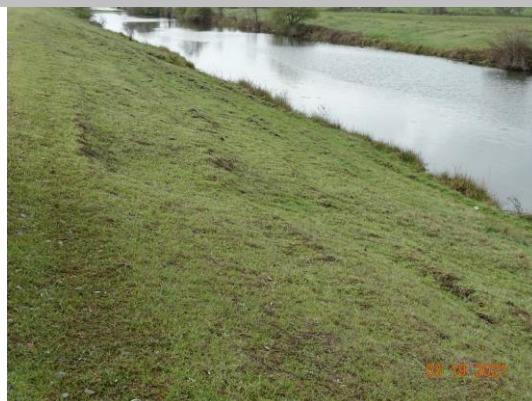
Photo 1 of 1 : SP_2022_RD2098_248_11_20220310_00003.jpg

View of terracing due to cows on the landside slope (Spring 2021).

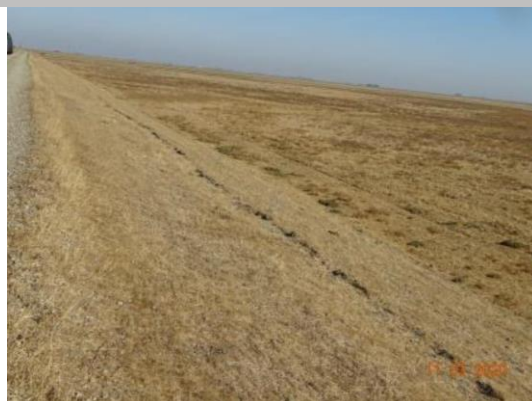
Photo 1 of 1 : SP_2022_RD2098_248_10_20220310_00002.jpg

View looking upstream at depressions in the landside slope due to cows (Fall 2020).

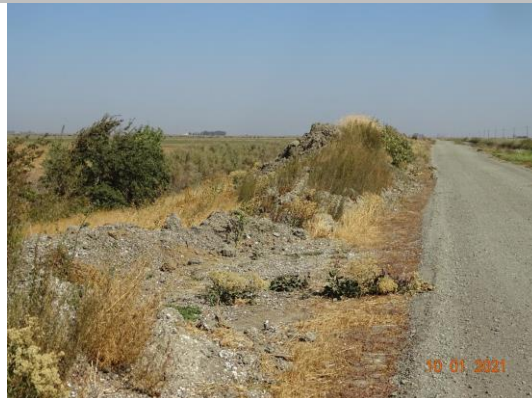
Photo 1 of 1 : SP_2022_RD2098_248_8_20220310_00001.jpg

View looking upstream at dredge materials on the waterside hinge (Fall 2021).

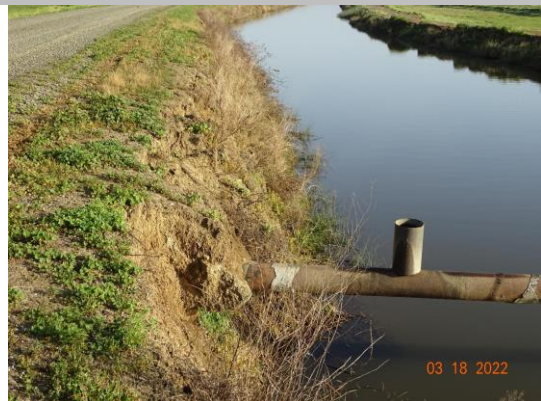
Photo 1 of 1 : SP_2022_RD2098_248_15_20220318_00023.jpg

View looking upstream at erosion into the landside slope (Spring 2022).

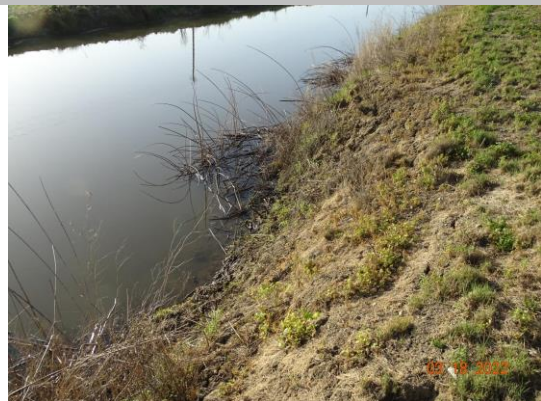
Photo 1 of 1 : SP_2022_RD2098_248_14_20220318_00024.jpg

View looking downstream at erosion into the landside slope (Spring 2022).

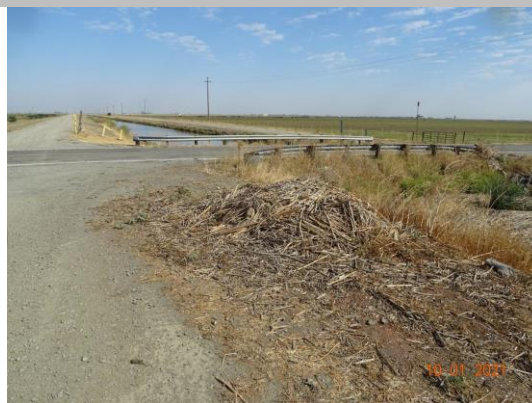
Photo 1 of 1 : SP_2022_RD2098_248_13_20220310_00004.jpg

View of cattails on the landside hinge (Fall 2021).
