**Flood Control Project Maintenance
Levee Inspections**

Maintenance Issue Types Only, Levee Inspection Report By Mile - Spring 2023

Reclamation District No. 2098 Cache and Haas Slough

Waterway	Bank	Unit Miles	Inspection Start/End	Inspector
Unit No. 01 Yolo Bypass	Right	3.60	05/17/2023 05/17/2023	Saskia Donovan

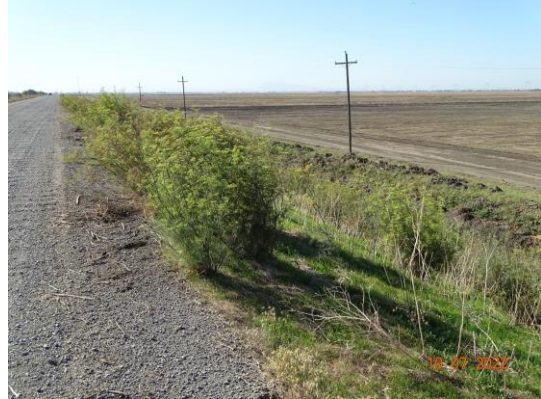
Photo 1 of 1 : SP_2023_RD2098_244_24_20230206_00006.jpg

LM Start	0.15	Rating **	A/W	Issue No.	24
LM End	0.15	Issue Type +	Ma	Location *	LS
Category	Earthen Levee			GPS Latitude/Longitude	
				Start	End
Item	Vegetation			38.326891°	38.326891°
				-121.694074°	-121.694074°
DWR ID	DWR_RD2098_01_f_2022_24				
Comment Code					
V1 : Control annual grass and weeds on the levee slopes and easements.					
Inspector Comment					
The annual vegetation on the LS slope needs to be maintained. Spring 2023: Rated A/W due to ongoing habitat restoration and flood improvement project.

View of the annual vegetation on the LS slope (Fall 2022).

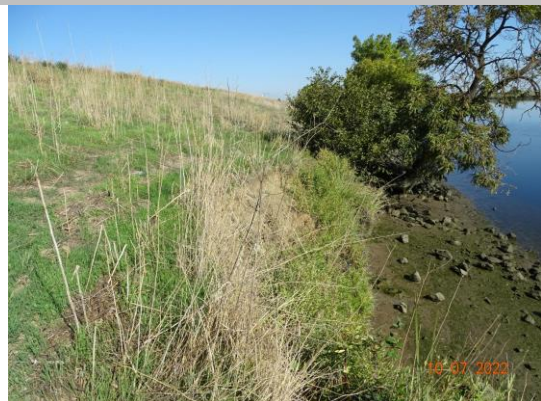
Photo 1 of 1 : SP_2023_RD2098_244_13_20230206_00002.jpg

LM Start	0.57	Rating **	A/W	Issue No.	13
LM End	1.06	Issue Type +	Ma	Location *	WS
Category	Earthen Levee			GPS Latitude/Longitude	
				Start	End
Item	Erosion / Bank Caving			38.320755°	38.313700°
				-121.693982°	-121.693639°
DWR ID	DWR_RD2098_01_s_2017_13				
Comment Code					
E2 : Schedule repair of erosion site prior to the next inspection.					
Inspector Comment					
There is erosion on the waterside slope. Several areas of pocket erosion on the bank are encroaching into the extended levee prism. There is some riprap protection on the lower slope in some areas. Spring 2023: Rated A/W due to ongoing habitat restoration and flood improvement project.

View of the erosion on the WS bank (Fall 2022).

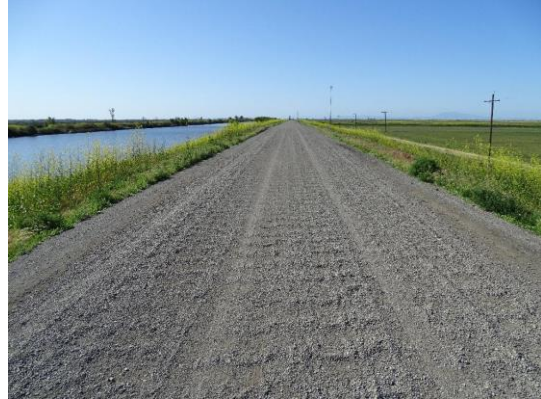
Photo 1 of 3 : UCIP_SP_2023_74264_111252.jpg

Comment Code						
Inspector Comment						
DS_ID:20997 FS_ID:74264 EP_NO: N/A Repair Type: Non-Urgent EVAL Issue: Crossing Status: Not Found UCIP Comments: 04/12/2022 Record remains Non-Urgent. Geophysical results did not confirm presence of pipe through levee. Record will remain in UCIP's inspection records until future Levee Improvement Project can confirm no crossing was found through the levee. System Feature. (D.Sanoski - DWR UCIP) FIELD_STRUCT_DESC: 42-inch drainage pipe of an unknown material through the levee, 21 feet below the crown. [Additional Reference(s): USACE Sacramento O&M Manual 109, April 1962, (HLM 0.69)]. FS Date: 4/12/2022 10:30:41 AM

View of levee crown.

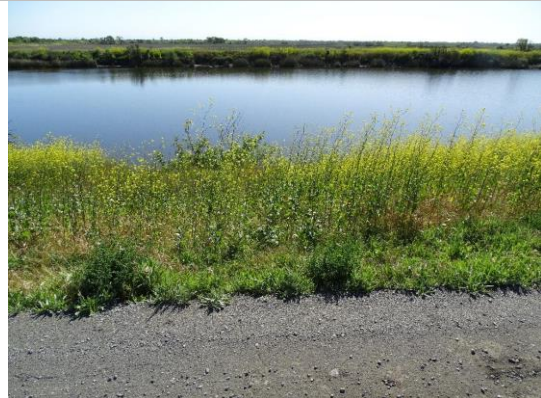
Photo 2 of 3 : UCIP_SP_2023_74264_111251.jpg

View of WS slope.

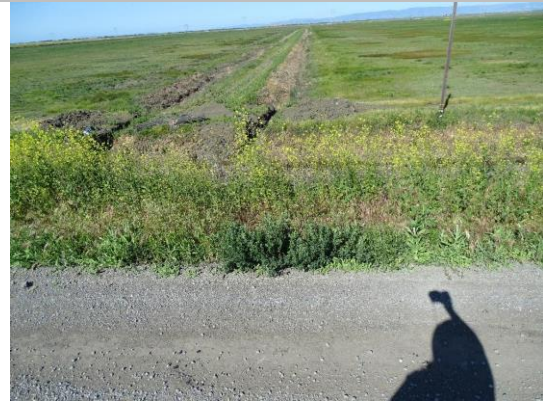
Photo 3 of 3 : UCIP_SP_2023_74264_111253.jpg

View of LS slope.

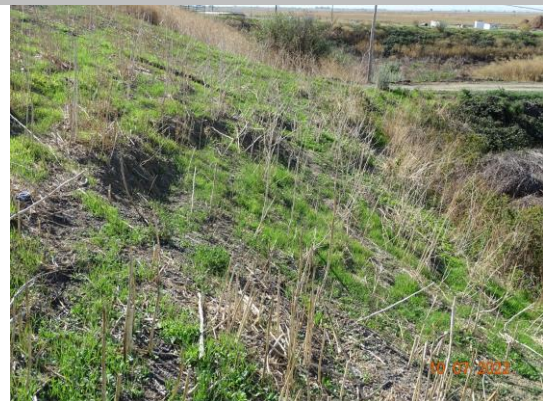
Photo 1 of 1 : SP_2023_RD2098_244_19_20230206_00004.jpg

This was a 2017 Storm Damage site. The damage consists of cracking and sloughing of the lower landside levee slope.
Site ID No:414
Site Designation:LMA-241 Spring 2023: Rated A/W due to ongoing habitat restoration and flood improvement project.

View of the sloughing/caving on the LS slope (Fall 2022).

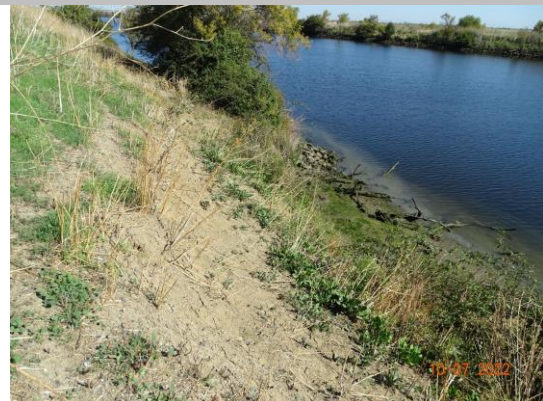
Photo 1 of 1 : SP_2023_RD2098_244_18_20230206_00003.jpg

LM Start	1.76	Rating **	A/W	Issue No.	18
LM End	1.76	Issue Type +	Ma	Location *	WS
Category	Earthen Levee		GPS Latitude/Longitude		
			Start	End	
Item	Erosion / Bank Caving		38.303611°	38.303611°	
			-121.693607°	-121.693607°	
DWR ID	DWR_RD2098_01_s_2018_18

View of the erosion on the WS toe (Fall 2022).

E2 : Schedule repair of erosion site prior to the next inspection.

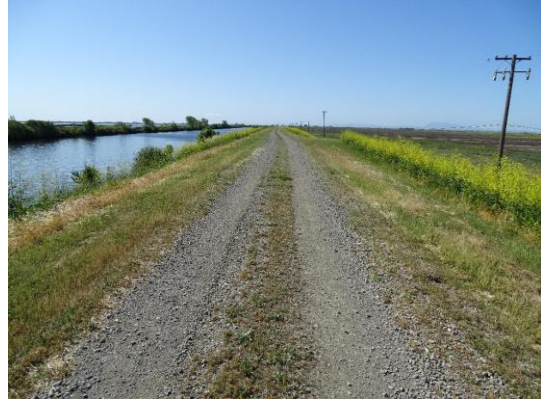
Photo 1 of 3 : UCIP_SP_2023_74544_111287.jpg

Comment Code						
Inspector Comment						
DS_ID:20965 FS_ID:74544 EP_NO: 10168 Repair Type: Non-Urgent EVAL Issue: 6, Levee Damage or Threat for Levee Damage Crossing Status: Found UCIP Comments: 04/12/2022 Record remains Non-Urgent. Threat for levee damage with same erosion under pipe at WS toe. System Feature. (D.Sanoski - DWR UCIP) 12/22/2016 Met with Mike Hadesty, LMA Superintendent, and Brian Bush, LMA General Manager, to go over the list of pipes in RD2098. Per LMA records, this pipe has a different owner. (O. Magana - DWR UCIP) 03/18/2014 Erosion under pipe at WS toe. (W. Wylie - DWR UCIP) FIELD_STRUCT_DESC: 10-inch steel drainage pipe through the levee, 2.8 feet below the crown. Pump in pump house off the landside (LS). (This pipe was retained under Automatic Board Order (ABO) issued as Permit No. 10168, 1974 - Moresco Brothers). [Additional Reference(s): DWR Levee Log, 2003. USACE Sacramento O&M Manual 109, April 1962, (HLM 1.80)]. FS Date: 4/12/2022 12:51:06 PM

View of levee crown.

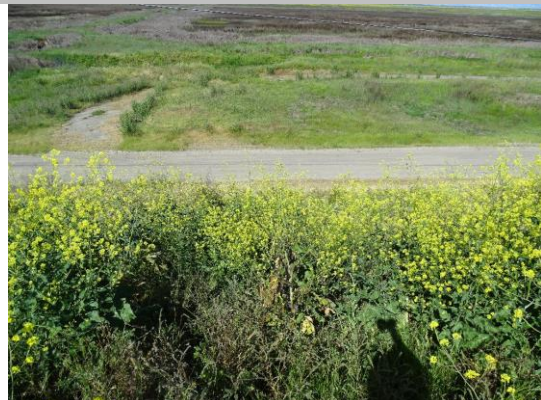
Photo 2 of 3 : UCIP_SP_2023_74544_111286.jpg

View of LS slope and no sign of pumphouse off toe.

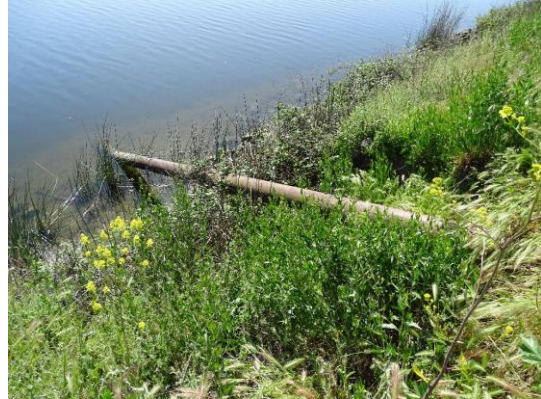
Photo 3 of 3 : UCIP_SP_2023_74544_111285.jpg

View of pipe out of WS slope with same erosion under pipe.

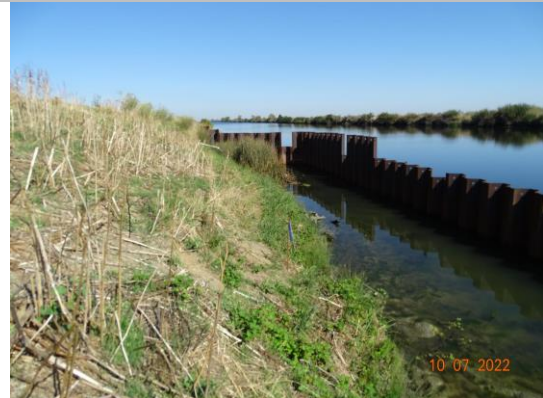
Photo 1 of 1 : SP_2023_RD2098_244_37_20230206_00011.jpg

LM Start	2.99	Rating **	A/W	Issue No.	37
LM End	3.29	Issue Type +	Ma	Location *	WS
Category	Earthen Levee			GPS Latitude/Longitude	
				Start	End
Item	Erosion / Bank Caving			38.285700°	38.281500°
				-121.693500°	-121.694300°
DWR ID	LMA-259				
Comment Code					
E2 : Schedule repair of erosion site prior to the next inspection.					
Inspector Comment					
Fall 2022: Site is pending repair. This was a 2017 Storm Damage site. The damage consists of scour and sloughing of the waterside levee slope.					
Site ID No:432					
Site Designation:LMA-259 Spring 2023: Rated A/W due to ongoing habitat restoration and flood improvement project.

View of the erosion on the WS slope (Fall 2022).

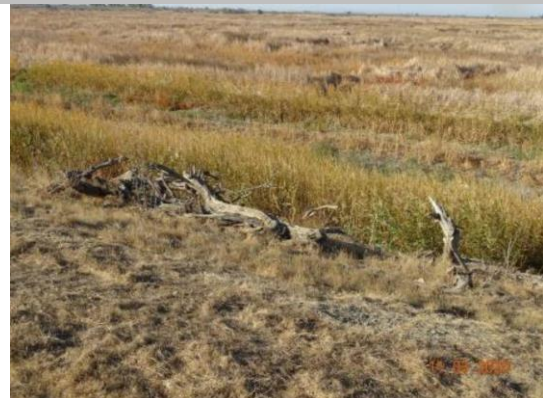
Photo 1 of 1 : SP_2023_RD2098_244_20_20230206_00005.jpg

LM Start	3.13	Rating **	A/W	Issue No.	20
LM End	3.13	Issue Type +	Ma	Location *	LS
Category	Earthen Levee			GPS Latitude/Longitude	
				Start	End
Item	Trim / Thin Trees			38.283800°	38.283800°
				-121.693618°	-121.693618°
DWR ID	DWR_RD2098_01_s_2020_20				
Comment Code					
T2 : Tree or limb.					
Inspector Comment					
Spring 2023: Rated A/W due to ongoing habitat restoration and flood improvement project.

View of tree limb on the landside slope (Fall 2020).

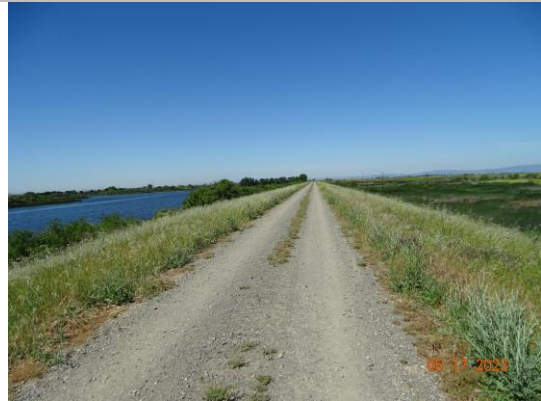
Photo 1 of 1 : SP_2023_RD2098_245_1_20230519_00002.jpg

View of the annual vegetation looking west (Spring 2023).

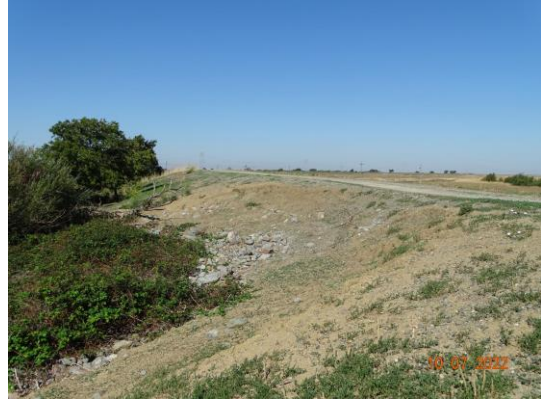
Photo 1 of 1 : SP_2023_RD2098_246_11_20230206_00002.jpg

LM Start	5.88	Rating **	A/W	Issue No.	11
LM End	5.88	Issue Type +	Ma	Location *	WS
Category	Earthen Levee			GPS Latitude/Longitude	
				Start	End
Item	Erosion / Bank Caving			38.282946°	38.282946°
				-121.710902°	-121.710902°
DWR ID	DWR_RD2098_02_f_2020_11				
Comment Code					
E2 : Schedule repair of erosion site prior to the next inspection.					
Inspector Comment					
This waterside slump site is not new, and is somewhat protected by riprap and thick brushy vegetation, but it has the potential to erode into crown during high water with a strong south wind. It currently has a two-foot vertical scarp at the levee shoulder. Spring 2023: Rated A/W due to ongoing habitat restoration and flood improvement project.

View of the erosion on the WS slope (Fall 2022).

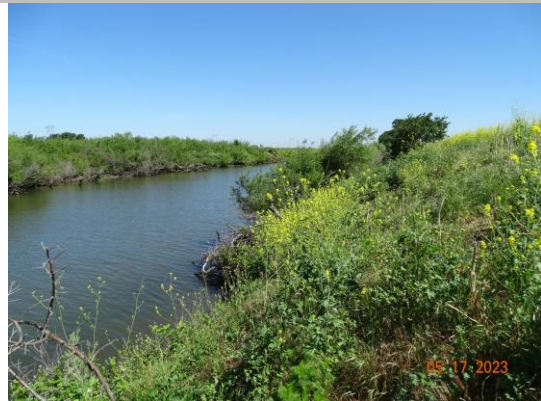
Photo 1 of 1 : SP_2023_RD2098_246_15_20230519_00011.jpg

LM Start	6.46	Rating **	A/W	Issue No.	15
LM End	6.48	Issue Type +	Ma	Location *	WS
Category	Earthen Levee			GPS Latitude/Longitude	
				Start	End
Item	Erosion / Bank Caving			38.288700°	38.289061°
				-121.717000°	-121.716885°
DWR ID	LMA-267				
Comment Code					
E2 : Schedule repair of erosion site prior to the next inspection.					
Inspector Comment					
This was a 2017 Storm Damage site. The damage consists of scour of the lower and mid waterside levee slope. Site ID No:440 & 441 Site Designation:LMA-267 & LMA-268 Spring 2023: Rated A/W due to ongoing habitat restoration and flood improvement project.

View of the erosion on the WS (Spring 2023).

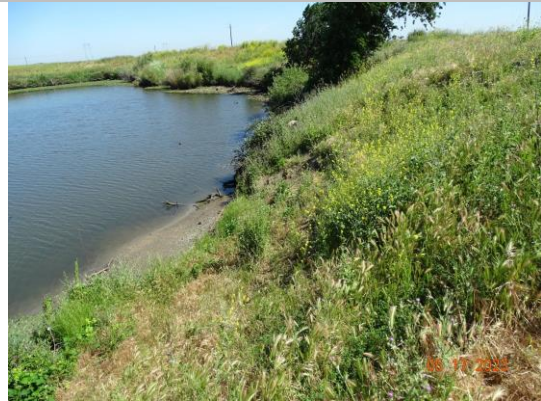
Photo 1 of 1 : SP_2023_RD2098_246_18_20230519_00012.jpg

LM Start	6.64	Rating **	A/W	Issue No.	18
LM End	6.65	Issue Type +	Ma	Location *	WS
Category	Earthen Levee			GPS Latitude/Longitude	
				Start	End
Item	Erosion / Bank Caving			38.291300°	38.291400°
				-121.716100°	-121.716000°
DWR ID	LMA-269				
Comment Code					
E2 : Schedule repair of erosion site prior to the next inspection.					
Inspector Comment					
This was a 2017 Storm Damage site.					
The damage consists of scour, cracking, instability, and sloughing of the waterside levee slope.					
Site ID No:442					
Site Designation:LMA-269 Spring 2023: Rated A/W due to ongoing habitat restoration and flood improvement project.

View of the erosion on the WS (Spring 2023).

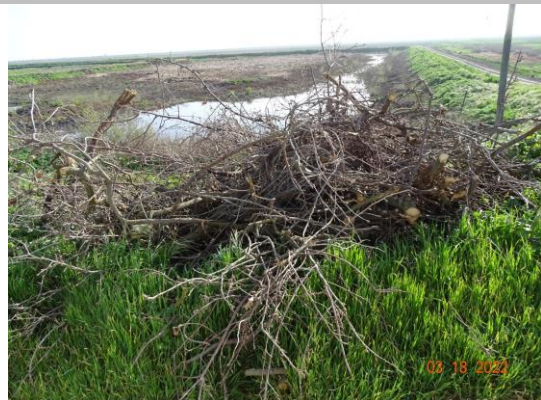
Photo 1 of 1 : SP_2023_RD2098_246_9_20230206_00001.jpg

LM Start	6.68	Rating **	A/W	Issue No.	9
LM End	6.68	Issue Type +	Ma	Location *	LS
Category	Earthen Levee			GPS Latitude/Longitude	
				Start	End
Item	Encroachments			38.291779°	38.291779°
				-121.715727°	-121.715727°
DWR ID	DWR_RD2098_02_s_2022_9				
Comment Code					
PR : Prunings					
Inspector Comment					
Remove tree prunings on the landside shoulder. Spring 2023: Rated A/W due to ongoing habitat restoration and flood improvement project.

View of cut up tree limbs on the landside shoulder (Spring 2022).

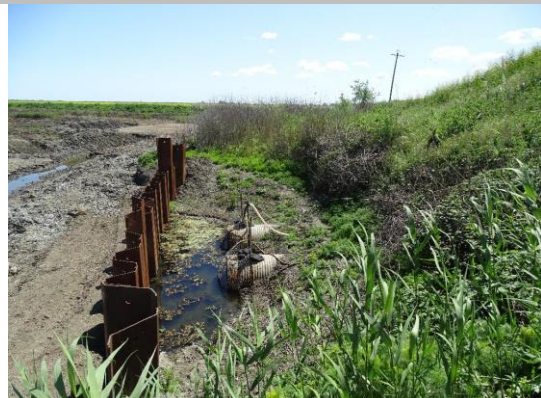
Photo 2 of 3 : UCIP_SP_2023_74585_111406.jpg

View of pipe out of LS slope with metal retaining wall.

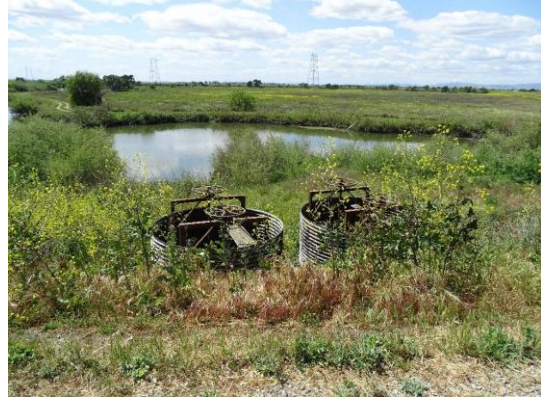
Photo 3 of 3 : UCIP_SP_2023_74585_111409.jpg

View of WS shoulder with CMP riser on slope.

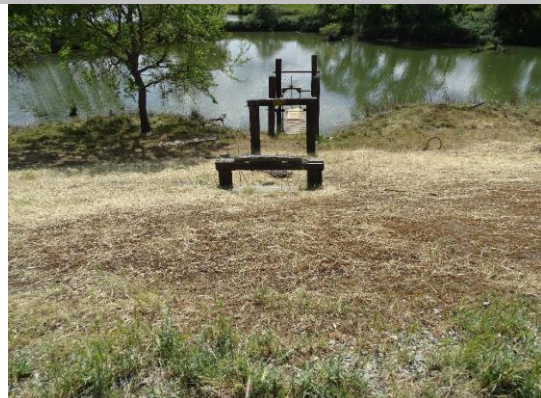
Photo 2 of 3 : UCIP_SP_2023_74598_111455.jpg

Comment Code						
Inspector Comment						
DS_ID:20981 FS_ID:74598 EP_NO: 10174 Repair Type: Non-Urgent EVAL Issue: Crossing Status: Found UCIP Comments: 04/12/2022 Record updated from No Action Needed to Non-Urgent. Crossing appears abandoned per Superintendent Bryce Hall per Lookout Slough Rehabilitation Project. System Feature. (D.Sanoski - DWR UCIP) 12/22/2016 Crossing has been downgraded from Urgent to No Action Needed walkways on both WS and LS have been rebuilt and the WS gate has been upgraded to stainless steel where previous corrodable material was present. (O. Magana - DWR UCIP)03/19/2014 Current walkway to slidegate on WS toe does not provide safe access to operate slidegate. (W. Wylie - DWR UCIP) FIELD_STRUCT_DESC: 36-inch steel dual-purpose irrigation and drainage pipe through the levee, 26 feet below the crown. Two corrugated metal cutoff walls around the pipe. Walkway to the slide gate on the waterside (WS) end. Combination slide and flap gate on the landside (LS) end. 48-inch corrugated metal pipe (CMP) riser and an adjoining pump on a metal pier at the LS toe. (36-inch pipe [HLM 8.20] authorized under Automatic Board Order (ABO) issued as Permit No. 10174, 1974 - Glen A. Bowsbey). [Additional Reference(s): DWR Levee Log, 2003. USACE Sacramento O&M Manual 109, April 1962, (HLM 8.20)]. FS Date: 4/12/2022 1:01:14 PM

View of WS slope and abandoned pier on toe.

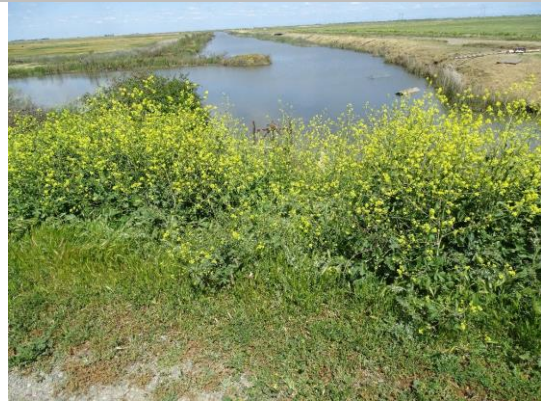
Photo 2 of 3 : UCIP_SP_2023_74612_111495.jpg

View of LS shoulder and overgrown slope.

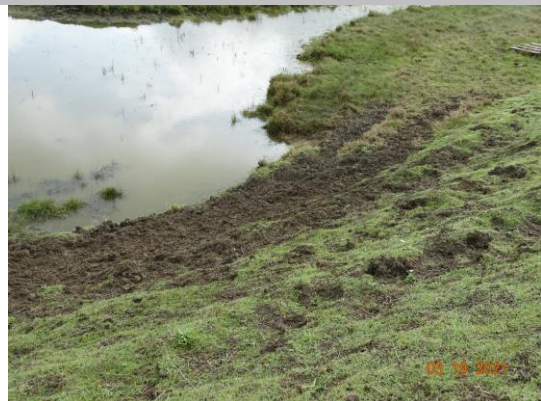
Photo 1 of 1 : SP_2023_RD2098_247_4_20230206_00001.jpg

View of slope terracing caused by cattle on the landside slope (Spring 2021).

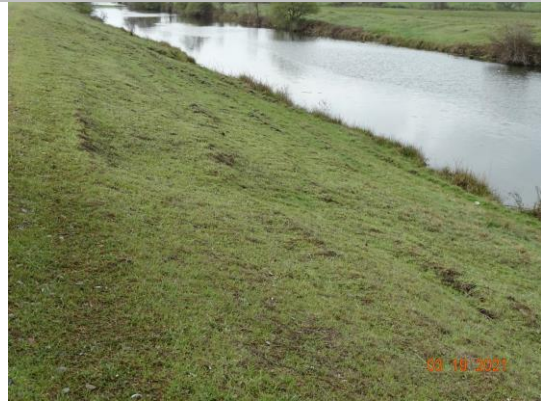
Photo 1 of 1 : SP_2023_RD2098_248_11_20230206_00003.jpg

View of terracing due to cows on the landside slope (Spring 2021).

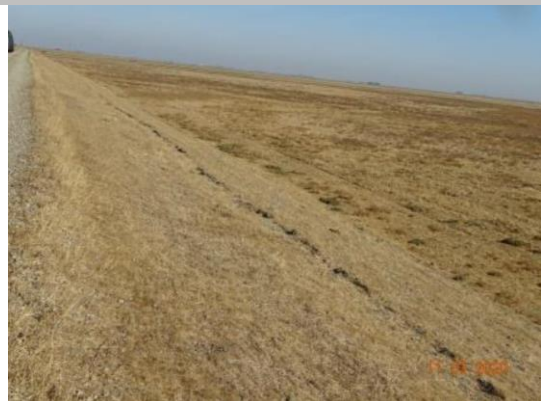
Photo 1 of 1 : SP_2023_RD2098_248_10_20230206_00002.jpg

View looking upstream at depressions in the landside slope due to cows (Fall 2020).

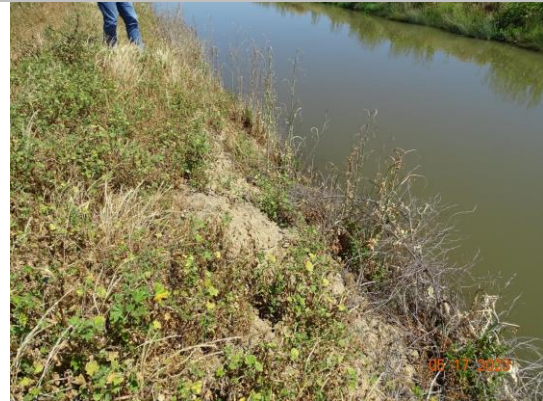
Photo 1 of 1 : SP_2023_RD2098_248_15_20230519_00019.jpg

View of the erosion on the LS (Spring 2023).

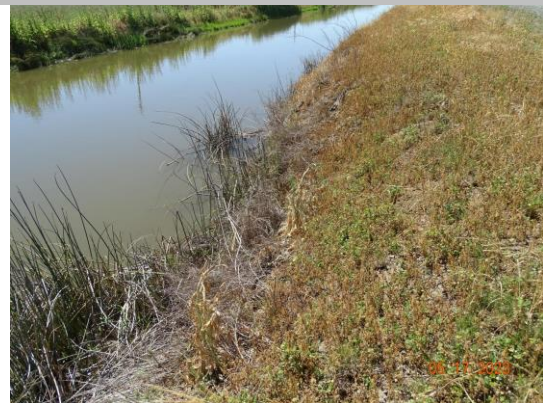
Photo 1 of 1 : SP_2023_RD2098_248_14_20230519_00020.jpg

View of the erosion on the LS (Spring 2023).
