**Flood Control Project Maintenance  
Levee Inspections**

## Maintenance Issue Types Only, Levee Inspection Report By Mile - Spring 2024

### Reclamation District No. 2098 Cache and Haas Slough

Waterway	Bank	Unit Miles	Inspection Start/End	Inspector
Unit No. 01 Yolo Bypass	Right	3.60	04/02/2024 04/02/2024	Gregg McMillon

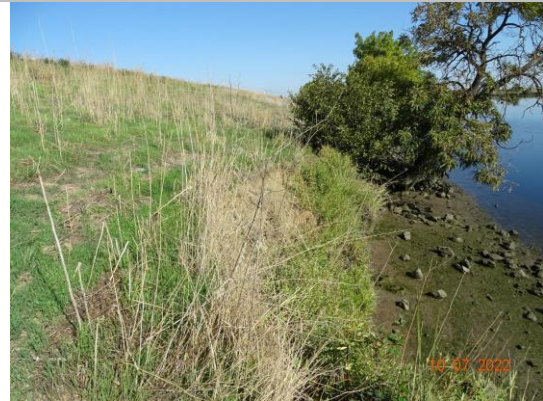
Photo 1 of 1 : SP\_2024\_RD2098\_244\_13\_20240301\_00004.jpg

LM Start	0.57	Rating **	A/W	Issue No.	13
LM End	1.06	Issue Type +	Ma	Location *	WS
Category	Earthen Levee			GPS Latitude/Longitude	
				Start	End
Item	Erosion / Bank Caving			38.320755°	38.313700°
				-121.693982°	-121.693639°
DWR ID	DWR_RD2098_01_s_2017_13				
Comment Code					
E2 : Schedule repair of erosion site prior to the next inspection.					
Inspector Comment					
There is erosion on the waterside slope. Several areas of pocket erosion on the bank are encroaching into the extended levee prism. There is some riprap protection on the lower slope in some areas. Spring 2023: Rated A/W due to ongoing habitat restoration and flood improvement project.

View of the erosion on the WS bank (Fall 2022).

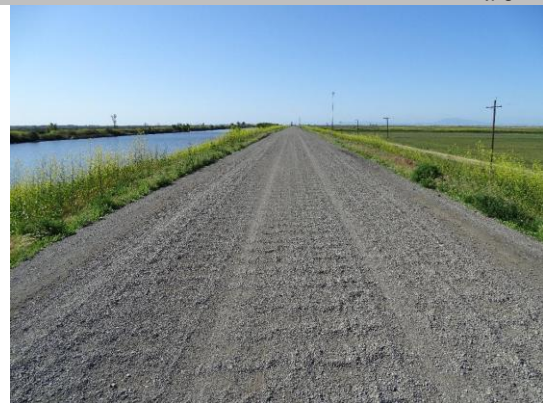
Photo 1 of 3 : UCIP\_SP\_2024\_74264\_111252.jpg

Comment Code					
Inspector Comment					
DS_ID:20997					
FS_ID:74264					
EP_NO: N/A					
Repair Type: Non-Urgent					
EVAL Issue:					
Crossing Status: Not Found					
UCIP Comments: 04/12/2022 Record remains Non-Urgent. Geophysical results did not confirm presence of pipe through levee. Record will remain in UCIP's inspection records until future Levee Improvement Project can confirm no crossing was found through the levee. System Feature. (D.Sanoski - DWR UCIP)					
FIELD_STRUCT_DESC: 42-inch drainage pipe of an unknown material through the levee, 21 feet below the crown. [Additional Reference(s): USACE Sacramento O&M Manual, Unit 109, April 1962, Revised 29 December 2016, (HLM 0.69), listed as 42-inch pipe].					
FS Date: 4/12/2022 10:30:41 AM

View of levee crown.

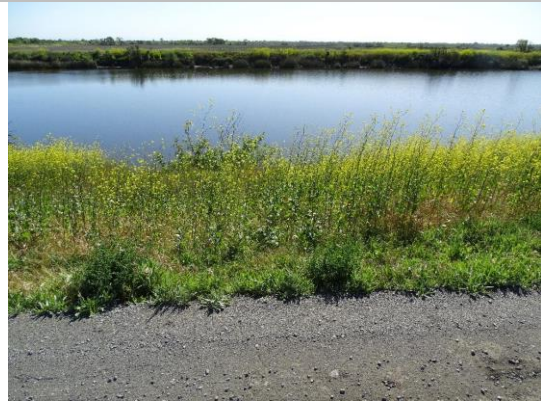
Photo 2 of 3 : UCIP\_SP\_2024\_74264\_111251.jpg

View of WS slope.

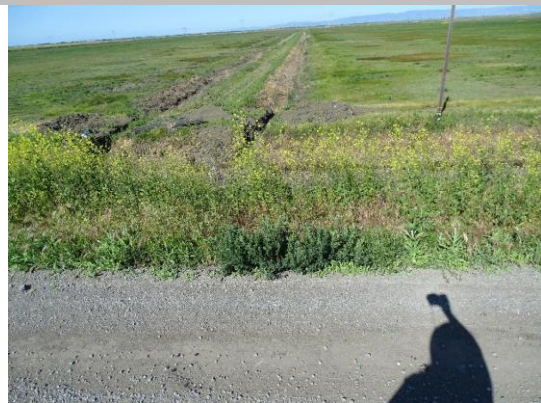
Photo 3 of 3 : UCIP\_SP\_2024\_74264\_111253.jpg

View of LS slope.

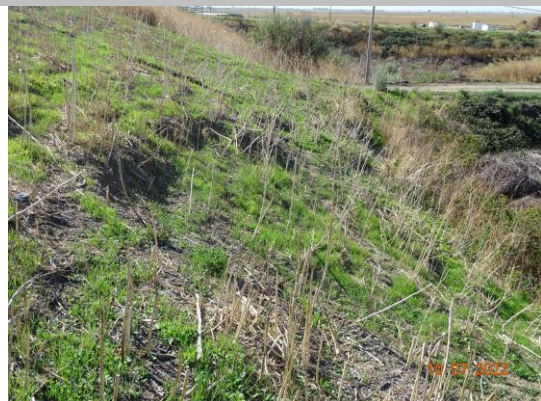
Photo 1 of 1 : SP\_2024\_RD2098\_244\_19\_20240301\_00006.jpg

LM Start	0.96	Rating **	A/W	Issue No.	19
LM End	0.96	Issue Type +	Ma	Location *	LS
Category	Earthen Levee			GPS Latitude/Longitude	
				Start	End
Item	Erosion / Bank Caving			38.315200°	38.315100°
				-121.694100°	-121.694100°
DWR ID	DWR_RD2098_01_s_2021_19				
Comment Code					
E1 : Note and monitor erosion site.					
Inspector Comment					
This was a 2017 Storm Damage site. The damage consists of cracking and sloughing of the lower landside levee slope.					
Site ID No:414					
Site Designation:LMA-241 Spring 2023: Rated A/W due to ongoing habitat restoration and flood improvement project.

View of the sloughing/caving on the LS slope (Fall 2022).

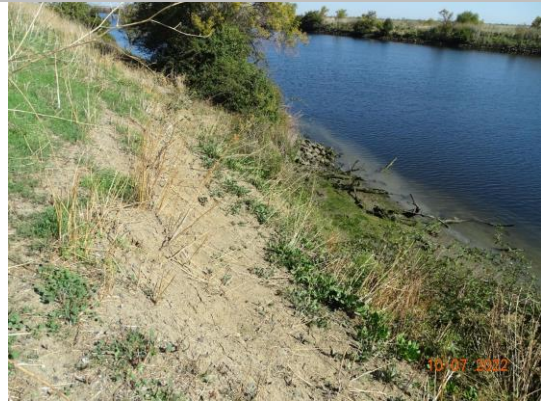
Photo 1 of 1 : SP\_2024\_RD2098\_244\_18\_20240301\_00005.jpg

LM Start	1.76	Rating **	A/W	Issue No.	18
LM End	1.76	Issue Type +	Ma	Location *	WS
Category	Earthen Levee			GPS Latitude/Longitude	
				Start	End
Item	Erosion / Bank Caving			38.303611°	38.303611°
				-121.693607°	-121.693607°
DWR ID	DWR_RD2098_01_s_2018_18				
Comment Code					
E2 : Schedule repair of erosion site prior to the next inspection.					
Inspector Comment					
There is erosion at the waterside toe. Spring 2023: Rated A/W due to ongoing habitat restoration and flood improvement project.

View of the erosion on the WS toe (Fall 2022).

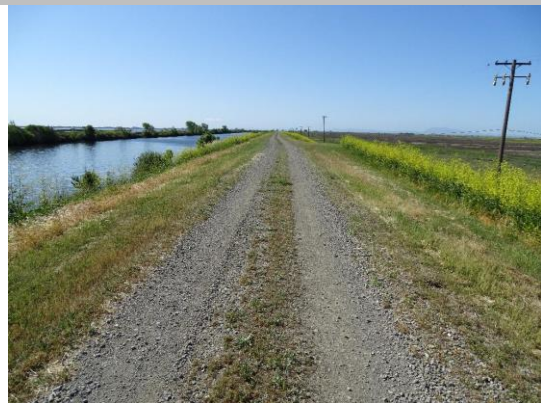
Photo 1 of 3 : UCIP\_SP\_2024\_82369\_111287.jpg

Comment Code					
Inspector Comment					
DS_ID:20965 FS_ID:82369 EP_NO: 10168 Repair Type: Non-Urgent EVAL Issue: 6, Levee Damage or Threat for Levee Damage Crossing Status: Found UCIP Comments: 04/12/2022 Record remains Non-Urgent. Threat for levee damage with same erosion under pipe at WS toe. System Feature. (D.Sanoski - DWR UCIP) 12/22/2016 Met with Mike Hadesty, LMA Superintendent, and Brian Bush, LMA General Manager, to go over the list of pipes in RD2098. Per LMA records, this pipe has a different owner. (O. Magana - DWR UCIP) 03/18/2014 Erosion under pipe at WS toe. (W. Wylie - DWR UCIP) FIELD_STRUCT_DESC: 10-inch steel drainage pipe through the levee, 2.8 feet below the crown. Pump in pump house off the landside (LS). (10-inch pipe [HLM 1.80] authorized under Automatic Board Order (ABO) issued as Permit No. 10168, 1974 - Moresco Brothers). [Additional Reference(s): DWR Levee Log, 2003 (HLM 1.80). USACE Sacramento O&M Manual, Unit 109, April 1962, Revised 29 December 2016, (HLM 1.80), listed as 10-inch pipe]. FS Date: 4/12/2022 12:51:06 PM

View of levee crown.

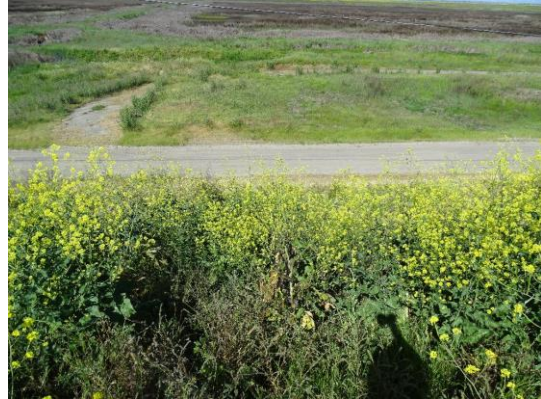
Photo 2 of 3 : UCIP\_SP\_2024\_82369\_111286.jpg

View of LS slope and no sign of pumphouse off toe.

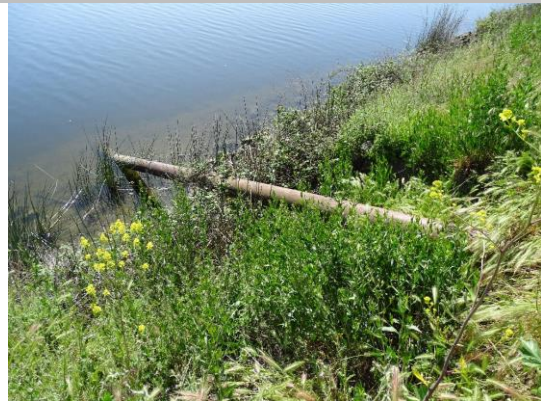
Photo 3 of 3 : UCIP\_SP\_2024\_82369\_111285.jpg

View of pipe out of WS slope with same erosion under pipe.

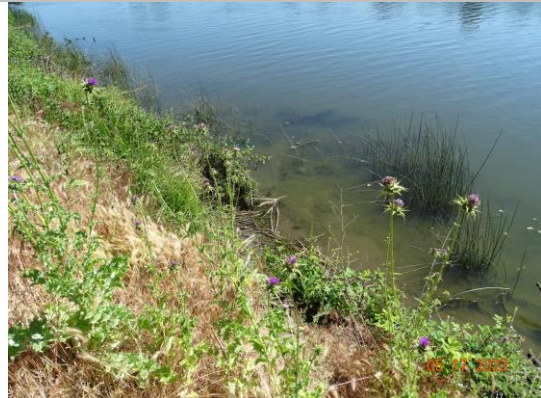
Photo 1 of 1 : SP\_2024\_RD2098\_244\_28\_20240301\_00009.jpg

LM Start	2.35	Rating **	A/W	Issue No.	28
LM End	2.39	Issue Type +	Ma	Location *	WS
Category	Earthen Levee			GPS Latitude/Longitude	
				Start	End
Item	Erosion / Bank Caving			38.295100°	38.294500°
				-121.693400°	-121.693400°
DWR ID	LMA-250				
Comment Code					
E2 : Schedule repair of erosion site prior to the next inspection.					
Inspector Comment					
This was a 2017 Storm Damage site. The damage consists of scour, sloughing, and cracking of the lower and mid waterside levee slope. Site ID No:423 Site Designation:LMA-250 Spring 2023: Rated A/W due to ongoing habitat restoration and flood improvement project.

View of the erosion on the WS slope (Spring 2023).

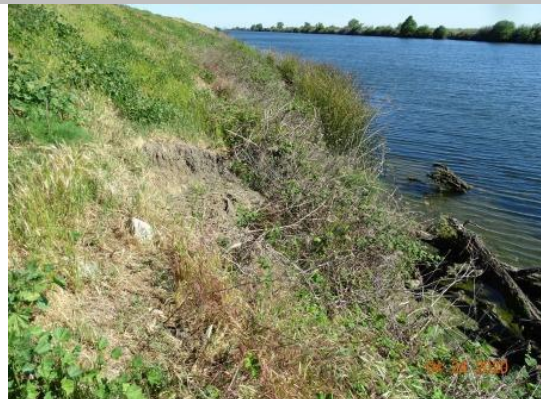
Photo 1 of 1 : SP\_2024\_RD2098\_244\_36\_20240301\_00011.jpg

This was a 2017 Storm Damage site.  
The damage consists of scour and sloughing of the waterside levee slope.  
Site ID No:431  
Site Designation:LMA-258 Spring 2023: Rated A/W due to ongoing habitat restoration and flood improvement project.

View looking upstream at erosion into the waterside slope (Spring 2020).

E2 : Schedule repair of erosion site prior to the next inspection.

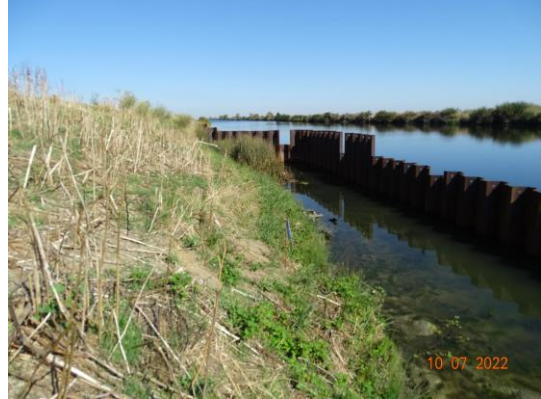
Photo 1 of 1 : SP\_2024\_RD2098\_244\_37\_20240301\_00012.jpg

LM Start	2.99	Rating **	A/W	Issue No.	37
LM End	3.29	Issue Type +	Ma	Location *	WS
Category	Earthen Levee			GPS Latitude/Longitude	
				Start	End
Item	Erosion / Bank Caving			38.285700°	38.281500°
				-121.693500°	-121.694300°
DWR ID	LMA-259				
Comment Code					
E2 : Schedule repair of erosion site prior to the next inspection.					
Inspector Comment					
Fall 2022: Site is pending repair. This was a 2017 Storm Damage site. The damage consists of scour and sloughing of the waterside levee slope.					
Site ID No:432					
Site Designation:LMA-259 Spring 2023: Rated A/W due to ongoing habitat restoration and flood improvement project.

View of the erosion on the WS slope (Fall 2022).

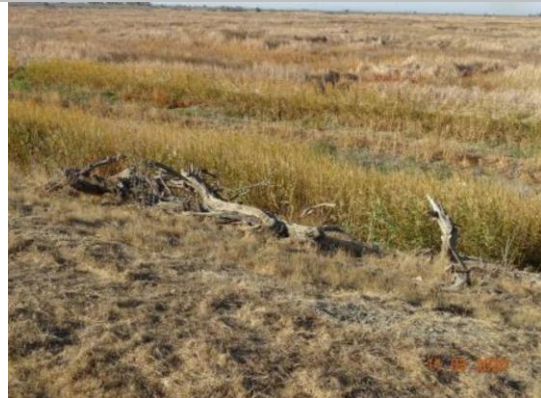
Photo 1 of 1 : SP\_2024\_RD2098\_244\_20\_20240301\_00007.jpg

LM Start	3.13	Rating **	A/W	Issue No.	20
LM End	3.13	Issue Type +	Ma	Location *	LS
Category	Earthen Levee			GPS Latitude/Longitude	
				Start	End
Item	Trim / Thin Trees			38.283800°	38.283800°
				-121.693618°	-121.693618°
DWR ID	DWR_RD2098_01_s_2024_20				
Comment Code					
T2 : Tree or limb.					
Inspector Comment					
Spring 2023: Rated A/W due to ongoing habitat restoration and flood improvement project.

View of tree limb on the landside slope (Fall 2020).

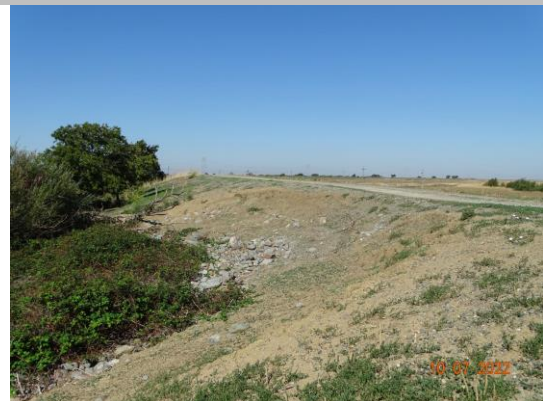
Photo 1 of 1 : SP\_2024\_RD2098\_246\_11\_20240301\_00002.jpg

LM Start	5.88	Rating **	A/W	Issue No.	11
LM End	5.88	Issue Type +	Ma	Location *	WS
Category	Earthen Levee			GPS Latitude/Longitude	
				Start	End
Item	Erosion / Bank Caving			38.282946°	38.282946°
				-121.710902°	-121.710902°
DWR ID	DWR_RD2098_02_f_2020_11				
Comment Code					
E2 : Schedule repair of erosion site prior to the next inspection.					
Inspector Comment					
This waterside slump site is not new, and is somewhat protected by riprap and thick brushy vegetation, but it has the potential to erode into crown during high water with a strong south wind. It currently has a two-foot vertical scarp at the levee shoulder. Spring 2023: Rated A/W due to ongoing habitat restoration and flood improvement project.

View of the erosion on the WS slope (Fall 2022).

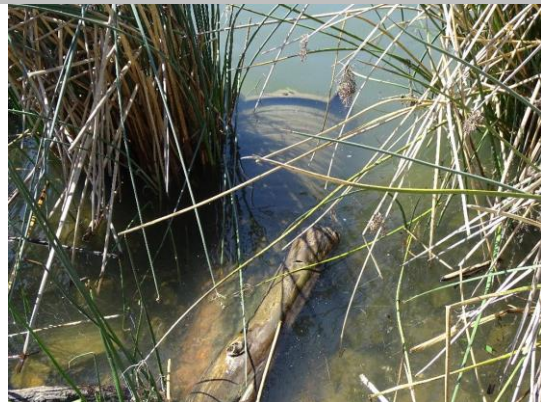
Photo 2 of 3 : UCIP\_SP\_2024\_74580\_111389.jpg

View of pipe with flap gate out of WS toe.

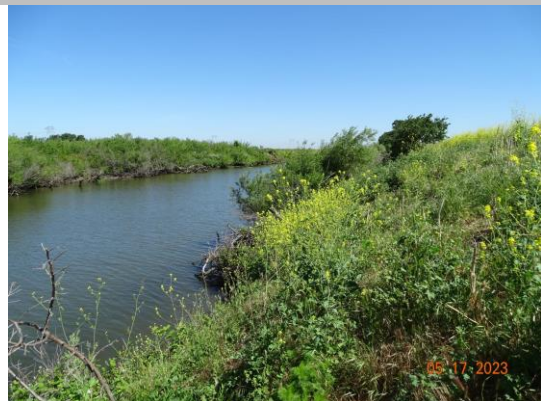
Photo 1 of 1 : SP\_2024\_RD2098\_246\_15\_20240301\_00003.jpg

This was a 2017 Storm Damage site.  
The damage consists of scour of the lower and mid waterside levee slope.  
Site ID No:440 & 441  
Site Designation:LMA-267 & LMA-268 Spring 2023: Rated A/W due to ongoing habitat restoration and flood improvement project.

View of the erosion on the WS (Spring 2023).

E2 : Schedule repair of erosion site prior to the next inspection.

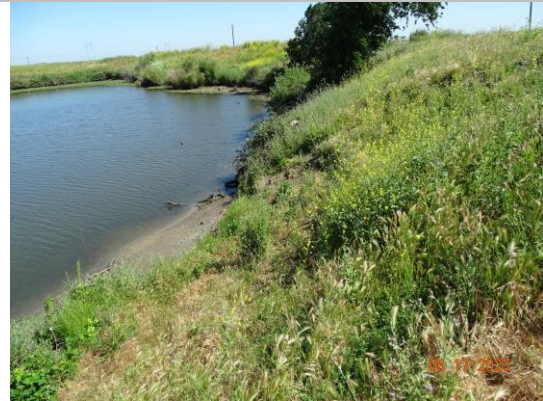
Photo 1 of 1 : SP\_2024\_RD2098\_246\_18\_20240301\_00004.jpg

LM Start	6.64	Rating **	A/W	Issue No.	18
LM End	6.65	Issue Type +	Ma	Location *	WS
Category	Earthen Levee			GPS Latitude/Longitude	
				Start	End
Item	Erosion / Bank Caving			38.291300°	38.291400°
				-121.716100°	-121.716000°
DWR ID	LMA-269				
Comment Code					
E2 : Schedule repair of erosion site prior to the next inspection.					
Inspector Comment					
This was a 2017 Storm Damage site.					
The damage consists of scour, cracking, instability, and sloughing of the waterside levee slope.					
Site ID No:442					
Site Designation:LMA-269 Spring 2023: Rated A/W due to ongoing habitat restoration and flood improvement project.

View of the erosion on the WS (Spring 2023).

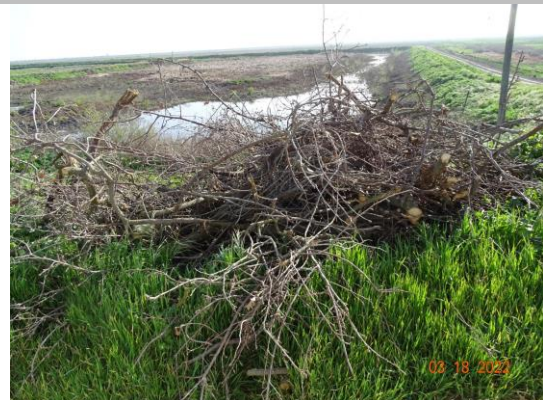
Photo 1 of 1 : SP\_2024\_RD2098\_246\_9\_20240301\_00001.jpg

LM Start	6.68	Rating **	A/W	Issue No.	9
LM End	6.68	Issue Type +	Ma	Location *	LS
Category	Earthen Levee			GPS Latitude/Longitude	
				Start	End
Item	Encroachments			38.291779°	38.291779°
				-121.715727°	-121.715727°
DWR ID	DWR_RD2098_02_s_2022_9				
Comment Code					
PR : Prunings					
Inspector Comment					
Remove tree prunings on the landside shoulder. Spring 2023: Rated A/W due to ongoing habitat restoration and flood improvement project.

View of cut up tree limbs on the landside shoulder (Spring 2022).

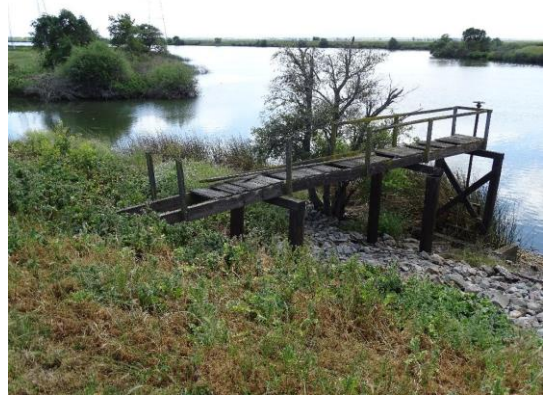
Photo 3 of 3 : UCIP\_SP\_2024\_74588\_111424.jpg

Comment Code					
Inspector Comment					
DS_ID:20977 FS_ID:74588 EP_NO: 10171 Repair Type: Non-Urgent EVAL Issue: Crossing Status: Found UCIP Comments: 04/12/2022 Record remains Non-Urgent. Crossing appears abandoned. System Feature. (D.Sanoski - DWR UCIP) (D.Sanoski - DWR UCIP) 12/22/2016 Met with Mike Hadesty, LMA Superintendent, and Brian Bush, LMA General Manager, to go over the list of pipes in RD2098. Per LMA, pipe is a drainage pipe.(O. Magana - DWR UCIP) 03/18/2014 Pipe appears to be abandoned and if so it should be done so properly. Walkway to gate valve actuator on WS slope is in disrepair and does not appear to be safe for use. (W. Wylie - DWR UCIP) FIELD_STRUCT_DESC: 36-inch corrugated metal drainage pipe through the levee, 23 feet below the crown. Walkway to slide gate on the waterside (WS) end. Slide gate at the landside (LS) toe. (36-inch pipe [HLM 7.23] authorized under Automatic Board Order (ABO) issued as Permit No. 10171, 1974 - Glenn A. Bowsbey). [Additional Reference(s): DWR Levee Log, 2003 (HLM 7.23). USACE Sacramento O&M Manual, Unit 109, April 1962, Revised 29 December 2016, (HLM 7.23), listed as 36-inch pipe]. FS Date: 4/12/2022 12:56:49 PM

View of WS slope and abandoned walkway.

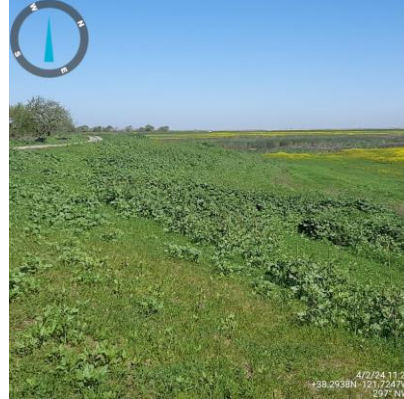
Photo 1 of 1 : SP\_2024\_RD2098\_247\_14\_20240404\_00017.jpg

View of vegetation blocking visibility to LS slope. (Spring 2024)

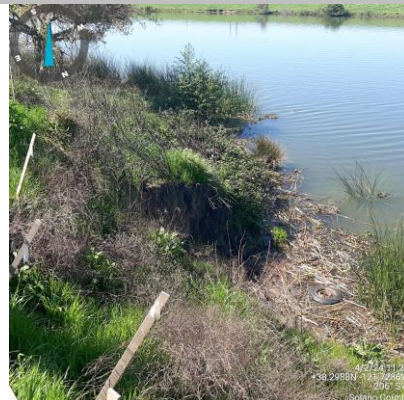
Photo 1 of 1 : SP\_2024\_RD2098\_247\_15\_20240404\_00018.jpg

LM Start	7.67	Rating **	A/W	Issue No.	15
LM End	7.67	Issue Type +	Ma	Location *	WS
Category	Earthen Levee			GPS Latitude/Longitude	
				Start	End
Item	Erosion / Bank Caving			38.298779°	38.298779°
				-121.728582°	-121.728582°
DWR ID	DWR_RD2098_03_s_2024_15				
Comment Code					
E1 : Note and monitor erosion site.					
Inspector Comment					
Bank caving observed at location that appears to be an old erosion site.

View of erosion on the WS slope. (Spring 2024)

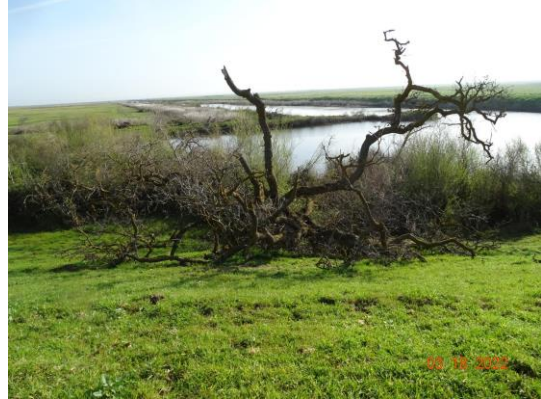
Photo 1 of 1 : SP\_2024\_RD2098\_247\_12\_20240301\_00006.jpg

View of downed tree on the landside slope (Spring 2022).

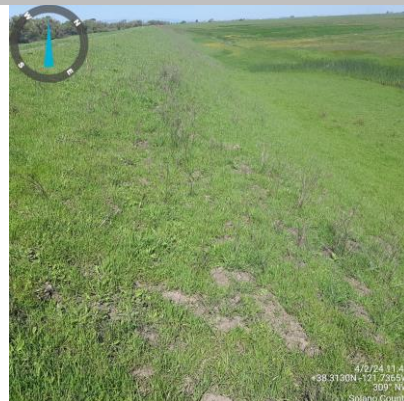
Photo 1 of 1 : SP\_2024\_RD2098\_247\_4\_20240404\_00019.jpg

View of slope terracing caused by cattle on the landside slope (Spring 2024).

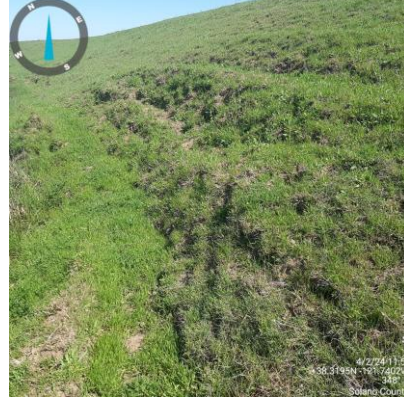
Photo 1 of 1 : SP\_2024\_RD2098\_248\_11\_20240404\_00020.jpg

View of terracing due to cows on the waterside slope (Spring 2024).

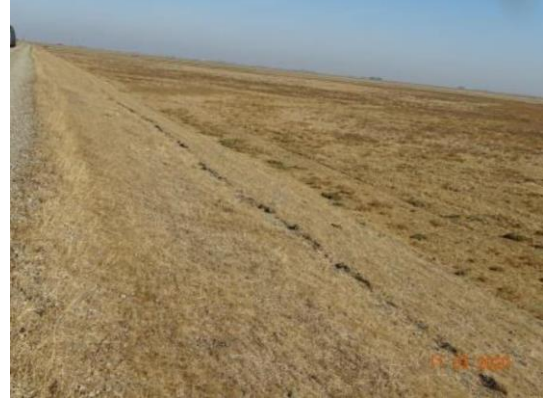
Photo 1 of 1 : SP\_2024\_RD2098\_248\_10\_20240301\_00004.jpg

View looking upstream at depressions in the landside slope due to cows (Fall 2020).

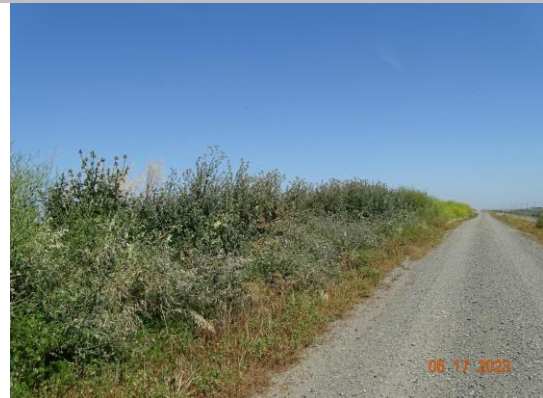
Photo 1 of 1 : SP\_2024\_RD2098\_248\_8\_20240301\_00003.jpg

View of the overgrown dredge material on the WS shoulder (Spring 2023).

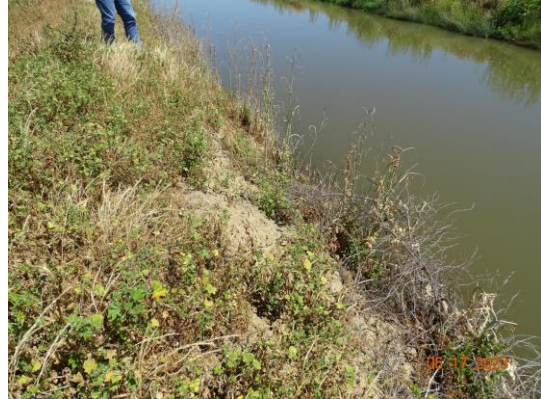
Photo 1 of 1 : SP\_2024\_RD2098\_248\_15\_20240301\_00007.jpg

View of the erosion on the LS (Spring 2023).

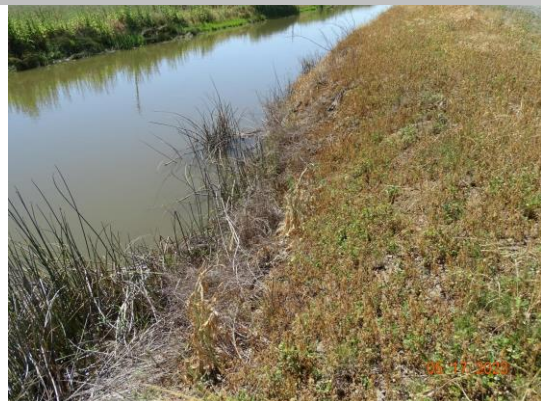
Photo 1 of 1 : SP\_2024\_RD2098\_248\_14\_20240301\_00006.jpg

View of the erosion on the LS (Spring 2023).
